== USS ESTOCIN (FFG-15) ==
SEMAT SHELL CONDITION ASSESSMENT
SURVEY
INTERIOR AREAS

PREPARED BY
SUPERVISOR OF SHIPBUILDING CONVERSION
AND
REPAIR
PORTSMOUTH, VIRGINIA
3/13/02 TO 3/22/02

SHELL CONDITION ASSESSMENT SURVEY INTERIOR AREAS TABLE OF CONTENTS

A SEMAT UNDERWATER HULL AND SUPPORTING STRUCTURE SURVEY OF INTERIOR AREAS WAS CONDUCTED ON BOARD **USS ESTOCIN (FFG-15)** FROM 03/13/02 TO 03/22/02 AT NAVAL STATION MAYPORT, JACKSONVILLE FLORIDA.

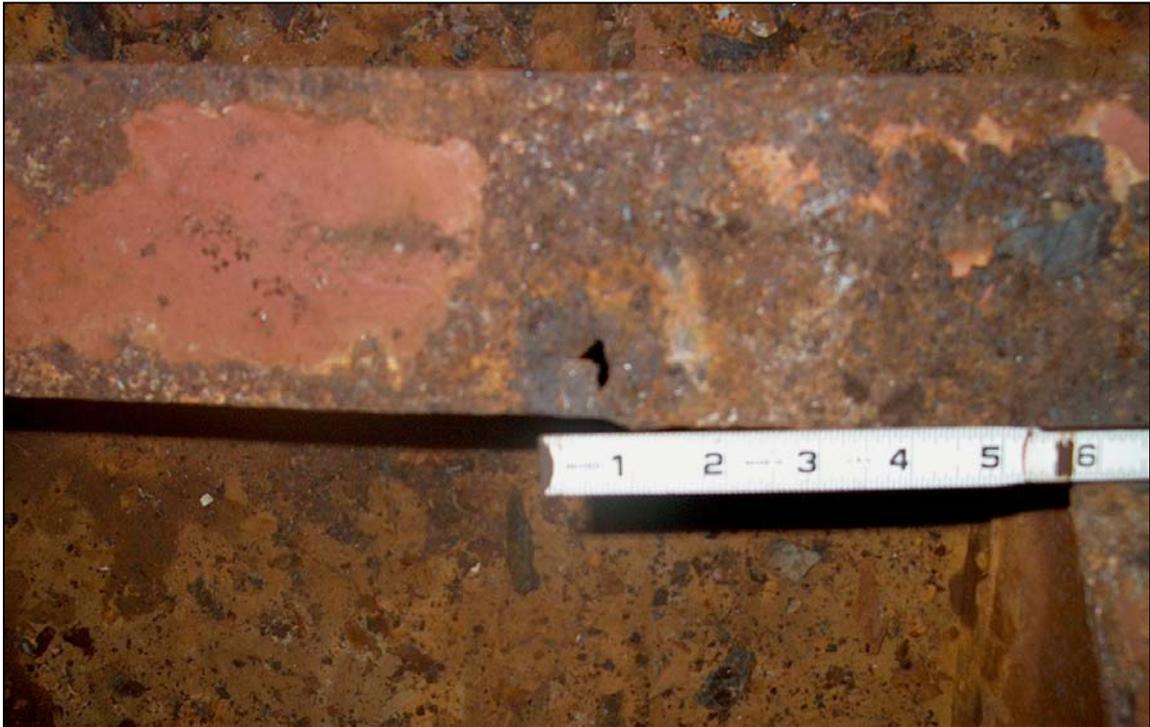
STBD SIDE EDUCTOR SPACE AT BHD (368)

| CSMP SUMMARY: 1 ST AND 2 ND STRINGERS ARE DETERIORATED. | | | | | | | TEST# MRC 1102/1 | | |

HOLE IN FLANGE OF 2ND STRINGER OUTBOARD OF SWASH BULKHEAD

| RECOMMENDED REPAIRS: RECOMMEND REPAIR ACTIVITY CUT OUT AND REPLACE APPROXIMATELY 8 LF OF 1 ST AND 2 ND STRINGERS 16' TOTAL, REPLACE WITH (8 X 4 X 10# T-BEAM). RECOMMEND REPAIRS BE CONDUCTED DURING DRYDOCK AVAILABILITY. | | | | | | | | | |

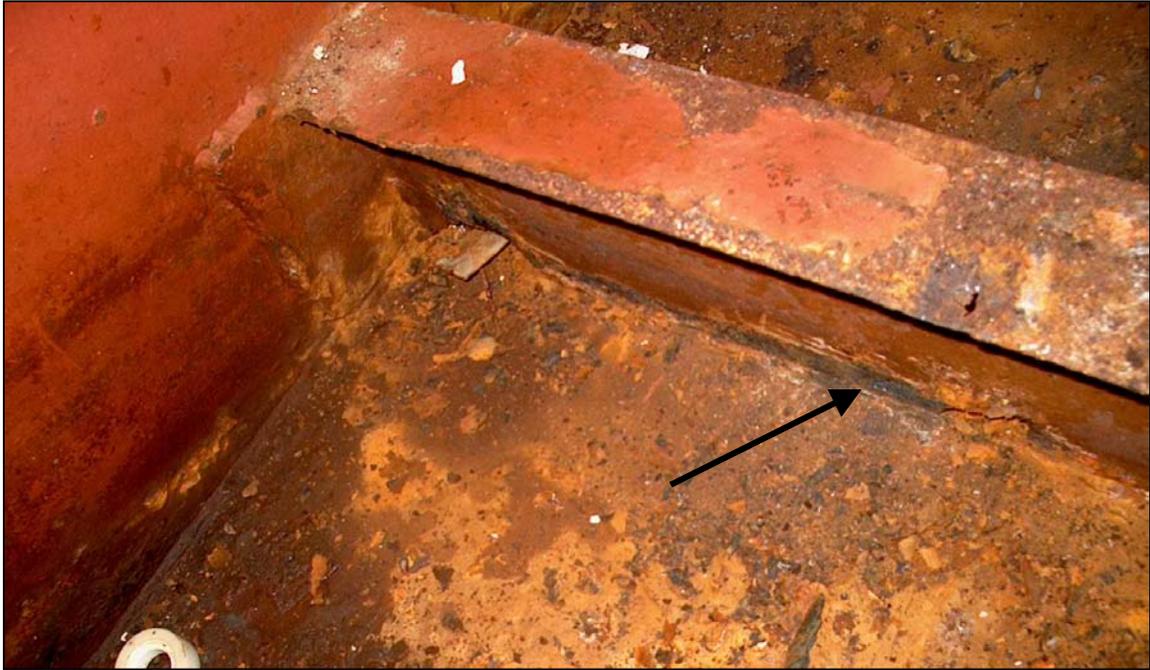
ARROW INDICATES WASHOUT OF WELD ON 2ND STRINGER OUTBOARD OF SWASH BULKHEAD.

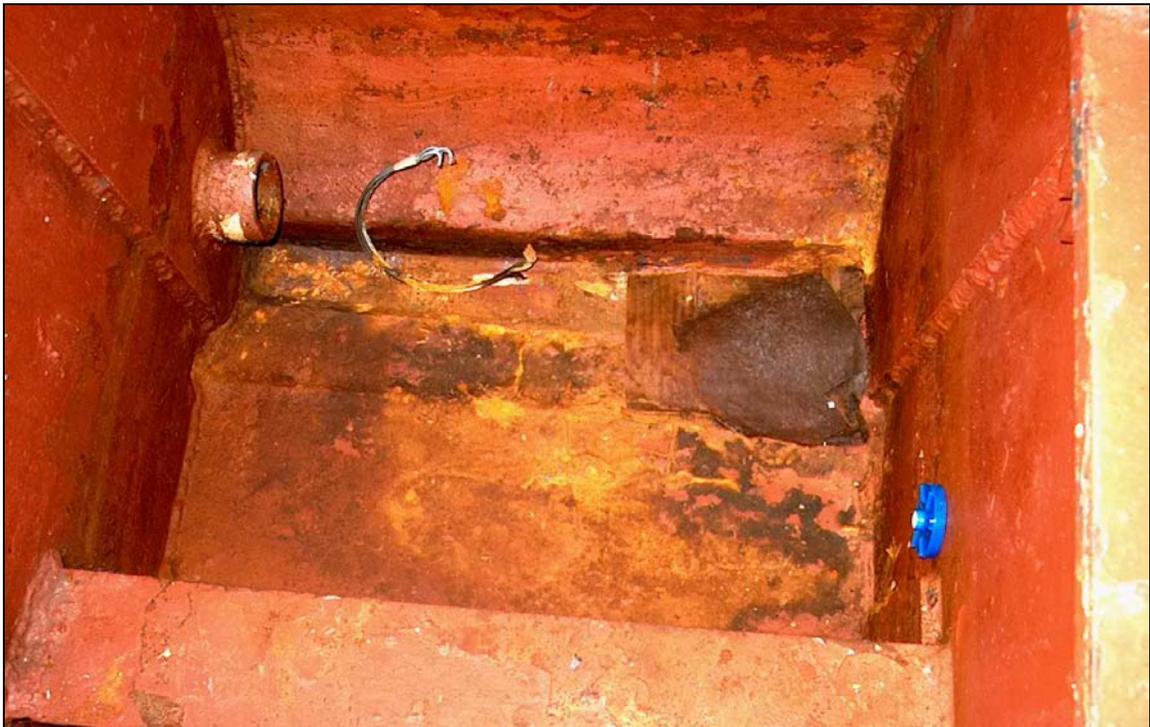
CORROSION ON SHELL AFT OF WEB FRAME (376)

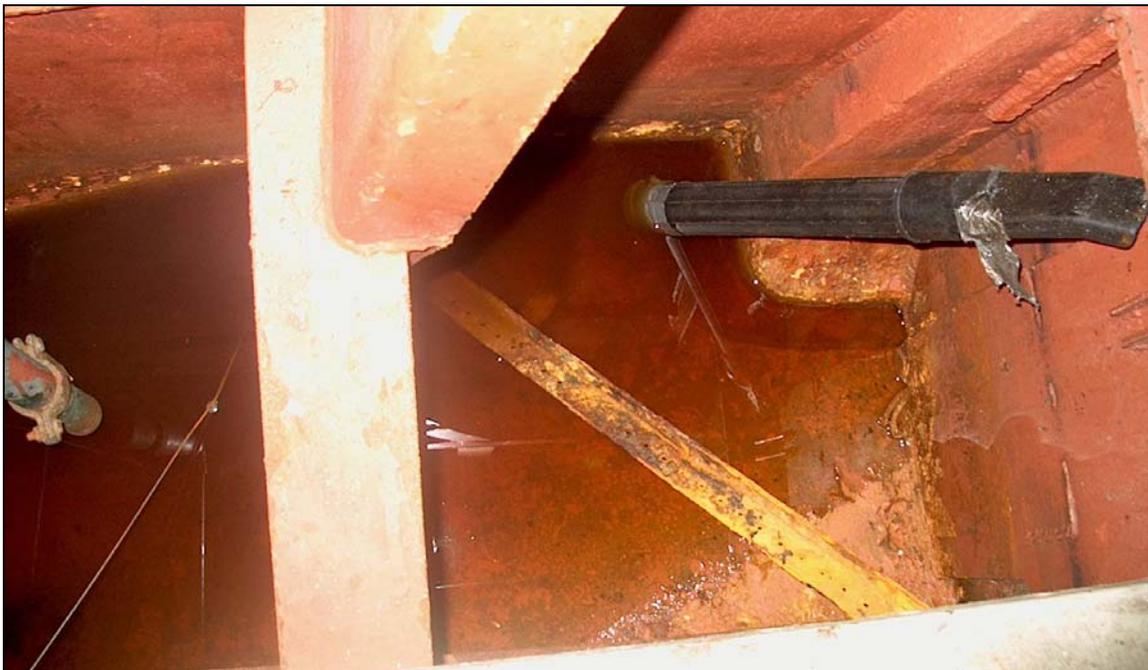
PORT SIDE EDUCTOR SPACE AT BULKHEAD (368)

| DISCREPANCY DESCRIPTION: PER SEMAT II UNDERWATER HULL ASSESSMENT: STEERING GEAR ROOM (5-368-01-E), PORT AND STARBOARD EDUCTOR SPACES HAVE APPROXIMATELY 140 SF OF HEAVY PAINT SEPARATION AND RUST. | | | | | | | |

STANDING WATER, HEAVY PAINT SEPARATION AND CORROSION ON SHELL AND FRAMES
AFT OF BHD (368).

| RECOMMENDED REPAIRS: RECOMMEND SHIPS FORCE POWER CLEAN APPROXIMATELY 140 SF OF AREA, PRIME AND PAINT USING EURO-NAVY COATING. | | | | | | | |

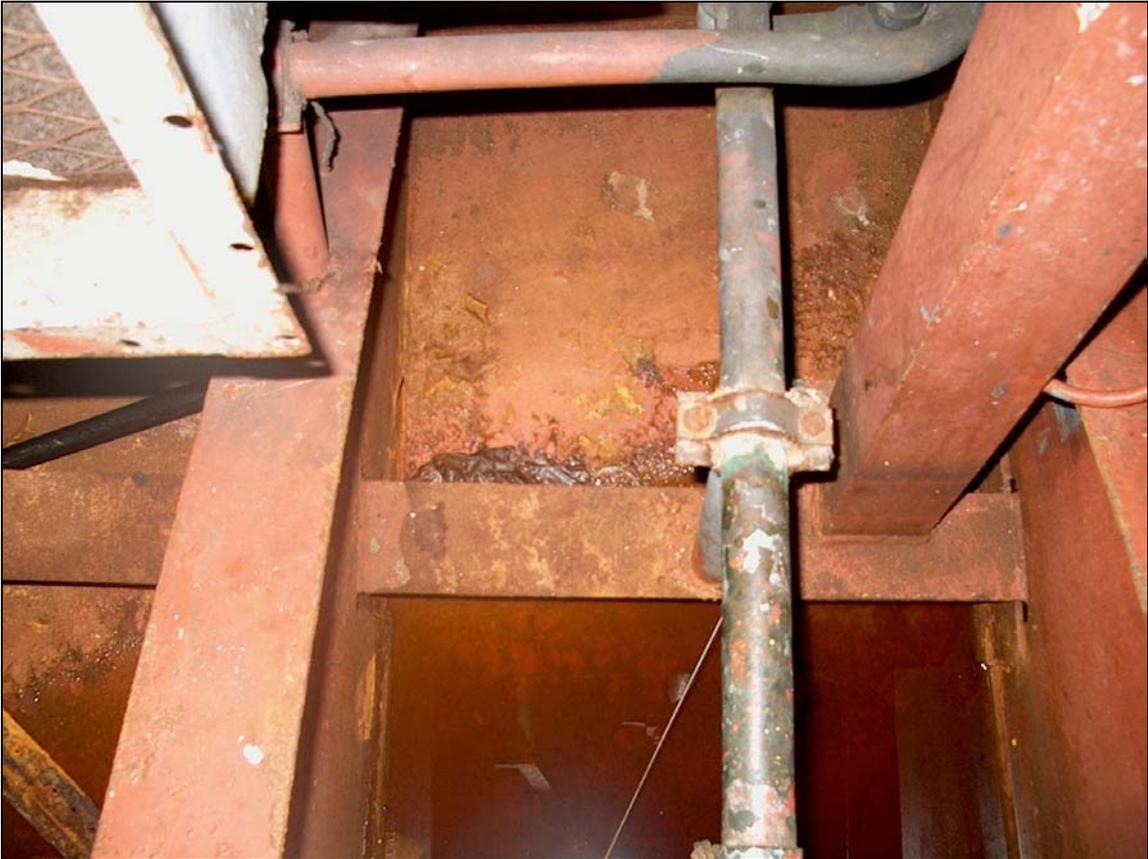
CORROSION AND WATER UNDER FAN COIL UNIT.

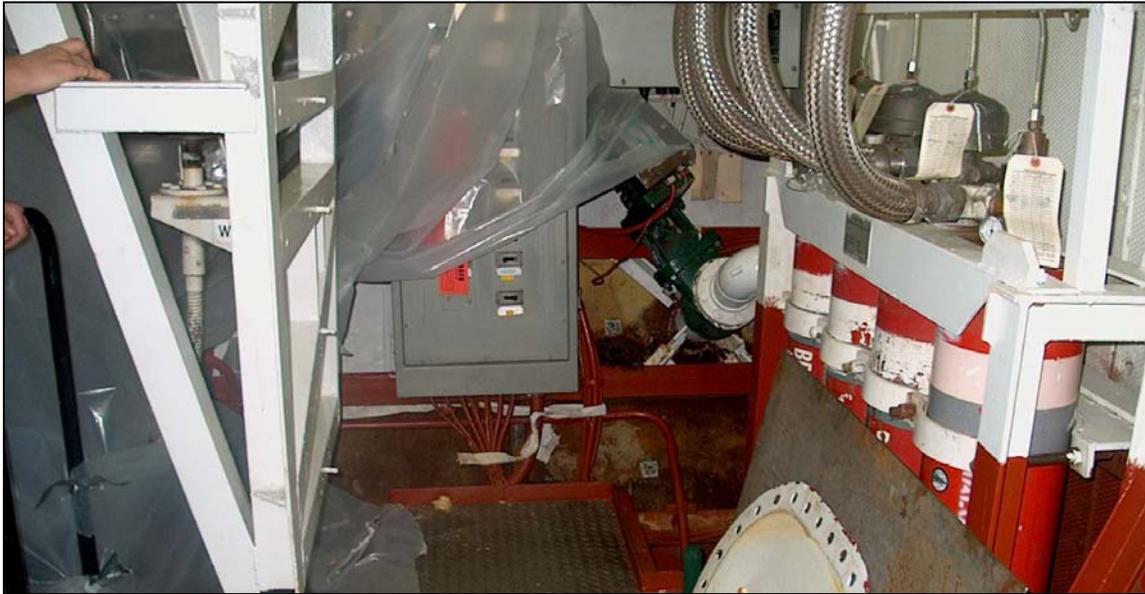
| 6 X 4 STRINGER AT DECK LEVEL UNDER POWER PANEL. (3-319-2) IS SEVERELY DETERIORATED. THE SHELL IS THINNING IN SEVERAL PLACES ALONG THIS STRINGER AND THE ONE ABOVE. WEB FRAME (316) IS HOLED IN SEVERAL PLACES. THE HULL INSULATION IS TRAPPING WATER AND HIDING CORROSION. | | | | | | |

DETERIORATED STRINGER, THINNING HULL AND HOLES IN WEB FRAME (316) ARE LOCATED BELOW POWER PANEL AND TLI

| RECOMMEND REPAIR ACTIVITY REMOVE HULL INSULATION FROM DECK LEVEL UP APPROXIMATELY 5', FROM WEB FRAME (316) TO BHD (328). CUT OUT APPROXIMATELY 60 SF OF HULL FROM WELD SEAM ABOVE (7 X 6 T-BEAM) TO STRINGER ABOVE OVBD DISCHARGE FROM WEB FRAME (316) TO BHD (328), REPLACE WITH .313 OS. CUT OUT AND REPLACE APPROX 10' OF (6 X 4 T-BEAM). CUT OUT AND REPLACE LOWER 10" OF FRAME (316) FROM SIDE OF TANK (5-308-2-W) TO STRINGER BELOW OVBD DISCHARGE, REPLACE WITH .250 OS. PRIME AND PAINT, REPLACEMENT OF INSULATION IS NOT RECOMMENDED | | | | | | |

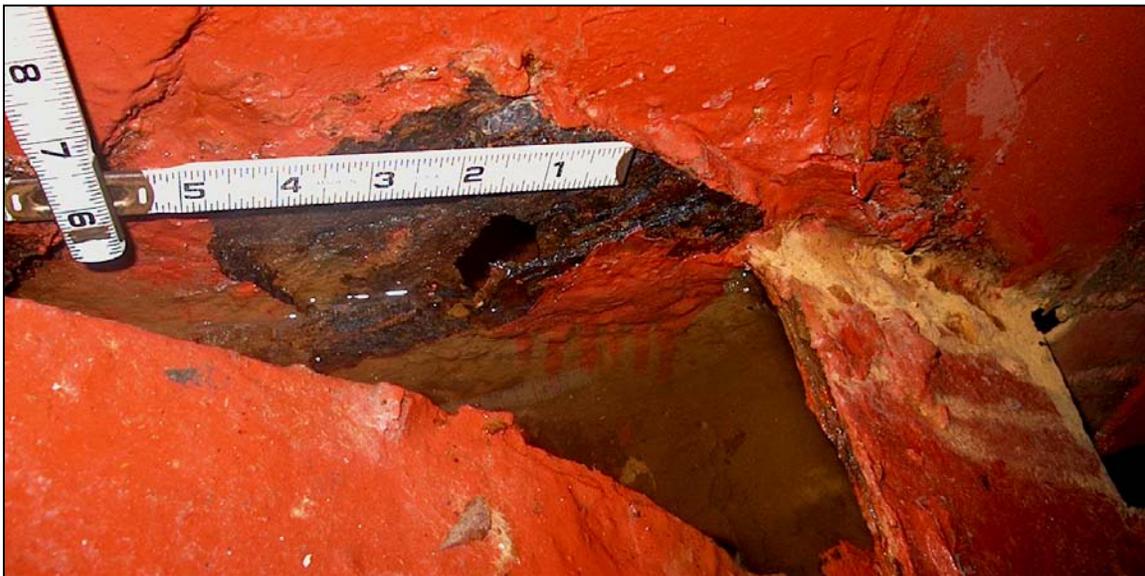
HOLE IN WEB FRAME (316), AFT SIDE OF NO. 4 SSDG ENCLOSURE

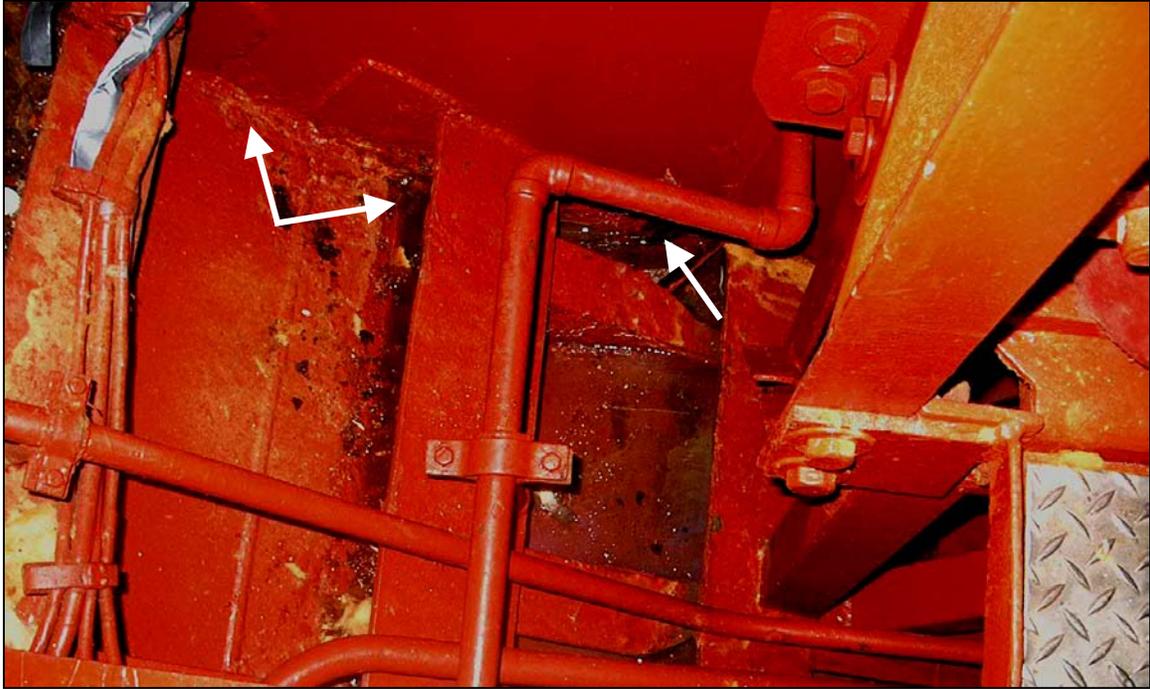
ARROWS INDICATE SEVERAL HOLES IN WEB FRAME (316)

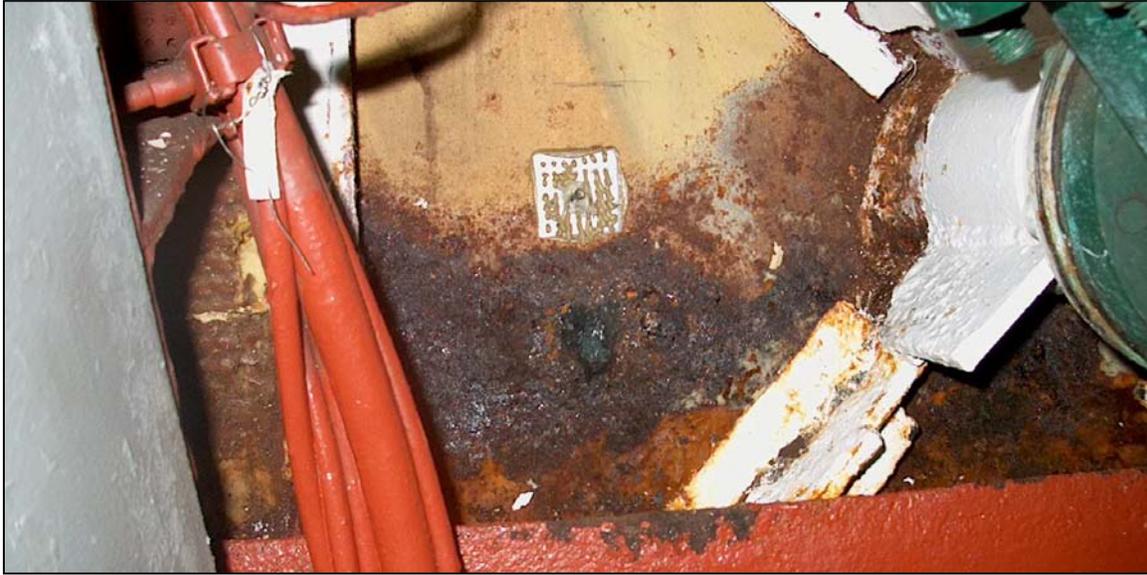
CORROSION ON SHELL HIDDEN BY HULL INSULATION.

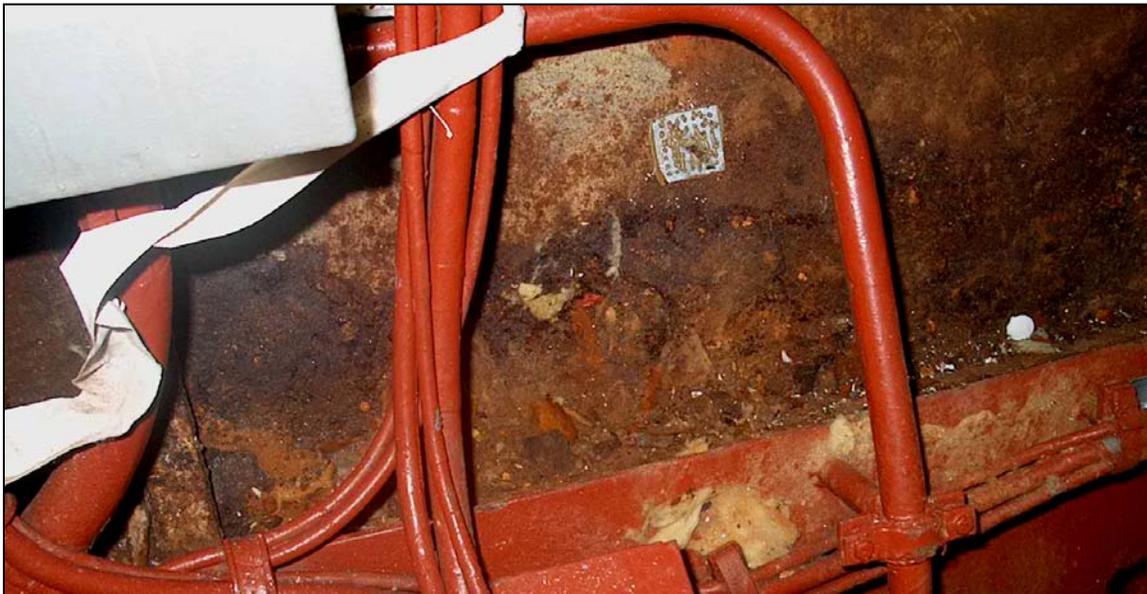
CORROSION ON SHELL BELOW OVBD DISCHARGE. REMOVAL OF INSULATION FROM DECK LEVEL TO BOTTOM OF TLI AND FROM WEB FRAME (316) TO BHD (328) IS HIGHLY RECOMMENDED

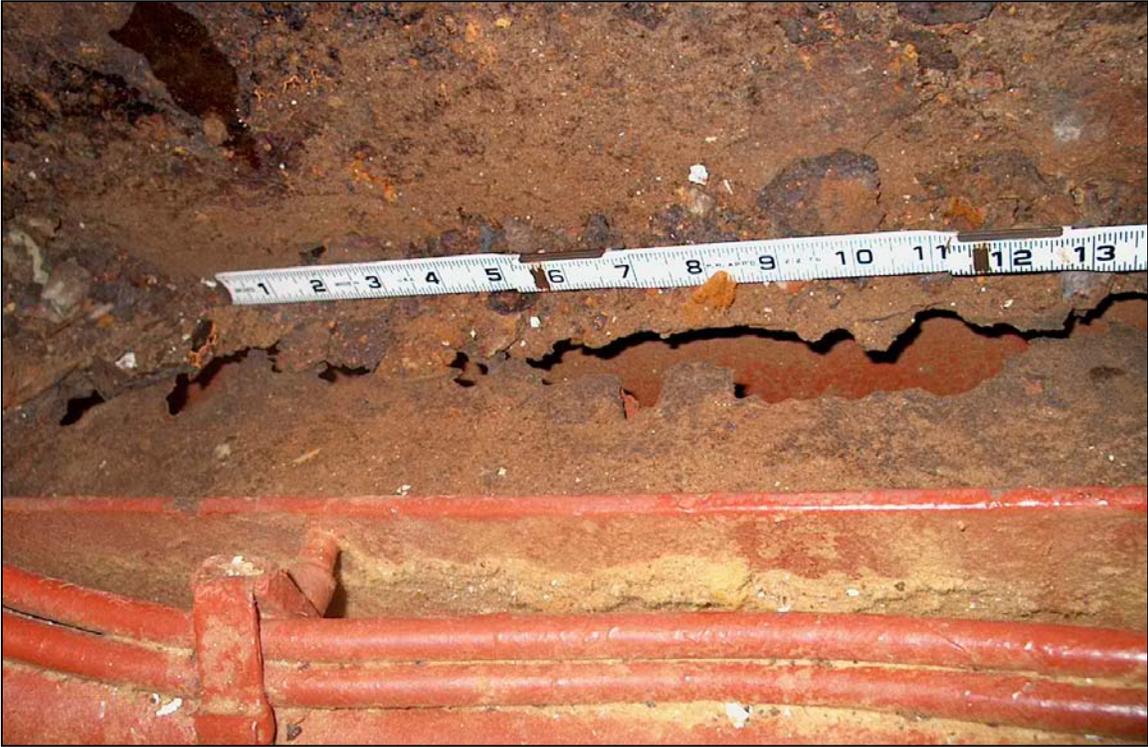
WEB OF (6 X 4 T-BEAM) AT DECK LEVEL BELOW POWER PANEL (3-319-2).
LOW U/T READINGS ON THE SHELL WERE REVEALED AT THE WELD JUNCTION.
REFER TO DRAWING FOR U/T READINGS OF AREA.

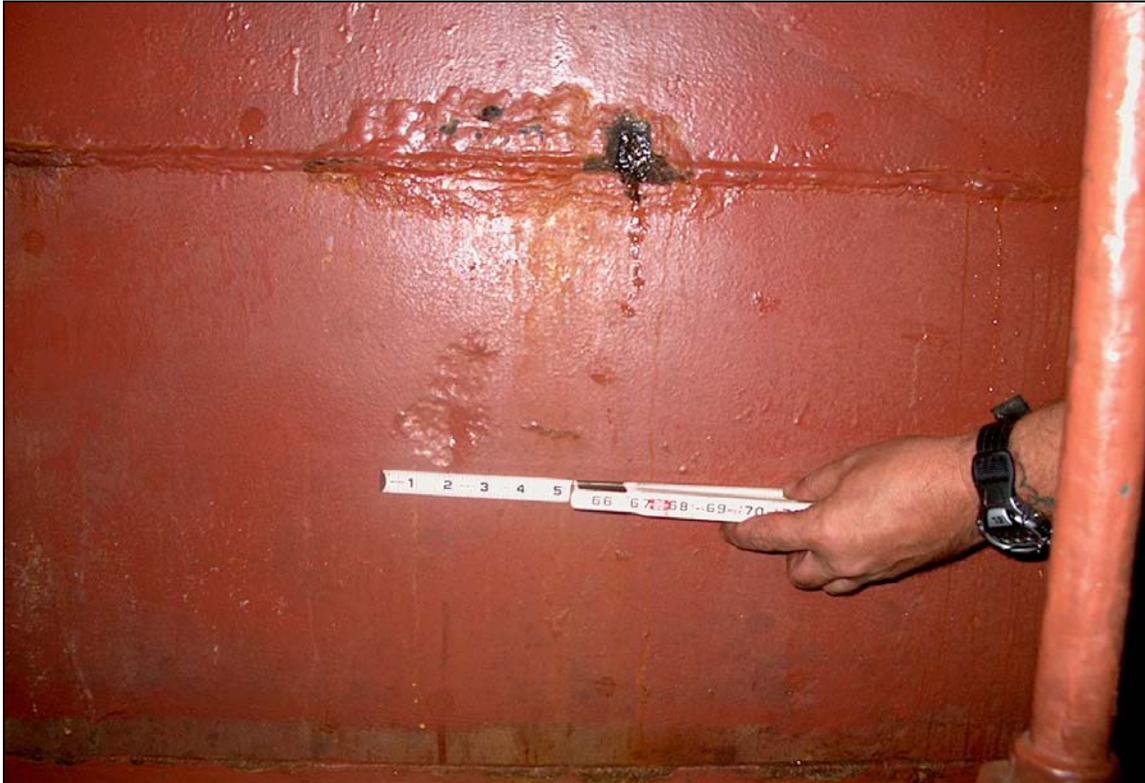
| POTABLE WATER TANK (5-292-3-W) LOCATED APPROXIMATELY 6 FT OUTBOARD OF CENTER LINE. THE INBOARD SIDE AND AFTER END REVEALED SPOTS OF HEAVY CORROSION AND LOW U/T READINGS. TRANSVERSE WEB FRAME (306) IS HOLED APPROXIMATELY 2" INBOARD OF TANK SIDE. | | | | | | | | | |

HEAVY PITTING ON INBOARD SIDE OF POTABLE WATER TANK (5-292-3-W)
NOTE CORROSION AT WELD SEAM. U/T READING OF PIT WAS .136 THE MINIMUM FOR .250
STEEL IS .187.

| RECOMMENDED REPAIRS: RECOMMEND REPAIR ACTIVITY CUT OUT AND REPLACE THE ENTIRE INBOARD SIDE AND AFT END OF TANK. APPROXIMATELY 70 SF OF .250 MILD STEEL. IN CONJUNCTION WITH REPAIRS TO TANK CUT OUT AND REPLACE APPROXIMATELY 1 SF OF THE WEB OF FRAME (306) WITH .250 OS. PRIME AND PAINT. | | | | | | | | | |

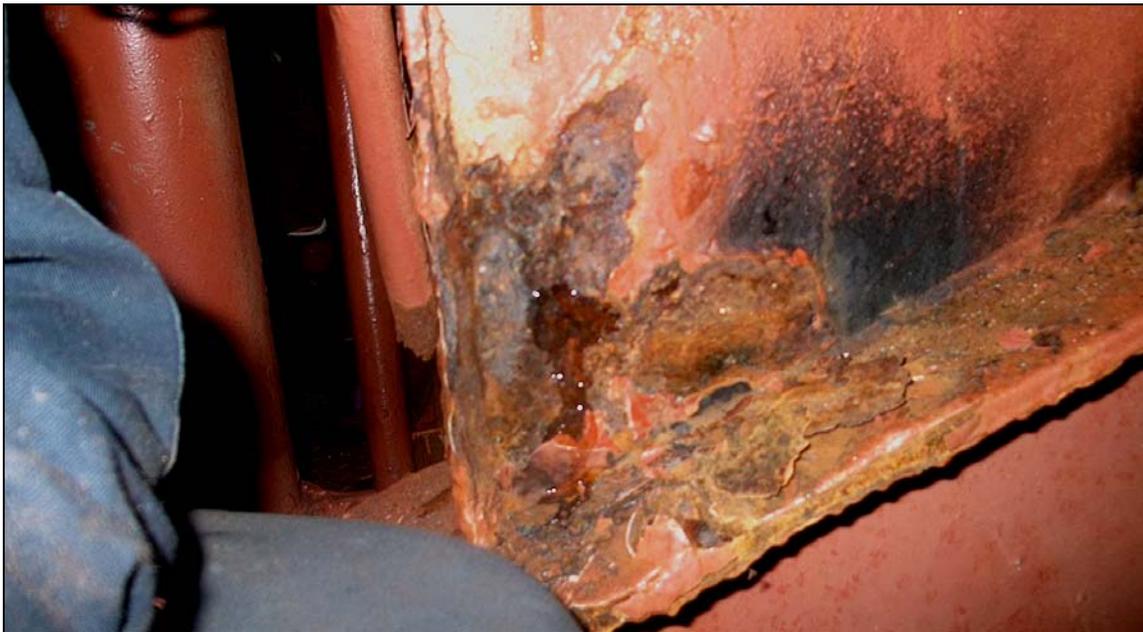
INBOARD AFTER CORNER OF POTABLE WATER TANK (5-292-3-W) REVEALED LOW U/T
READINGS

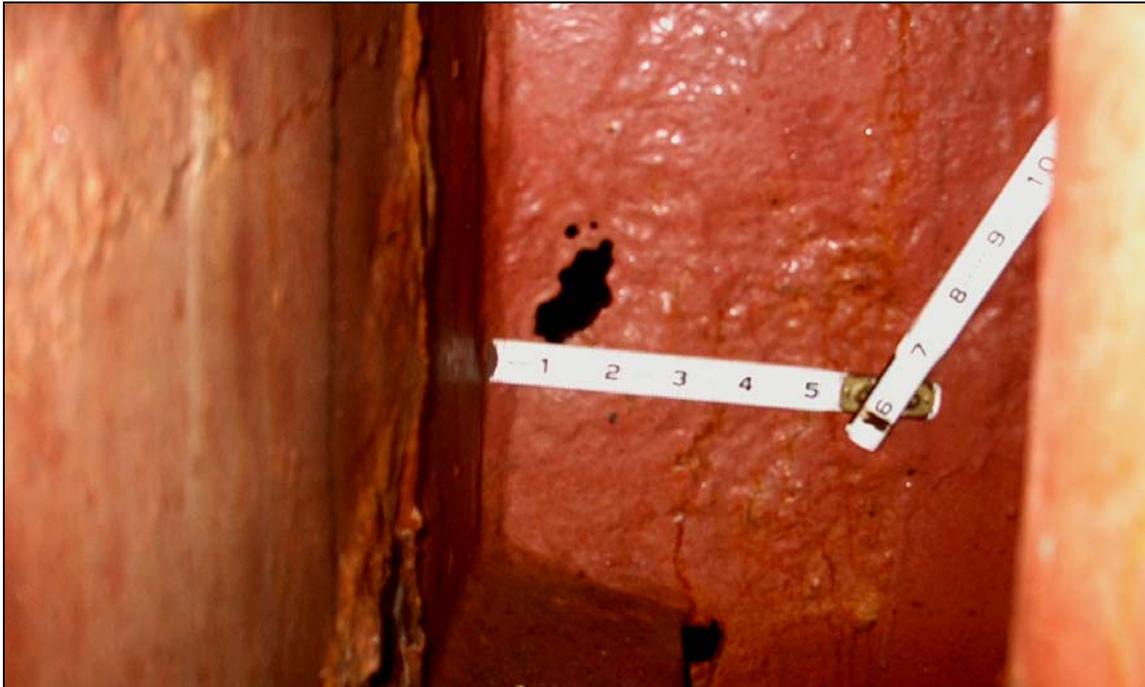
HOLE IN WEB OF FRAME (306) LOOKING AFT APPROXIMATELY 2" INBOARD OF POTABLE WATER TANK (5-292-3-W)

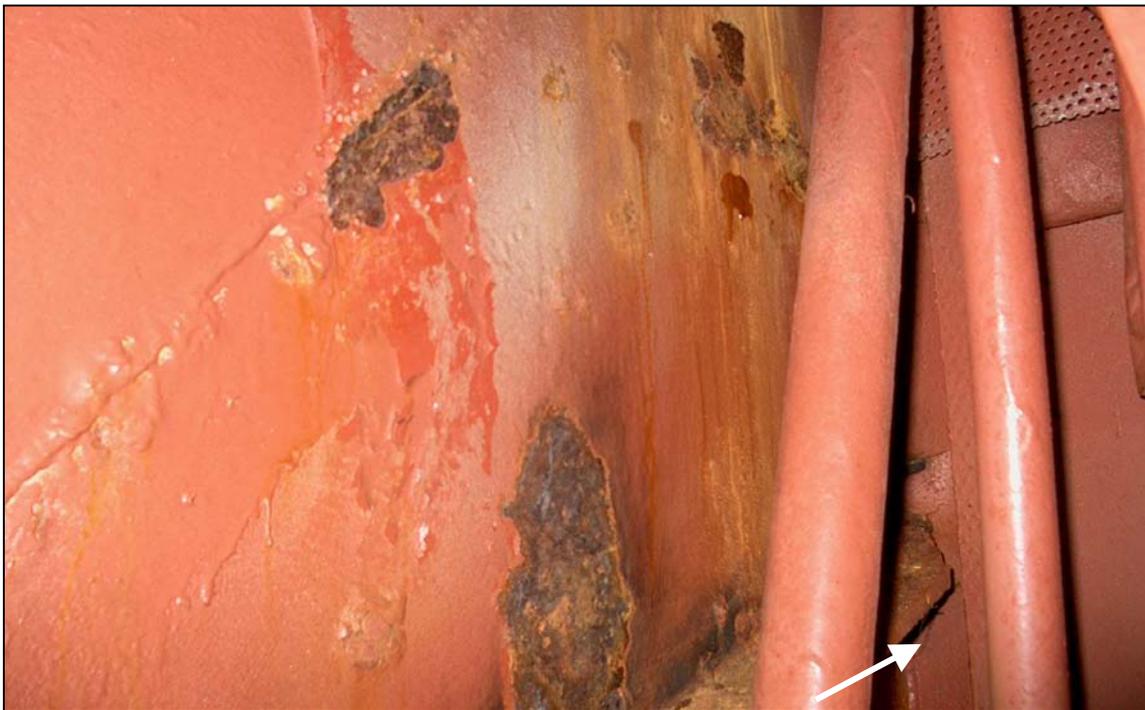
CORROSION ON AFTER END OF POTABLE WATER TANK (5-292-3-W). ARROW INDICATES TRANSVERSE WEB FRAME (306).

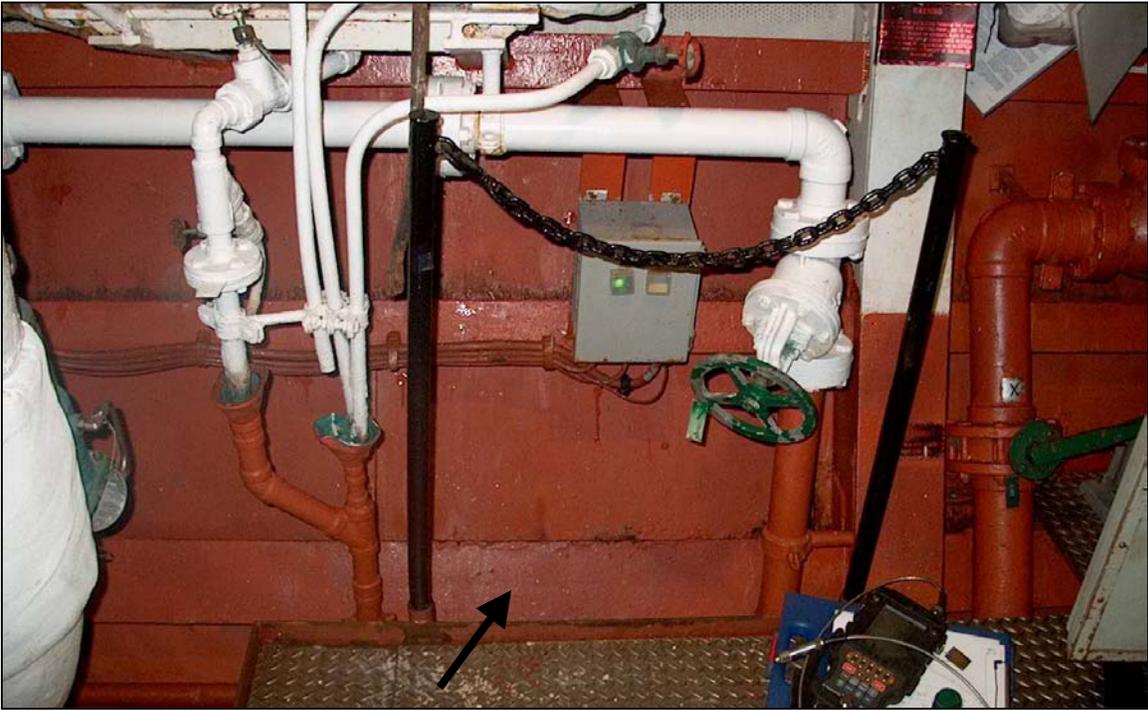
BETWEEN FRAMES (264) AND (270), ARROW INDICATES 7 X 6 T-BEAM. THINNING OF THE HULL WAS DETECTED AT THE WELD CONNECTION WITH A LOW READING OF .215 AT WEB FRAME (264). WATER TRAPPED IN THE STRINGERS AND A POOR PAINT APPLICATION ARE THE MAIN CAUSE. REFER TO DRAWING FOR U/T READINGS.

| RECOMMENDED REPAIRS: RECOMMEND REPAIR ACTIVITY, CLAD WELD THINNING AREAS ON SHELL PORT AND STARBOARD AND REPAIR TRANSVERSE WELD SEAM PORT SIDE, PRIME AND PAINT. | | | | | | | | | |

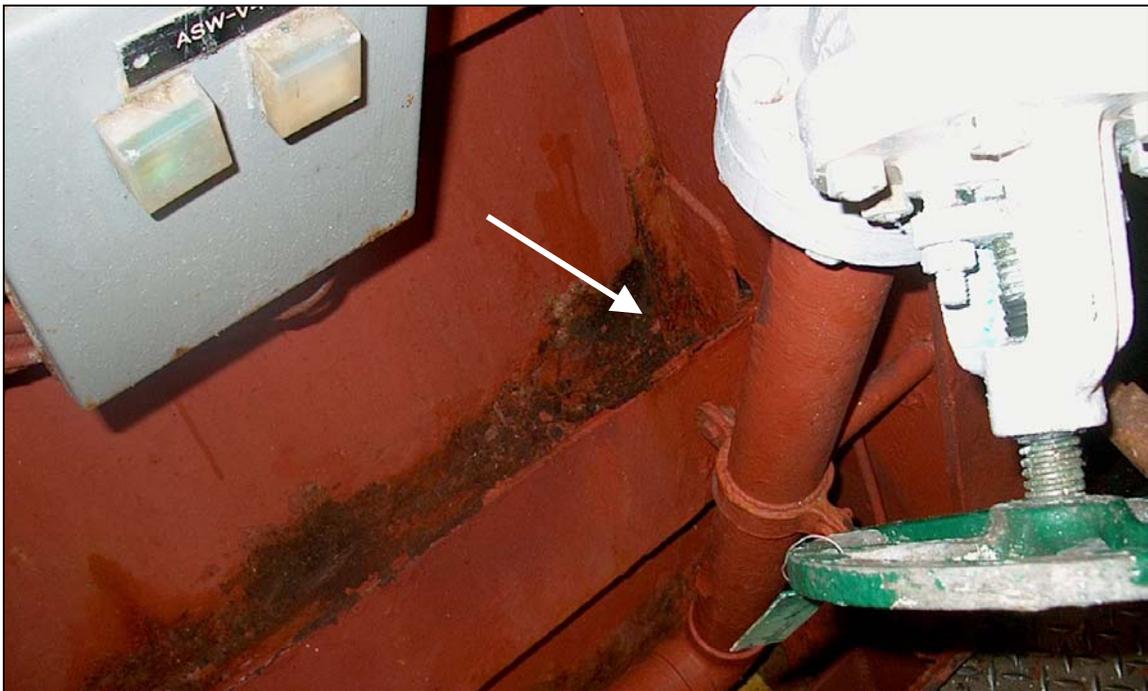
ARROW INDICATES LOCATION OF LOW U/T READING.

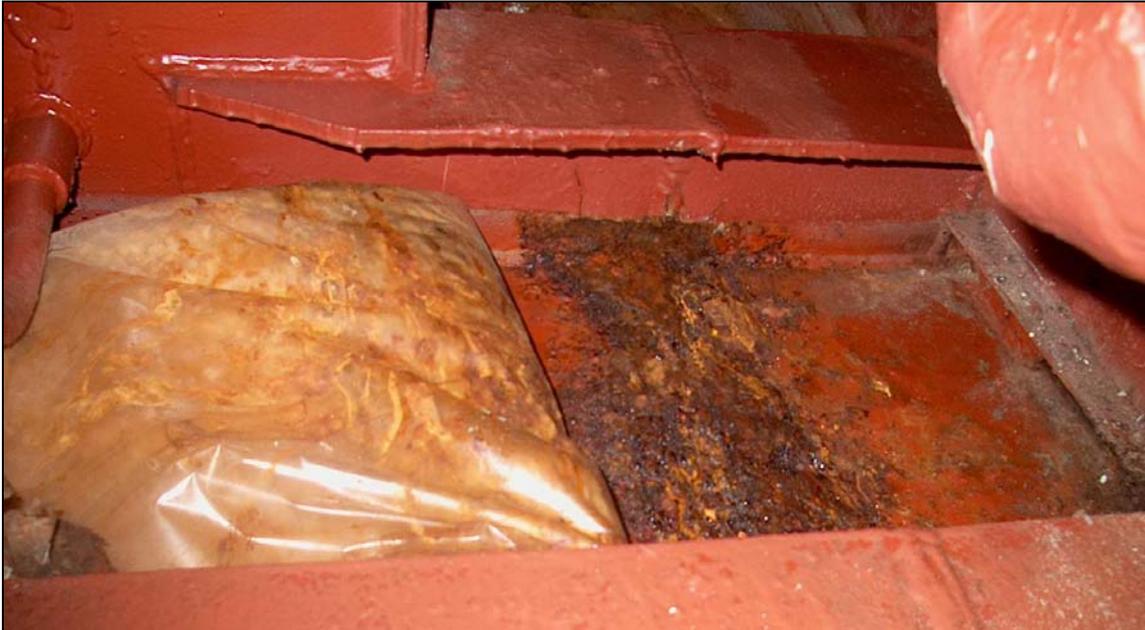
CORROSION ON SHELL PLATE AT TRANSVERSE WELD SEAM APPROXIMATELY 1 FT AFT OF WEB FRAME (270). THIS CORROSION WAS HIDDEN BY HULL INSULATION. MINOR THINNING OF THE HULL WAS NOTED. THE WELD PROFILE IN SEVERAL AREAS IS ALMOST FLUSH WITH SHELL PLATE. REMOVAL OF HULL INSULATION TO APPROXIMATELY 4 FT ABOVE THE DECK LEVEL IS RECOMMENDED.

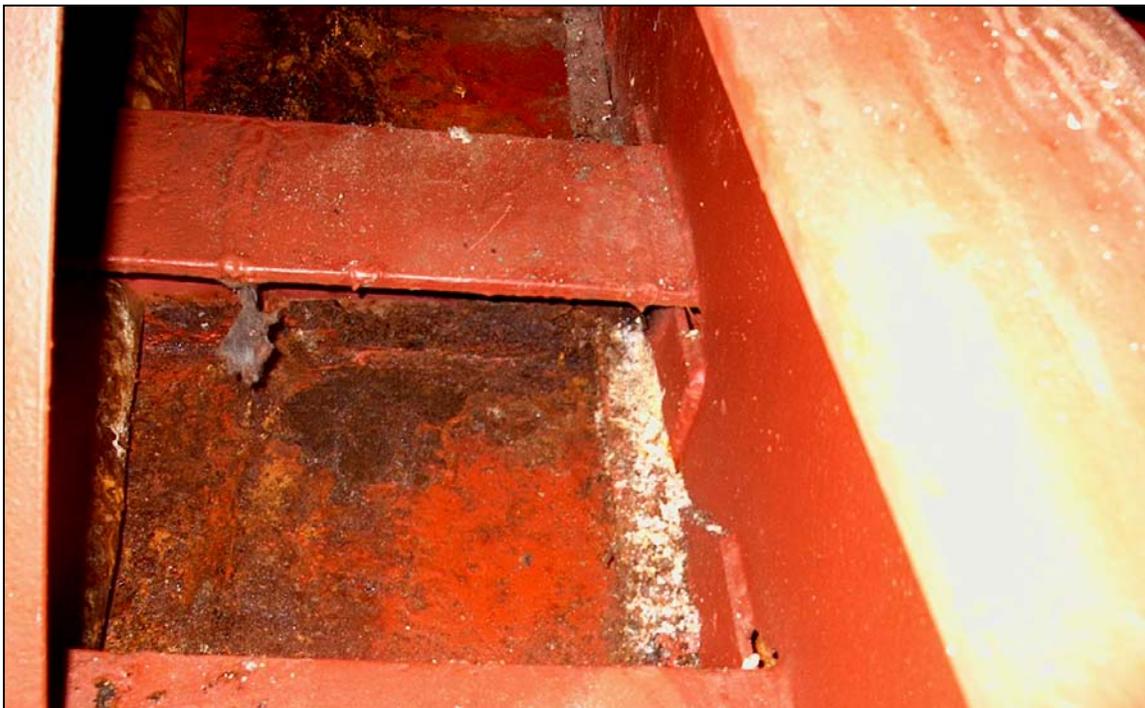
BETWEEN FRAMES (264-270) ARROW INDICATES LOCATION OF LOW U/T READINGS.

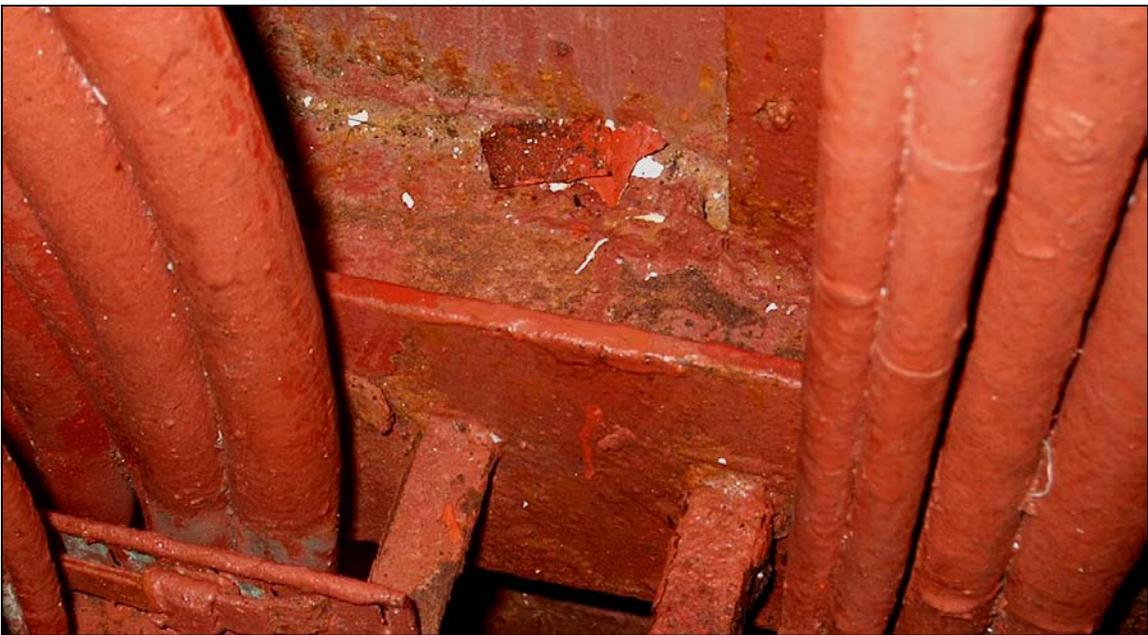
HEAVY PAINT SEPARATION AND CORROSION. FIRST STRINGER UP FROM DECK LEVEL.

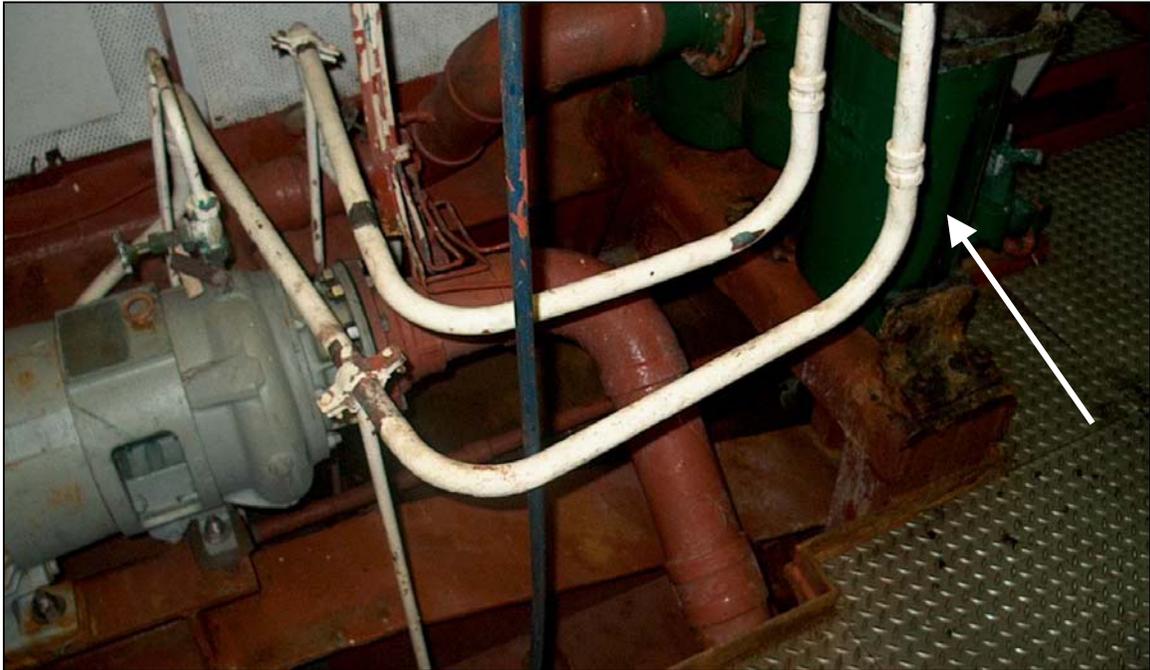
| PORT AND STARBOARD SIDES, LOWER LEVEL BETWEEN FRAMES (228-236) BELOW SW STRAINERS APPROXIMATELY 120 SF OF PAINT FAILURE AND MILD CORROSION. | | | | | | |

ARROW INDICATES NO. 3 SSDG SW STRAINER. APPROXIMATELY 60 SF OF PAINT SEPARATION AND MILD SURFACE RUST IS LOCATED BETWEEN FRAMES (228-236). FOUNDATION FOR SW STRAINER HAS HEAVY RUST AND PAINT SCALING.

| RECOMMENDED REPAIRS: RECOMMEND SHIPS FORCE POWER CLEAN AREA TO BARE METAL, PRIME AND PAINT USING EURO-NAVY COATING. | | | | | | |

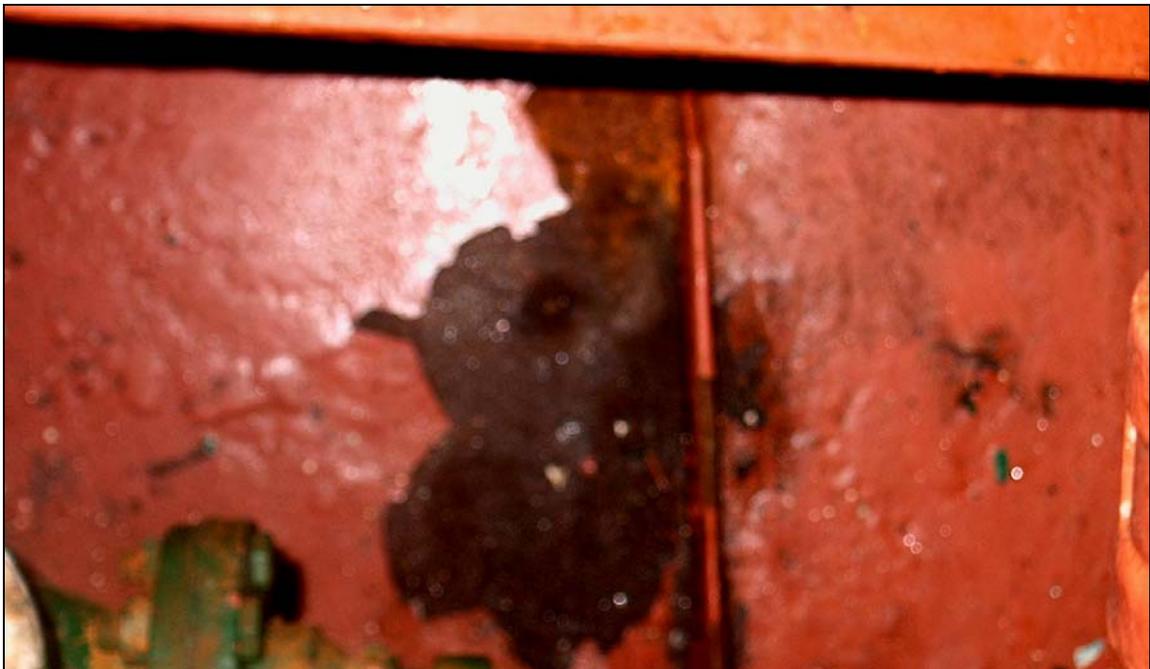
SHELL PLATE INBOARD OF NO. 3 SSDG ENCLOSURE.

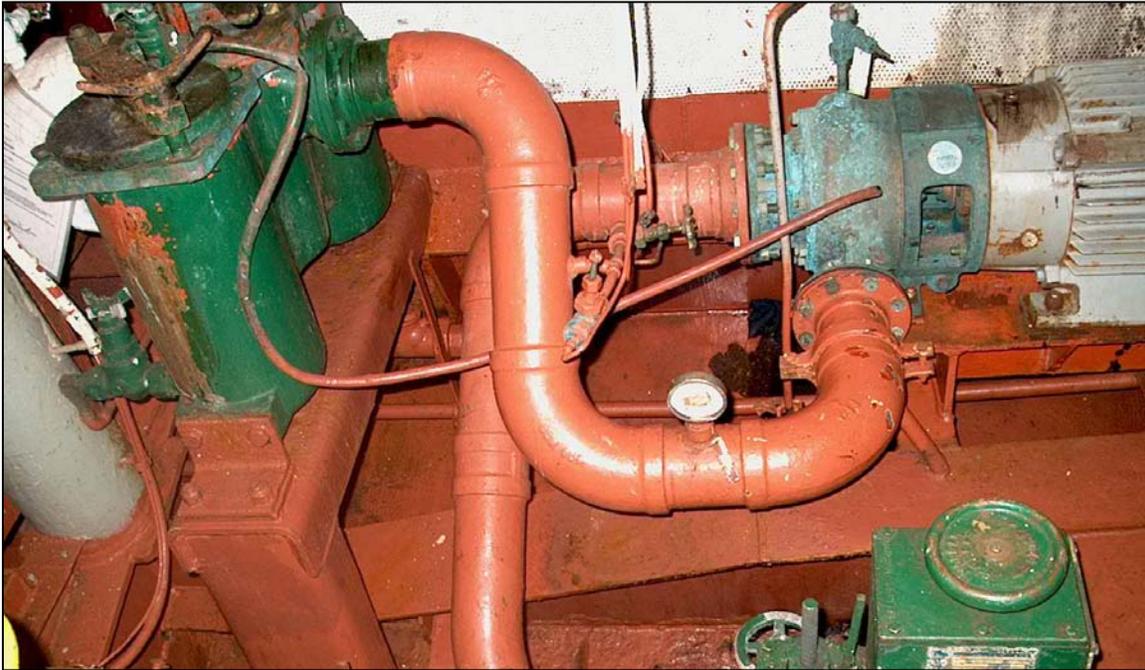
SW STRAINER FOR NO. 2 SSDG. APPROXIMATELY 60 SF OF PAINT FAILURE IS LOCATED BETWEEN FRAMES (228-236).

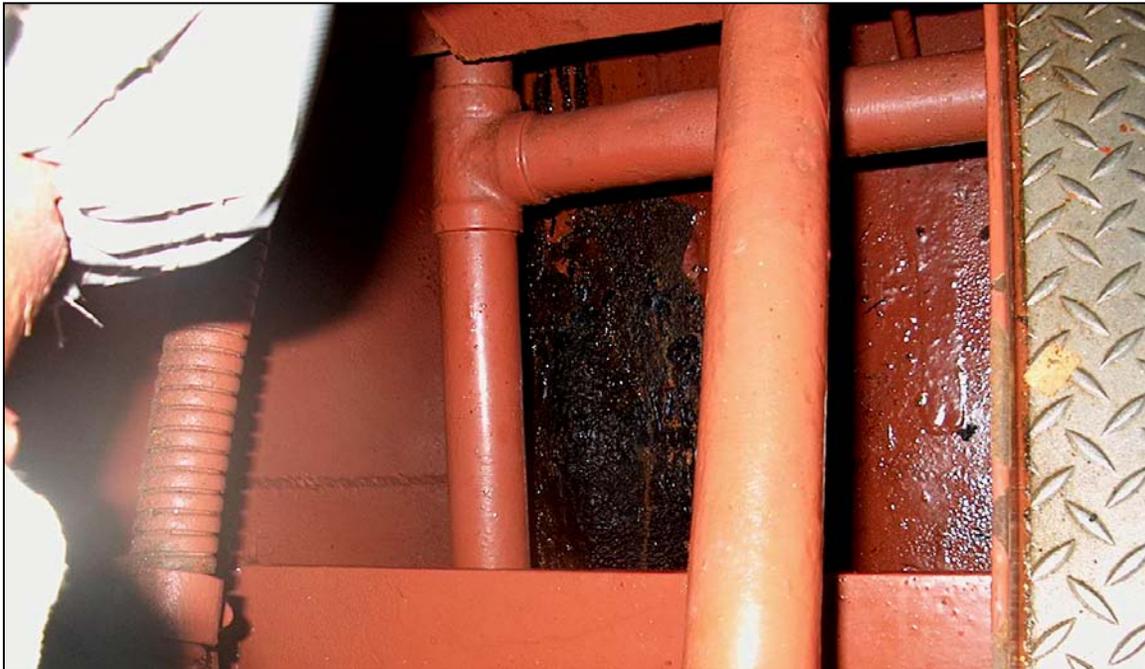
TYPICAL VIEW OF PAINT FAILURE.

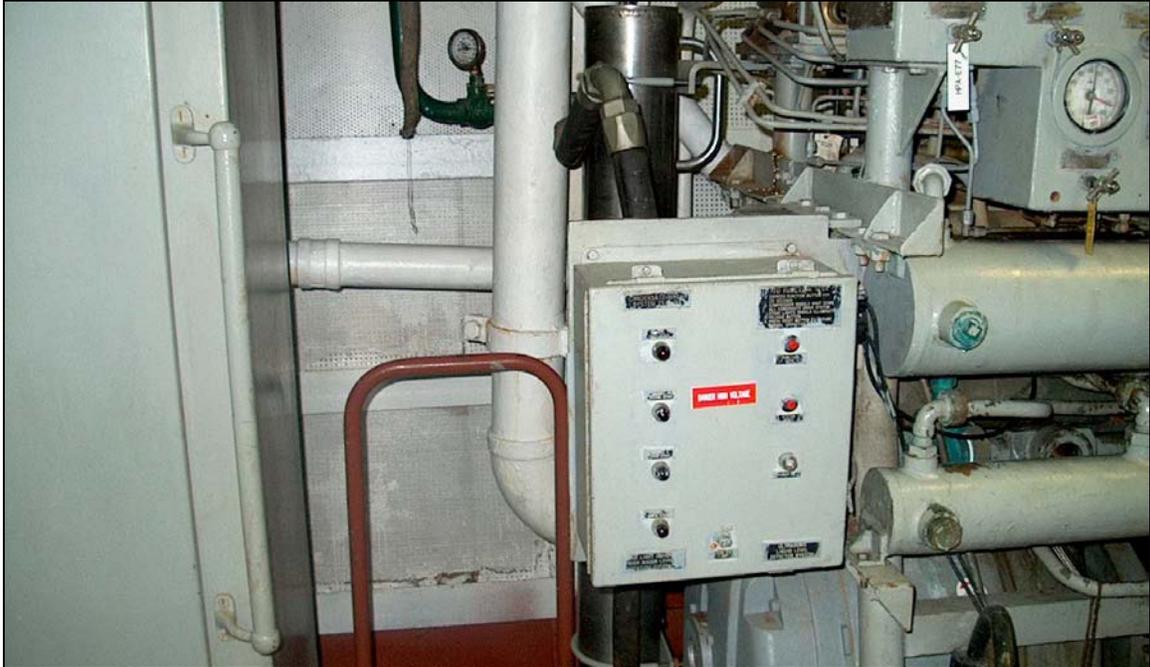
HPAC AFT OF BHD (212). REMOVAL OF PERFORATED METAL AND HULL INSULATION IS HIGHLY RECOMMENDED.

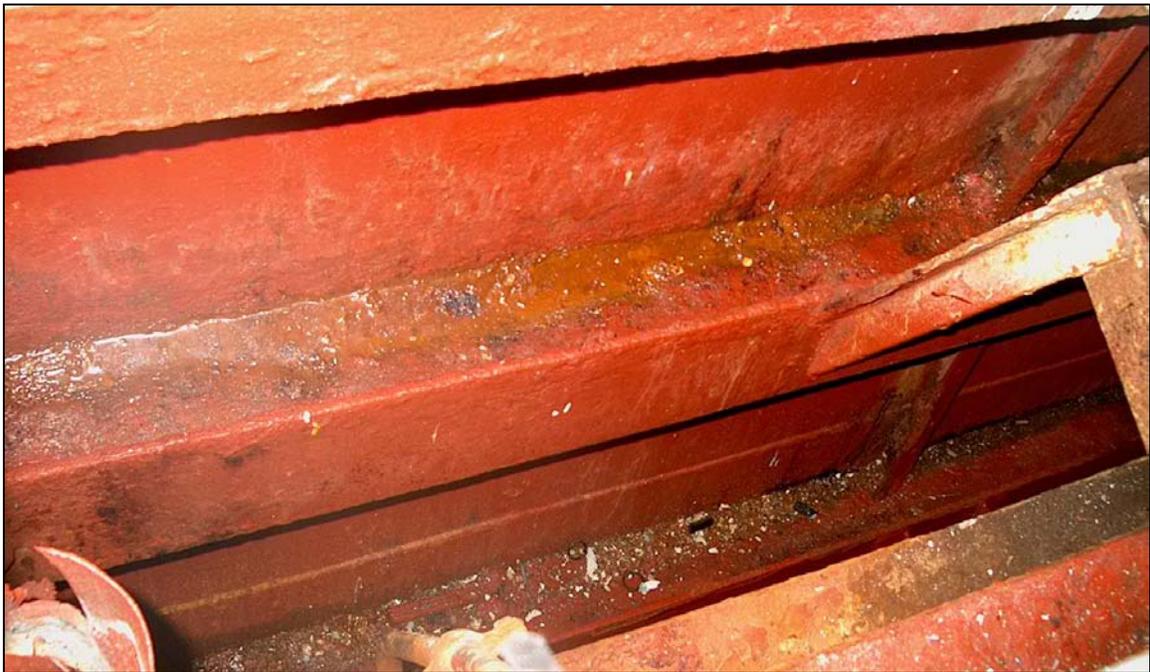
MILD CORROSION AND PAINT SCALING OUTBOARD AND BELOW HPAC.

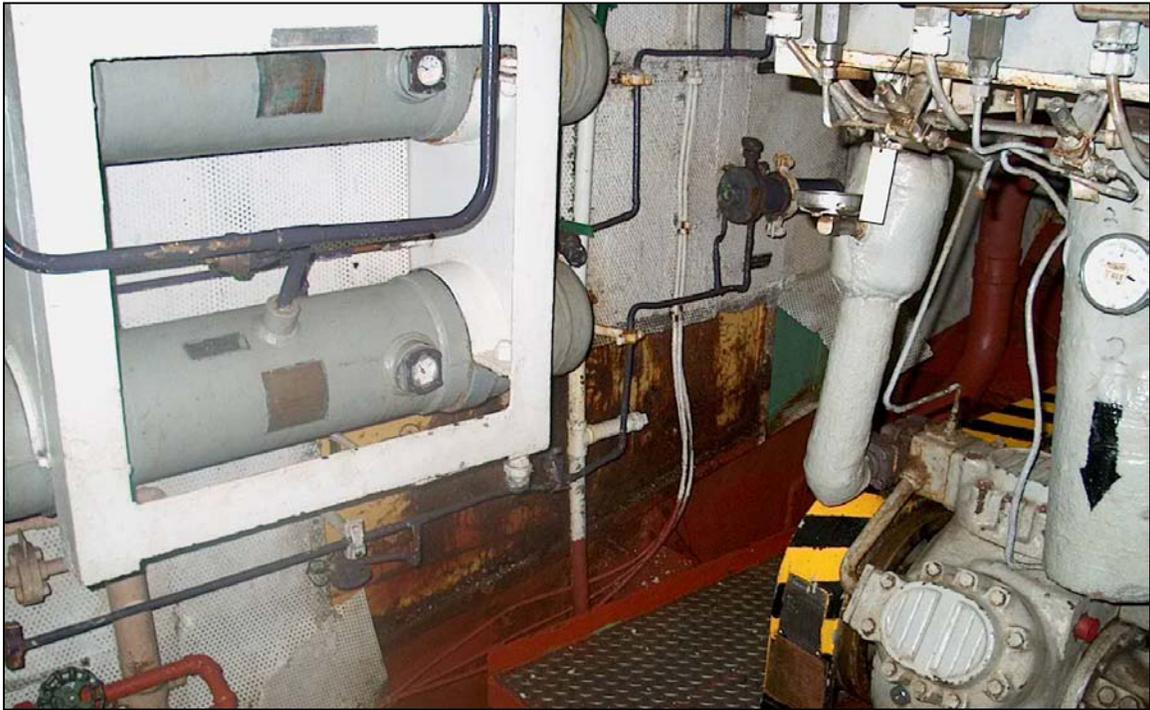
FORWARD END OF FO TANK (5-204-2-F) SEVERE PITTING AND HEAVY CORROSION IS HIDDEN BY INSULATION. A STRONG ODOR OF DIESEL FUEL WAS DETECTED AFTER REMOVING INSULATION.
