== USS ESTOCIN (FFG-15) ==
SEMAT SHELL CONDITION ASSESSMENT
SURVEY
INTERIOR AREAS

PREPARED BY
SUPERVISOR OF SHIPBUILDING CONVERSION
AND
REPAIR
PORTSMOUTH, VIRGINIA
3/13/02 TO 3/22/02

SHELL CONDITION ASSESSMENT SURVEY INTERIOR AREAS TABLE OF CONTENTS

A SEMAT UNDERWATER HULL AND SUPPORTING STRUCTURE SURVEY OF INTERIOR AREAS WAS CONDUCTED ON BOARD **USS ESTOCIN (FFG-15)** FROM 03/13/02 TO 03/22/02 AT NAVAL STATION MAYPORT, JACKSONVILLE FLORIDA.

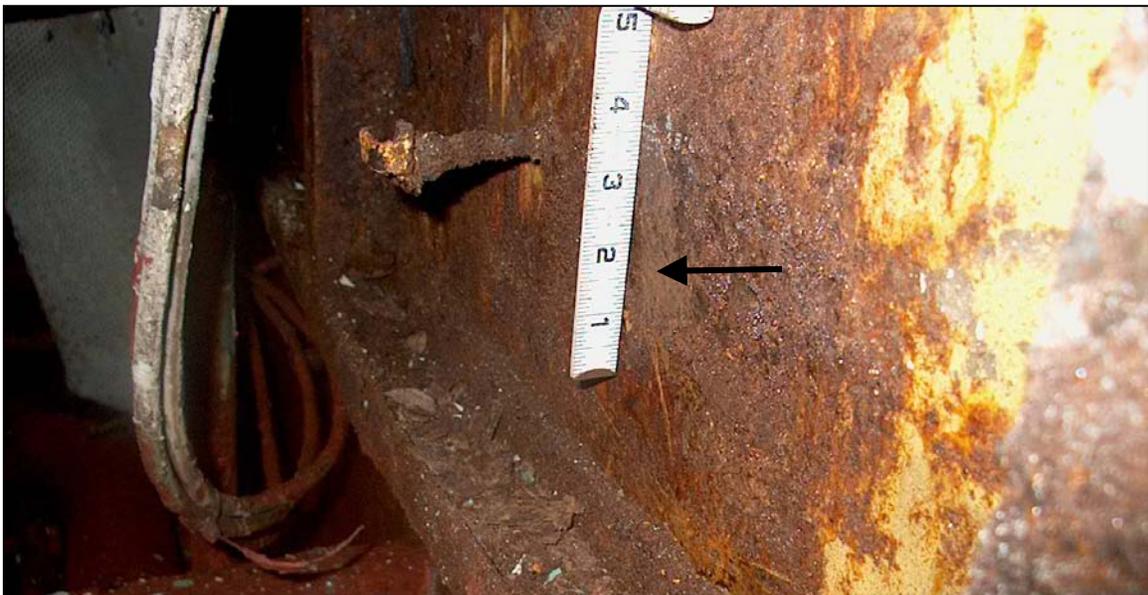
ARROW INDICATES ONE OF SEVERAL DEEP PITS IN TANK. THE EXTENT OF DETERIORATION IS UNKNOWN AS THE ENTIRE TANK IS INSULATED AND COVERED WITH PERFORATED METAL. CORROSION IS SO SEVERE THAT ACCURATE U/T READINGS CANNOT BE TAKEN.

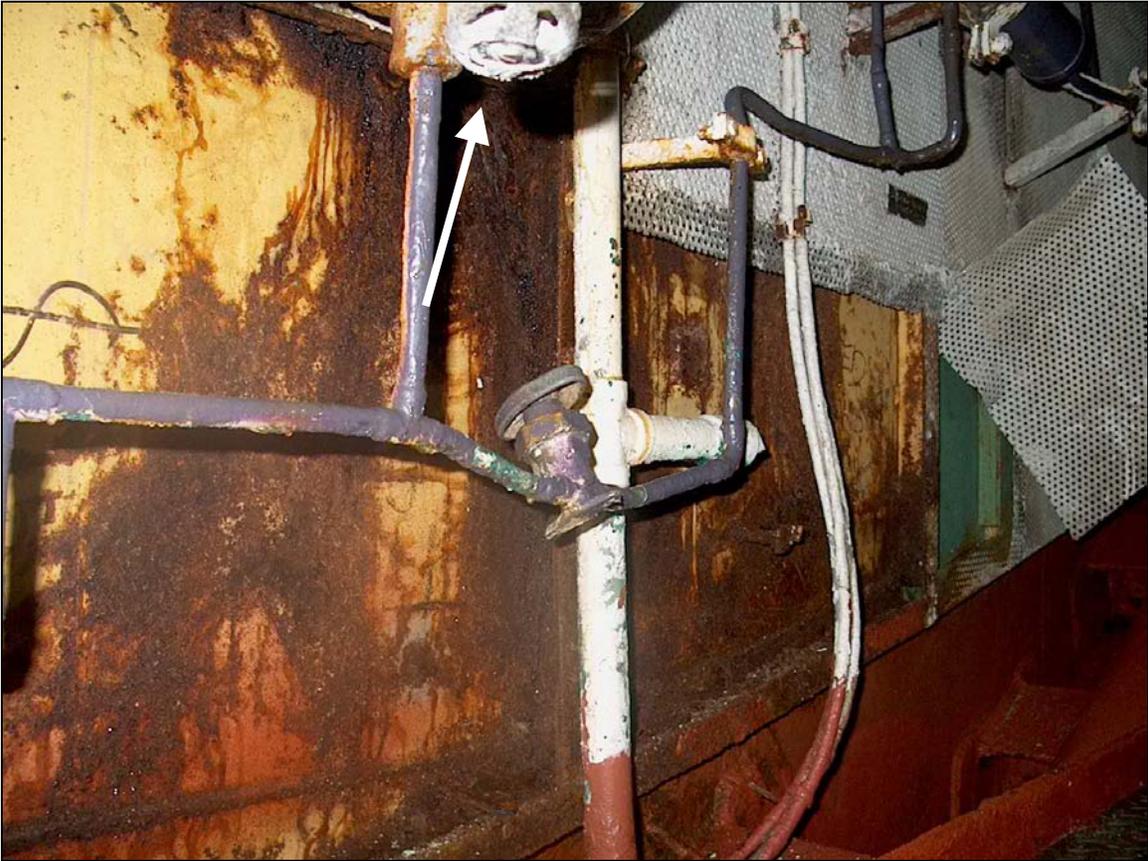
ARROW INDICATES POSSIBLE AREA OF LEAK. AN ULTRASONIC THICKNESS TEST FROM THE INSIDE OF TANK IS HIGHLY RECOMMENDED.

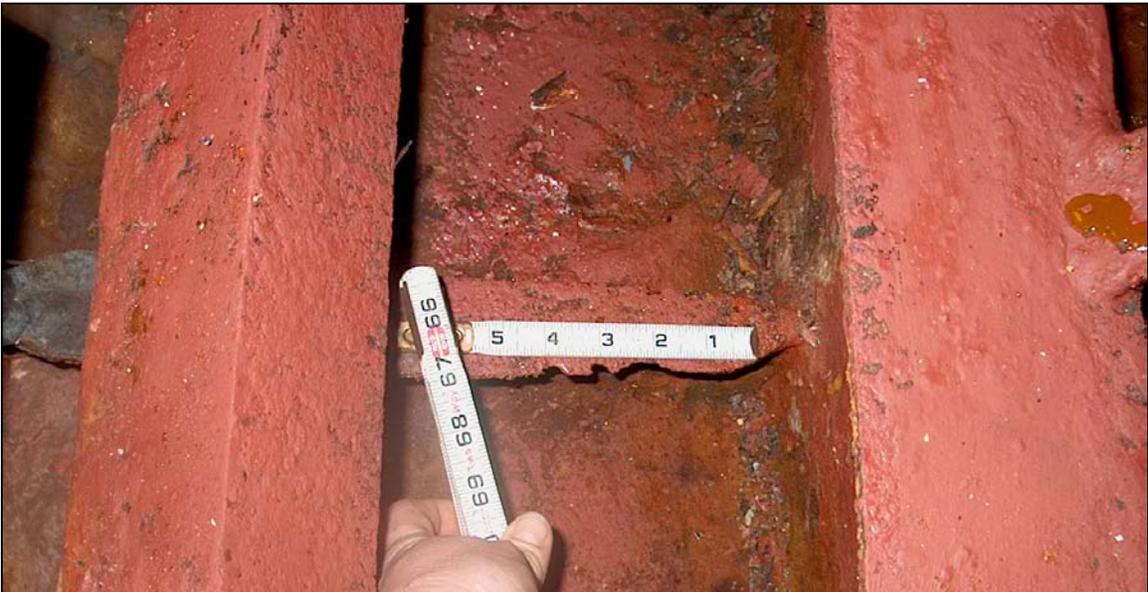
PORT SIDE, 3 X 2 VERTICAL STIFFENER. APPROXIMATELY 16 FT OF THESE STIFFENERS ARE CORRODED, PORT AND STARBOARD.

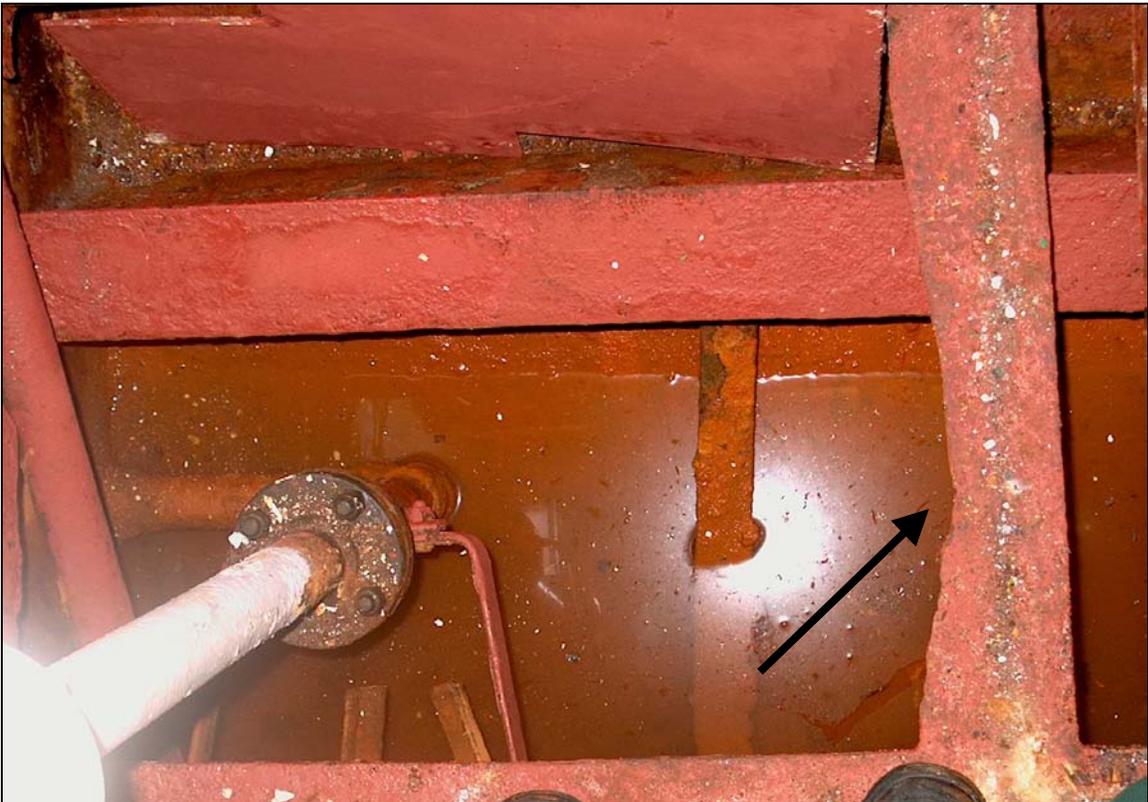
CORRODED 3 X 3 X .250 DECK SUPPORT ANGLE

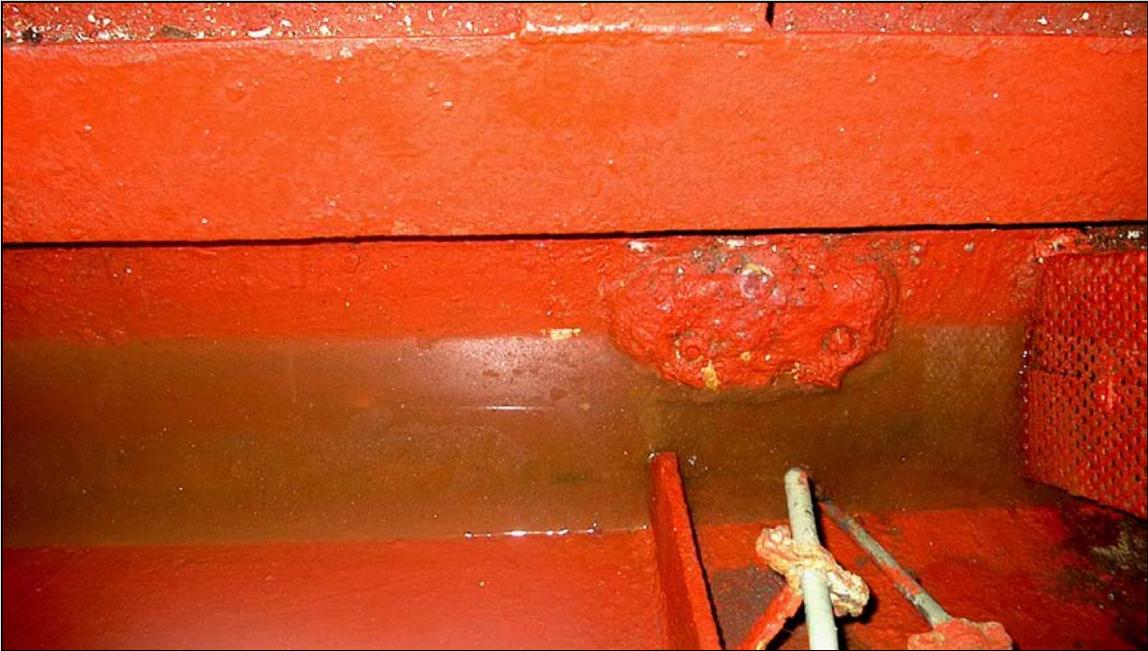
DETERIORATED ZINC ANNODE. REPLACEMENT IS RECOMMENDED.

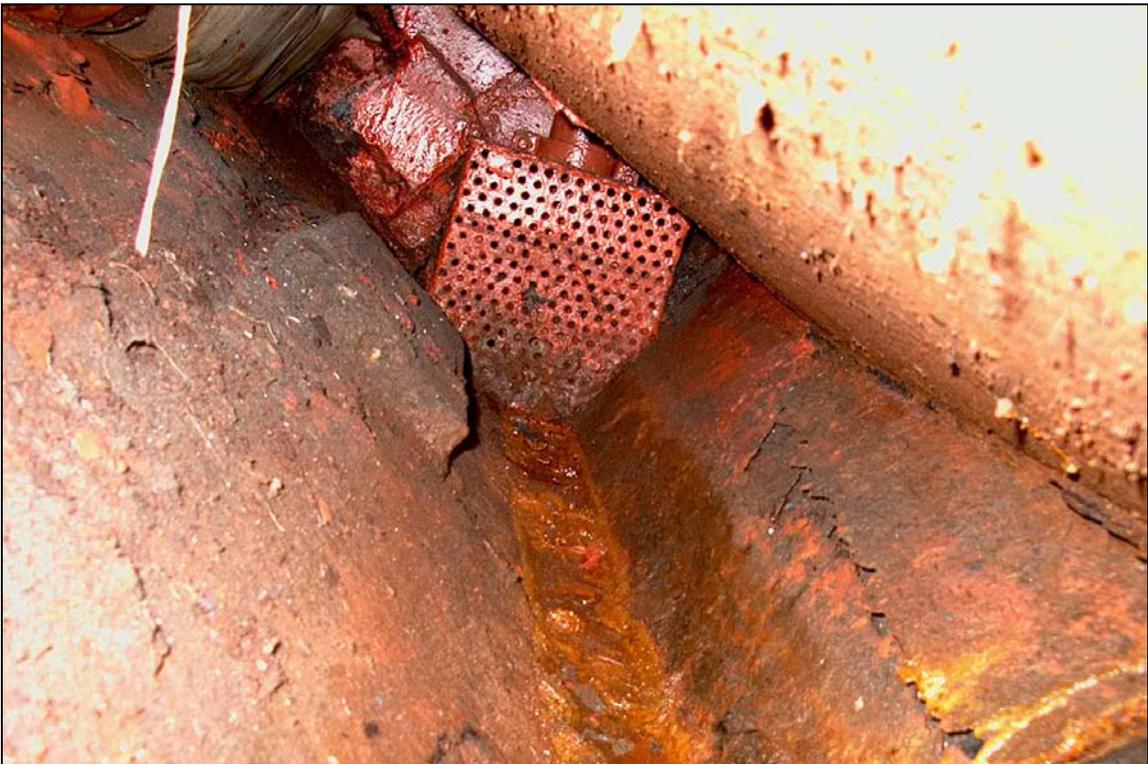
STARBOARD SIDE BILGE POCKET LOOKING AFT. U/T READINGS ARE SATISFACTORY

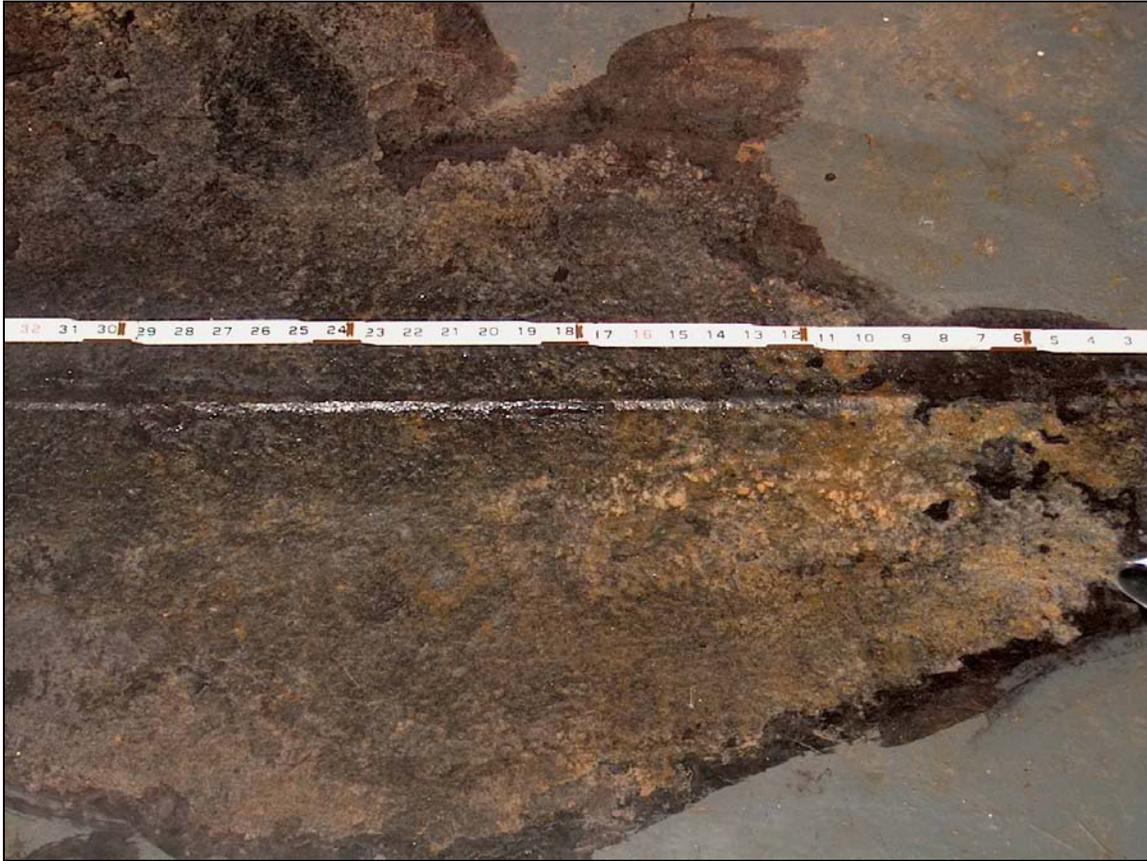
TANK TOP / DECK (5-164-0-F) PORT SIDE, JUST AFT OF SINK. TANK TOP IS BUCKLED AND THINNING IN A 2'X 3' AREA, REFER TO DRAWING FOR U/T READINGS.

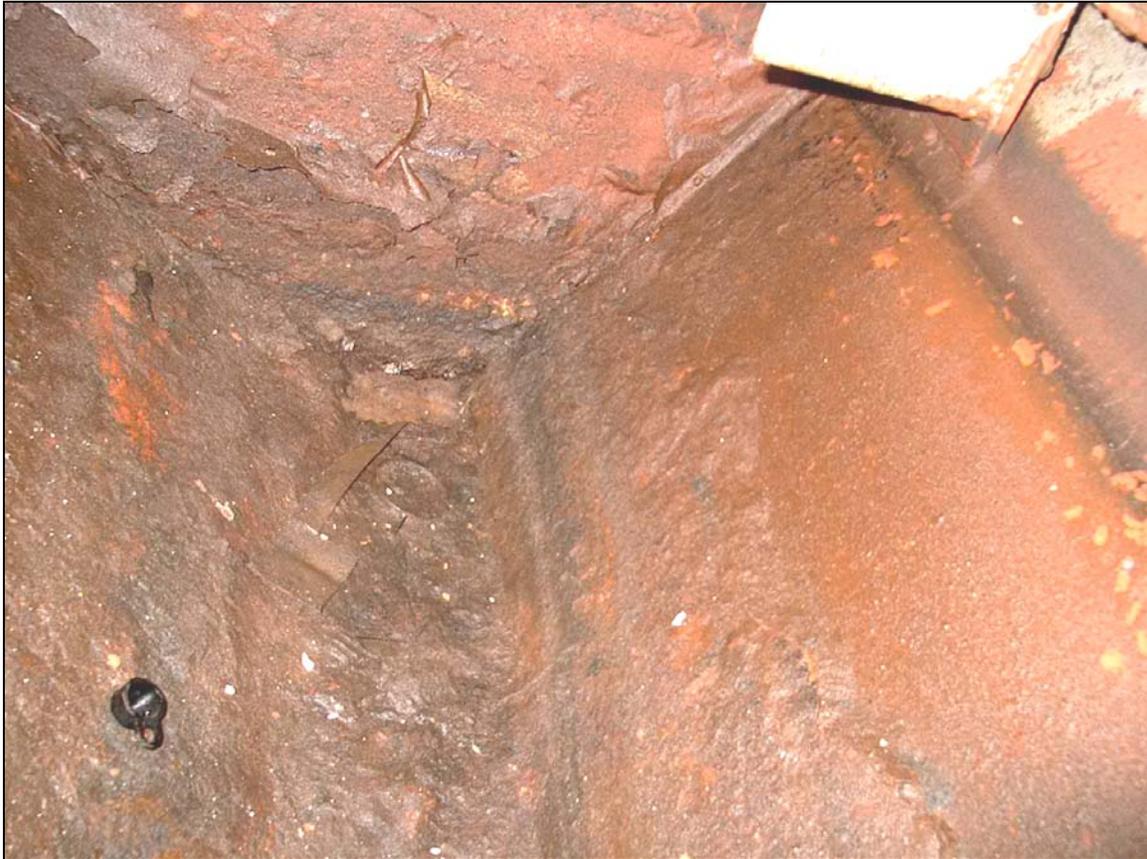
HEAVY PAINT SEPARATION / MILD CORROSION. U/T READINGS ARE SATISFACTORY.

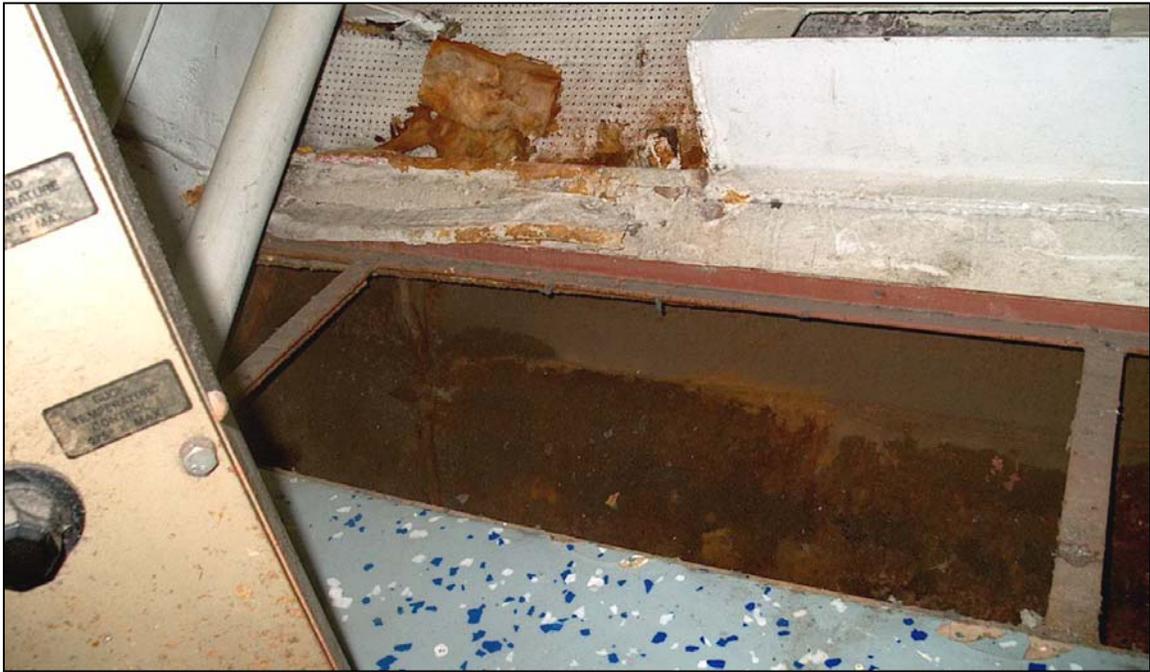
CORROSION IN BILGE POCKET AT BHD (160).

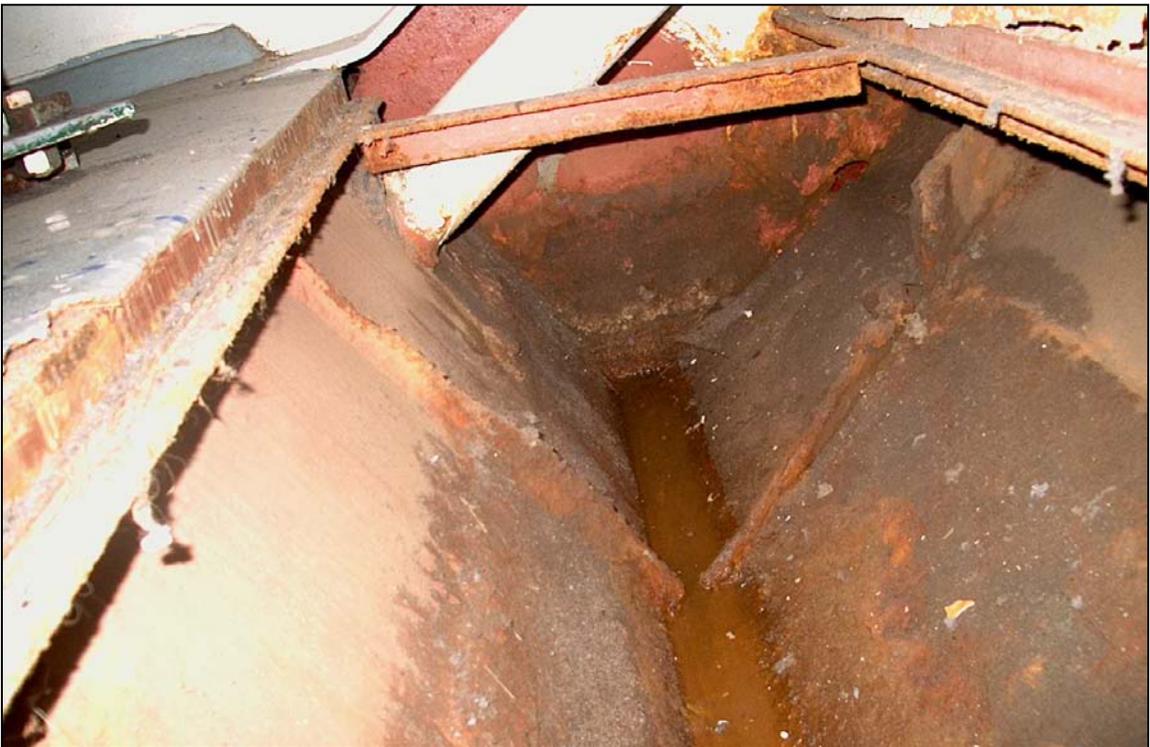
CORROSION AND PAINT FAILURE. U/T READINGS ARE SATISFACTORY.

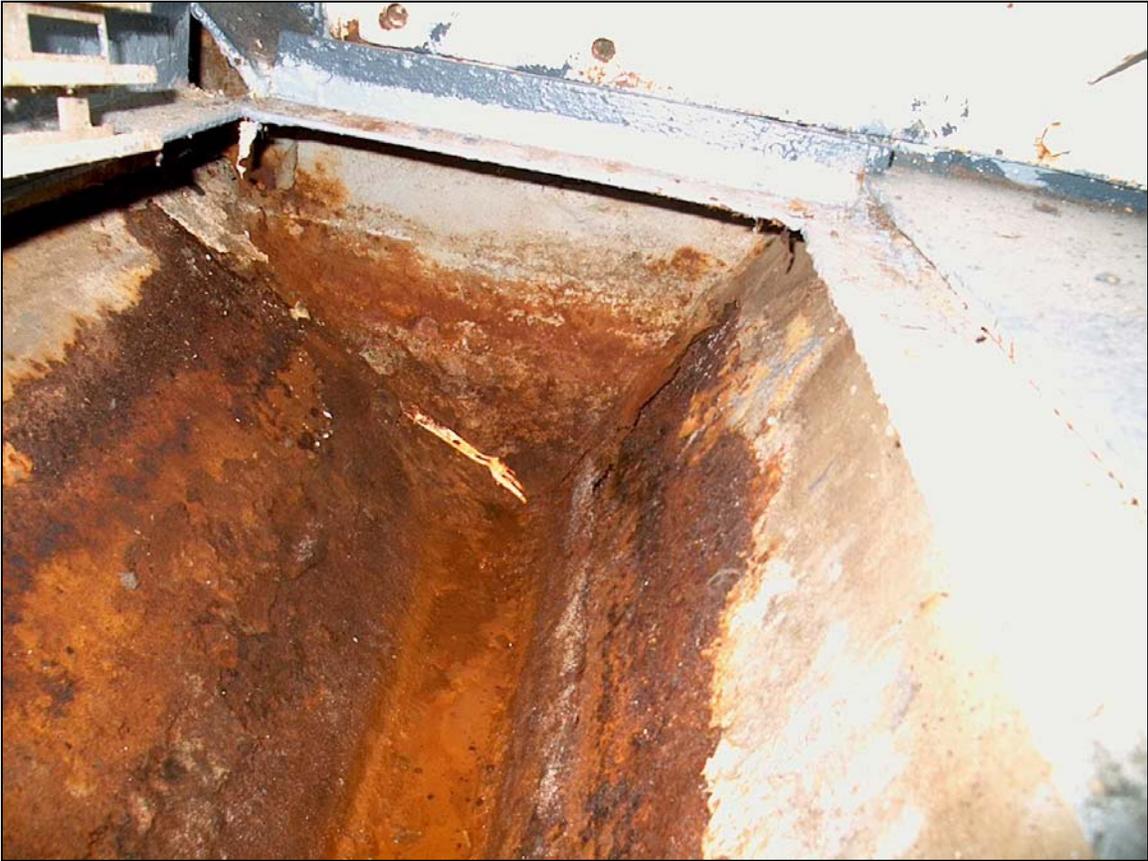
BILGE AREA CORROSION AND HEAVY PAINT SCALING. U/T READINGS ARE SATISFACTORY.

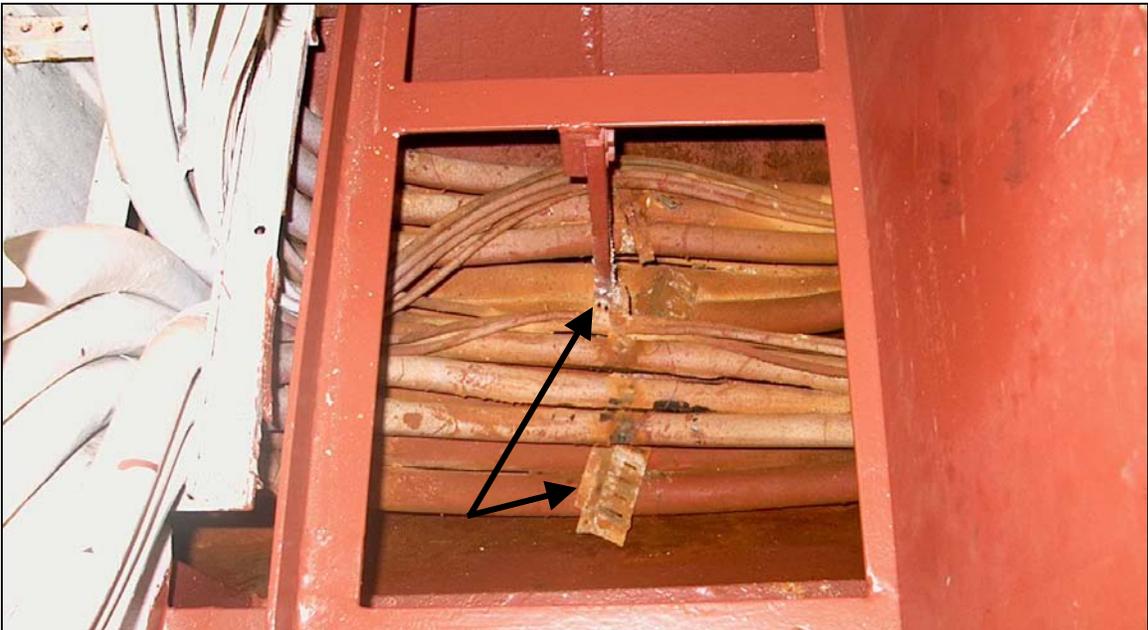
STARBOARD SIDE, BETWEEN POWER DISTRIBUTION PANELS AND BHD (100)
ARROWS INDICATE BROKEN CABLE HANGER.

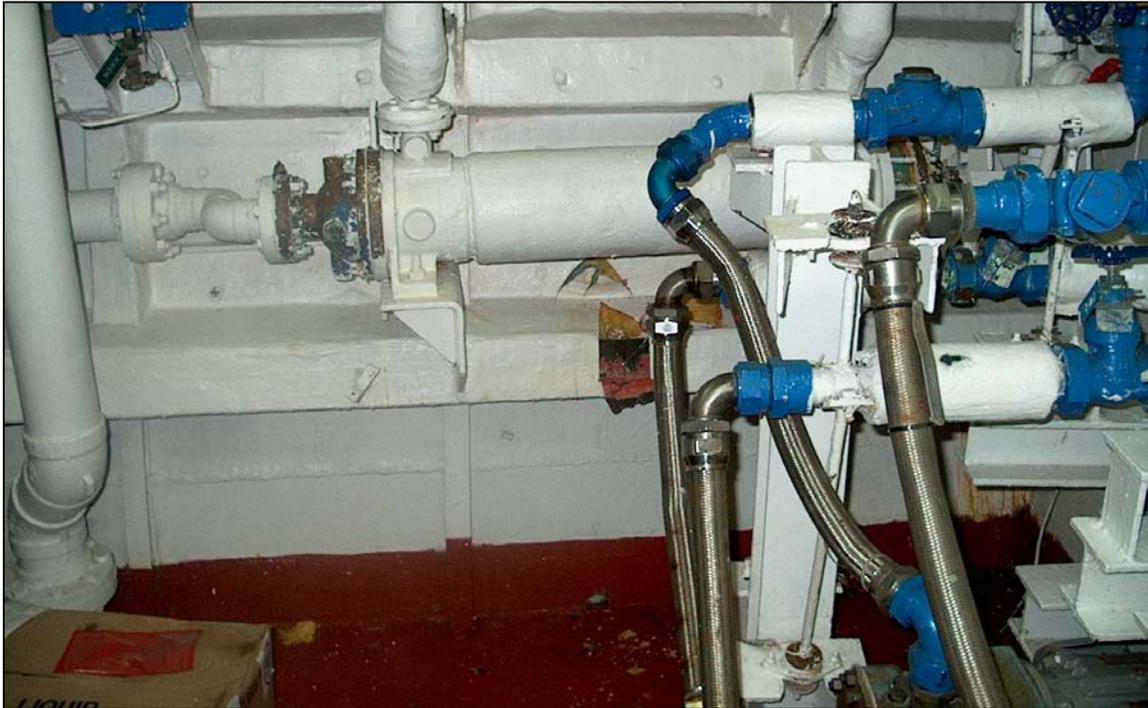
STARBOARD SHELL, 1ST STRINGER FROM DECK IS HOLED AT BHD (56). HULL INSULATION IS SATURATED FROM 1ST STRINGER TO APPROXIMATELY 5' OFF THE DECK . THIS IS A COMMON PROBLEM ON FFG-7 CLASS SHIPS.

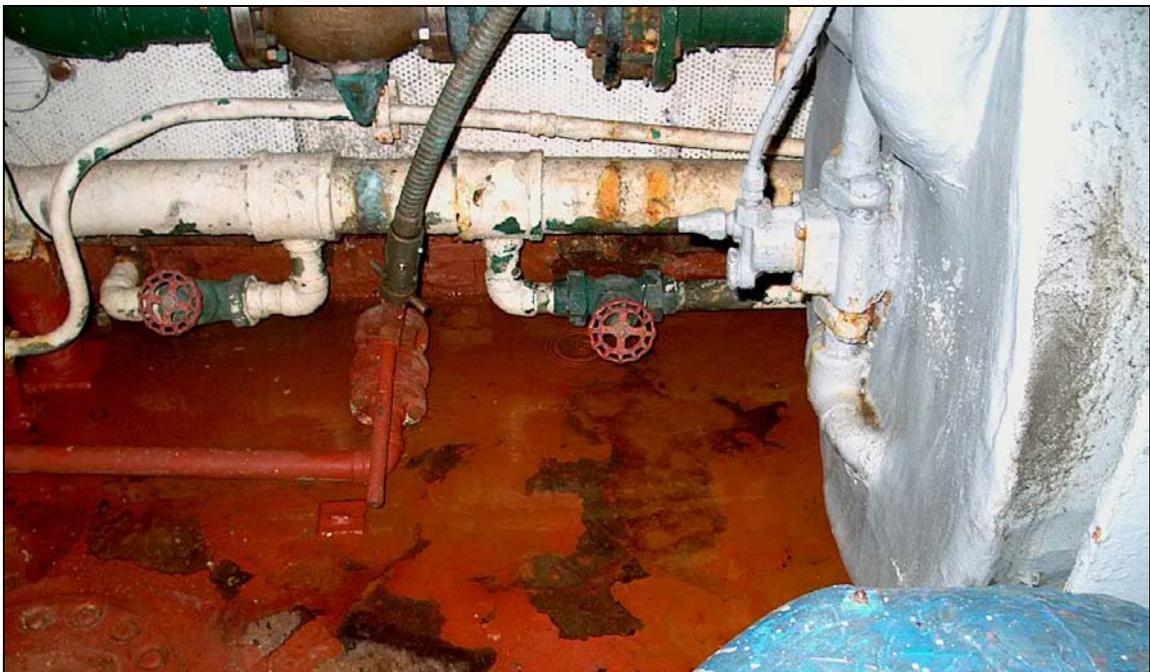
HEAVY PAINT SCALING INBOARD OF A/C PLANT NO. 1, THIS AREA HAS SEVERAL LOW U/T READINGS, REFER TO DRAWING.

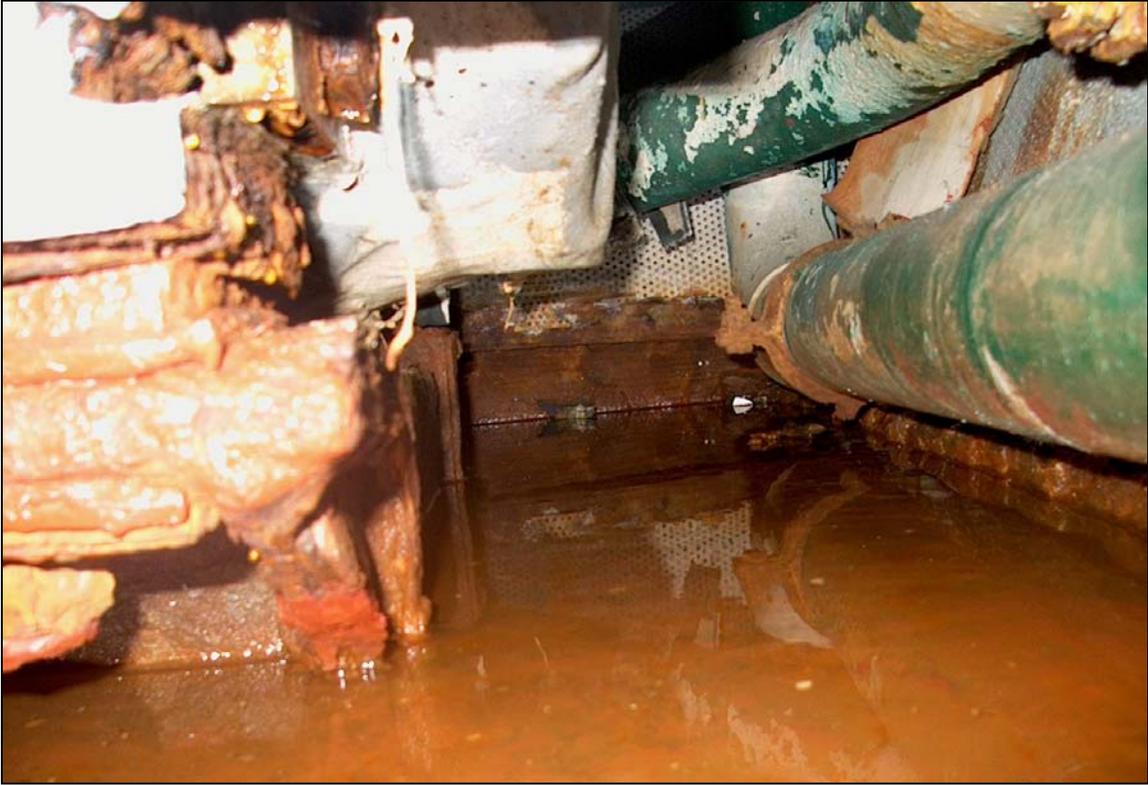
STANDING WATER BETWEEN A/C PLANT AND SHELL

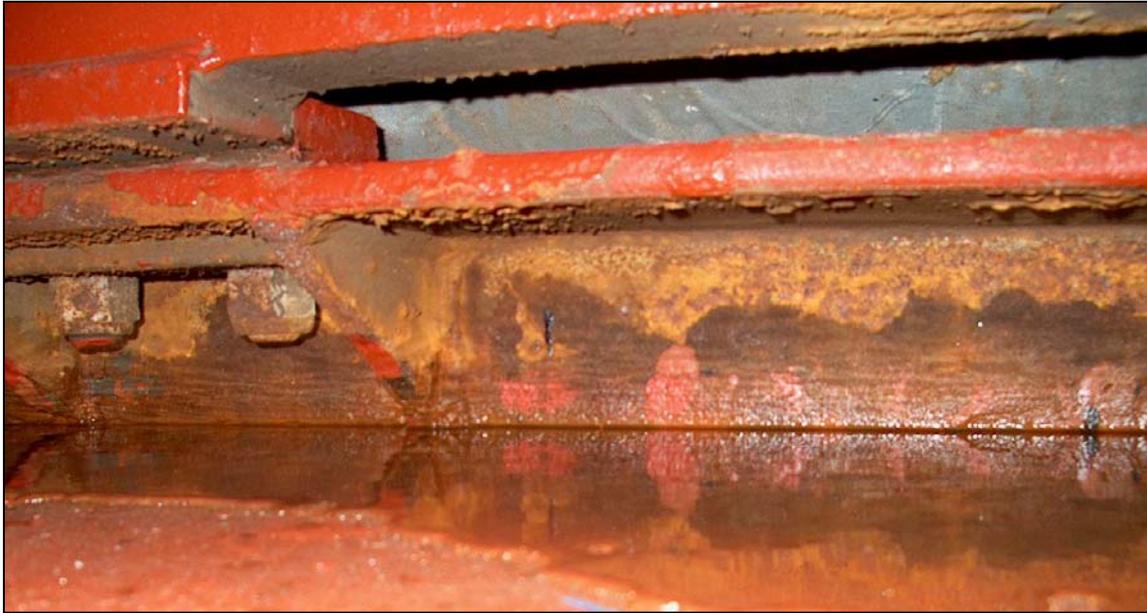
CORROSION ON A/C PLANT FOUNDATION.

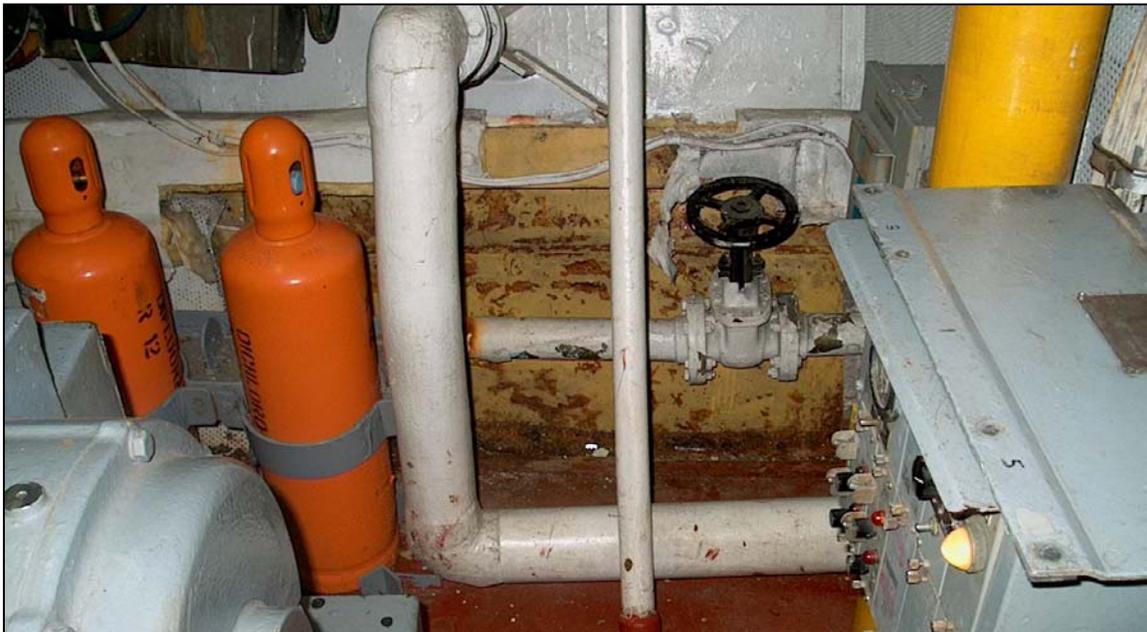
CORROSION ON SHELL AT BHD (84)
