— USS STEPHEN W GROVES —

(FFG-29)

**SEMAT II SHELL CONDITION ASSESSMENT SURVEY
INTERIOR AREAS
6/24/01 – 7/6/01**

**PREPARED BY SUPSHIP
PORTSMOUTH
07/10/01**

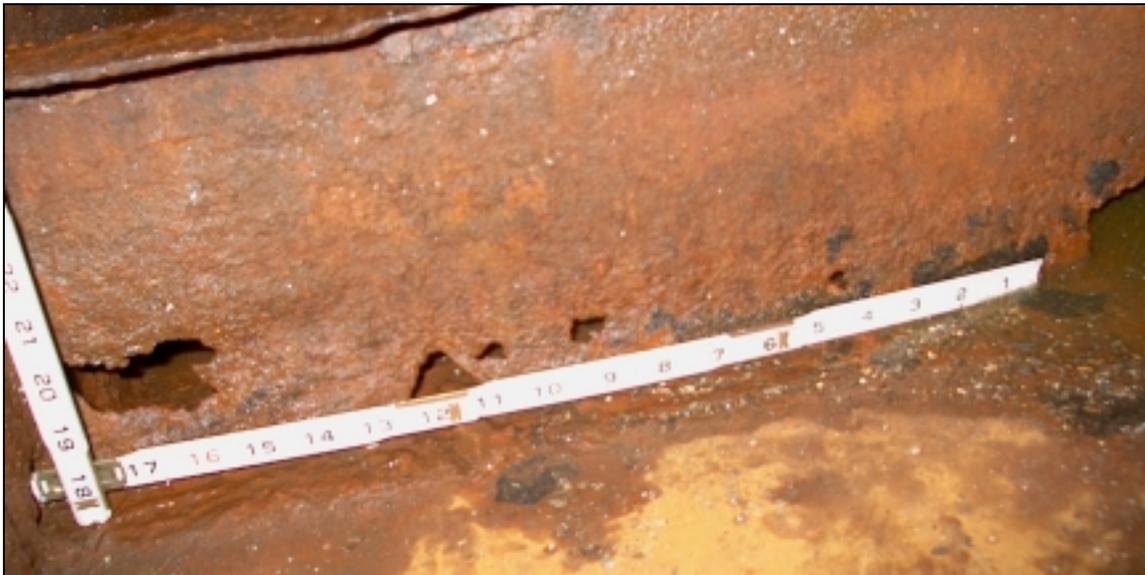
LOCATION	AREA	RESULTS
5-368-0-E STEERING GEAR RM	STBD SIDE, AFT OF BHD (368) STRINGERS (8-9)	STRINGERS (8-9) ARE HOLED FROM BHD (368) APPROXIMATELY 2' OUT.
5-292-0-E AUX 3	PORT SIDE, AFT OF SSDG #4 STRINGER 11.	STRINGER (11) IS HOLED. APPROXIMATELY 8FT AFT OF SSDG #4.
5-292-0-E AUX 3	PORT SIDE, 2FT AFT OF WF (316) BTWN STRINGERS (9-10)	APPROXIMATELY 1SF BETWEEN STRINGERS (9-10) SHELL IS THINNING.
5-292-0-E AUX 3	CENTER LINE, TRANSVERSE WEB FRAME (316)	APPROXIMATELY 16SF OF TRANSVERSE WEB FRAME HAS HEAVY PITTING AND HOLES, ASSOCIATED HORIZONTAL AND VERTICAL STIFFNERS ARE CORRODED.
5-292-0-E AUX 3	SHAFT AT TRANSVERSE WEB FRAME (316)	APPROXIMATELY 58SF OF SHAFT HAS HEAVY RUST AND PAINT SEPARATION.
5-292-0-E AUX 3	STBD SIDE, UNDER HOT POTABLE WATER TANK STRINGER (8) BTWN BHD (292) AND WF (300)	APPROXIMATELY 4 LF OF STRINGER (8) IS HOLED.
5-250-0-E MER	PORT SIDE, WF (264-270) FROM MARGIN PLATE TO STRINGER (11) APPROXIMATELY 2 FT AFT OF WF (270) AT TRANSVERSE WELD SEAM.	APPROXIMATELY 100 SF OF SURFACE RUST AND PAINT SEPARATION.

STBD SIDE LOOKING INBOARD, WHERE STRINGER (8) MEETS BHD (368)

SAFETY HAZARD: 1. SERIOUS - CORRECT AS SOON AS POSSIBLE 2. SERIOUS - SUSPENSION OF EQUIPMENT/SYSTEM/SPACE REQUIRED 3. SERIOUS - WAIVER OF EQUIPMENT/SYSTEM 4. SAFETY ITEM - MINOR 5. COMBUSTIBLE MATERIAL		1. MAINTENANCE ACTION COMPLETED: PARTS DRAWN FROM SUPPLY 2. MAINTENANCE ACTION COMPLETED: REQUIRED PARTS NOT DRAWN FROM SUPPLY 3. MAINTENANCE ACTION COMPLETED: NO PARTS REQUIRED 4. CANCELLED - DEFERRAL WILL BE REMOVED FROM CSMP 7. MAINTENANCE ACTION COMPLETED: 3-M CAPABILITY UTILIZED 0. NONE OF THE ABOVE, DESCRIBE IN REMARKS/DESCRIPTION SECTION			1. MANDATORY 2. ESSENTIAL 3. HIGHLY DESIRABLE 4. DESIRABLE		
DISCREPANCY DESCRIPTION: PER SEMAT II UNDERWATER HULL ASSESSMENT: STBD SIDE, (5-368-0-E) EDUCTOR ROOM AFT OF BHD (368)							
STRINGERS (8-9) ARE HOLED AND SEVERILY DETERIORATED. APPROXIMATELY 8 LF OF 4X6 T-BEAM.							
RECOMMENDED REPAIRS: CUT OUT AND REPLACE APPROXIMATELY 8 LF OF 4X6 T-BEAM, PRESERVE AND PAINT TO MATCH.

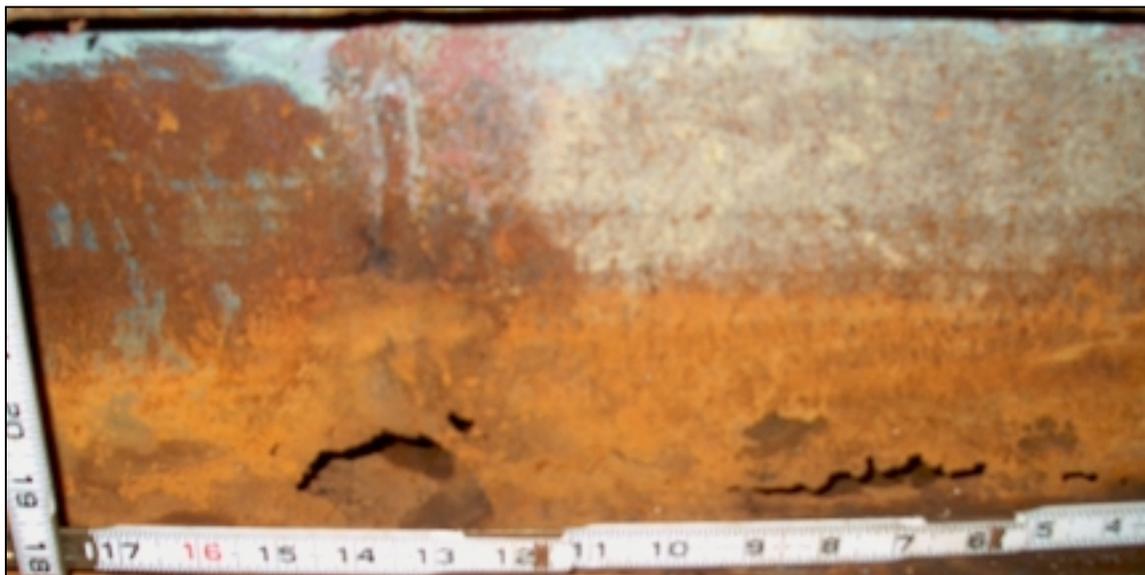
STBD SIDE, STRINGER (9)

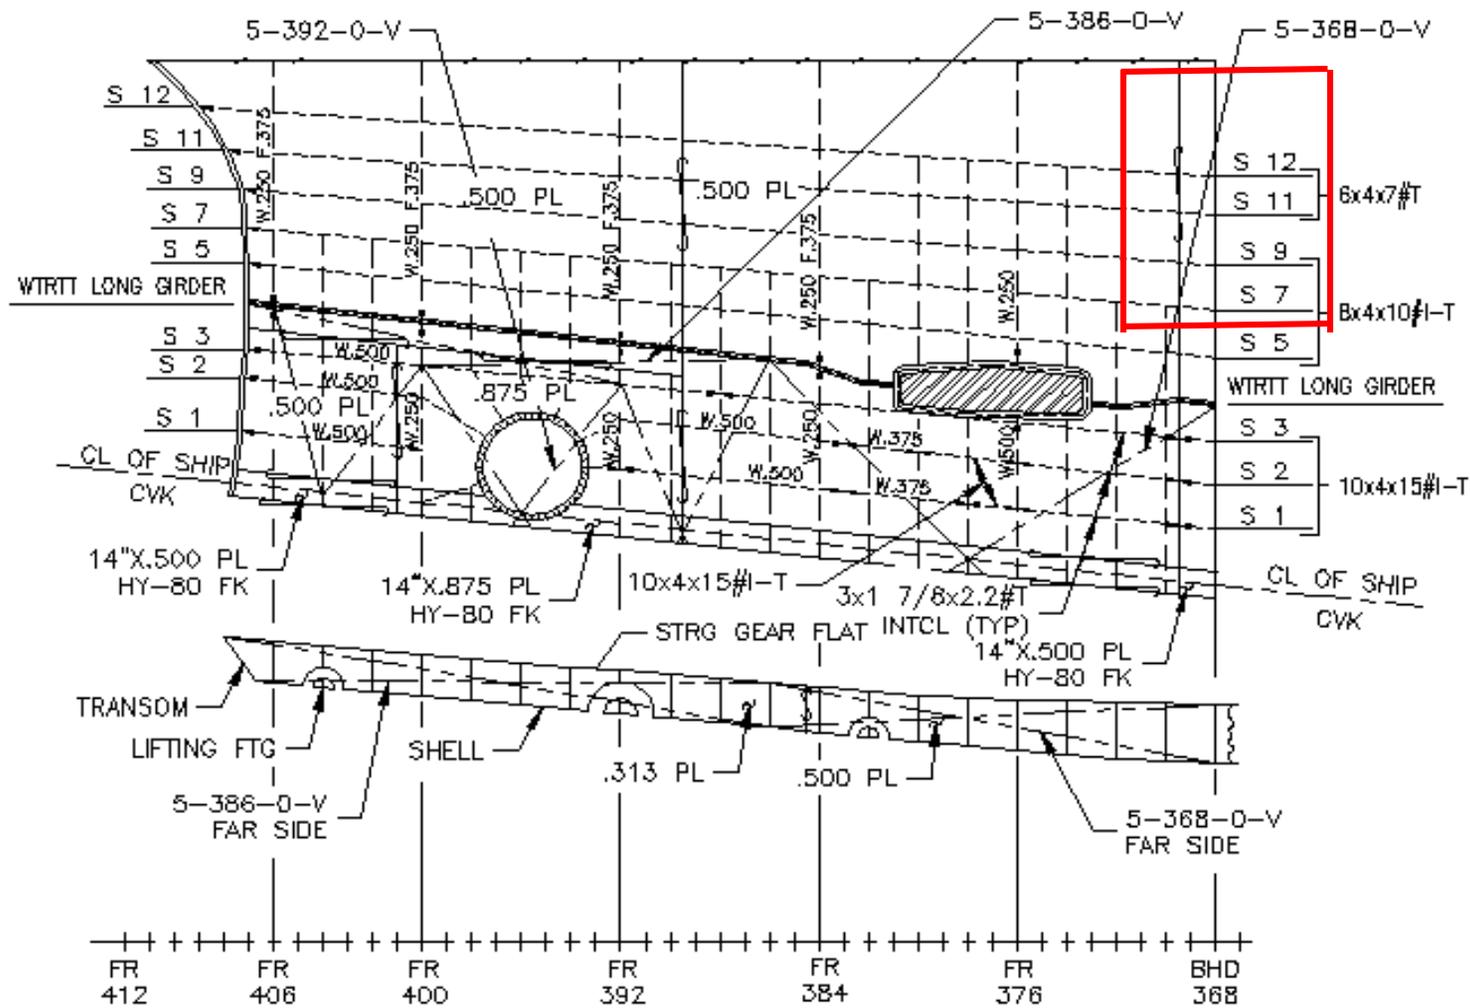
USS STEPHEN W GROVES (FFG-29)
 STEERING GEAR ROOM (5-368-0-E)
 STBD SIDE LOOKING PORT EXPANDED
 VERTICALLY

RED BOX INDICATES AREA WHERE U/T
 READINGS WERE TAKEN
 SEE PAGE 10

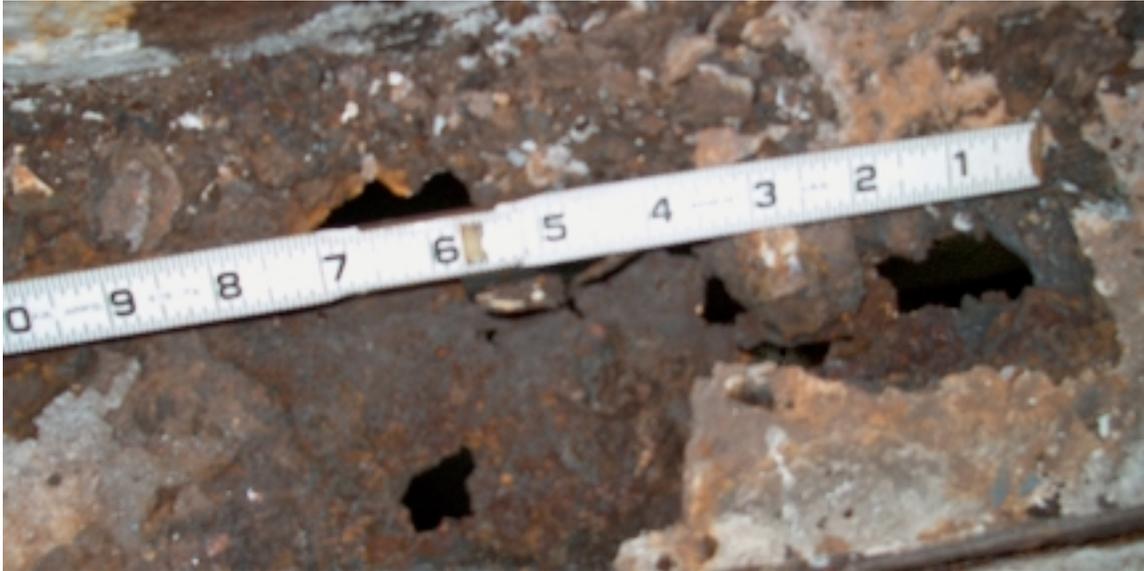
SAFETY HAZARD: 1. SERIOUS - CORRECT AS SOON AS POSSIBLE 2. SERIOUS - SUSPENSION OF EQUIPMENT/SYSTEM/SPACE REQUIRED 3. SERIOUS - WAIVER OF EQUIPMENT/SYSTEM 4. SAFETY ITEM - MINOR 5. COMBUSTIBLE MATERIAL			1. MAINTENANCE ACTION COMPLETED: PARTS DRAWN FROM SUPPLY 2. MAINTENANCE ACTION COMPLETED: REQUIRED PARTS NOT DRAWN FROM SUPPLY 3. MAINTENANCE ACTION COMPLETED: NO PARTS REQUIRED 4. CANCELLED - DEFERRAL WILL BE REMOVED FROM CSMP 7. MAINTENANCE ACTION COMPLETED: 3-M CAPABILITY UTILIZED 0. NONE OF THE ABOVE. DESCRIBE IN REMARKS/DESCRIPTION SECTION		1. MANDATORY 2. ESSENTIAL 3. HIGHLY DESIRABLE 4. DESIRABLE		
DISCREPANCY DESCRIPTION: PER SEMAT II UNDERWATER HULL ASSESSMENT: PORT SIDE, (5-292-0-E) AUX 3, BETWEEN WF (316-324)							
STRINGER (11) BEHIIND/UNDER POWER PNL (3-319-2) IS HOLED. SHELL PLATE APPROXIMATELY 1.5" ABOVE HOLES IN							
STRINGER (11) IS THINNING. REFER TO DRAWING FOR U/T READINGS.

TOP VIEW OF STRINGER (11) FWD OF WF (324).

RECOMMENDED REPAIRS: REMOVE AND REPLACE APPROXIMATELY 8 LINEAR FEET OF 4X6 T-BEAM. PRESERVE AND PAINT TO MATCH.							
FTSC is to conduct risk assessment and make final repair recommendations.							
SSPORT C221 POC: F. PRAISSMAN (757) 396-4001 EXT 2130, TPOC: B. WILLIAMS/M. MELVIN							
CSMP SUMMARY: STRINGER (11) BETWEEN WF (316-324) IS DETERIORATED.				TEST# MRC 1102/1			
ROOT CAUSE/AMPLIFICATION: H1				STEP# 1,2,3,4 & 5			
SYSTEM LEVEL IMPACT:							
PART NO.	NOMEMCLATURE			QTY	NSN	COST	
1							
2							
3							
4							
5							
6							
FIRST CONTACT HURST	RATE HTC	SECOND CONTACT GERMAN		RATE ENS	PHONE		
ASSESSOR / ACT / TECH ID# J. LaROCK/ T. ILGENFRITZ QED SYSTEMS INC.			TD	TL	LOGISTICIAN	TSP

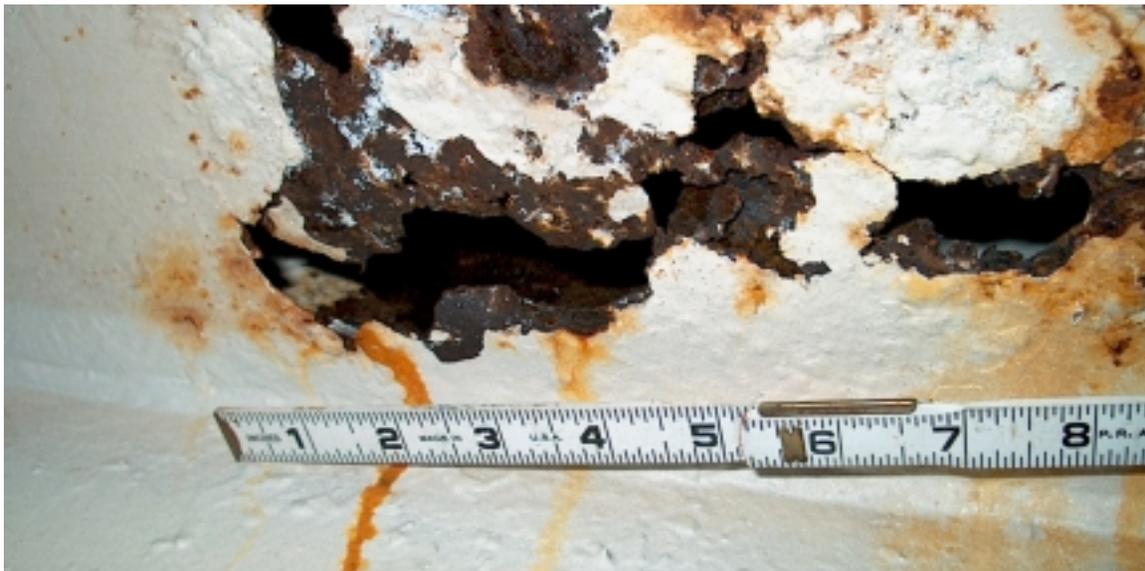
UNDERNEATH VIEW OF STRINGER (11)
RECOMMENDED FOR REPLACEMENT.

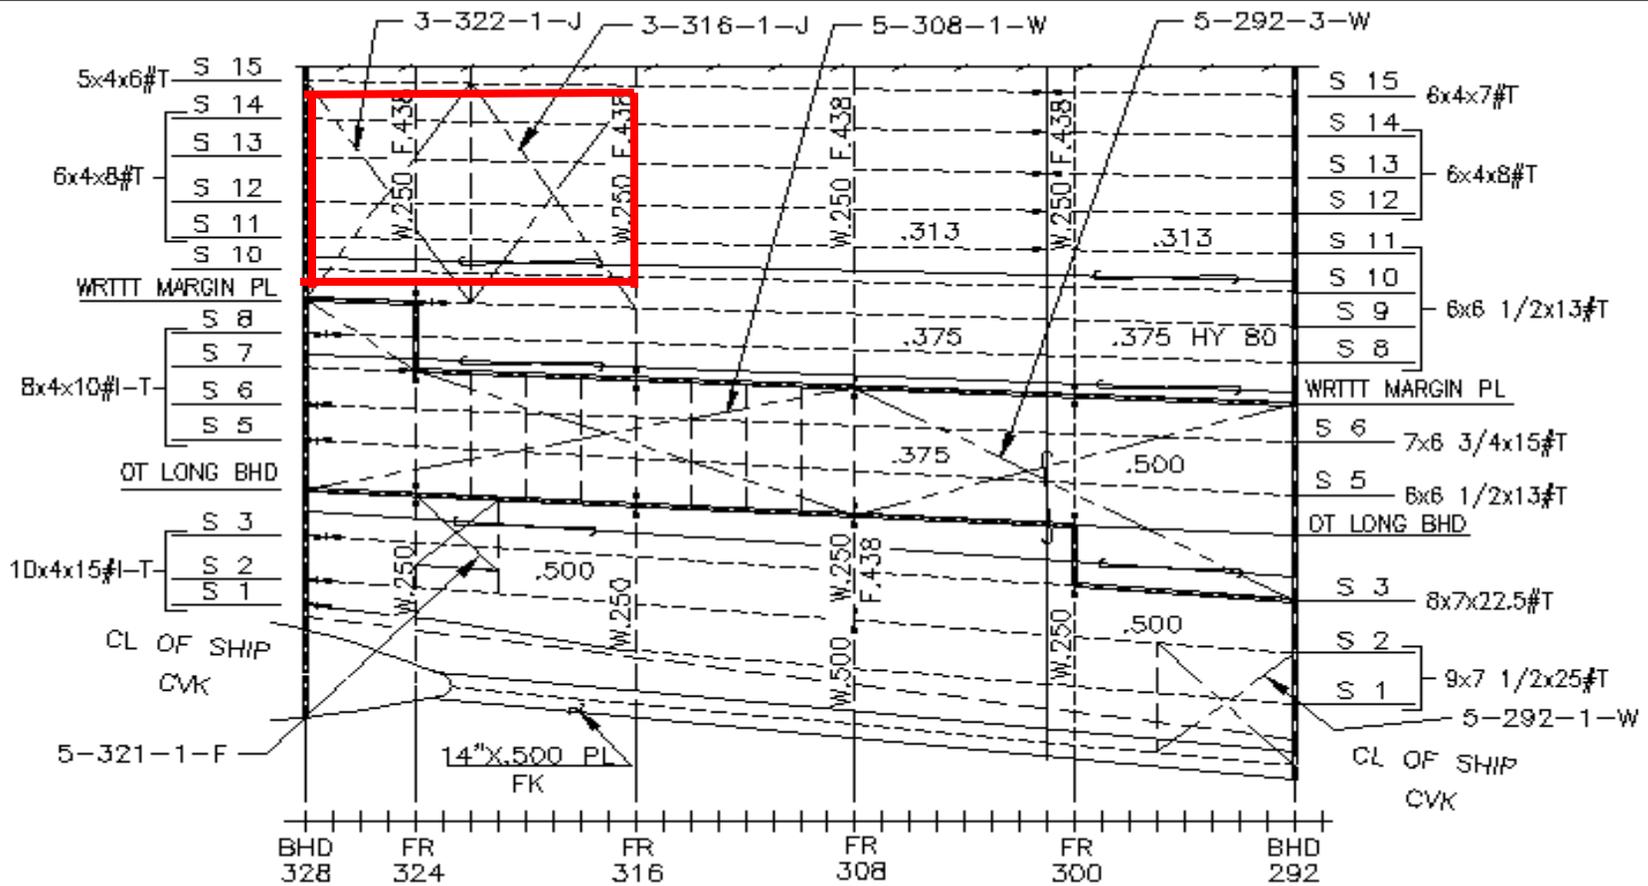
USS STEPHEN W GROVES (FFG-29)
 AUXILIARY MACHINERY ROOM 3
 (5-292-0-E) PORT SIDE

RED BOX INDICATES LOCATION
 OF U/T READINGS
 DRAWING ON FOLLOWING PAGE

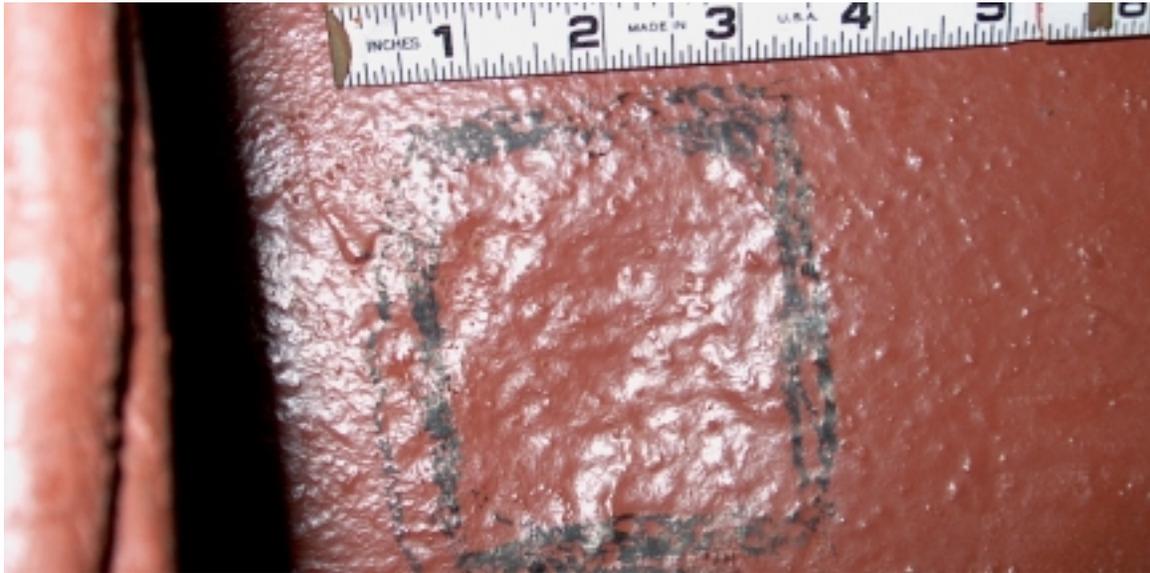
SHELL PLATE 2FT AFT OF WF (316) BTWN STRINGERS (9-10)
REFER TO DRAWING FOR U/T READINGS

SAFETY HAZARD: 1. SERIOUS - CORRECT AS SOON AS POSSIBLE 2. SERIOUS - SUSPENSION OF EQUIPMENT/SYSTEM/SPACE REQUIRED 3. SERIOUS - WAVIER OF EQUIPMENT/SYSTEM 4. SAFETY ITEM - MINOR 5. COMBUSTIBLE MATERIAL			1. MAINTENANCE ACTION COMPLETED: PARTS DRAWN FROM SUPPLY 2. MAINTENANCE ACTION COMPLETED: REQUIRED PARTS NOT DRAWN FROM SUPPLY 3. MAINTENANCE ACTION COMPLETED: NO PARTS REQUIRED 4. CANCELLED - DEFERRAL WILL BE REMOVED FROM CSMP 7. MAINTENANCE ACTION COMPLETED: 3-M CAPABILITY UTILIZED 0. NONE OF THE ABOVE, DESCRIBE IN REMARKS/DESCRIPTION SECTION		1. MANDATORY 2. ESSENTIAL 3. HIGHLY DESIRABLE 4. DESIRABLE		
DISCREPANCY DESCRIPTION: PER SEMAT II UNDERWATER HULL ASSESSMENT: PORT SIDE, (5-292-0-E) AUX 3, APPROXIMATELY 2FT AFT OF							
WF (316) BETWEEN STRINGERS (9-10) SHELL PLATE THINNING AT .225. APPROXIMATELY 9 square inches.							
Refer to attached drawing.							
RECOMMENDED REPAIRS: CUT OUT AND REPLACE APPROXIMATELY 1SF OF SHELL PLATING. PRESERVE AND PAINT TO MATCH.

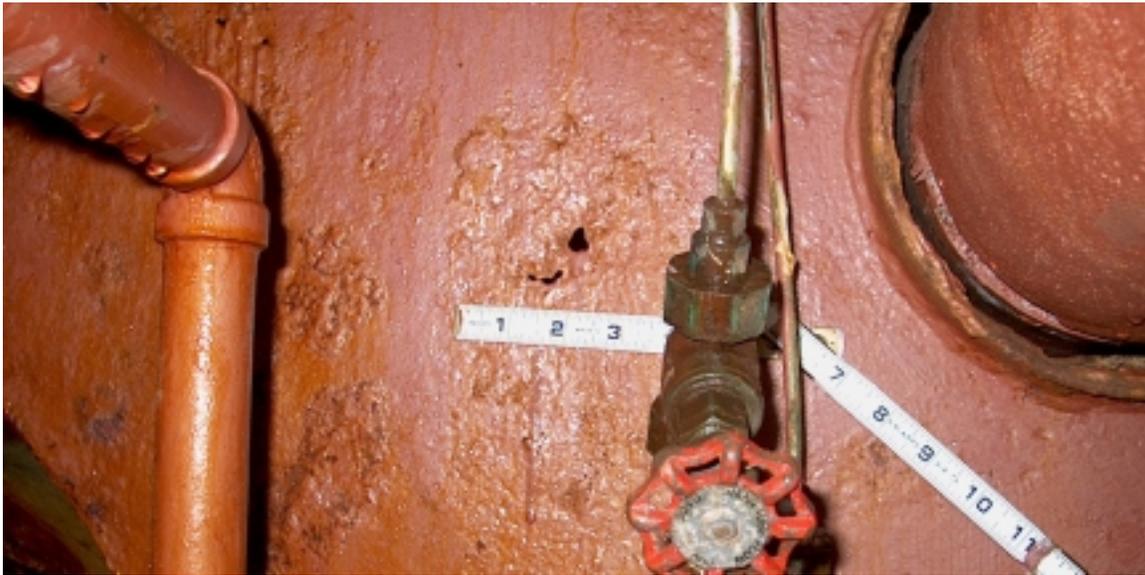
SAFETY HAZARD: 1. SERIOUS - CORRECT AS SOON AS POSSIBLE 2. SERIOUS - SUSPENSION OF EQUIPMENT/SYSTEM/SPACE REQUIRED 3. SERIOUS - WAIVER OF EQUIPMENT/SYSTEM 4. SAFETY ITEM - MINOR 5. COMBUSTIBLE MATERIAL		1. MAINTENANCE ACTION COMPLETED: PARTS DRAWN FROM SUPPLY 2. MAINTENANCE ACTION COMPLETED: REQUIRED PARTS NOT DRAWN FROM SUPPLY 3. MAINTENANCE ACTION COMPLETED: NO PARTS REQUIRED 4. CANCELLED - DEFERRAL WILL BE REMOVED FROM CSMP 7. MAINTENANCE ACTION COMPLETED: 3-M CAPABILITY UTILIZED 0. NONE OF THE ABOVE, DESCRIBE IN REMARKS/DESCRIPTION SECTION			1. MANDATORY 2. ESSENTIAL 3. HIGHLY DESIRABLE 4. DESIRABLE		
DISCREPANCY DESCRIPTION: PER SEMAT I INSPECTION (5-292-0-E), Transverse WF (316) at center line has heavy pitting and holes U/T readings are noted on drawing. Horizontal stiffener on fwd side of WF above shaft opening is severely corroded. The vertical stiffeners on both sides are severely corroded and holed. Approximately 16 SF of .250 plate and 14 linear feet of 4x3x.375 angle.

TRANSVERSE WEB FRAME (316) STBD OF CENTER LINE LOOKING FWD
REFER TO DRAWING REGARDING U/T READINGS.

RECOMMENDED REPAIRS: Cut out and replace approximately 16 SF of transverse WF (316), and 14 linear ft of associated Stiffeners. FTSC IS TO CONDUCT RISK ASSESSMENT AND MAKE FINAL REPAIR RECOMMENDATIONS.							
SSPORT C221 POC: F. PRAISSMAN (757) 396-4001 EXT 2130, TPOC: B. WILLIAMS/ M. MELVIN							
CSMP SUMMARY: Transverse WF (316) showing signs of deterioration.				TEST# MRC 1102/1			
ROOT CAUSE/AMPLIFICATION: H1				STEP# 1,2,3,4 & 5			
SYSTEM LEVEL IMPACT:							
PART NO.	NOMENCLATURE			QTY	NSN	COST	
1							
2							
3							
4							
5							
6							
FIRST CONTACT HURST	RATE HTC	SECOND CONTACT GERMAN		RATE ENS	PHONE		
ASSESSOR / ACT / TECH ID# J. LaROCK / T. ILGENFRITZ QED SYSTEMS			TD	TL	LOGISTICIAN	TSP

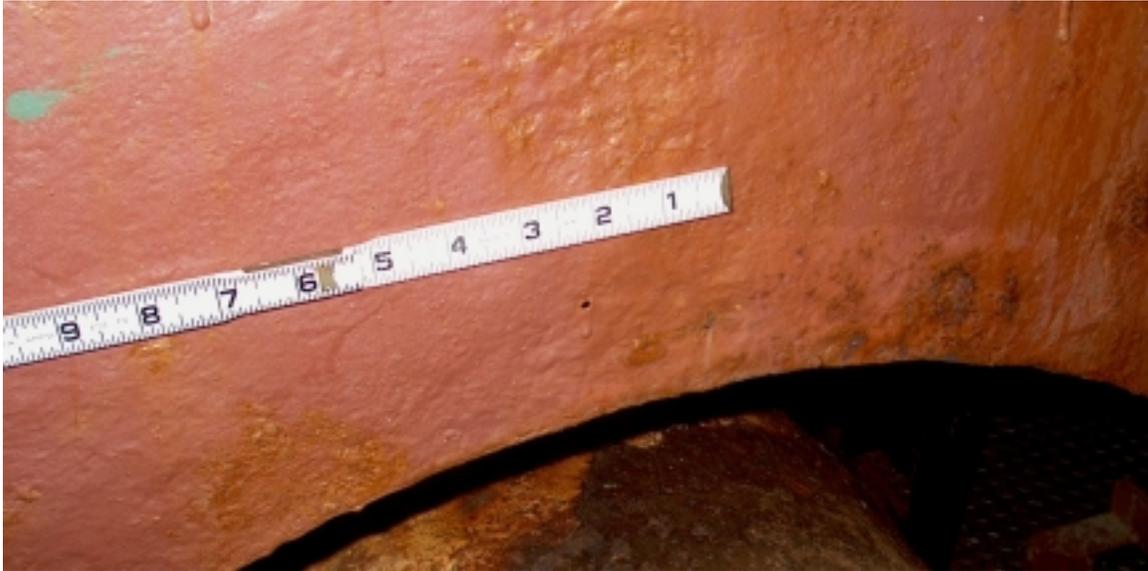
TRANSVERSE WEB FRAME (316) AT CENTER LINE LOOKING FWD
REFER TO DRAWING REGARDING U/T READINGS.

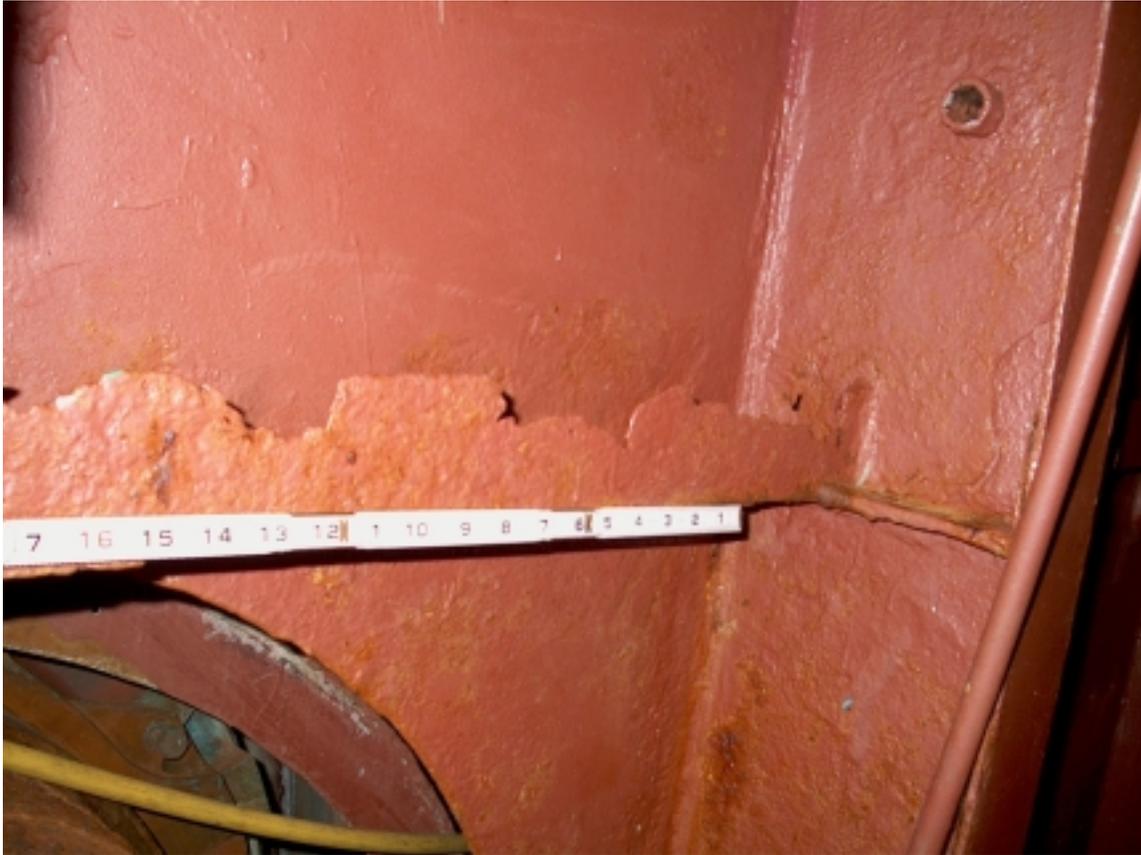
TRANSVERSE WEB FRAME (316) CENTER LINE LOOKING AFT
NOTE HEAVY DETERIORATION OF HORIZONTAL STIFFENER

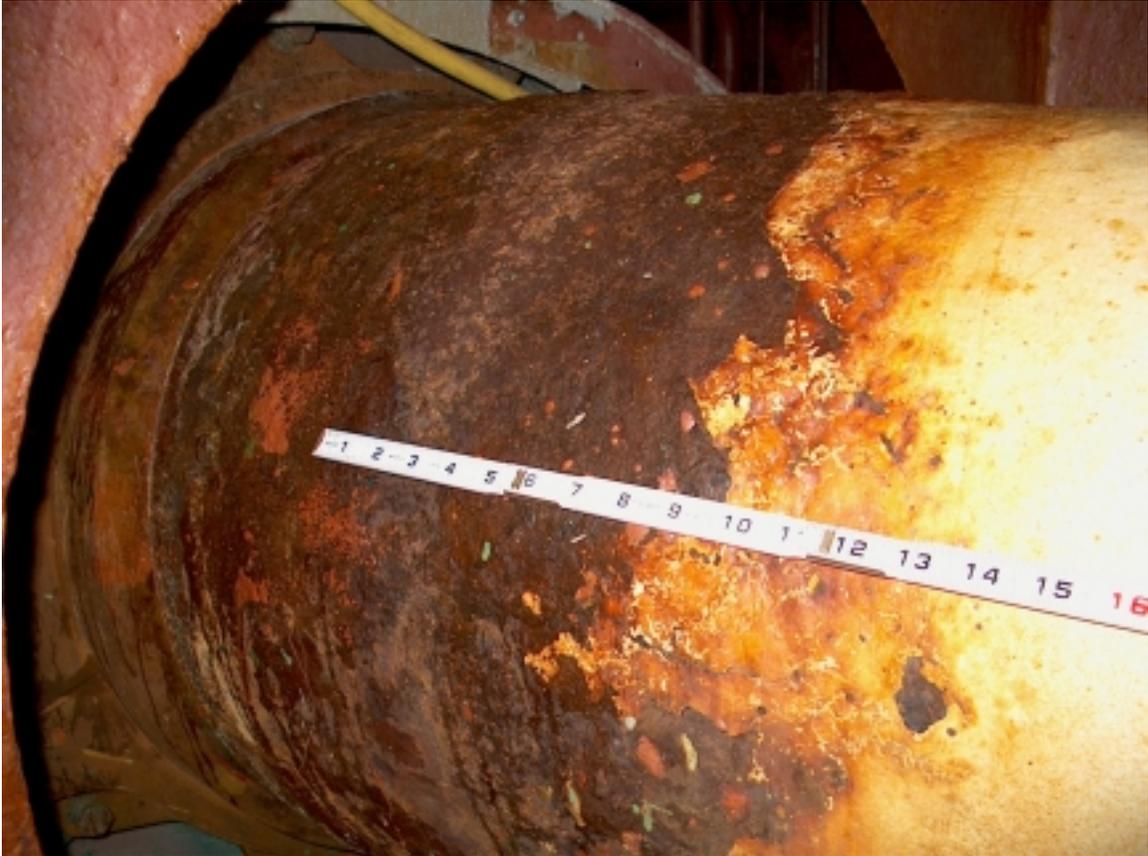
DISCREPANCY DESCRIPTION: PER SEMAT II UNDERWATER HULL ASSESSMENT: (5-292-0-E), CENTER LINE AT TRANSVERSE WEB FRAME (316) APPROXIMATELY 58 SF OF SHAFT HAS HEAVY RUST AND PAINT SEPARATION.						
RECOMMENDED REPAIRS: NEEDLE-GUN APPROXIMATELY 58 SF OF SHAFT, PRESERVE AND PAINT TO MATCH.						
CSMP SUMMARY: SHAFT HAS HEAVY RUST AND PAINT SEPARATION.						
SSPORT C221 POC: F. PRAISSMAN (757) 396-4001 EXT 2130, TPOC: B. WILLIAMS/ M. MELVIN						
				TEST#	MRC 1102/1	
ROOT CAUSE/AMPLIFICATION: H1				STEP#	1,2,3,4 & 5	
SYSTEM LEVEL IMPACT:						
PART NO.	NOMEMCLATURE			QTY	NSN	COST
1						
2						
3						
4						
5						
FIRST CONTACT HURST	RATE HTC	SECOND CONTACT GERMAN		RATE ENS	PHONE	
ASSESSOR / ACT / TECH ID# J. LaROCK/ T. ILGENFRITZ QED SYSTEMS INC.			TD	TL	LOGISTICIAN	TSP

SHAFT AT TRANSVERSE WEB FRAME (316)
SHOWING HEAVY PAINT SEPARATION
AREA RECOMMENDED FOR PRESERVATION.

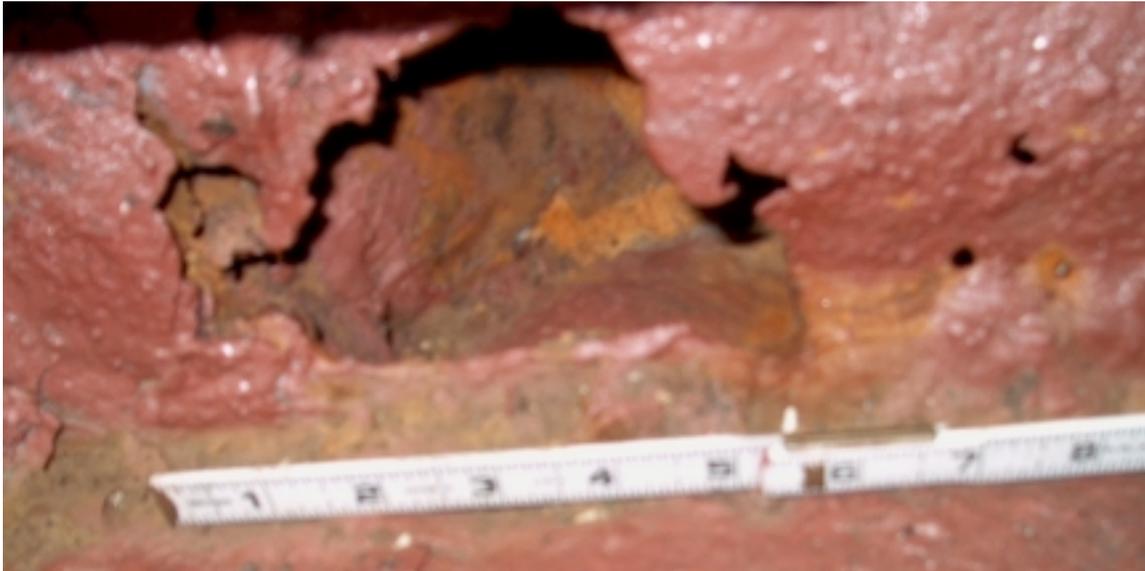
SAFETY HAZARD: 1. SERIOUS - CORRECT AS SOON AS POSSIBLE 2. SERIOUS - SUSPENSION OF EQUIPMENT/SYSTEM/SPACE REQUIRED 3. SERIOUS - WAIVER OF EQUIPMENT/SYSTEM 4. SAFETY ITEM - MINOR 5. COMBUSTIBLE MATERIAL		1. MAINTENANCE ACTION COMPLETED: PARTS DRAWN FROM SUPPLY 2. MAINTENANCE ACTION COMPLETED: REQUIRED PARTS NOT DRAWN FROM SUPPLY 3. MAINTENANCE ACTION COMPLETED: NO PARTS REQUIRED 4. CANCELLED - DEFERRAL WILL BE REMOVED FROM CSMP 7. MAINTENANCE ACTION COMPLETED: 3-M CAPABILITY UTILIZED 0. NONE OF THE ABOVE, DESCRIBE IN REMARKS/DESCRIPTION SECTION		1. MANDATORY 2. ESSENTIAL 3. HIGHLY DESIRABLE 4. DESIRABLE			
DISCREPANCY DESCRIPTION: PER SEMAT II UNDERWATER HULL ASSESSMENT: (5-292-0-E), STBD SIDE, BETWEEN BHD (292) AND WF (300) UNDER HOT POTABLE WATER ACCUMULATOR TANK STRINGER (8) HAS HEAVY DETERIORATION AND LARGE HOLES. UNABLE TO DO U/T SURVEY, DUE TO LOCATION. REFER TO PICTURE PAGE FOR REFERENCE.

STBD SIDE UNDER HOT POTABLE WATER ACCUMULATOR TANK
STRINGER (8) HAS HEAVY DETERIORATION.

RECOMMENDED REPAIRS: CUT OUT AND REPLACE APPROXIMATELY 8 LINEAR FEET OF 6X6 T-BEAM. PRESERVE AND PAINT TO MATCHL. FTSC IS TO CONDUCT RISK ASSESSMENT AND MAKE FINAL REPAIR RECOMMENDATIONS.							
CSMP SUMMARY: STRINGER 8 IS HEAVILY DETERIORATED.							
SSPORT C221 POC: F. PRAISSMAN (757) 396-4001 EXT 2130, TPOC: B. WILLIAMS/ M. MELVIN							
				TEST# MRC 1102/1			
ROOT CAUSE/AMPLIFICATION: H1				STEP# 1,2,3,4 & 5			
SYSTEM LEVEL IMPACT:							
PART NO.	NOMEMCLATURE			QTY	NSN	COST	
1							
2							
3							
4							
5							
6							
FIRST CONTACT HURST	RATE HTC	SECOND CONTACT GERMAN		RATE ENS	PHONE		
ASSESSOR / ACT / TECH ID# J. LaROCK/ T. ILGENFRITZ QED SYSTEMS INC.			TD	TL	LOGISTICIAN	TSP

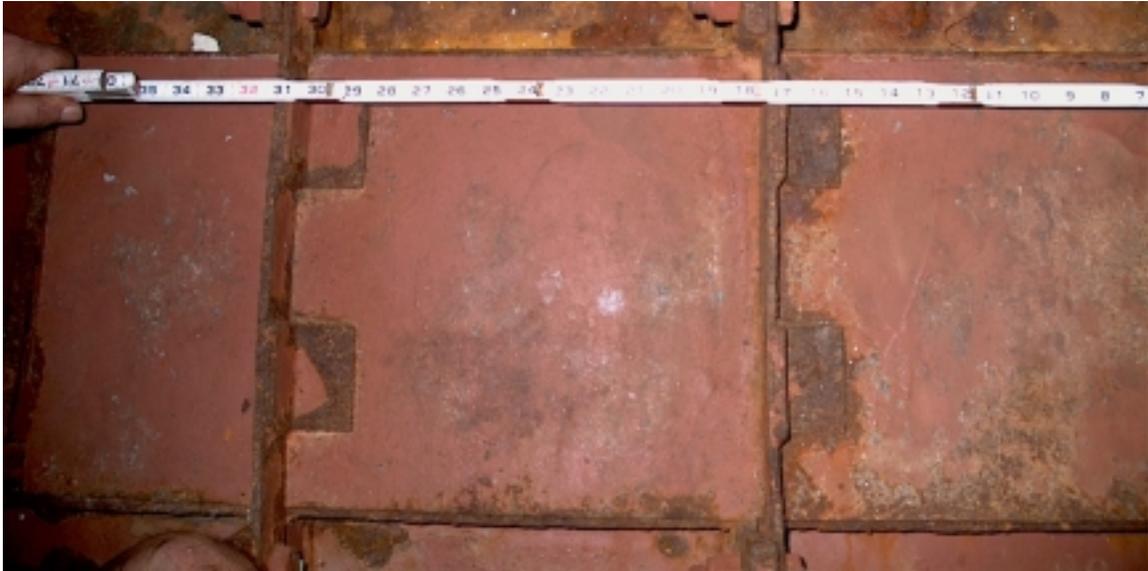
SAFETY HAZARD: 1. SERIOUS - CORRECT AS SOON AS POSSIBLE 2. SERIOUS - SUSPENSION OF EQUIPMENT/SYSTEM/SPACE REQUIRED 3. SERIOUS - WAIVER OF EQUIPMENT/SYSTEM 4. SAFETY ITEM - MINOR 5. COMBUSTIBLE MATERIAL		1. MAINTENANCE ACTION COMPLETED: PARTS DRAWN FROM SUPPLY 2. MAINTENANCE ACTION COMPLETED: REQUIRED PARTS NOT DRAWN FROM SUPPLY 3. MAINTENANCE ACTION COMPLETED: NO PARTS REQUIRED 4. CANCELLED - DEFERRAL WILL BE REMOVED FROM CSMP 7. MAINTENANCE ACTION COMPLETED: 3-M CAPABILITY UTILIZED 0. NONE OF THE ABOVE, DESCRIBE IN REMARKS/DESCRIPTION SECTION			1. MANDATORY 2. ESSENTIAL 3. HIGHLY DESIRABLE 4. DESIRABLE		
DISCREPANCY DESCRIPTION: PER SEMAT II INSPECTION :							
Port side (5-250-0-E), between WF (264-270), from margin plate to stringer (11) approximately 70sf of rust and heavy paint							
Separation, there is lead ballast blocks between stringers (8-10). The transverse weld seam AFT of WF (270) approximately

PORT SIDE, SHOWING LEAD BALLAST

30SF of surface rust and paint separation.							
RECOMMEND REPAIR ACTIVITY:							
Recommend removal of lead ballast blocks for safety, needle-gun approximately 100sf of area, preserve and paint to match.							
FTSC IS TO CONDUCT RISK ASSESSMENT AND MAKE FINAL REPAIR RECOMMENDATIONS.							
SSPORT C221 POC: F. PRAISSMAN (757) 396-4001 EXT 2130, TPOC: B. WILLIAMS/M. MELVIN							
CSMP SUMMARY: APPROXIMATELY 100 SF OF SURFACE RUST AND PAINT SEPARATION.					TEST# MRC 1102/1		
ROOT CAUSE/AMPLIFICATION: H1					STEP# 1,2,3,4 & 5		
SYSTEM LEVEL IMPACT:							
PART NO.	NOMEMCLATURE			QTY	NSN	COST	
1							
2							
3							
4							
5							
6							
FIRST CONTACT HURST	RATE HTC	SECOND CONTACT GERMAN		RATE ENS	PHONE		
ASSESSOR / ACT / TECH ID# J. LaROCK / T. ILGENFRITZ QED SYSTEMS				TD	TL	LOGISTICIAN	
						TSP

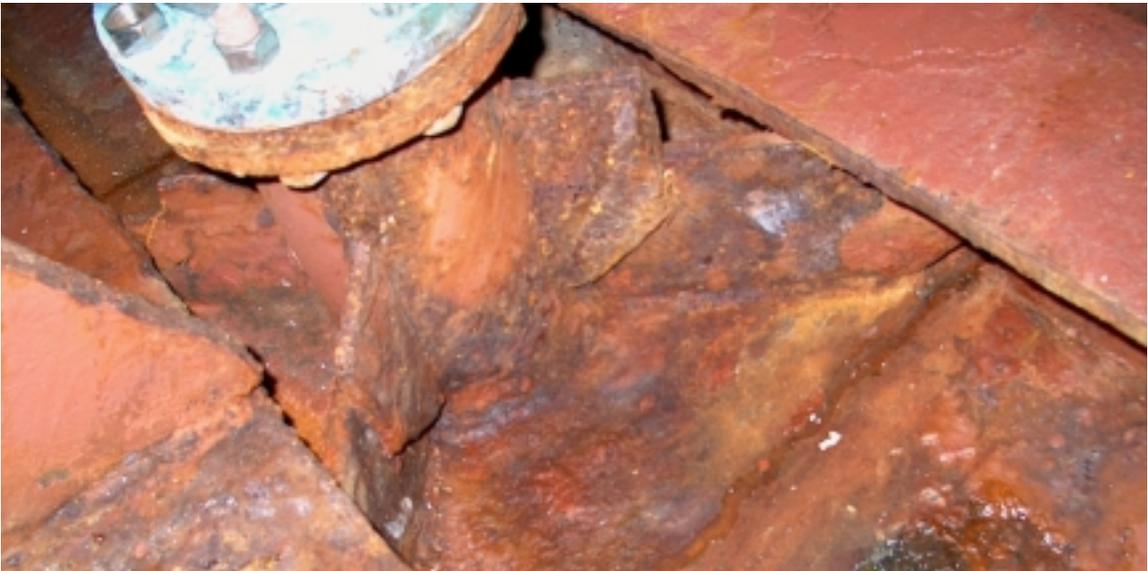
PORT SIDE, OVBD DISCHARGE ABOVE BALLAST
AREA RECOMMENDED FOR CLEANING AND PRESERVATION.

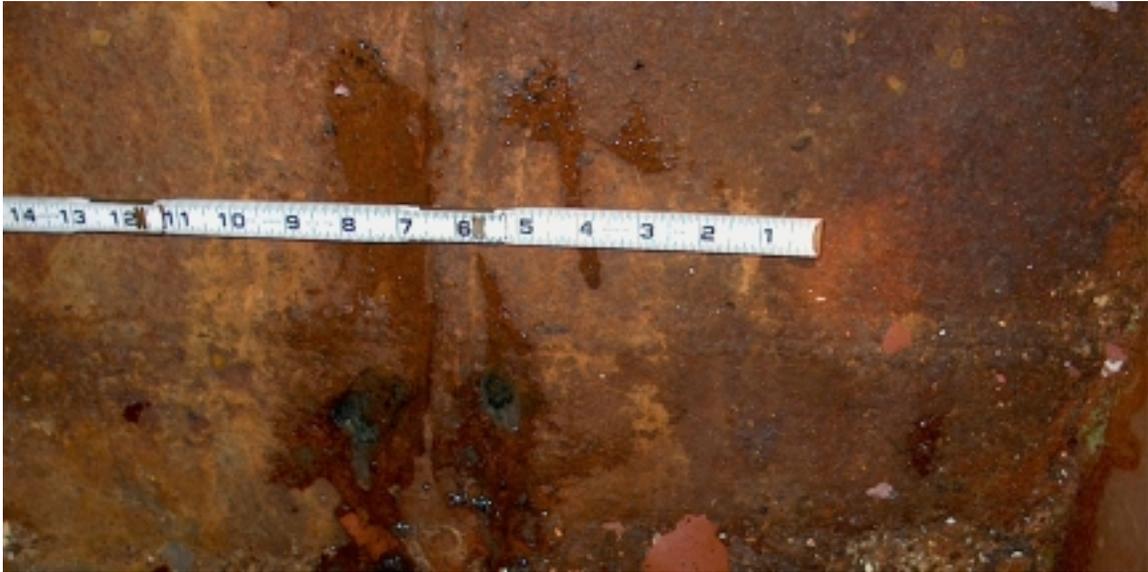
PORT SIDE, AT TRANSVERSE WELD SEAM AFT OF WF (270)

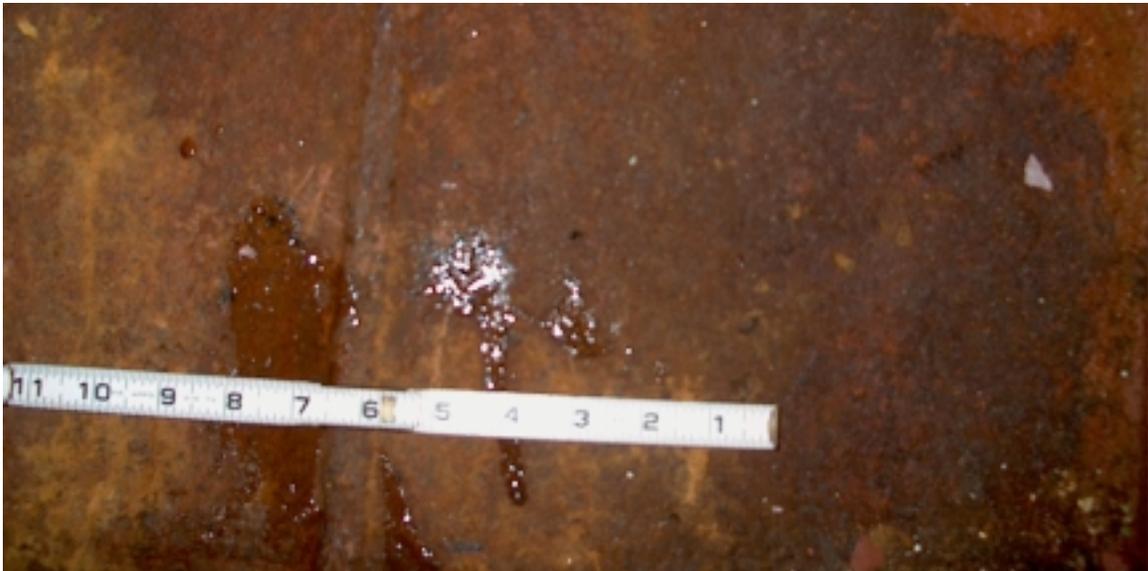
TRANSVERSE WELD SEAM, REFER TO DRAWING FOR U/T READINGS.

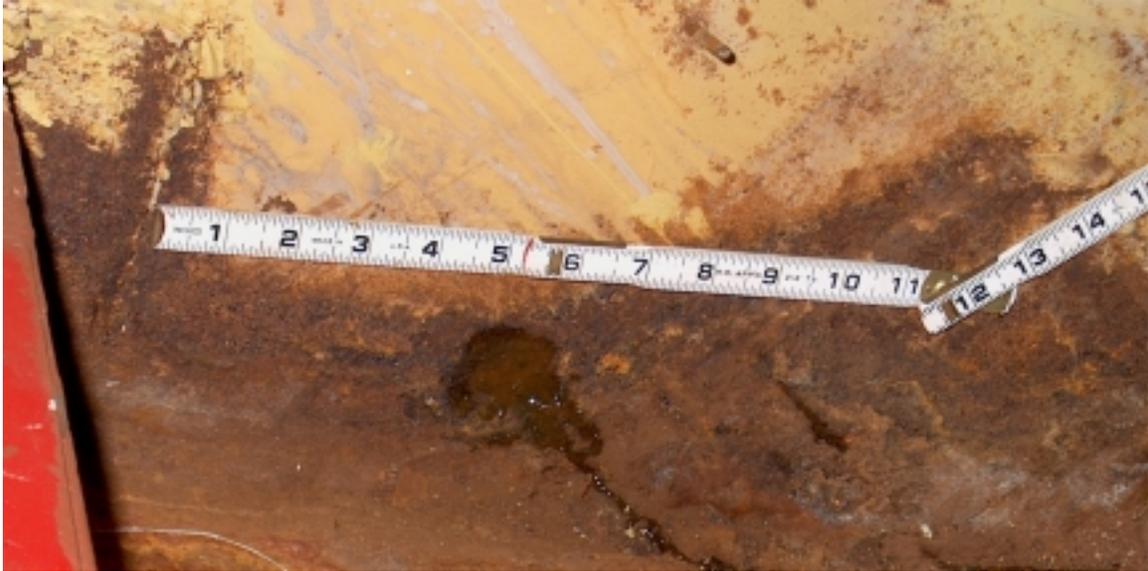
SSPORT C221 POC: F. PRAISSMAN (757) 396-4001 EXT 2130, TPOC: B. WILLIAMS/ M. MELVIN							
CSMP SUMMARY: 10 SF OF RUST AND PAINT SEPARATION .				TEST# MRC 1102/1			
ROOT CAUSE/AMPLIFICATION: H1				STEP# 1,2,3,4 & 5			
SYSTEM LEVEL IMPACT:							
PART NO.	NOMEMCLATURE			QTY	NSN	COST	
1							
2							
3							
4							
5							
6							
FIRST CONTACT HURST	RATE HTC	SECOND CONTACT GERMAN		RATE ENS	PHONE		
ASSESSOR / ACT / TECH ID# J. LaROCK/ T. ILGENFRITZ OED SYSTEMS INC.			TD	TL	LOGISTICIAN	TSP

PORT SIDE, WHERE BHD (212) MEETS SHELL PLATE
U/T READINGS ARE NOTED IN DRAWINGS

SAFETY HAZARD: 1. SERIOUS - CORRECT AS SOON AS POSSIBLE 2. SERIOUS - SUSPENSION OF EQUIPMENT/SYSTEM/SPACE REQUIRED 3. SERIOUS - WAIVER OF EQUIPMENT/SYSTEM 4. SAFETY ITEM - MINOR 5. COMBUSTIBLE MATERIAL			1. MAINTENANCE ACTION COMPLETED: PARTS DRAWN FROM SUPPLY 2. MAINTENANCE ACTION COMPLETED: REQUIRED PARTS NOT DRAWN FROM SUPPLY 3. MAINTENANCE ACTION COMPLETED: NO PARTS REQUIRED 4. CANCELLED - DEFERRAL WILL BE REMOVED FROM CSMP 7. MAINTENANCE ACTION COMPLETED: 3-M CAPABILITY UTILIZED 0. NONE OF THE ABOVE, DESCRIBE IN REMARKS/DESCRIPTION SECTION		1. MANDATORY 2. ESSENTIAL 3. HIGHLY DESIRABLE 4. DESIRABLE		
DISCREPANCY DESCRIPTION: PER SEMAT II UNDERWATER HULL ASSESSMENT: PORT SIDE, (5-212-0-E) WHERE BHD (212) MEETS SHELL PLATE, FROM STRINGER (7-11), APPROXIMATELY 10SF OF SURFACE RUST AND PAINT SEPARATION.							
RECOMMENDED REPAIRS: NEEDLE-GUN APPROXIMATELY 10SF PRESERVE AND PAINT TO MATCH AREA.

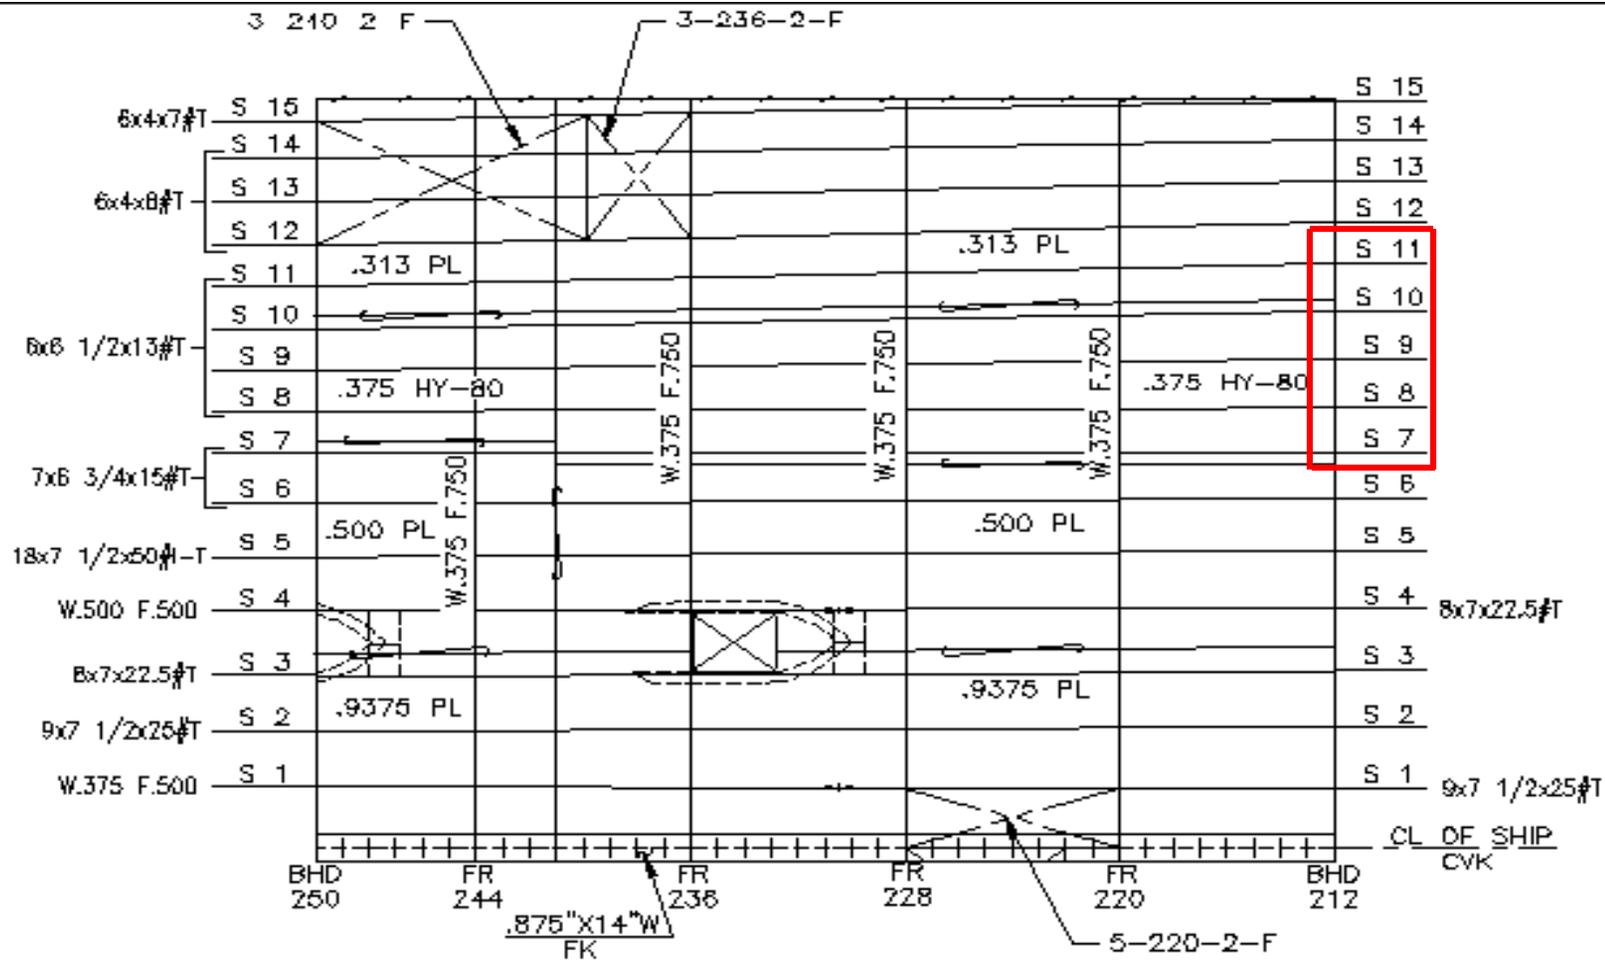
USS STEPHEN W GROVES
 AUXILIARY MACHINERY ROOM 2 (5-212-0-E)
 PORT SIDE

RED BOX INDICATES AREA WHERE U/T
 READINGS WERE TAKEN
 SEE PAGE 31

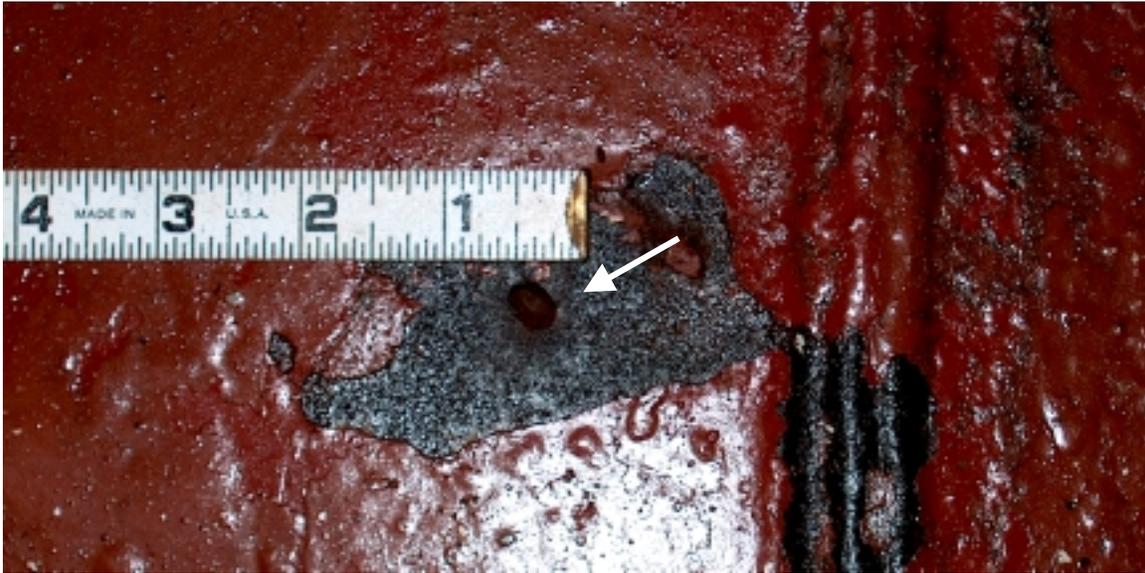
SSPORT C221 POC: F. PRAISSMAN (757) 396-4001 EXT 2130, TPOC: B. WILLIAMS/ M. MELVIN							
CSMP SUMMARY: SHELL HAS SMALL PIT'S				TEST# MRC 1102/1			
ROOT CAUSE/AMPLIFICATION: H1				STEP# 1,2,3,4 & 5			
SYSTEM LEVEL IMPACT:							
PART NO.	NOMEMCLATURE			QTY	NSN	COST	
1							
2							
3							
4							
5							
6							
FIRST CONTACT HURST	RATE HTC	SECOND CONTACT GERMAN		RATE ENS	PHONE		
ASSESSOR / ACT / TECH ID# J. LaROCK/ T. ILGENFRITZ OED SYSTEMS INC.			TD	TL	LOGISTICIAN	TSP

STBD SIDE, INSIDE SSDG ENCLOSURE BETWEEN STRINGERS (10-11)
34" AFT OF WF 196

SAFETY HAZARD: 1. SERIOUS - CORRECT AS SOON AS POSSIBLE 2. SERIOUS - SUSPENSION OF EQUIPMENT/SYSTEM/SPACE REQUIRED 3. SERIOUS - WAIVER OF EQUIPMENT/SYSTEM 4. SAFETY ITEM - MINOR 5. COMBUSTIBLE MATERIAL		1. MAINTENANCE ACTION COMPLETED: PARTS DRAWN FROM SUPPLY 2. MAINTENANCE ACTION COMPLETED: REQUIRED PARTS NOT DRAWN FROM SUPPLY 3. MAINTENANCE ACTION COMPLETED: NO PARTS REQUIRED 4. CANCELLED - DEFERRAL WILL BE REMOVED FROM CSMP 7. MAINTENANCE ACTION COMPLETED: 3-M CAPABILITY UTILIZED 0. NONE OF THE ABOVE, DESCRIBE IN REMARKS/DESCRIPTION SECTION			1. MANDATORY 2. ESSENTIAL 3. HIGHLY DESIRABLE 4. DESIRABLE		
DISCREPANCY DESCRIPTION: PER SEMAT II UNDERWATER HULL ASSESSMENT: STBD SIDE, (5-180-0-E) INSIDE THE SSDG ENCLOSURE BETWEEN STRINGERS (10-11) 34" AFT OF WF (196) SHELL HAS SMALL PIT'S. U/T READINGS ARE WITHIN THE 25% ALLOWABLE THICKNESS.							
RECOMMENDED REPAIRS: RECOMMEND SHIP'S FORCE, CLAD WELD AREA, PRESERVE AND PAINT TO MATCH.

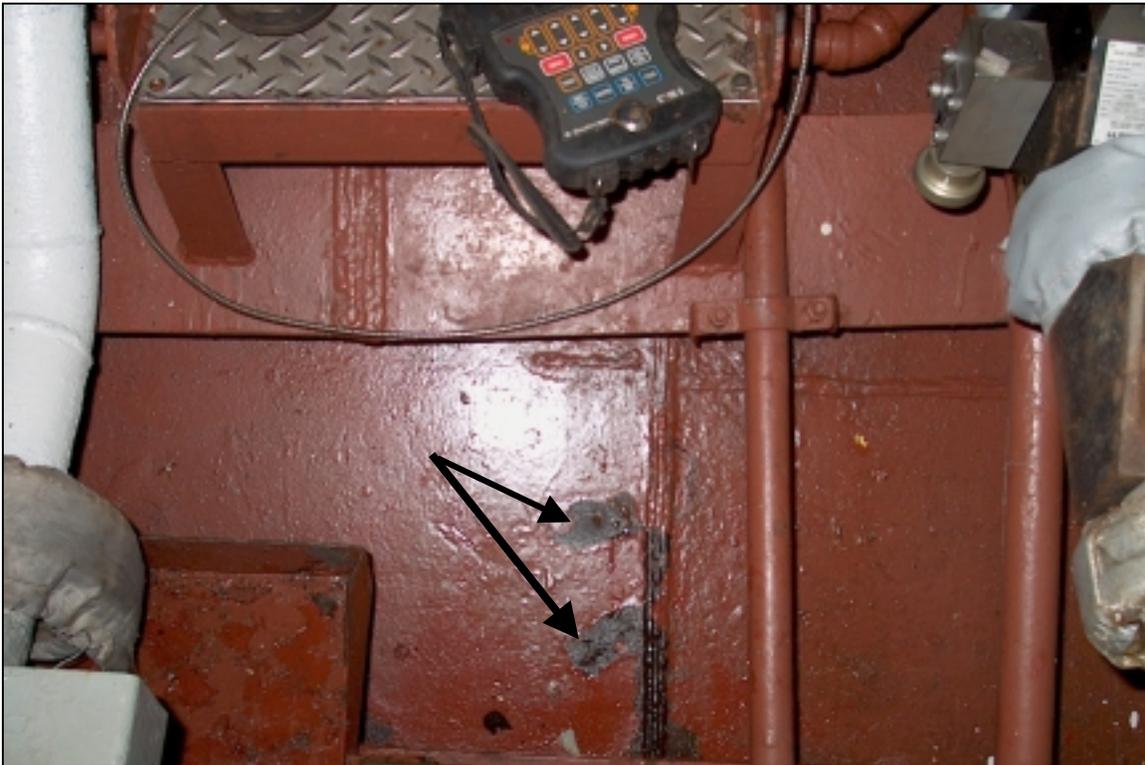
ARROWS INDICATE LOCATION OF PITTING

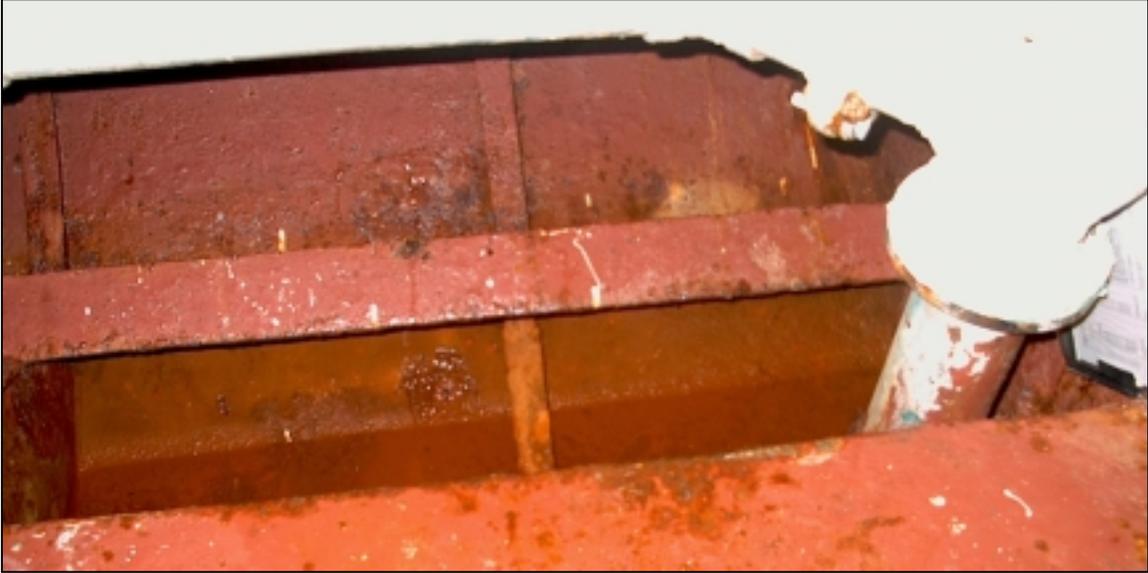
DISCREPANCY DESCRIPTION: PER SEMAT II UNDERWATER HULL ASSESSMENT: (5-51-0-Q) FWD EDUCATOR ROOM,, ENTIRE						
BILGE AREA HAS RUST AND HEAVY PAINT SEPARATION. APPROXIMATELY 60 SF.						
RECOMMENDED REPAIRS: NEEDLE-GUN APPROXIMATELY 60 SF (ENTIRE BILGE AREA), PRESERVE AND PAINT TO MATCH AREA.						
SSPORT C221 POC: F. PRAISSMAN (757) 396-4001 EXT 2130, TPOC: B. WILLIAMS/ M. MELVIN						
CSMP SUMMARY: ENTIRE BILGE AREA HAS RUST AND PAINT SEPARATION.				TEST# MRC 1102/1		
ROOT CAUSE/AMPLIFICATION: H1				STEP# 1,2,3,4 & 5		
SYSTEM LEVEL IMPACT:						
PART NO.	NOMEMCLATURE			QTY	NSN	COST
1						
2						
3						
4						
5						
6						
FIRST CONTACT HURST	RATE HTC	SECOND CONTACT GERMAN		RATE ENS	PHONE	
ASSESSOR / ACT / TECH ID# J. LaROCK/ T. ILGENFRITZ QED SYSTEMS INC.			TD	TL	LOGISTICIAN	TSP

STBD SIDE, BILGE POCKET

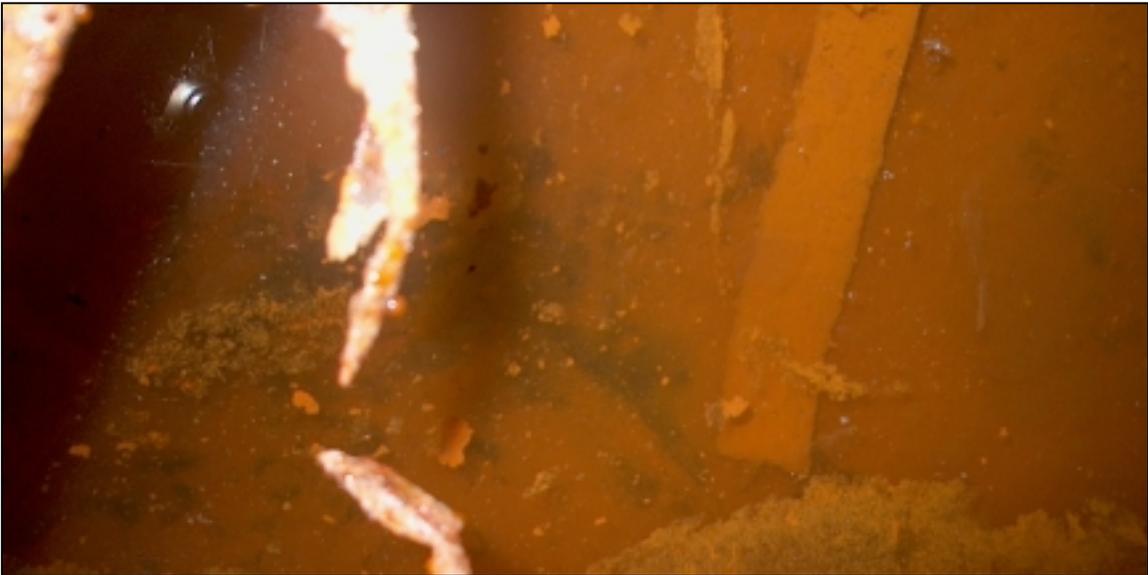
STBD SIDE, BILGE POCKET FULL OF WATER.
