— USS STEPHEN W GROVES —

(FFG-29)

**SEMAT II SHELL CONDITION ASSESSMENT SURVEY
INTERIOR AREAS
6/24/01 – 7/6/01**

**PREPARED BY SUPSHIP
PORTSMOUTH
07/10/01**

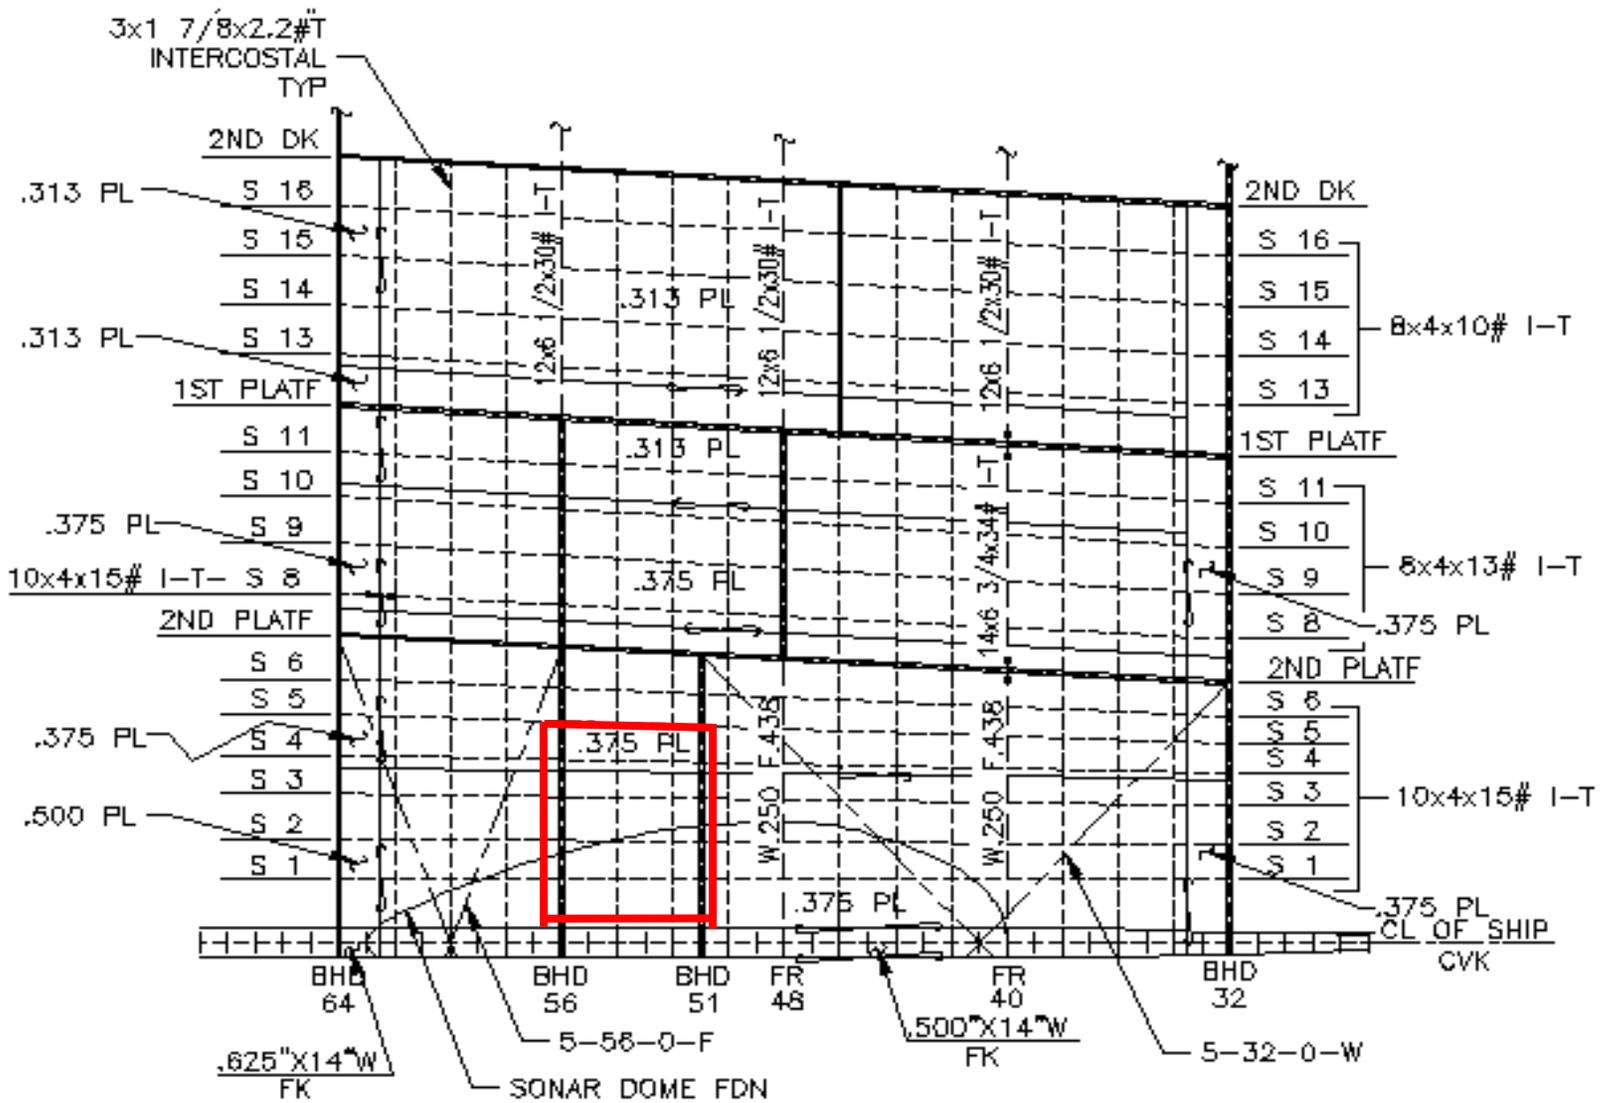
USS STEPHEN W GROVES (FFG-29)
EDUCATOR ROOM (5-51-0-Q)
STBD SIDE

RED BOX INDICATES AREA WHERE U/T
READINGS WERE TAKEN
SEE PAGE 36

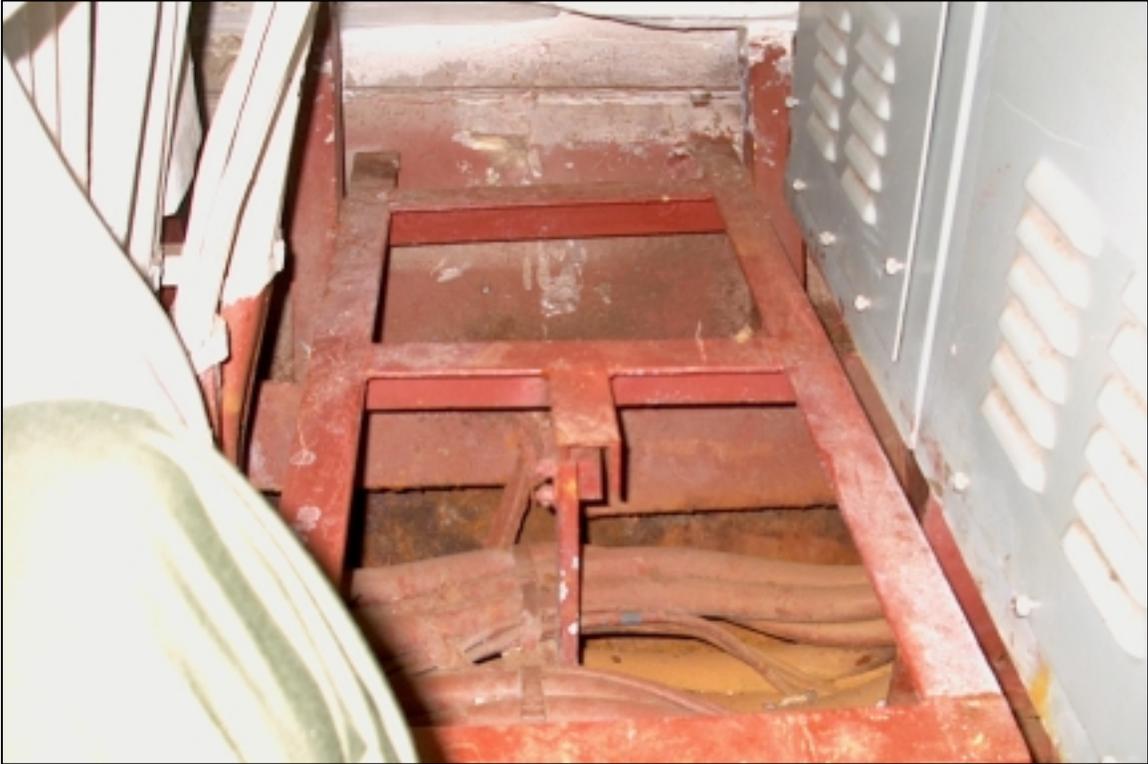
DISCREPANCY DESCRIPTION: PER SEMAT II UNDERWATER HULL ASSESSMENT: APU WELL STBD SIDE, (4-100-0-E) ENTIRE BILGE POCKET HAS HEAVY RUST AND PAINT SEPARATION. APPROXIMATELY 40 SF						
RECOMMENDED REPAIRS: NEEDLE-GUN APPROXIMATELY 40 SF OF BILGE POCKET, PRESERVE AND PAINT TO MATCH AREA.						
SSPORT C221 POC: F. PRAISSMAN (757) 396-4001 EXT 2130, TPOC: B. WILLIAMS/ M. MELVIN						
CSMP SUMMARY: STBD BILGE POCKET HAS SURFACE RUST AND PAINT SEPARATION.				TEST# MRC 1102/1		
ROOT CAUSE/AMPLIFICATION: H1				STEP# 1,2,3,4 & 5		
SYSTEM LEVEL IMPACT:						
PART NO.	NOMEMCLATURE			QTY	NSN	COST
1						
2						
3						
4						
5						
6						
FIRST CONTACT HURST	RATE HTC	SECOND CONTACT GERMAN		RATE ENS	PHONE	
ASSESSOR / ACT / TECH ID# J. LaROCK/ T. ILGENFRITZ QED SYSTEMS INC.			TD	TL	LOGISTICIAN	TSP

STBD SIDE, AREA VIEW OF BILGE POCKET

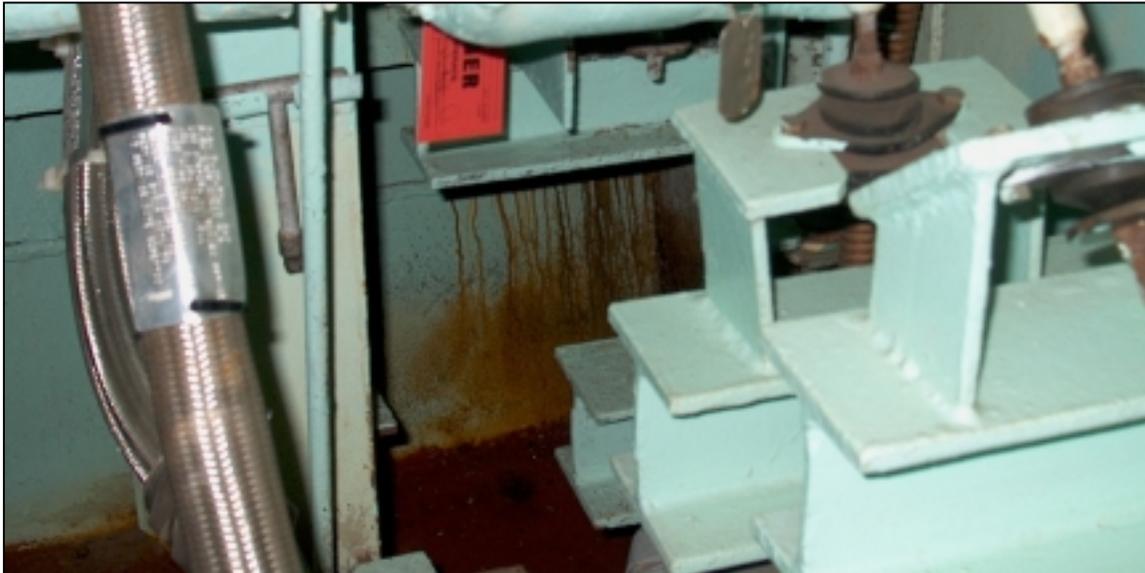
DISCREPANCY DESCRIPTION: PER SEMAT II UNDERWATER HULL ASSESSMENT: SONAR COOLING RM, STBD SIDE (4-48-1-Q), APPROXIMATELY 6SF OF STRINGERS AND SHELL PLATE BETWEEN BHD (56) AND FIRST VERTICAL STIFFNER UP TO THIRD STRINGER OFF THE DECK AND APPROXIMATELY 6SF OF DECK HAVE SURFACE RUST AND PAINT SEPARATION.						
RECOMMENDED REPAIRS: NEEDLE-GUN APPROXIMATELY 12 SF OF AREA, PRESERVE AND PAINT TO MATCH.						
SSPORT C221 POC: F. PRAISSMAN (757) 396-4001 EXT 2130, TPOC: B. WILLIAMS/ M. MELVIN						
CSMP SUMMARY: DECK AND STRINGERS FROM BHD (56) AND FIRST VERTICAL STIFFNER HAVE RUST.				TEST# MRC 1102/1		
ROOT CAUSE/AMPLIFICATION: H1				STEP# 1,2,3,4 & 5		
SYSTEM LEVEL IMPACT:						
PART NO.	NOMEMCLATURE			QTY	NSN	COST
1						
2						
3						
4						
5						
6						
FIRST CONTACT HURST	RATE HTC	SECOND CONTACT GERMAN		RATE ENS	PHONE	
ASSESSOR / ACT / TECH ID# J. LaROCK/ T. ILGENFRITZ QED SYSTEMS INC.			TD	TL	LOGISTICIAN	TSP

AREA VIEW LOOKING STBD

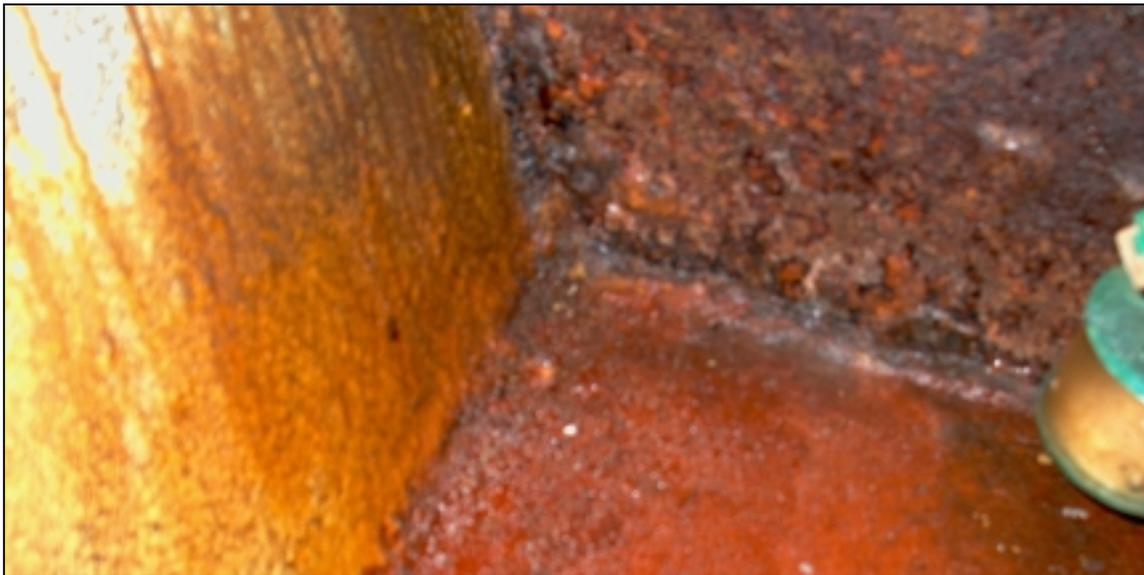
STBD SIDE, WHERE BHD (56) MEETS THE DECK AND SHELL PLATE

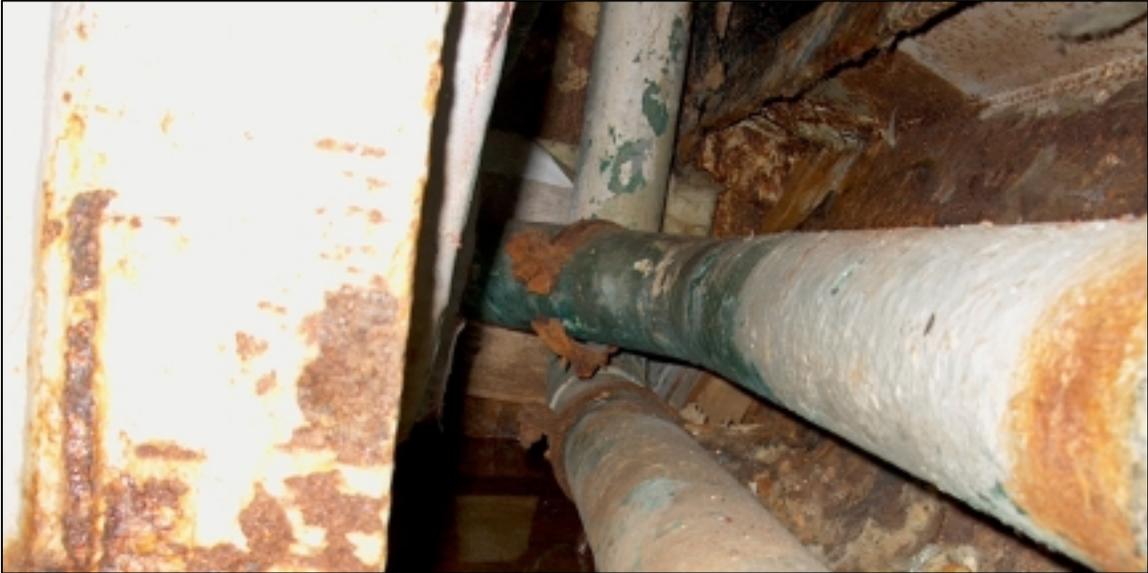
SSPORT C221 POC: F. PRAISSMAN (757) 396-4001 EXT 2130, TPOC: B. WILLIAMS/ M. MELVIN							
CSMP SUMMARY: SHELL AND STRINGER ARE RUSTED WITH PAINT SEPARATION.				TEST# MRC 1102/1			
ROOT CAUSE/AMPLIFICATION: H1				STEP# 1,2,3,4 & 5			
SYSTEM LEVEL IMPACT:							
PART NO.	NOMEMCLATURE			QTY	NSN	COST	
1							
2							
3							
4							
5							
6							
FIRST CONTACT HURST	RATE HTC	SECOND CONTACT GERMAN		RATE ENS	PHONE		
ASSESSOR / ACT / TECH ID# J. LaROCK/ T. ILGENFRITZ QED SYSTEMS INC.			TD	TL	LOGISTICIAN	TSP

PORT SIDE VIEW OF STRINGER AND SHELL

SAFETY HAZARD: 1. SERIOUS - CORRECT AS SOON AS POSSIBLE 2. SERIOUS - SUSPENSION OF EQUIPMENT/SYSTEM/SPACE REQUIRED 3. SERIOUS - WAIVER OF EQUIPMENT/SYSTEM 4. SAFETY ITEM - MINOR 5. COMBUSTIBLE MATERIAL		1. MAINTENANCE ACTION COMPLETED: PARTS DRAWN FROM SUPPLY 2. MAINTENANCE ACTION COMPLETED: REQUIRED PARTS NOT DRAWN FROM SUPPLY 3. MAINTENANCE ACTION COMPLETED: NO PARTS REQUIRED 4. CANCELLED - DEFERRAL WILL BE REMOVED FROM CSMP 7. MAINTENANCE ACTION COMPLETED: 3-M CAPABILITY UTILIZED 0. NONE OF THE ABOVE, DESCRIBE IN REMARKS/DESCRIPTION SECTION			1. MANDATORY 2. ESSENTIAL 3. HIGHLY DESIRABLE 4. DESIRABLE		
DISCREPANCY DESCRIPTION: PER SEMAT II UNDERWATER HULL ASSESSMENT: PORT SIDE, (3-84-0-E) BETWEEN BHD (100) AND WF (90)							
FIRST STRINGER OFF THE DECK, HAS RUST AND PAINT SEPARATION. APPROXIMATELY 20 SF OF SHELL INCLUDING THE STRINGER.							
RECOMMENDED REPAIRS: NEEDLE-GUN APPROXIMATELY 20 SF OF SHELL AND STRINGER FROM WF (90) TO BHD (100), PRESERVE AND PAINT AREA TO MATCH.

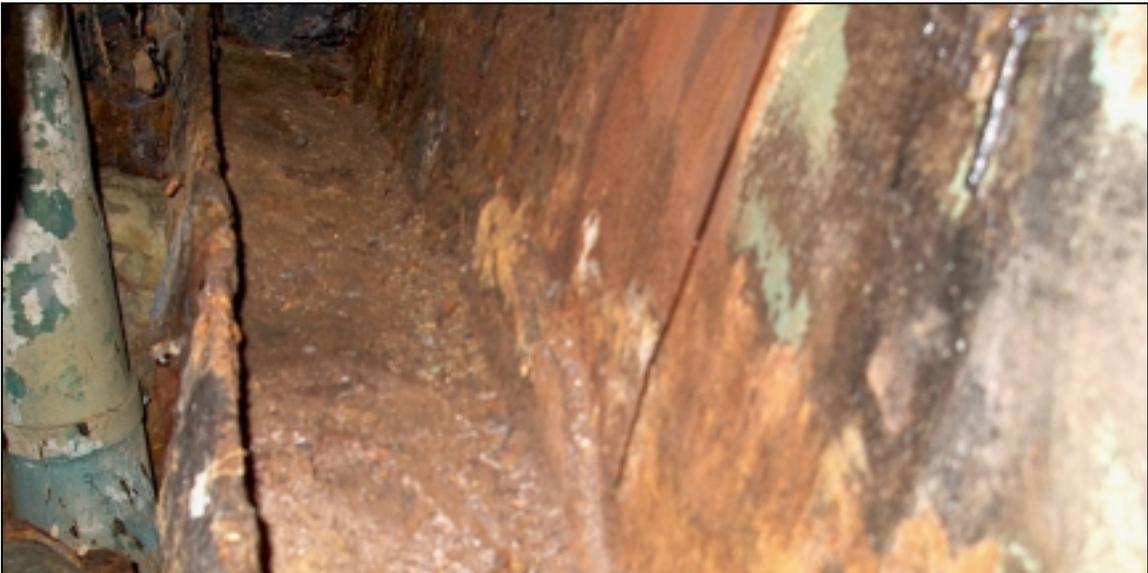
TOP VIEW OF FIRST STRINGER OFF THE DECK BETWEEN WF (90) AND BHD (100)

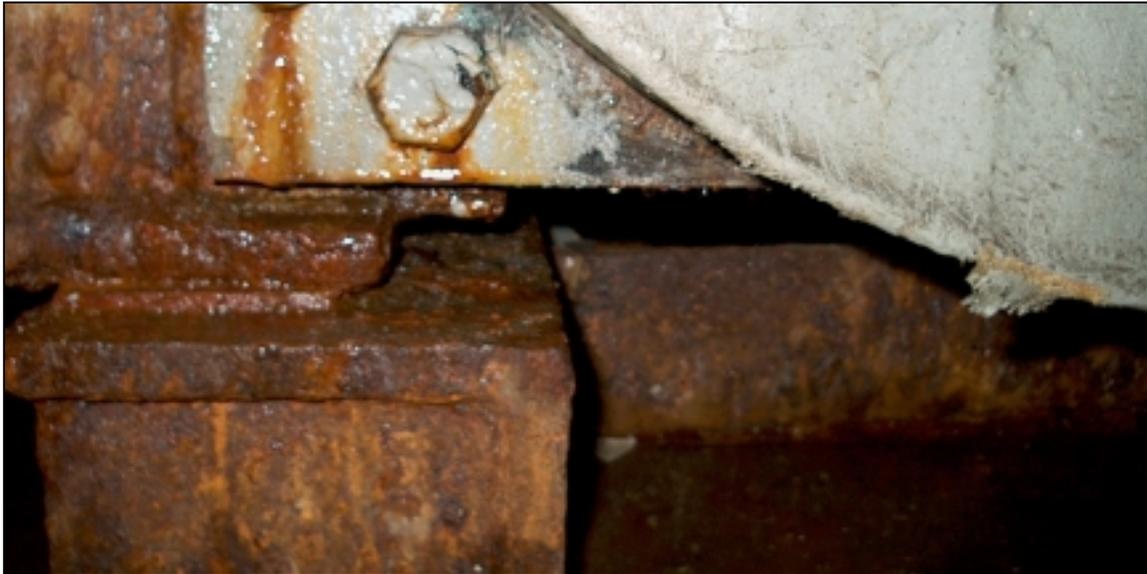
DISCREPANCY DESCRIPTION: PER SEMAT II UNDERWATER HULL ASSESSMENT: PORT SIDE, (3-84-0-E) FOUNDATION UNDER THE A/C						
UNIT NO. 1 AND SURROUNDING TANK TOP/DECK HAS SURFACE RUST AND PAINT SEPARATION, APPROXIMATELY 50 SF						
U/T READINGS WERE FOUND SATISFACTORY. REFER TO DRAWING FOR U/T HISTORY						
RECOMMENDED REPAIRS: NEEDLE-GUN APPROXIMATELY 50 SF OF TANK TOP/DECK INCLUDING FOUNDATION, PRESERVE AND PAINT TO MATCH.						
SSPORT C221 POC: F. PRAISSMAN (757) 396-4001 EXT 2130, TPOC: B. WILLIAMS/ M. MELVIN						
CSMP SUMMARY: TANK TOP/DECK AND FOUNDATION UNDER A/C UNIT ARE RUSTY W/ PAINT SEPARA				TEST # MRC 1102/1		
ROOT CAUSE/AMPLIFICATION: H1				STEP # 1,2,3,4 & 5		
SYSTEM LEVEL IMPACT:						
PART NO.	NOMEMCLATURE			QTY	NSN	COST
1						
2						
3						
4						
5						
6						
FIRST CONTACT HURST	RATE HTC	SECOND CONTACT GERMAN		RATE ENS	PHONE	
ASSESSOR / ACT / TECH ID# J. LaROCK/ T. ILGENFRITZ QED SYSTEMS INC.			TD	TL	LOGISTICIAN	TSP

A/C UNIT NO.1 FOUNDATION LOOKING PORT FWD OF BHD (100)

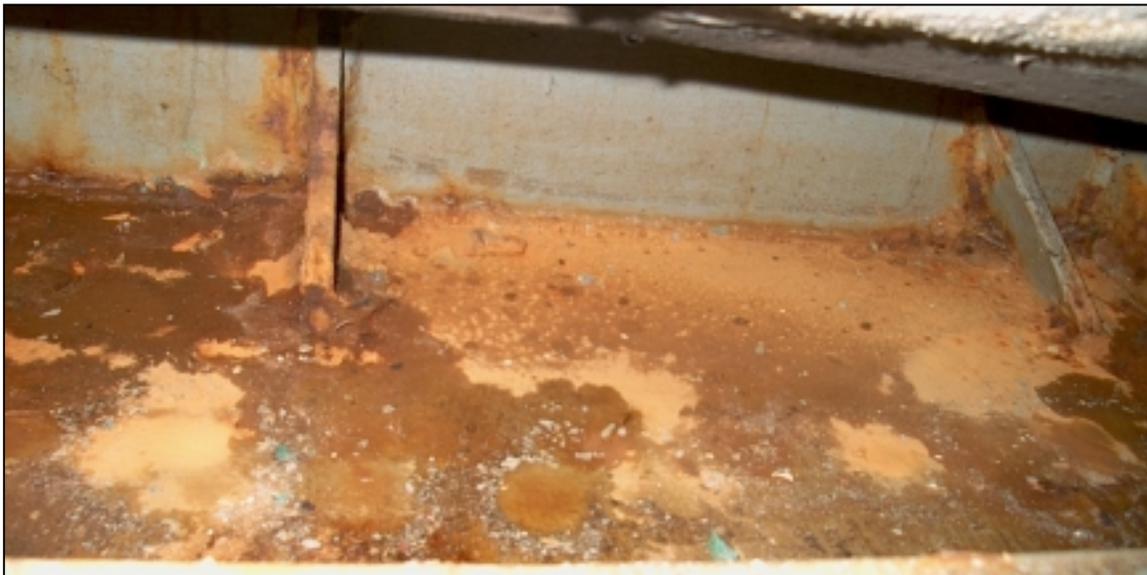
TANK TOP/ DECK UNDER A/C UNIT NO. 1
