USS UNDERWOOD (FFG 36)

SEMAT II SHELL CONDITION ASSESSMENT SURVEY
INTERIOR AREAS

7/23/01 TO 8/3/01

PREPARED BY
SUPERVISOR OF SHIPBUILDING CONVERSION AND REPAIR
PORTSMOUTH, VIRGINIA

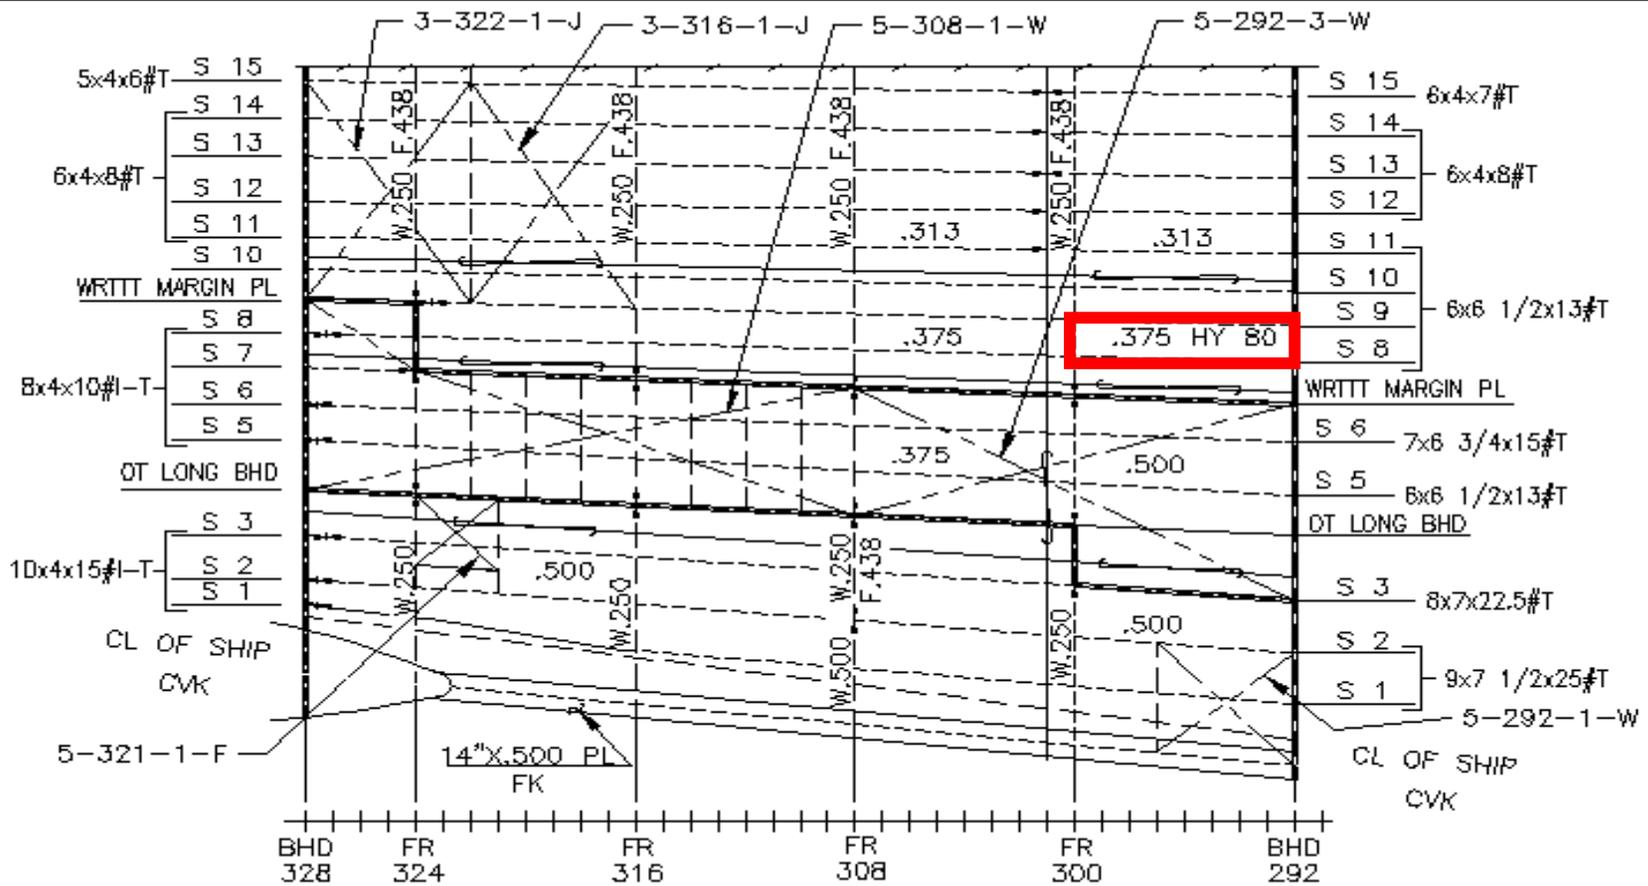
USS UNDERWOOD (FFG-36)
 AUXILIARY MACHINERY ROOM 3
 (5-292-0-E) STBD SIDE

RED BOX INDICATES LOCATION
 OF HOLE ON STRINGER 8
 PICTURE ON FOLLOWING PAGE

RECOMMENDED REPAIRS: CUT OUT AND REPLACE APPROXIMATELY 8 LINEAR FEET OF 6X6 T-BEAM. PRESERVE AND PAINT TO MATCHL. FTSC IS TO CONDUCT RISK ASSESSMENT AND MAKE FINAL REPAIR RECOMMENDATIONS.							
CSMP SUMMARY: STRINGER 8 IS HEAVILY DETERIORATED.							
SSPORT C221 POC: F. PRAISSMAN (757) 396-4001 EXT 2130, TPOC: N. TAGLIANETTI							
					TEST# MRC 1102/1		
ROOT CAUSE/AMPLIFICATION: H1					STEP# 1,2,3,4 & 5		
SYSTEM LEVEL IMPACT:							
PART NO.	NOMENCLATURE			QTY	NSN	COST	
1							
2							
3							
4							
5							
6							
FIRST CONTACT LARSEN	RATE HT1	SECOND CONTACT DUNN		RATE HT2	PHONE		
ASSESSOR / ACT / TECH ID# J. LaROCK / T. ILGENFRITZ QED SYSTEMS INC.				TD	TL	LOGISTICIAN	TSP

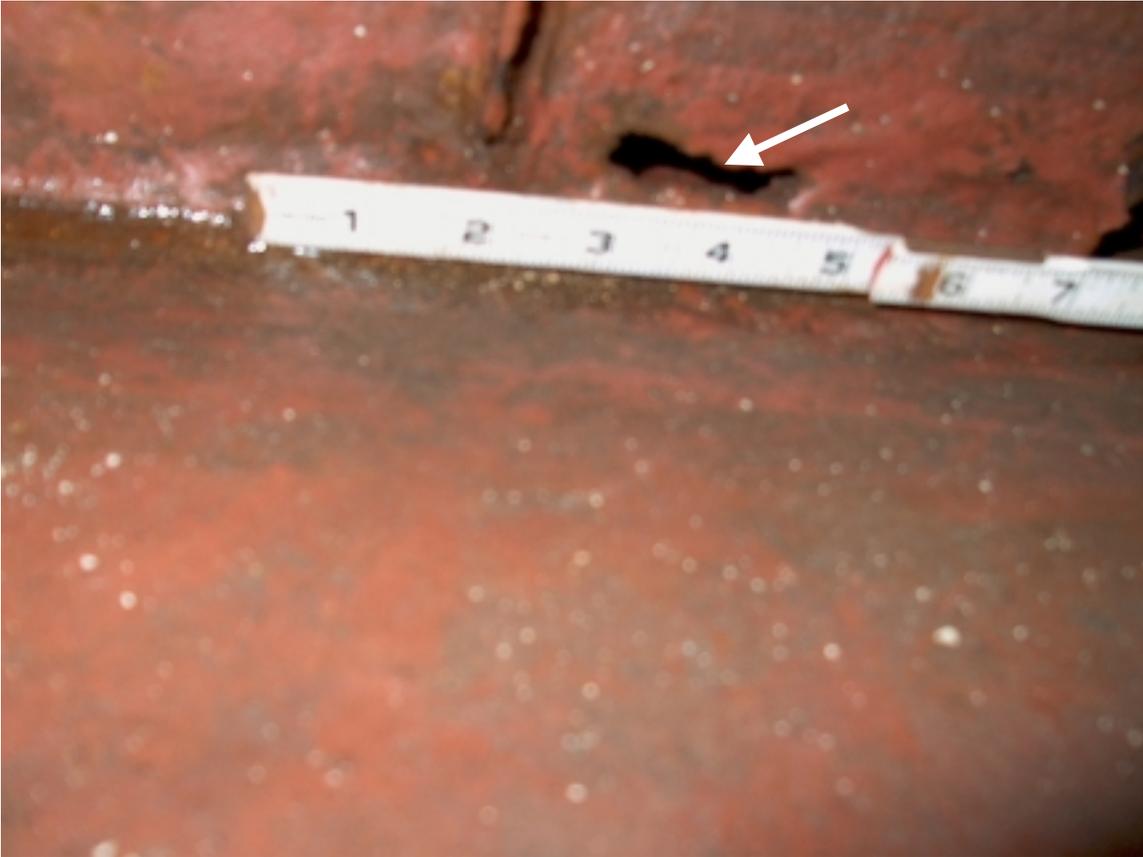
STRINGER 8 UNDER THE HOT POTABLE WATER ACCUMULATOR TANK
ARROW INDICATES HOLE IN WEB.

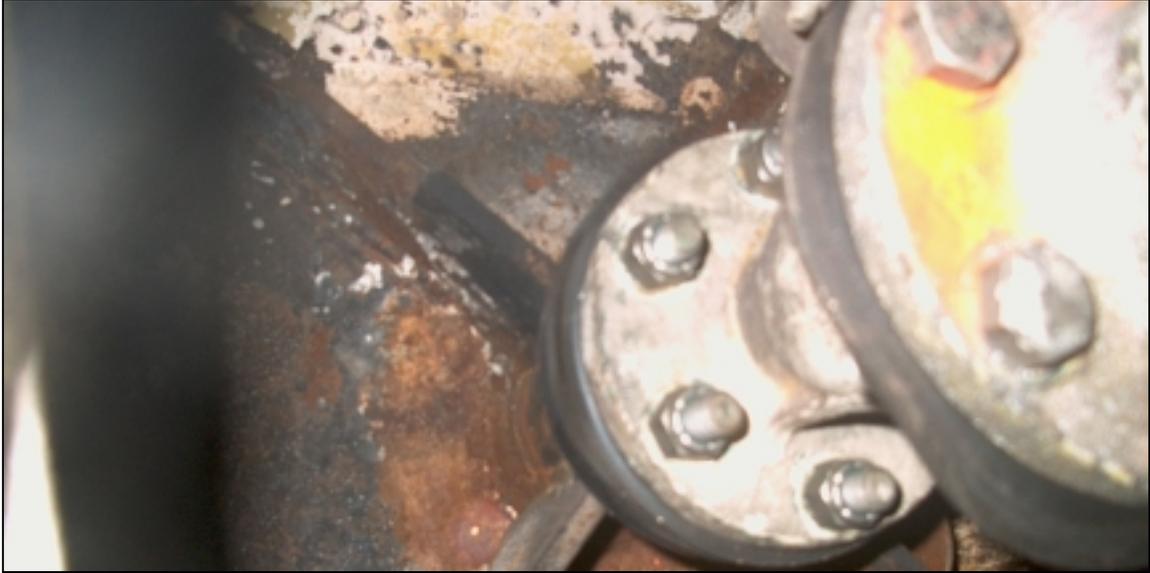
OVBD DISCHARGE INSIDE THE SSDG ENCLOSURE HAS SURFACE RUST

SAFETY HAZARD: 1. SERIOUS - CORRECT AS SOON AS POSSIBLE 2. SERIOUS - SUSPENSION OF EQUIPMENT/SYSTEM/SPACE REQUIRED 3. SERIOUS - WAIVER OF EQUIPMENT/SYSTEM 4. SAFETY ITEM - MINOR 5. COMBUSTIBLE MATERIAL		1. MAINTENANCE ACTION COMPLETED: PARTS DRAWN FROM SUPPLY 2. MAINTENANCE ACTION COMPLETED: REQUIRED PARTS NOT DRAWN FROM SUPPLY 3. MAINTENANCE ACTION COMPLETED: NO PARTS REQUIRED 4. CANCELLED - DEFERRAL WILL BE REMOVED FROM CSMP 5. MAINTENANCE ACTION COMPLETED: 3-M CAPABILITY UTILIZED 6. NONE OF THE ABOVE, DESCRIBE IN REMARKS/DESCRIPTION SECTION			1. MANDATORY 2. ESSENTIAL 3. HIGHLY DESIRABLE 4. DESIRABLE		
DISCREPANCY DESCRIPTION: PER SEMAT II UNDERWATER HULL ASSESSMENT: PORT SIDE, (5-292-0-E) FROM WF (316) TO BHD (328)							
STRINGERS (7-12) APPROXIMATELY 46SF OF SURFACE RUST AND PAINT SEPARATION.							
SEE ATTACHED DRAWING FOR U/T READINGS							
RECOMMENDED REPAIRS: NEEDLE GUN APPROXIMATELY 46 SF OF AREA, PRIME AND PAINT TO MATCH

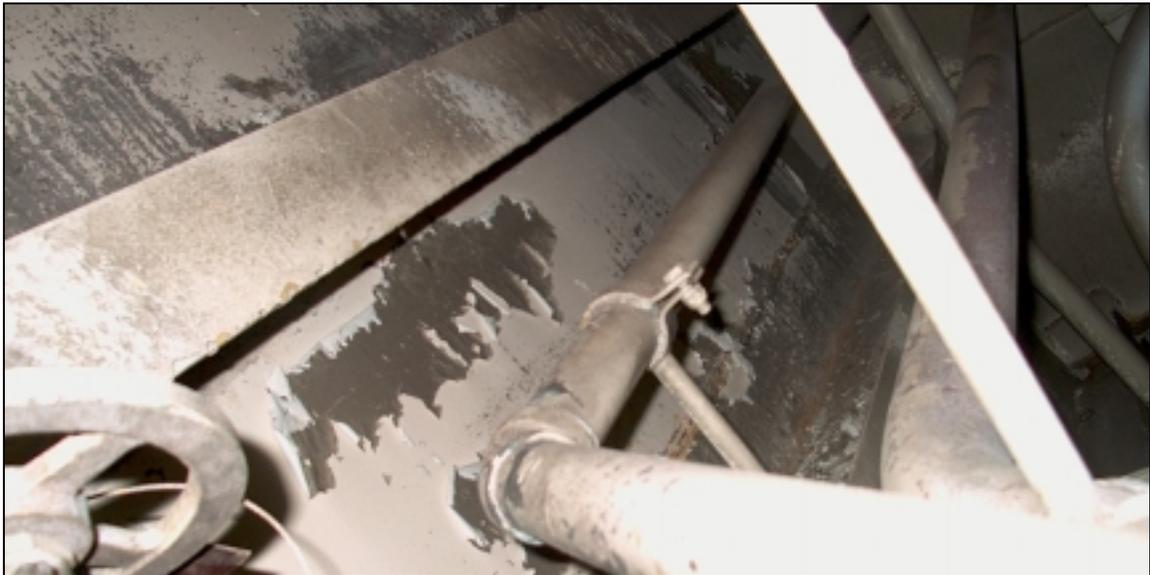
SHELL PLATE AFT OF BHD (292) INSIDE SSDG ENCLOSURE.

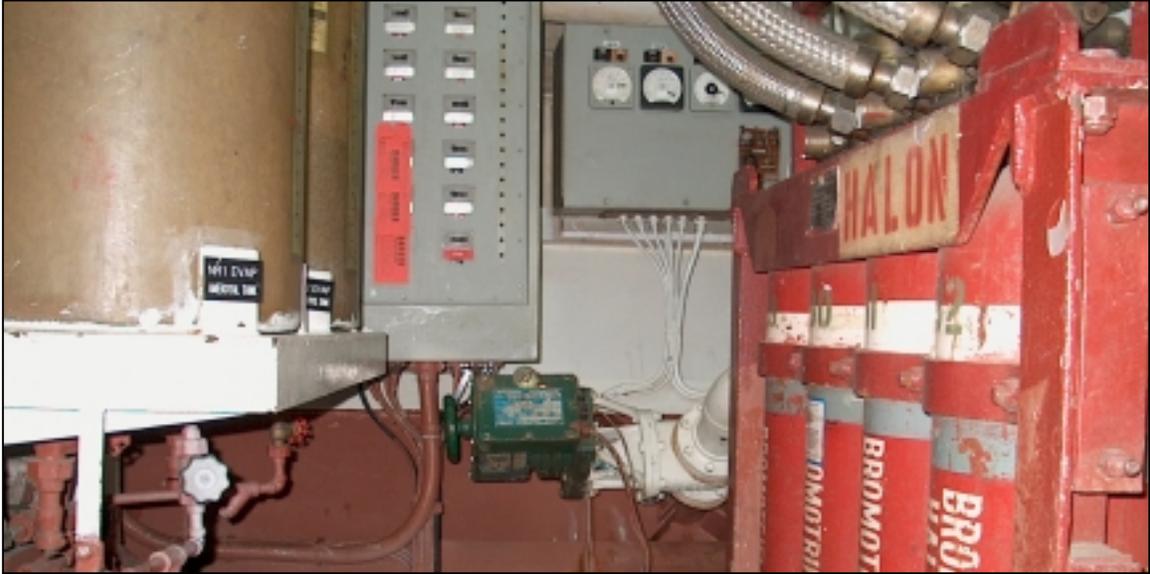
PORT SIDE, AREA WHERE U/T READINGS WERE TAKEN
REFER TO DRAWING.

REFER TO DRAWING FOR U/T READINGS.							
RECOMMENDED REPAIRS: REMOVE AND REPLACE APPROXIMATELY 1SF OF TANK TOP, WITH .250 STEEL. NEEDLE-GUN APPROXIMATELY 50SF OF TANK TOP, PRESERVE AND PAINT TO MATCH.							
FTSC is to conduct risk assessment and make final repair recommendations.							
SSPORT C221 POC: F. PRAISSMAN (757) 396-4001 EXT 2130, TPOC: N. TAGLIANETTI							
CSMP SUMMARY: WATER TANK (5-292-1-W) HAS PITS AND HEAVY PAINT SEPARATION.				TEST# MRC 1102/1			
ROOT CAUSE/AMPLIFICATION: H1				STEP# 1,2,3,4 & 5			
SYSTEM LEVEL IMPACT:							
PART NO.	NOMEMCLATURE			QTY	NSN	COST	
1							
2							
3							
4							
5							
6							
FIRST CONTACT LARSEN	RATE HT1	SECOND CONTACT DUNN		RATE HT2	PHONE		
ASSESSOR / ACT / TECH ID# J. LaROCK/ T. ILGENFRITZ QED SYSTEMS INC.			TD	TL	LOGISTICIAN	TSP

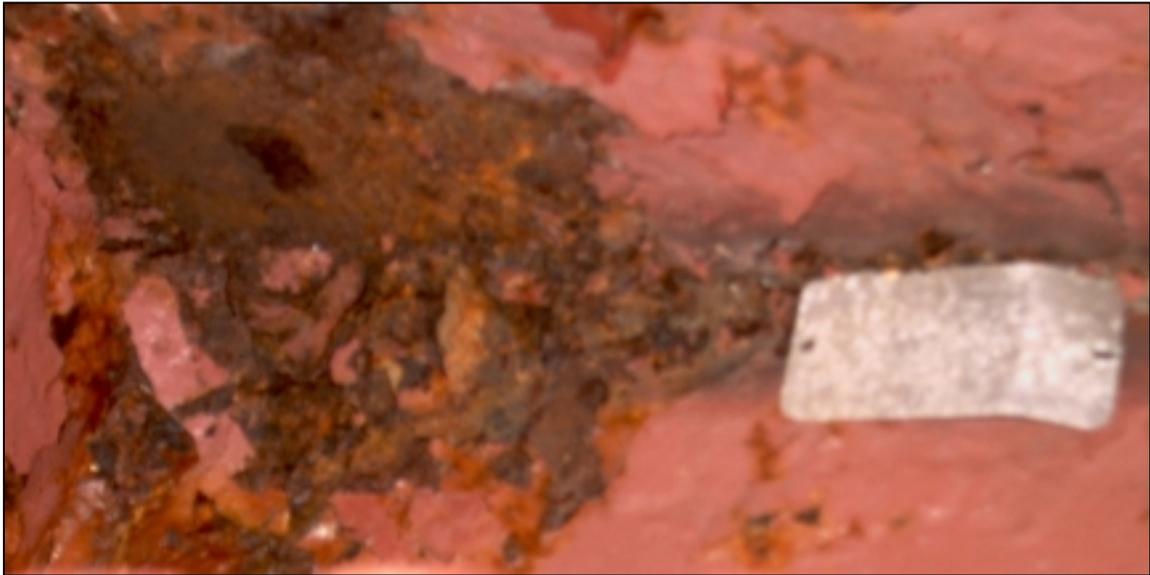
CLOSE UP OF BILGE AREA

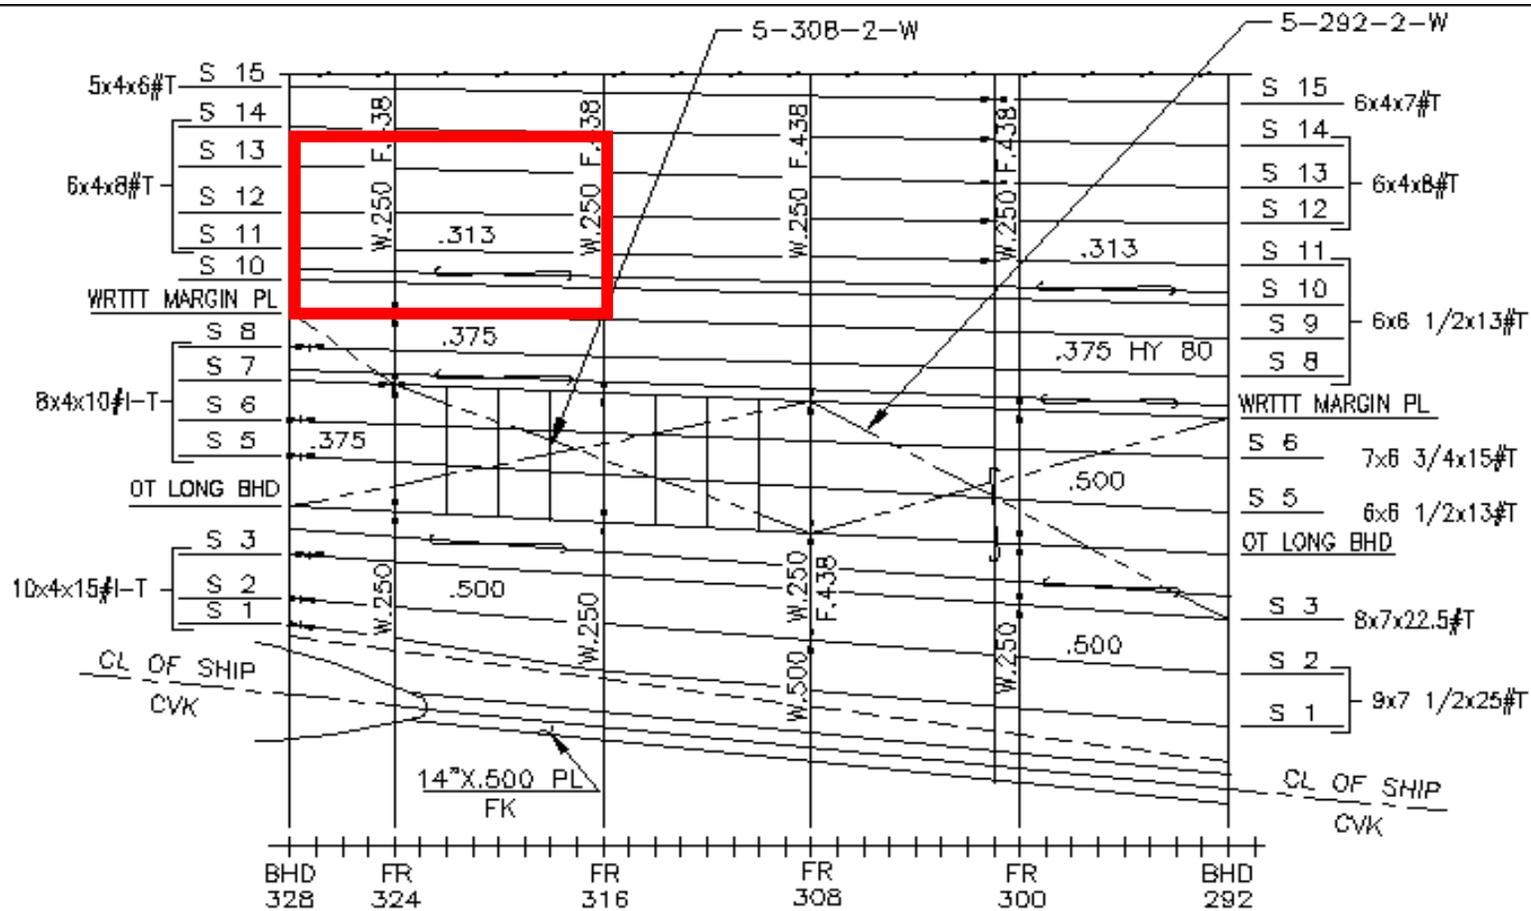
USS UNDERWOOD (FFG-36)
 AUXILIARY MACHINERY ROOM 3
 (5-292-0-E) PORT SIDE

RED BOX INDICATES LOCATION
 OF U/T READINGS
 DRAWING ON FOLLOWING PAGE

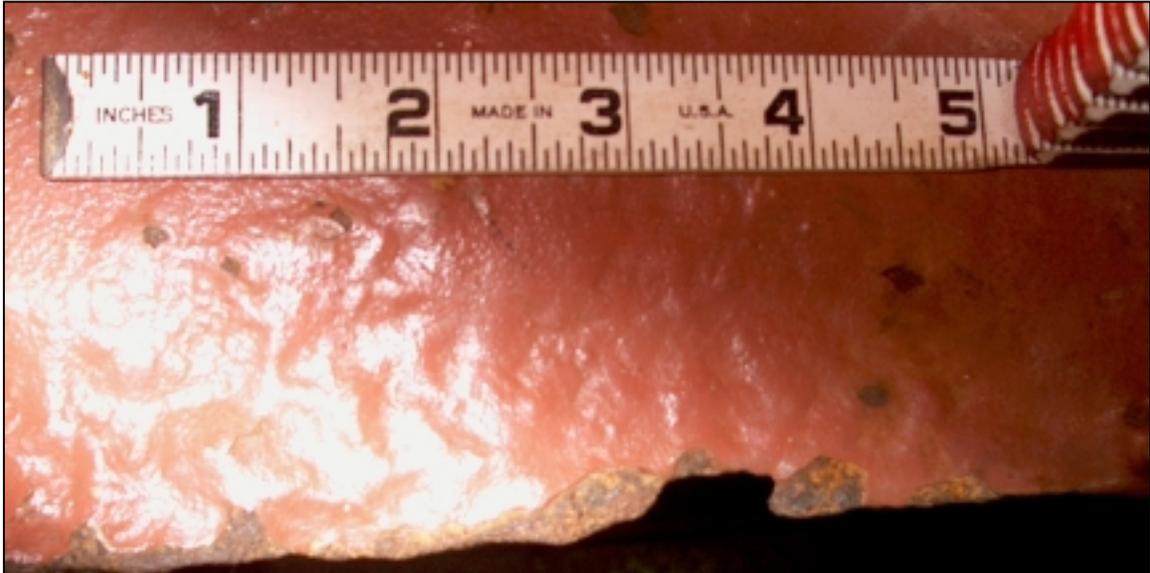
TOP OF WATER TANK (5-292-1-W)
WHERE LOW U/T READINGS WERE TAKEN.
REFER TO DRAWING FOR U/T READINGS.

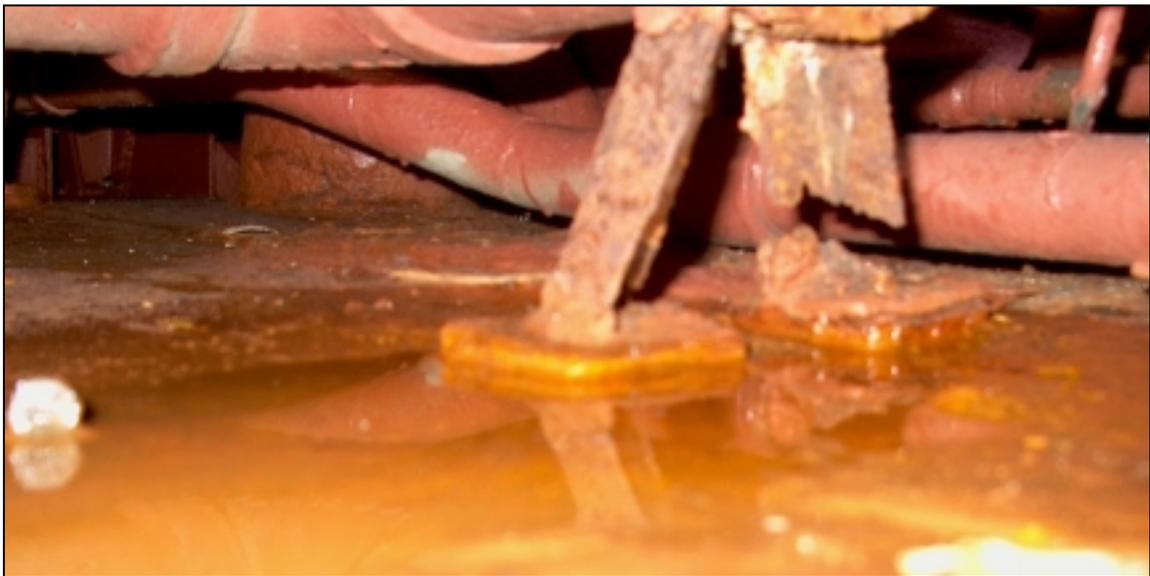
TOP OF WATER TANK (5-292-1-W) NOTE STANDING WATER
WHICH IS MAIN CAUSE FOR CORROSION.

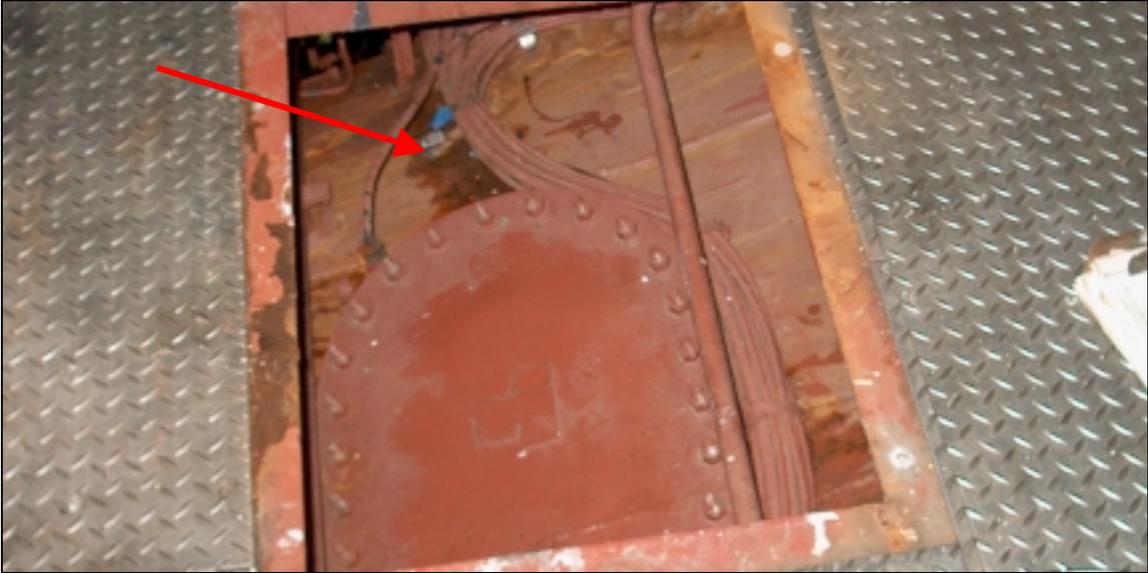
SSPORT C221 POC: F. PRAISSMAN (757) 396-4001 EXT 2130, TPOC: N. TAGLIANETTI							
CSMP SUMMARY: TANK TOP (5-308-2-W) HAS RUST AND PAINT SEPARATION.					TEST# MRC 1102/1		
ROOT CAUSE/AMPLIFICATION: H1					STEP# 1,2,3,4 & 5		
SYSTEM LEVEL IMPACT:							
PART NO.	NOMEMCLATURE			QTY	NSN		COST
1							
2							
3							
4							
5							
6							
FIRST CONTACT LARSEN	RATE HT1	SECOND CONTACT DUNN		RATE HT2	PHONE		
ASSESSOR / ACT / TECH ID# J. LaROCK/ T. ILGENFRITZ QED SYSTEMS INC.				TD	TL	LOGISTICIAN	TSP

TOP OF POTABLE WATER TANK (5-308-2-W)

SAFETY HAZARD: 1. SERIOUS - CORRECT AS SOON AS POSSIBLE 2. SERIOUS - SUSPENSION OF EQUIPMENT/SYSTEM/SPACE REQUIRED 3. SERIOUS - WAIVER OF EQUIPMENT/SYSTEM 4. SAFETY ITEM - MINOR 5. COMBUSTIBLE MATERIAL		1. MAINTENANCE ACTION COMPLETED: PARTS DRAWN FROM SUPPLY 2. MAINTENANCE ACTION COMPLETED: REQUIRED PARTS NOT DRAWN FROM SUPPLY 3. MAINTENANCE ACTION COMPLETED: NO PARTS REQUIRED 4. CANCELLED - DEFERRAL WILL BE REMOVED FROM CSMP 5. MAINTENANCE ACTION COMPLETED: 3-M CAPABILITY UTILIZED 6. NONE OF THE ABOVE, DESCRIBE IN REMARKS/DESCRIPTION SECTION			1. MANDATORY 2. ESSENTIAL 3. HIGHLY DESIRABLE 4. DESIRABLE		
DISCREPANCY DESCRIPTION: PER SEMAT II UNDERWATER HULL ASSESSMENT: PORT SIDE (5-292-0-E) POTABLE WATER TANK TOP (5-308-2-W) HAS APPROX 40SF OF HEAVY RUST AND PAINT SEPARATION. U/T READINGS WERE SATISFACTORY. SEE ATTACHED DRAWING.							
RECOMMENDED REPAIRS: NEEDLE-GUN APPROXIMATELY 40SF OF TANK TOP, PRESERVE AND PAINT AREA TO MATCH.

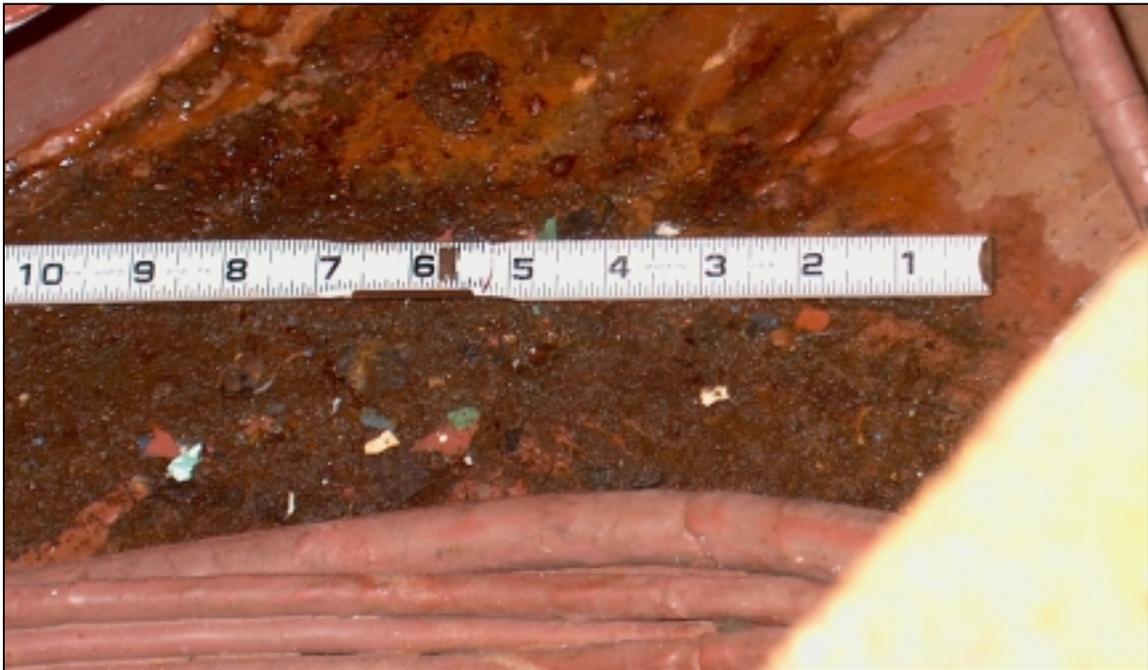
CORROSION ON TOP OF TANK REFER TO DRAWING FOR U/T READINGS.

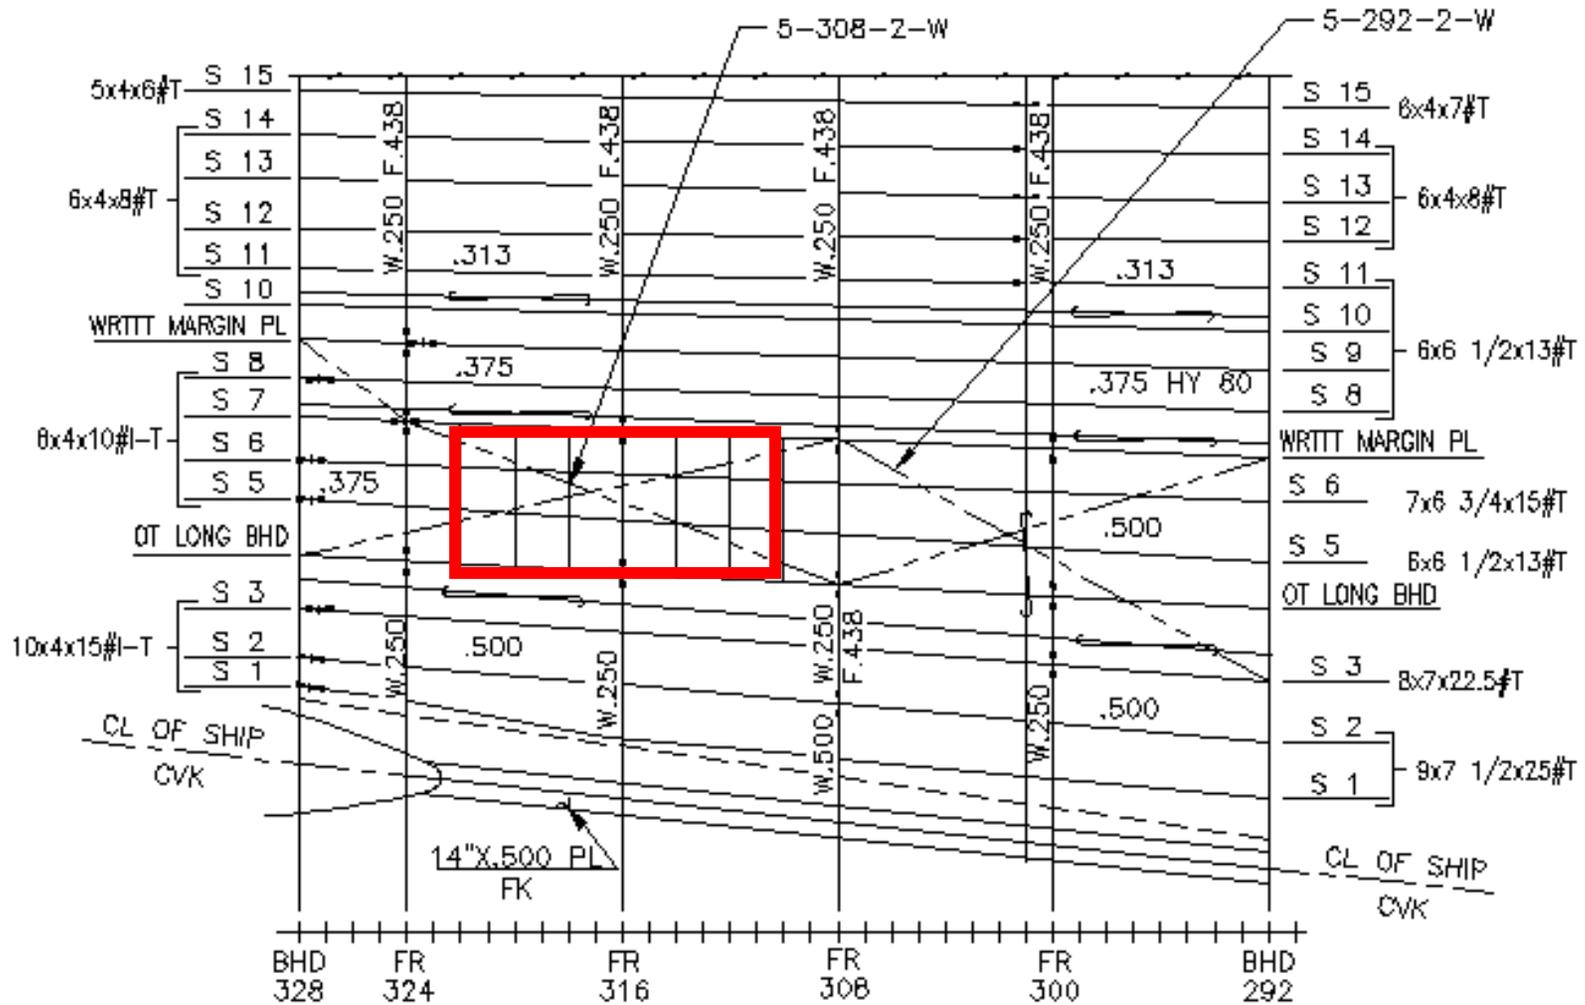
AUXILIARY MACHINERY ROOM 3
 (5-292-0-E) PORT SIDE
 POTABLE WATER TANK (5-308-2-W)

RED BOX INDICATES WHERE U/T
 READINGS WERE TAKEN
 SEE FOLLOWING PAGE

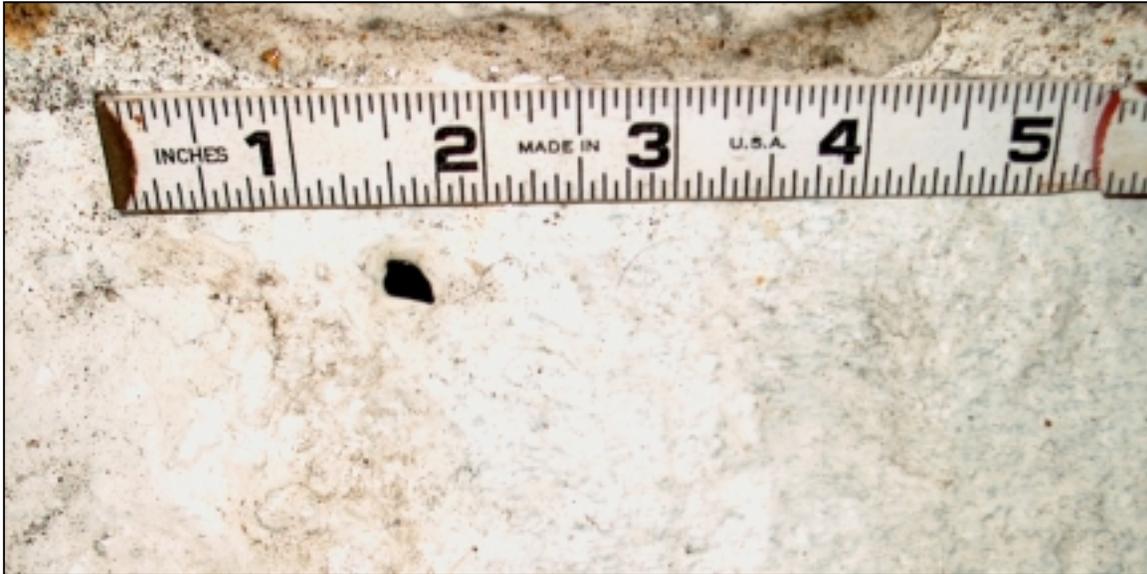
STBD SIDE, BETWEEN WF (258-264) STRINGER (11) HOLE IS APPROXIMATELY 10" AFT OF WF (258).

RECOMMENDED REPAIRS: REMOVE AND REPLACE APPROXIMATELY 8LF OF 6X4 T-BEAM. REMOVE AND REPLACE APPROXIMATELY 3SF OF SHELL PLATE PRESERVE AND PAINT TO MATCH AREA. FTSC is to conduct risk assessment and make final repair recommendations.							
SSPORT C221 POC: F. PRAISSMAN (757) 396-4001 EXT 2130, TPOC: N. TAGLIANETTI							
CSMP SUMMARY: STRINGER (11) IS HOLED, SHELL IS THINNING.				TEST# MRC 1102/1			
ROOT CAUSE/AMPLIFICATION: H1				STEP# 1,2,3,4 & 5			
SYSTEM LEVEL IMPACT:							
PART NO.	NOMEMCLATURE			QTY	NSN	COST	
1							
2							
3							
4							
5							
6							
FIRST CONTACT LARSEN	RATE HT1	SECOND CONTACT DUNN		RATE HT2	PHONE		
ASSESSOR / ACT / TECH ID# J. LaROCK/ T. ILGENFRITZ OED SYSTEMS INC.			TD	TL	LOGISTICIAN	TSP

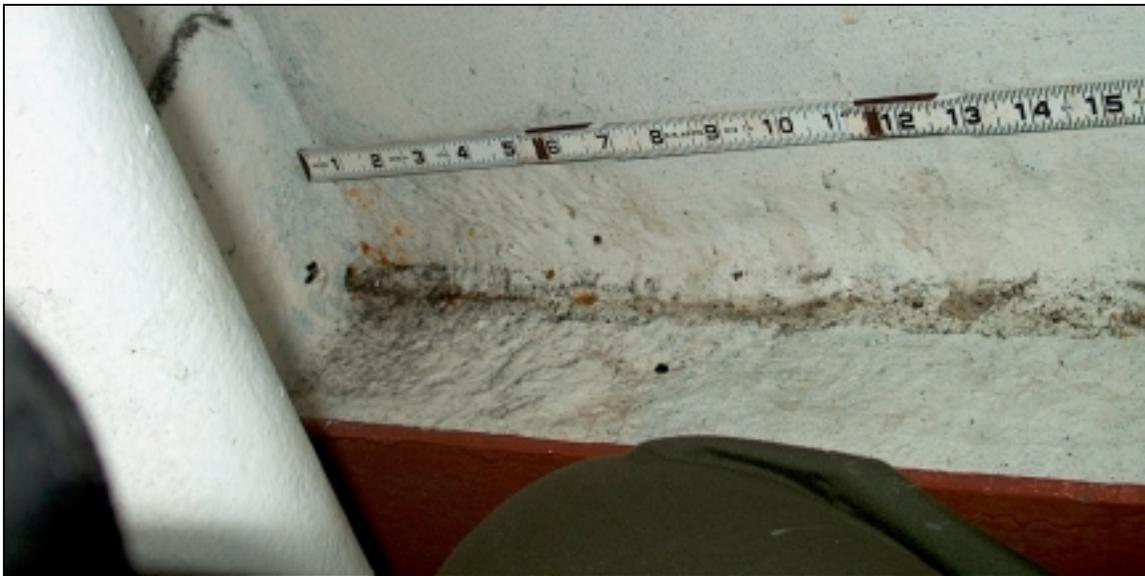
STBD SIDE, AFT OF WF (258) SHELL PLATE AT STRINGER (11) IS THINNING. REFER TO DRAWING FOR U/T READINGS.

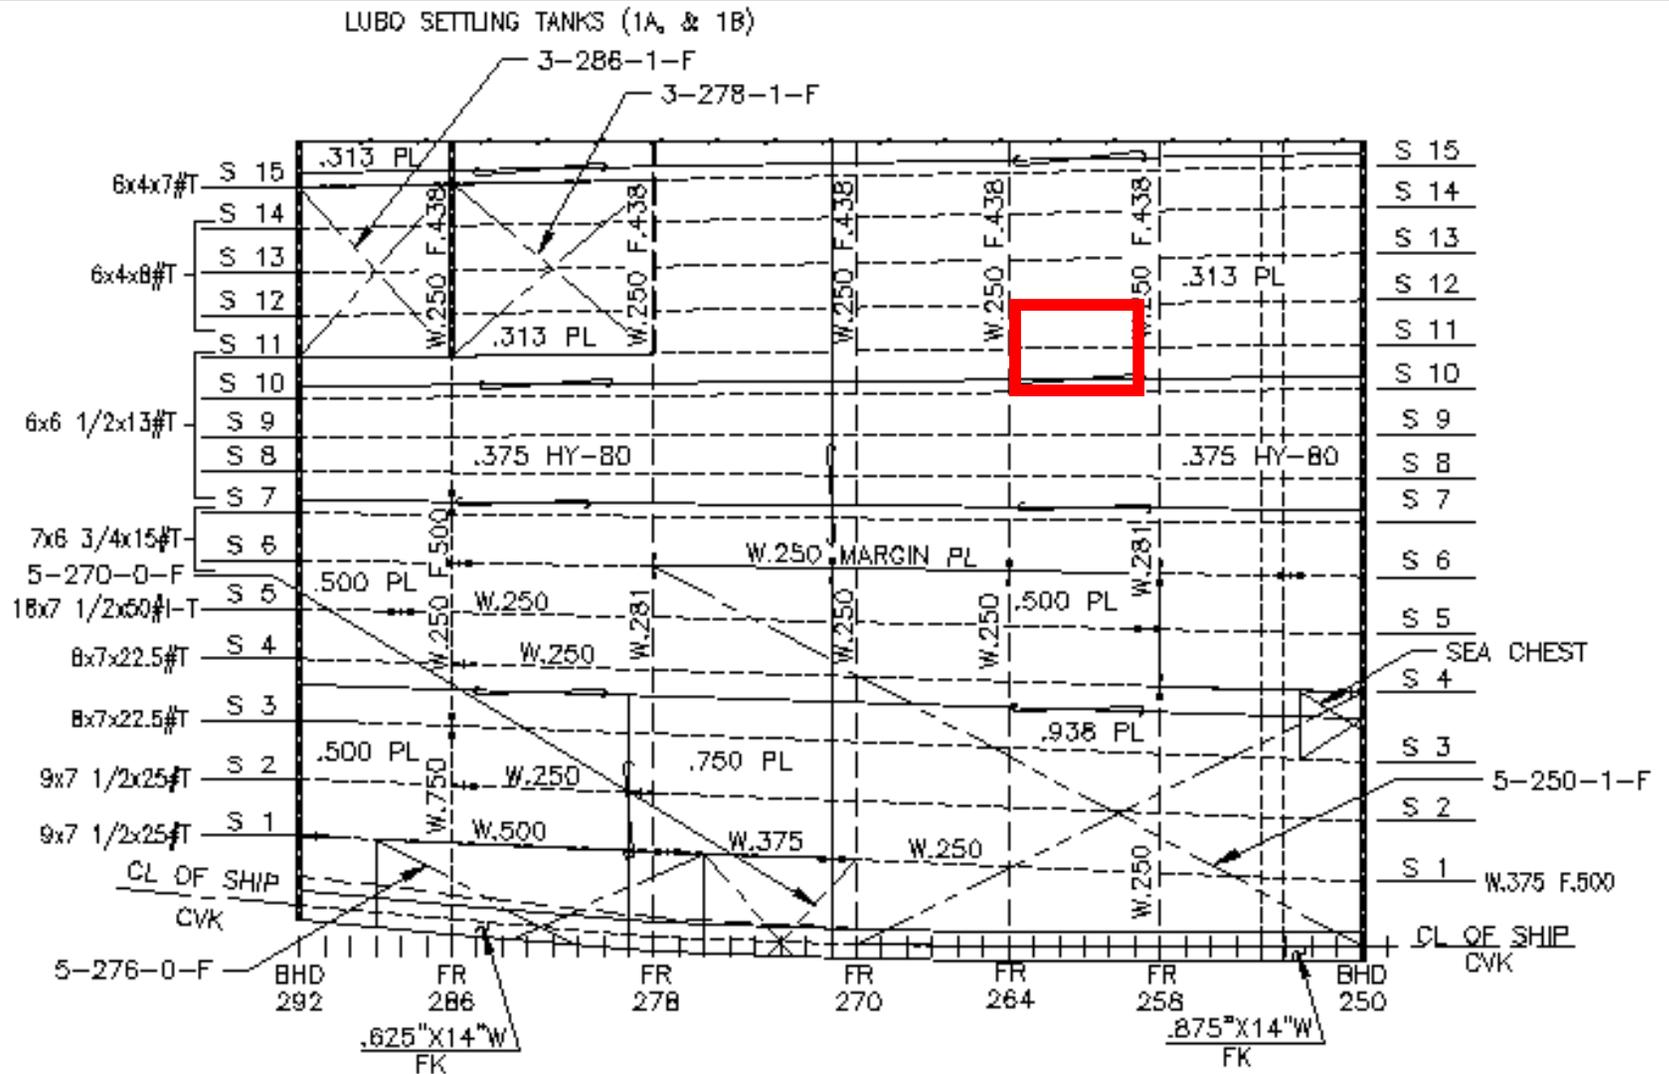
MAIN ENGINE ROOM (5-250-0-E)
STBD SIDE AT STRINGER (11)

RED BOX INDICATES WHERE U/T
READINGS WERE TAKEN
SEE FOLLOWING PAGE FOR DRAWING

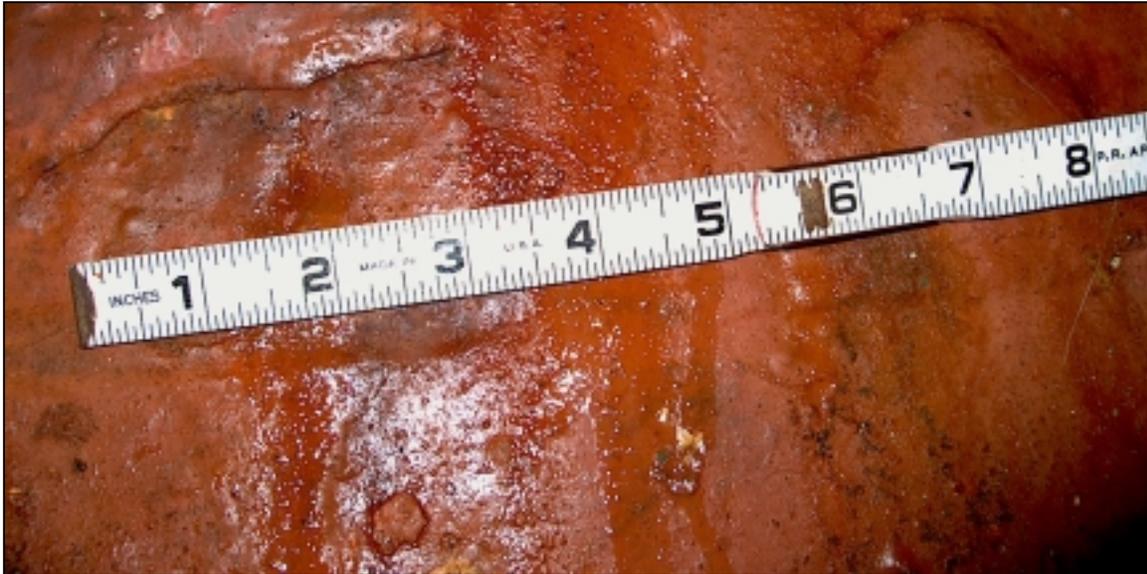
PORT SIDE, LARGE PIT IN SHELL PLATING U/T READING IN THIS AREA WAS (.210)
REFER TO DRAWING FOR LOCATION AND U/T READINGS OF SURROUNDING AREA.

OVBD DISCHARGE HAS SURFACE RUST AND PAINT SEPARATION.							
RECOMMENDED REPAIRS: CLAD WELD APPROXIMATELY 6 Sq INCHES OF PITTED AREA, NEEDLE-GUN APPROXIMATELY 20 SF OF SURROUNDING AREA PRESERVE AND PAINT TO MATCH.							
FTSC is to conduct risk assessment and make final repair recommendations.							
SSPORT C221 POC: F. PRAISSMAN (757) 396-4001 EXT 2130, TPOC: N. TAGLIANETTI							
CSMP SUMMARY: BETWEEN STRINGERS (9-10) SHELL HAS 2"X3" PIT.				TEST# MRC 1102/1			
ROOT CAUSE/AMPLIFICATION: H1				STEP# 1,2,3,4 & 5			
SYSTEM LEVEL IMPACT:							
PART NO.	NOMEMCLATURE			QTY	NSN		COST
1							
2							
3							
4							
5							
6							
FIRST CONTACT LARSEN	RATE HT1	SECOND CONTACT DUNN		RATE HT2	PHONE		
ASSESSOR / ACT / TECH ID# J. LaROCK/ T. ILGENFRITZ OED SYSTEMS INC.				TD	TL	LOGISTICIAN	TSP

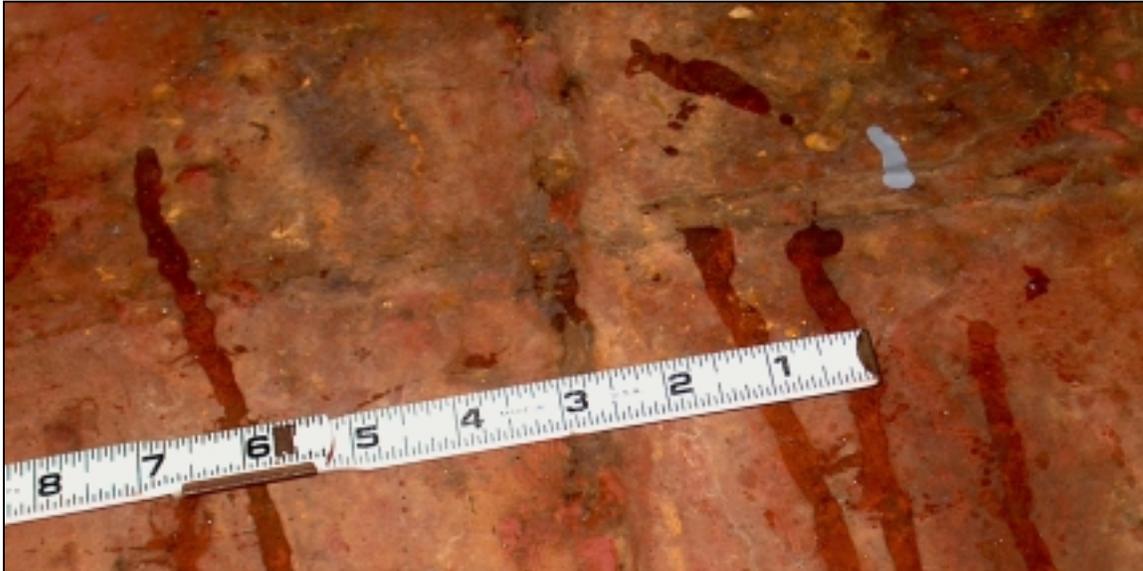
PORT SIDE, TRANSVERSE WELD SEAM AFT OF WF (270)
U/T READINGS ARE NOTED IN DRAWING.

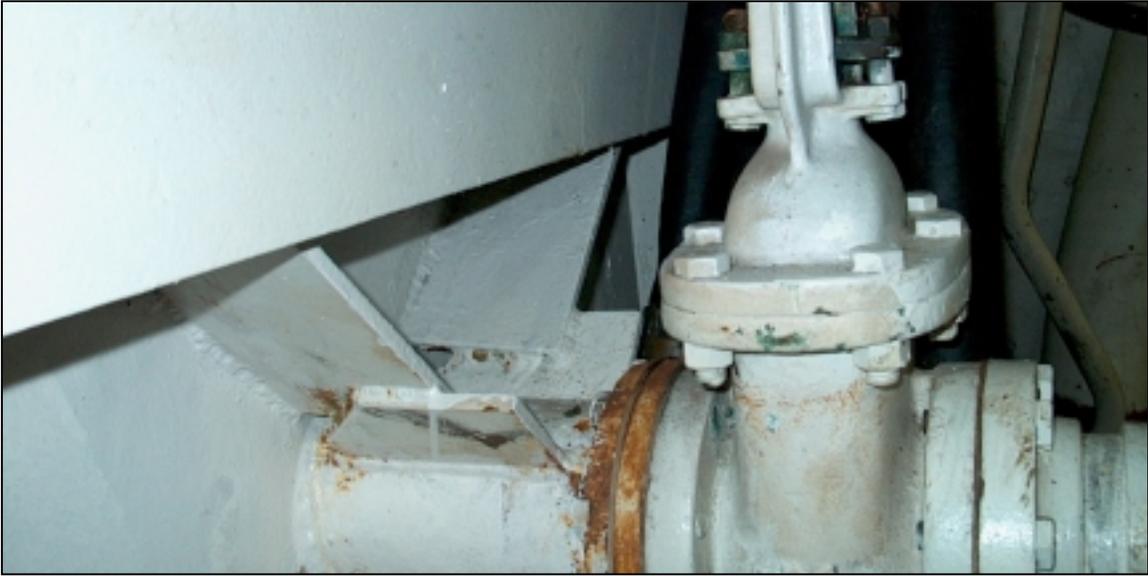
PORT SIDE, OVBD DISCHARGE AFT OF BHD (250) BETWEEN STRINGERS (10-11)

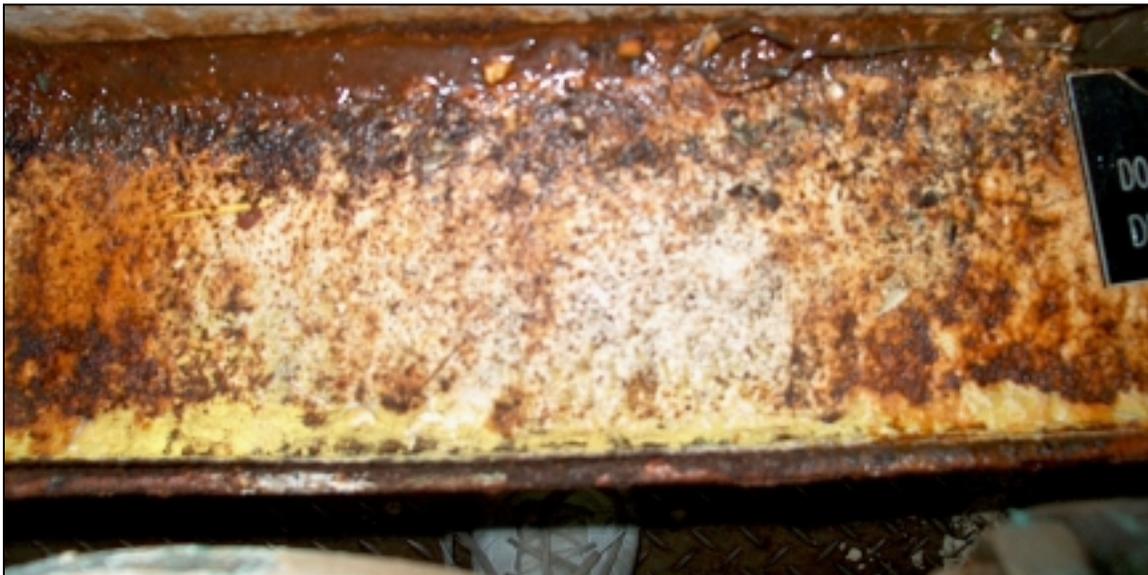
PORT SIDE, STRINGER (10) BETWEEN BHD (250) AND WF (264)
REFER TO DRAWING FOR U/T READINGS.

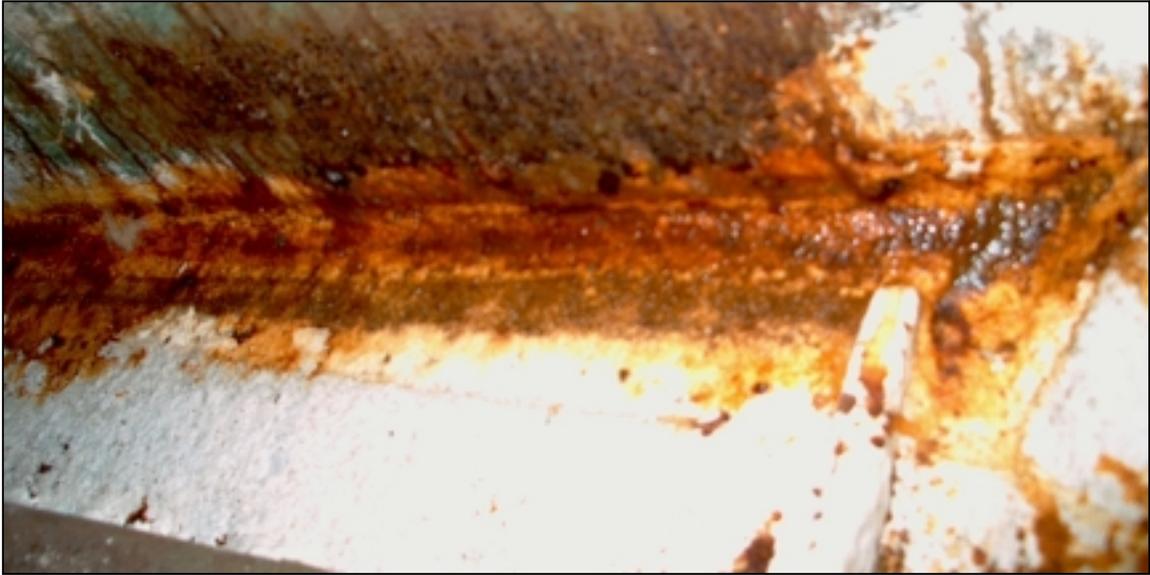
STBD SIDE BETWEEN WF (264-270) CORROSION ON STRINGER (12).
REFER TO DRAWING FOR U/T READINGS OF AREA.

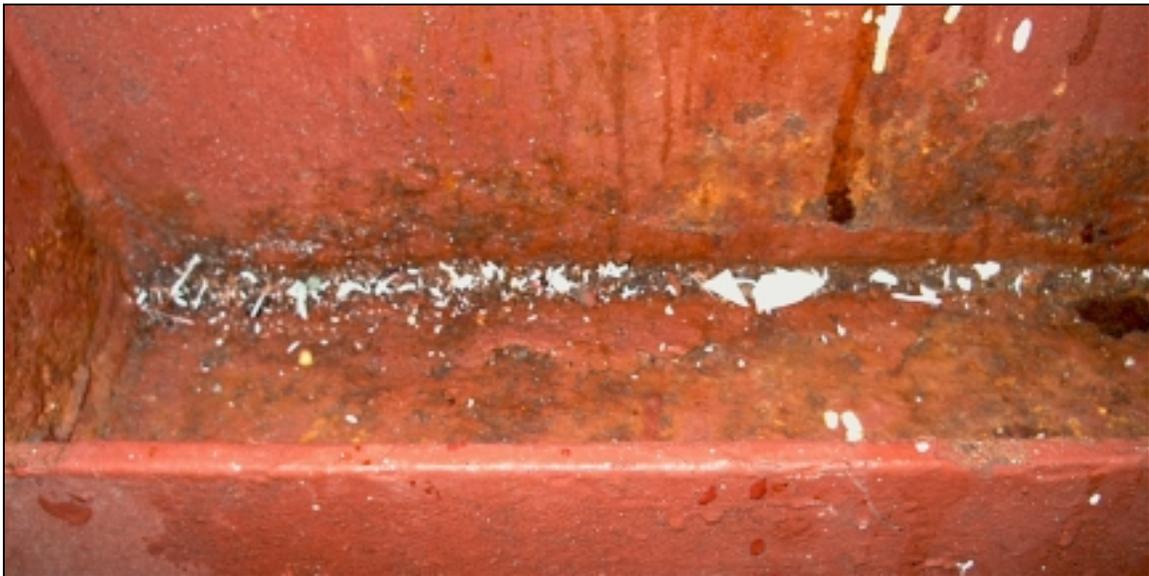
STBD SIDE, STRINGER (10) BETWEEN WF (264-270).

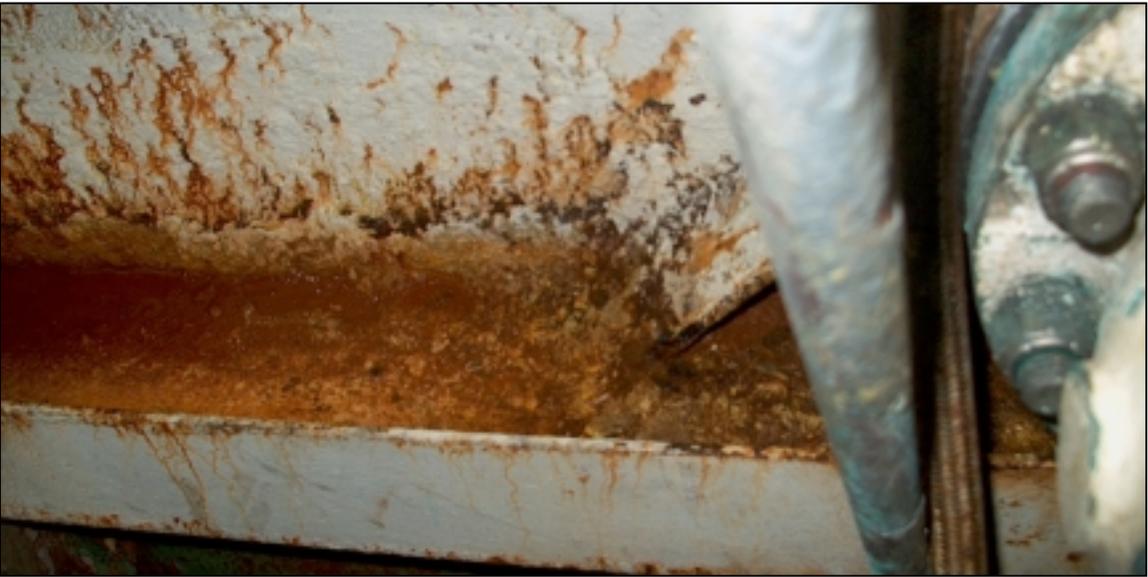
PORT SIDE, UNDER HPAC, NEXT TO OVBD DISCHARGE.

RECOMMENDED REPAIRS: NEEDLE-GUN APPROXIMATELY 80 SF OF AREA, CLEAN OUT WEEP HOLES IN STRINGERS TO DRAIN WATER, PRESERVE AND PAINT TO MATCH SURROUNDING AREA.								
SSPORT C221 POC: F. PRAISSMAN (757) 396-4001 EXT 2130, TPOC: N. TAGLIANETTI								
CSMP SUMMARY: SHELL AND STRINGERS HAVE SURFACE RUST AND WATER.					TEST# MRC 1102/1			
ROOT CAUSE/AMPLIFICATION: H1					STEP# 1,2,3,4 & 5			
SYSTEM LEVEL IMPACT:								
PART NO.	NOMEMCLATURE			QTY	NSN		COST	
1								
2								
3								
4								
5								
6								
FIRST CONTACT LARSEN		RATE HT1	SECOND CONTACT DUNN		RATE HT2	PHONE		
ASSESSOR / ACT / TECH ID# J. LaROCK/ T. ILGENFRITZ OED SYSTEMS INC.				TD	TL	LOGISTICIAN	TSP

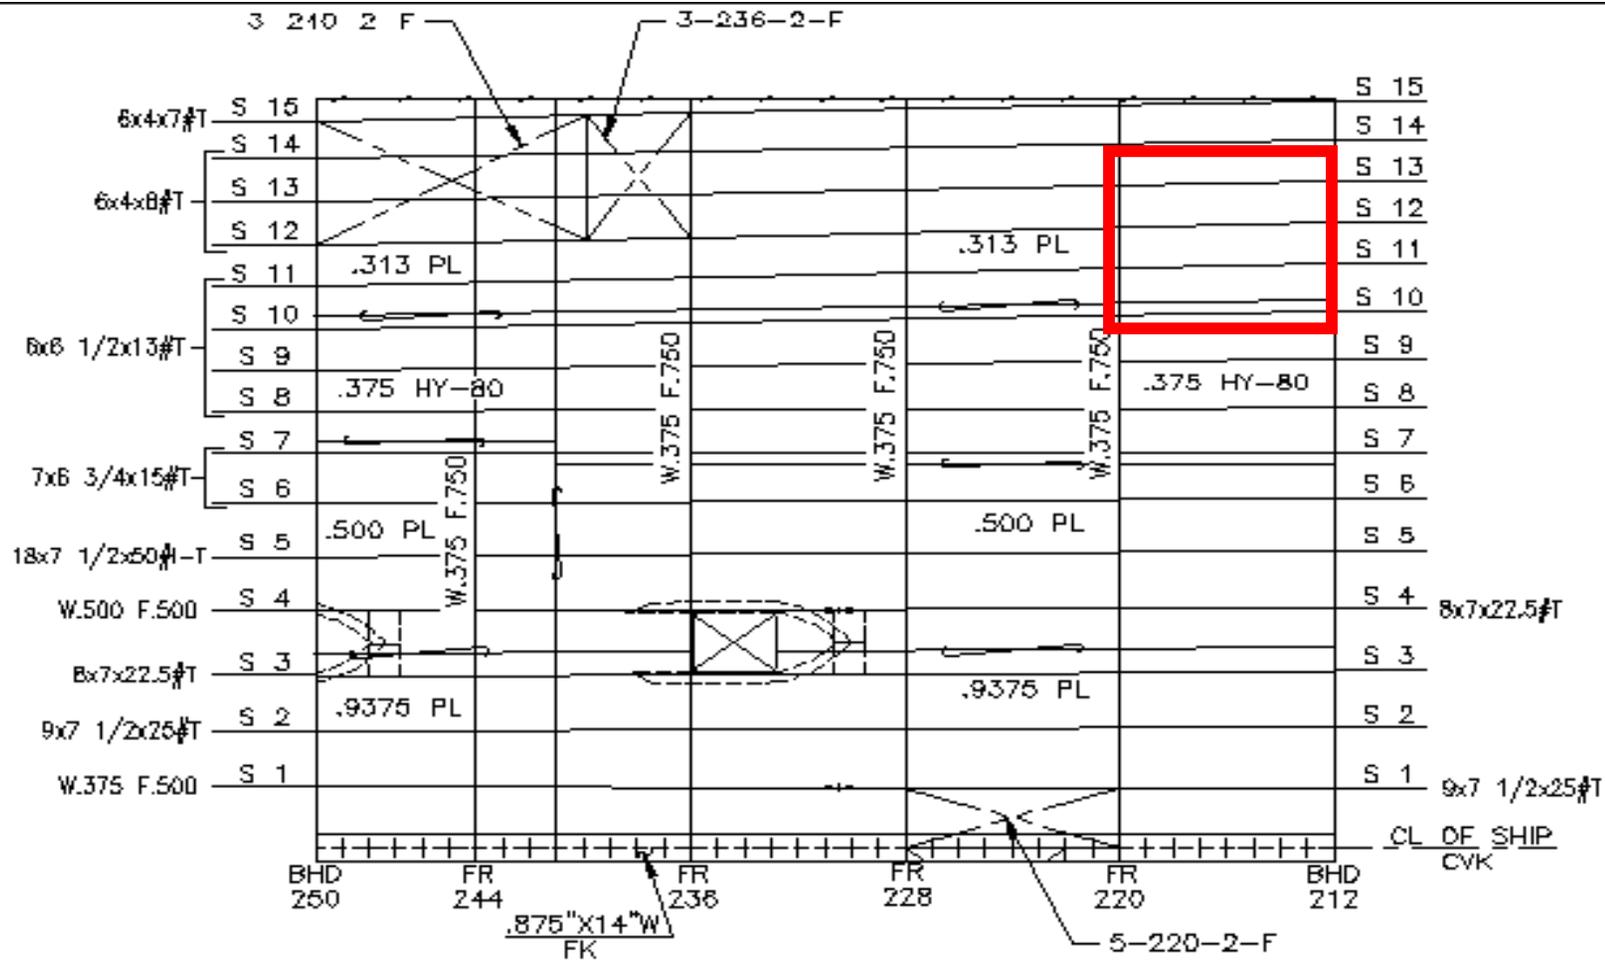
AUXILIARY MACHINERY ROOM 2 (5-212-0-E)
 PORT SIDE, BETWEEN BHD (212) AND WF
 (220), FROM STRINGERS (10-13)

RED BOX INDICATES AREA WHERE U/T
 READINGS WERE TAKEN.
 REFER TO FOLLOWING PAGE FOR DRAWING.
