USS UNDERWOOD (FFG 36)

SEMAT II SHELL CONDITION ASSESSMENT SURVEY
INTERIOR AREAS

7/23/01 TO 8/3/01

PREPARED BY
SUPERVISOR OF SHIPBUILDING CONVERSION AND REPAIR
PORTSMOUTH, VIRGINIA

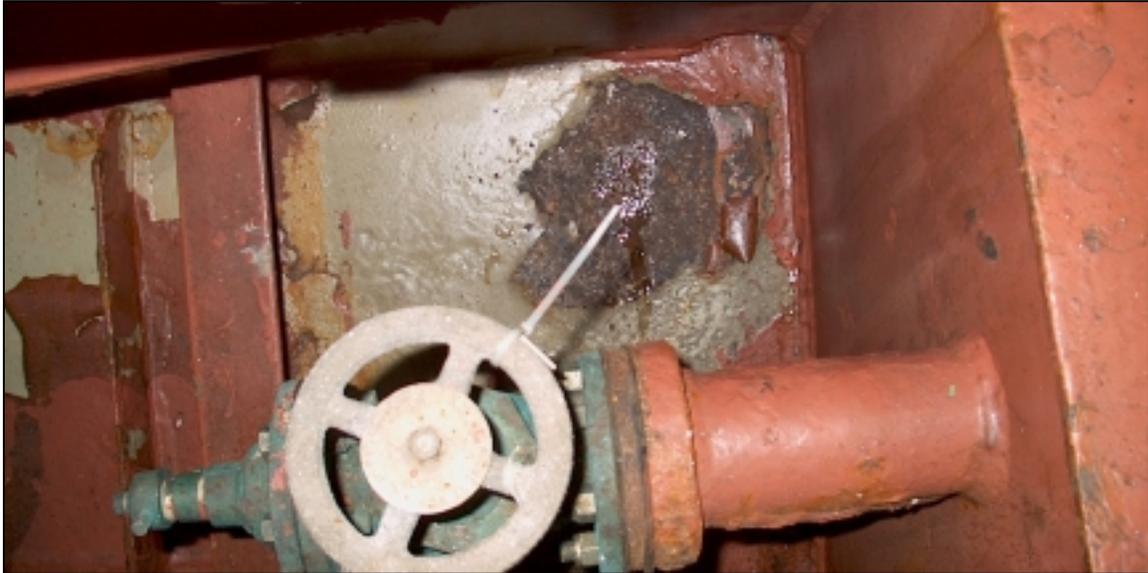
STBD SIDE, INBOARD OF SSDG ENCLOSURE BETWEEN WF (236-244)

RECOMMENDED REPAIRS: NEEDLE-GUN APPROXIMATELY 32 SF OF AREA, PRESERVE AND PAINT TO MATCH.							
SSPORT C221 POC: F. PRAISSMAN (757) 396-4001 EXT 2130, TPOC: N. TAGLIANETTI							
CSMP SUMMARY: BILGE AREA HAS SURFACE RUST AND PAINT SEPARATION.					TEST# MRC 1102/1		
ROOT CAUSE/AMPLIFICATION: H1					STEP# 1,2,3,4 & 5		
SYSTEM LEVEL IMPACT:							
PART NO.	NOMEMCLATURE			QTY	NSN	COST	
1							
2							
3							
4							
5							
6							
FIRST CONTACT LARSEN	RATE HT1	SECOND CONTACT DUNN		RATE HT2	PHONE		
ASSESSOR / ACT / TECH ID# J. LaROCK/ T. ILGENFRITZ OED SYSTEMS INC.			TD	TL	LOGISTICIAN	TSP

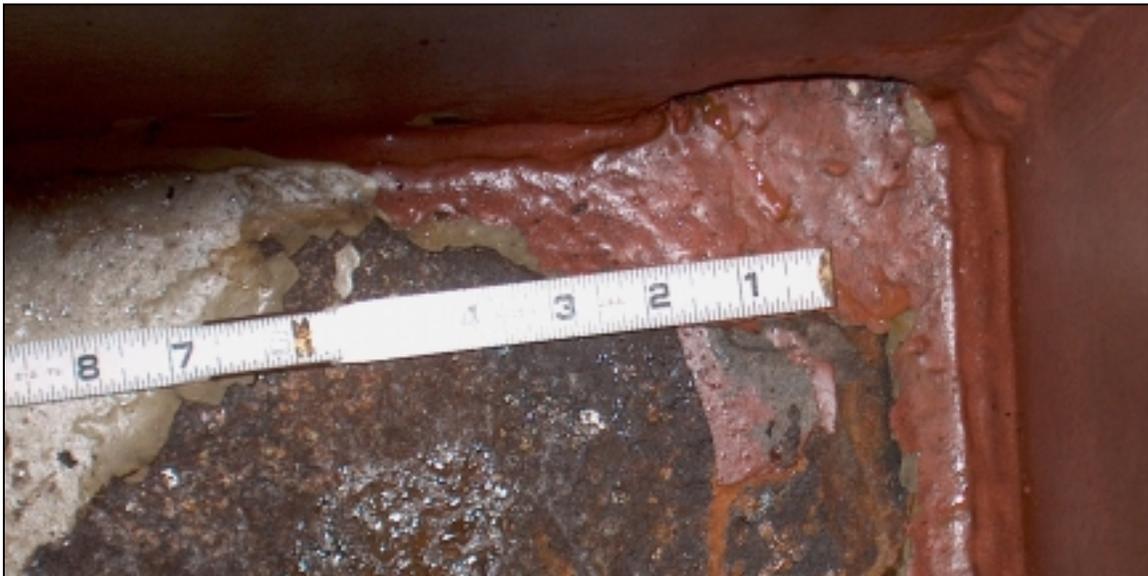
CLOSER VIEW OF AREA, U/T READING IN CENTER OF RUST IS (.395)
THE MINIMUM FOR (.500 IS .375)

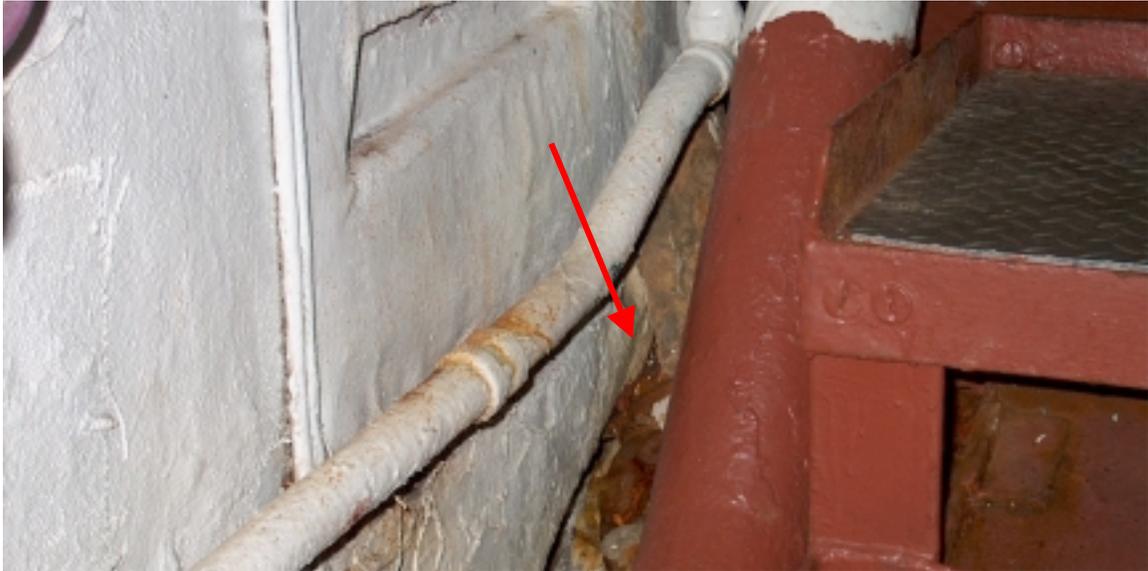
SSPORT C221 POC: F. PRAISSMAN (757) 396-4001 EXT 2130, TPOC: N. TAGLIANETTI							
CSMP SUMMARY: BILGE AREA AT BHD (204) HAS RUST AND PAINT SEPARATION.					TEST # MRC 1102/1		
ROOT CAUSE/AMPLIFICATION: H1					STEP # 1,2,3,4 & 5		
SYSTEM LEVEL IMPACT:							
PART NO.	NOMEMCLATURE			QTY	NSN		COST
1							
2							
3							
4							
5							
6							
FIRST CONTACT LARSEN		RATE HT1	SECOND CONTACT DUNN		RATE HT2	PHONE	
ASSESSOR / ACT / TECH ID# J. LaROCK/ T. ILGENFRITZ OED SYSTEMS INC.				TD	TL	LOGISTICIAN	TSP

PORT SIDE, BHD (204)
CORROSION FOUND IN BILGE AREA.

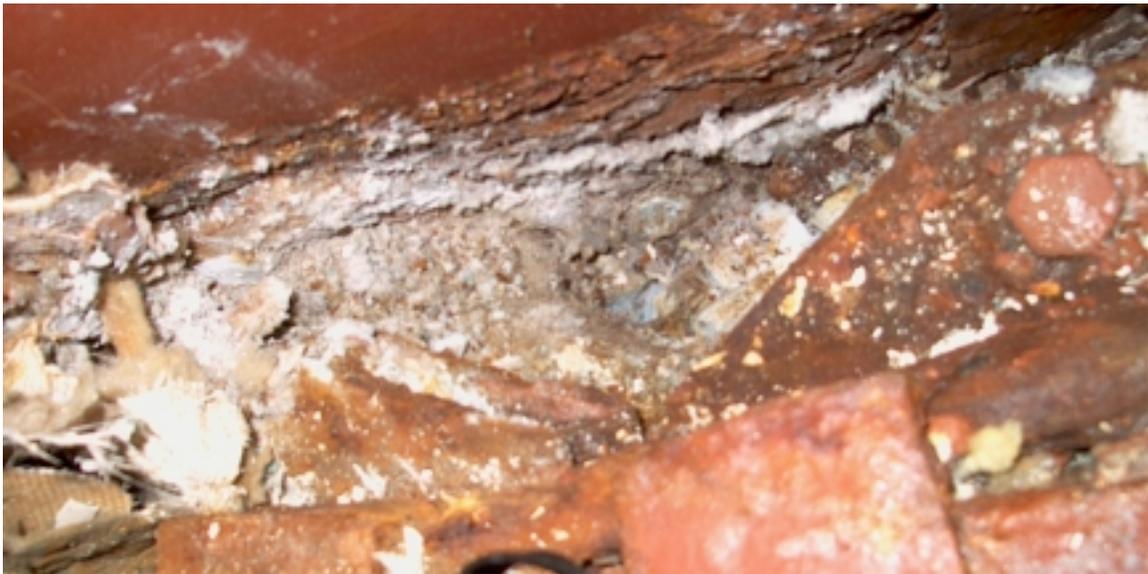
BILGE AREA AT BHD (204)

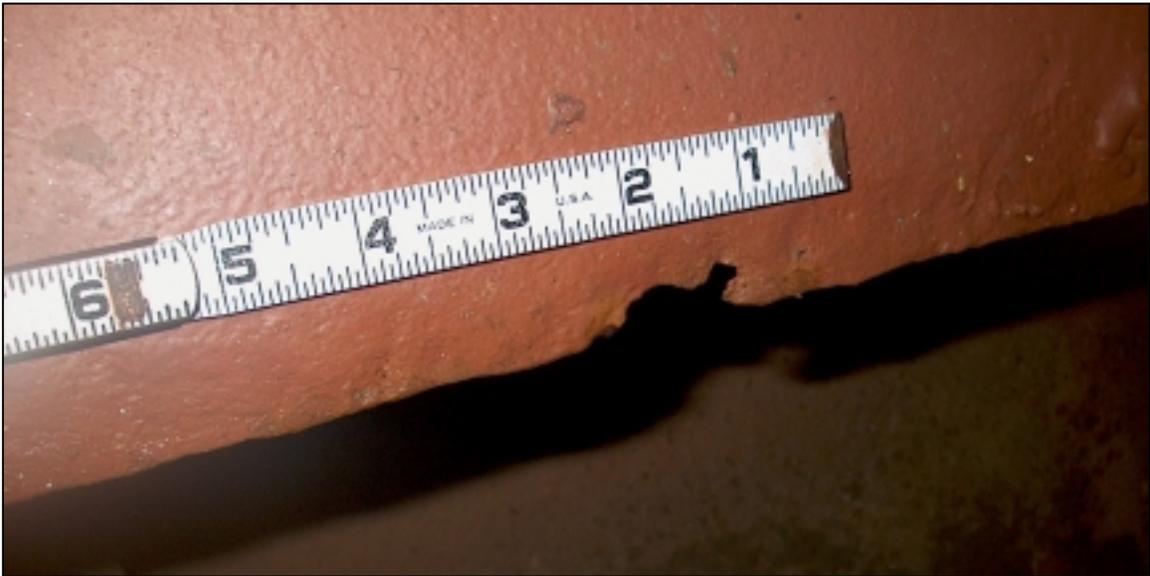
STBD SIDE, CORRODED FLANGE ON STRINGER (1)

APPROXIMATELY 100 SF OF ENTIRE SPACE							
RECOMMENDED REPAIRS:							
CUT OUT AND REPLACE FLANGE ON STRINGER (1), APPROXIMATELY 6 LF. REPLACE FLANGE ON FIRST VERTICAL STIFFNER APPROXIMATELY 2 LF OF 2"X .250 STEEL. REPLACE APPROXIMATELY 4 LF OF VERTICAL STIFFNER 3"X2". CLEAN, PRESERVE AND PAINT ENTIRE SPACE.							
FTSC is to conduct risk assessment and make final repair recommendations.							
SSPORT C221 POC: F. PRAISSMAN (757) 396-4001 EXT 2130, TPOC: N. TAGLIANETTI							
CSMP SUMMARY: CORROSION IN STRINGERS AND STIFFNERS.				TEST# MRC 1102/1			
ROOT CAUSE/AMPLIFICATION: H1				STEP# 1,2,3,4 & 5			
SYSTEM LEVEL IMPACT:							
PART NO.	NOMENCLATURE			QTY	NSN	COST	
1							
2							
3							
4							
5							
6							
FIRST CONTACT LARSEN	RATE HT1	SECOND CONTACT DUNN		RATE HT2	PHONE		
ASSESSOR / ACT / TECH ID# J. LaROCK/ T. ILGENFRITZ QED SYSTEMS INC.			TD	TL	LOGISTICIAN	TSP

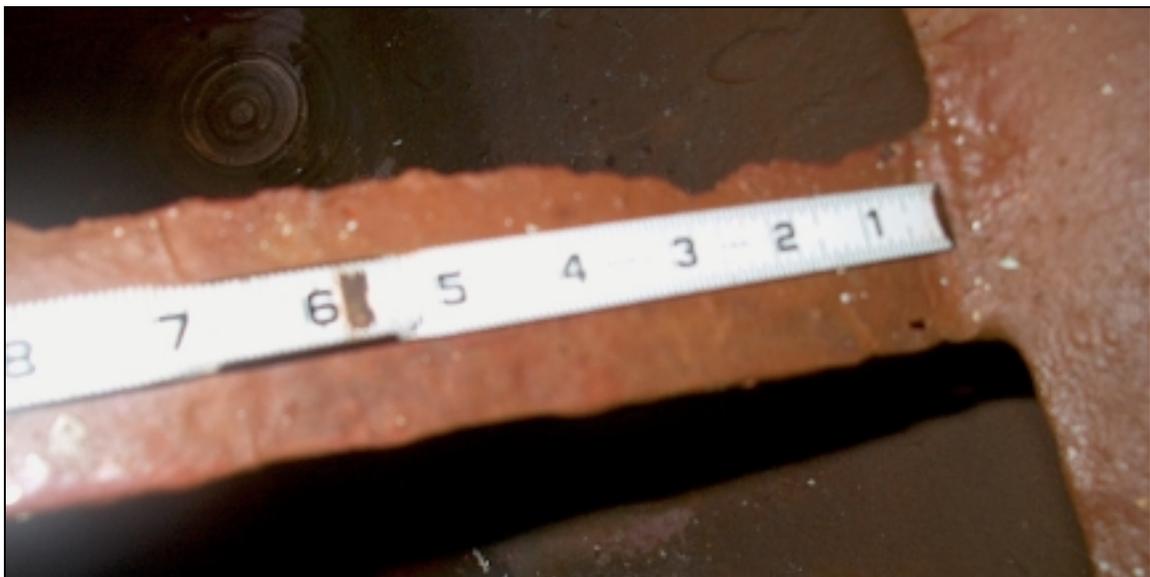
STBD SIDE, CORRODED FLANGE ON STIFFNER.

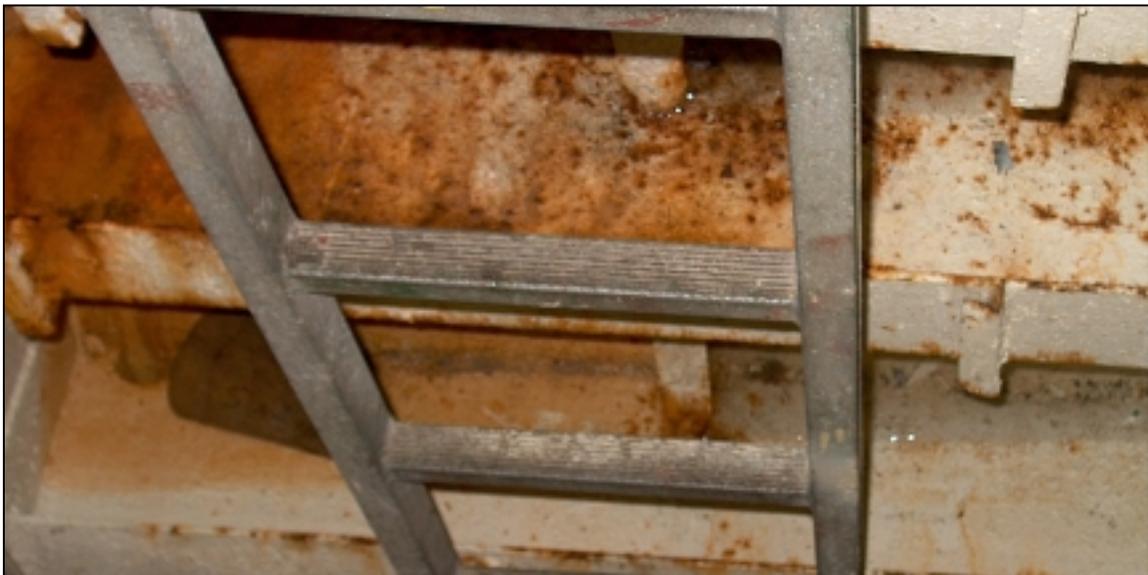
PORT SIDE, SURFACE RUST ON STRINGERS.

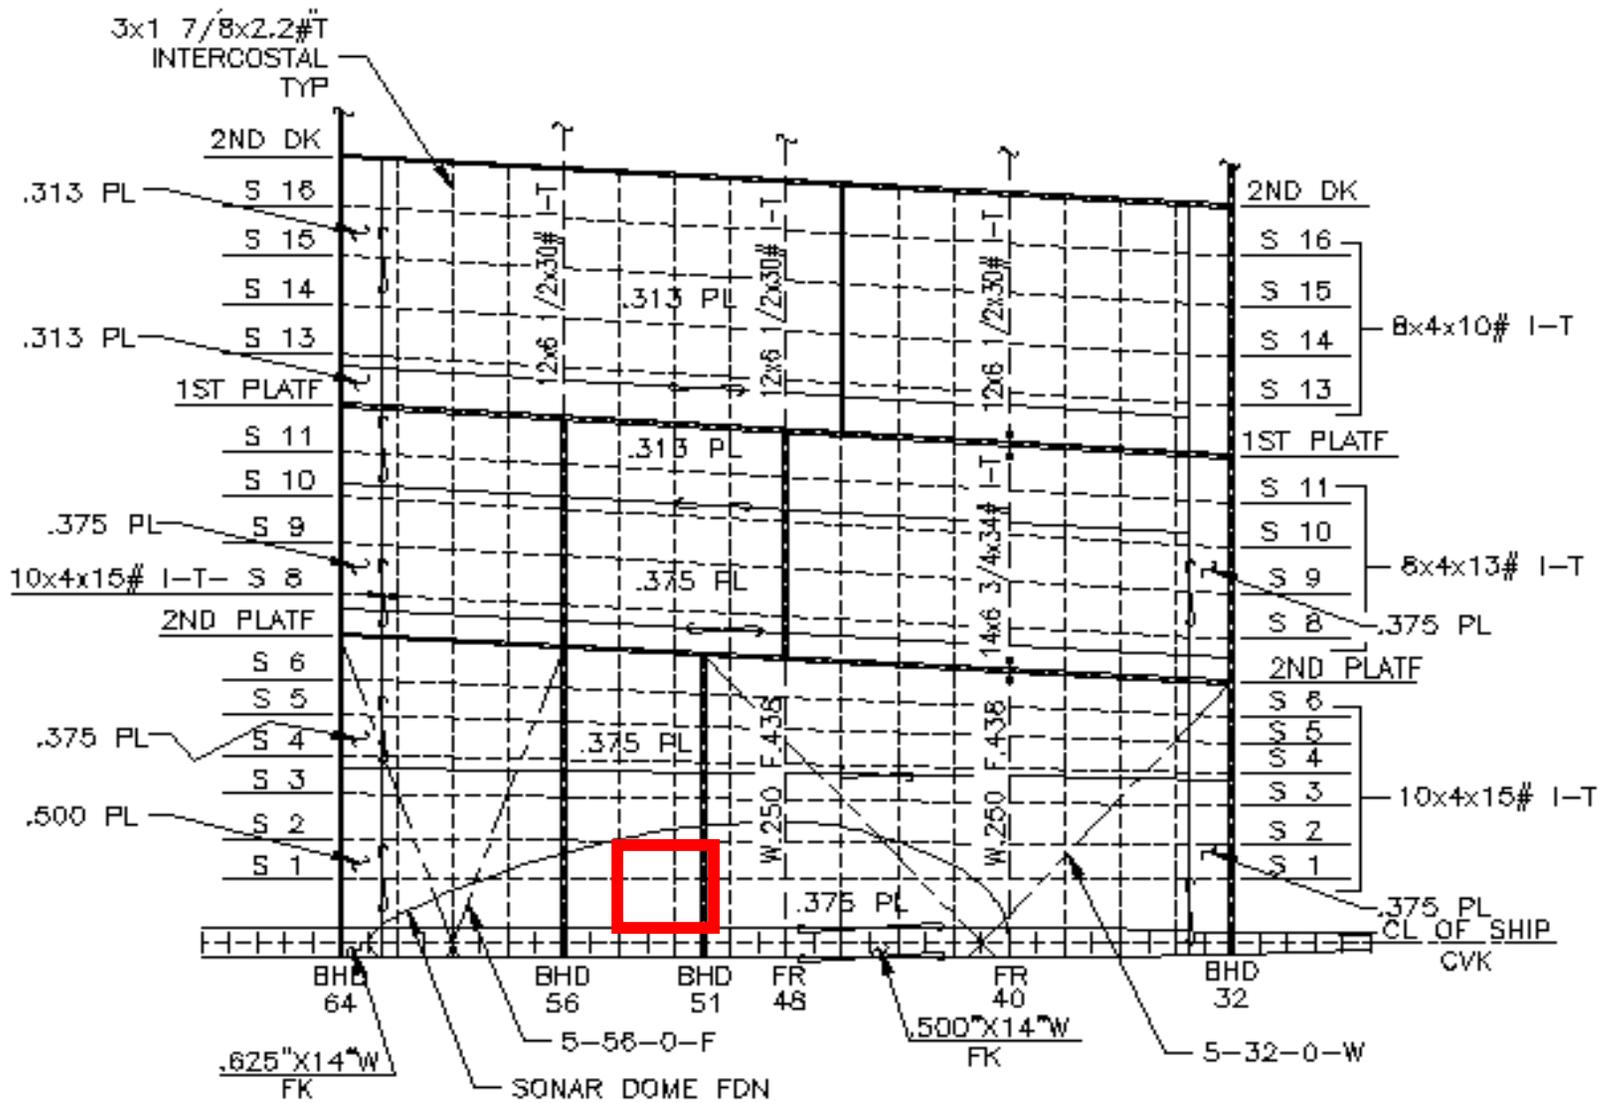
USS UNDERWOOD (FFG-36)
EDUCTOR ROOM (5-51-0-Q)

RED BOX INDICATES AREA WHERE U/T
READINGS WERE TAKEN
SEE FOLLOWING PAGE FOR DRAWING

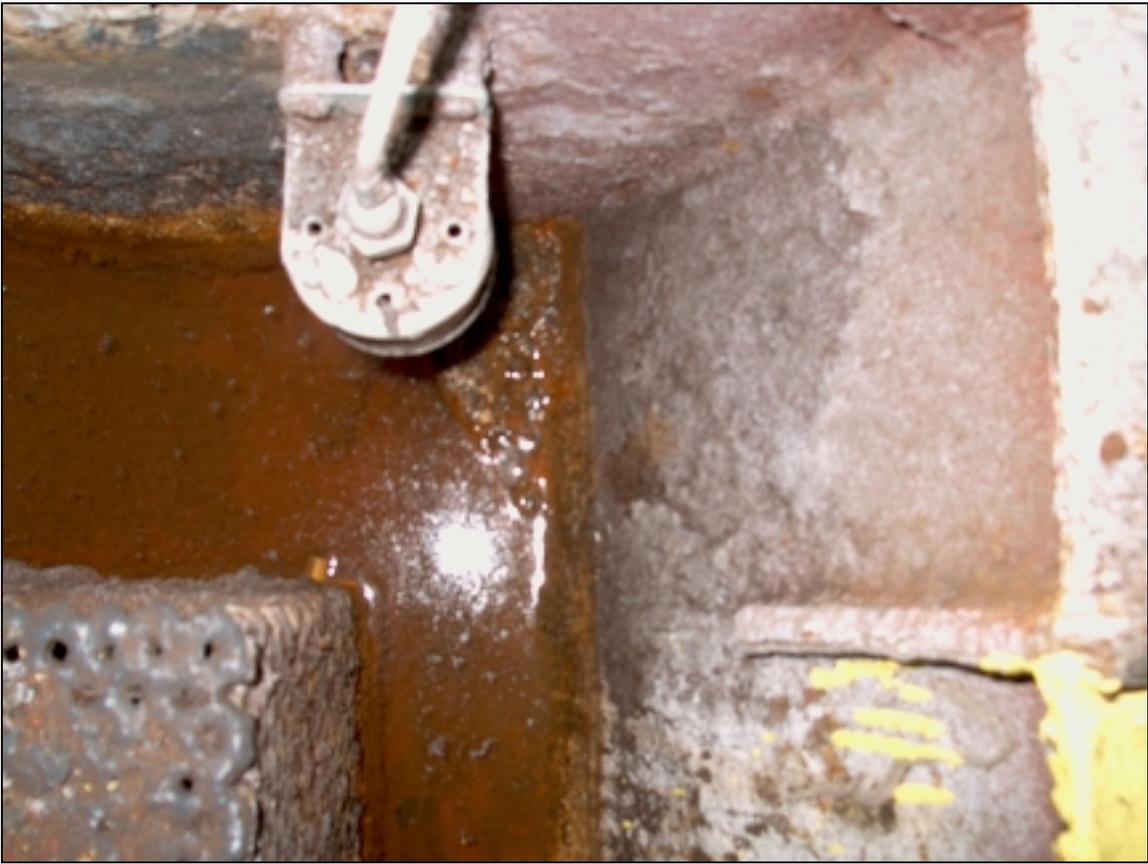
SSPORT C221 POC: F. PRAISSMAN (757) 396-4001 EXT 2130, TPOC: N. TAGLIANETTI							
CSMP SUMMARY: BILGE POCKET HAD SURFACE RUST AND PAINT SEPARATION.					TEST# MRC 1102/1		
ROOT CAUSE/AMPLIFICATION: H1					STEP# 1,2,3,4 & 5		
SYSTEM LEVEL IMPACT:							
PART NO.	NOMEMCLATURE			QTY	NSN		COST
1							
2							
3							
4							
5							
6							
FIRST CONTACT LARSEN	RATE HT1	SECOND CONTACT DUNN		RATE HT2	PHONE		
ASSESSOR / ACT / TECH ID# J. LaROCK/ T. ILGENFRITZ OED SYSTEMS INC.				TD	TL	LOGISTICIAN	TSP

BILGE POCKET SHOWING SURFACE RUST AND PAINT SEPARATION.
AREA RECOMMENDED FOR PRESERVATION.,

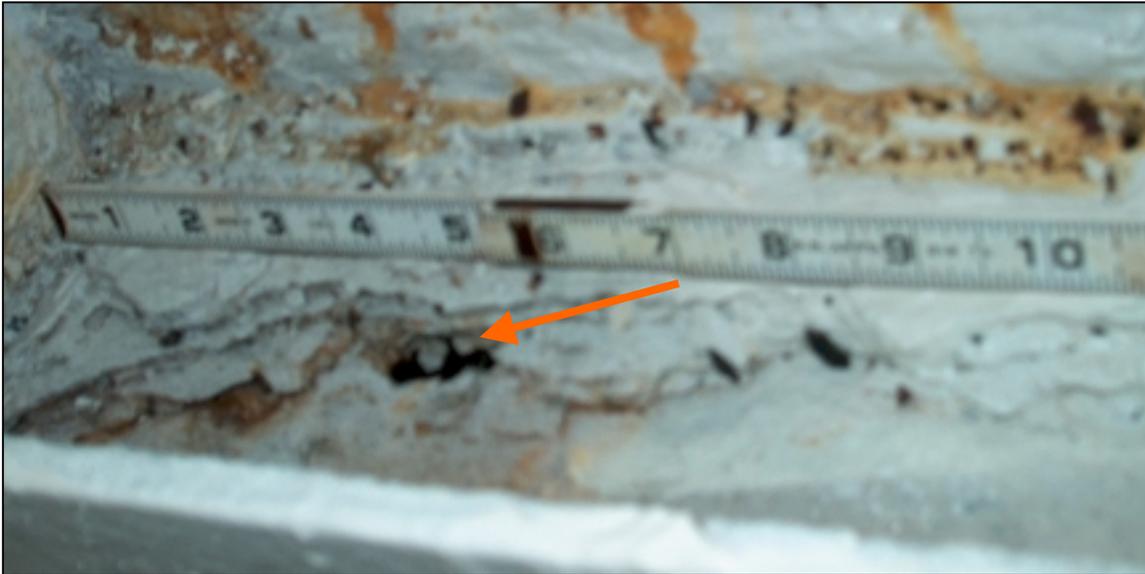
STBD SIDE, STRINGER (8) ARROW INDICATES HOLE IN WEB.
NOTE HEAVY DETERIORATION.

FTSC is to conduct risk assessment and make final repair recommendations.							
SSPORT C221 POC: F. PRAISSMAN (757) 396-4001 EXT 2130, TPOC: N. TAGLIANETTI							
CSMP SUMMARY: STRINGERS (8-9) ON STBD SIDE CHT ROOM ARE HOLED.					TEST# MRC 1102/1		
ROOT CAUSE/AMPLIFICATION: H1					STEP# 1,2,3,4 & 5		
SYSTEM LEVEL IMPACT:							
PART NO.	NOMENCLATURE			QTY	NSN	COST	
1							
2							
3							
4							
5							
6							
FIRST CONTACT LARSEN		RATE HT1	SECOND CONTACT DUNN		RATE HT2	PHONE	
ASSESSOR / ACT / TECH ID# J. LaROCK/ T. ILGENFRITZ QED SYSTEMS INC.				TD	TL	LOGISTICIAN	TSP

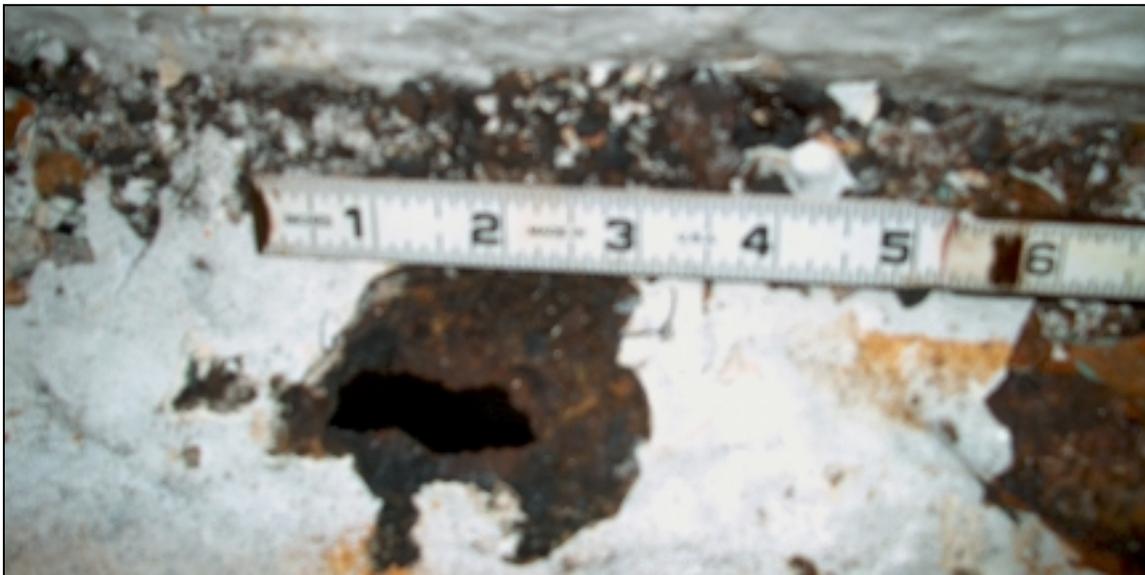
STBD SIDE, LARGE HOLE IN WEB OF STRINGER (9).

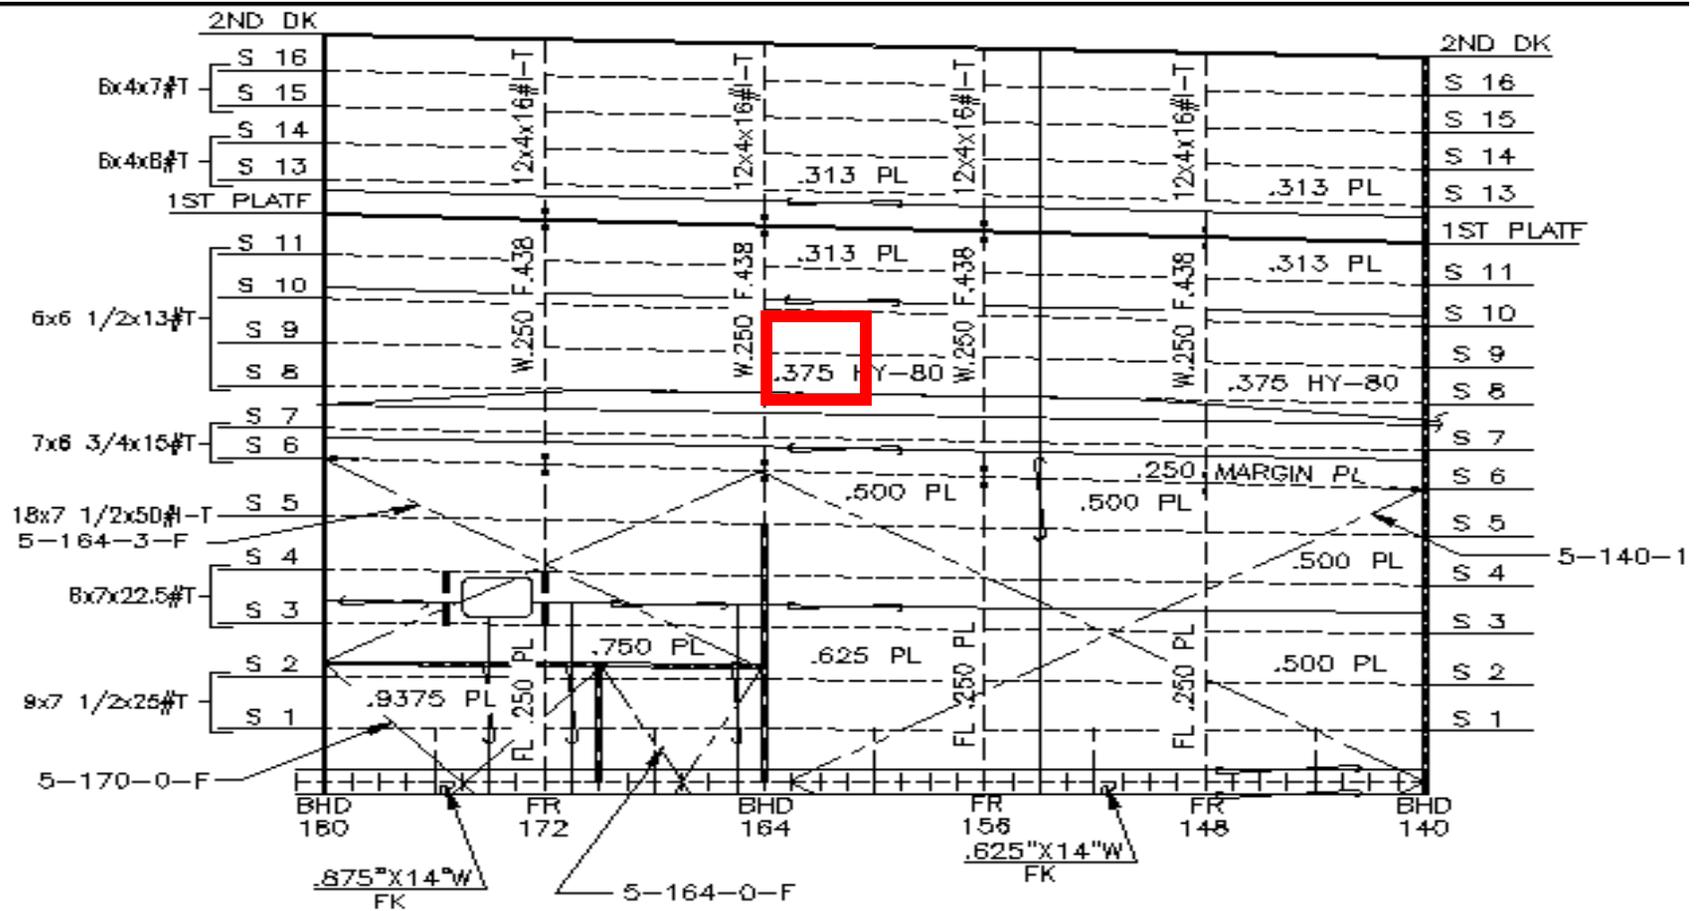
CHT ROOM (4-160-0-Q)
STBD SIDE, BETWEEN BHD (160) AND WF
(164) STRINGERS (8-9)

RED BOX INDICATES AREA WHERE U/T
READINGS WERE TAKEN
SEE THE FOLLOWING PAGE FOR DRAWING

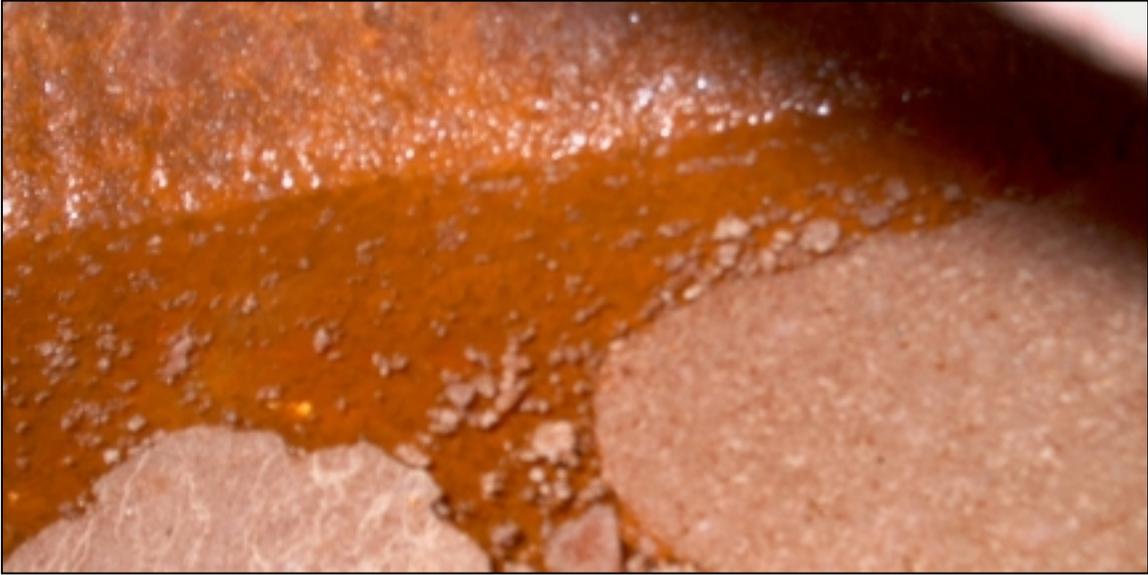
SSPORT C221 POC: F. PRAISSMAN (757) 396-4001 EXT 2130, TPOC: N. TAGLIANETTI						
CSMP SUMMARY: BILGE POCKETS HAVE SURFACE RUST AND PAINT SEPARATION.				TEST# MRC 1102/1		
ROOT CAUSE/AMPLIFICATION: H1				STEP# 1,2,3,4 & 5		
SYSTEM LEVEL IMPACT:						
PART NO.	NOMEMCLATURE			QTY	NSN	COST
1						
2						
3						
4						
5						
6						
FIRST CONTACT LARSEN	RATE HT1	SECOND CONTACT DUNN		RATE HT2	PHONE	
ASSESSOR / ACT / TECH ID# J. LaROCK/ T. ILGENFRITZ OED SYSTEMS INC.			TD	TL	LOGISTICIAN	TSP

STBD SIDE, AFT OF BHD (100) BILGE POCKET.
NOTE STANDING WATER AND CORROSION.

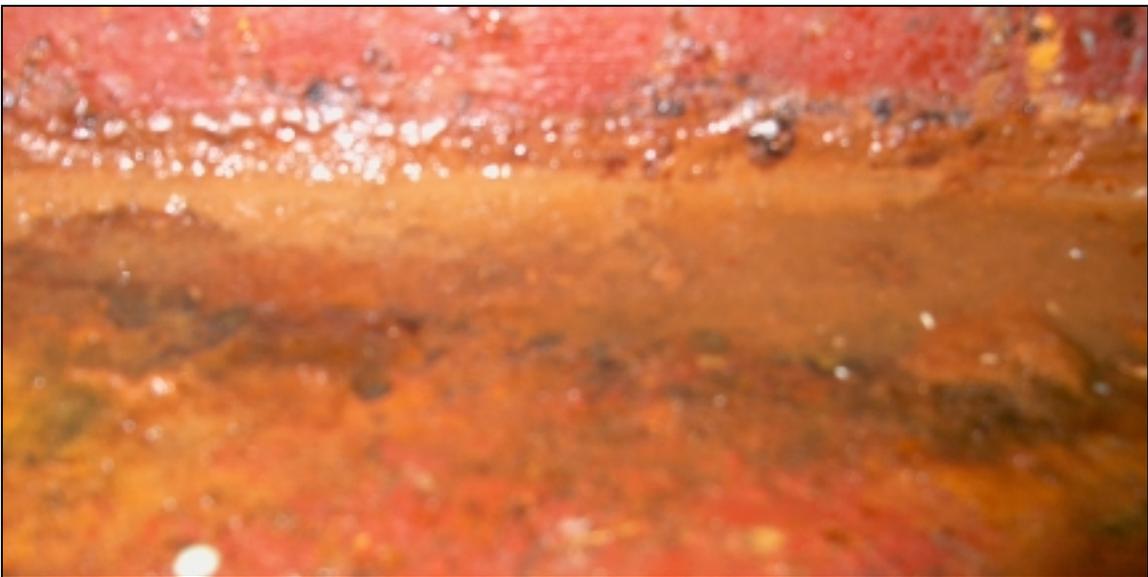
PORT SIDE BILGE POCKET.

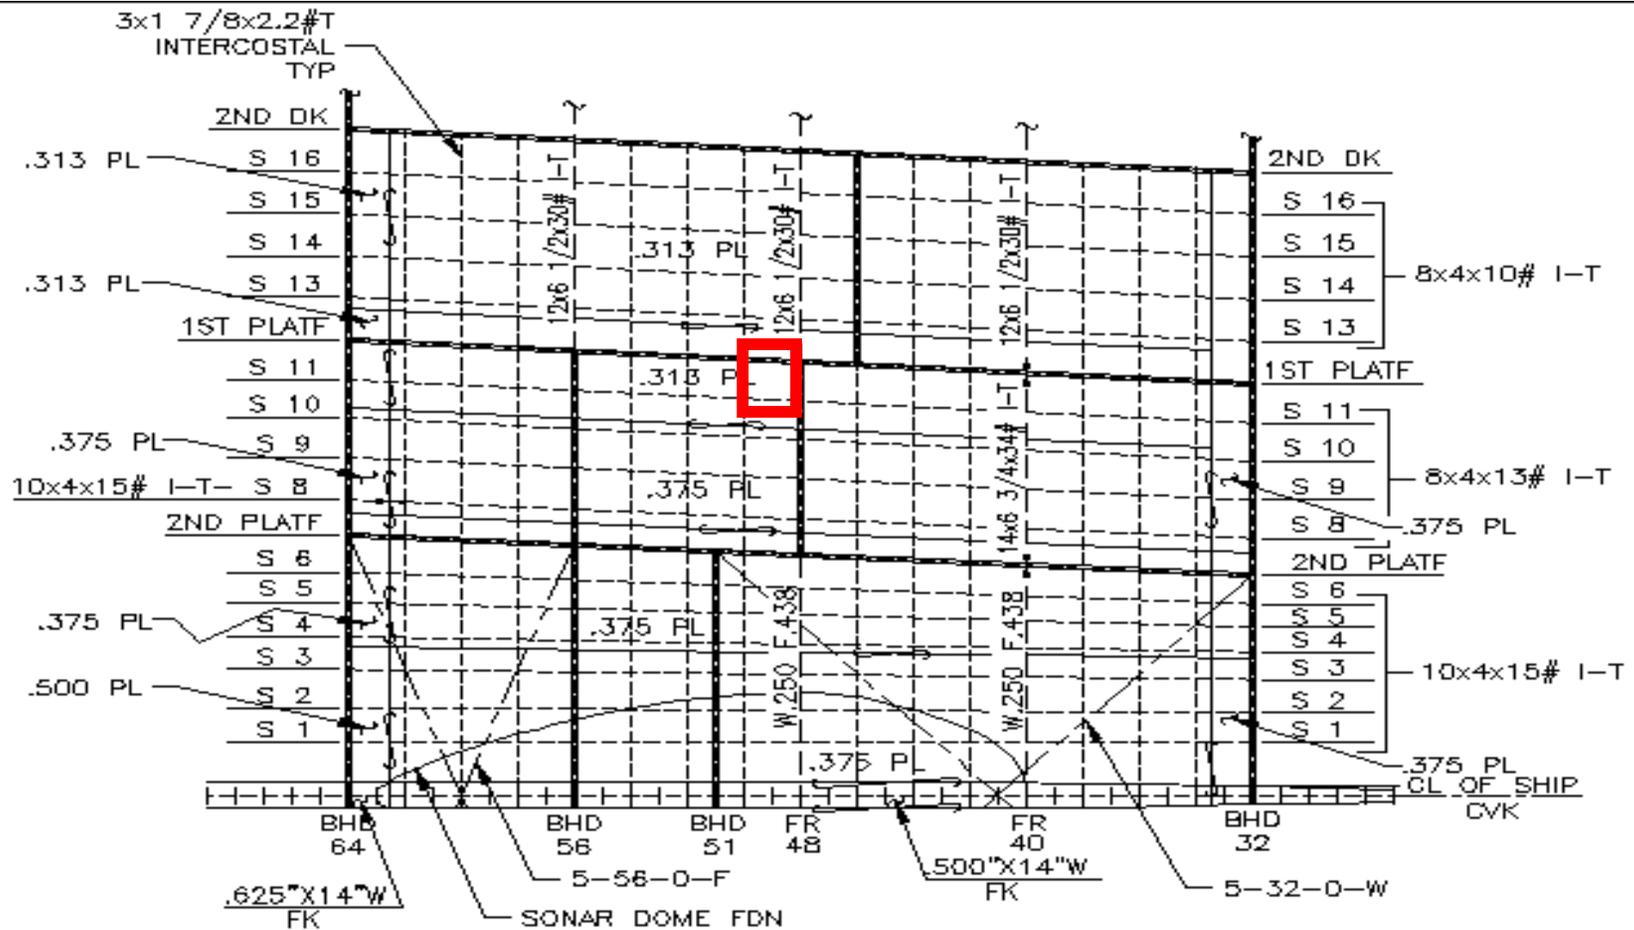
SONAR COOLING ROOM (4-48-1-Q)
STBD SIDE, AFT OF BHD (48)

RED BOX INDICATES AREA WHERE
U/T READINGS WERE TAKEN
REFER TO THE FOLLOWING PAGE FOR
DRAWING

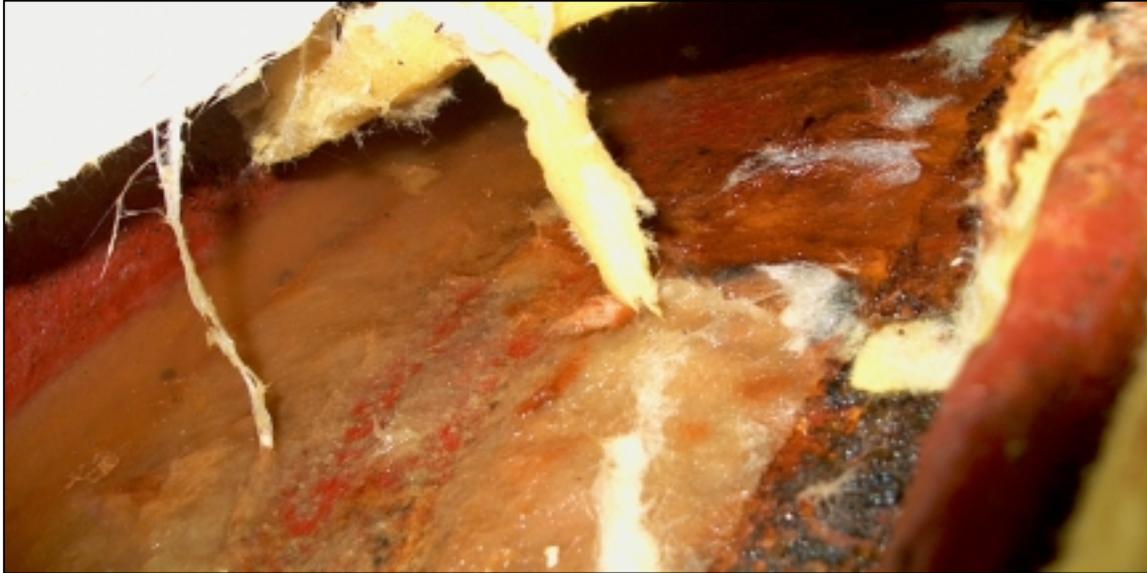
CORROSION IS CAUSED BY WATER TRAPPED UNDER LAGGING.
REMOVAL OF LAGGING, AND PAINTING WITH ANTI-SWEAT COATING IS RECOMMENDED.

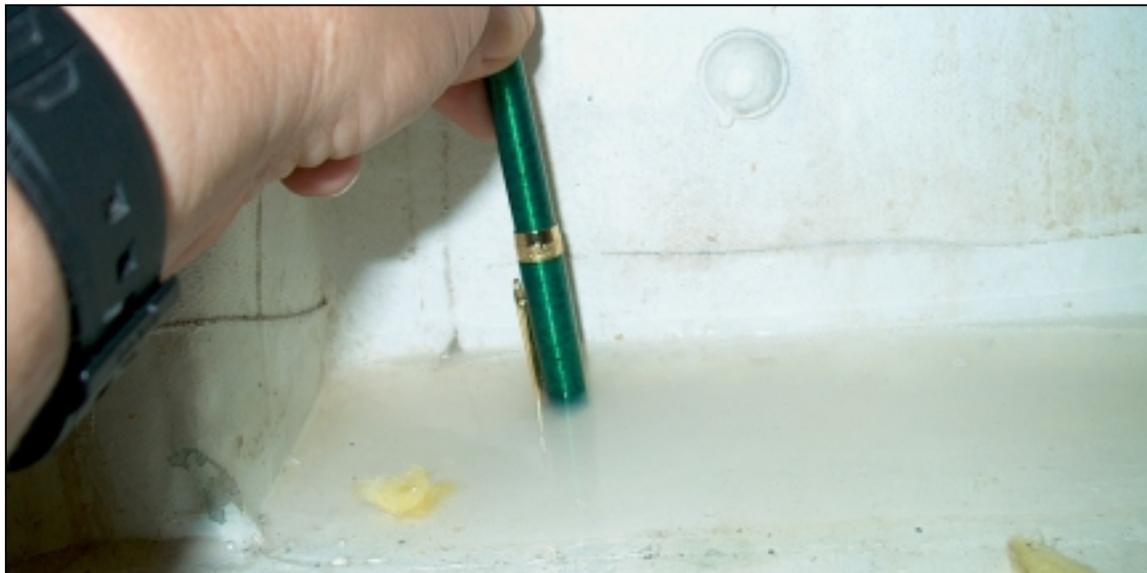
STANDING WATER ON INSULATION.
THIS PROBLEM IS COMMON FOR THIS AREA ON FFG-7 CLASS SHIPS
