USS KLAKRING - FFG 42

SHELL CONDITION ASSESSMENT SURVEY
INTERIOR AREAS
DECEMBER 3, 2001 - DECEMBER 14, 2001

PREPARED BY SUPSHIP PORTSMOUTH
JANUARY 2002

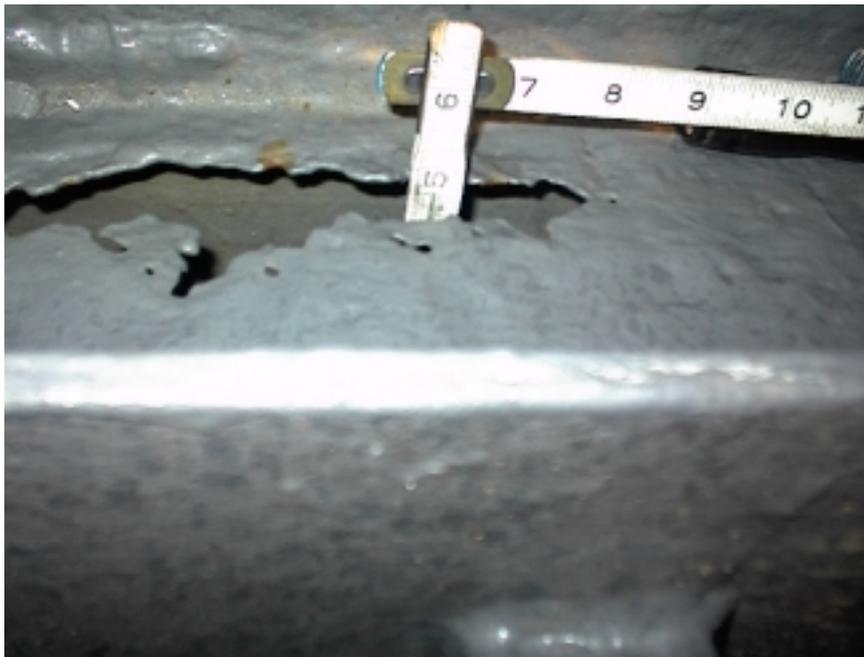
EMO4-P423

STIFFENER S7(7"X6 3/4"T) FROM FR 160-172, S8 & S9(6"X 6 1/2"T) FROM FR 164- 172 AND P7(7"X6 3/4"T FROM FR 170-175 WERE FOUND CORRODED AND HOLED. UT READINGS 4/4/01 AND 12/01 INDICATE STIFFENERS ARE BELOW MINIMUM TOLERANCES

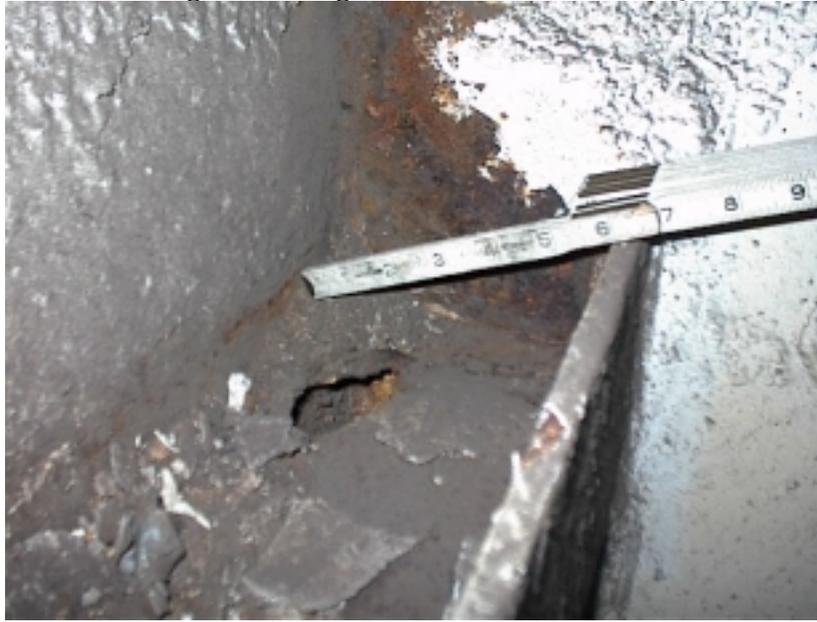
EM04-P423

STIFFENER S7(7"X6 ¾"T) FROM FR 160-172, S8 & S9(6"X 6 ½"T) FROM FR 164- 172 AND P7(7"X6 ¾"T FROM FR 170-175 WERE FOUND CORRODED AND HOLED. UT READINGS 4/4/01 AND 12/01 INDICATE STIFFENERS ARE BELOW MINIMUM TOLERANCES

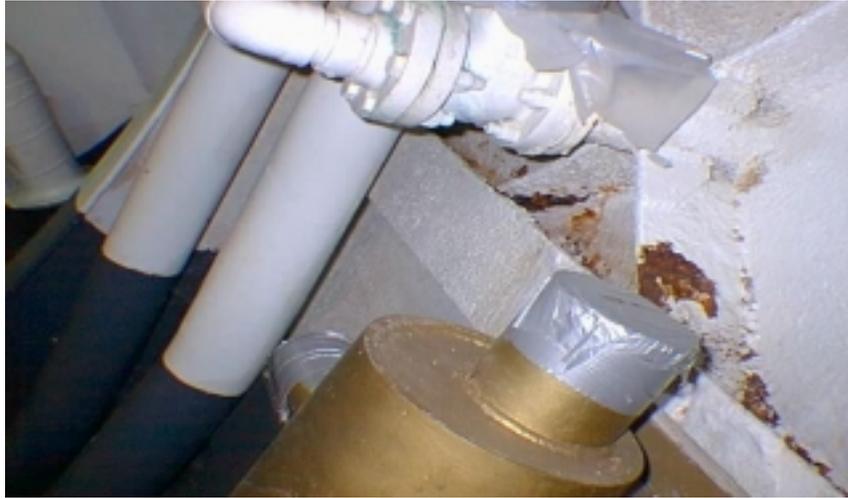
EM04-P423

Heavy corrosion around CHT overboard, stbd shell, and stringer no. 9, FR 166. Shell is thinned but is still over 75% of original thickness. Stringer is holed.

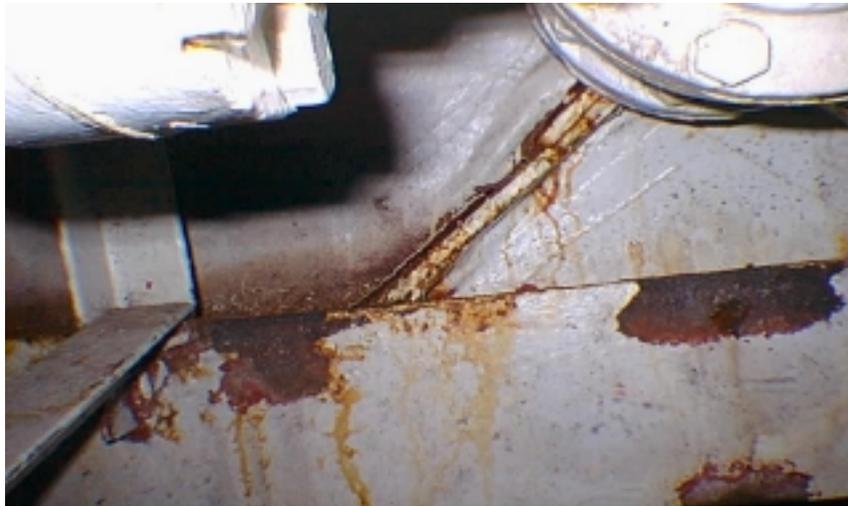
EM04-P423

Close-up view of overboard area, stringer no. 7 at FR 166, stbd.

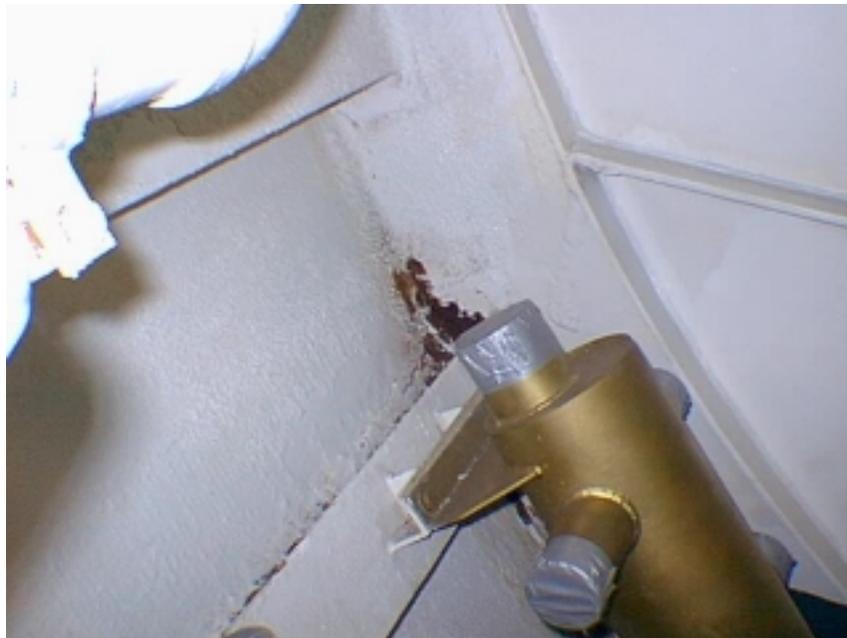
EM04-P423

Corrosion at Fr 172, stbd, bhd to F/F PUMP ROOM. Bhd is thin, but not holed after needle gunning

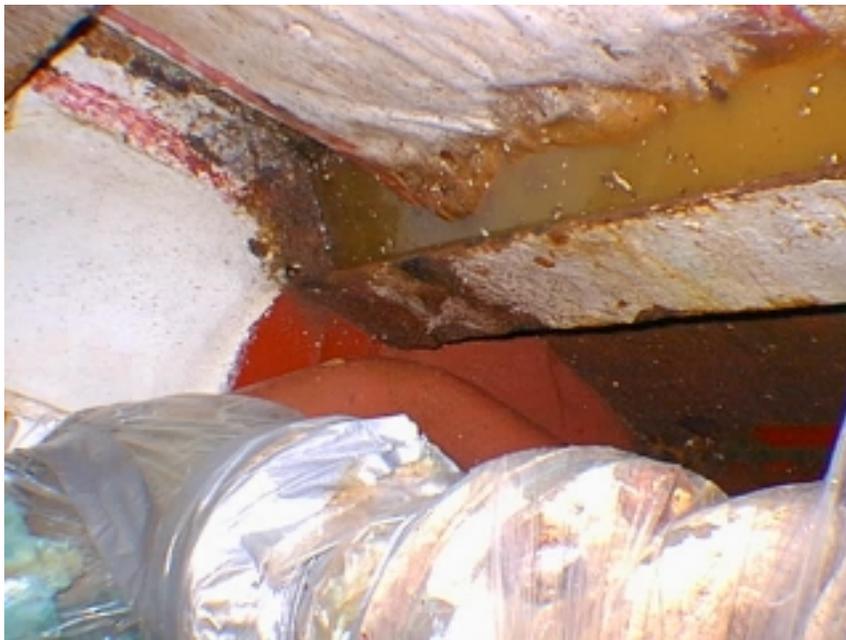
EM02-P030/A745

Stiffener P8, Fr 218. The web of the stiffener is corroded.

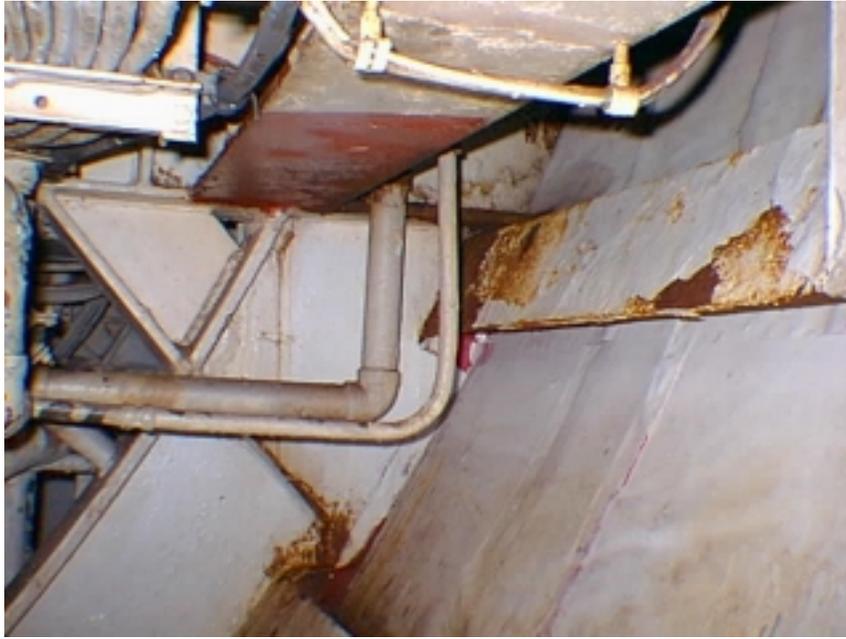
EM02-P030/A745

Corrosion, portside, outboard of the HPAC, Fr 218, just below the U/L grating.

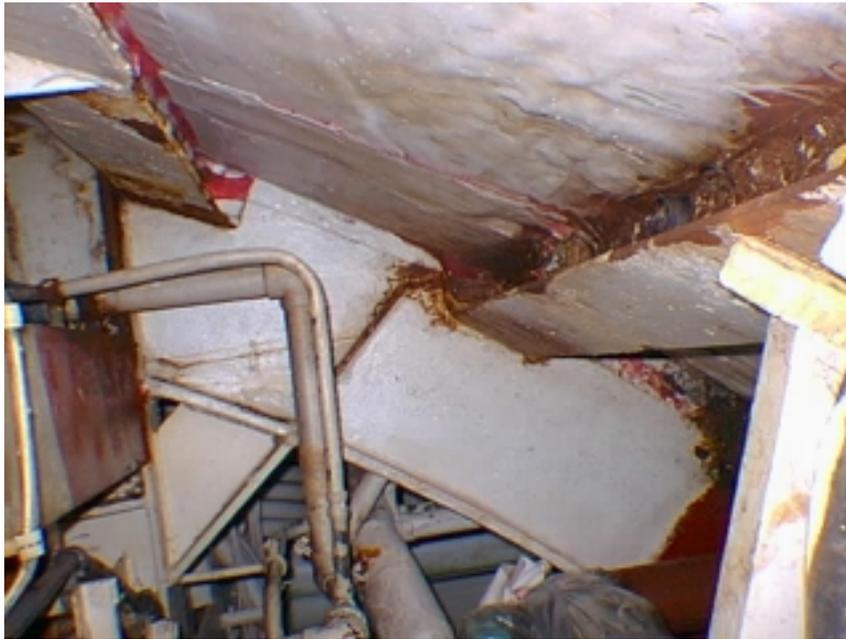
EM02-P030/A745

Corrosion in the web of P9.

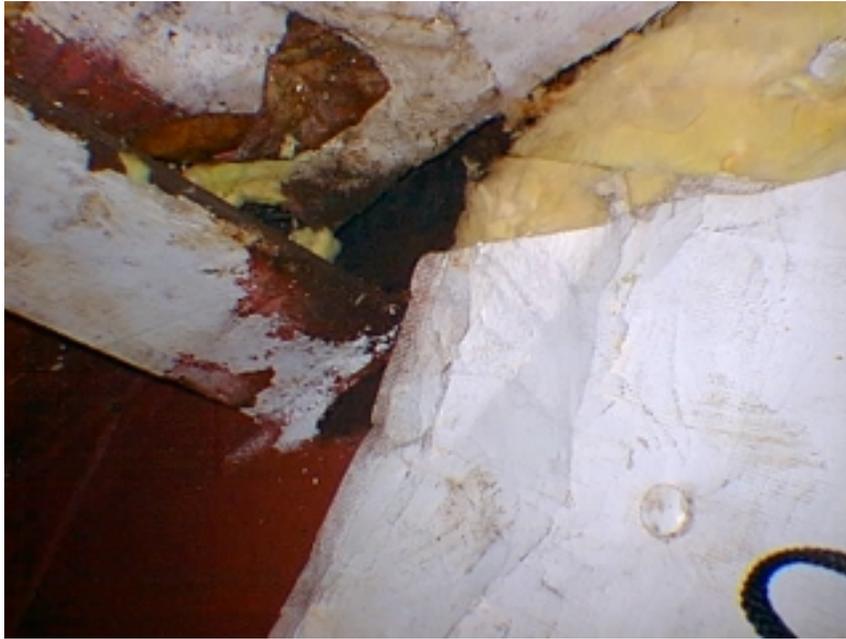
EM02-P030/A745

Corrosion at the intersection of BHD 212, port shell and P9. Areas look bad, but UT's indicate they are within specs. Another place that should not be lagged.

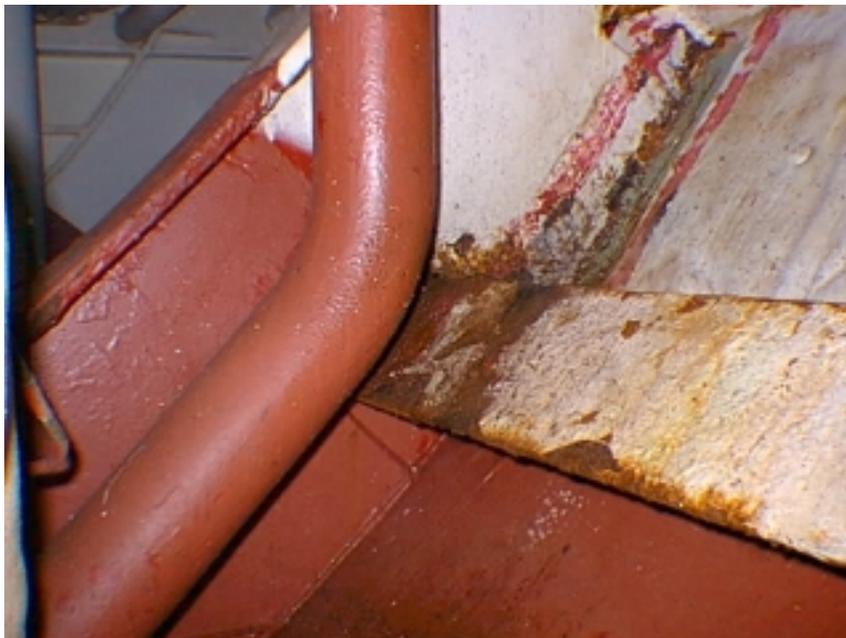
EM02-P030/A745

The flange and web of P8 at Fr 218 are very thin but within specs. Web holed, see A747.

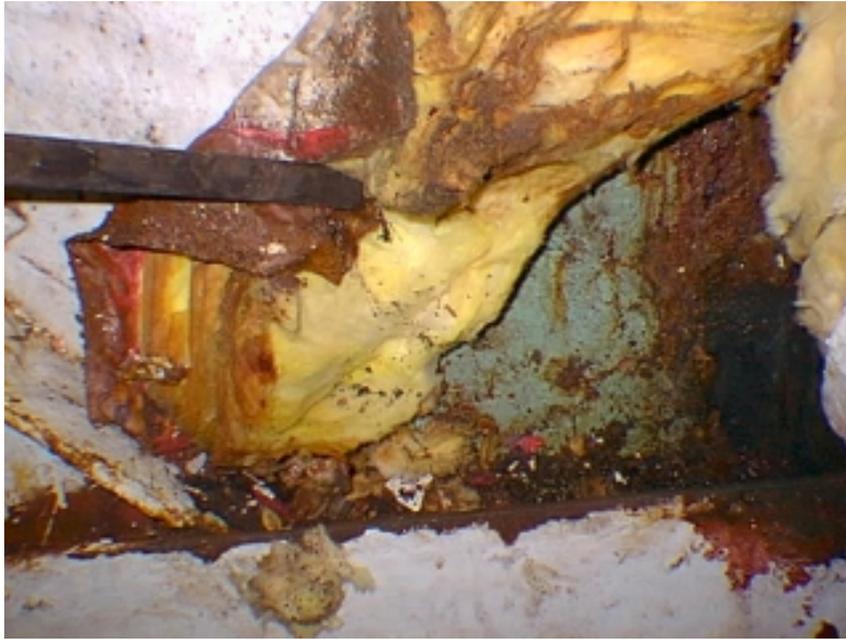
EM02-P030

Heavy corrosion behind lagging at the connection between P9, the shell and BHD 212. UT readings indicate thinned areas but all within specs

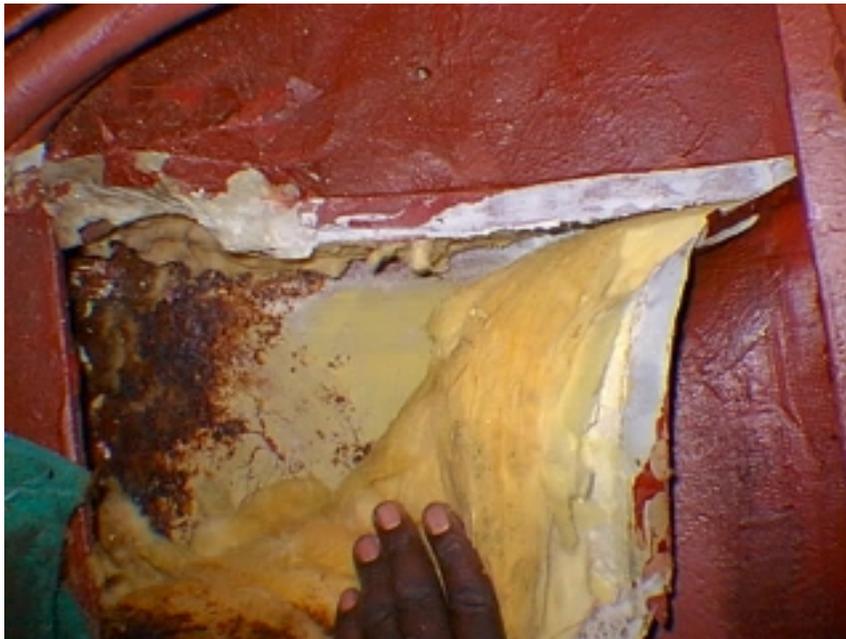
EM02-P030

Similar corrosion on P9 at Fr 226. UT's indicate this is mainly surface corrosion at this time.

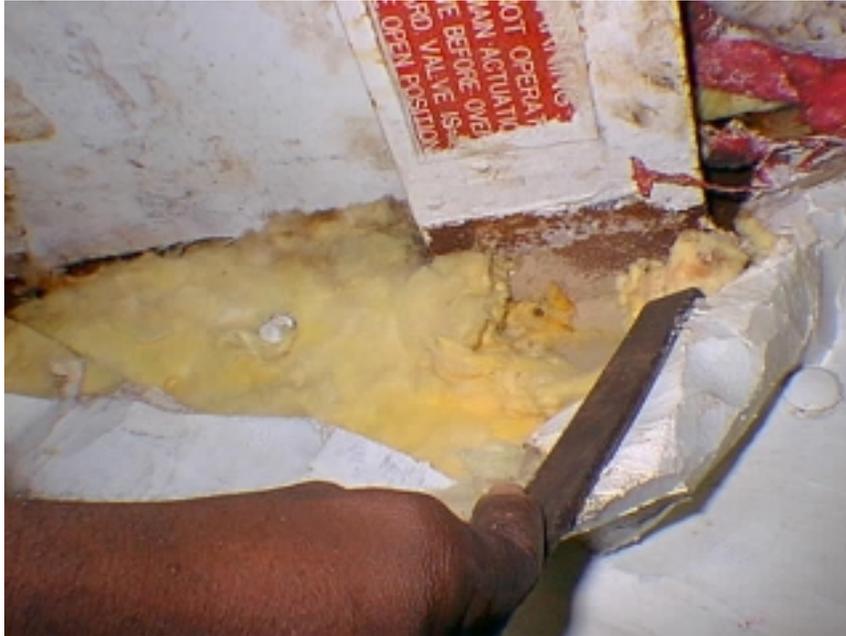
EM02-P030

Corrosion at the connection between the shell and the Transverse bhd at Fr 212. Bhd is thinned but within specs.

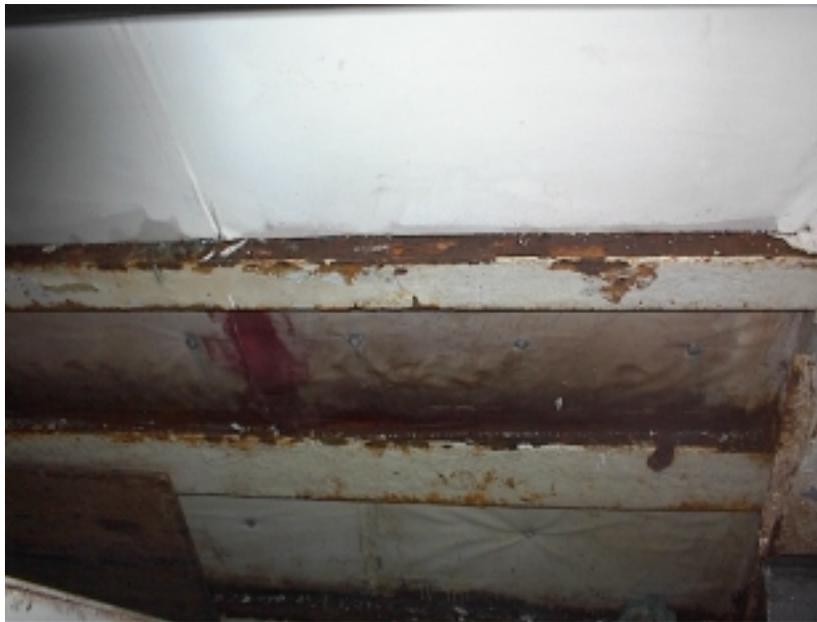
EM02-A745/P030

THE SHELL LAGGING STBDSIDE, FR 212-226, FROM THE BOTTOM EDGE OF THE LAGGING TO 1' ABOVE THE U/L GRATING & PORTSIDE, FR 212-226, FROM THE BOTTOM EDGE OF THE LAGGING TO 1' ABOVE THE U/L GRATING WAS FOUND SATURATED

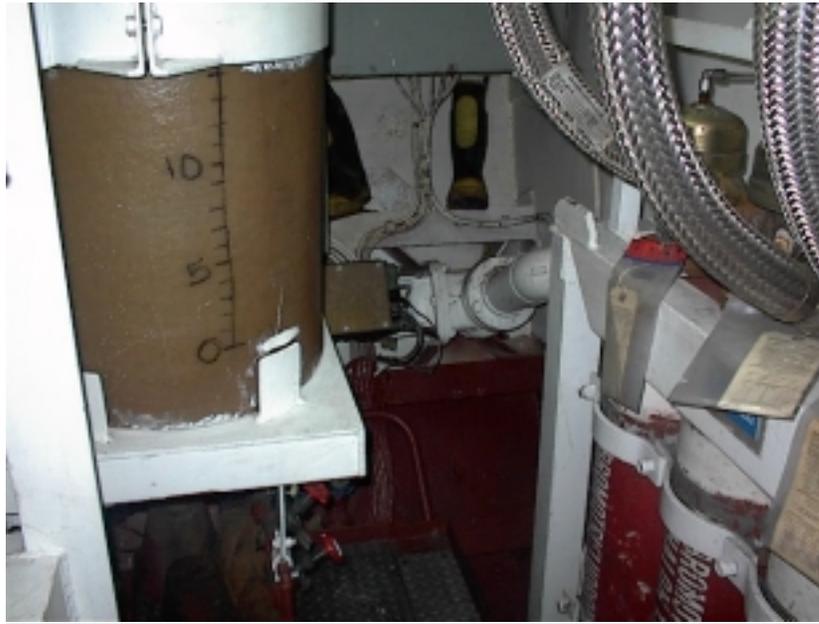
**EM02-A747, A748/P028, A745/P030
STIFFENERS P9(6"X6 1/2"T) FROM FR 214-221 & P10 (6"X6 1/2"T) FROM FR 215-219 WERE FOUND
CORRODED. UT READINGS 4/5/01 INDICATE STIFFENERS ARE BELOW MINIMUM TOLERANCES.**

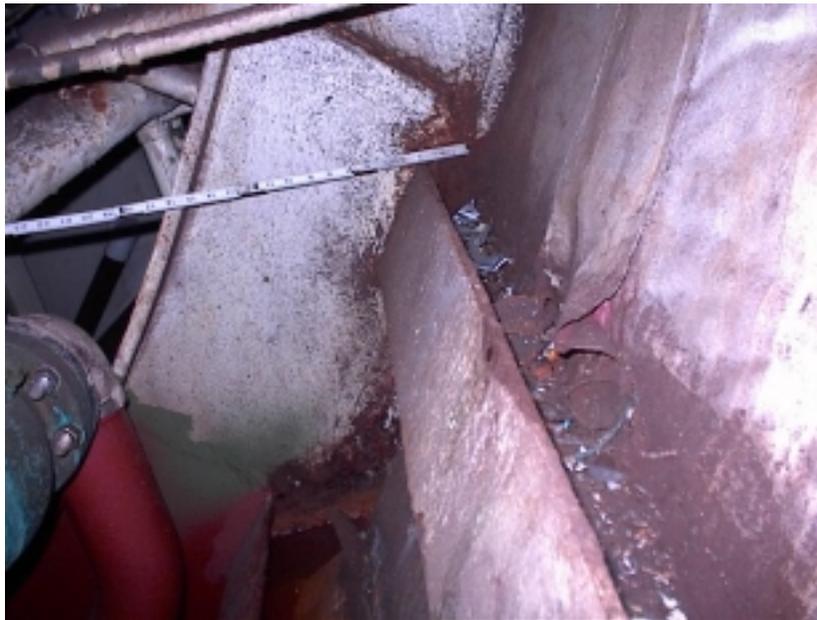
**EM02-A747
WEB FRAME 220 ABOVE SHELL STRINGER #8 P IS HOLED DUE TO STANDING WATER.**

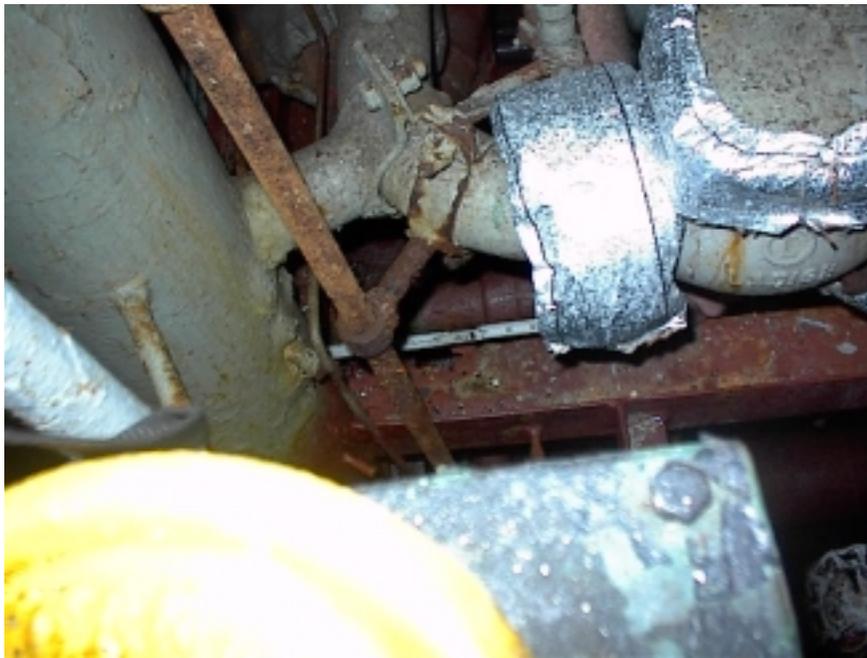
EMO1-POO5/A19

STIFFENER P9 (6"X 6 1/2" T) FROM FR 270-272 WAS FOUND CORRODED AND HOLED. UT READINGS 4/4/01 INDICATE STIFFENER IS BELOW MINIMUM TOLERANCES

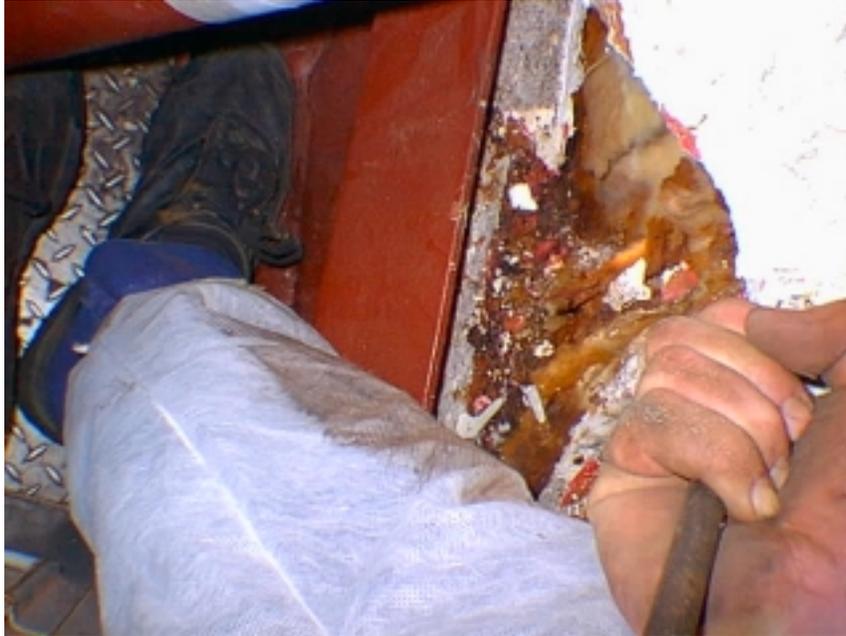
EM01-P006/A198

This level of corrosion was common on all L/L areas where lagging was opened for inspection.

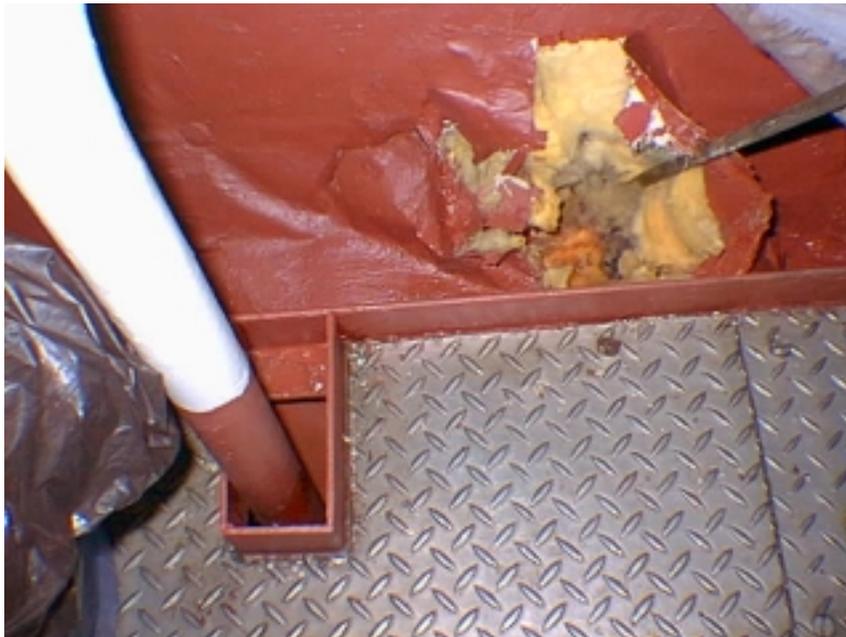
EM01-P006/A198

Areas of shell in way of weep holes below overboards was typically found with heavy corrosion

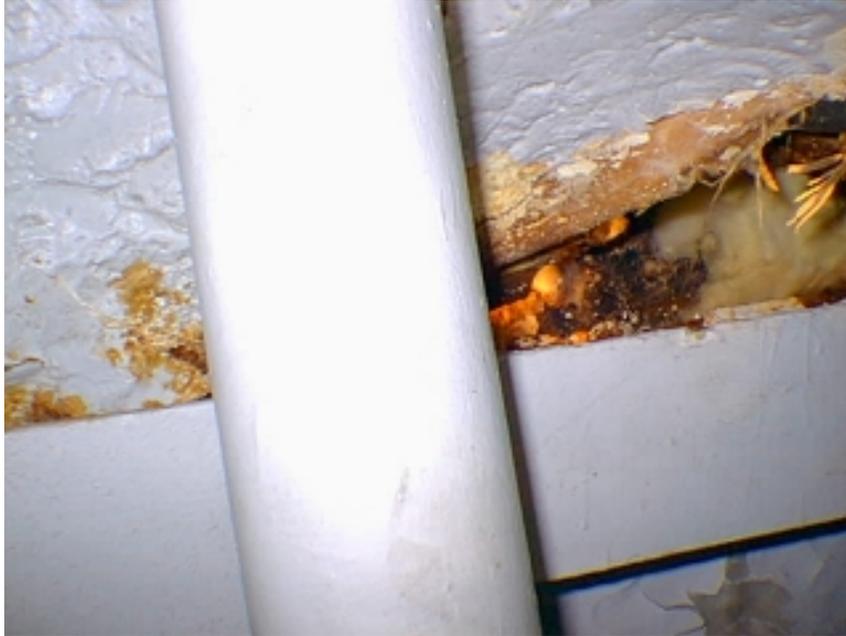
EM01-P006/A198

Lagging saturated above the bilge level, Fr 260, stbd side.

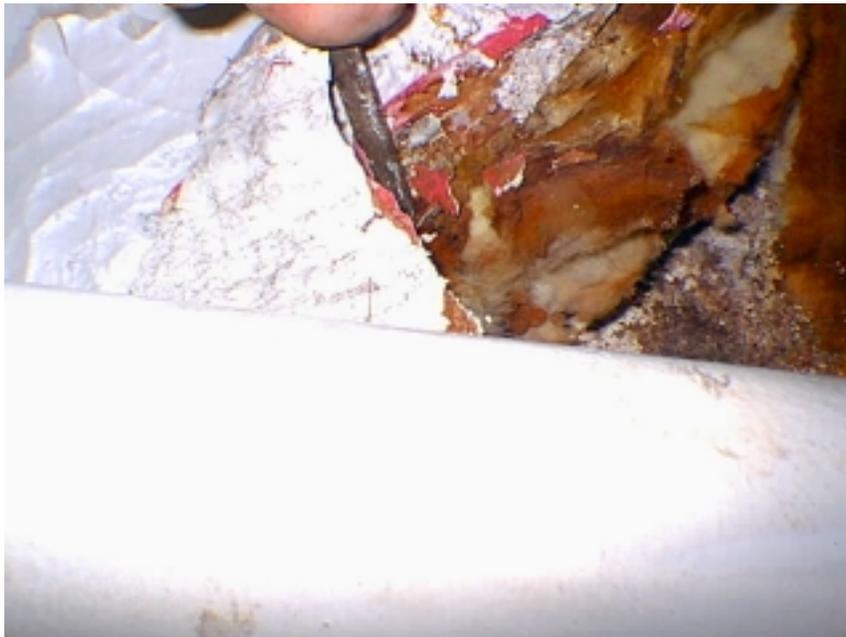
EM01-P006/A198

Extreme corrosion behind lagging in way of lube oil cooler ovbd, Fr 272 stbd side.

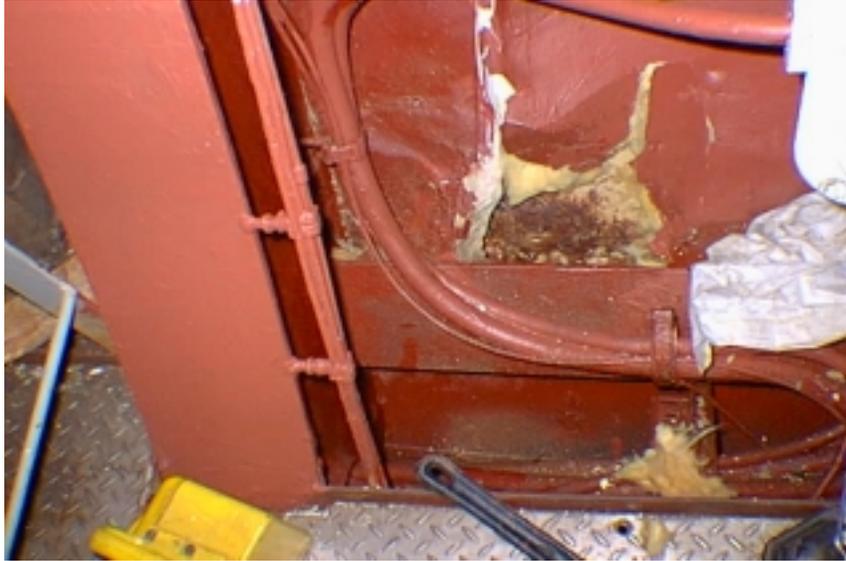
EM01-P006/A198

Corrosion behind lagging that otherwise appears satisfactory.

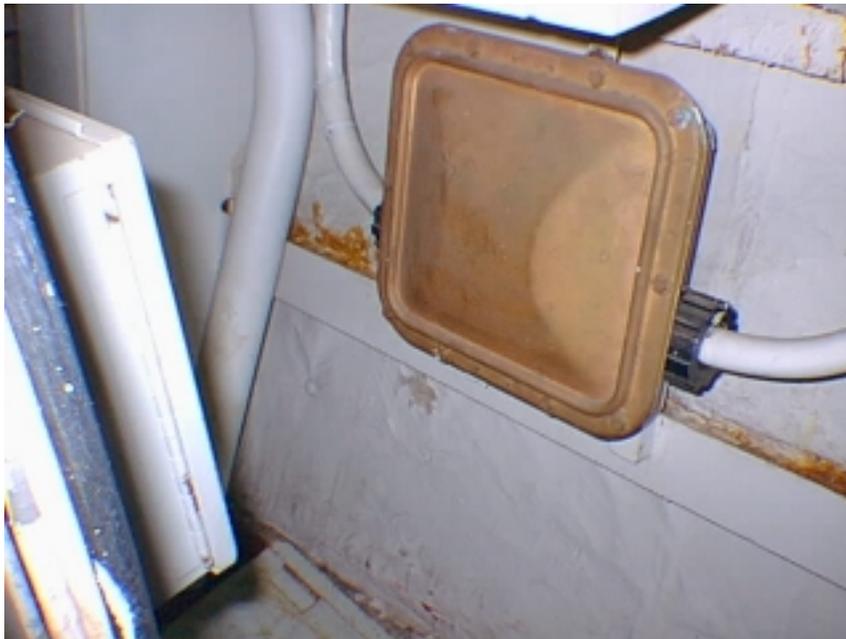
EM01-P006/A198

Lagging showing signs of saturation

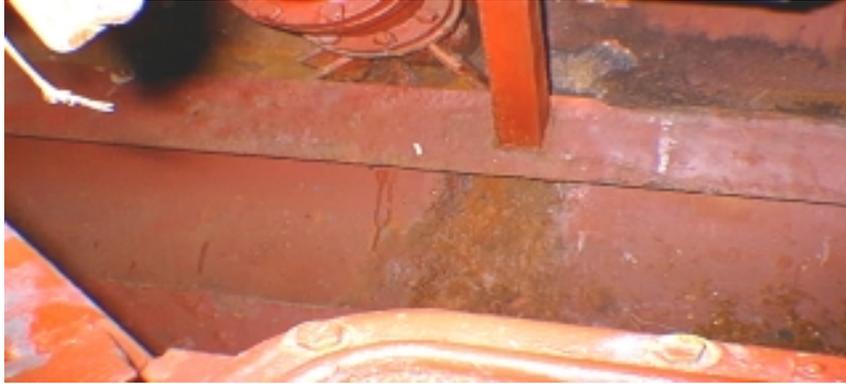
EM01-P006/A199
Corrosion under Prairie Masker cooler, around overboard. Some thin plate was determined by UT. See UT grid.

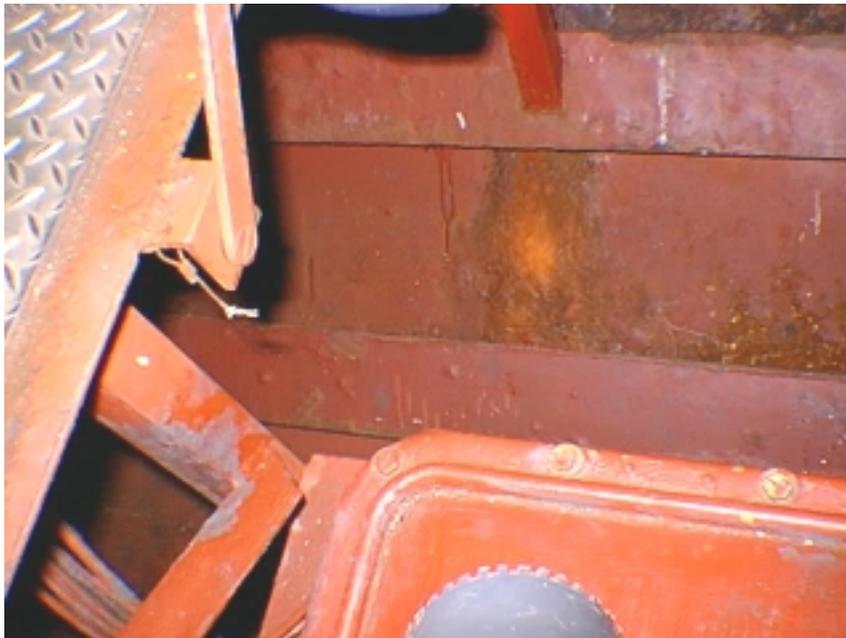
EM01-P006/A199
Additional view of same area

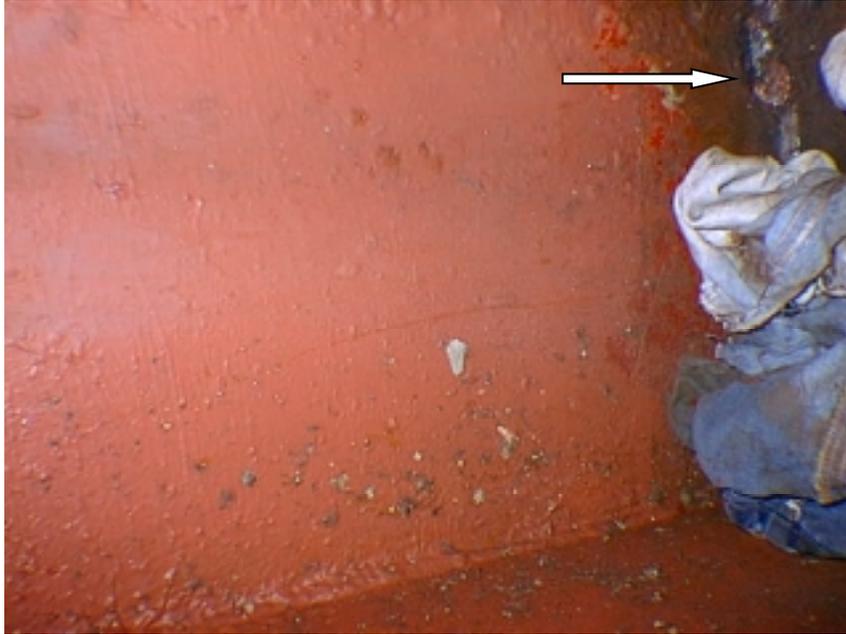
EM01-P006/A198

Arrow indicates what appears to be a doubler plate on the keel side of the margin plate. Anomaly is at Fr 271, port side. Note the heavy corrosion of the area. Shipsforce indicated the bilges were to be cleaned and preserved by the shipyard.

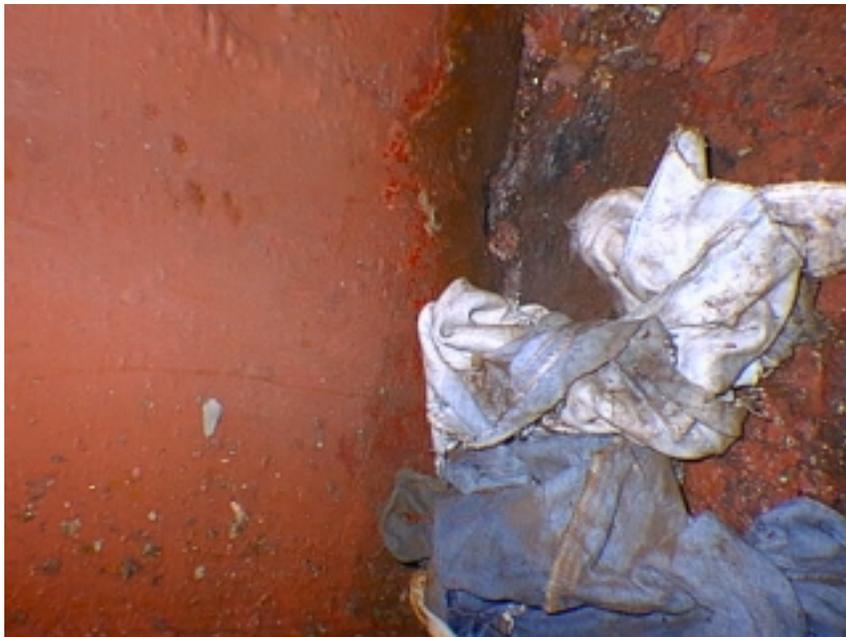
EM01-P006/A198

Closer view of doubler plate. No action needs to be taken.

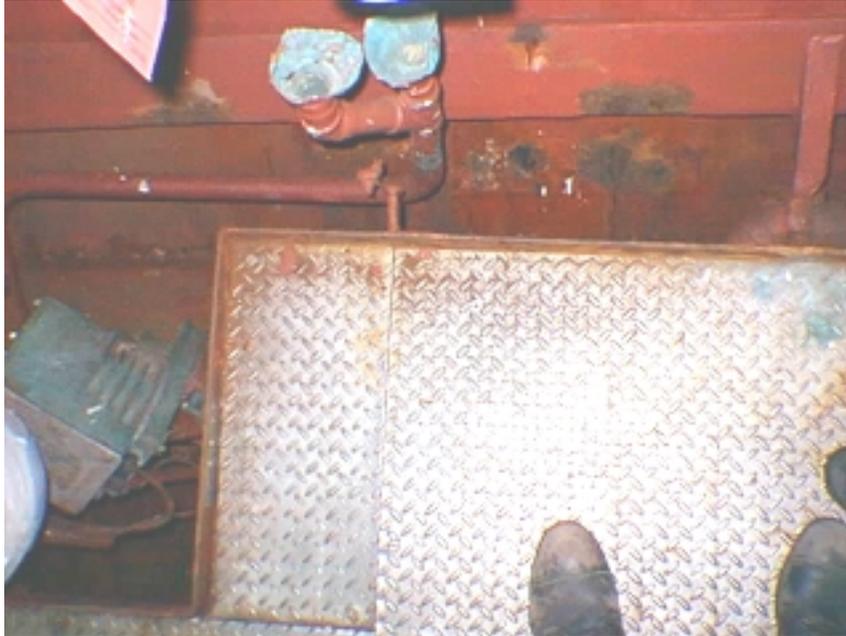
EM01-P006/A198

Area under Prairie Masker cooler, Fr 268, port side L/L. Seawater leakage and drains have caused localized shell thinning. See UT grids.

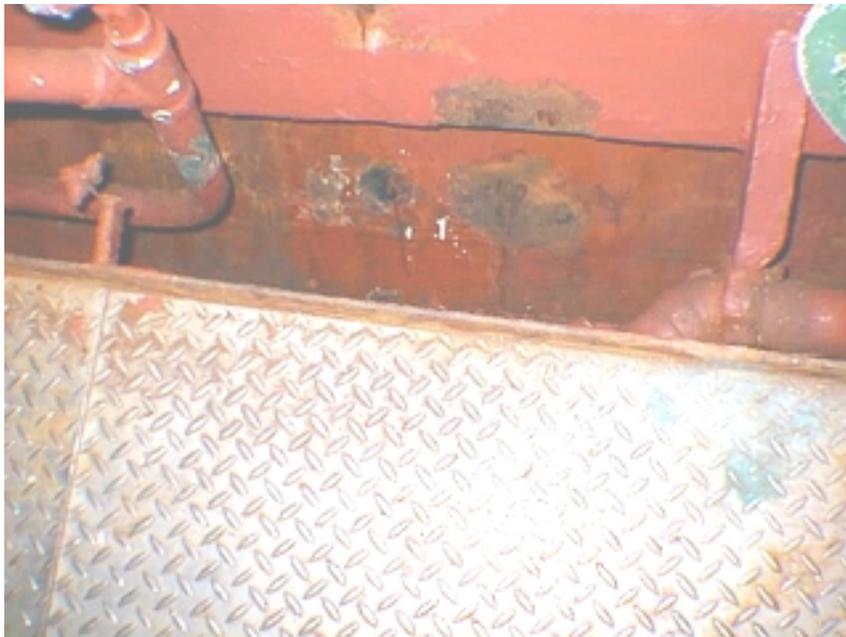
EM01-P006/A198

Closer view of areas defined above.

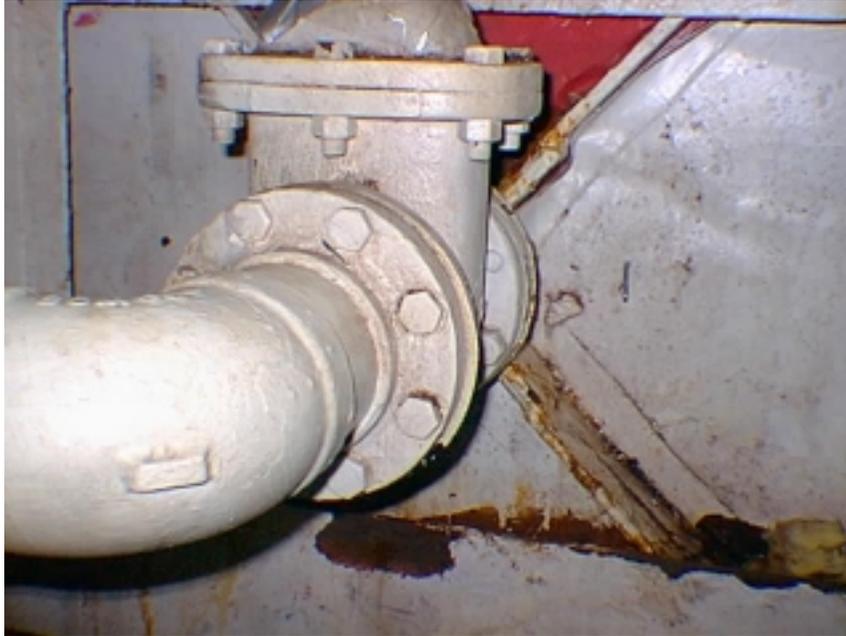
EM01-P006/A198

Area around eductor overboard, Fr 256, port side, L/L. Structure is satisfactory, but saturated lagging has caused considerable corrosion.

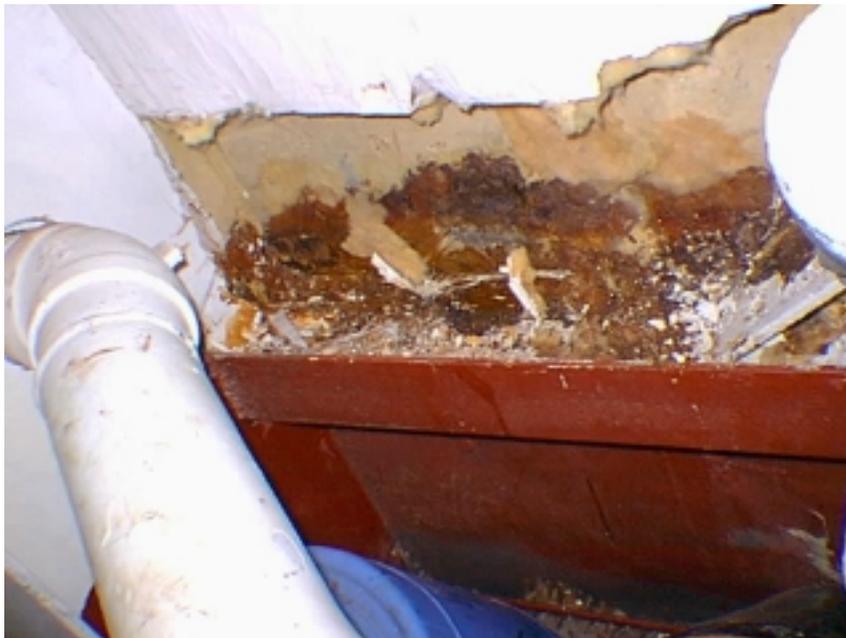
EM01-P006/A198

Different view of areas defined above

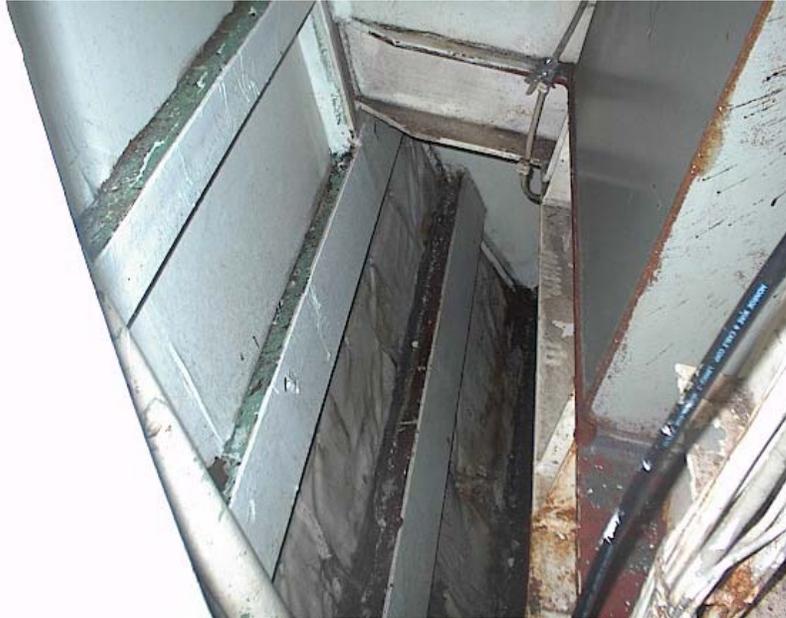
EM02-A746/749

FR.316-328,P, SHELL AND STRINGERS BETWEEN STRINGERS P9-P13 ARE RUSTED DUE TO STANDING WATER.

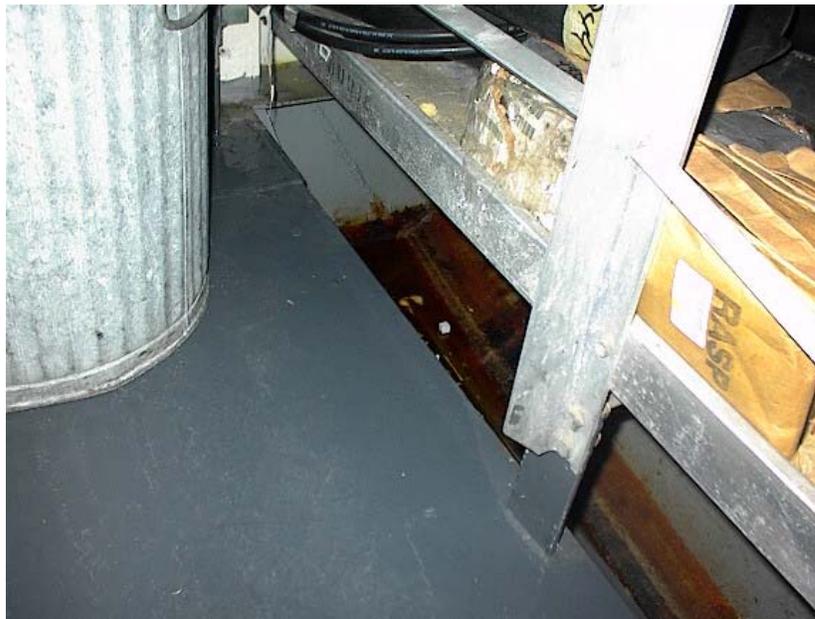
SS01-A009

FR.328-336,P/S,TROUGH BETWEEN TANK MARGIN PLATE & SHELL AND BULKHEAD, FR.328,IS RUSTED DUE TO STANDING WATER.

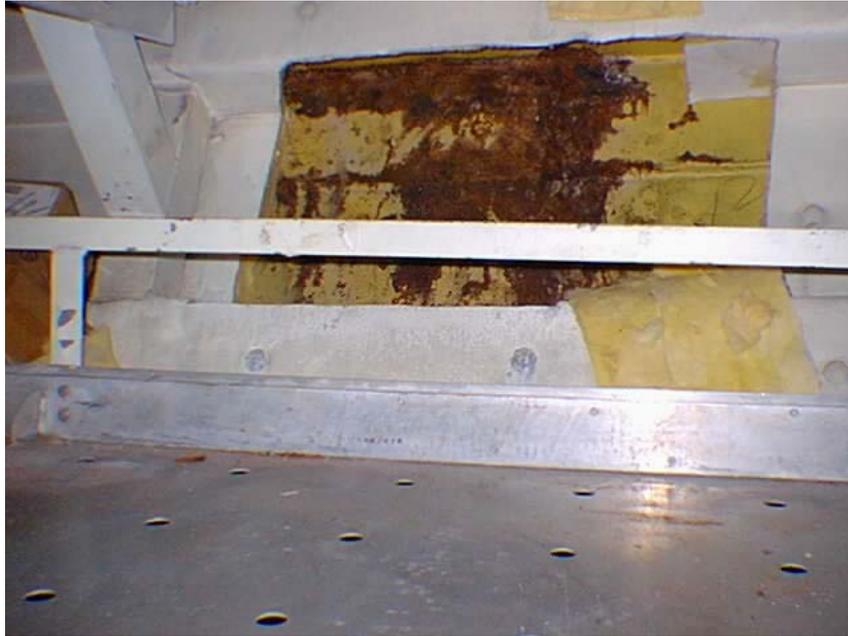
SS01-P003

Heavy surface corrosion at a stiffener weep hole, FR 350 (COMPLETE)

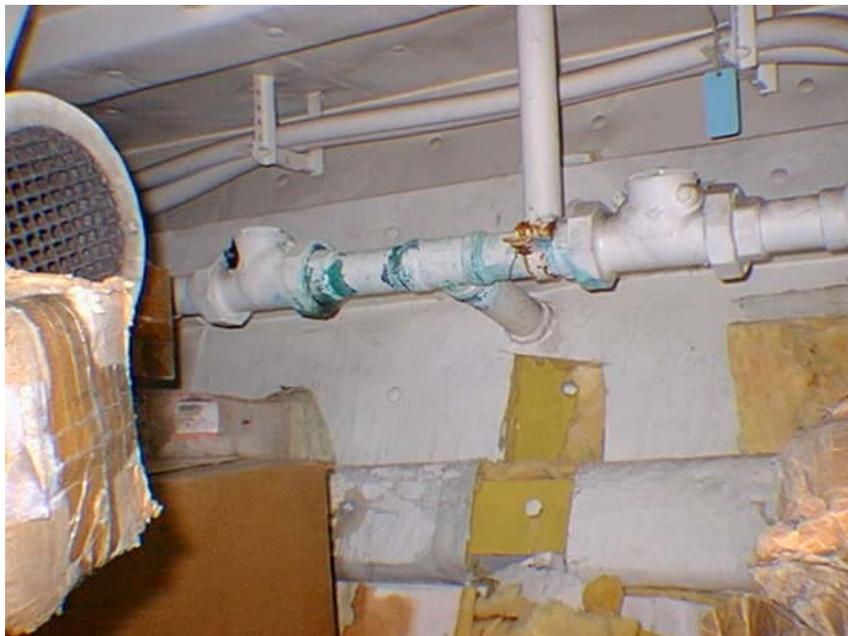
SS01-P001

Deck drain piping. Note corrosion in way of several joints and hanger.

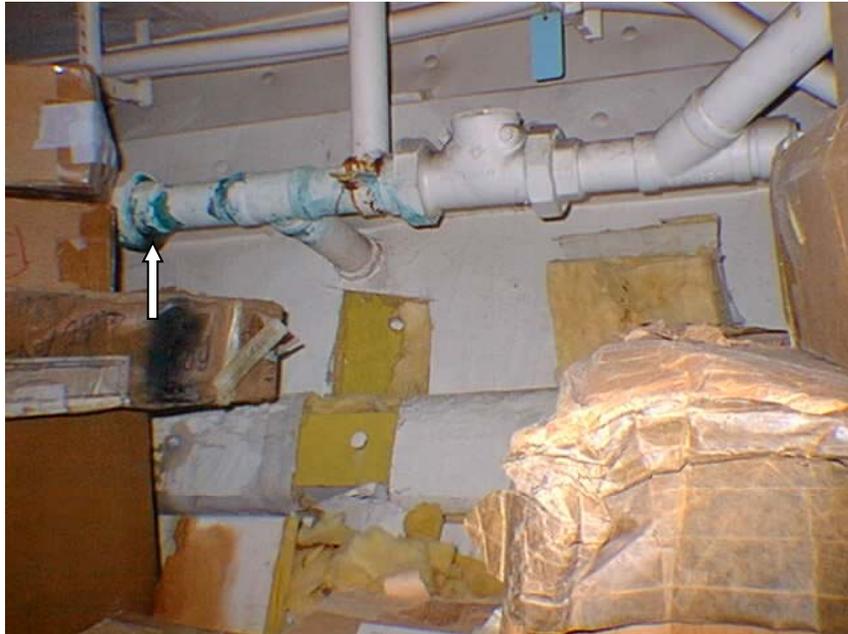
SS01-P001

Arrow indicates leaking deck drain piping. Lagging removed for evaluation

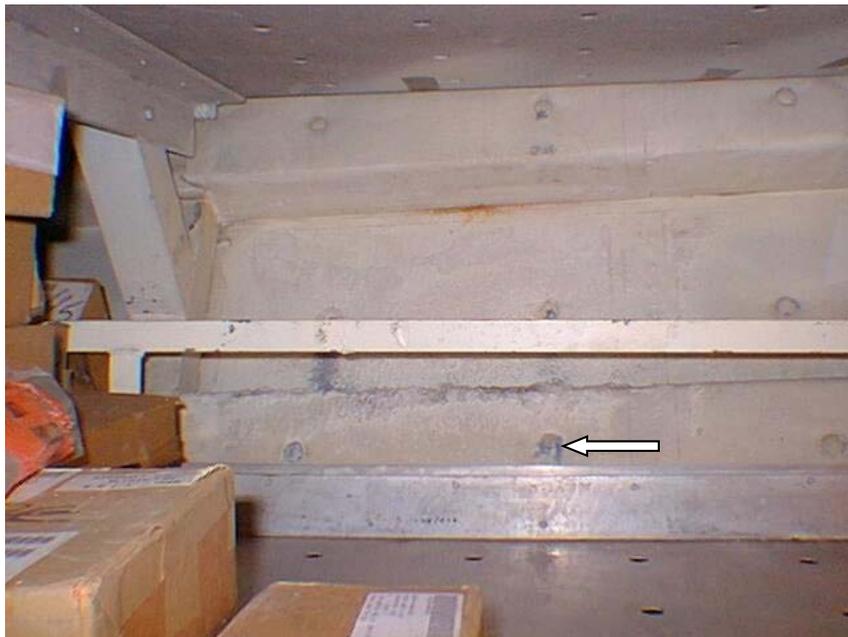
SS01-P003

Lagging retaining buttons are completely corroded away, indicating long-term saturation. (COMPLETE)

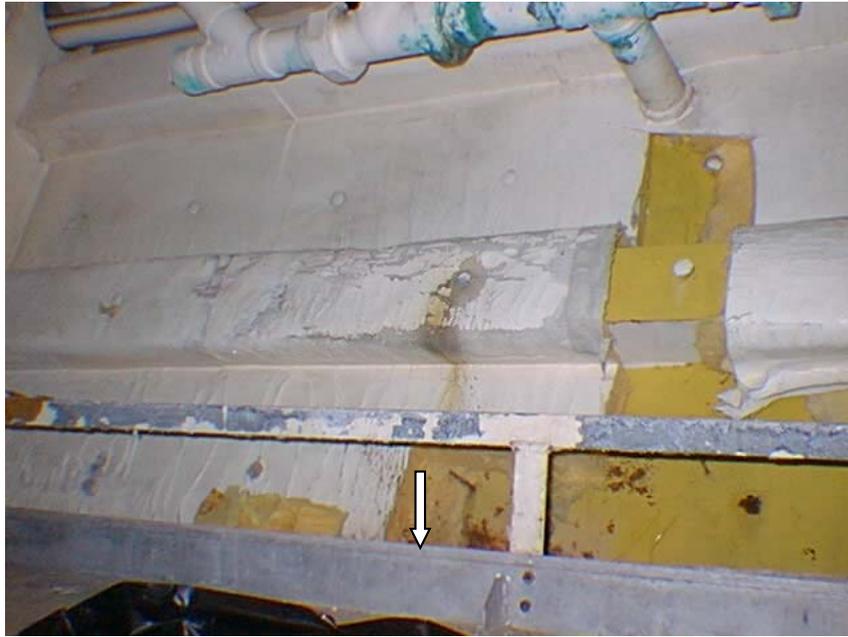
SS01-P001

Lagging removed to ensure that overboard piping is not leaking. Corrosion starts on the next stringer down, in line with longitudinal pipe run. (COMPLETE)

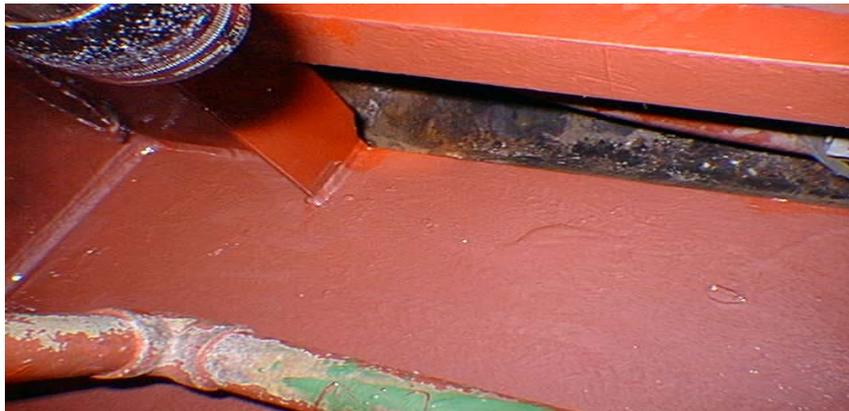
Corrosion under APU control unit. Shipyard is investigating how to get to the area and UTing. . (COMPLETE)

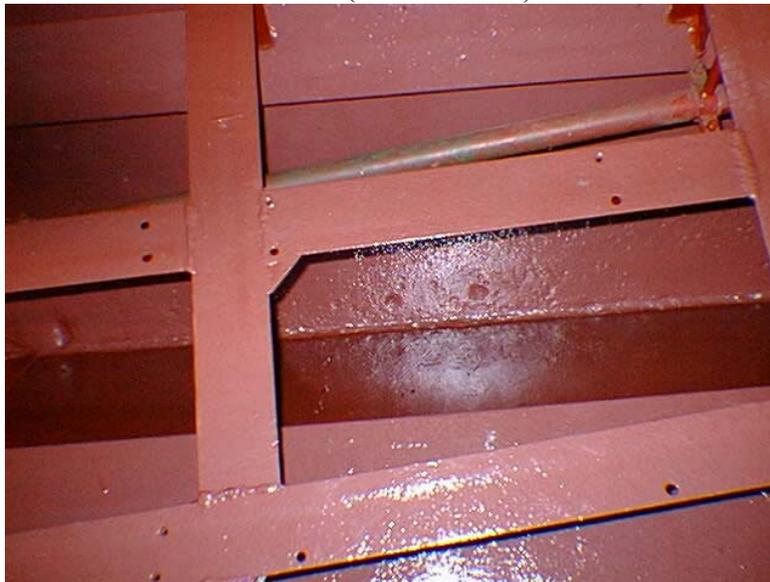
Additional view of deep pit at Fr 106 port and (2) smaller ones at approx. Fr 104. Shell is 1/2" thick. . (COMPLETE)

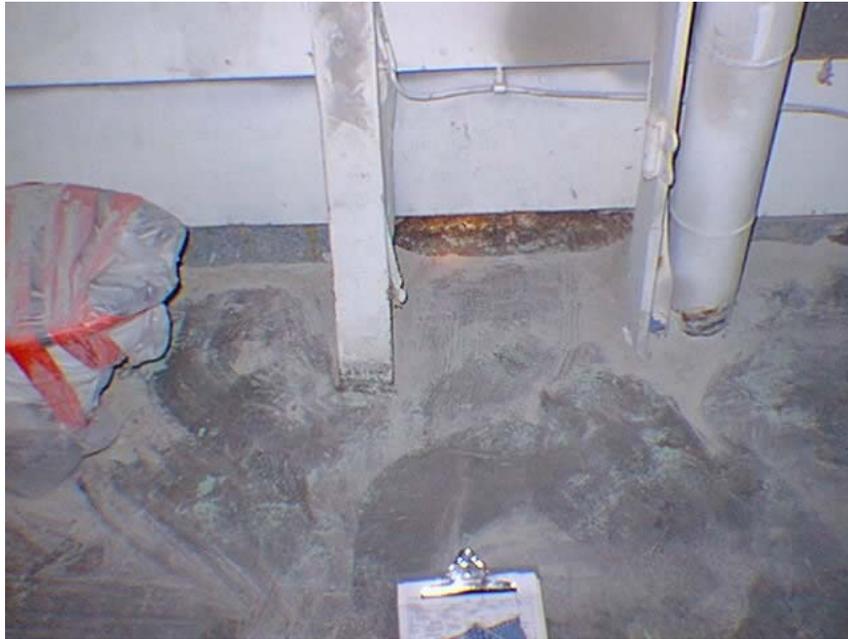
CS03-A037

Corrosion noted at the connection between the 3rd deck and shell. Shipyard will clean and preserve as part of space rehab

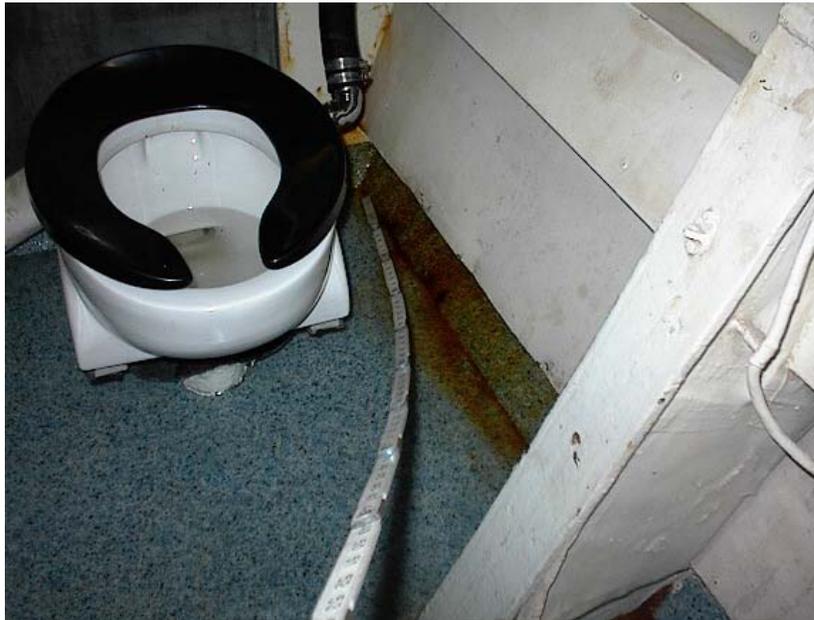
CS03-A037 – 12/01

FR 113-116, S, 1ST LONGITUDINAL DOWN TO DECK UNDER SHELL LAGGING WITH SHEATHING IS RUSTING FROM LEAKING FLUSHING VALVE.
