USS KLAKRING - FFG 42

SHELL CONDITION ASSESSMENT SURVEY
INTERIOR AREAS
DECEMBER 3, 2001 - DECEMBER 14, 2001

PREPARED BY SUPSHIP PORTSMOUTH
JANUARY 2002

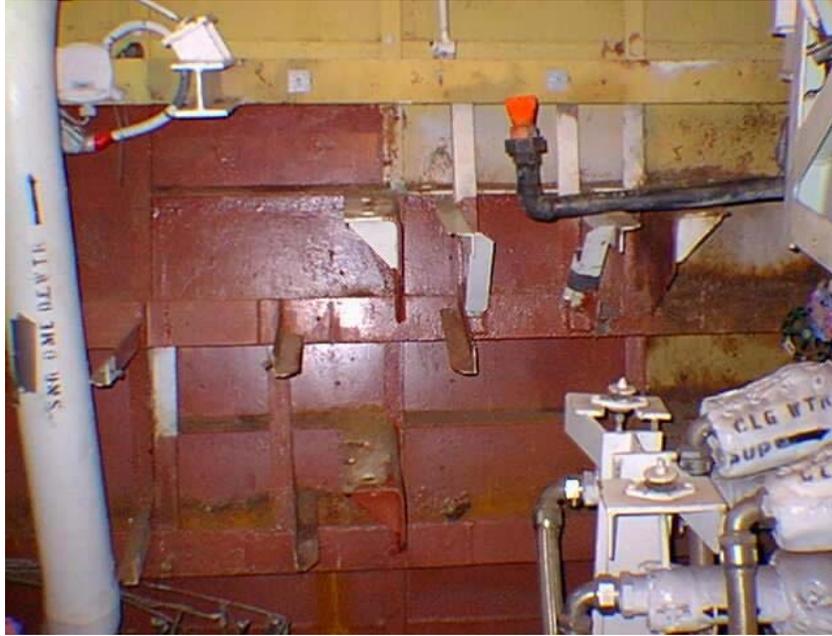
View of shell, stbd side Fr 49, 4th deck. Corrosion is typical of the class. Shipyard is replacing a stiffener and preserving the area (COMPLETE).

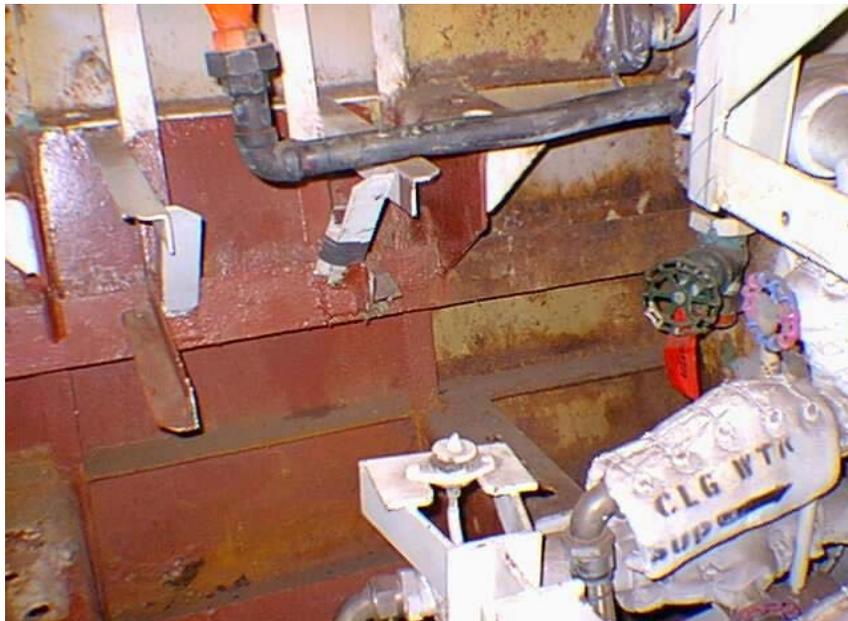
View of after bhd, showing corrosion in areas not accessible when equipment is installed. (COMPLETE).

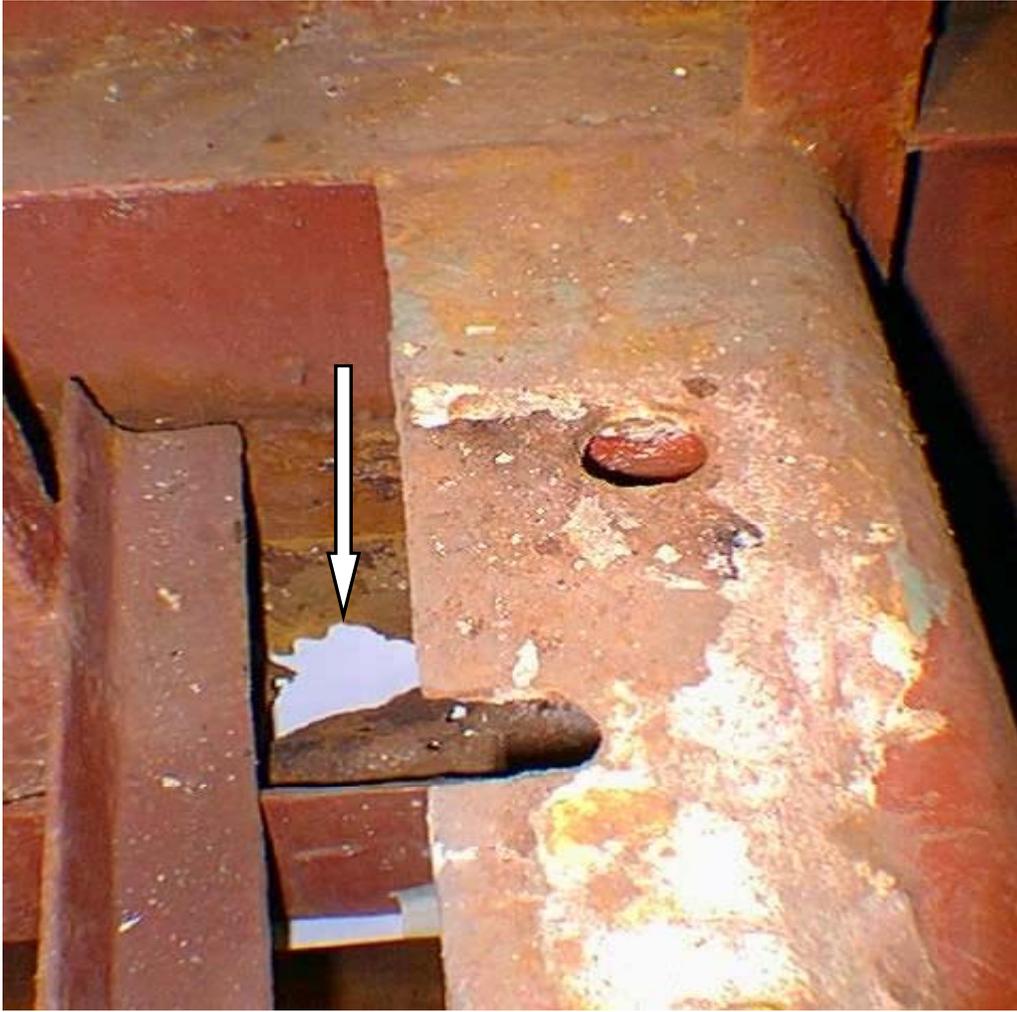
Arrow indicates a hole in the web of the web of the stiffener. A sheet of paper is under the hole to help show it . Shipyard is going to replace 12' of stiffener.
