USS NICHOLAS (FFG-47)

SEMAT SHELL CONDITION ASSESSMENT SURVEY INTERIOR AREAS

11/12/01 TO 11/21/01

**PREPARED BY
SUPERVISOR OF SHIPBUILDING CONVERSION AND REPAIR
PORTSMOUTH, VIRGINIA**

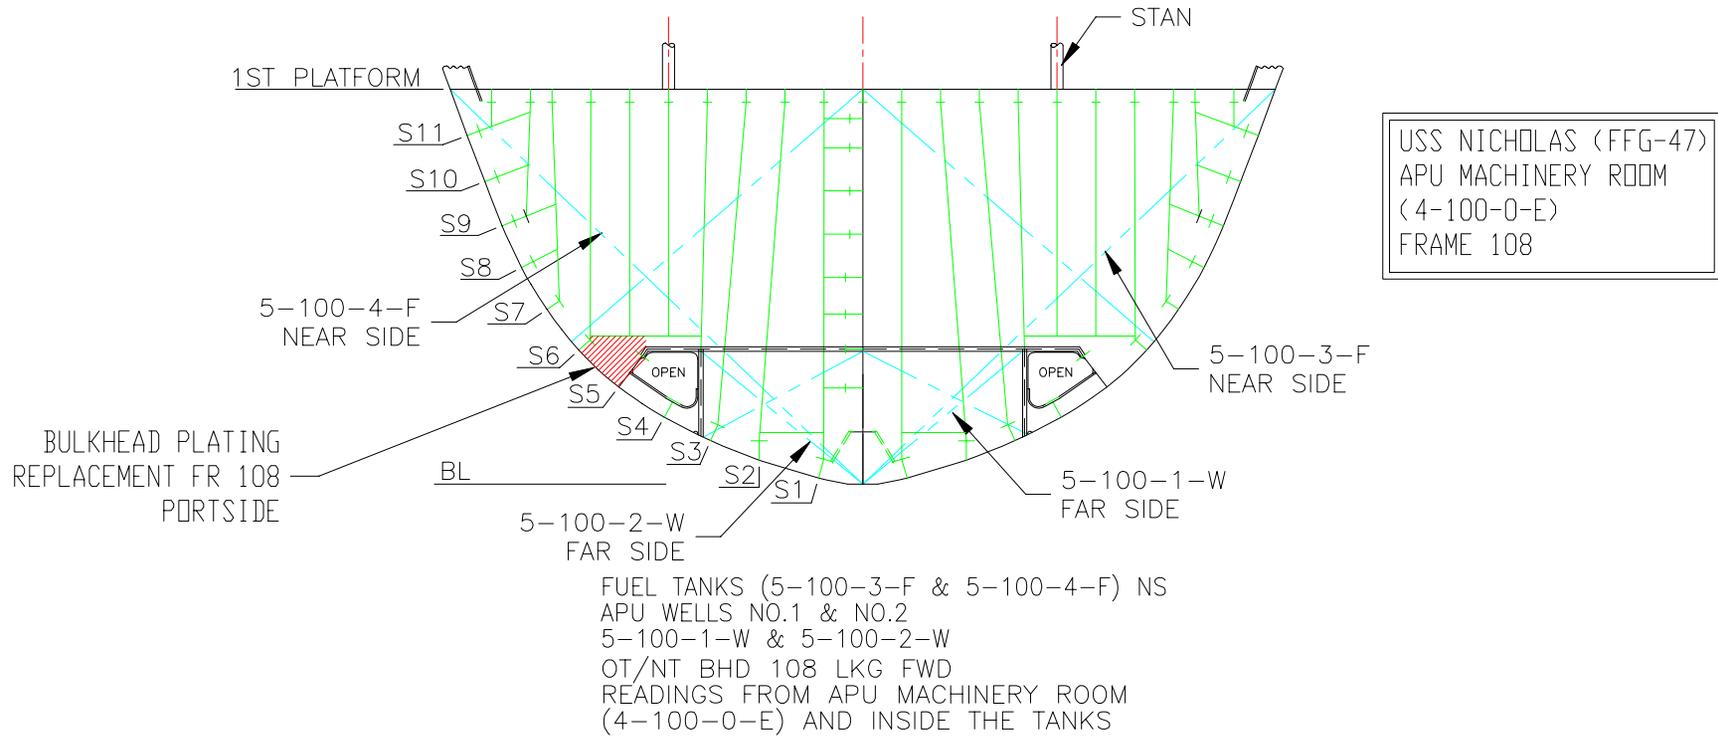
APU MACHINERY ROOM FRAME 108 STRUCTURE DIAGRAM

LOCATION	NAME	AREA	RESULTS	ACTION
4-100-0-E	AUXILIARY PROPULSION UNIT (APU) MACHINERY ROOM	PORTSIDE BILGE AREA, FR 100-108	PORTSIDE BILGE POCKET DECK PLATE SUPPORTS AT FR 108 TO 36 INCHES FWD OF FR 108 AND FROM SHELL TO 60 INCHES INBOARD OF SHELL AT FR 108 ARE DETERIORATED.	REPLACE THE DECK PLATE SUPPORTS IN AREA NOTED.
4-100-0-E	AUXILIARY PROPULSION UNIT (APU) MACHINERY ROOM	PORTSIDE BILGE AREA, FR 100-108	FR 108 BULKHEAD IN BILGE POCKET BELOW MINIMUM THICKNESS.	REPLACE THREE SQUARE FEET FR 108 BULKHEAD PLATE IN BILGE POCKET PORTSIDE, FROM FUEL TANK (5-100-4-F) OUTBOARD LONGITUDINAL BULKHEAD TO 1 ST LONGITUDINAL PORTSIDE AND FROM THE BOTTOM OF THE BILGE WELL TO 12 INCHES UP FROM THE BOTTOM OF THE BILGE WELL.
4-100-0-E	AUXILIARY PROPULSION UNIT (APU) MACHINERY ROOM	STARBOARD SIDE BILGE AREA, FR 100-108	BILGE POCKET DETERIORATED.	CLEAN AND PRESERVE 48 INCH BY 94 INCH SECTION OF STARBOARD SIDE BILGE AREA BETWEEN FR 100-108 INCLUDING FOUR SQUARE FEET OF FR 100 AND FR 108 BULKHEAD PLATING IN WAY OF BILGE AREA.

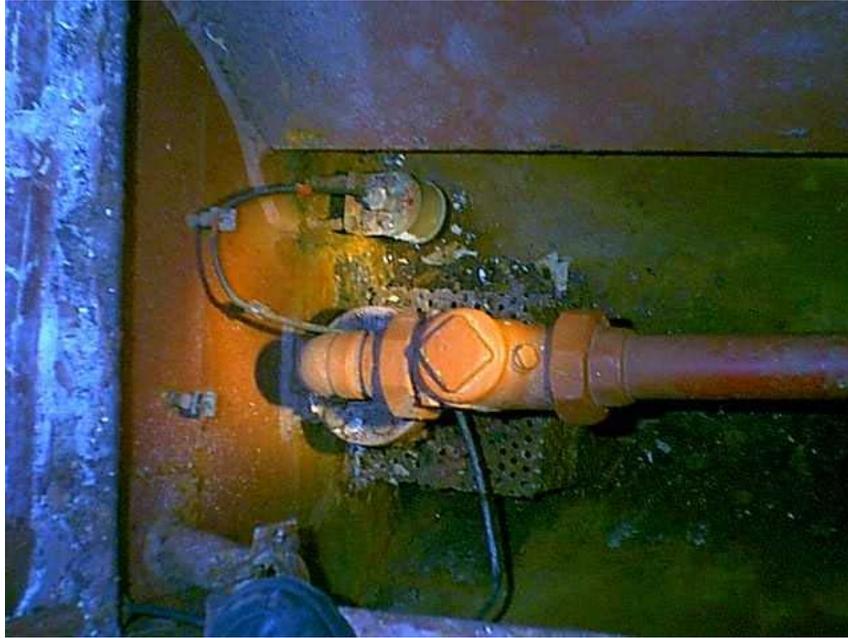
Photo 1: DETERIORATED BILGE POCKET PORTSIDE AFT, FRAME 108, LOOKING DOWN/AFT/OUTBOARD

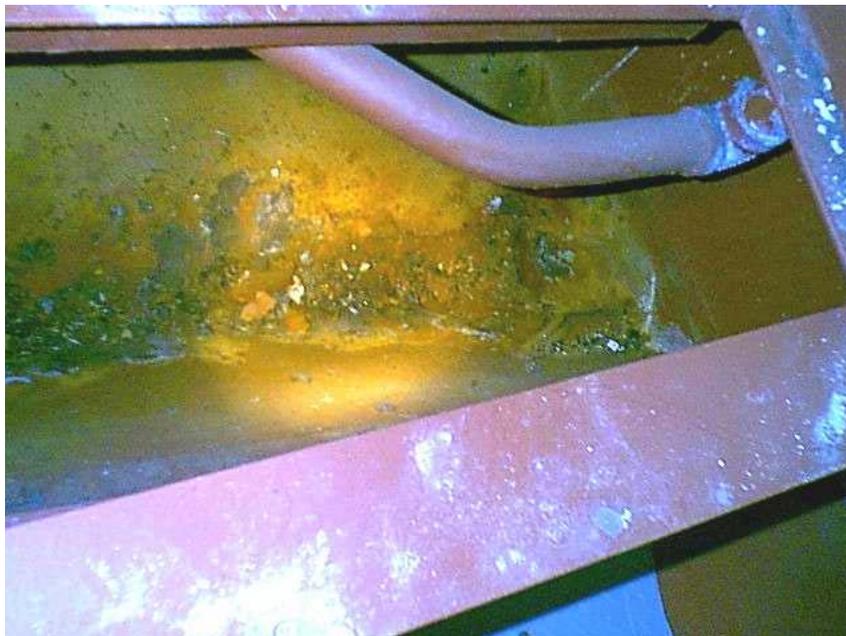
Photo 2: DETERIORATED BILGE PORTSIDE FWD FRAME 100, LOOKING FORWARD/OUTBOARD

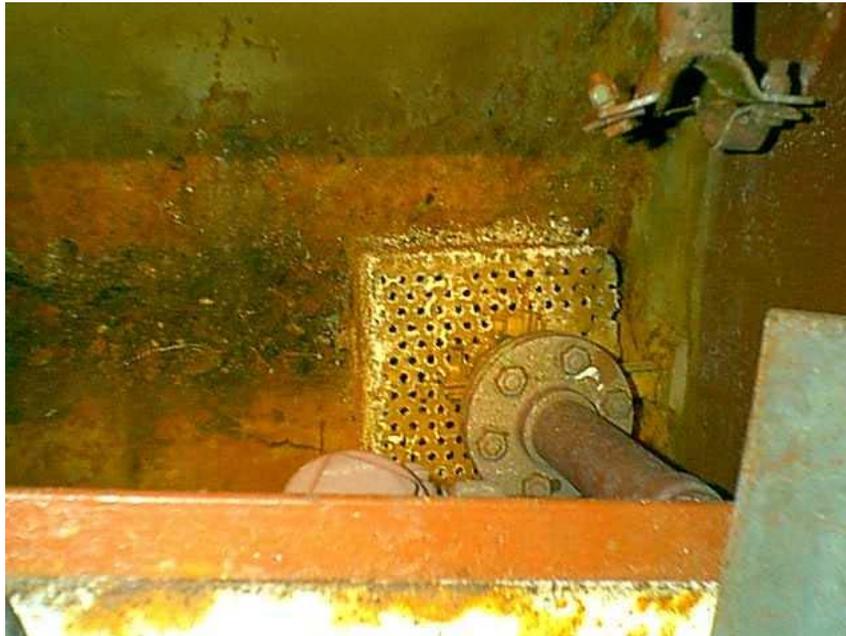
Photo 3: DETERIORATED BILGE POCKET, STBD SIDE
FRAME 108, LOOKING DOWN

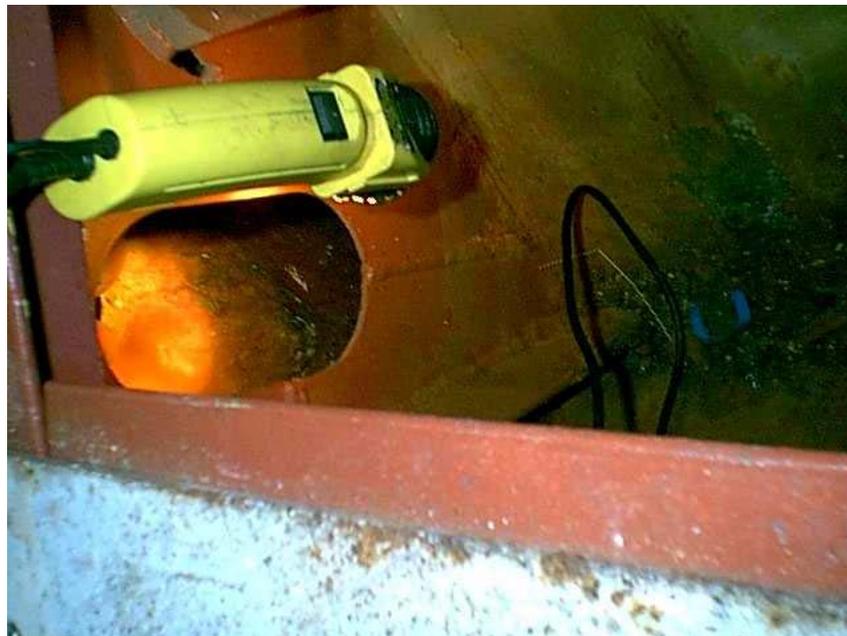
4-100-0-E	AUXILIARY PROPULSION UNIT (APU) MACHINERY ROOM	STARBOARD SIDE BELOW APU ELECTRICAL POWER DISTRIBUTION PANEL No. 1	STARBOARD SIDE POCKET BELOW APU ELECTRICAL POWER DISTRIBUTION PANEL No. 1 IS DETERIORATED.	CLEAN AND PRESERVE 16 SQUARE FEET OF STARBOARD SIDE POCKET BELOW AND FORWARD OF APU ELECTRICAL POWER DISTRIBUTION PANEL No. 1.
4-100-0-E	AUXILIARY PROPULSION UNIT (APU) MACHINERY ROOM	PORTSIDE BILGE AREA, FR 100-108	PORTSIDE BILGE POCKET STRUCTURE ALONG APU WELL NO 2 OUTBOARD LONGITUDINAL BULKHEAD BELOW MINIMUM THICKNESS IAW UT.	REPLACE TWO SQUARE FEET FUEL TANK (5-100-4-F) OUTBOARD LONGITUDINAL BULKHEAD FROM HULL TO 12 INCHES ABOVE THE HULL FROM FR 108 TO 24 INCHES FORWARD OF FR 108 (INSIDE THE BILGE).

Photo 4: BILGE AREA STBD SIDE BELOW No 1 APU
DISTRIBUTION PANEL, LOOKING FWD

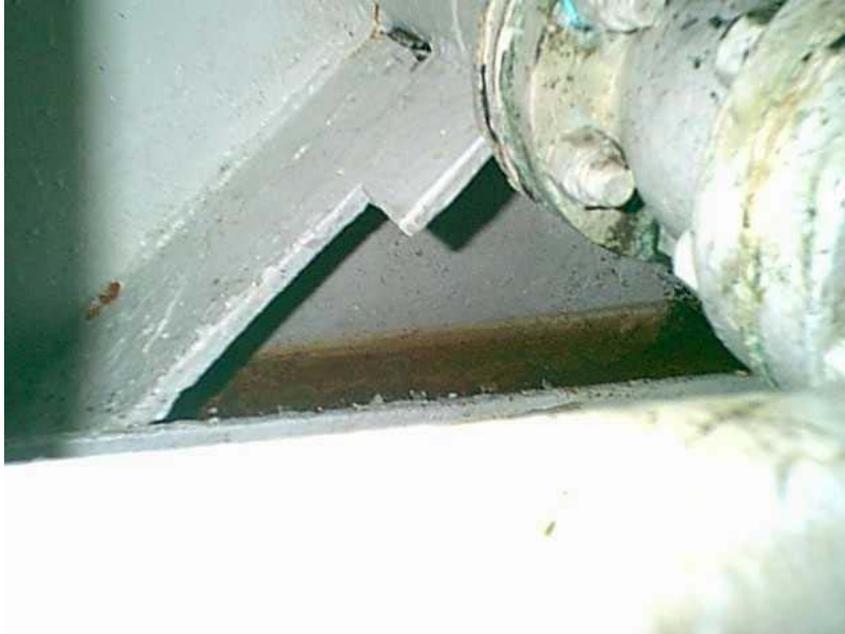
Photo 8: OVERBOARD DISCHARGE 4-172-1, SHELL
AND LONGITUDINAL DETERIORATION, LOOKING
OUTBOARD

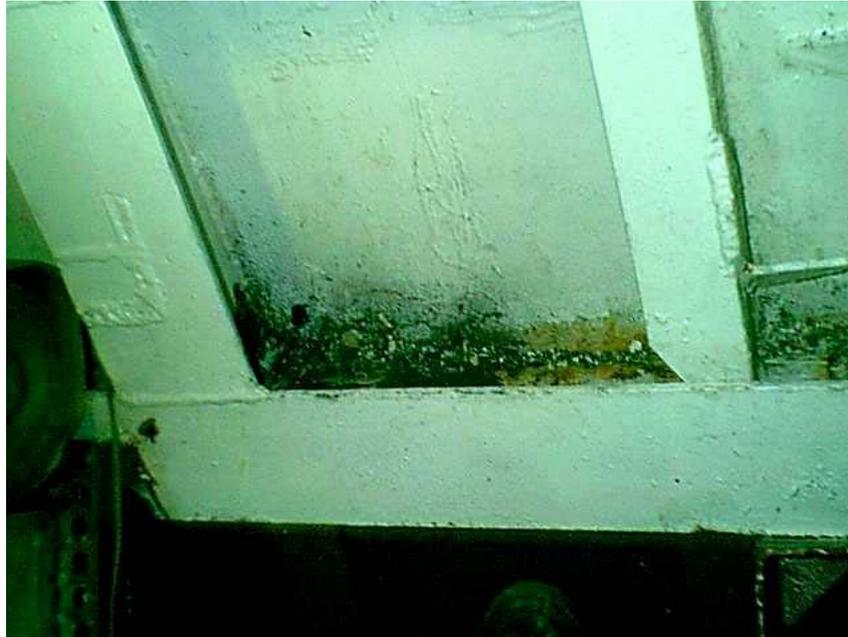
Photo 9: PORTSIDE SHELL FRAME 171 AND
LONGITUDINAL No. 5 FROM OVERHEAD,
DETERIORATION, LOOKING OUTBOARD

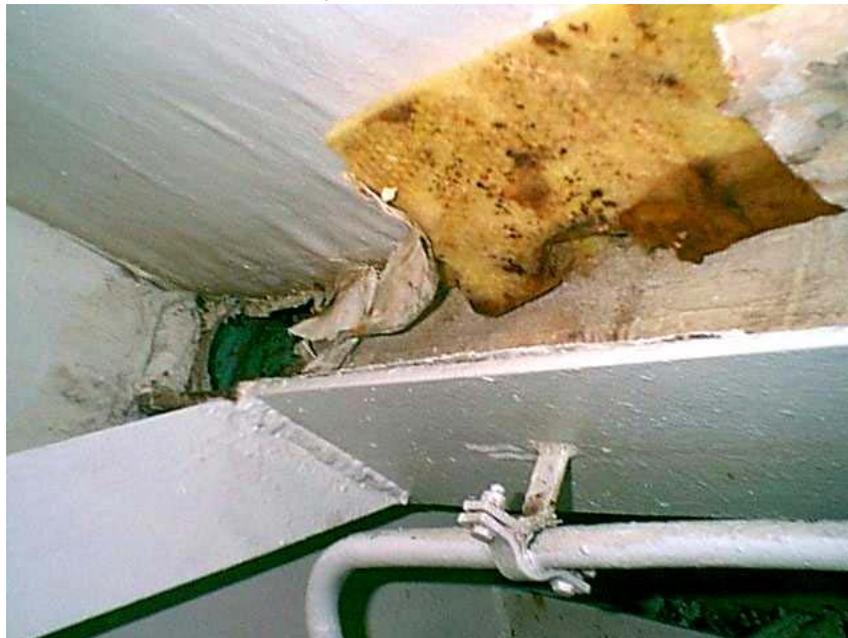
Photo 10: PORTSIDE SHELL FRAME 178 AND
LONGITUDINAL No. 3 FROM OVERHEAD,
DETERIORATION, LOOKING AFT/OUTBD

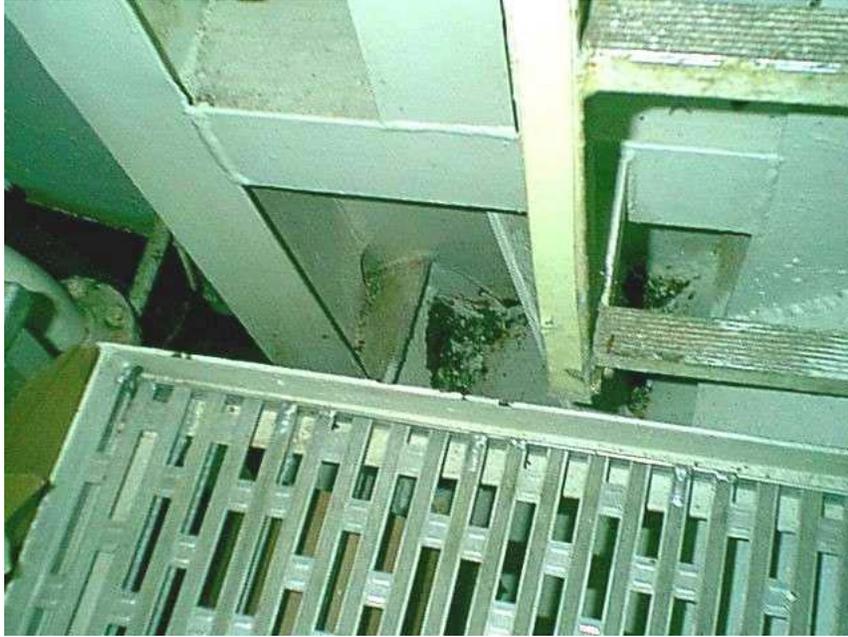
Photo 11: FRAME 178, PORTSIDE, LOOKING AFT/DOWN

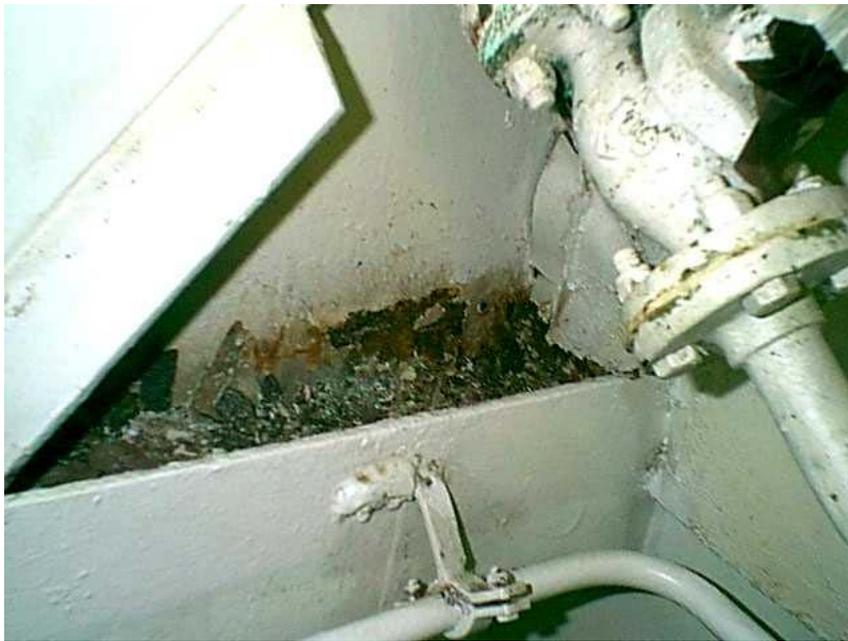
Photo 12: DETERIORATION BELOW OVBD DISCHARGE
4-172-2, LOOKING OUTBOARD/FORWARD

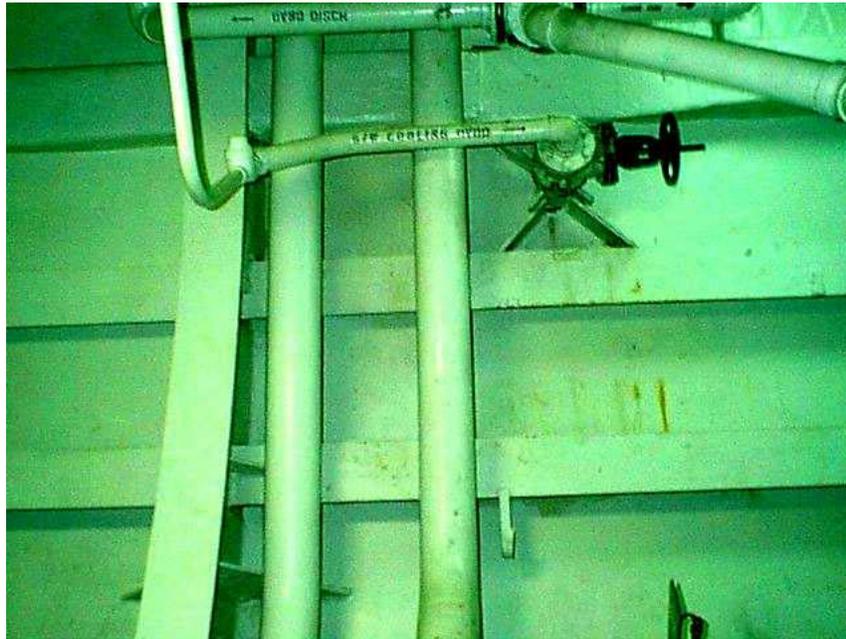
Photo 13: 4-172-1 OVBD DISCHARGE, STBD SIDE SHELL, LOOKING OUTBOARD

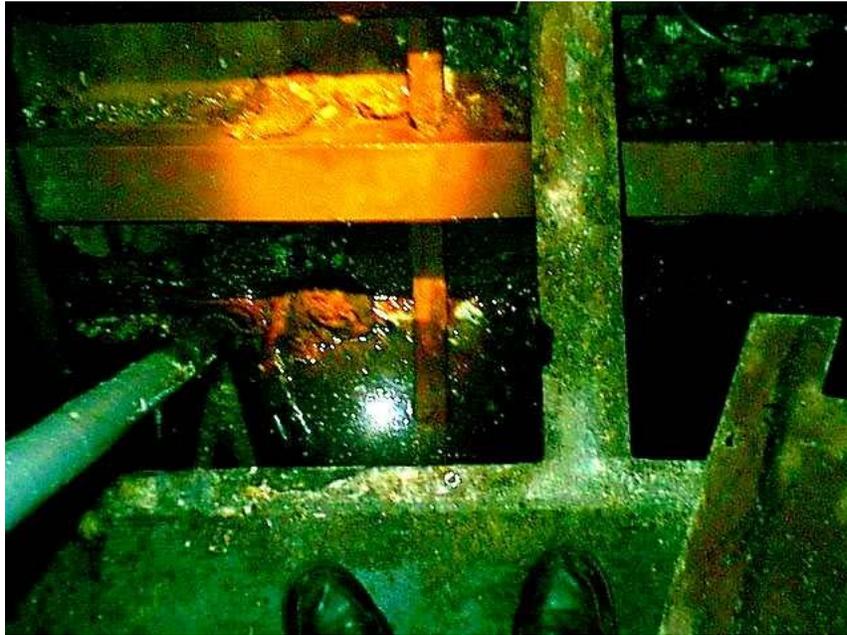
Photo 17: DETERIORATED AFT PORTSIDE BILGE
POCKET, SHELL, LOOKING DOWN/OUTBOARD

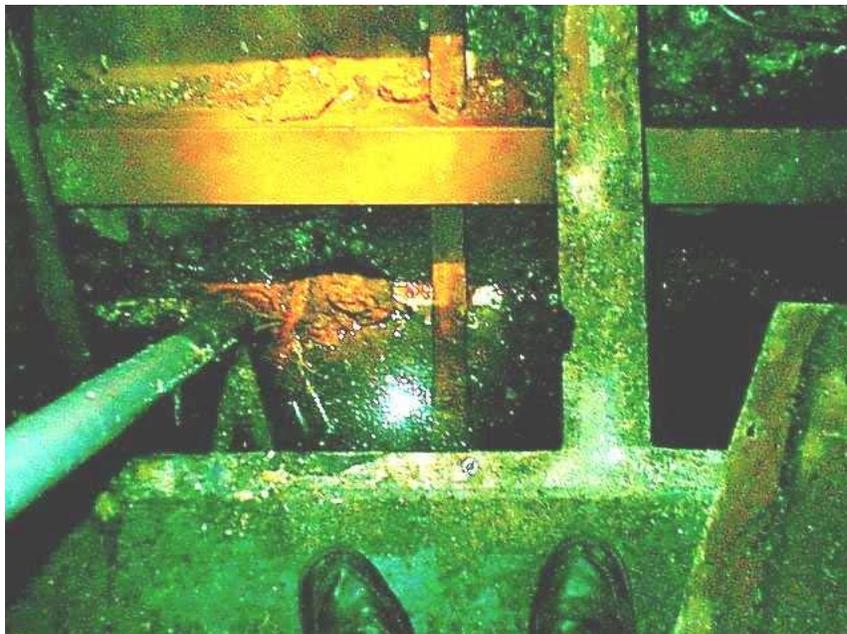
Photo 18: DETERIORATED AFT PORTSIDE BILGE
POCKET, SHELL, LOOKING DOWN/OUTBOARD

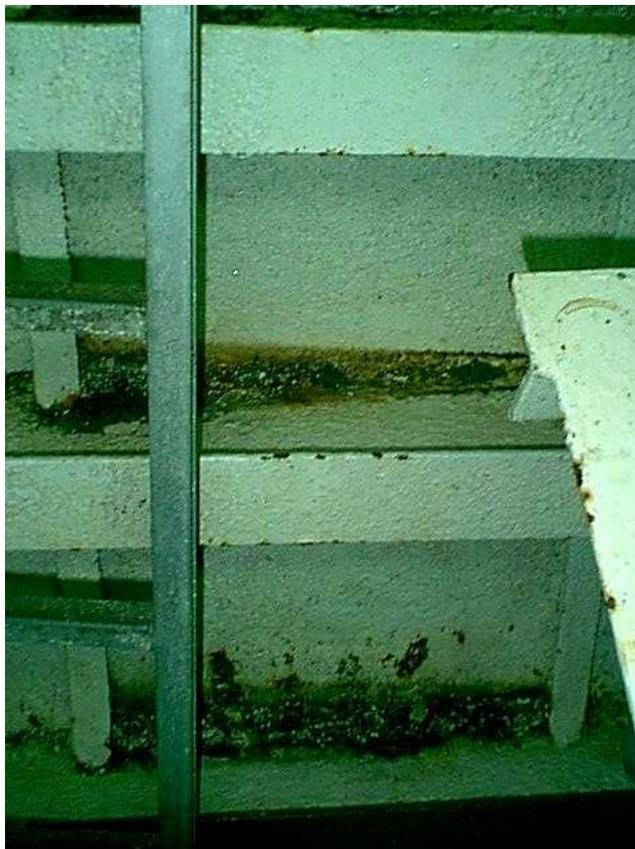
Photo 22: PORTSIDE
SHELL AND
LONGITUDINALS
DETERIORATED,
LOOKING
OUTBOARD

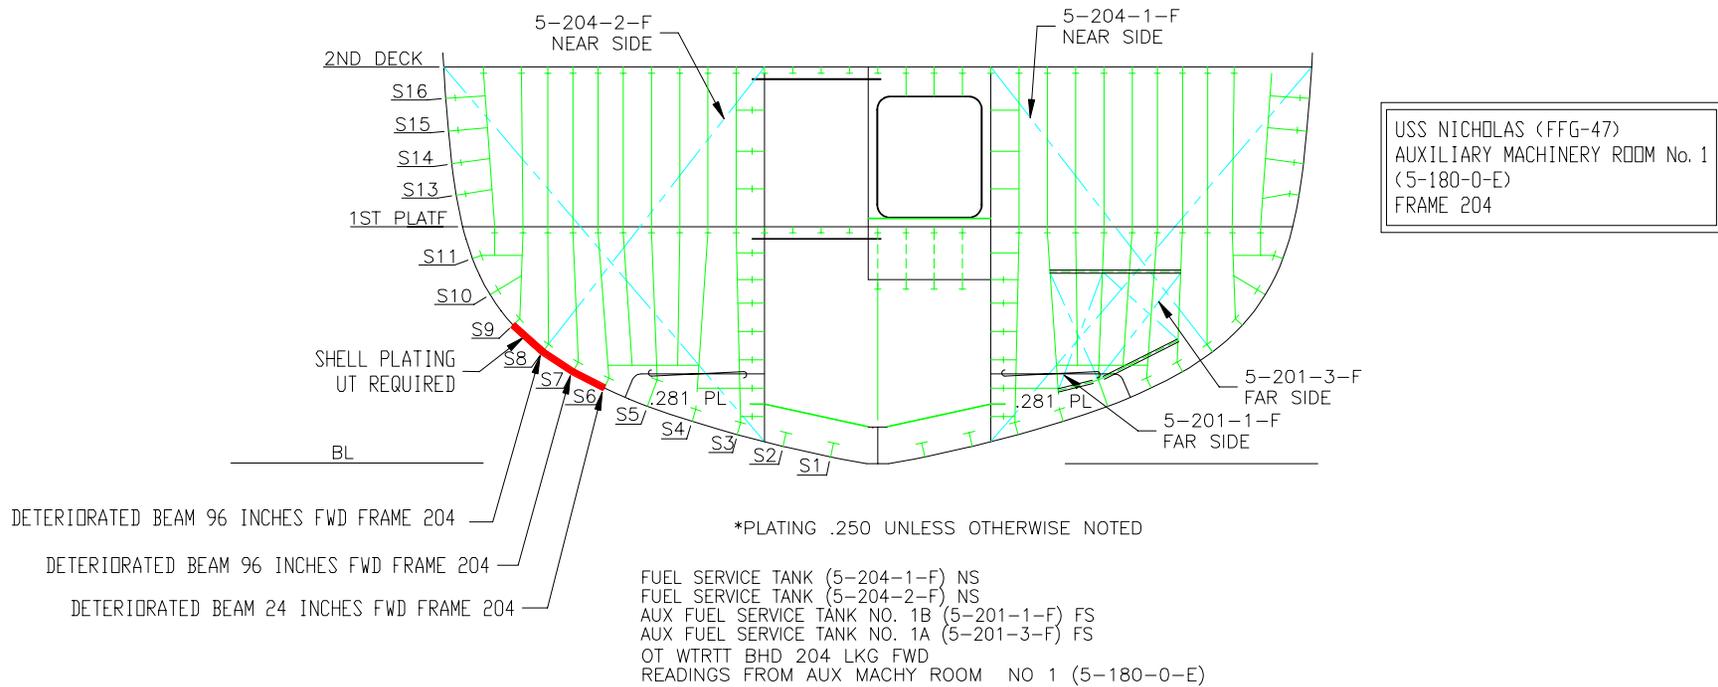
AMR No. 1 FRAME 204 STRUCTURE DIAGRAM

5-180-0-E	AUXILIARY MACHINERY ROOM No.1	BILGE AREA, FR 204 TO 24 INCHES FWD FR 204, LONG No. 6.	DETERIORATED LONGITUDINAL.	REPLACE 24 INCHES OF LONGITUDINAL No. 6 FROM FR 204 FWD 24 INCHES.
5-180-0-E	AUXILIARY MACHINERY ROOM No.1	BILGE AREA, FR 204-196, LONGITUDINAL No. 7 AND 8.	DETERIORATED LONGITUDINALS.	REPLACE 96 INCHES OF LONGITUDINAL No. 7 AND 8 FROM FR 204-196.
5-180-0-E	AUXILIARY MACHINERY ROOM No.1	BILGE AREA, FR 204 TO 24 INCHES FWD FR 204, BTWN LONGITUDINAL No. 6 AND 9.	DETERIORATED SHELL PLATING.	CLEAN AND UT SHELL PLATING AT LOCATION NOTED. REMOVE AND REPLACE SHELL PLATING AS DETERMINED BY UT READINGS.
5-180-0-E	AUXILIARY MACHINERY ROOM No.1	TOP OF 5-188-2-F HYDRAULIC OIL SUPPLY TANK	PAINT FAILURE.	CLEAN AND PRESERVE 96 INCH BY 7 INCH SECTION AT LOCATION NOTED.
5-180-01-E	SSDG No. 1 ENCLOSURE	FR 180-188, STBD SIDE, LONGITUDINALS 1, 2 AND 3 FROM OVERHEAD.	DETERIORATED LONGITUDINALS.	CLEAN AND PRESERVE THREE LONGITUDINALS AT LOCATION NOTED.

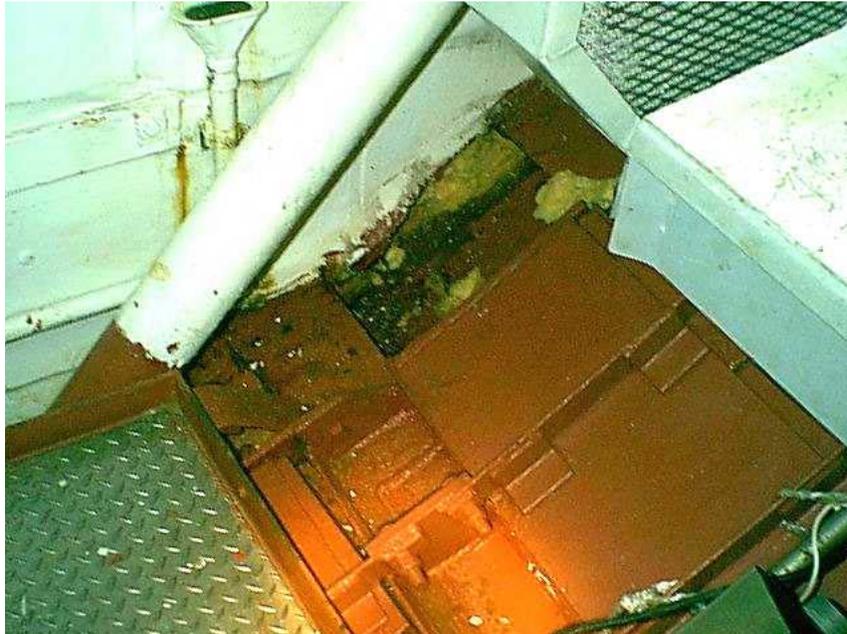
Photo 23: PORTSIDE FRAME 204 AND LONGITUDINAL No. 7 AND 8 DETERIORATION, BALLAST, LOOKING AFT/OUTBOARD

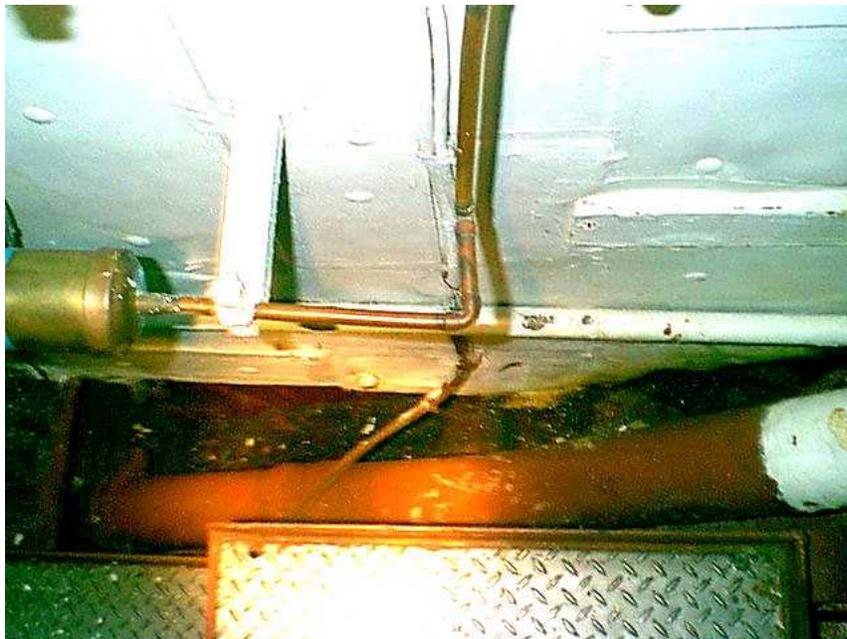
Photo 24: PORTSIDE FRAME 204 AND LONGITUDINAL No. 6 TO 8 DETERIORATION, LOOKING DOWN/AFT

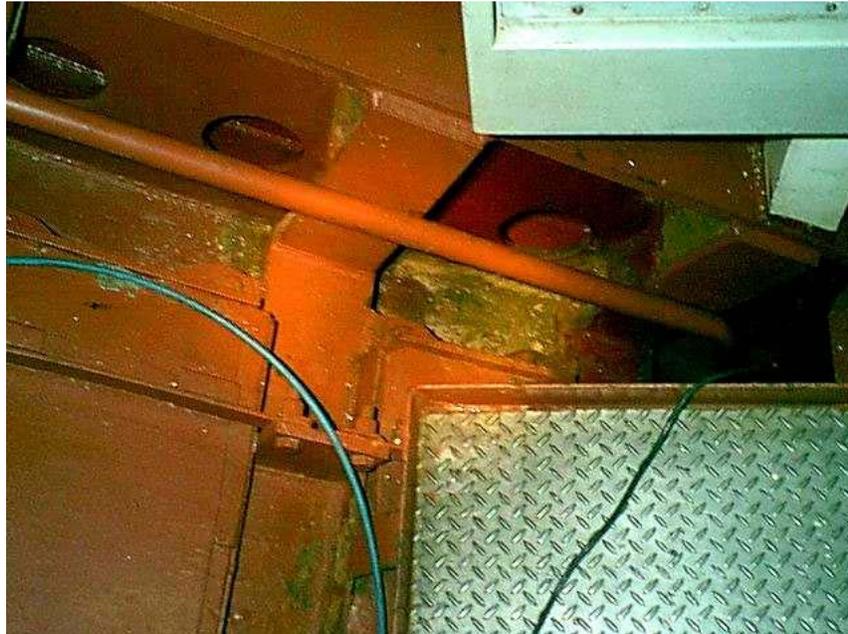
Photo 25: PORTSIDE FRAME 196, LONGITUDINAL
No. 7 AND 8, BALLAST, LOOKING FWD

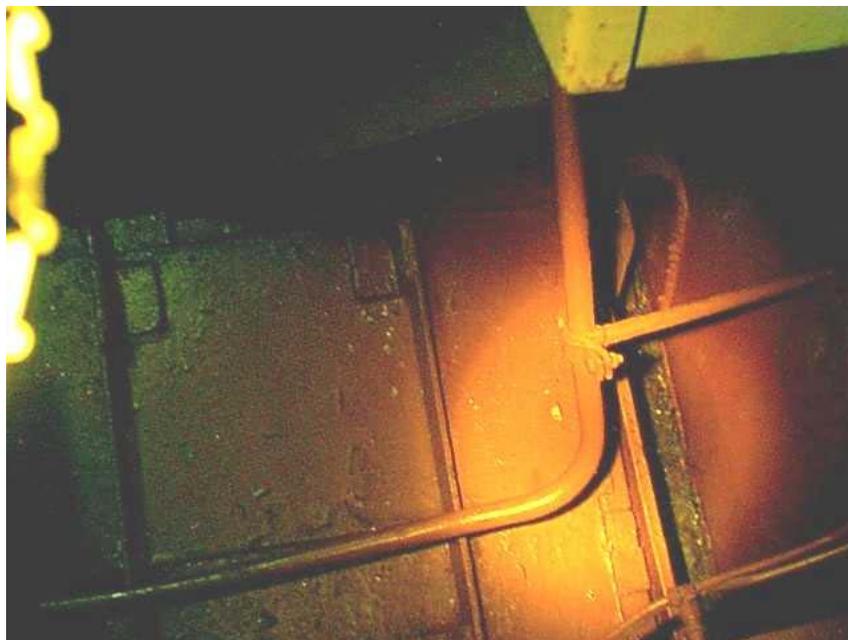
Photo 26: PORTSIDE FRAME 180, LONGITUDINAL
No. 5 AND 6, BALLAST, LOOKING OUTBOARD

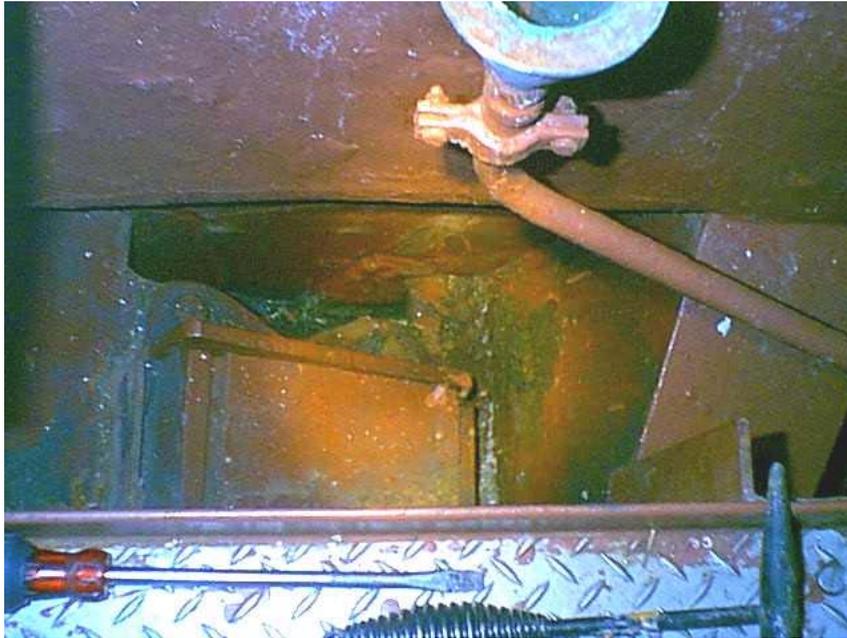
Photo 27: DETERIORATION AT FRAME 180 PORTSIDE LONGITUDINAL No. 6 AND 7, SSDG JW FUNNEL, LOOKING FORWARD

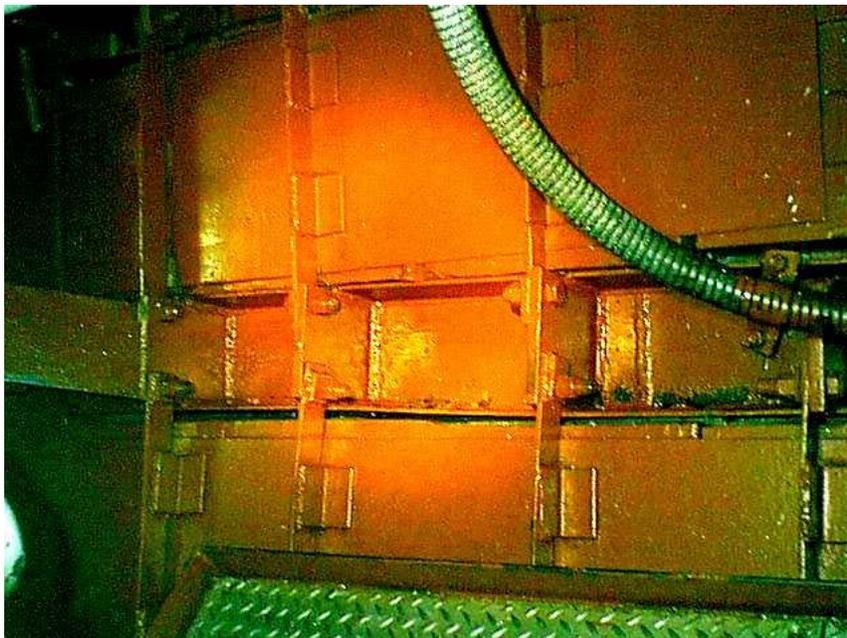
Photo 28: BALLAST FRAME 180 TO 188 PORTSIDE DETERIORATION AT LONGITUDINALS, LOOKING OUTBOARD/AFT

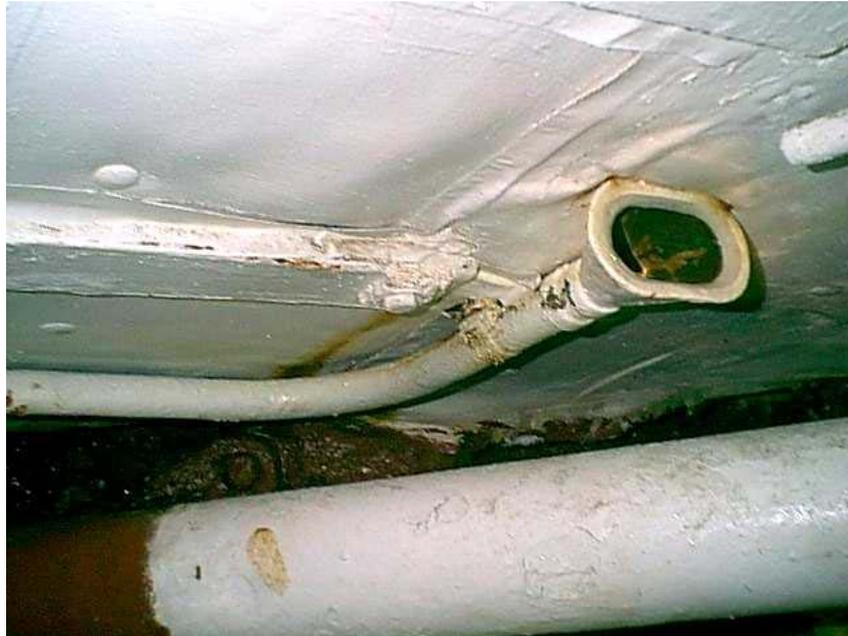
Photo 29: FRAME 204 PORTSIDE FILLED FUNNEL
LOOKING OUTBOARD/AFT

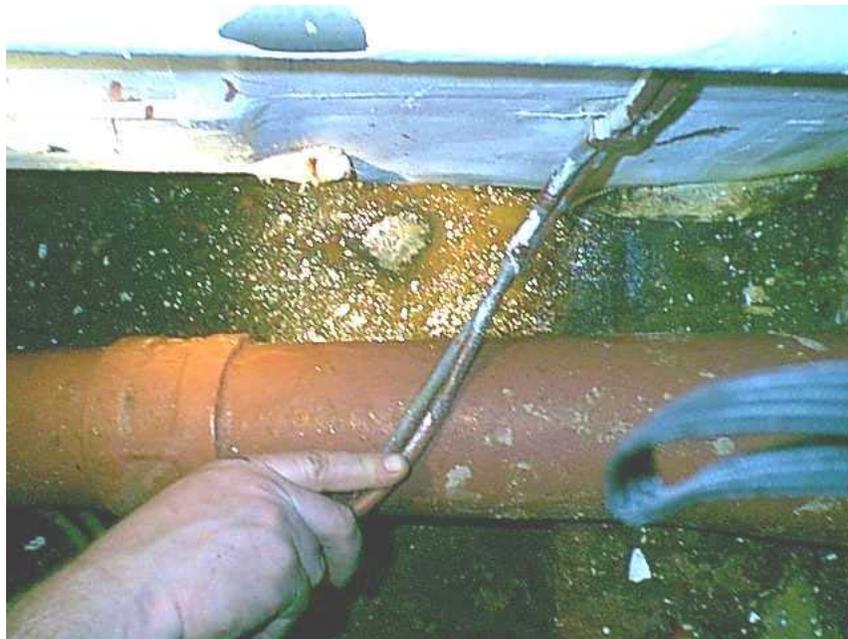
Photo 30: UT AREA, FRAME 204 PORTSIDE SHELL
PLATING BETWEEN LONGITUDINAL No. 6 AND 7
LOOKING DOWN/AFT

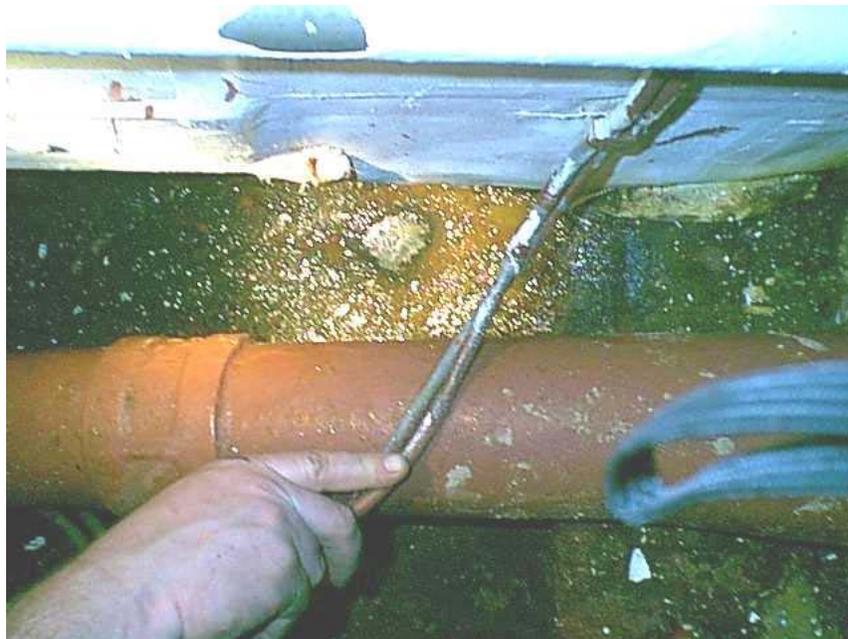
Photo 30: UT AREA, FRAME 204 PORTSIDE SHELL
PLATING BETWEEN LONGITUDINAL No. 6 AND 7
LOOKING DOWN/AFT

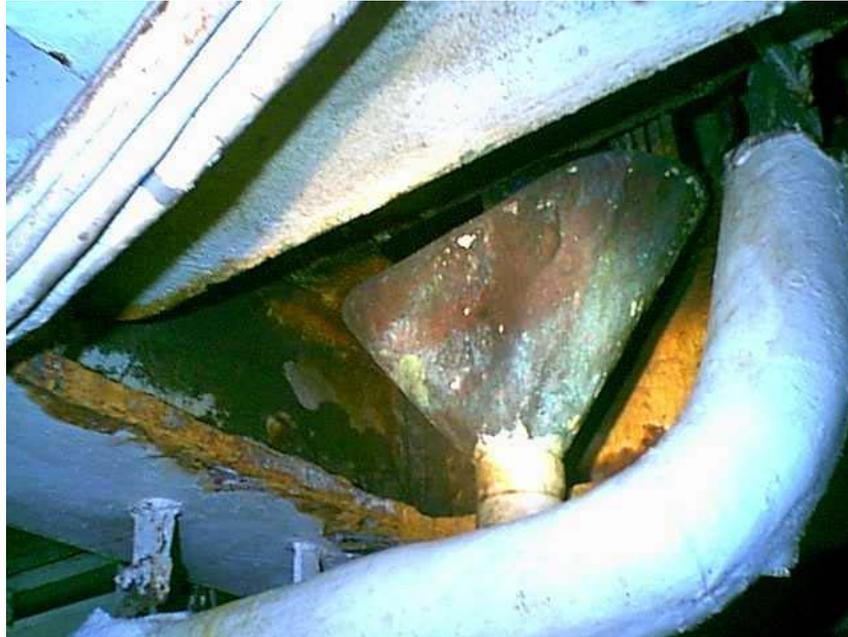
Photo 32: LOWER LEVEL PORTSIDE BELOW HPAC,
DETERIORATED FOUNDATION, LOOKING UP/OUTBOARD

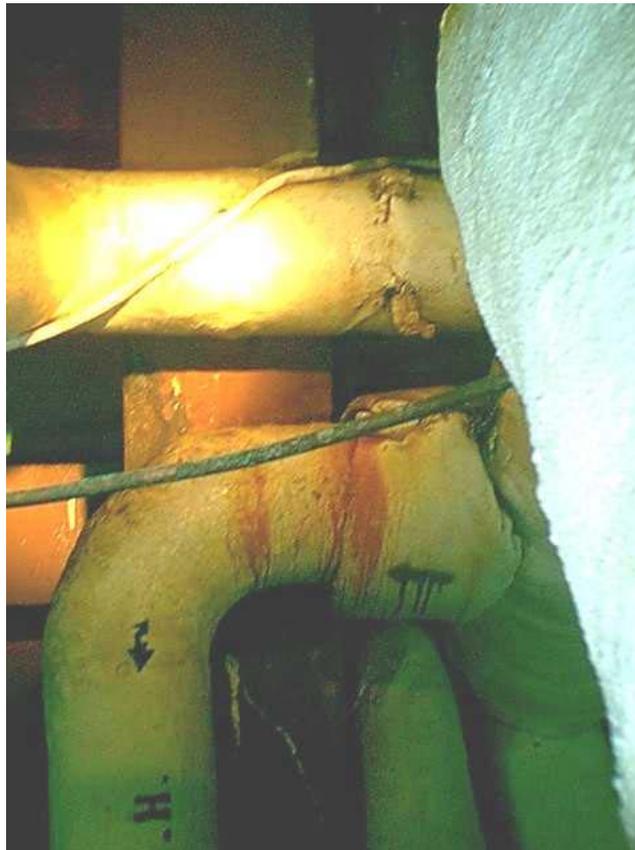
Photo 33: LOWER
LEVEL PORTSIDE
BELOW HPAC,
TOP OF FRAME
220 TRANSVERSE
MEMBER,
DETERIORATED
FLANGE,
LOOKING
OUTBOARD

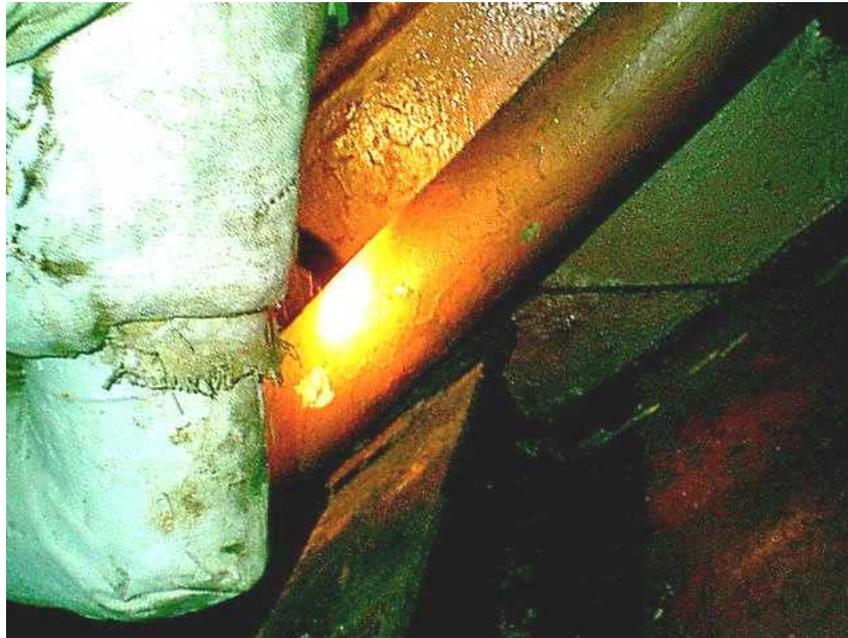
Photo 34: PORTSIDE FRAME 220 AND LONGITUDINAL No. 8 DETERIORATION, LOOKING AFT

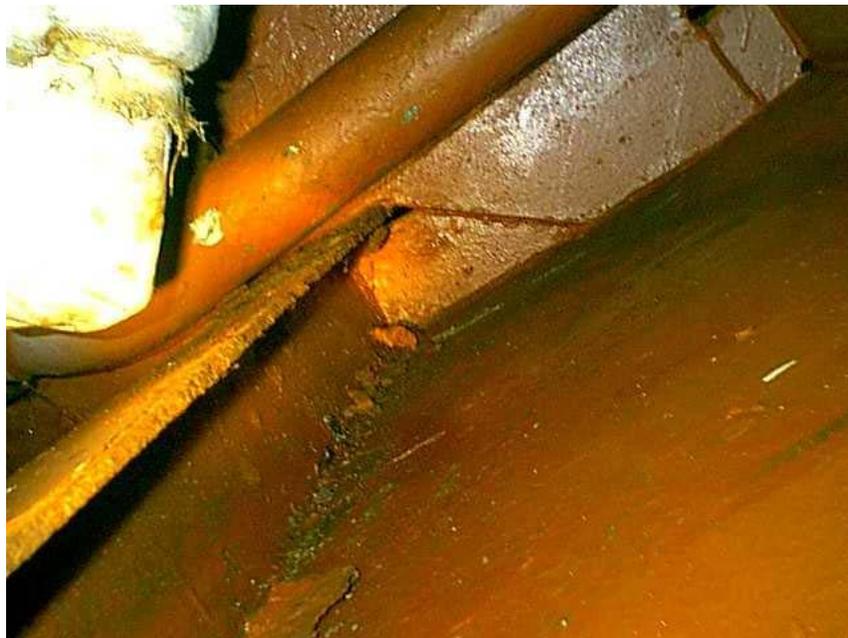
Photo 35: UT SECTION OF PORTSIDE FRAME 220 AND LONGITUDINAL No. 8, LOOKING AFT

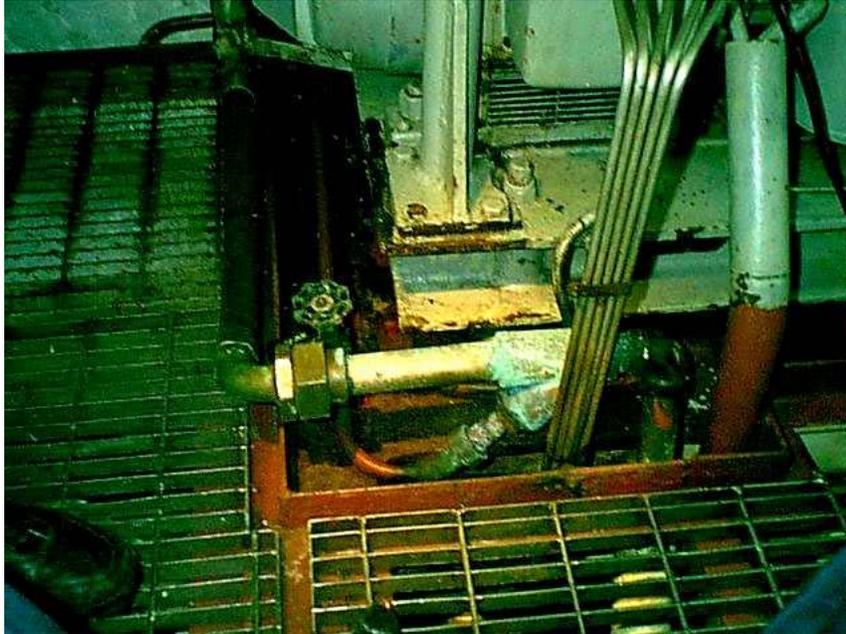
Photo 36: PORTSIDE UPPER LEVEL, HPAC LEAKING
DRAIN SYSTEM, FRAME 220, LOOKING OUTBOARD

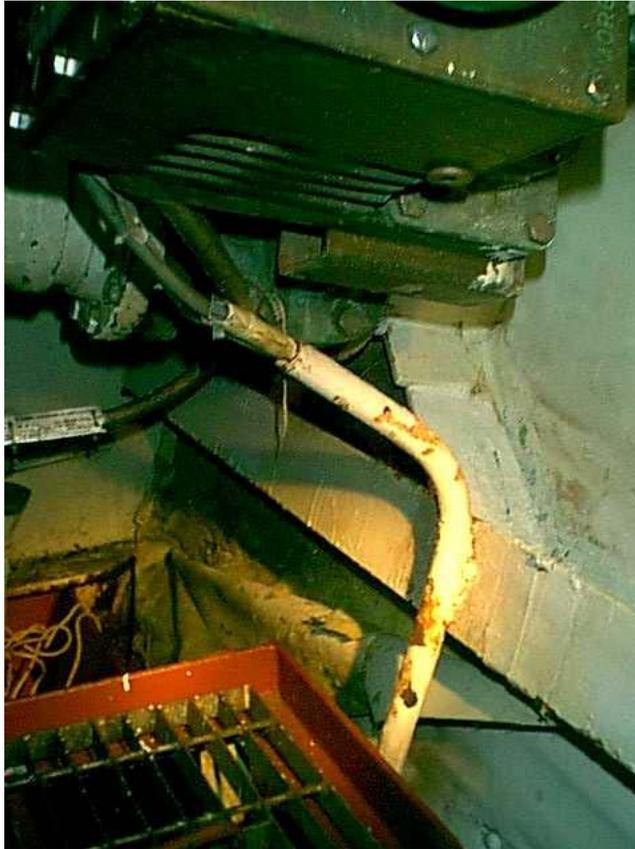
Photo 37: UPPER
LEVEL PORTSIDE
SHELL AND
LONGITUDINALS
IMPACTED BY
COOLING WATER
OVBD VALVE,
LOOKING AFT /
OUTBOARD
BEHIND HPAC

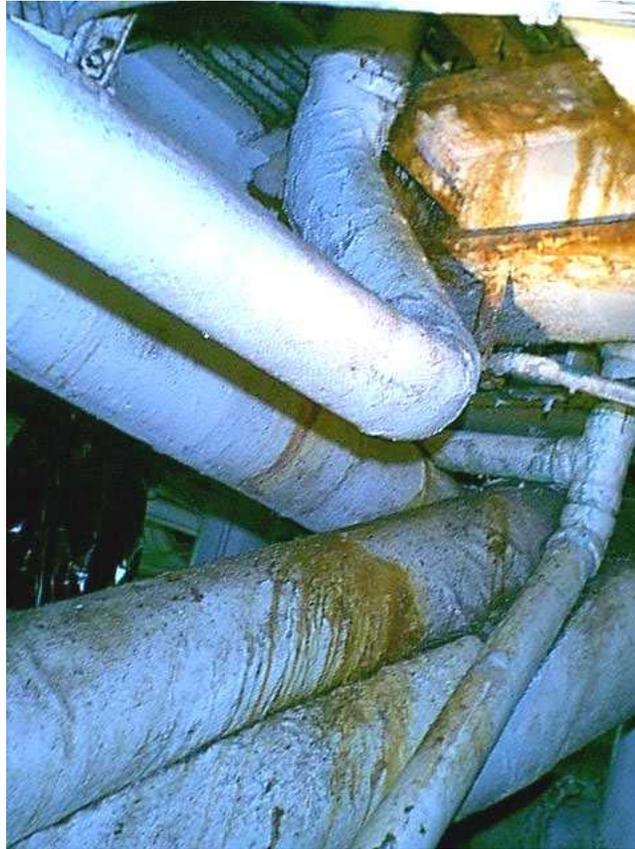
Photo 39: LOWER
LEVEL
STARBOARD SIDE
BELOW LPAC,
DETERIORATION
LOOKING
UP/INBOARD/AFT

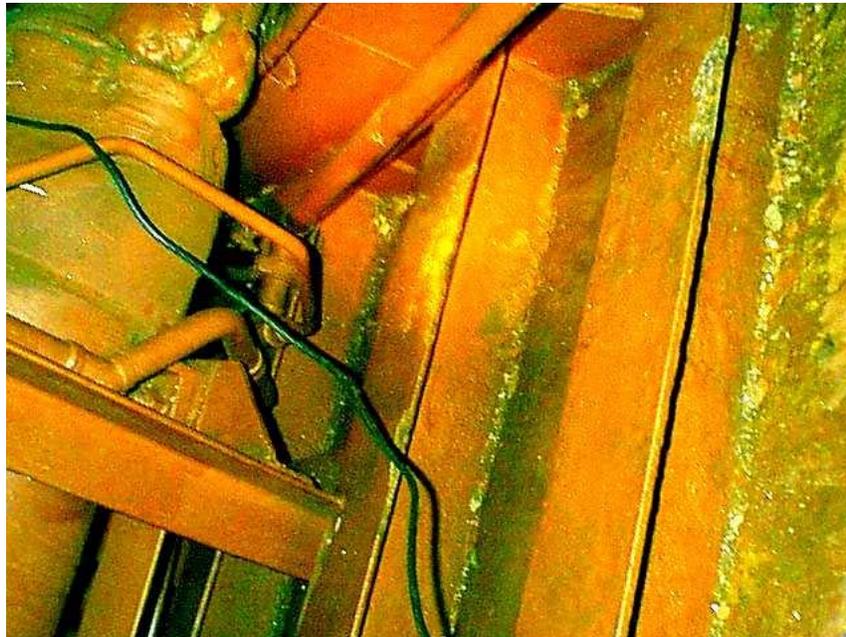
5-212-0-E	AUXILIARY MACHINERY ROOM No. 2	LPAC FOUNDATION STBD SIDE UPPER LEVEL	FOUNDATION AND SUPPORTING DECK AND FOUNDATION STRUCTURE PAINT FAILURE AND CORROSION.	CLEAN AND PRESERVE LPAC FOUNDATION AND SUPPORTING STRUCTURE ON UPPER LEVEL AND BETWEEN UPPER AND LOWER LEVEL.
5-212-0-E	AUXILIARY MACHINERY ROOM No. 2	STBD SIDE, FR 220, TRANSVERSE MEMBER, LONGITUDINAL No. 6-11	FR 220 TRANSVERSE MEMBER DETERIORATED.	CLEAN AND PRESERVE STRUCTURAL MEMBERS AT LOCATION NOTED.
5-212-0-E	AUXILIARY MACHINERY ROOM No. 2	PORTSIDE, SSDG SW CLG PUMP SEA CHEST FWD BULKHEAD TO FIVE FEET FWD OF THAT BULKHEAD, BTWN LONGITUDINAL No. 3 AND 5.	LOCATION SHELL PLATING THICKNESS UNSATISFACTORY.	REPLACE SHELL PLATING AT LOCATION NOTED.
5-212-0-E	AUXILIARY MACHINERY ROOM No. 2	PORTSIDE, BELOW MD-V24-5-212-2, LONGITUDINAL No. 9	LOCATION LONGITUDINAL UT UNSATISFACTORY.	REPLACE TWO FEET LONGITUDINAL No. 9 CENTERED ON MD-V24-5-212-2.

Photo 40: SHELL AND LONGITUDINAL No. 6 TO 8
BELOW LPAC STBD SIDE LOWER LEVEL,
FRAME 220, LOOKING FWD/OUTBOARD/DOWN

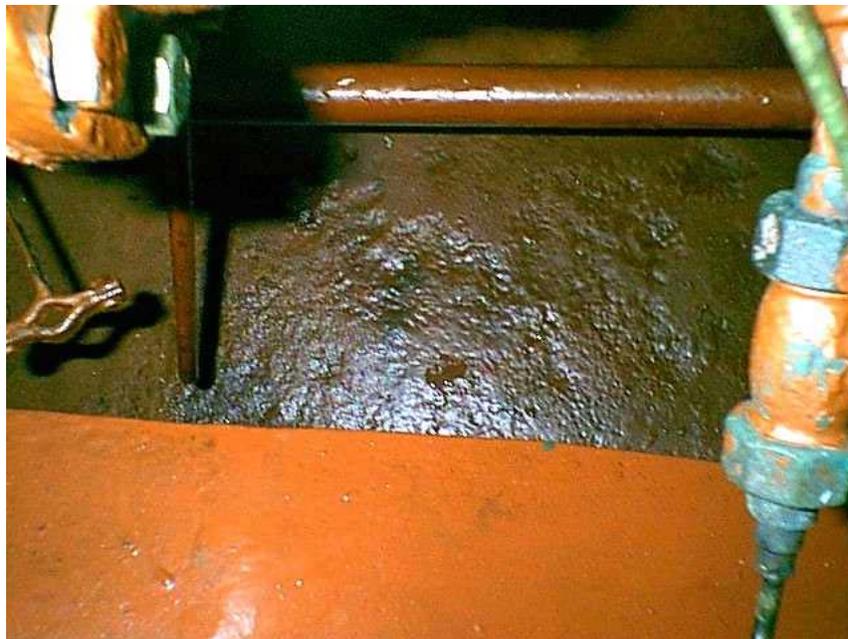
Photo 42: PITTED SHELL FWD/OUTBOARD SSDG SW CLG PUMP SEA CHEST, PORTSIDE BTWN LONGITUDINAL No. 4 and 5, LOOKING OUTBOARD

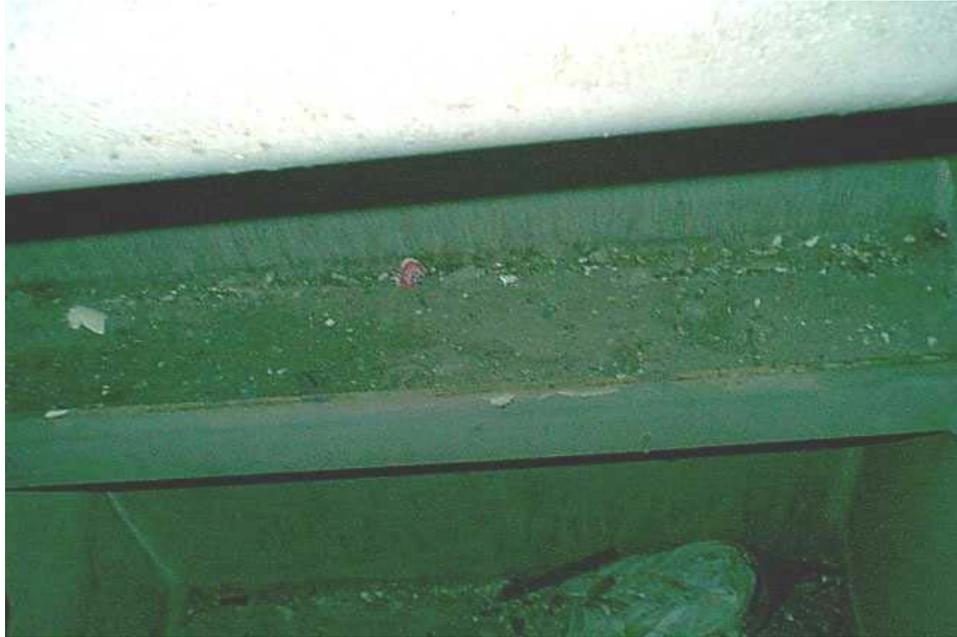
5-226-1-E	SSDG No. 2 ENCLOSURE	FR 226-250, STBD SIDE, DECK PLATE LEVEL TO OVERHEAD	PAINT FAILURE.	CLEAN AND PRESERVE SHELL AND STRUCTURAL MEMBERS AT LOCATION NOTED.

Photo 45: UNPRESERVED HULL AND STRUCTURAL MEMBERS BEHIND THE START AIR FLASK FORWARD STARBOARD SIDE LOOKING OUTBOARD.

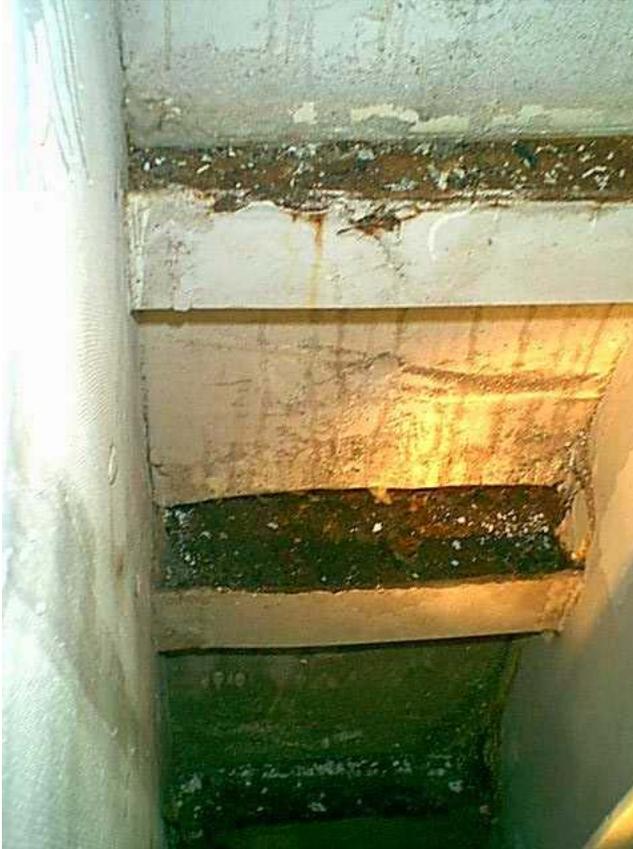
Photo 48: LOWER LEVEL
PORTSIDE FWD 1A LUBE OIL
STORAGE TANK,
DETERIORATED
LONGITUDINAL No. 4, 5 AND
6 FROM OVERHEAD,
LOOKING
OUTBOARD/DOWN

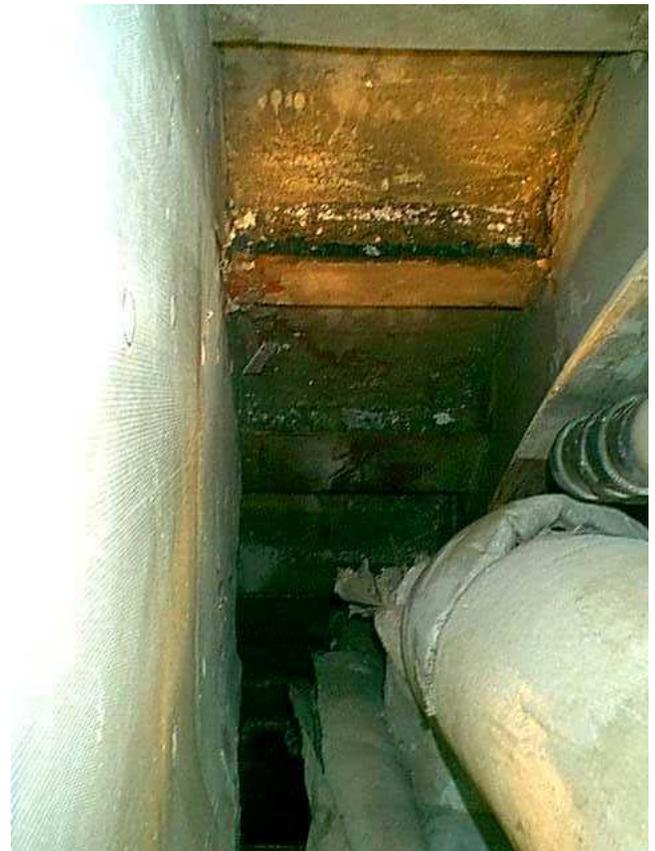
Photo 49: LOWER LEVEL
PORTSIDE FWD 1A LUBE OIL
STORAGE TANK,
DETERIORATED
LONGITUDINAL No. 4, 5 AND 6
FROM OVERHEAD, LOOKING
OUTBOARD/DOWN (SHOWING
AFT END OF PRAIRIE MASKER
AIR COOLER-PMAC.)
