USS NICHOLAS (FFG-47)

SEMAT SHELL CONDITION ASSESSMENT SURVEY INTERIOR AREAS

11/12/01 TO 11/21/01

**PREPARED BY
SUPERVISOR OF SHIPBUILDING CONVERSION AND REPAIR
PORTSMOUTH, VIRGINIA**

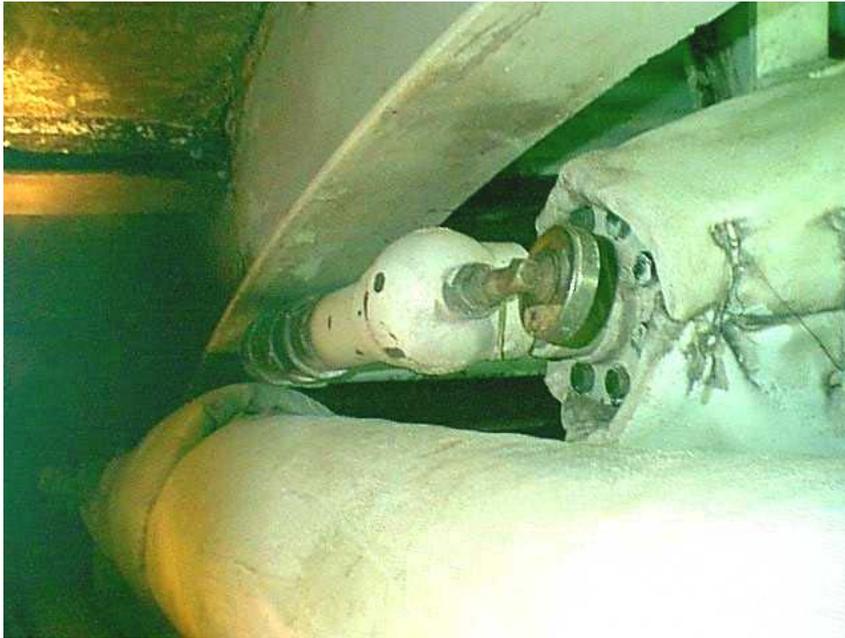
Photo 50: LOWER LEVEL PORTSIDE FWD 1A LUBE OIL STORAGE TANK, DETERIORATED LONGITUDINAL No. 5 FROM OVERHEAD, LOOKING OUTBOARD/DOWN/FWD (SHOWING AFT END OF PMAC).

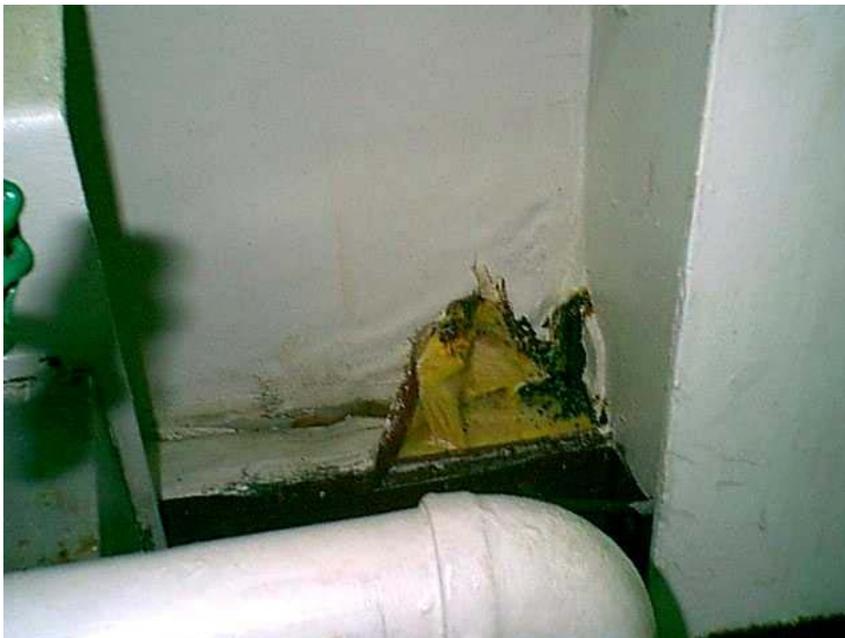
Photo 51: LOWER LEVEL AFT FRAME 259, SHELL AND LONGITUDINAL CONDITION OUTBOARD AND FWD OF PMAC, LOOKING OUTBOARD.

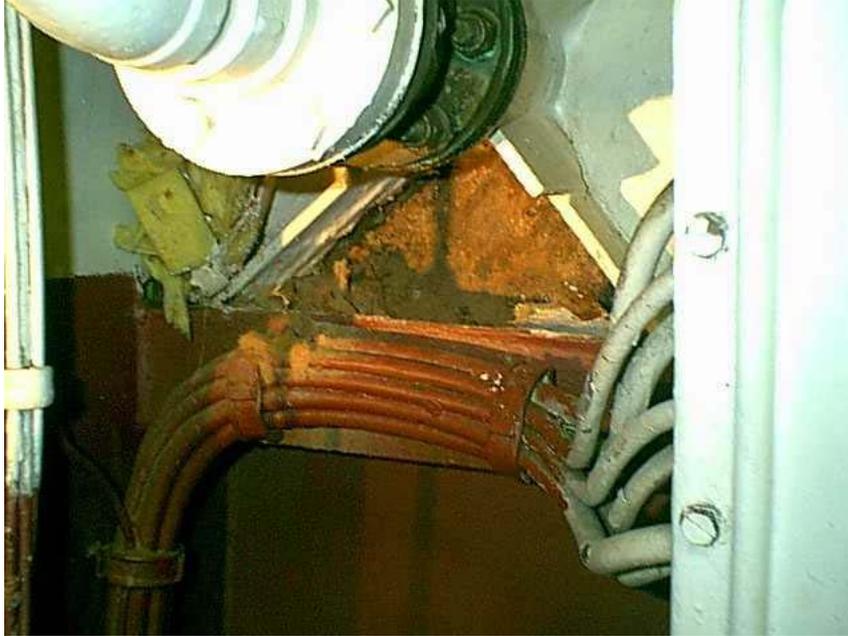
Photo 52: LOWER LEVEL FRAME 264 STBD SIDE
DETERIORATION BELOW GTRB CLR OBVD
DISCHARGE, LOOKING OUTBOARD/AFT

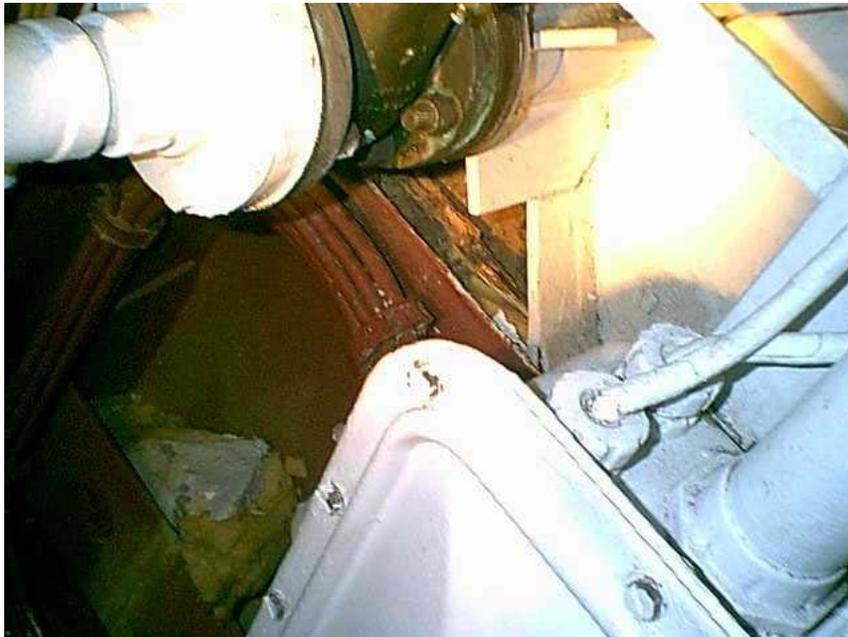
Photo 53: LOWER LEVEL FRAME 264 STBD SIDE
DETERIORATION BELOW GTRB CLR OBVD
DISCHARGE, LOOKING DOWN/OUTBOARD/AFT

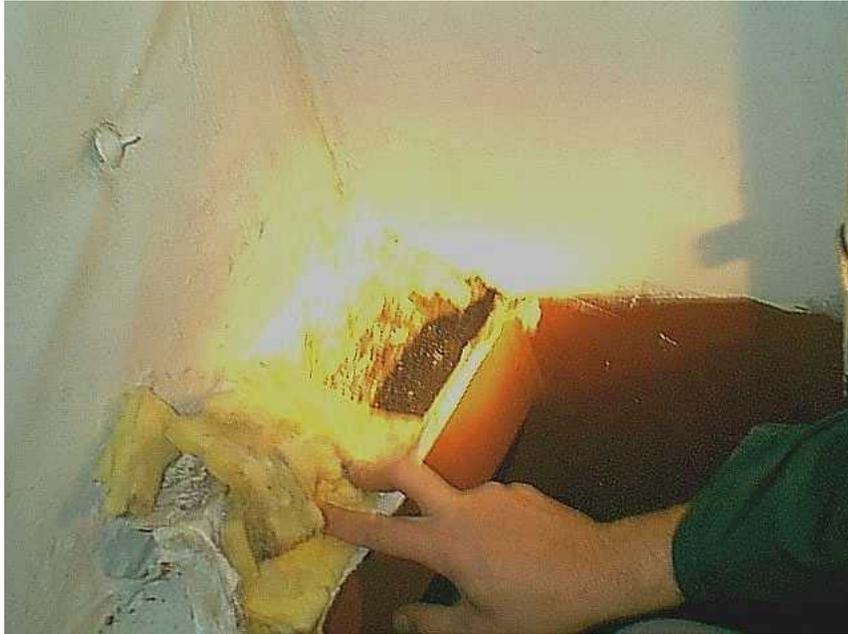
Photo 54: LOWER LEVEL STBDSIDE FWD FRAME 263,
SHELL AND LONGITUDINAL, DETERIORATION,
LOOKING DOWN/AFT/OUTBOARD

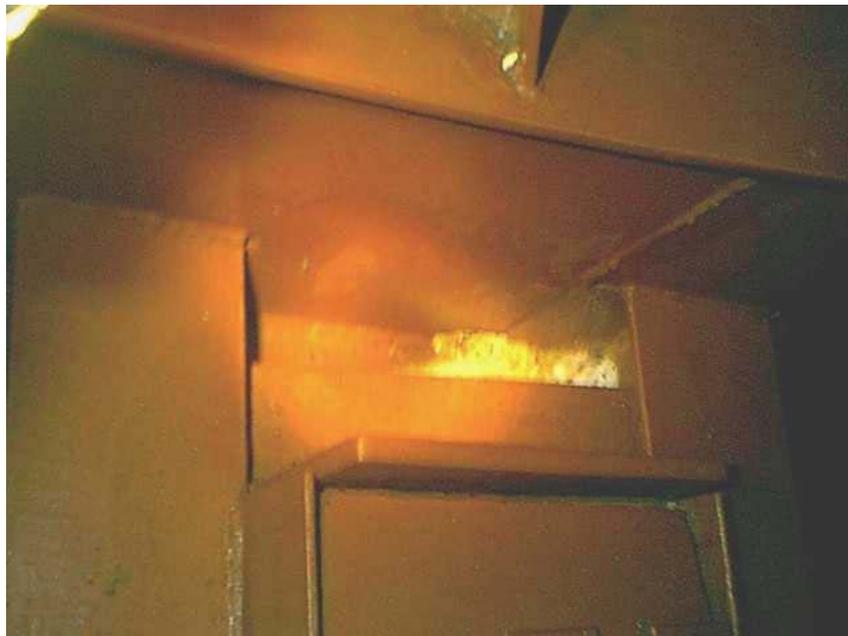
Photo 55: STBD SIDE BILGE BALLAST AREA, FWD
FRAME 262, SALT BUILDUP, LOOKING DOWN/AFT

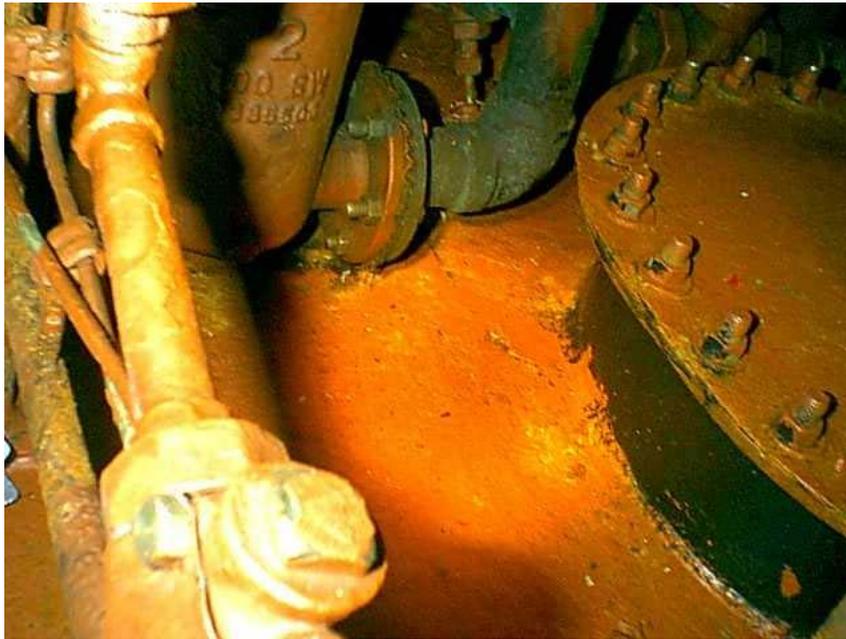
Photo 60: LOWER LEVEL STBD SIDE, TOP OF WASTE WATER TANK, LOOKING FWD/OUTBOARD

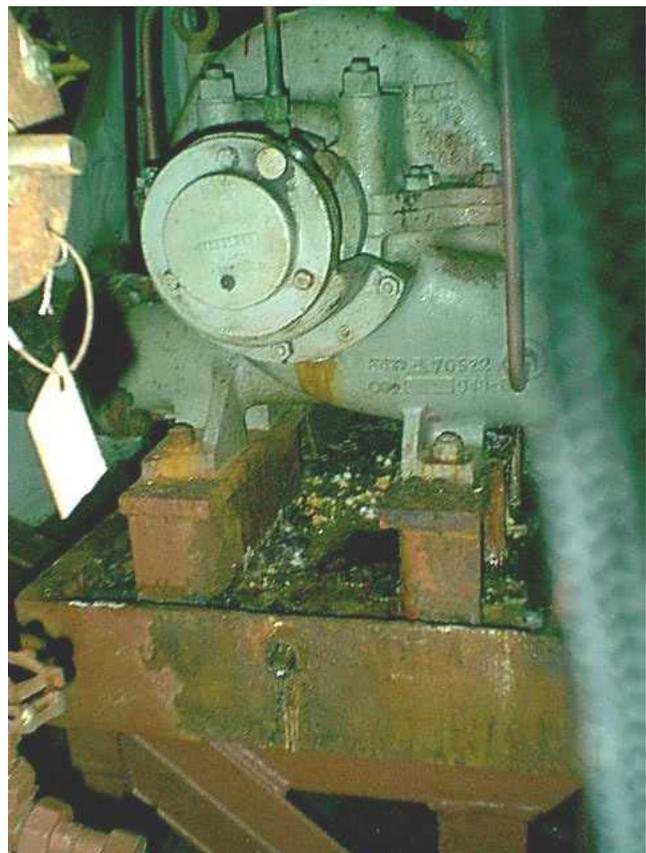
Photo 61: LOWER LEVEL STBD SIDE, FWD END OF No. 4 FIREPUMP AND FOUNDATION, LOOKING AFT

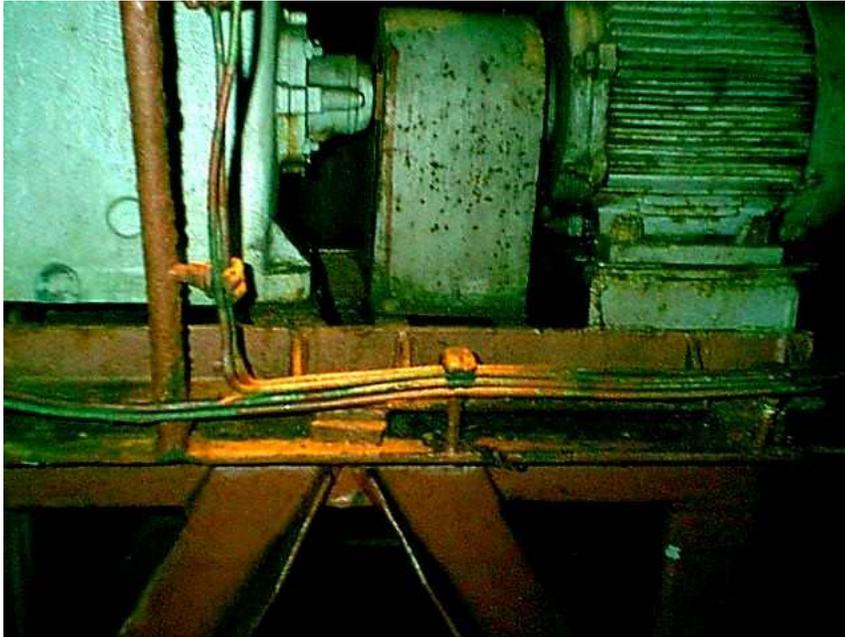
Photo 68: LOWER LEVEL STBD SIDE, WASTE WATER DRAIN PUMP FOUNDATION, INBOARD SIDE, LOOKING OUTBOARD

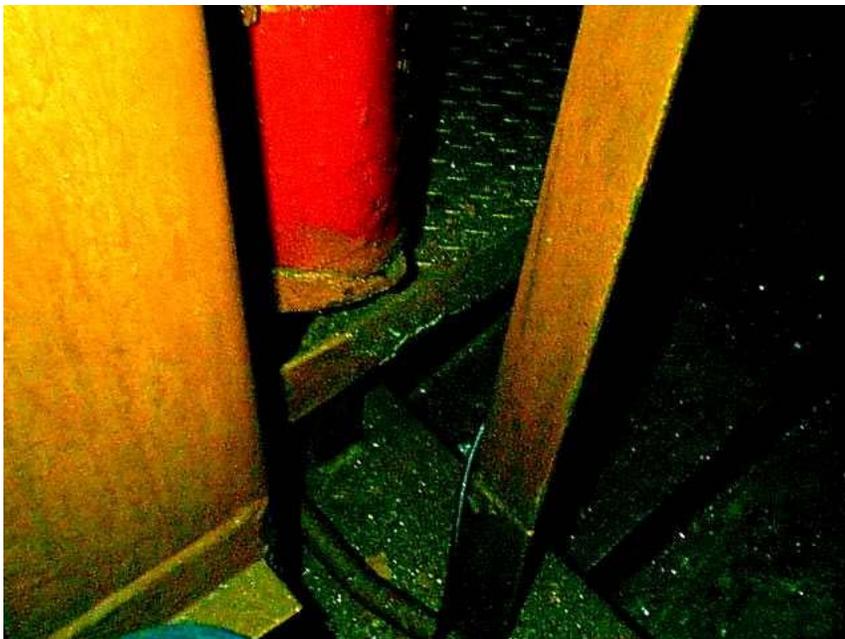
Photo 69: LOWER LEVEL STBD SIDE, DETERIORATED DECK PLATE SUPPORTS, FRAME 292, LOOKING FWD/ OUTBOARD BELOW PKP BOTTLE FOUNDATION

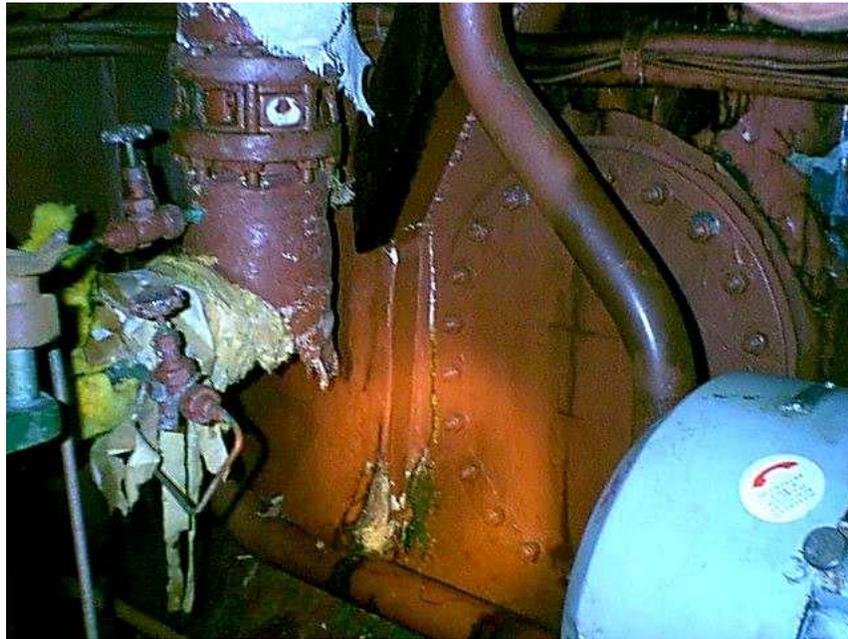
Photo 70: LOWER LEVEL PORTSIDE, OIL SOAKED AND DAMAGED INSULATION INBOARD BULKHEAD OF 5-308-2-W, FR 308-316, LOOKING AFT OUTBOARD

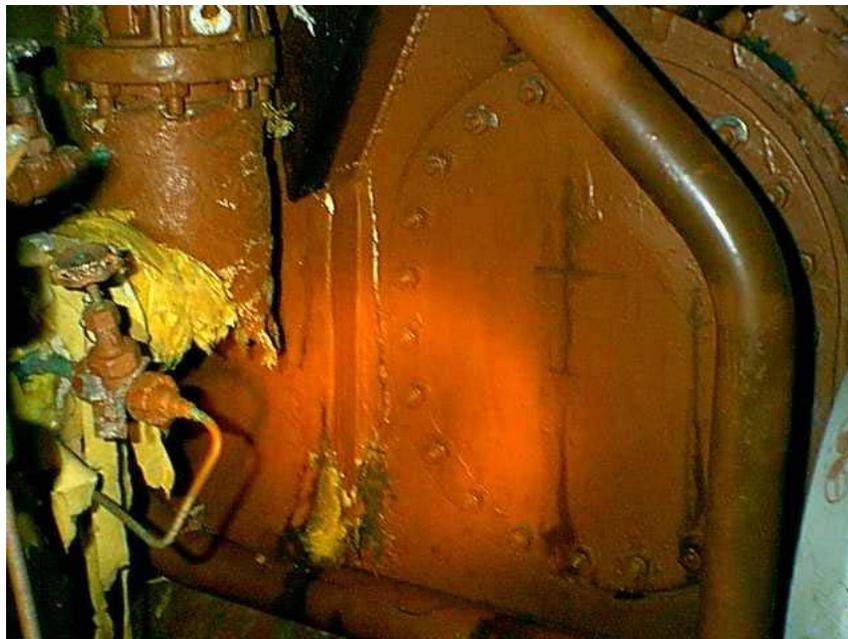
Photo 71: LOWER LEVEL PORTSIDE, OIL SOAKED AND DAMAGED INSULATION INBOARD BULKHEAD OF 5-308-2-W, FR 308-316, LOOKING AFT OUTBOARD

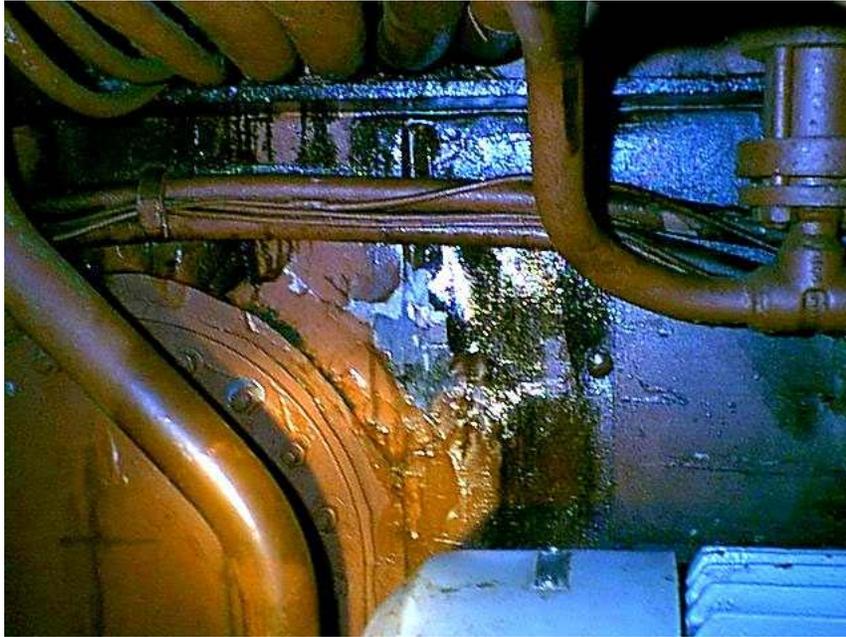
Photo 72: LOWER LEVEL PORTSIDE, OIL SOAKED AND DAMAGED INSULATION INBOARD BULKHEAD OF 5-308-2-W, FR 308-316, LOOKING OUTBOARD

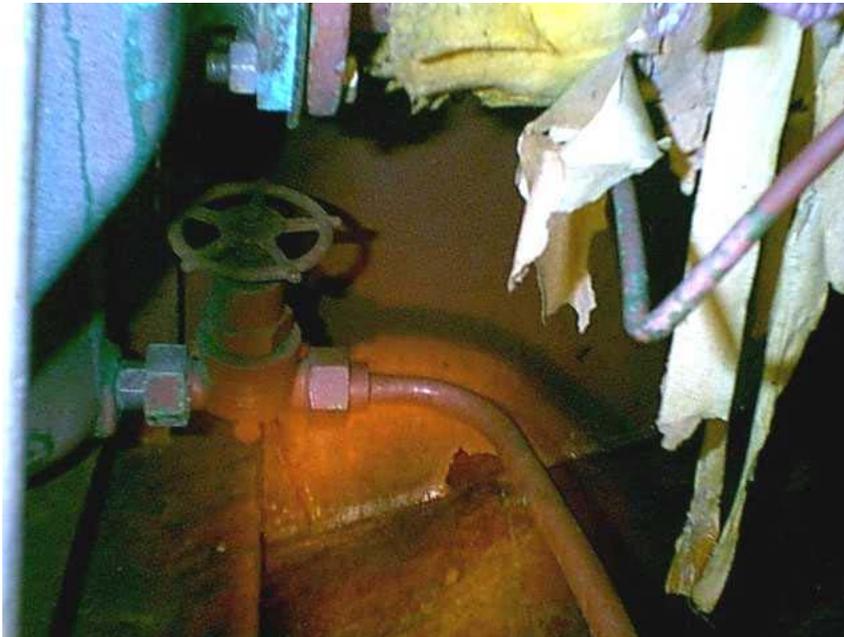
Photo 73: LOWER LEVEL PORTSIDE, DETERIORATED FRAME 316 BETWEEN LONGITUDINAL No. 3 AND 5-308-2-W, LOOKING AFT

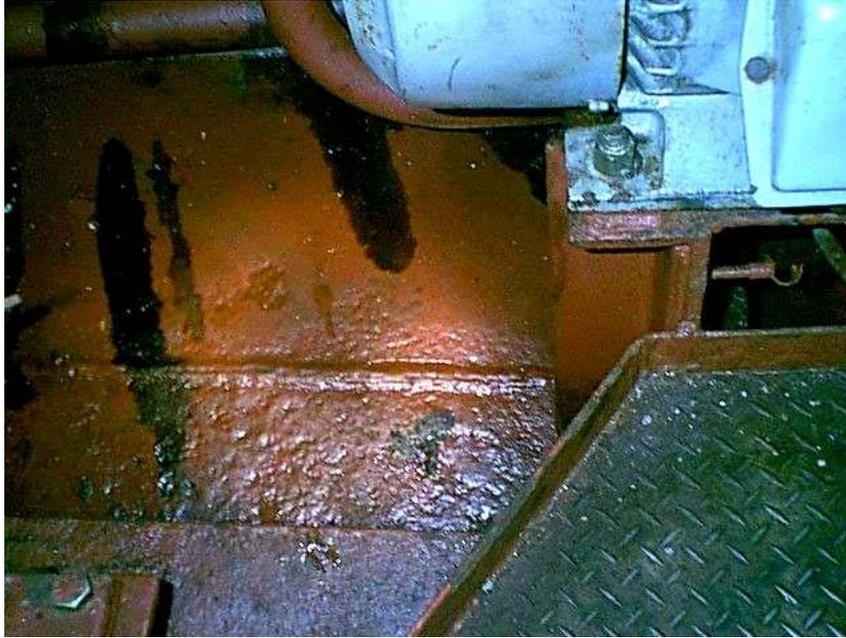
Photo 74: UT AREA LOWER LEVEL PORTSIDE BETWEEN FRAME 308 AND 316, WELD SEAM OUTBOARD LONGITUDINAL No. 3, LOOKING OUTBOARD

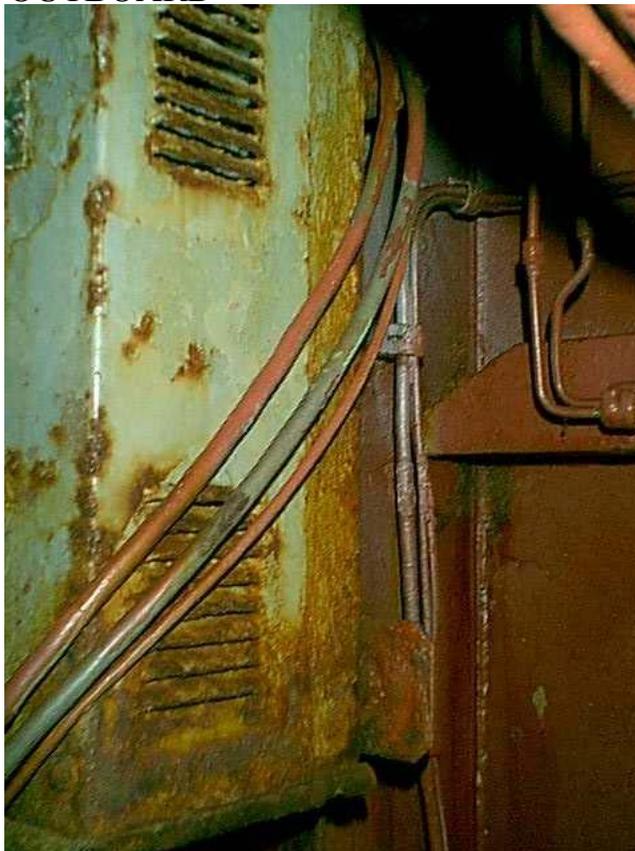
Photo 75: DAMAGED DISTILLATE PUMP VALVE CONTROL No. 2 AND BEAM AT FRAME 316 PORTSIDE LOWER LEVEL, LOOKING AFT/INBOARD

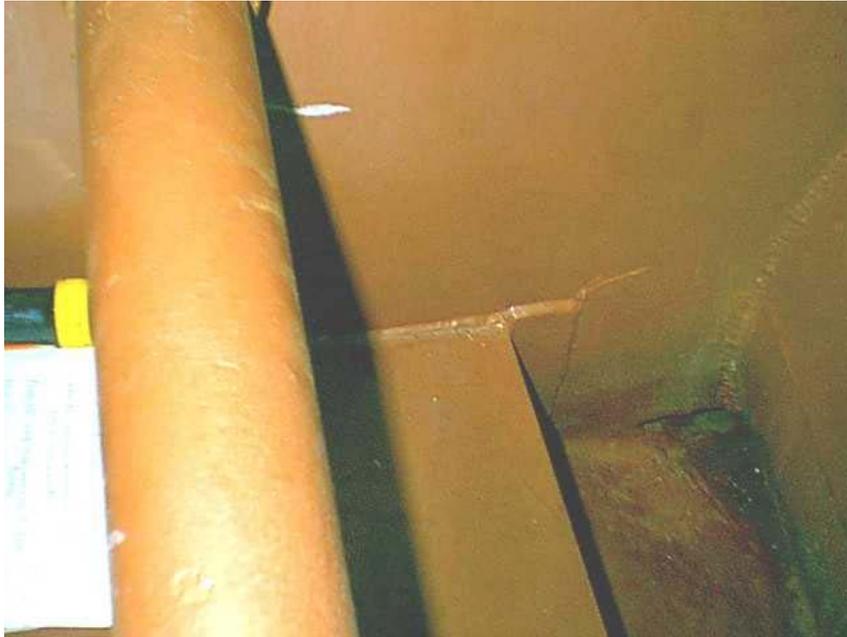
Photo 76: LOWER LEVEL PORTSIDE, AFT FRAME 324 BETWEEN LONGITUDINAL No 1 PORT AND SHAFT TUBE, DETERIORATED BULKHEAD, LOOKING FWD/INBOARD

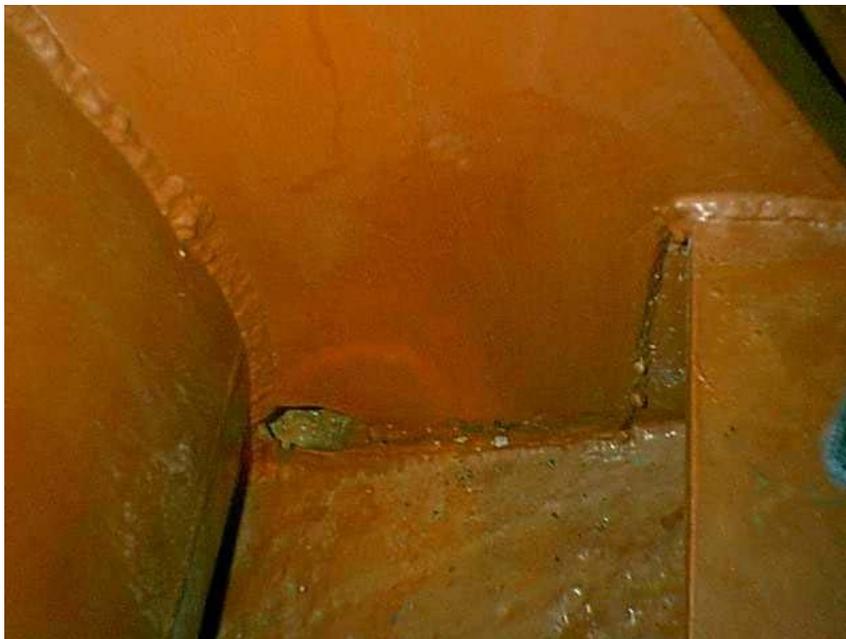
Photo 77: LOWER LEVEL PORTSIDE, FRAME 326 BETWEEN LONGITUDINAL No 1 PORT AND SHAFT TUBE, DETERIORATED SUPPORT STRUCTURE, LOOKING AFT/INBOARD

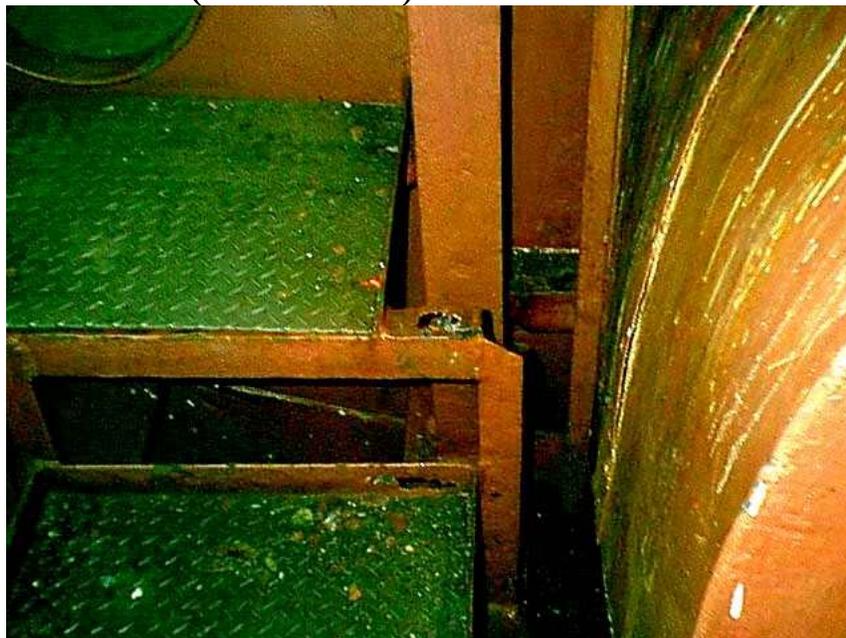
Photo 78: LOWER LEVEL STBD SIDE, FWD OF FRAME
316 DECK PLATE SUPPORT STRUCTURE
DETERIORATED, LOOKING AFT

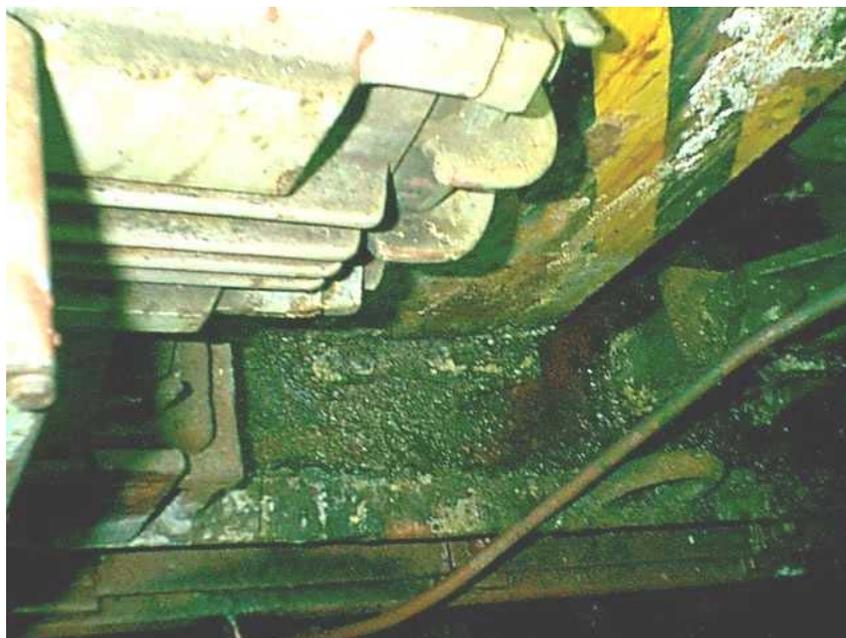
Photo 79: LOWER LEVEL STBD SIDE, No. 5 FIRE PUMP
FOUNDATION OUTBOARD SIDE, LOOKING DOWN/
INBOARD

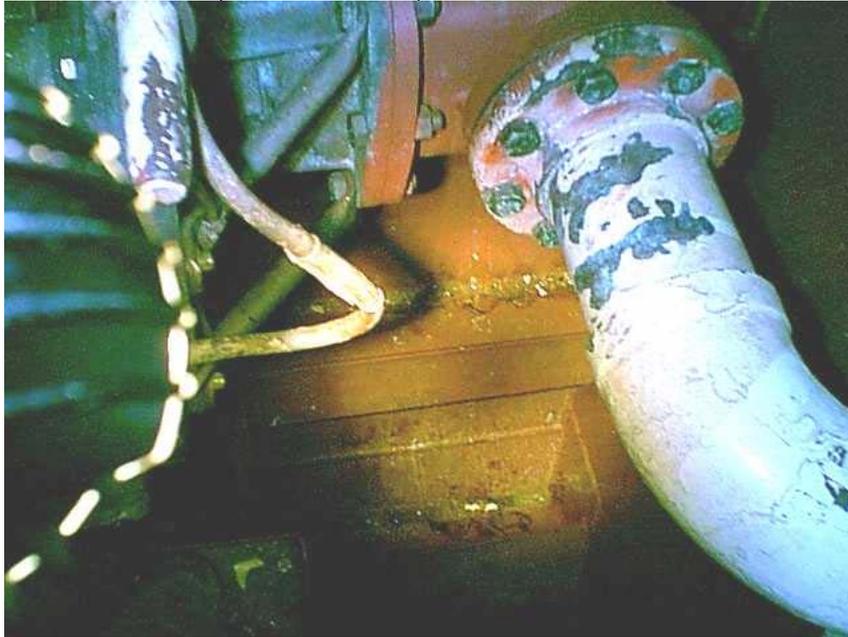
Photo 80: LOWER LEVEL PORTSIDE SHELL AND LONGITUDINAL No. 6 FROM OVERHEAD, AREA IS BELOW SSDG CLG WATER OVBD, LOOKING OUTBOARD/DOWN

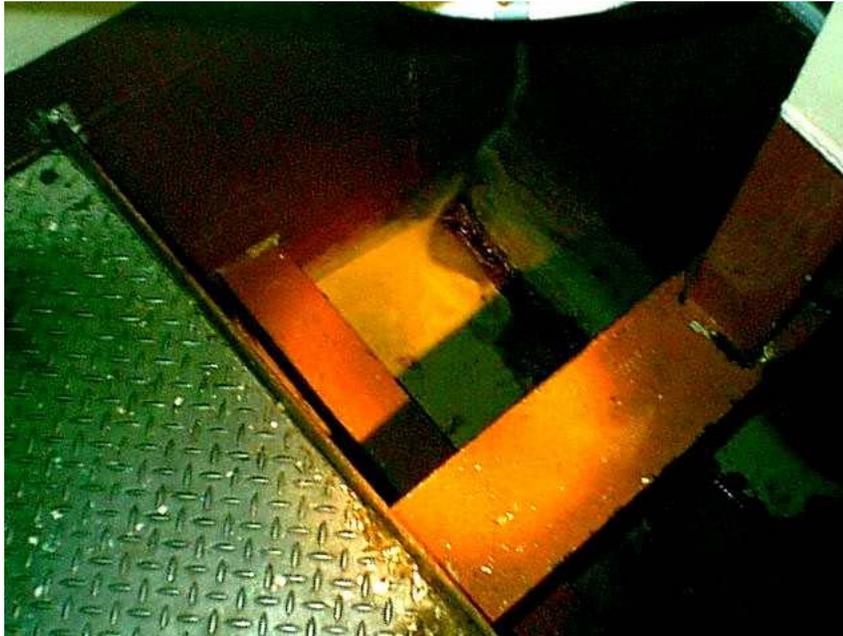
Photo 83: BILGE SECTION, BELOW STEERING GEAR ROOM DRAIN PUMP, LOOKING INBOARD/AFT
