USS ELROD (FFG-55)

SHELL CONDITION ASSESSMENT SURVEY INTERIOR AREAS

5/9/01 – 5/18/01

**PREPARED BY
SUPSHIP PORTSMOUTH
05/25/01**

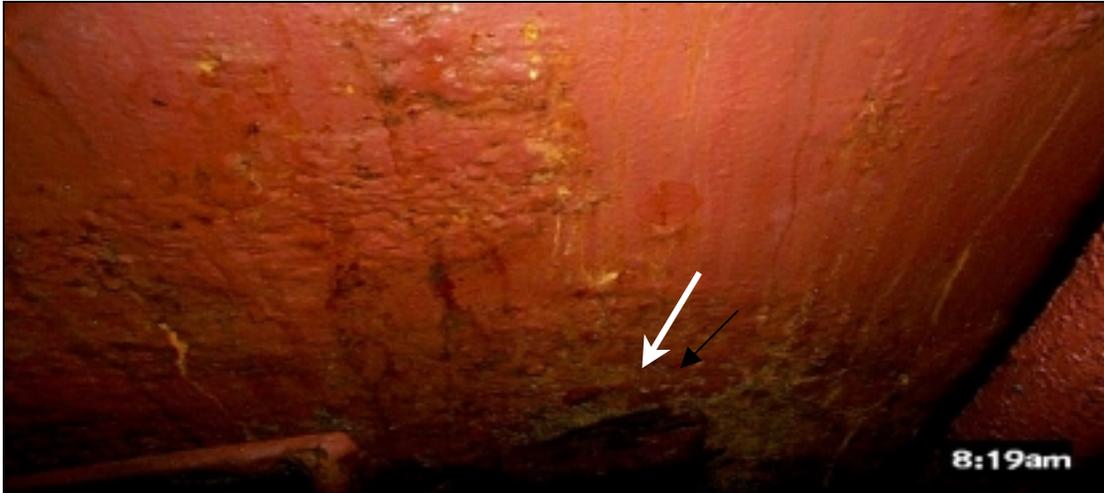
SAFETY HAZARD: 1. SERIOUS - CORRECT AS SOON AS POSSIBLE 2. SERIOUS - SUSPENSION OF EQUIPMENT/SYSTEM/SPACE REQUIRED 3. SERIOUS - WAIVER OF EQUIPMENT/SYSTEM 4. SAFETY ITEM - MINOR 5. COMBUSTIBLE MATERIAL				1. MAINTENANCE ACTION COMPLETED: PARTS DRAWN FROM SUPPLY 2. MAINTENANCE ACTION COMPLETED: REQUIRED PARTS NOT DRAWN FROM SUPPLY 3. MAINTENANCE ACTION COMPLETED: NO PARTS REQUIRED 4. CANCELLED - DEFERRAL WILL BE REMOVED FROM CSMP 7. MAINTENANCE ACTION COMPLETED: 3-M CAPABILITY UTILIZED 0. NONE OF THE ABOVE, DESCRIBE IN REMARKS/DESCRIPTION SECTION		1. MANDATORY 2. ESSENTIAL 3. HIGHLY DESIRABLE 4. DESIRABLE		
DISCREPANCY DESCRIPTION: PER SEMAT II INSPECTION Inboard side of AUX 3, (5-292-0-E) at PWT #3 did not pass the U/T reading. Design thickness is .250, the U/T reading revealed .113 reading Which is below the 25% desired thickness. PWT #3 has approx. 6sf, heavy pitting and corrosion.

(Top) Side View, Potable water tank #3
Arrow indicates Low U/T reading at **.113**

RECOMMENDED REPAIRS: Remove approx. 6sf up from bottom by length of tank and replace with .250 mil-S-22698 steel plate, prime and paint area to match.								
SSPORT C221 POC: F. PRAISSMAN (757) 396-4001 EXT 2130, TPOC: R. NORMAN /T. ZWOLAK								
CSMP SUMMARY PWT 3, in AUX 3 has heavy corrosion, and failed U/T reading at .113						TEST# MRC 1102/1		
ROOT CAUSE/AMPLIFICATION H1						STEP# 1,2,3,4 & 5		
SYSTEM LEVEL IMPACT								
PART NO.	NOMEMCLATURE			QTY	NSN		COST	
1								
2								
3								
4								
5								
FIRST CONTACT SHILES		RATE DC1	SECOND CONTACT ARNOLD		RATE DCC	PHONE		
ASSESSOR / ACT / TECH ID# J. LaROCK / T. ILGENFRITZ QED				TD	TL	LOGISTICIAN	TSP

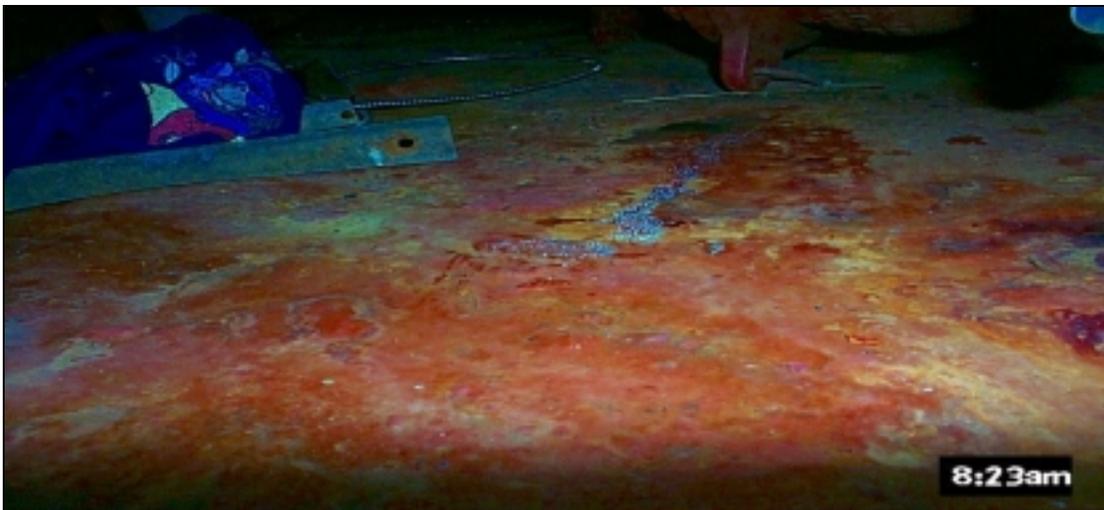
(Bottom) Top of Potable water tank #3, U/T readings satisfactory.
Area recommended for preservation.

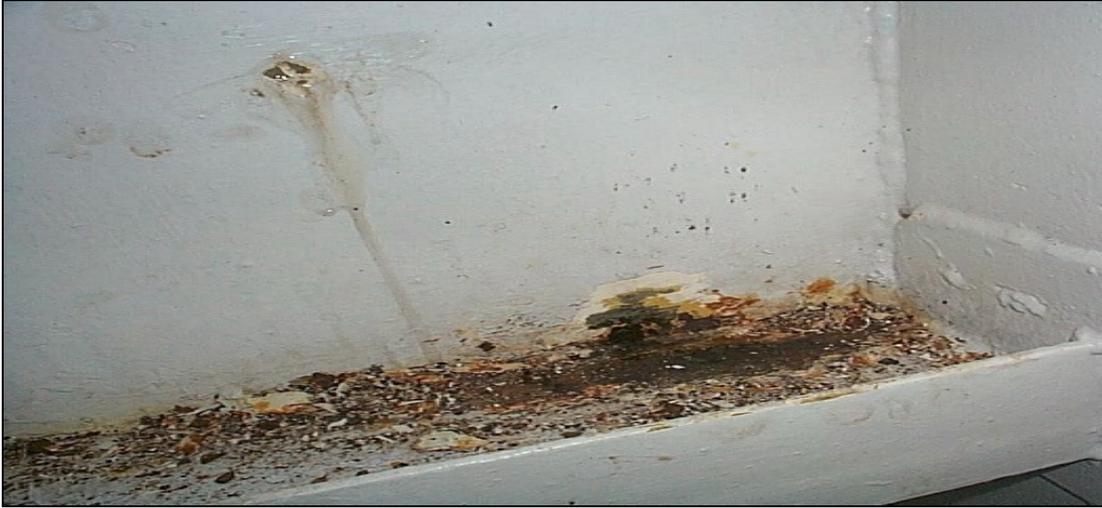
(Top) Port side view of stringer 10
Area recommended for preservation

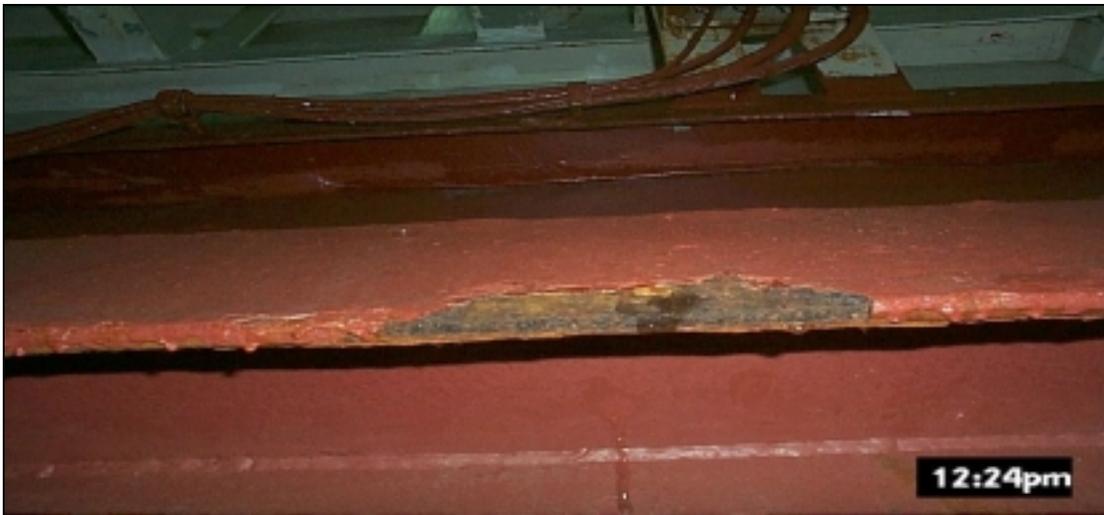
(Bottom) Port side, bilge area, under stringer 10
Area recommended for cleaning.

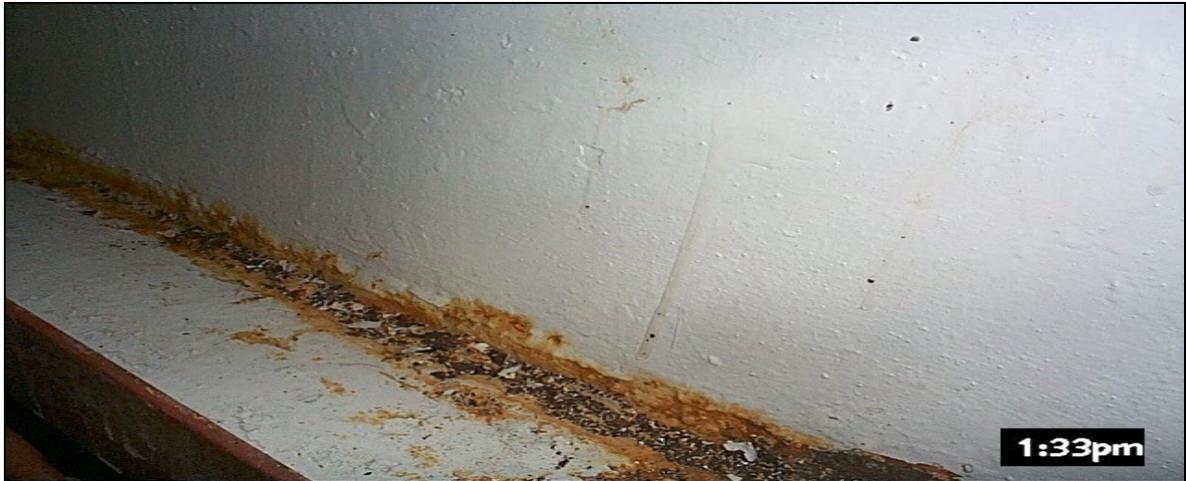
(Top) Port side stringer 9
Area recommended for preservation

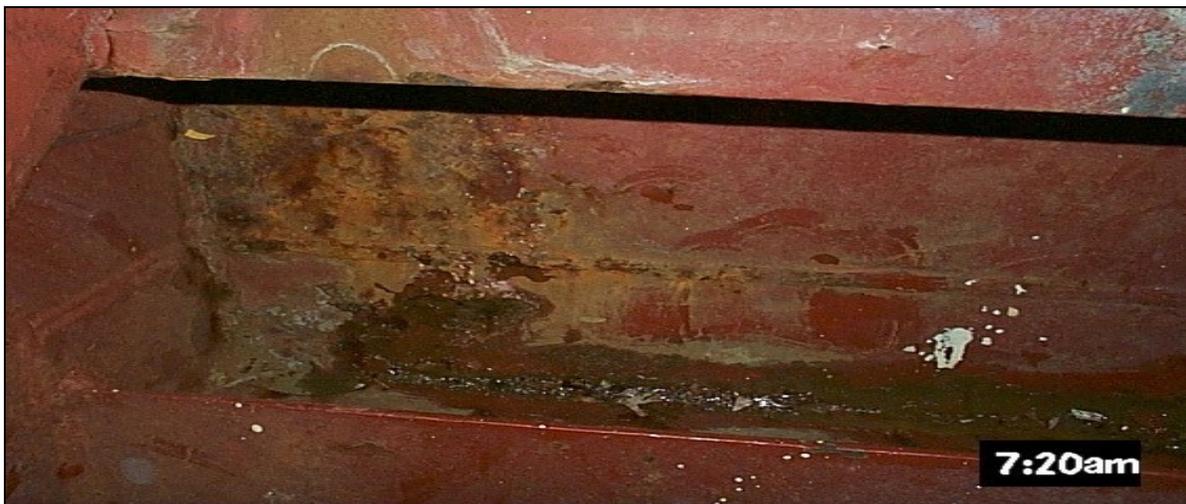
(Bottom) Port side between stringers 8 & 9
Area recommended for preservation.

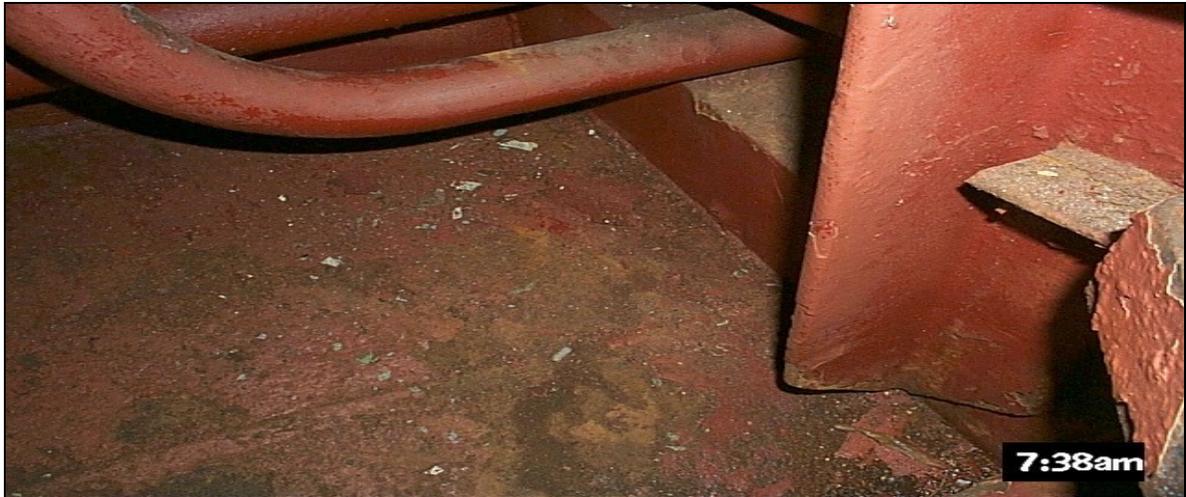
DISCREPANCY DESCRIPTION: PER SEMAT II INSPECTION Between WF (308-316) under (SSDG#4) approximately 20sf of light rust and paint separation.							
RECOMMENDED REPAIRS: Needle gun approximately 20sf of area preserve and paint to match surrounding area.							
SSPORT C221 POC: F. PRAISSMAN (757) 396-4001 EXT 2130, TPOC: R. NORMAN /T. ZWOLAK							
CSMP SUMMARY WF (308-316) under (SSDG#4) was found with rust and paint separation.					TEST# MRC 1102/1		
ROOT CAUSE/AMPLIFICATION H1					STEP# 1,2,3,4 & 5		
SYSTEM LEVEL IMPACT							
PART NO.	NOMEMCLATURE			QTY	NSN		COST
1							
2							
3							
4							
5							
6							
FIRST CONTACT SHILES	RATE DC1	SECOND CONTACT ARNOLD		RATE DCC	PHONE		
ASSESSOR / ACT / TECH ID# J. LaROCK / T. ILGENFRITZ QED				TD	TL	LOGISTICIAN	TSP

(Top) Port side under SSDG #4
Area recommended for preservation

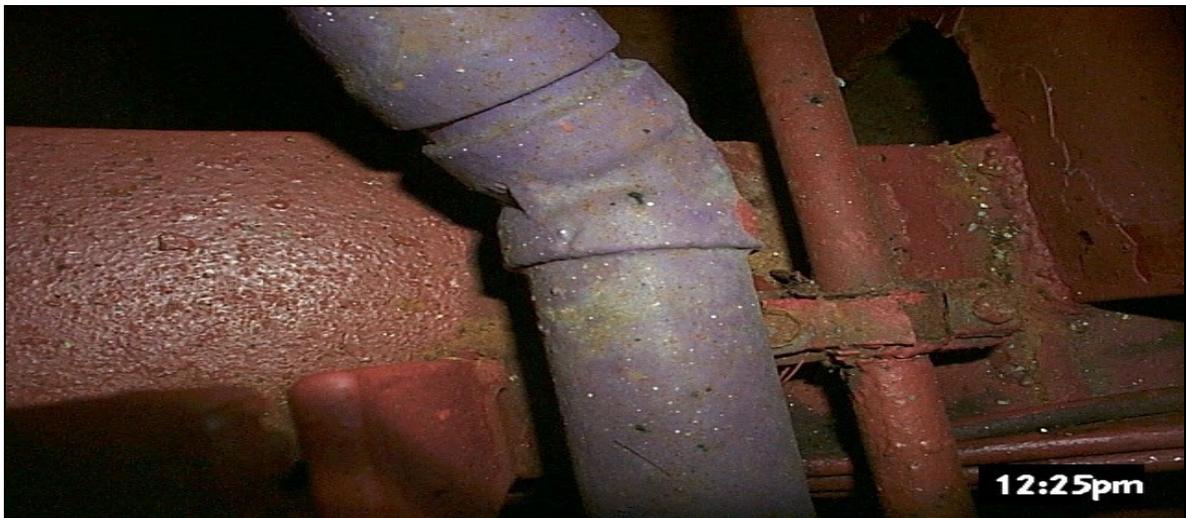
SSPORT C221 POC: F. PRAISSMAN (757) 396-4001 EXT 2130, TPOC: R. NORMAN / T. ZWOLAK								
CSMP SUMMARY Fr (324), tank top under foundation of JP5 service transfer filter has corrosion.					TEST# MRC 1102/1			
ROOT CAUSE/AMPLIFICATION H1					STEP# 1,2,3,4 & 5			
SYSTEM LEVEL IMPACT								
PART NO.	NOMEMCLATURE			QTY	NSN		COST	
1								
2								
3								
4								
5								
6								
FIRST CONTACT SHILES	RATE DC1	SECOND CONTACT ARNOLD		RATE DCC	PHONE			
ASSESSOR / ACT / TECH ID# J. LaROCK / T. ILGENFRITZ QED				TD	TL	LOGISTICIAN	TSP

(Bottom) Starboard side, foundation under JP5 Transfer filter.
Area recommended for preservation.

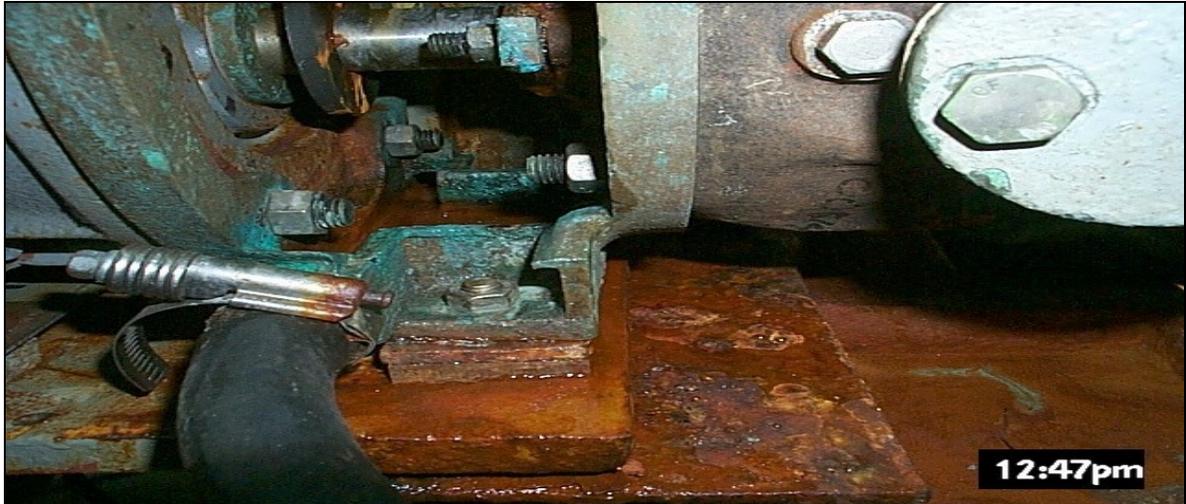
(Top) Foundation under distillation unit
U/T reading ok, light surface rust.

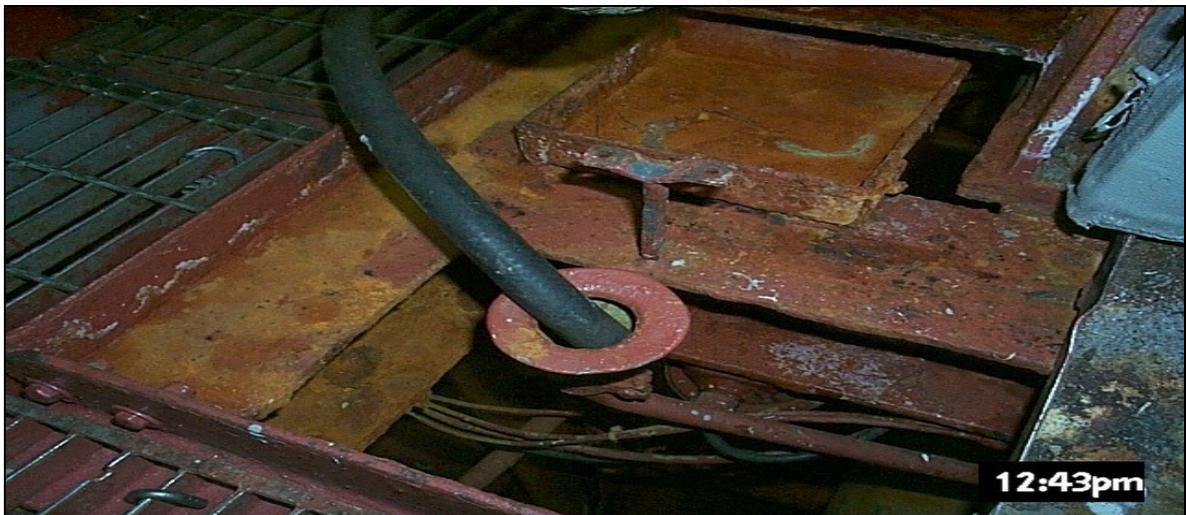
(Bottom) Foundation under distillation unit
Area recommended for preservation.

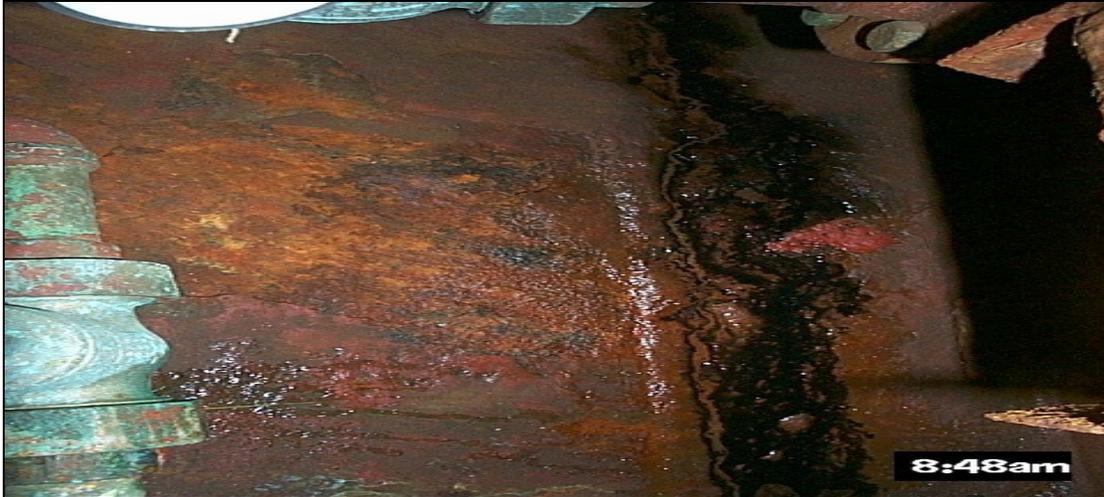
CSMP SUMMARY Approximately 20sf under shaft has rust and paint separation.				TEST# MRC 1102/1			
ROOT CAUSE/AMPLIFICATION H1				STEP# 1,2,3,4 & 5			
SYSTEM LEVEL IMPACT							
PART NO.	NOMEMCLATURE			QTY	NSN	COST	
1							
2							
3							
4							
5							
6							
FIRST CONTACT SHILES	RATE DC1	SECOND CONTACT ARNOLD		RATE DCC	PHONE		
ASSESSOR / ACT / TECH ID# J. LaROCK / T. ILGENFRITZ QED			TD	TL	LOGISTICIAN	TSP

(Top) AFT of WF 324, under shaft
Recommended for preservation

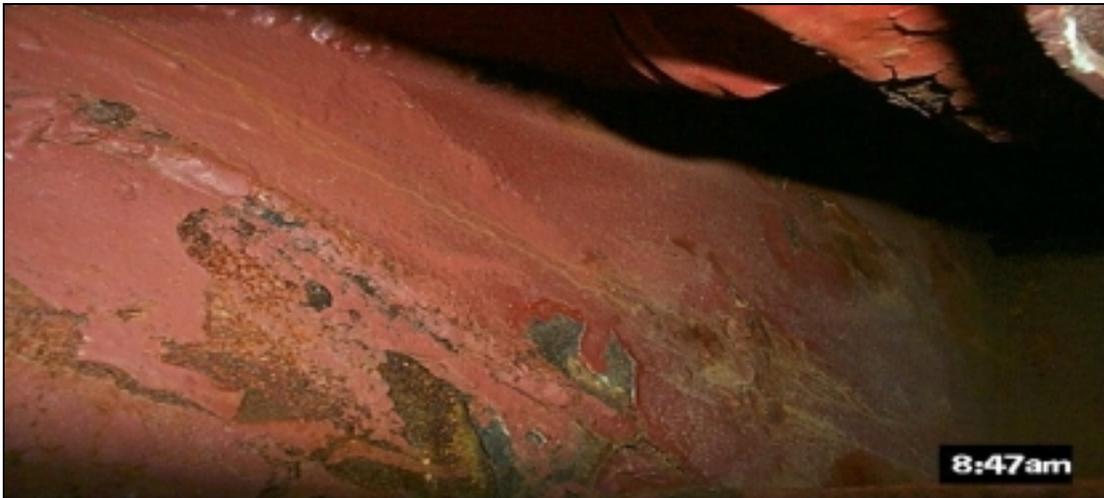
(Bottom) Shaft seal support, Rust and paint separation.
Area recommended for preservation.

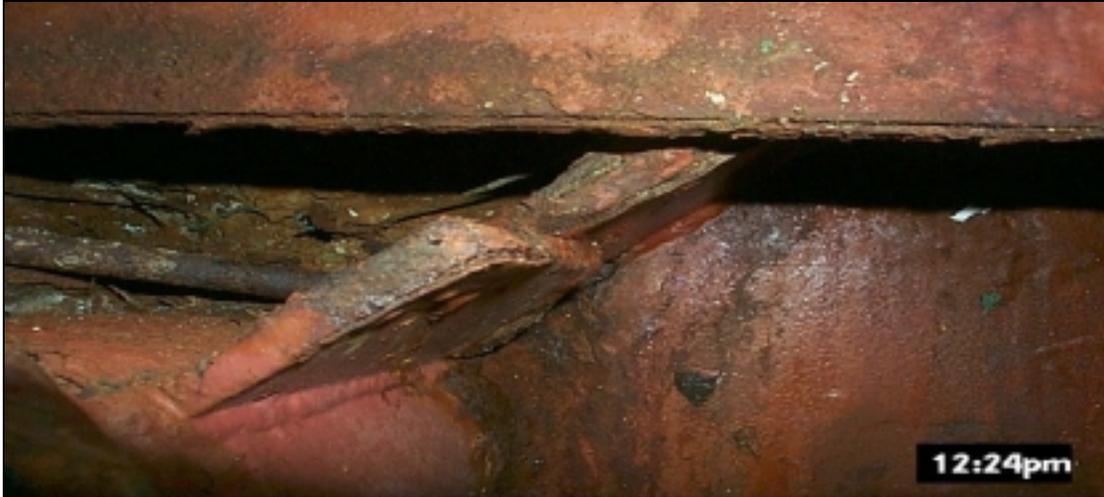
(Top) Port side, Prairie OVBD Discharge
Area recommended for preservation

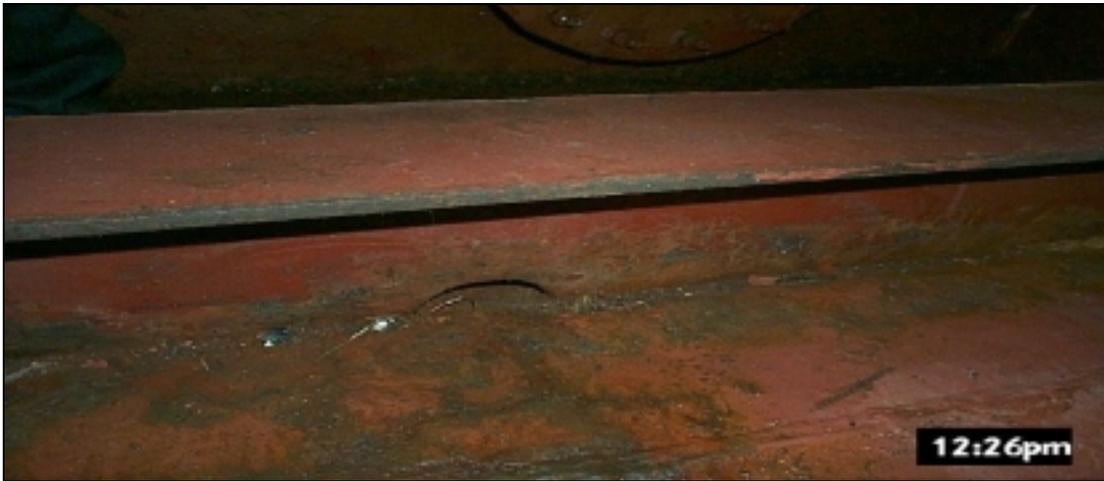
(Bottom) Port side view of area below OVBD discharge.
Area recommended for preservation.

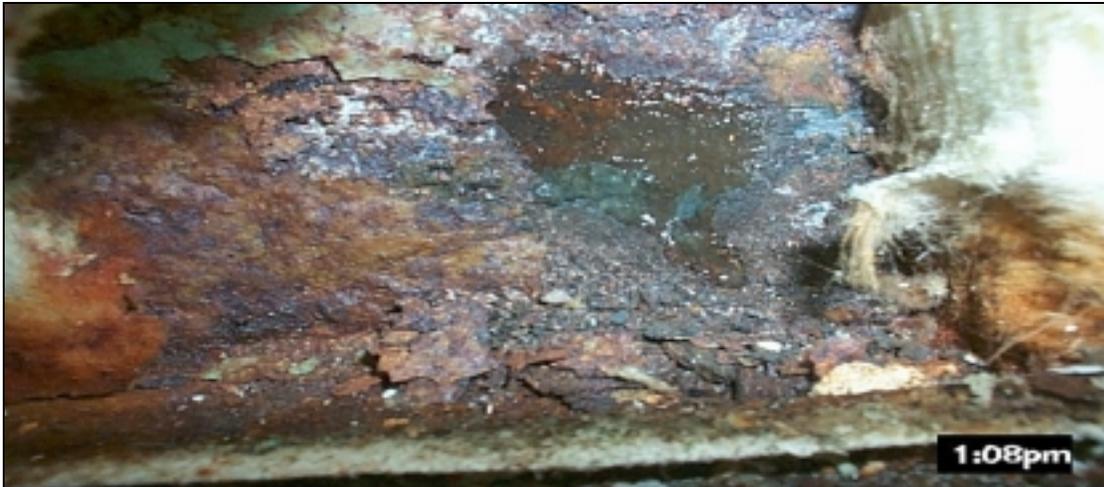
(Top) Port side, BTWN WF 258-264, stringer 12
Area recommended for preservation

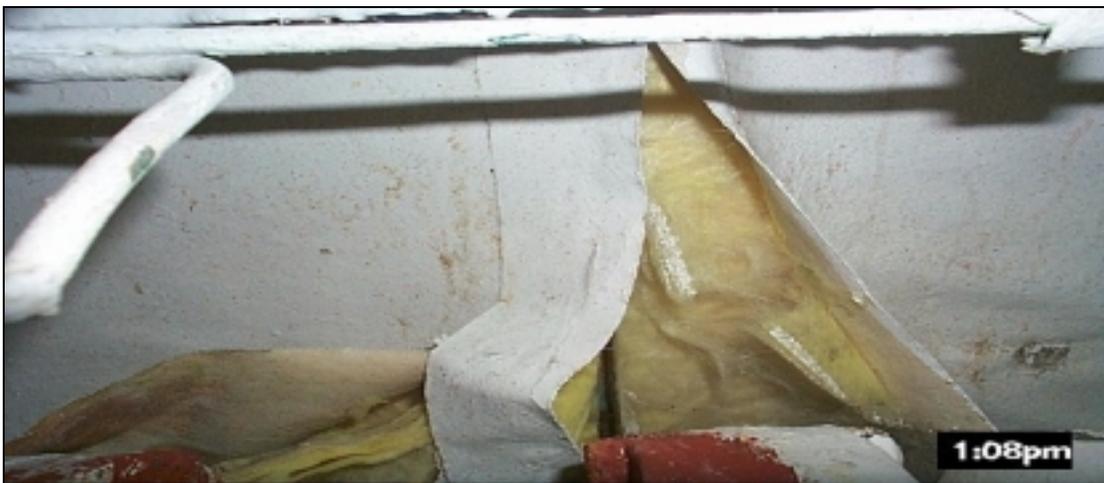
(Bottom) Port side Saturated lagging BTWN Stringers 12-13
Area recommended for preservation.

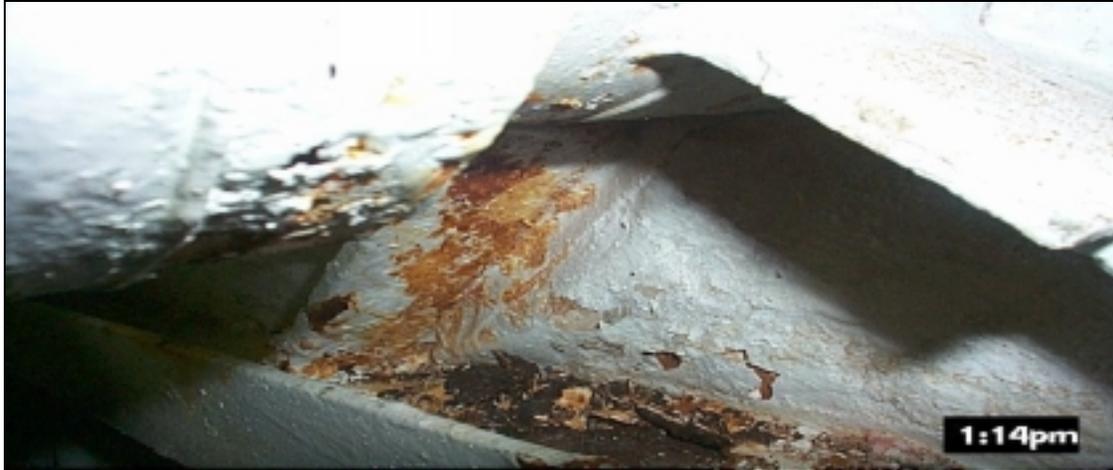
(Top) Port side, BTWN BHD 250 & WF 258, Stringer 11 below the Eductor OVBD discharge (MDV4).
Area recommended for preservation

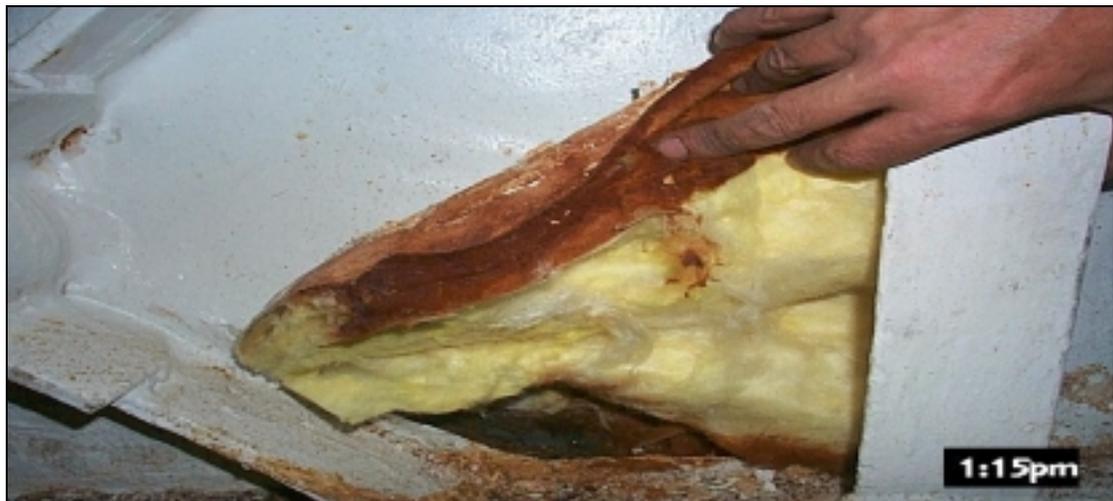
(Bottom) Port side Saturated lagging BTWN Stringers 11-12
Area recommended for preservation.

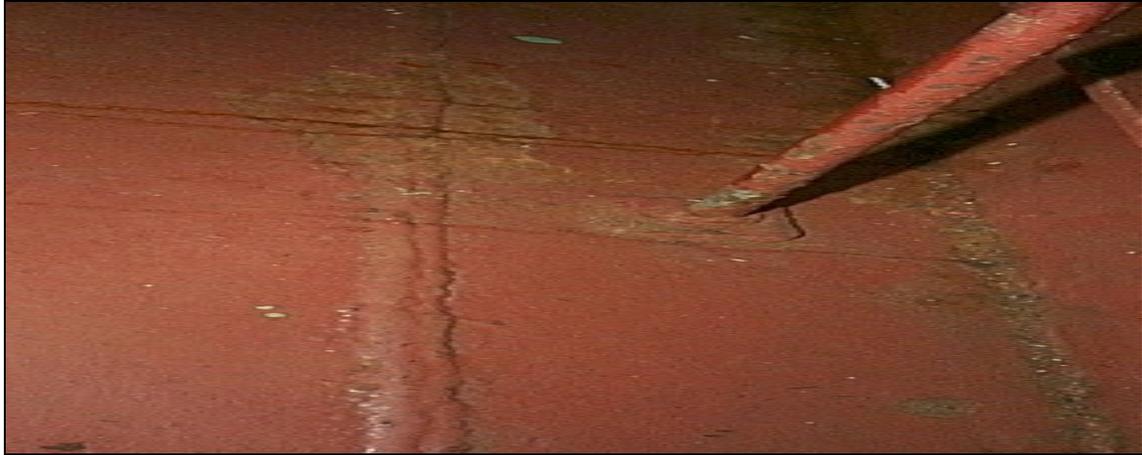
(Top) STBD side, between WF 258-264, under salt water strainer 1A/
Surface rust and paint separation on shell plating.
Area recommended for preservation

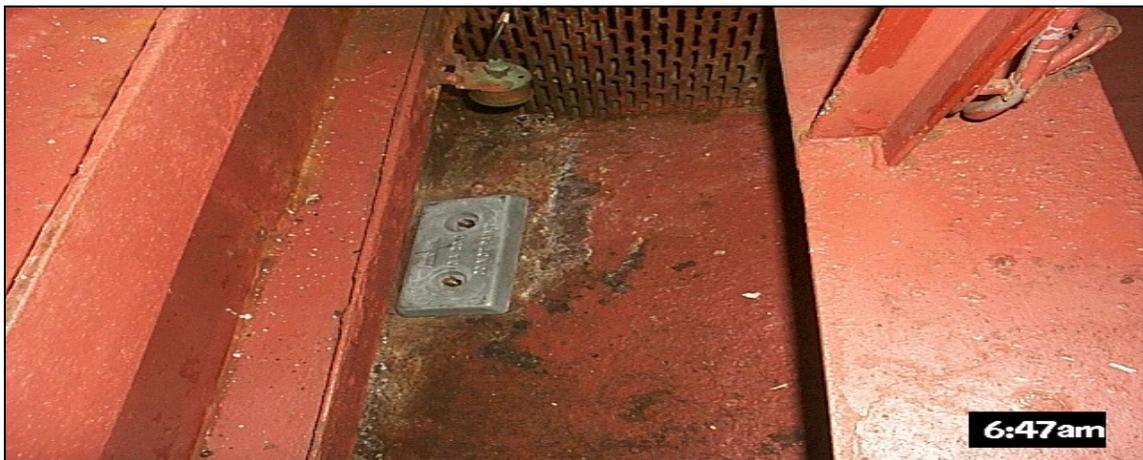
(Bottom) STBD side, aft of BHD 250, under stbd main engine foundation.
Area recommended for preservation.

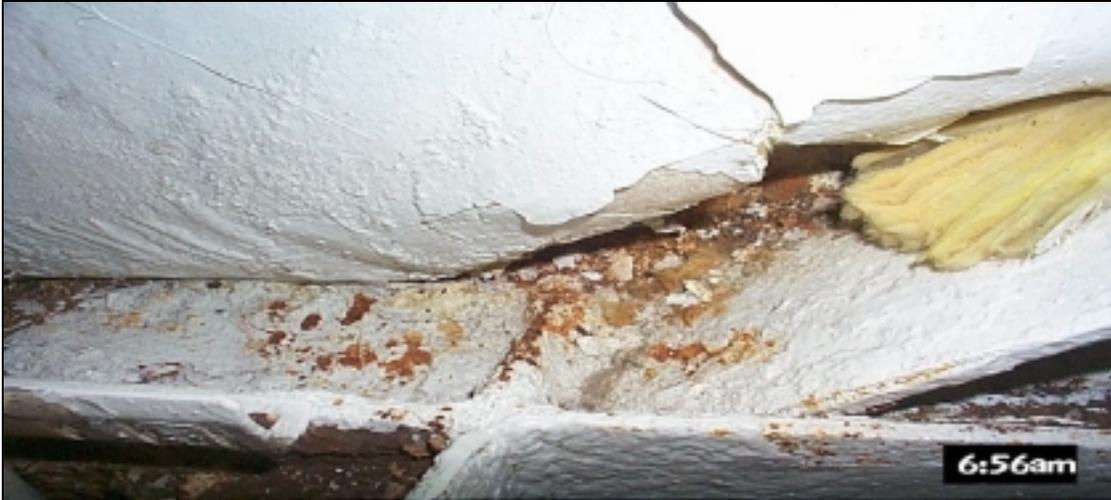
(Top) Port side, between WF 264-270 under OVBD discharge (ASWV7)
Saturated lagging.
Area recommended for preservation

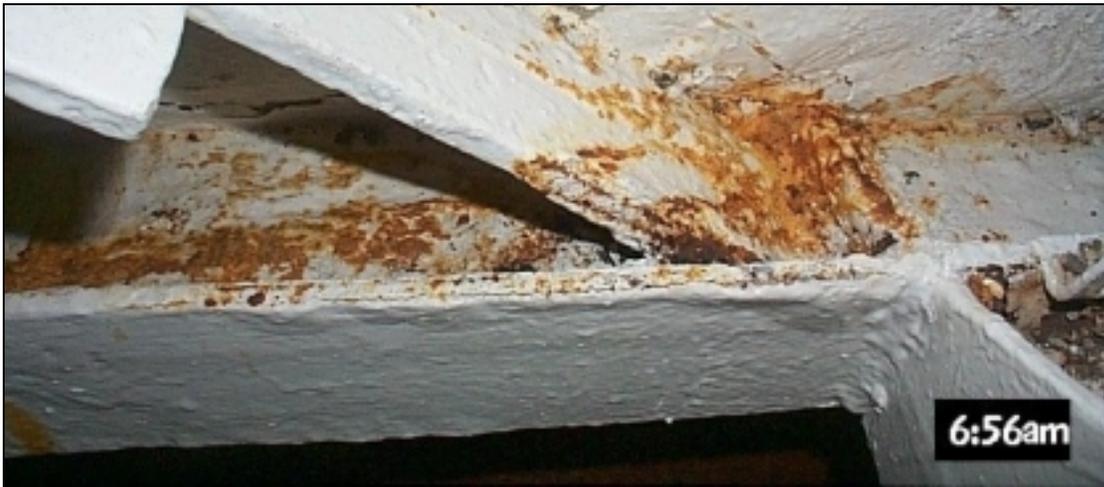
(Bottom) Port sides, OVBD discharge (ASWV7) Rust and paint separation.
Area recommended for preservation.

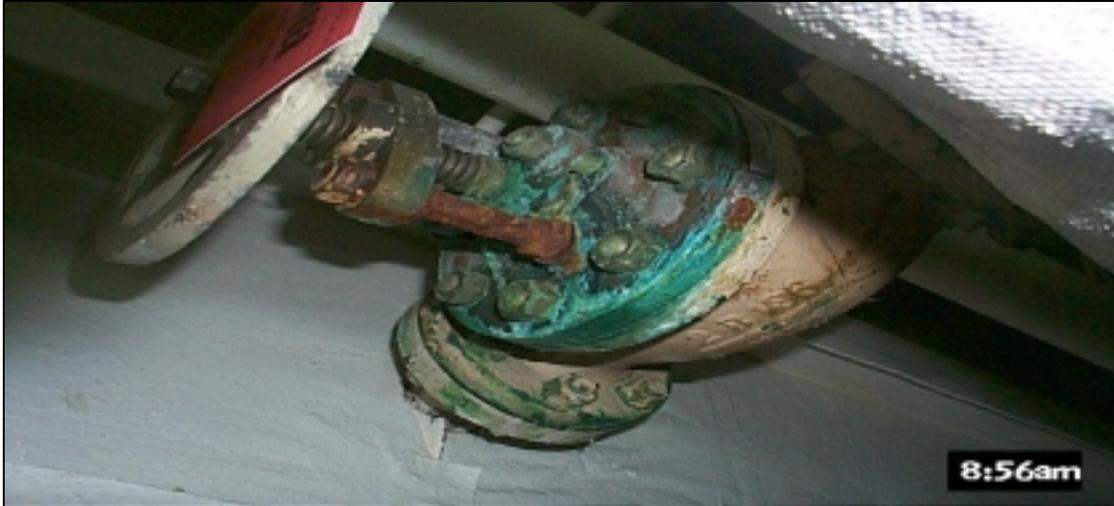
(Top) Starboard side, AFT of BHD (250), between stringers (13-14) bonnet/packing gland is leaking and is root cause of saturated lagging. Area recommended for preservation.

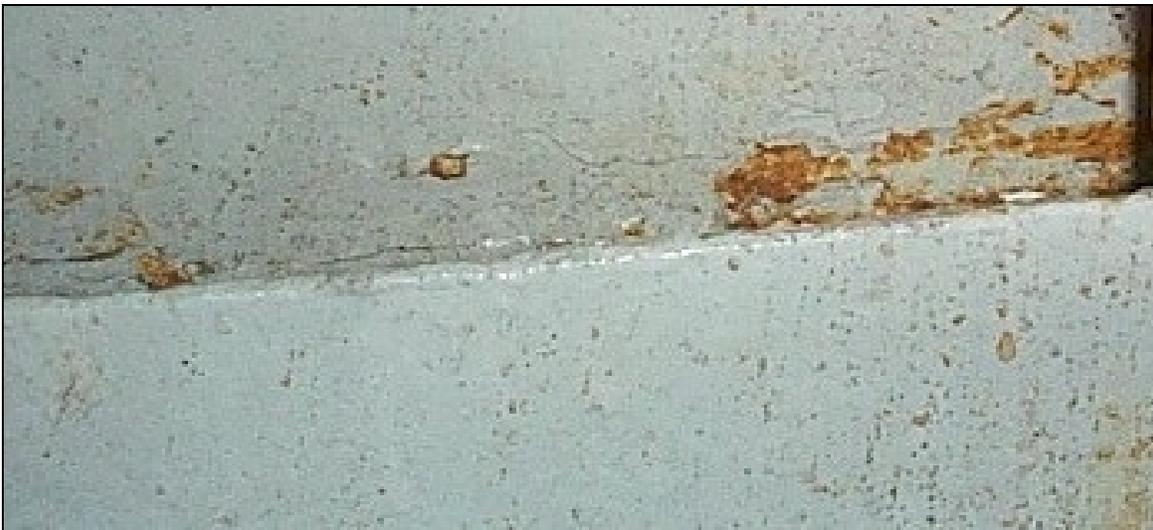
(Bottom) Starboard side saturated lagging below leaking valve. Area recommended for preservation.

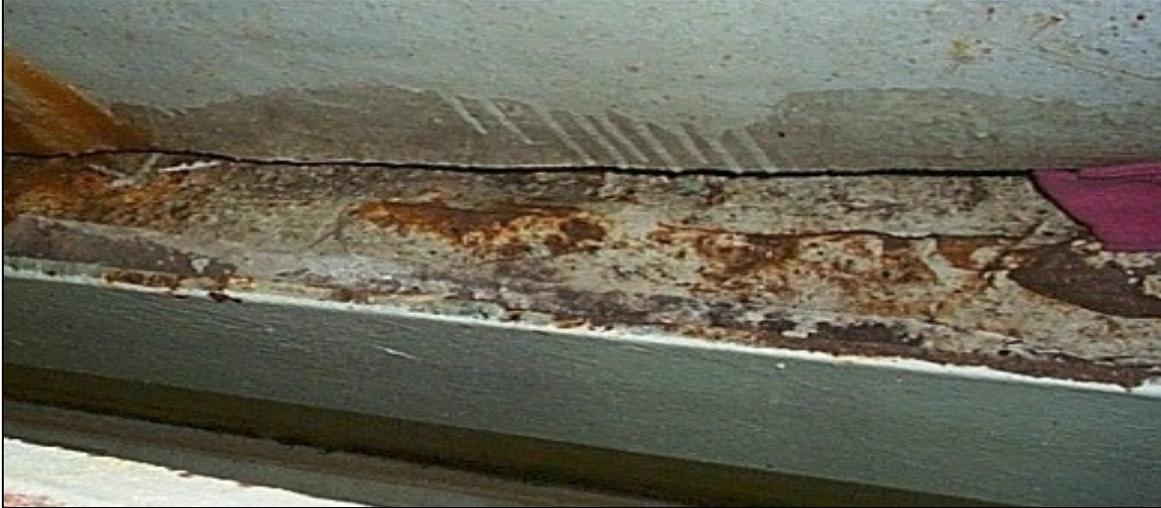
(Top) Port side, from BHD 212 to WF 228, stringer 11.
Area recommended for preservation.

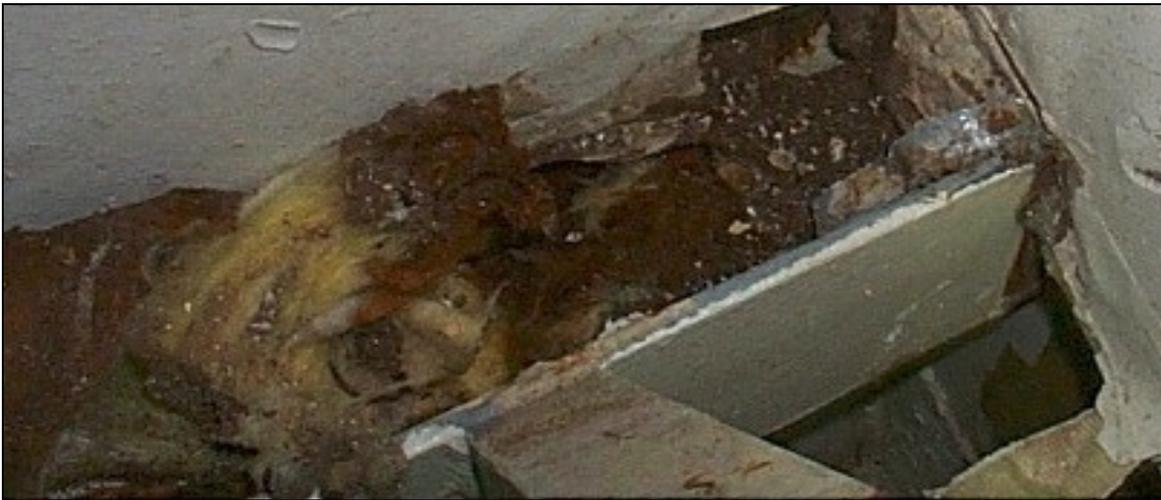
(Bottom) Port side, stringer 11 at BHD 212. Lagging
deteriorated/saturated.
Area recommended for preservation.

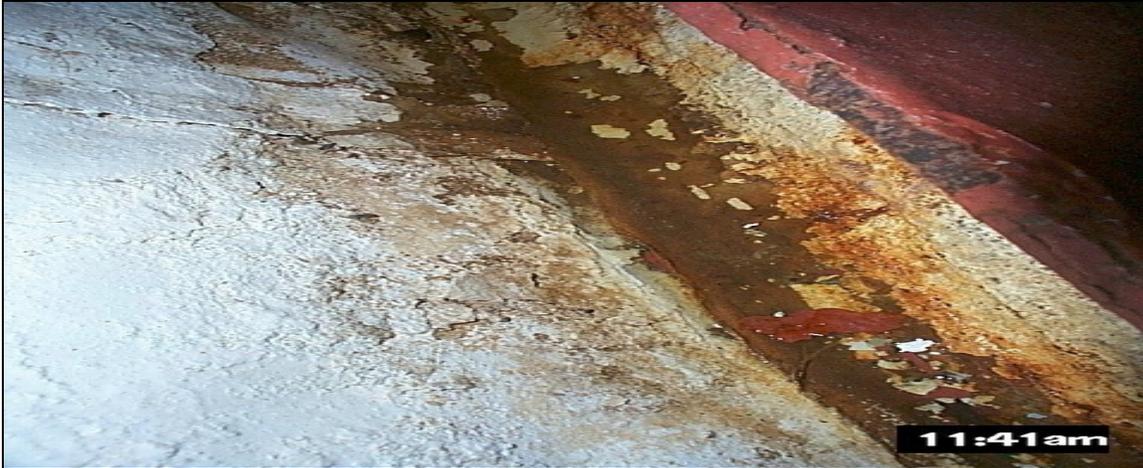
(Top) Starboard side, between BHD 212 and WF 228, stringer 9.
Area recommended for preservation.

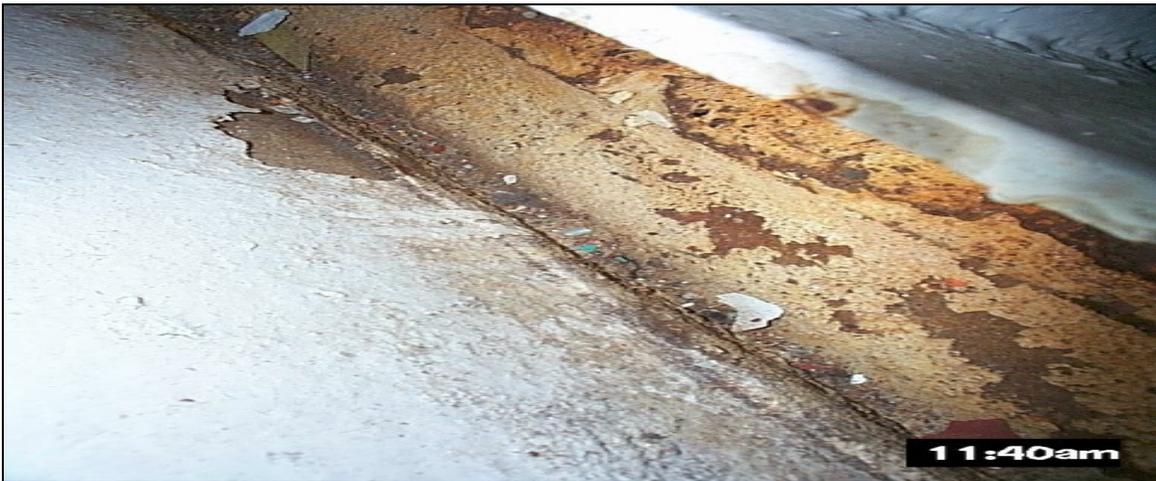
(Bottom) Starboard side, stringer 11. Lagging saturated, with surface
rust and paint separation.
Area recommended for preservation.

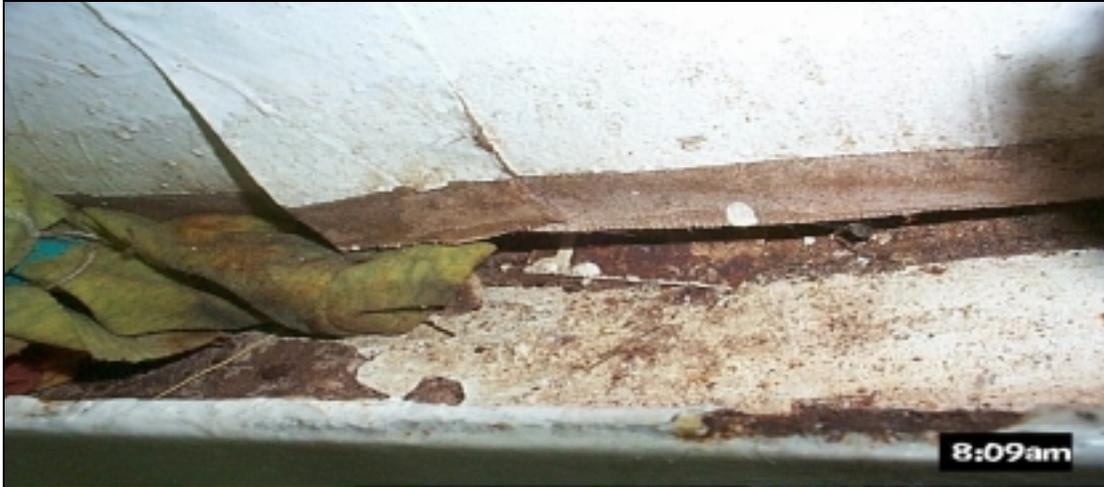
(Top) Port side, between BHD 212 and WF 228, stringer 9.
Area recommended for preservation.

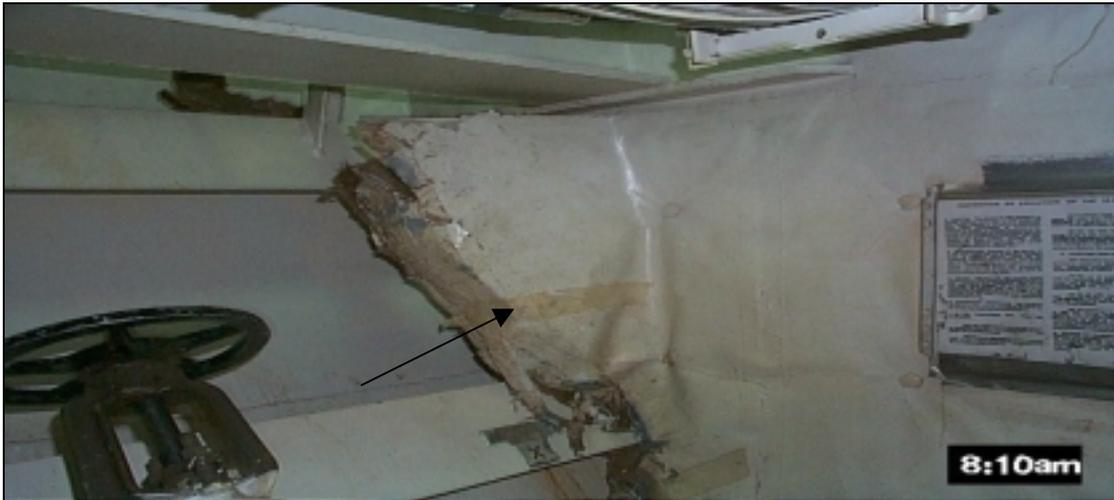
(Bottom) Port side, BHD 212 Lagging saturated.
Area recommended for lagging replacement.

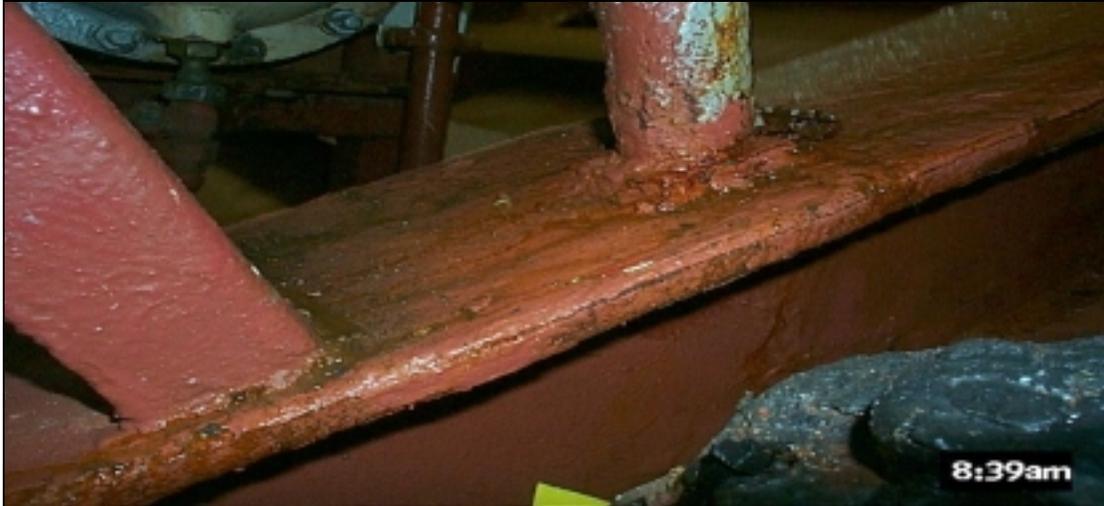
(Top) Port side, WF 220 has light corrosion and paint separation.
Area recommended for preservation.

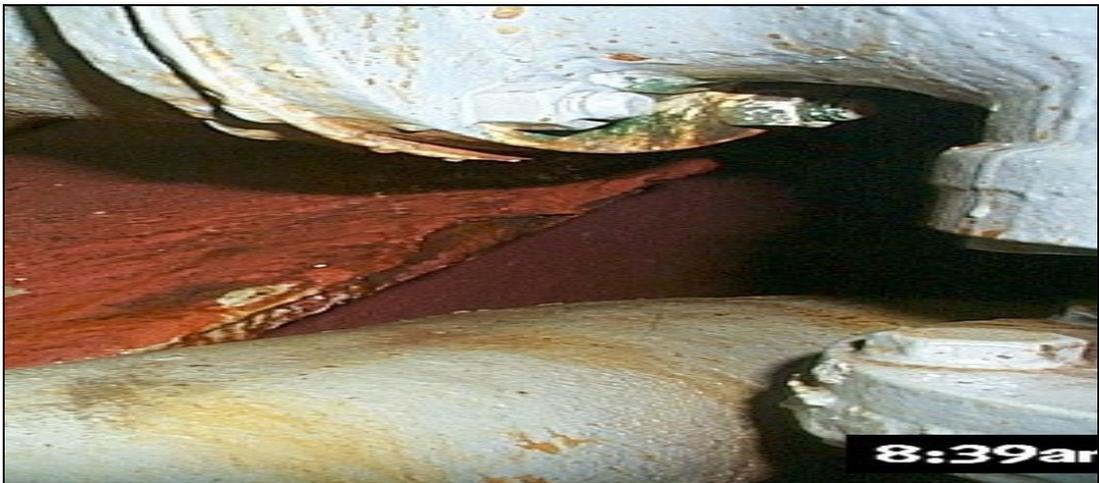
(Bottom) Port side, WF 220
Area recommended for preservation.

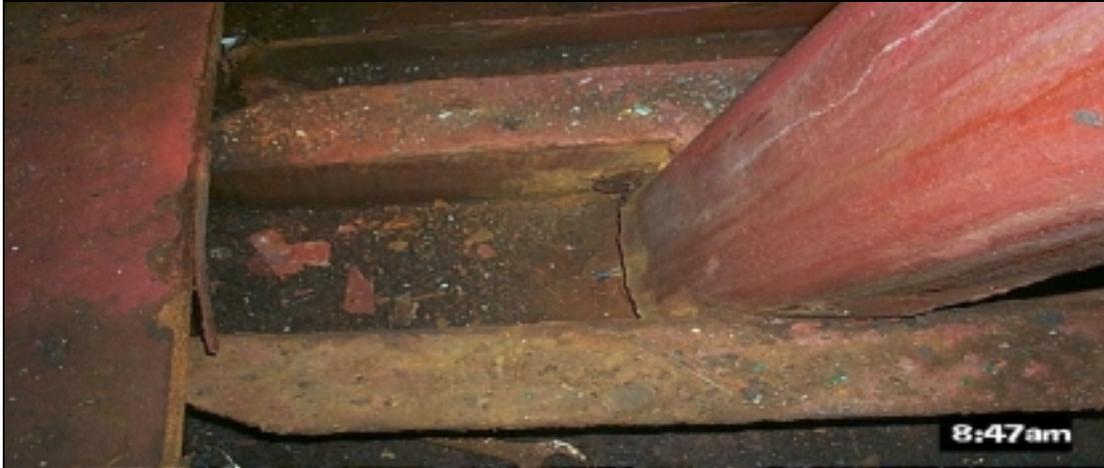
(Top) Port side, Aft of WF 228, under salt water strainer
at stringer no3.
Area recommended for preservation.

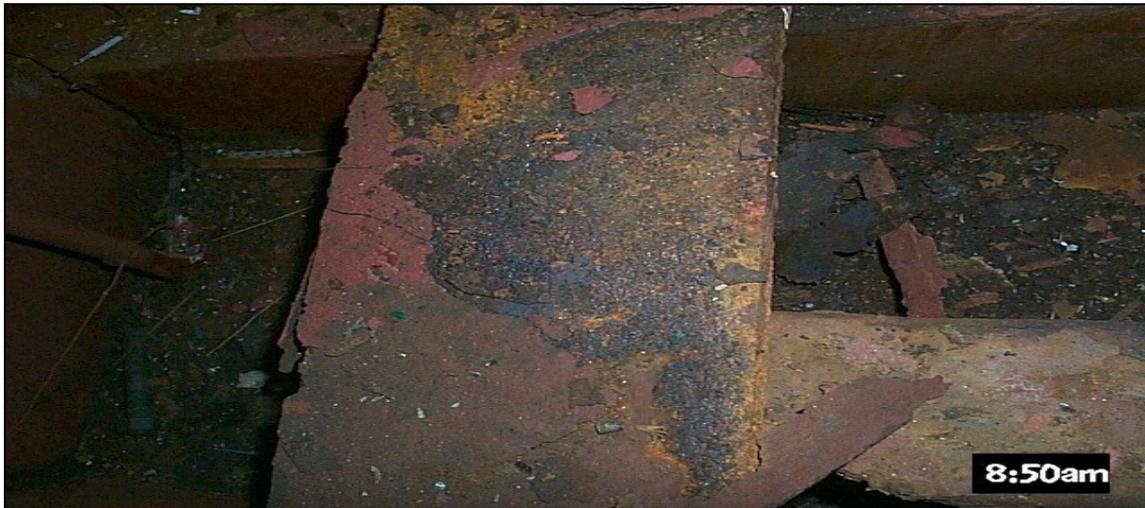
(Bottom) Port side, stringer no3 and surrounding area.
Area recommended for preservation.

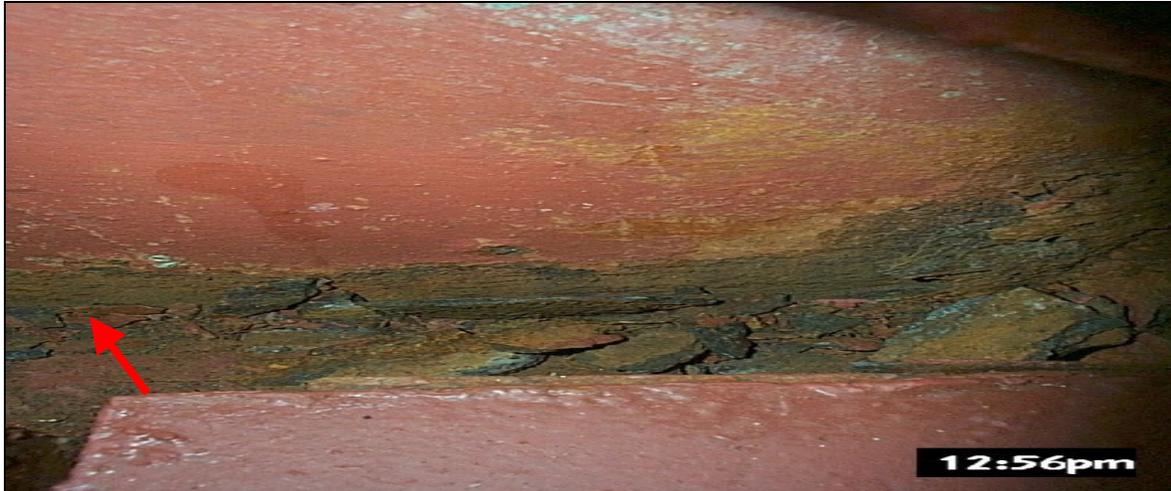
(Top) Port side, Gusset from stringer 7 to BHD 180
Area recommended for repair and preservation.

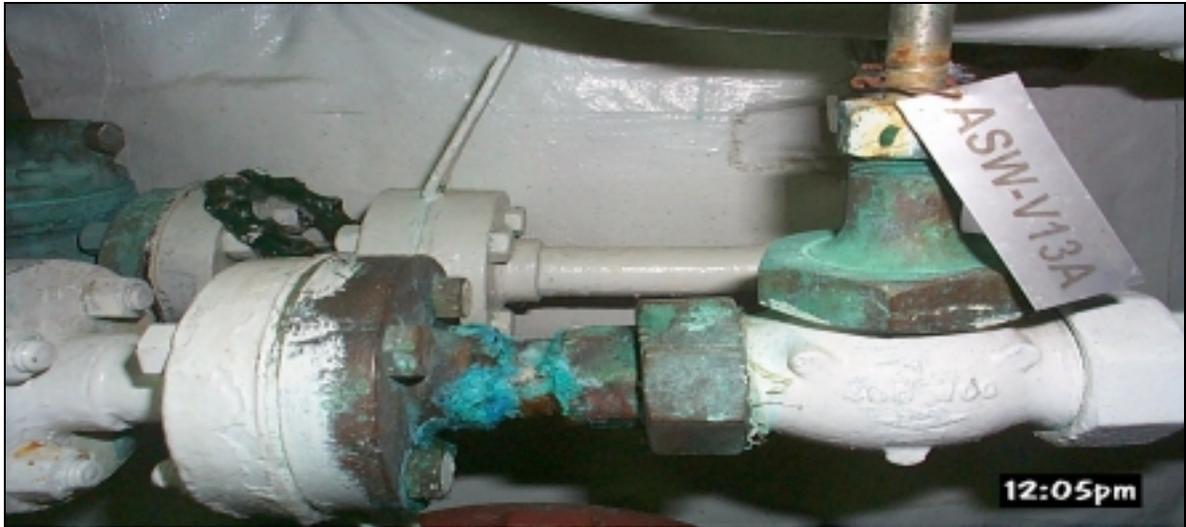
(Top) Port side, At BHD 204,OVBD discharge (5-203-2) LKDO, leaking at the valve and flange socket joint is the root cause of corrosion. Area recommended for repair and preservation.

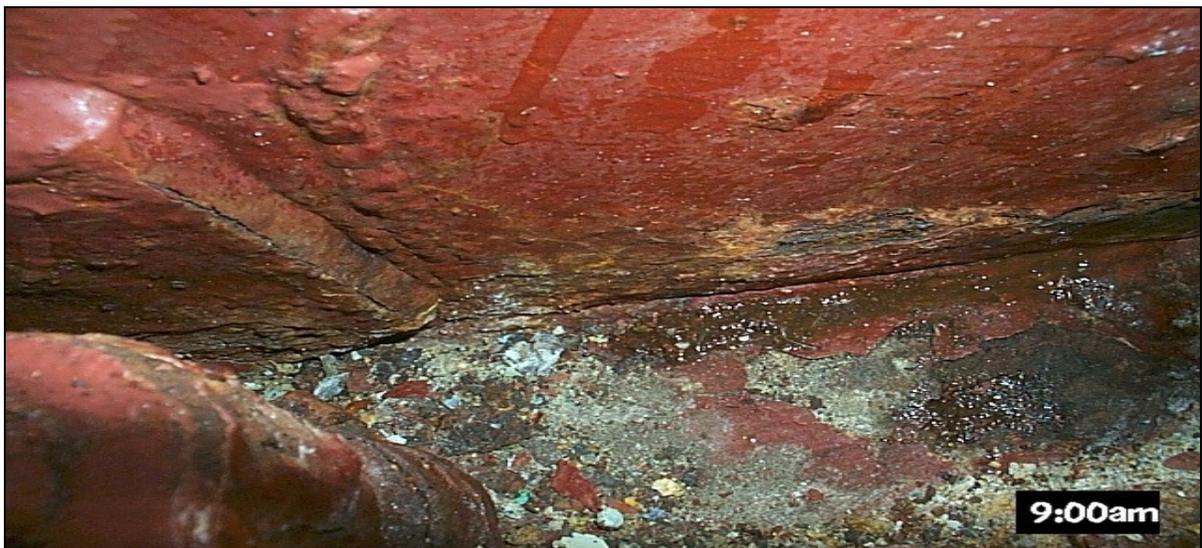
(Bottom) Port side, at BHD 204, stringer 4-8, with salt corrosion. Area recommended for preservation.
