USS ELROD (FFG-55)

SHELL CONDITION ASSESSMENT SURVEY INTERIOR AREAS

5/9/01 – 5/18/01

**PREPARED BY
SUPSHIP PORTSMOUTH
05/25/01**

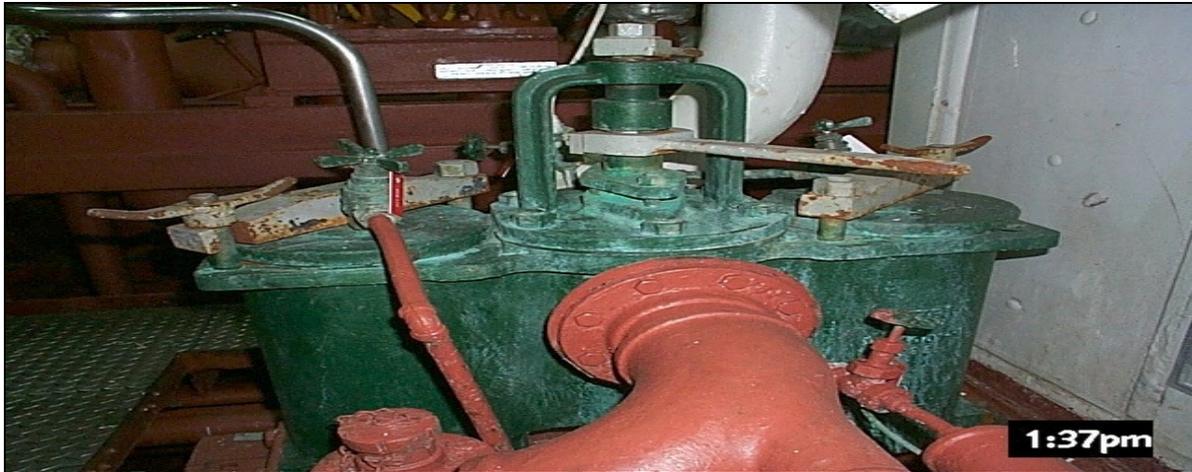
(Top) Port side, off centerline salt-water strainer and pump no1.
Are root cause for foundation corrosion.

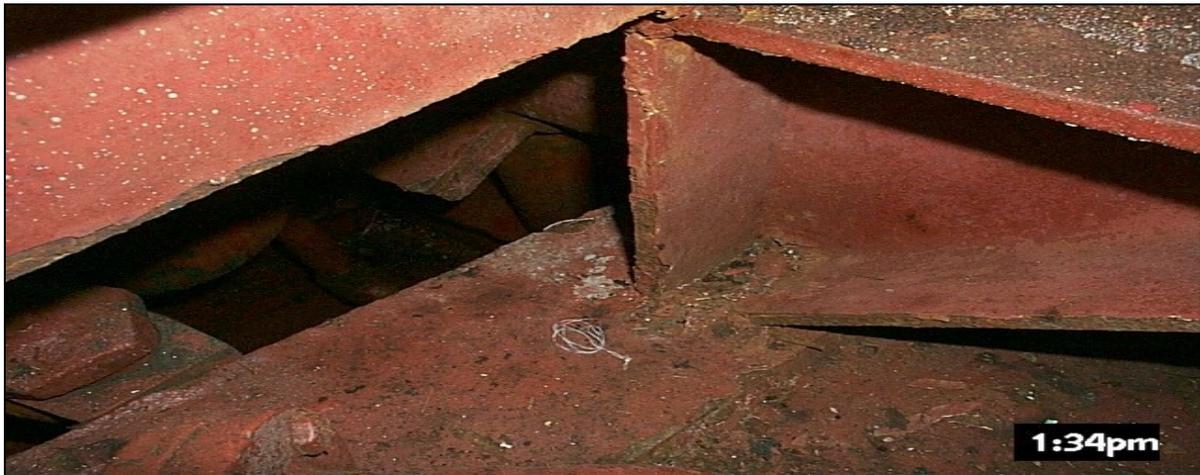
(Bottom) Port side, under salt-water strainer no1.
Area recommended for preservation.

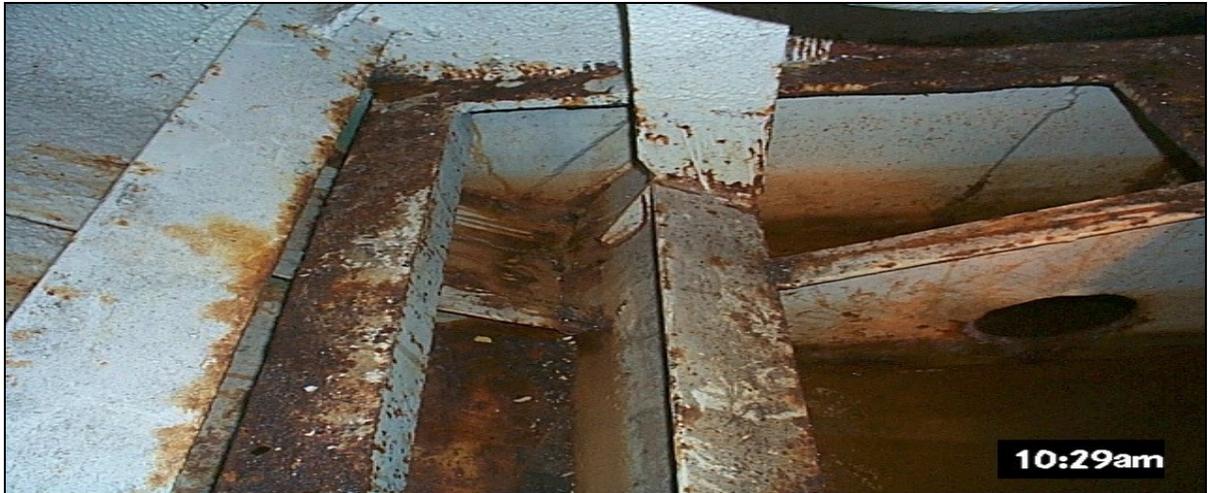
(Top) Port side, bilge pocket has surface rust and paint separation.
Entire bilge area recommended for preservation.

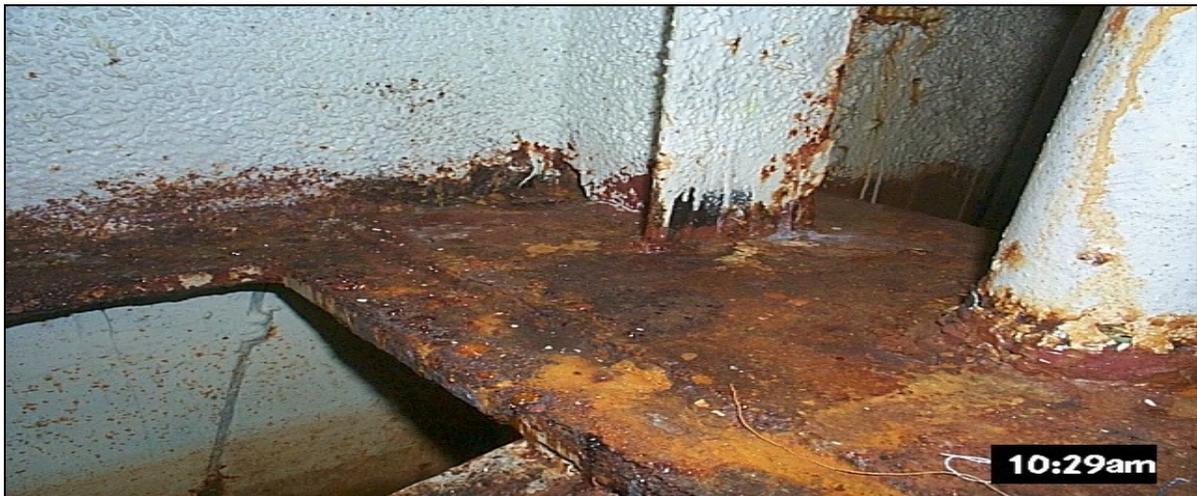
(Bottom) Keel has surface rust and paint separation.
Area recommended for preservation.

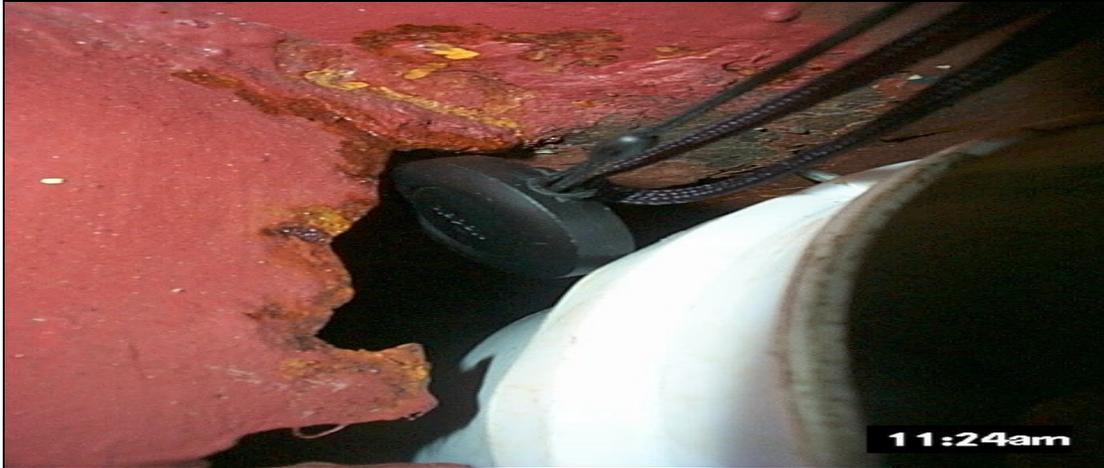
(Top) Starboard side, flange on stringer 1 is heavily deteriorated.
Area recommended for repair and preservation.

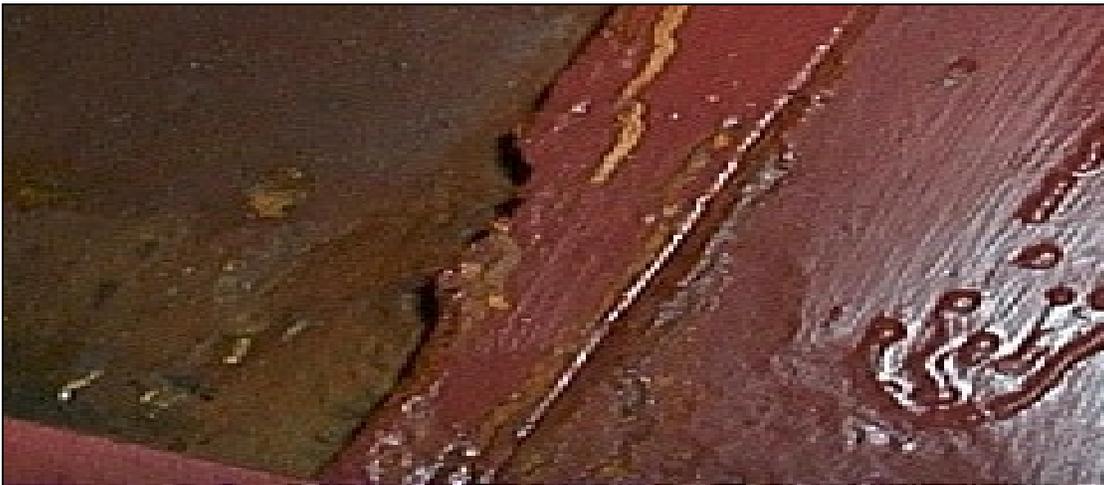
(Bottom) Starboard side, vertical stiffener between stringers 1-2, is
heavily deteriorated.
Area recommended for repair and preservation.

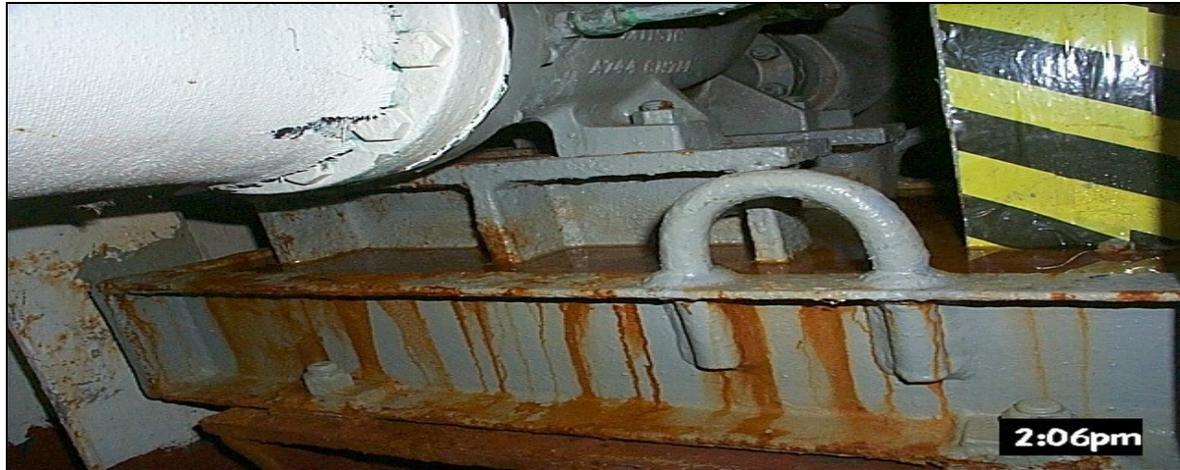
(Top) Fire pump foundation, is full of water and has surface rust and paint separation.
Area recommended for preservation.

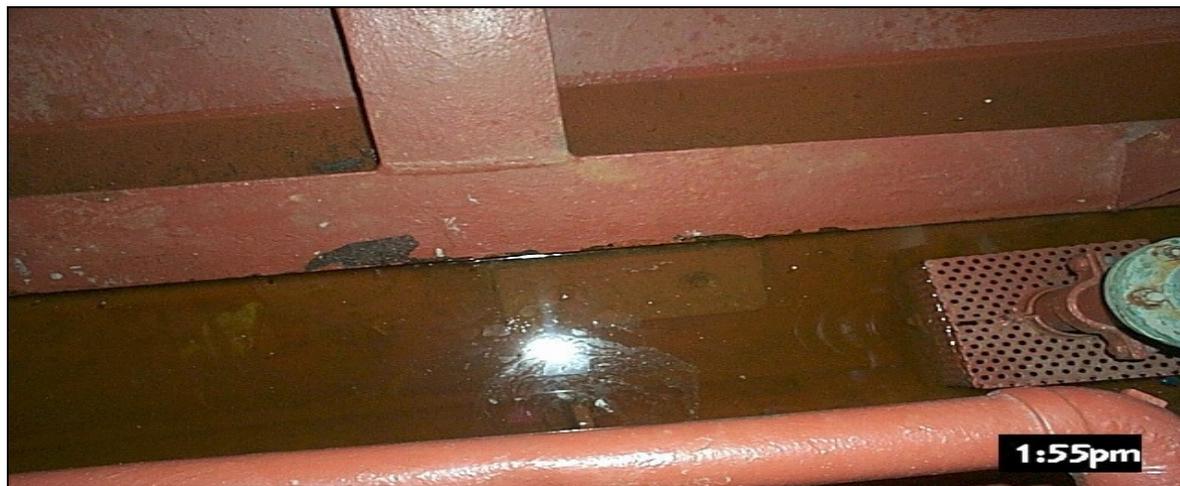
(Bottom) Starboard bilge pocket is full of water
Entire bilge area recommended for preservation.

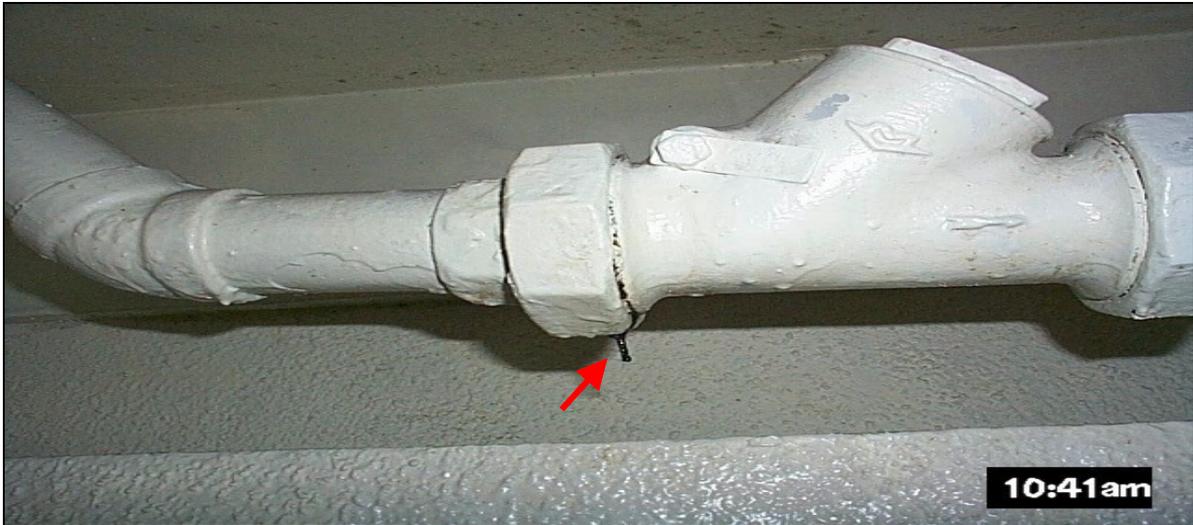
(Top) Port side, Union at check valve on soil drain line is leaking sewage.
Immediate repair is highly recommended.

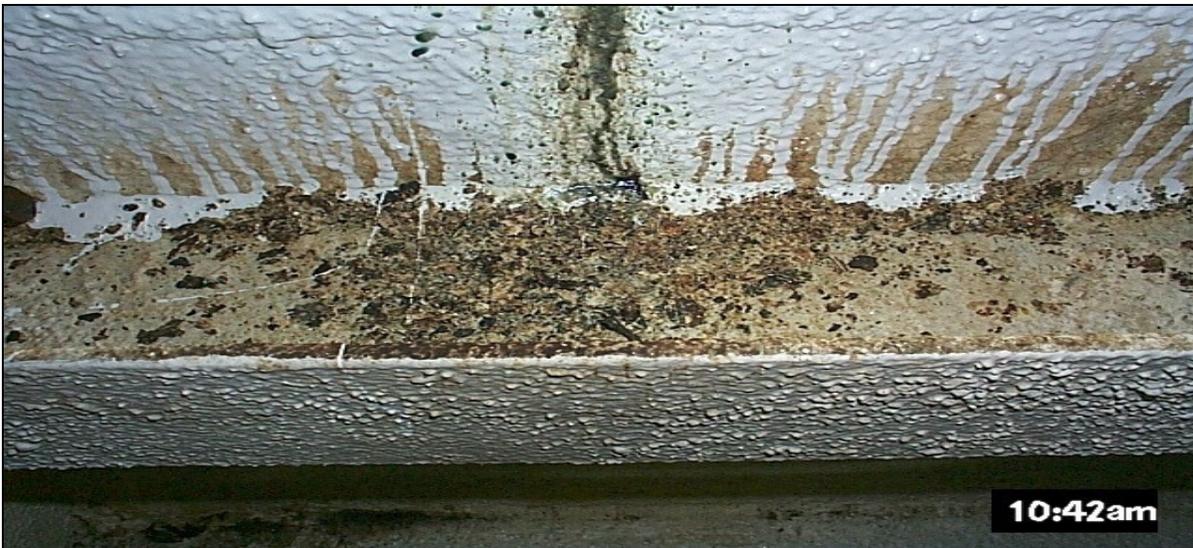
(Bottom) Port side, stringer under check valve and surrounding area has waste contamination.
Entire area recommended for cleaning and preservation.

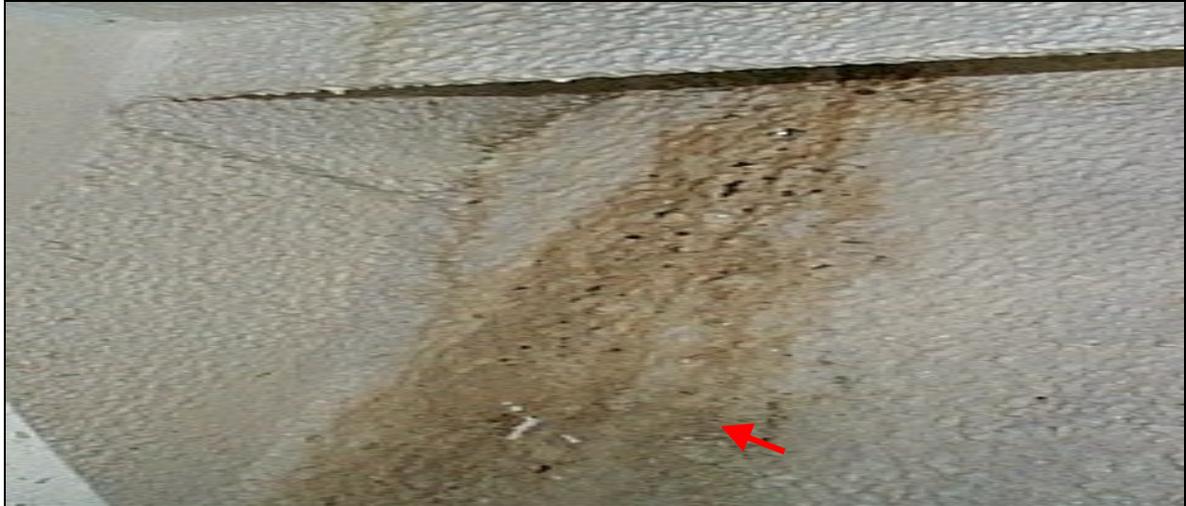
(Top) Port side, arrow denotes waste contamination on shell plate. Immediate attention recommended.

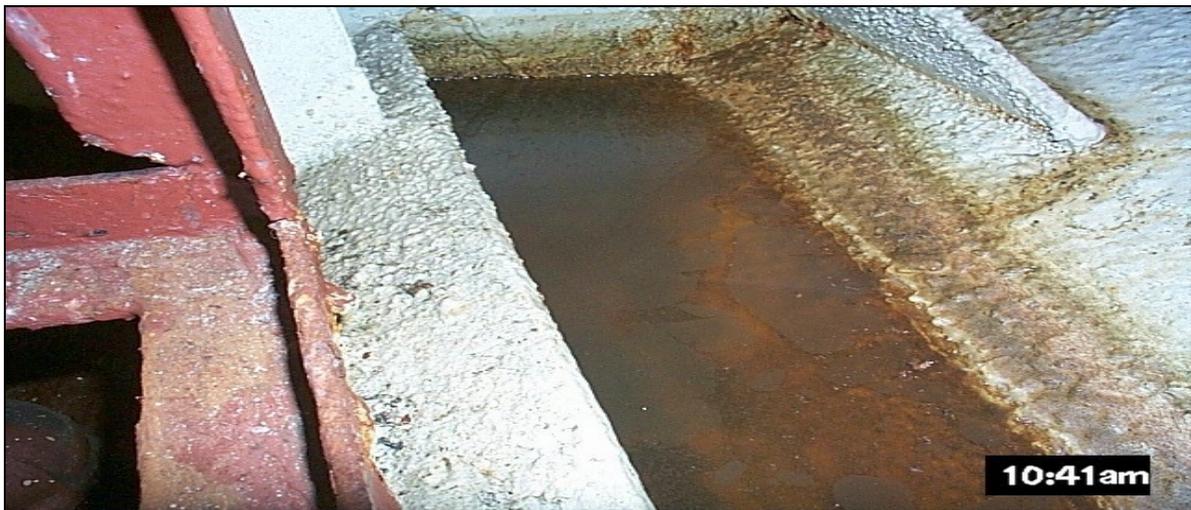
(Bottom) Port side, bilge pocket is containing waste. Entire area recommended for cleaning and preservation.

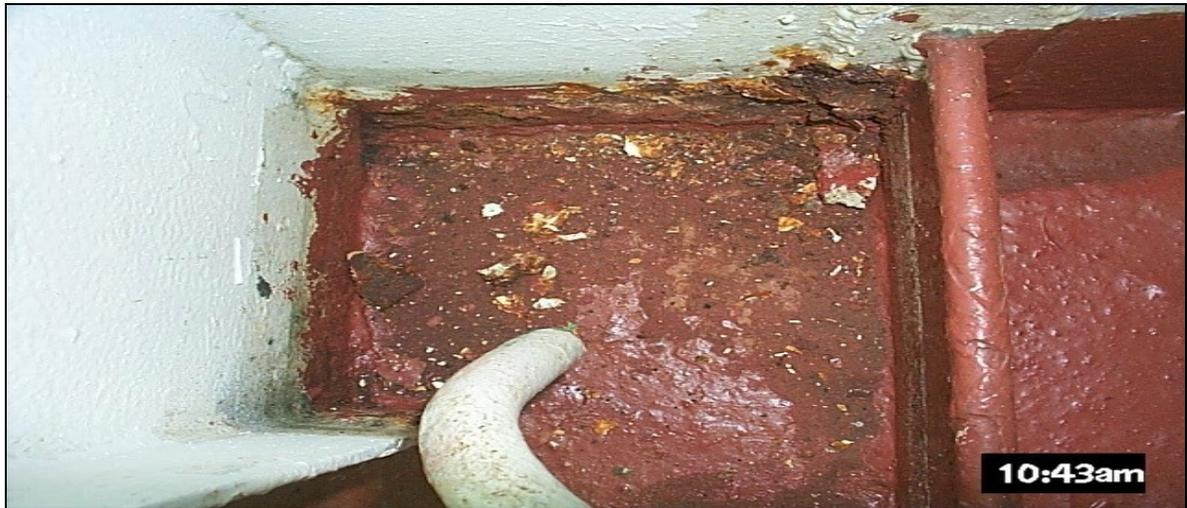
(Top) Port side, drain from sewage pump no2, causing mild corrosion.
Area recommended for preservation.

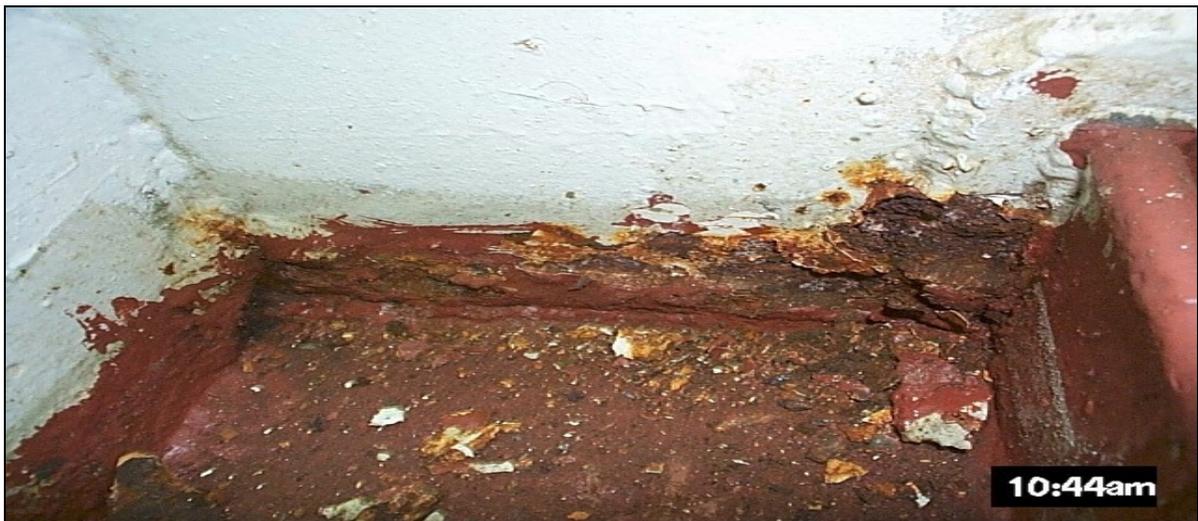
(Bottom) Port side, inside coaming at BHD 180.
Entire area recommended for cleaning and preservation.

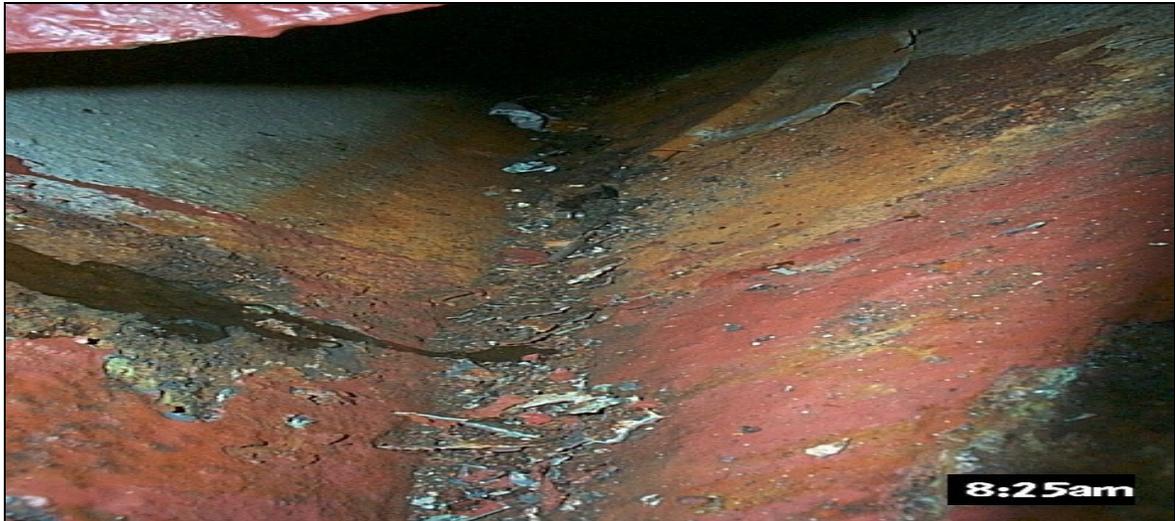
(Top) Starboard side, bilge pocket at BHD 160, rust and heavy paint separation.
Area recommended for preservation.

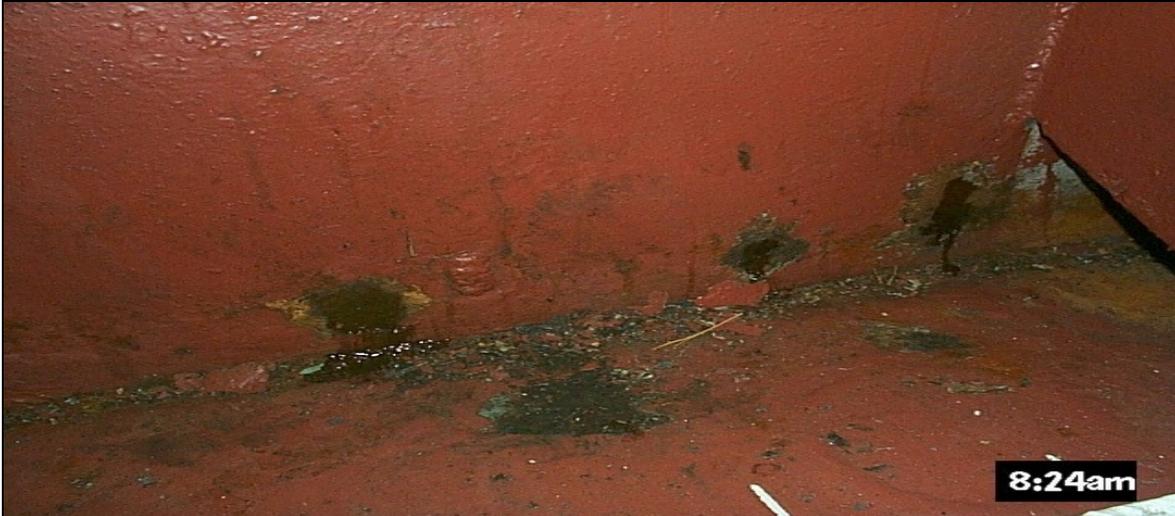
(Bottom) Starboard side, bilge pocket at BHD 160 U/T readings satisfactory
Entire area recommended for cleaning and preservation.

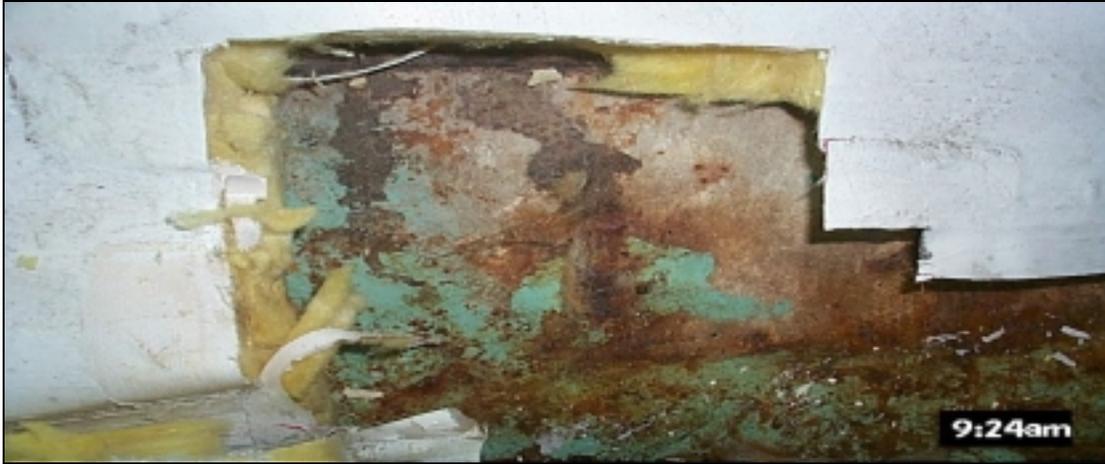
(Top) Port side, between WF 148-164 stringer 7 has saturated lagging, surface rust and heavy paint separation. Area recommended for repairs and preservation.

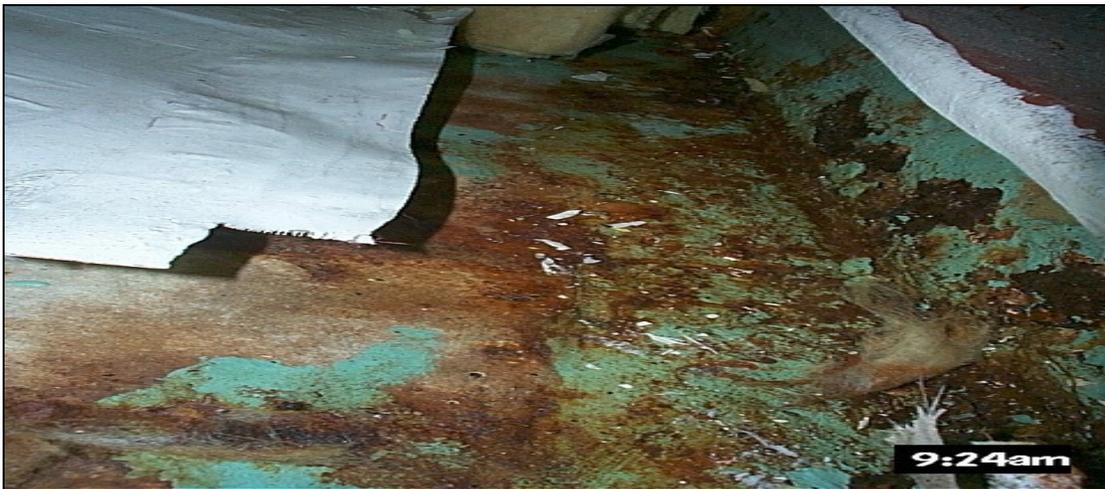
(Bottom) Port side, stringer 7
Entire area recommended for cleaning and preservation.

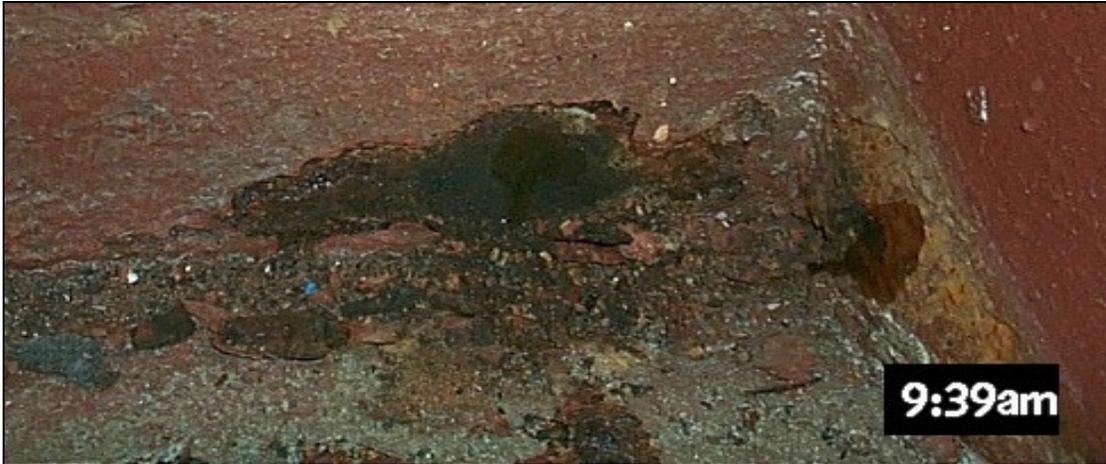
(Top) Port side, bilge pocket surface rust and heavy paint separation.
Area recommended for repairs and preservation.

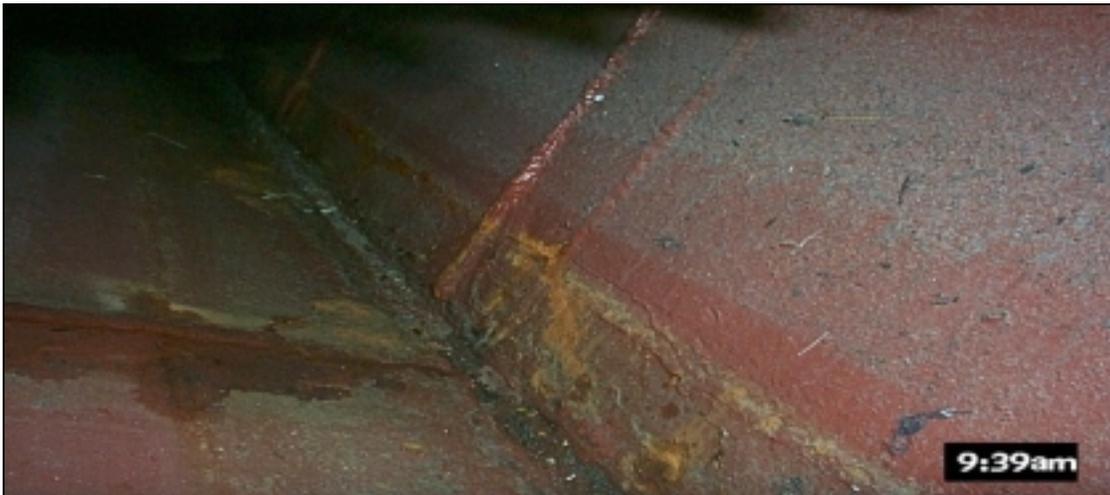
(Bottom) Port side, bilge pocket.
Entire area recommended for cleaning and preservation.

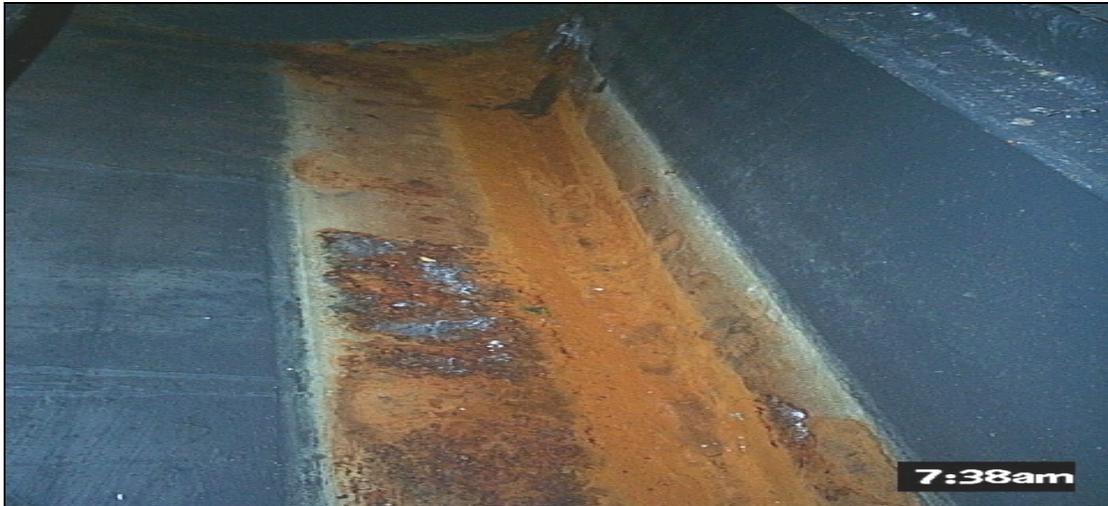
(Top) Starboard side, bilge pocket surface rust and heavy paint separation.
Area recommended for preservation.

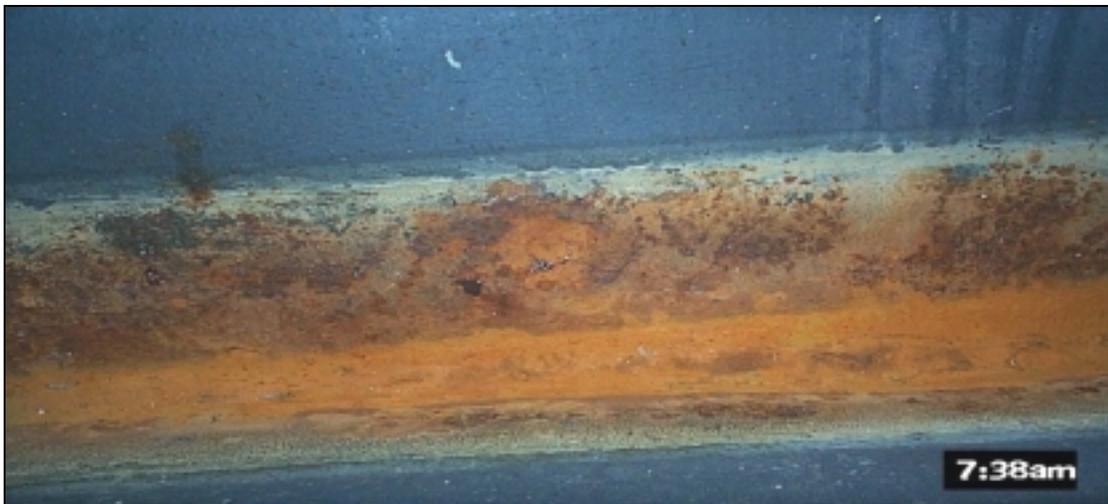
(Bottom) Starboard side, bilge pocket.
Entire area recommended for cleaning and preservation.

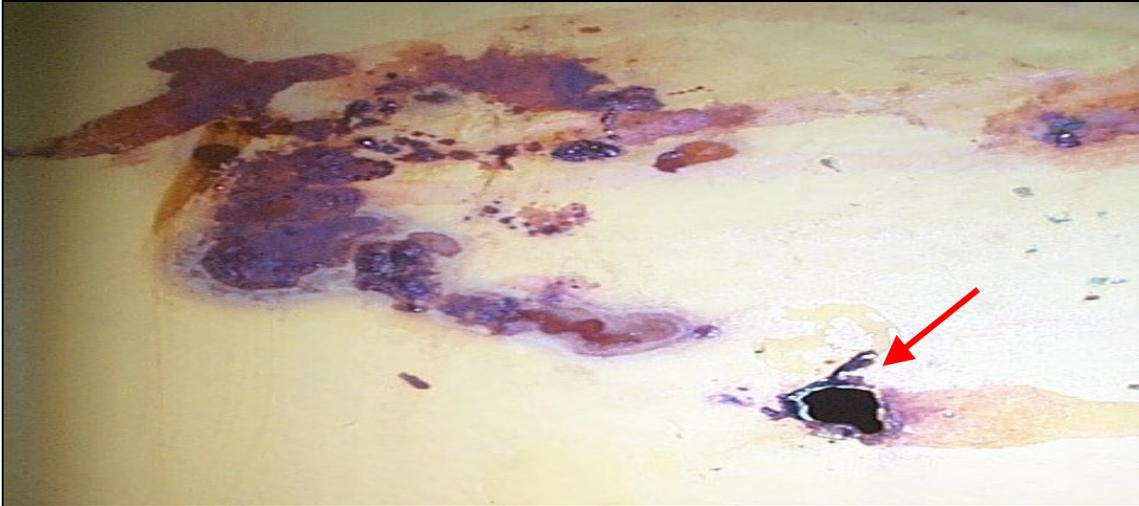
(Top) Starboard side, first stringer off the deck, arrow denotes hole. U/T readings indicate severe thinning with low reading at .090. Recommended for repairs.

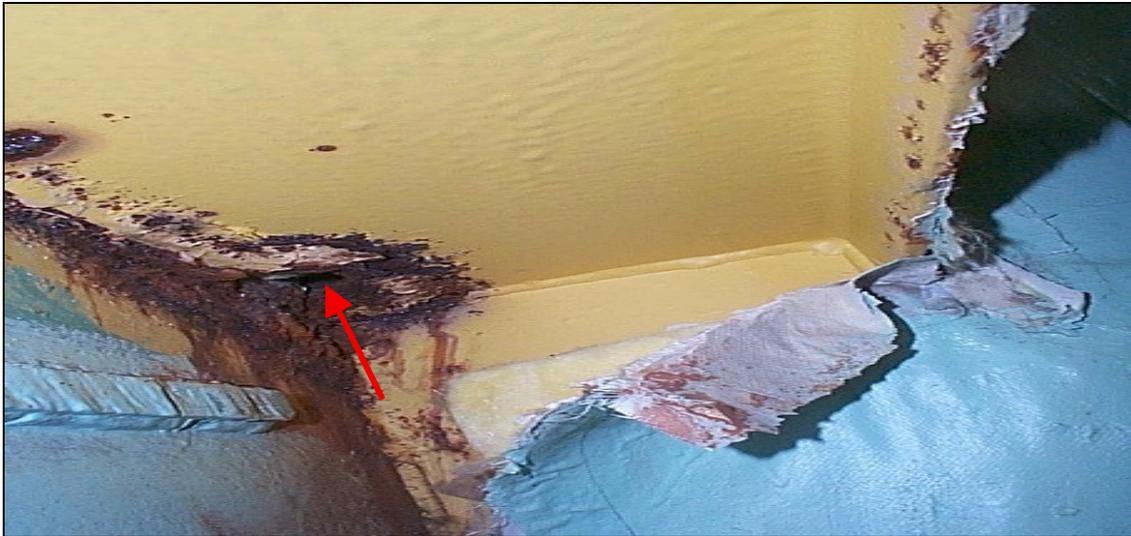
(Bottom) Starboard side, at BHD 56 arrow indicates 2nd hole in stringer.

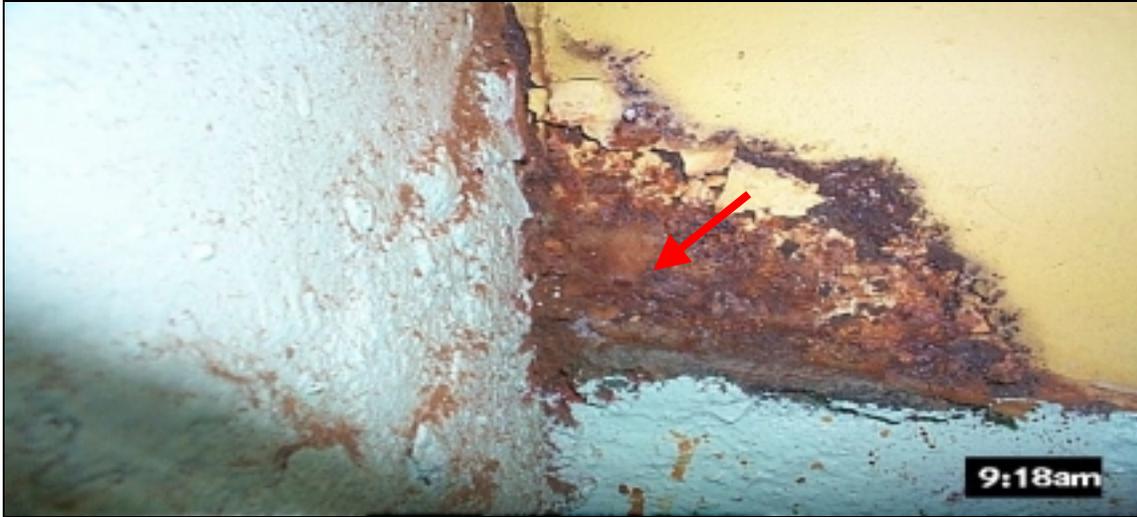
(Top) Starboard side, looking aft at BHD 56 arrow indicates severe thinning with U/T reading at .135.
Recommended for repairs.

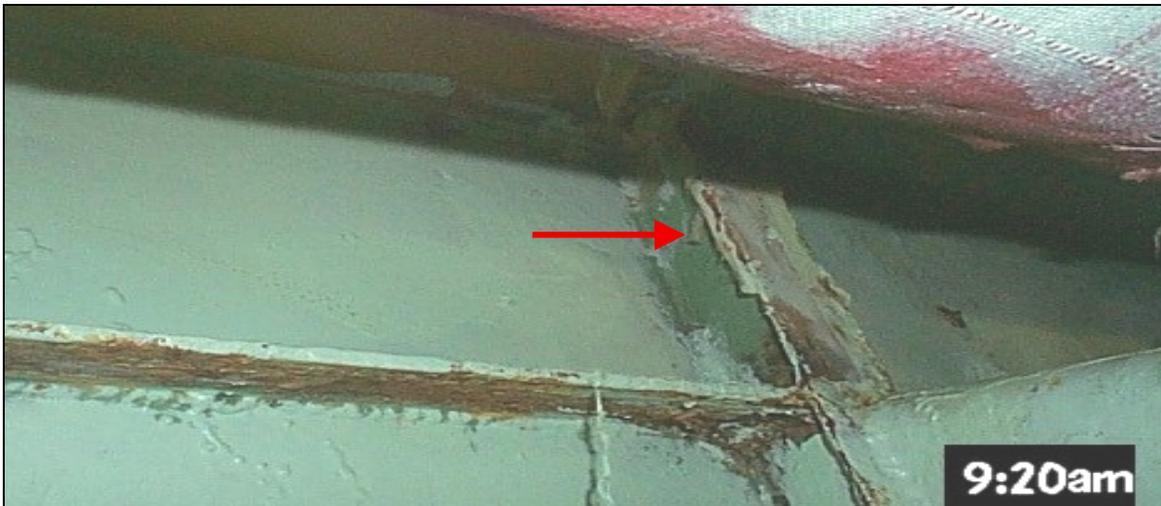
(Bottom) Starboard side, vertical stiffener between 1st and 2nd stringer severely corroded.
Entire area recommended for lagging removal and preservation.

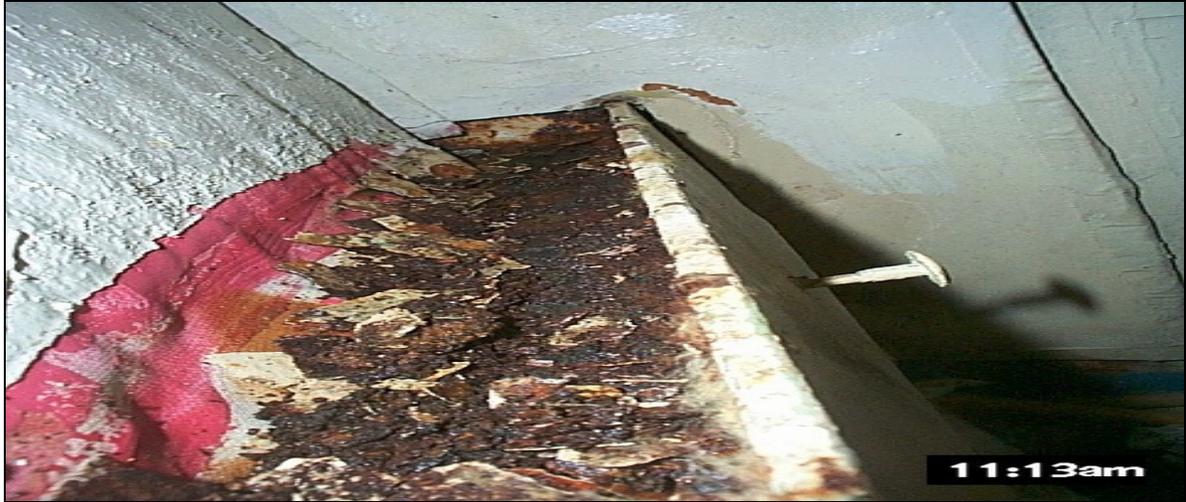
(Top) Starboard side, first stringer off the deck has saturated lagging and surface rust and paint separation. Recommended for repairs.

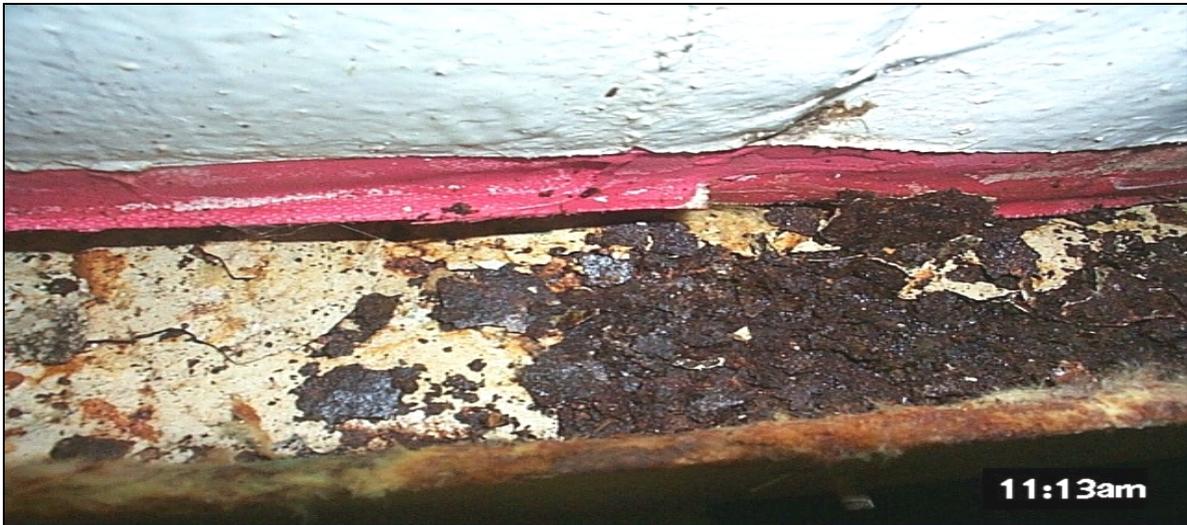
(Bottom) Starboard side, first stringer off the deck. Entire area recommended for lagging removal and preservation.

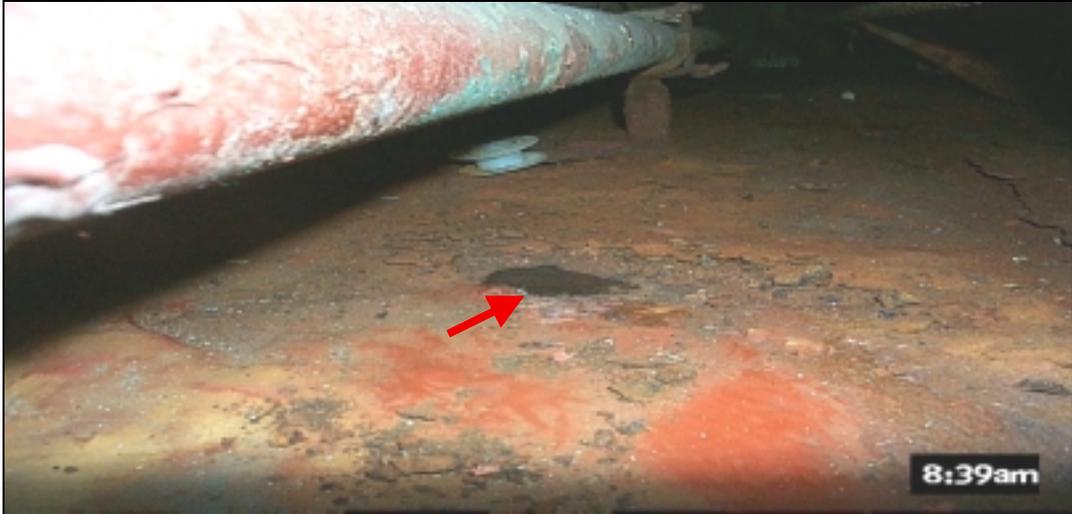
3-140-1-L STORAGE ROOM IN P-WAY	STBD, FIRST AND SECOND STRINGERS FROM DECK.	APPROX 20 SF OF SATURATED LAGGING, SURFACE RUST AND PAINT SEPARATION.
3-84-0-E A/C MACHINERY ROOM	PORT, TANK TOP/DECK AT BHD (100) BEHIND/UNDERNEATH AIRCONDITIONING CONDENSER.	TANK TOP IS BUCKLING, RANDOM U/T READINGS BEHIND AND PORT SIDE WERE BELOW THE MINIMUM DESIRABLE THICKNESS OF .213 AT .127, .209 AND .204 AREA BEHIND THE CONDENSER WAS UNACCESSABLE FOR FURTHER U/T READINGS.

(Top) Port side, behind A/C condenser at BHD 100 arrow indicates U/T reading at **.127**.
Recommend removal of approximately 50 SF of tank top.

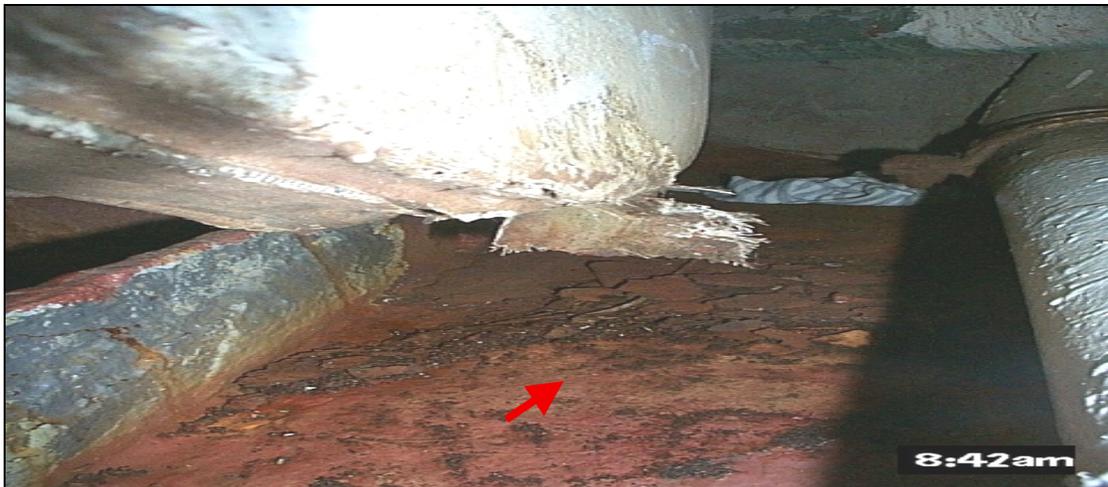
(Bottom) Port side, between condenser and shell arrow indicates low U/T reading at **.204**.
