# **USS ELROD (FFG-55)**

## **SPECIAL U/T SURVEY**

### **MAIN ENGINE ROOM (5-250-0-E)**

**AUGUST 28, 2002**

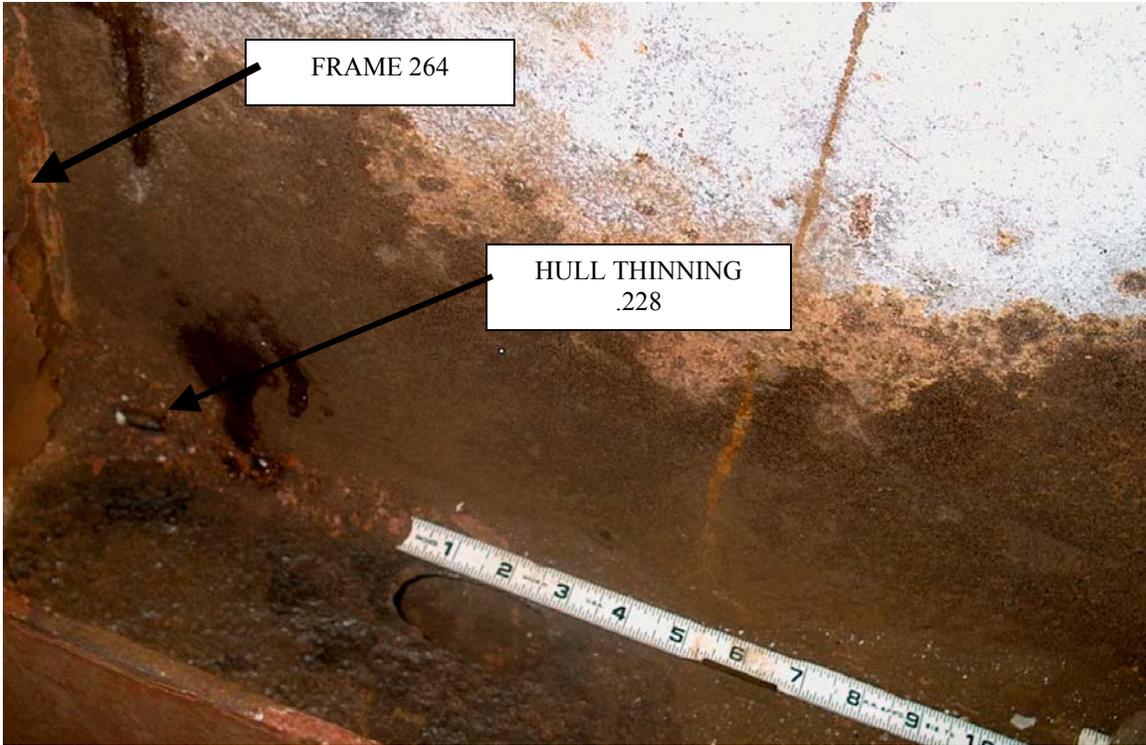
STRINGER 10 AT FRAME 264

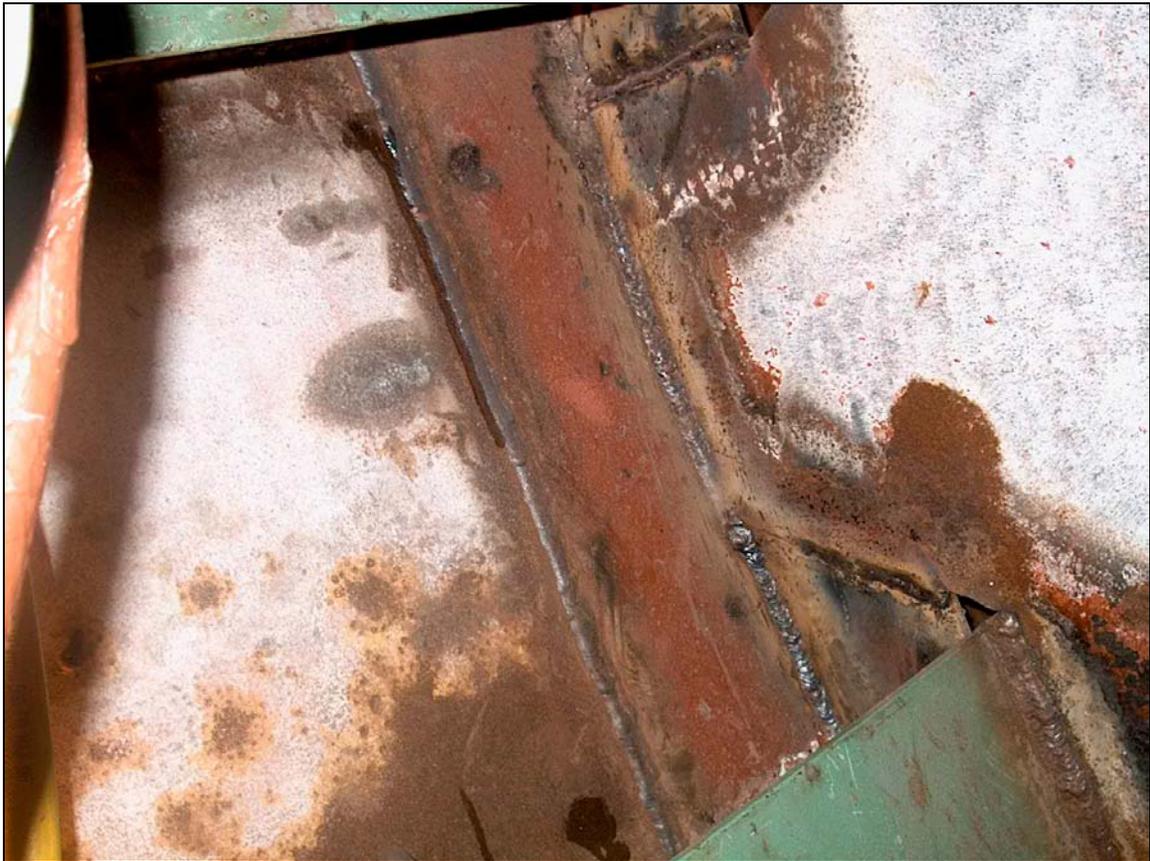
NEW PLATE AND STRINGERS AT FRAME 270

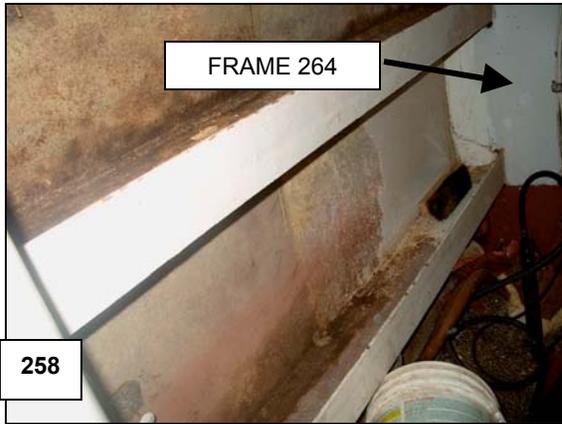
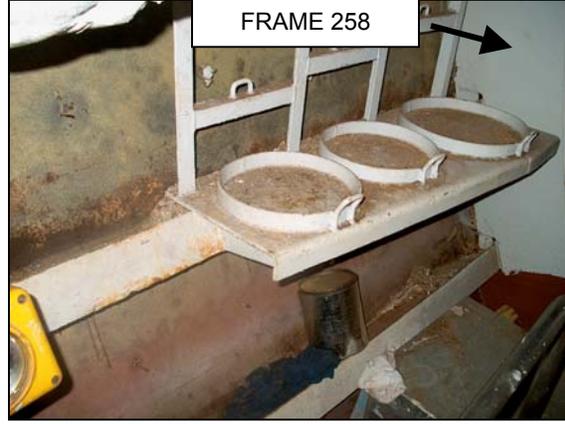
HULL INSULATION HAS BEEN REMOVED AND PRESERVATION IS IN PROGRESS BETWEEN FRAMES (264 AND BULKHEAD (250), STARBOARD SIDE.

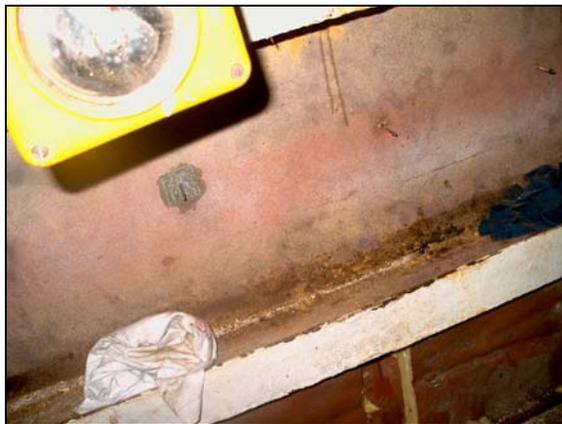
STRINGER (11) APPROXIMATELY 4 FT AFT OF BULKHEAD (250).

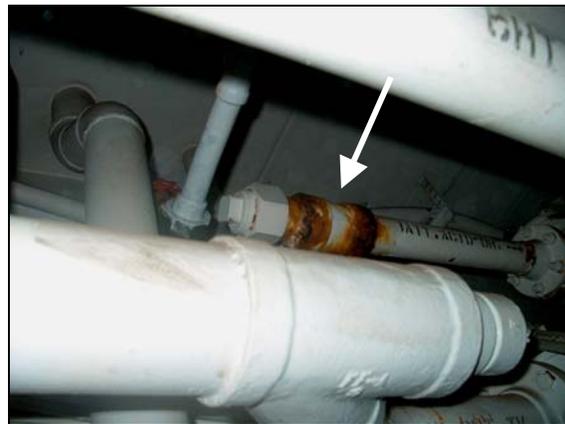
POSSIBLE LEAKING OF CORRODED BATTERY DRAIN BETWEEN FRAMES (258- 264) IS CAUSE FOR CORROSION.

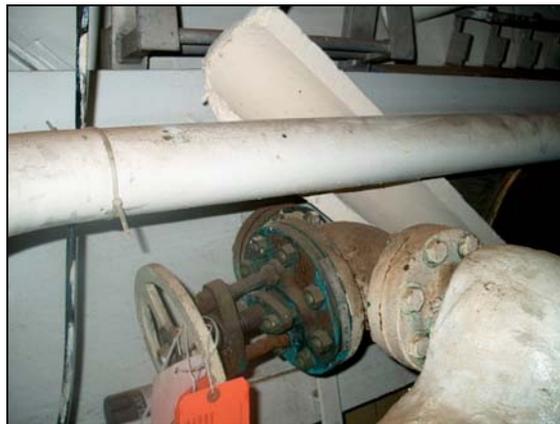
LEAKING VALVE APPROXIMATELY 3 FT AFT OF BHD (250) IS A POSSIBLE CAUSE OF CORROSION.

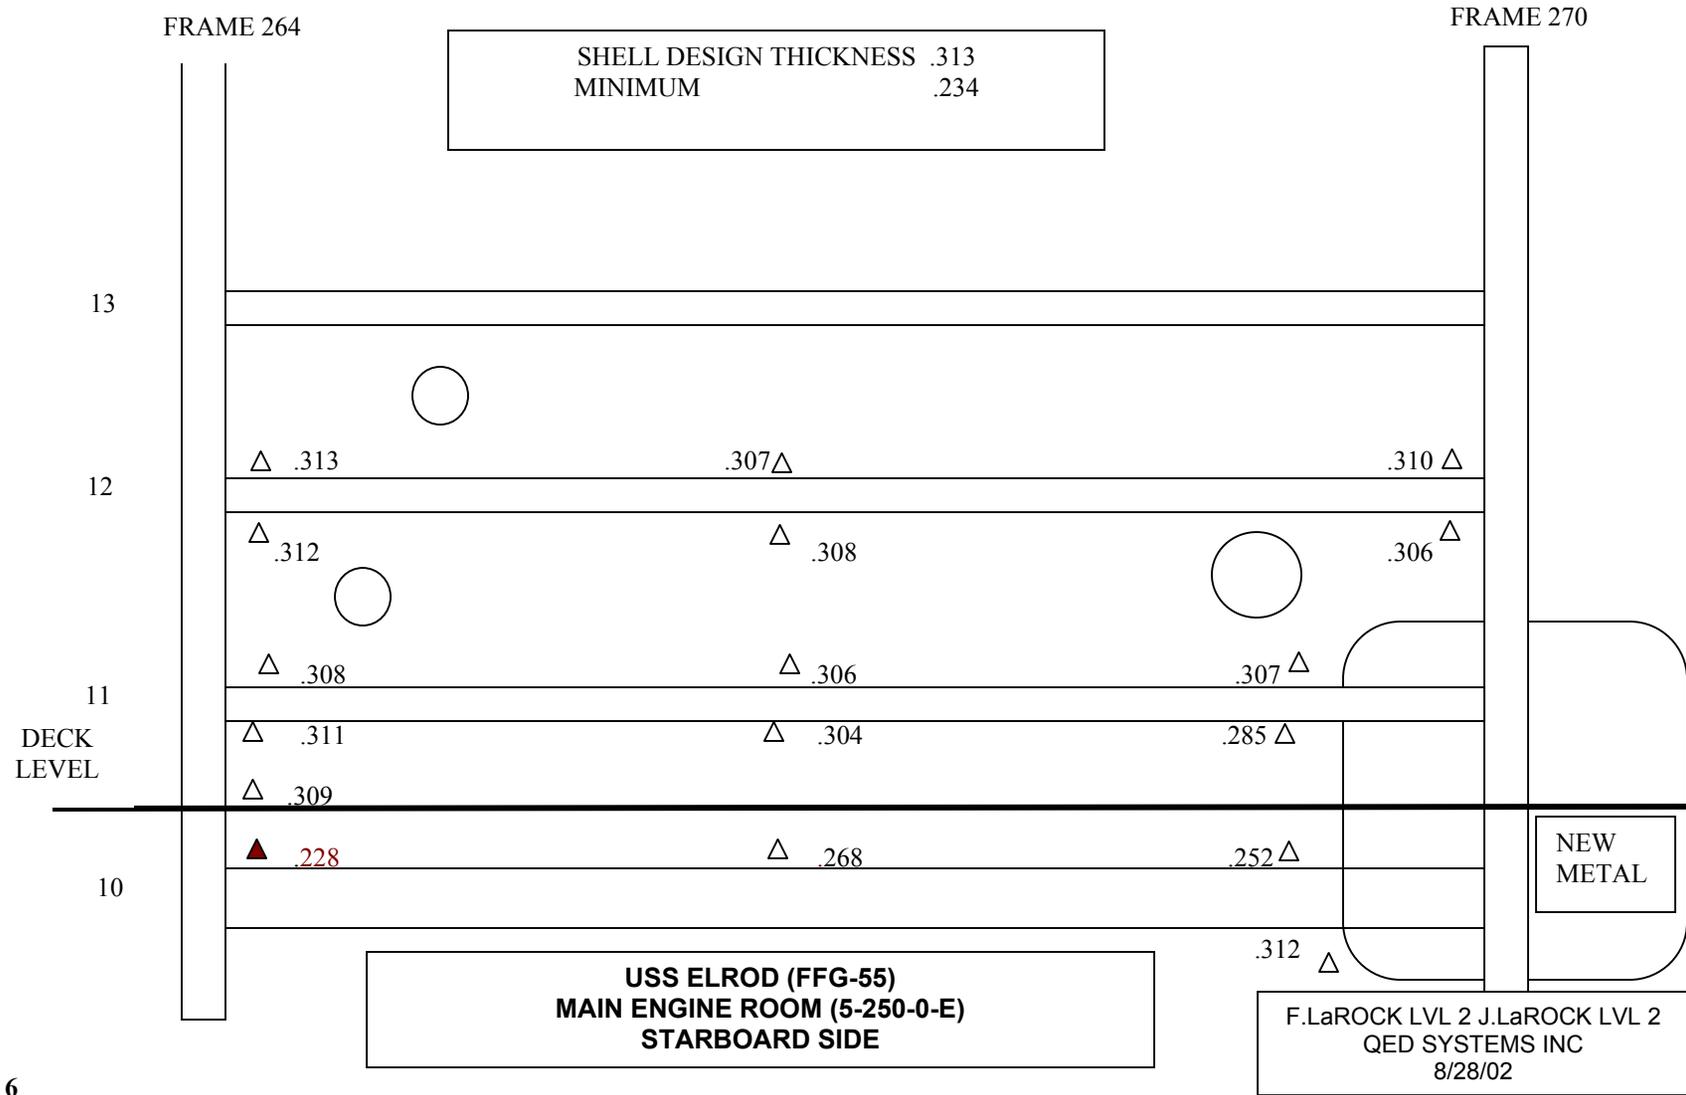
SHELL DESIGN THICKNESS .313  
 MINIMUM .234

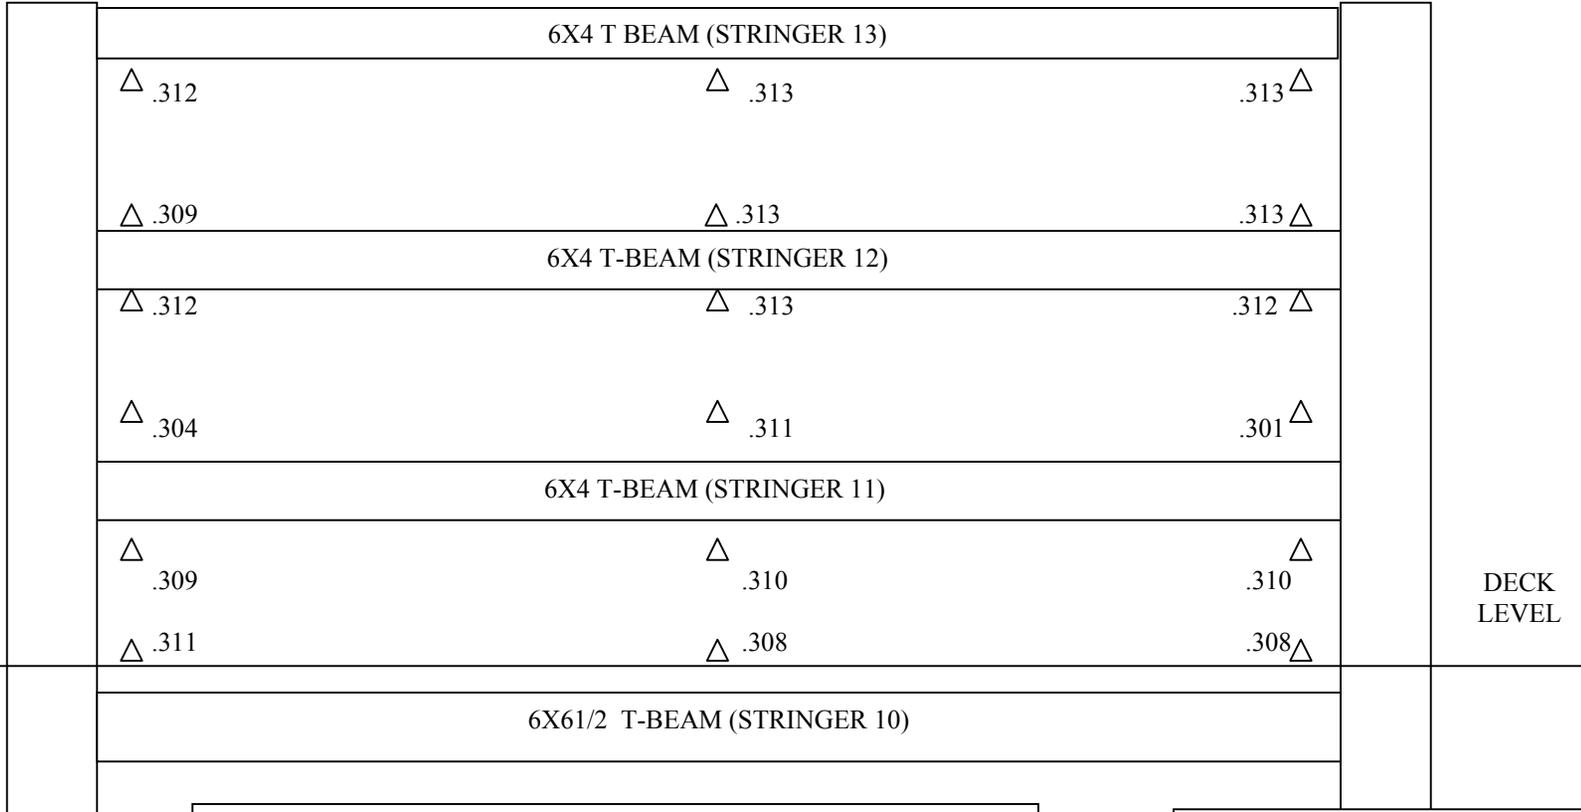
**USS ELROD (FFG-55)  
 MAIN ENGINE ROOM (5-250-0-E)  
 STARBOARD SIDE**

SHELL DESIGN THICKNESS .313  
 MINIMUM .234

6X4 T-BEAM (STRINGER 13)			
△ .319	△ .319	△ .316	.313 △
△ .317	△ .315	△ .313	.318 △
6X4 T-BEAM (STRINGER 12)			
△ .315	△ .319	△ .315	.312 △
△ .310	△ .311	△ .310	.312 △
6X4 T-BEAM (STRINGER 11)			
△ .312	△ .314	△ .312	.311 △
△ .273	△ .312	△ .313	.308 △
6X6 1/2 T-BEAM (STRINGER 10)

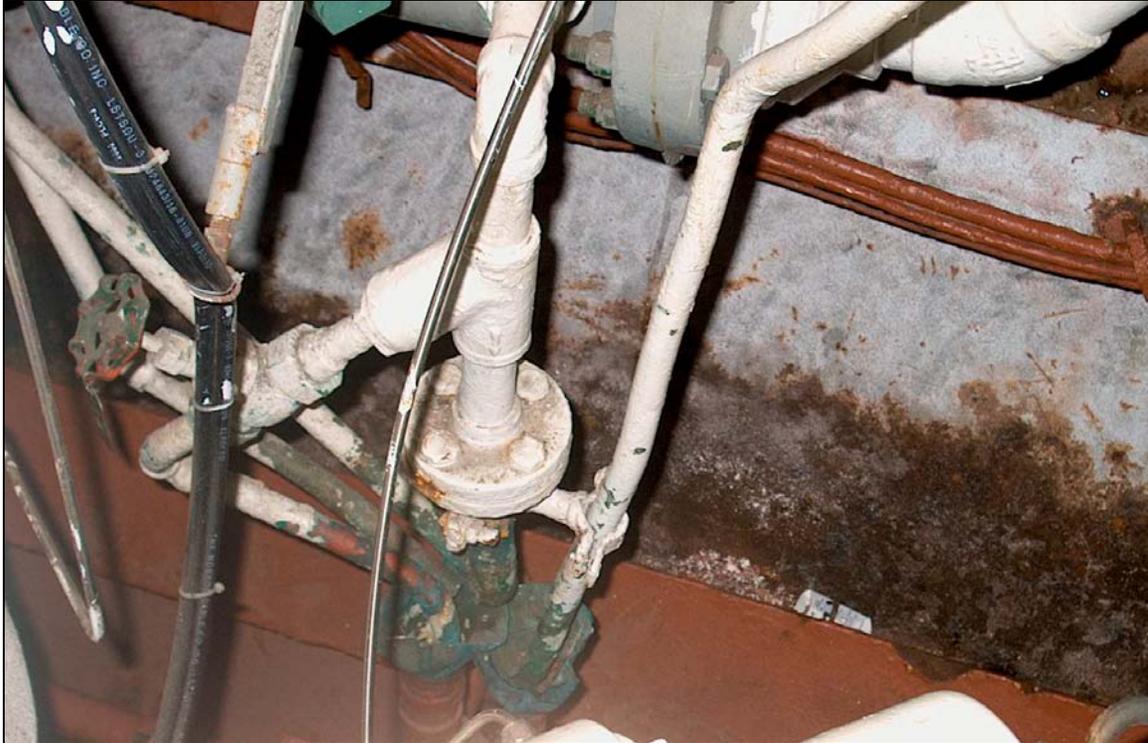
STRINGER (10) PORT SIDE BETWEEN FRAMES (264-270). WATER FROM PIPING DRAINS AND CONDENSATION FROM OVERBOARD DISCHARGES AND OTHER EQUIPMENT WAS TRAPPED BY THE HULL INSULATION CAUSING CORROSION. THIS AREA, PORT AND STARBOARD IS A CLASS WIDE PROBLEM. PERMANENT REMOVAL OF THE HULL INSULATION WILL REDUCE CORROSION AND ALLOW PROPER MAINTAINANCE OF THE HULL AND SUPPORTING STRUCTURAL MEMBERS.

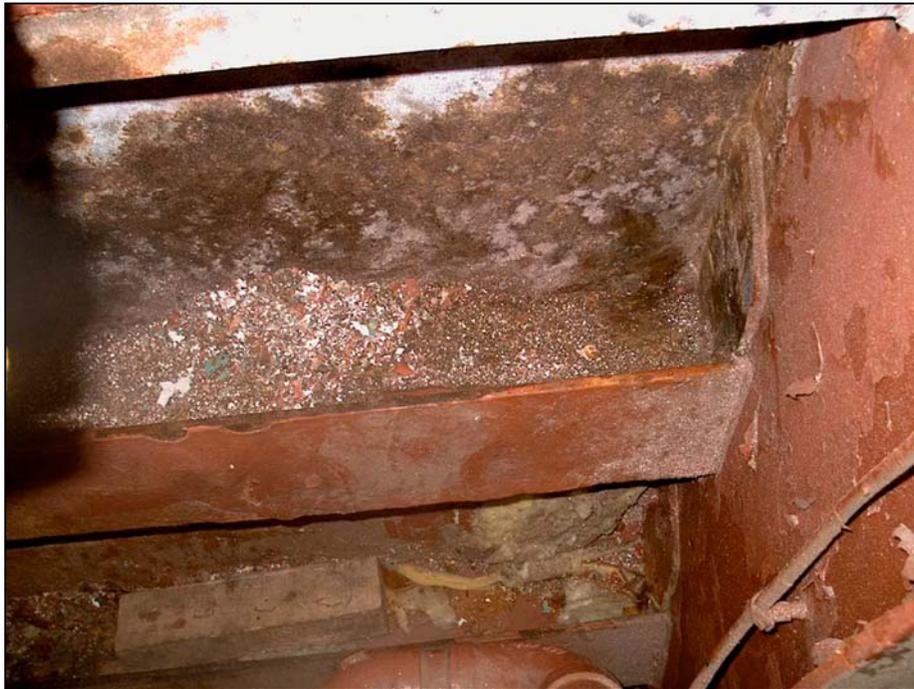
STRINGER (10) AT FRAME (264) PORT SIDE.

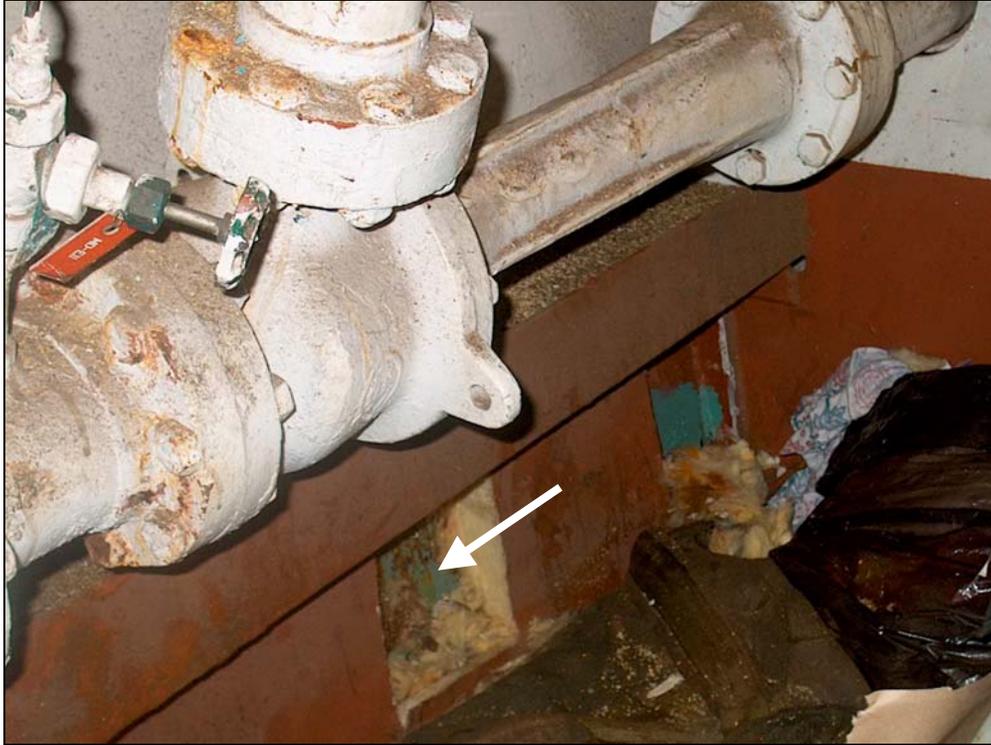
STRINGER (11) AT FRAME (258) PORT SIDE OUTBOARD OF THE ACCESS TRUNK.  
NOTE THE CORROSION ON THE SHELL WHERE THE INSULATION WAS REMOVED  
IN ORDER TO TAKE U/T READINGS.

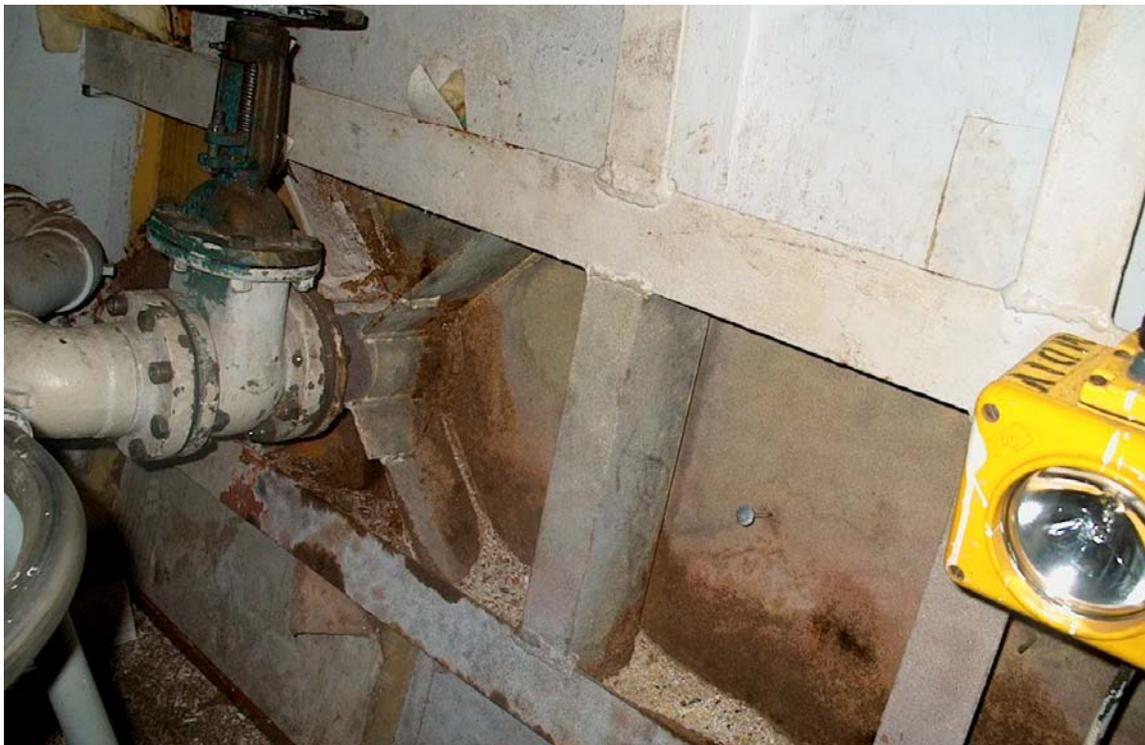
OVERBOARD DISCHARGE FORWARD OF FRAME (258) PORT SIDE BETWEEN STRINGERS (11 AND 12). THE HULL INSULATION ABOVE STRINGER (12) IS WET AND PERMANENT REMOVAL IS HIGHLY RECOMMENDED.

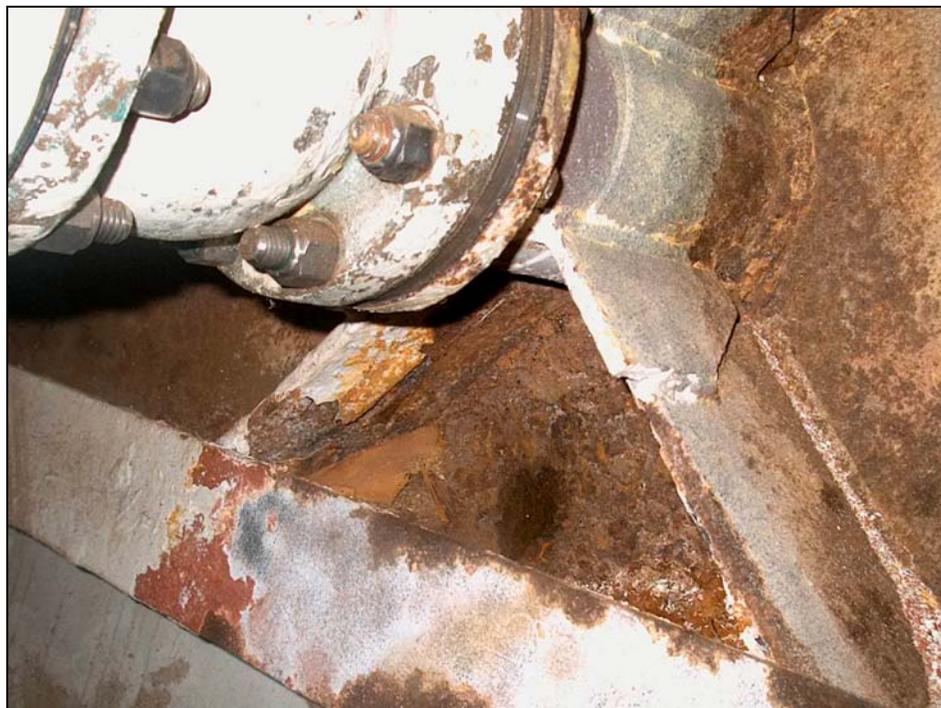
SHELL DESIGN THICKNESS .313  
 MINIMUM .234

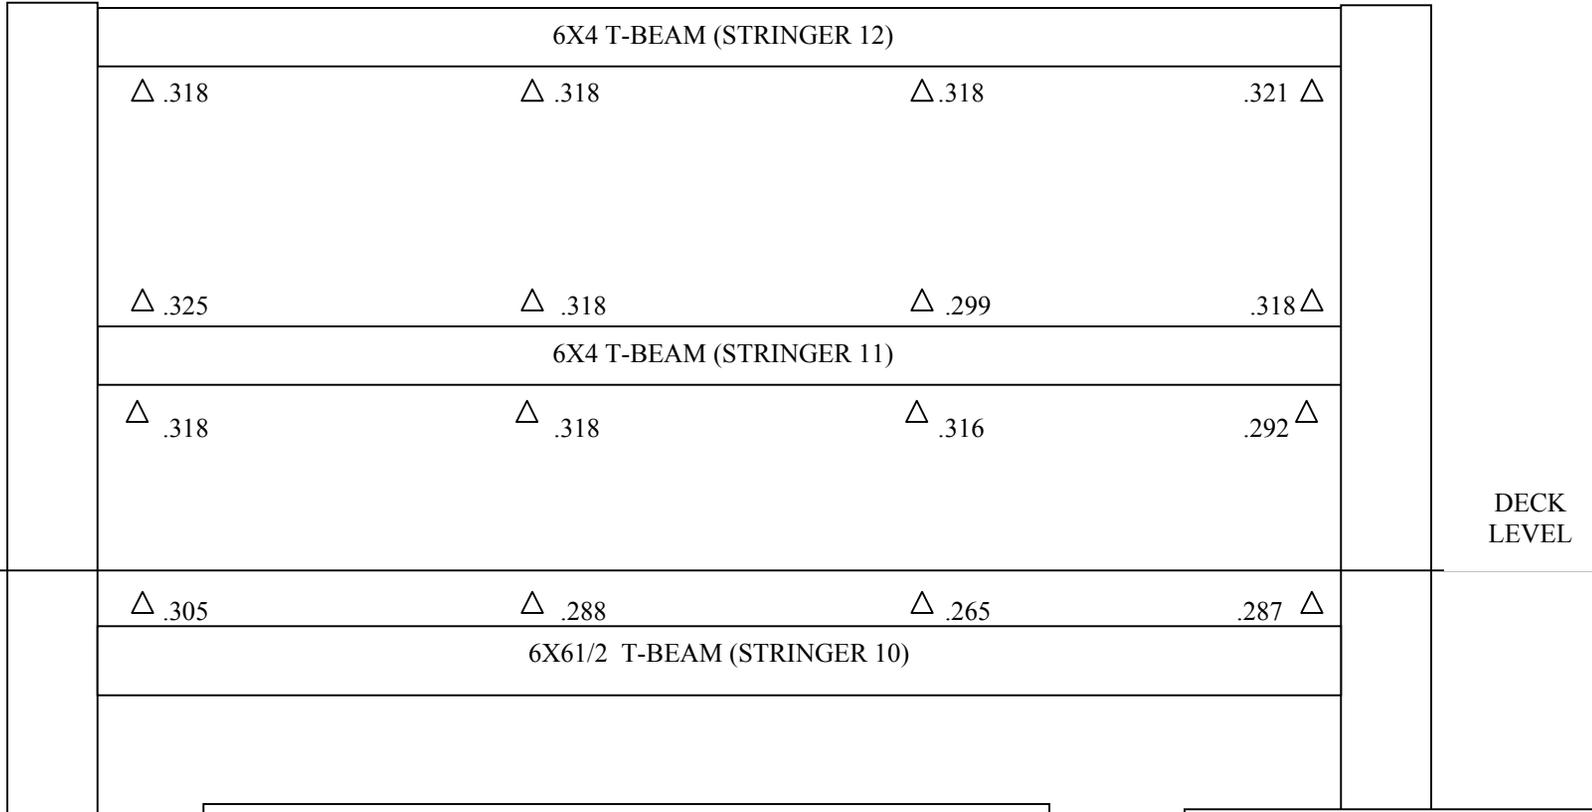
**USS ELROD (FFG-55)  
 MAIN ENGINE ROOM (5-250-0-E)  
 PORT SIDE**

SHELL DESIGN THICKNESS .313  
MINIMUM .234

△ .273

△ .291
