# SEMAT I

## USS SIMPSON (FFG 56)

### SHELL CONDITION ASSESSMENT SURVEY INTERIOR AREAS

6/1/01 TO 6/8/01

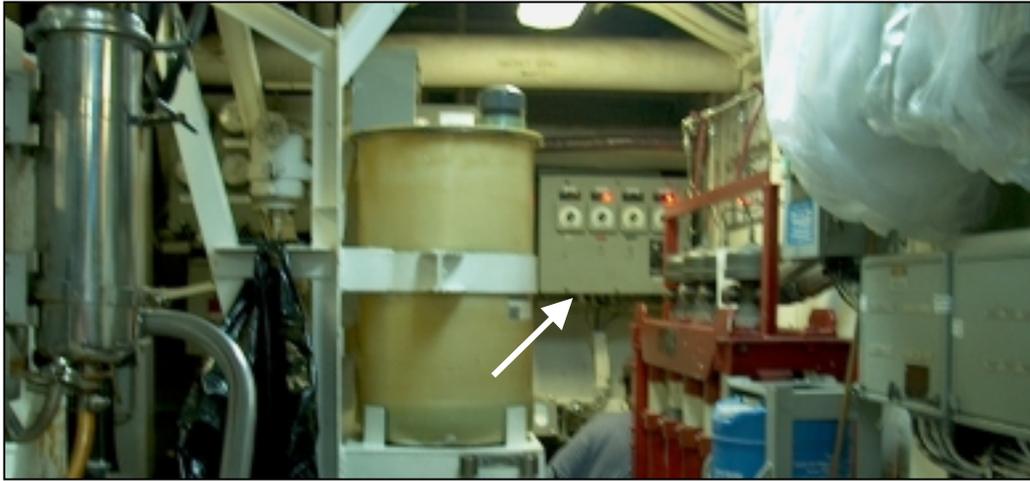
AREA VIEW, PORT SIDE  
ARROW INDICATES TLI RECEIVER

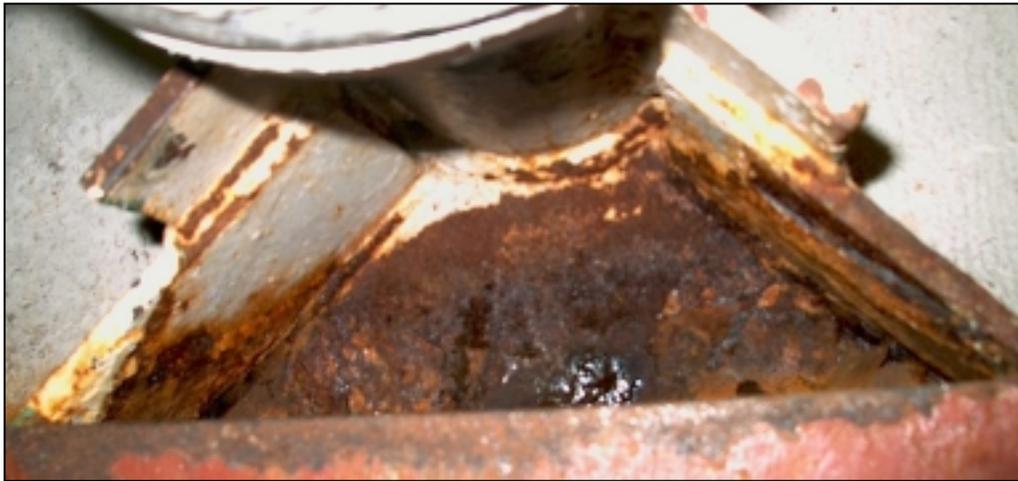
<b>SAFETY HAZARD:</b> 1. SERIOUS - CORRECT AS SOON AS POSSIBLE 2. SERIOUS - SUSPENSION OF EQUIPMENT/SYSTEM/SPACE REQUIRED 3. SERIOUS - WAIVER OF EQUIPMENT/SYSTEM 4. <b>SAFETY ITEM - MINOR</b> 5. COMBUSTIBLE MATERIAL			1. MAINTENANCE ACTION COMPLETED: PARTS DRAWN FROM SUPPLY 2. MAINTENANCE ACTION COMPLETED: REQUIRED PARTS NOT DRAWN FROM SUPPLY 3. MAINTENANCE ACTION COMPLETED: NO PARTS REQUIRED 4. CANCELLED - DEFERRAL WILL BE REMOVED FROM CSMP 7. <b>MAINTENANCE ACTION COMPLETED: 3-M CAPABILITY UTILIZED</b> 0. NONE OF THE ABOVE, DESCRIBE IN REMARKS/DESCRIPTION SECTION			1. MANDATORY 2. ESSENTIAL 3. HIGHLY DESIRABLE 4. <b>DESIRABLE</b>		
DISCREPANCY DESCRIPTION: PER SEMAT I INSPECTION								
Port side, (5-292-0-E) between WF(316-324), under the overboard discharge between stringers (10-11), the shell plate is thinning at <b>.287, .253, .251</b> , the shell between stringers (9-10) has shell thinning at <b>.296 &amp; .307</b> . behind the tank level indicator receiver, the shell is thinned at <b>.295</b> and The web on stringer (13) is thinned at <b>.190</b> , and the web at stringer (12) is thinned at <b>.193</b> , and the web at stringer (10) is thinned at <b>.190</b> .

OVERBOARD DISCHARGE BELOW TLI RECEIVER  
U/T READINGS ARE NOTED IN DRAWING  
AREA RECOMMENDED FOR PRESERVATION

RECOMMEND REPAIR ACTIVITY: Replace approximately 24 linear feet of 6x4 T-beam and approximately 64sf of shell plate with .313 steel, preserve and paint to match area. FTSC IS TO CONDUCT RISK ASSESSMENT AND MAKE FINAL REPAIR RECOMMENDATIONS								
SSPORT C221 POC: F. PRAISSMAN (757) 396-4001 EXT 2130, TPOC: T. ZWOLAK								
CSMP SUMMARY: SHELL AND STRINGERS THINNING.					TEST# MRC 1102/1			
ROOT CAUSE/AMPLIFICATION: H1					STEP# 1,2,3,4 & 5			
SYSTEM LEVEL IMPACT:								
PART NO.	NOMEMCLATURE			QTY	NSN		COST	
1								
2								
3								
4								
5								
6								
FIRST CONTACT LARSEN	RATE EN3	SECOND CONTACT LARSEN		RATE EN3	PHONE 22			
ASSESSOR / ACT / TECH ID# J. LaROCK / T. ILGENFRITZ QED SYSTEMS				TD	TL	LOGISTICIAN	TSP

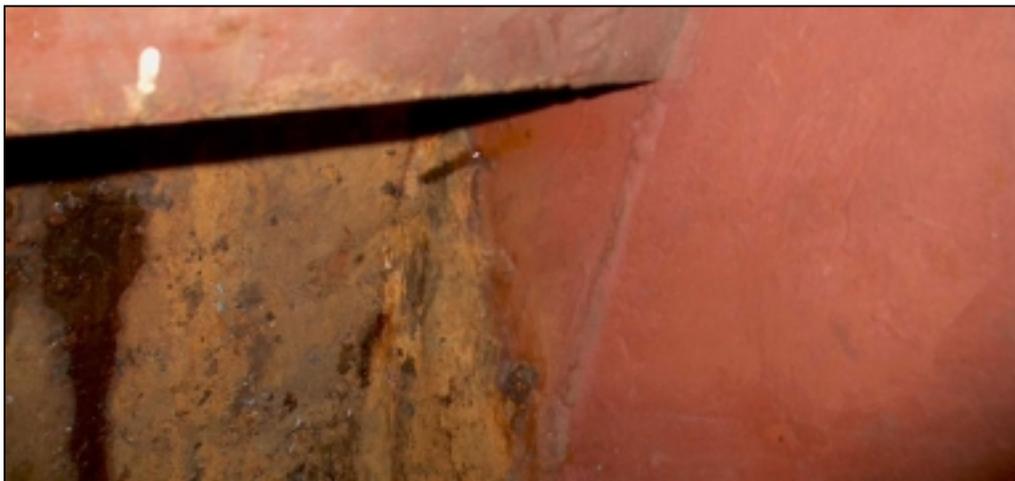
STRINGER 9 AND AREA BELOW  
U/T READINGS ARE NOTED IN DRAWING  
AREA RECOMMENDED FOR PRESERVATION

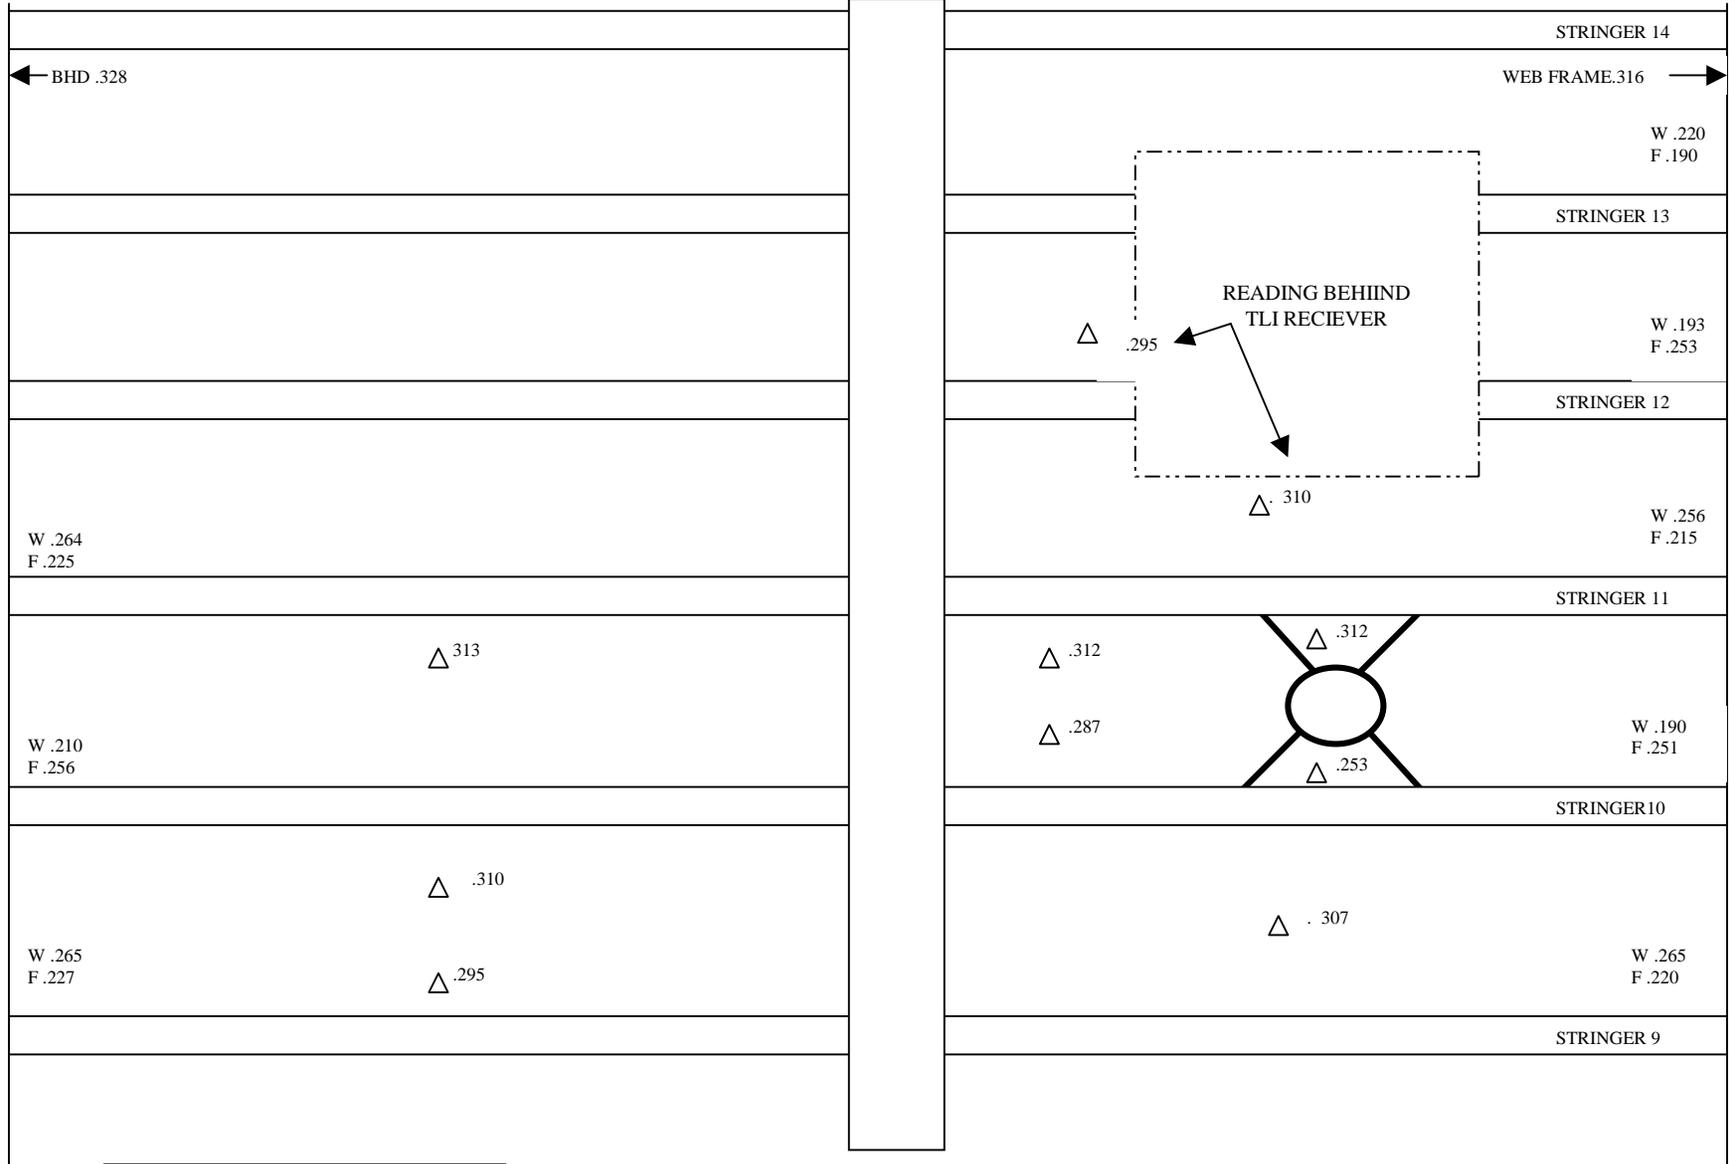
USS SIMPSON (FFG 56)  
AUXILLIARY MACH RM SSDG #4  
(5-292-0-E) PORT SIDE

W .220  
F .265

WEB FRAME  
.324

W .222  
F .372

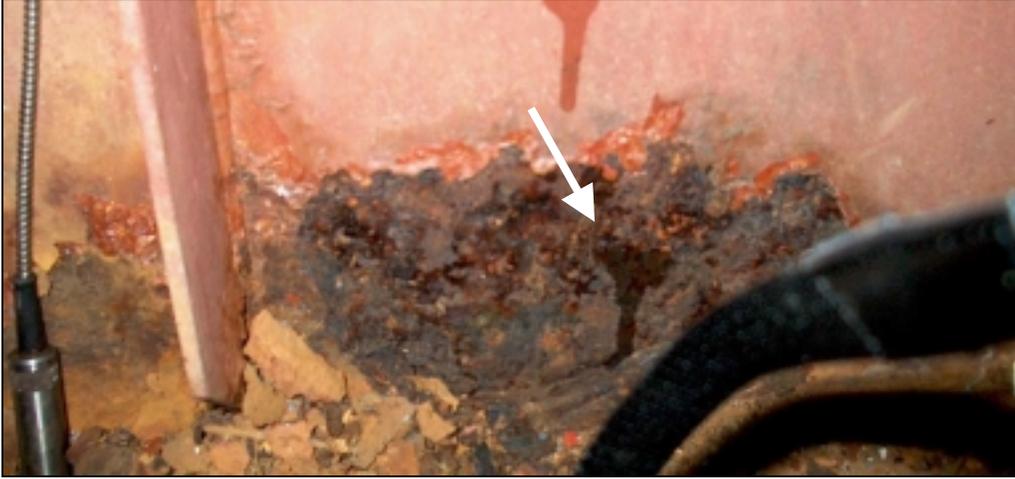
SSPORT C221 POC: F. PRAISSMAN (757) 396-4001 EXT 2130, TPOC: T. ZWOLAK							
CSMP SUMMARY: Margin plate is thinning.					TEST# MRC 1102/1		
ROOT CAUSE/AMPLIFICATION: H1					STEP# 1,2,3,4 & 5		
SYSTEM LEVEL IMPACT:							
PART NO.	NOMEMCLATURE			QTY	NSN	COST	
1							
2							
3							
4							
5							
6							
FIRST CONTACT LARSEN	RATE EN3	SECOND CONTACT LARSEN		RATE EN3	PHONE 22		
ASSESSOR / ACT / TECH ID# J. LaROCK / T. ILGENFRITZ QED SYSTEMS				TD	TL	LOGISTICIAN	TSP

PORT SIDE, BILGE POCKET FORWARD OF BHD 328  
ARROW INDICATES U/T READING OF .201

<b>SAFETY HAZARD:</b> 1. SERIOUS - CORRECT AS SOON AS POSSIBLE 2. SERIOUS - SUSPENSION OF EQUIPMENT/SYSTEM/SPACE REQUIRED 3. SERIOUS - WAIVER OF EQUIPMENT/SYSTEM 4. <b>SAFETY ITEM - MINOR</b> 5. COMBUSTIBLE MATERIAL		1. MAINTENANCE ACTION COMPLETED: PARTS DRAWN FROM SUPPLY 2. MAINTENANCE ACTION COMPLETED: REQUIRED PARTS NOT DRAWN FROM SUPPLY 3. MAINTENANCE ACTION COMPLETED: NO PARTS REQUIRED 4. CANCELLED - DEFERRAL WILL BE REMOVED FROM CSMP 7. <b>MAINTENANCE ACTION COMPLETED: 3-M CAPABILITY UTILIZED</b> 0. NONE OF THE ABOVE, DESCRIBE IN REMARKS/DESCRIPTION SECTION			1. MANDATORY 2. ESSENTIAL 3. HIGHLY DESIRABLE 4. <b>DESIRABLE</b>		
DISCREPANCY DESCRIPTION: PER SEMAT I INSPECTION							
Port side (5-292-0-E), 6" fwd of BHD (328), 4" up from the shell on the margin plate has a low U/T reading at <b>.201</b> , 10" above, the reading is <b>.252</b> .							
RECOMMEND REPAIR ACTIVITY: Cut out and replace approximately 6sf of margin plate with .250 steel. Preserve and paint to match area. FTSC is to conduct risk assessment and make final repair recommendations.

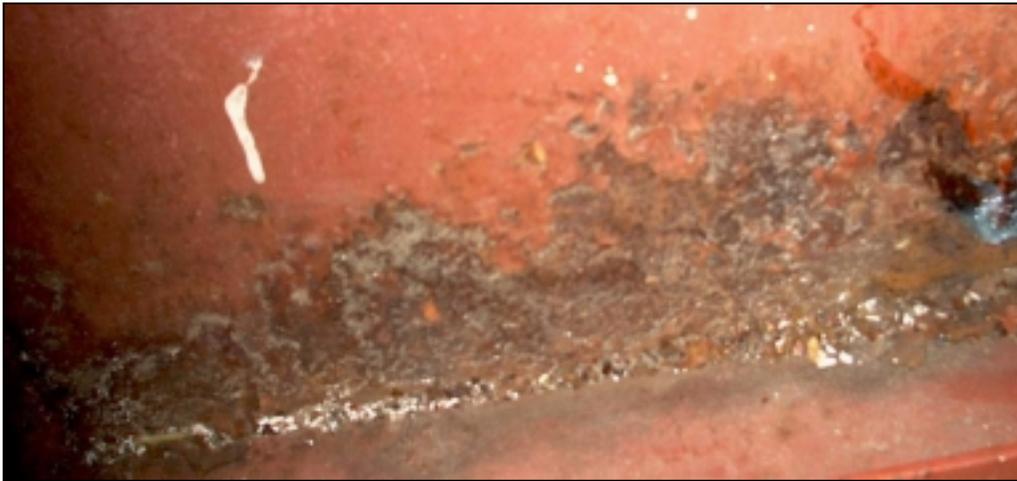
SHELL PLATE ABOVE STRINGER 8  
AREA RECOMMENDED FOR PRESERVATION

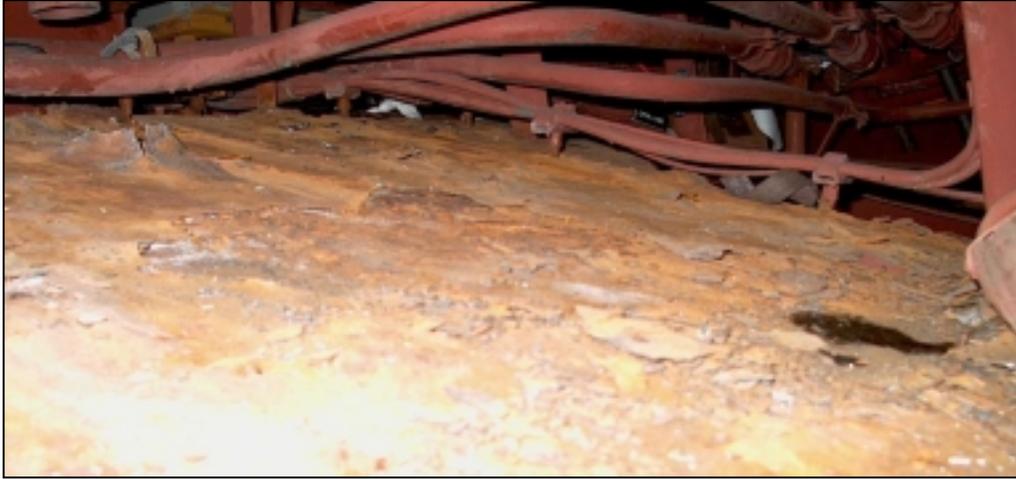
SSPORT C221 POC: F. PRAISSMAN (757) 396-4001 EXT 2130, TPOC: T. ZWOLAK								
CSMP SUMMARY: Potable water tank top needs preservation.					TEST# MRC 1102/1			
ROOT CAUSE/AMPLIFICATION: H1					STEP# 1,2,3,4 & 5			
SYSTEM LEVEL IMPACT:								
PART NO.	NOMEMCLATURE			QTY	NSN		COST	
1								
2								
3								
4								
5								
6								
FIRST CONTACT LARSEN	RATE EN3	SECOND CONTACT LARSEN		RATE EN3	PHONE 22			
ASSESSOR / ACT / TECH ID# J. LaROCK / T. ILGENFRITZ QED SYSTEMS				TD	TL	LOGISTICIAN	TSP

TOP OF POTABLE WATER TANK (5-308-2)

<b>SAFETY HAZARD:</b> 1. SERIOUS - CORRECT AS SOON AS POSSIBLE 2. SERIOUS - SUSPENSION OF EQUIPMENT/SYSTEM/SPACE REQUIRED 3. SERIOUS - WAIVER OF EQUIPMENT/SYSTEM 4. <b>SAFETY ITEM - MINOR</b> 5. COMBUSTIBLE MATERIAL		1. MAINTENANCE ACTION COMPLETED: PARTS DRAWN FROM SUPPLY 2. MAINTENANCE ACTION COMPLETED: REQUIRED PARTS NOT DRAWN FROM SUPPLY 3. MAINTENANCE ACTION COMPLETED: NO PARTS REQUIRED 4. CANCELLED - DEFERRAL WILL BE REMOVED FROM CSMP 7. <b>MAINTENANCE ACTION COMPLETED: 3-M CAPABILITY UTILIZED</b> 0. NONE OF THE ABOVE, DESCRIBE IN REMARKS/DESCRIPTION SECTION			1. MANDATORY 2. ESSENTIAL 3. HIGHLY DESIRABLE 4. <b>DESIRABLE</b>			
DISCREPANCY DESCRIPTION: PER SEMAT I INSPECTION								
Port side (5-292-0-E), top of potable water tank (5-308-2), has light surface rust and paint separation, approximately 80sf.								
<b>RECOMMENDED REPAIRS:</b> Needle-gun approximately 80sf of tank top, preserve and paint to match area.

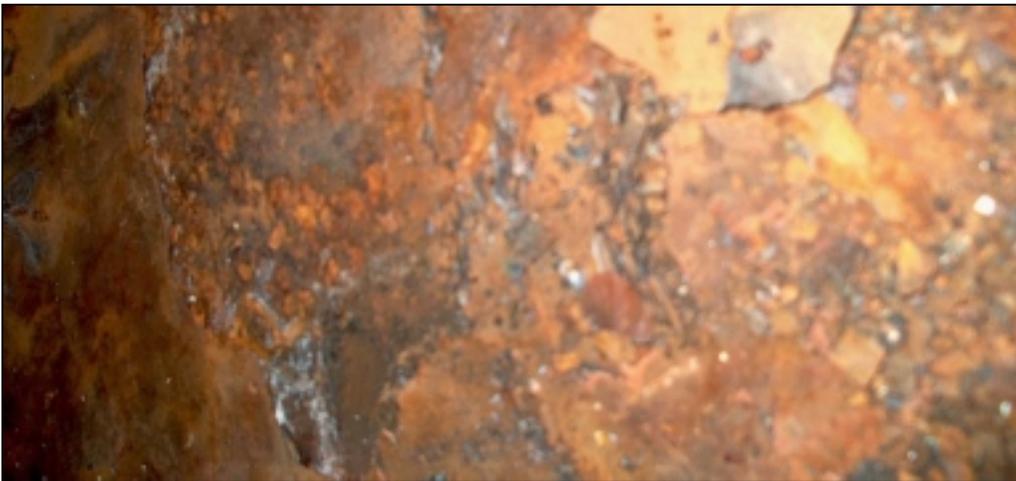
PORT SIDE, TOP OF POTABLE WATER TANK (5-308-2)  
AREA RECOMMENDED FOR PRESERVATION

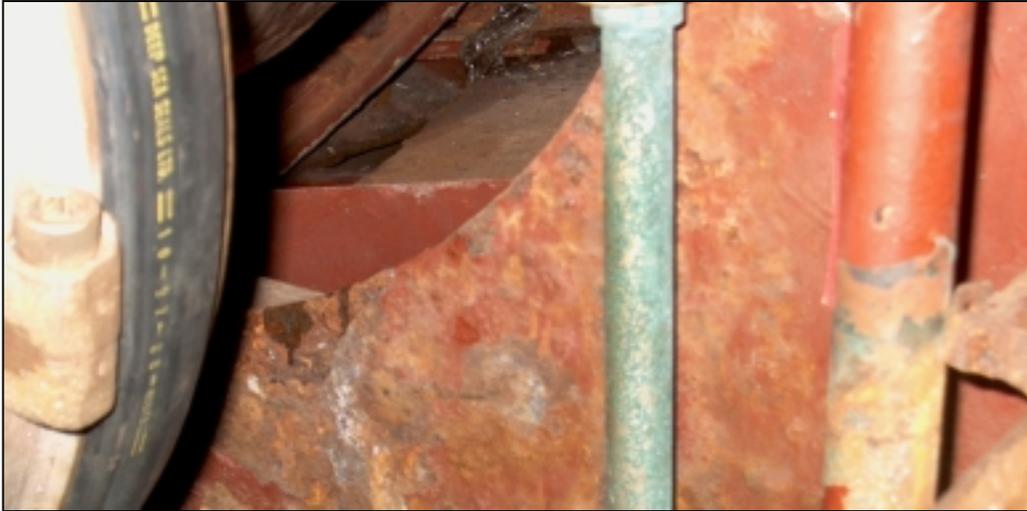
SSPORT C221 POC: F. PRAISSMAN (757) 396-4001 EXT 2130, TPOC: T. ZWOLAK								
CSMP SUMMARY: Transverse WF (316) showing signs of deterioration.					TEST# MRC 1102/1			
ROOT CAUSE/AMPLIFICATION: H1					STEP# 1,2,3,4 & 5			
SYSTEM LEVEL IMPACT:								
PART NO.	NOMENCLATURE			QTY	NSN		COST	
1								
2								
3								
4								
5								
6								
FIRST CONTACT LARSEN	RATE EN3	SECOND CONTACT LARSEN		RATE EN3	PHONE 22			
ASSESSOR / ACT / TECH ID# J. LaROCK / T. ILGENFRITZ QED SYSTEMS				TD	TL	LOGISTICIAN	TSP

STBD SIDE, TRANSVERSE WEB FRAM 316  
U/T READINGS NOTED IN DRAWING.

<b>SAFETY HAZARD:</b> 1. SERIOUS - CORRECT AS SOON AS POSSIBLE 2. SERIOUS - SUSPENSION OF EQUIPMENT/SYSTEM/SPACE REQUIRED 3. SERIOUS - WAIVER OF EQUIPMENT/SYSTEM 4. <b>SAFETY ITEM - MINOR</b> 5. COMBUSTIBLE MATERIAL		1. MAINTENANCE ACTION COMPLETED: PARTS DRAWN FROM SUPPLY 2. MAINTENANCE ACTION COMPLETED: REQUIRED PARTS NOT DRAWN FROM SUPPLY 3. MAINTENANCE ACTION COMPLETED: NO PARTS REQUIRED 4. CANCELLED - DEFERRAL WILL BE REMOVED FROM CSMP 7. <b>MAINTENANCE ACTION COMPLETED: 3-M CAPABILITY UTILIZED</b> 0. NONE OF THE ABOVE, DESCRIBE IN REMARKS/DESCRIPTION SECTION			1. MANDATORY 2. ESSENTIAL 3. HIGHLY DESIRABLE 4. <b>DESIRABLE</b>			
DISCREPANCY DESCRIPTION: PER SEMAT I INSPECTION (5-292-0-E), Transverse WF (316) has heavy pitting, heavy rust and heavy paint separation. U/T readings are satisfactory approximately 40sf.								
RECOMMENDED REPAIRS: Needle gun approximately 40sf of transverse WF (316), preserve and paint to match.

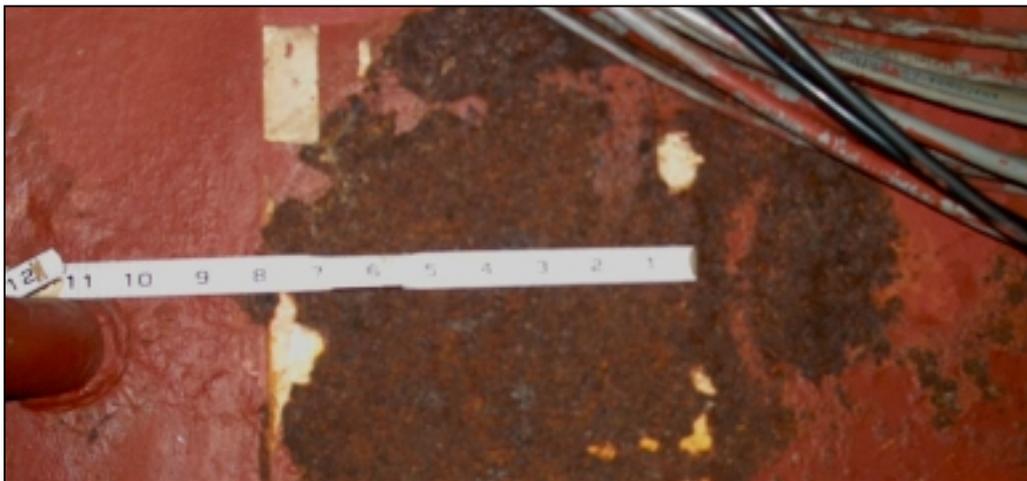
PORT SIDE, TRANSVERSE WEB 316  
AREA WITH HEAVY PITTING.

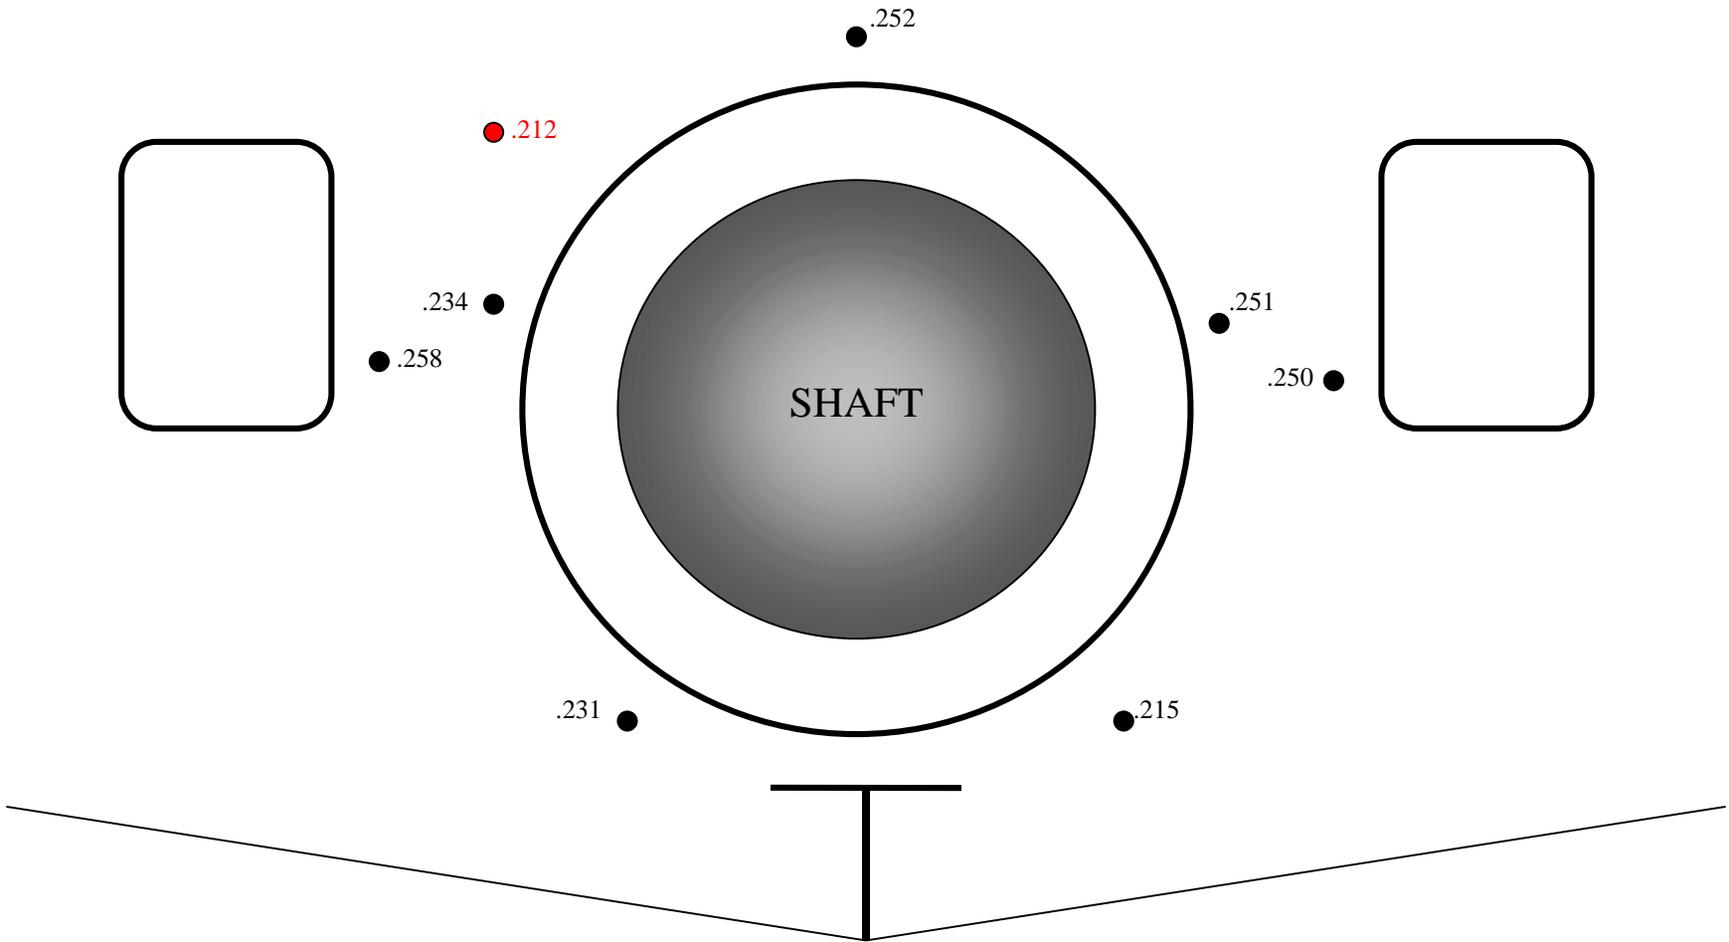
USS SIMPSON (FFG 56)  
AUXILIARY ROOM #3  
(5-292-0-E)

TRANSVERSE WEB FRAME 316  
LOOKING FORWARD

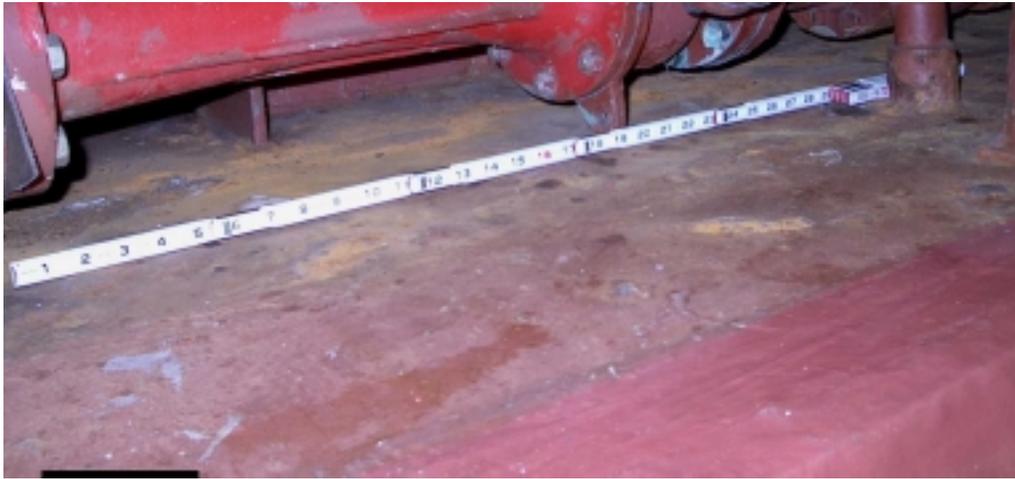
<b>SAFETY HAZARD:</b> 1. SERIOUS - CORRECT AS SOON AS POSSIBLE 2. SERIOUS - SUSPENSION OF EQUIPMENT/SYSTEM/SPACE REQUIRED 3. SERIOUS - WAIVER OF EQUIPMENT/SYSTEM 4. <b>SAFETY ITEM - MINOR</b> 5. COMBUSTIBLE MATERIAL		1. MAINTENANCE ACTION COMPLETED: PARTS DRAWN FROM SUPPLY 2. MAINTENANCE ACTION COMPLETED: REQUIRED PARTS NOT DRAWN FROM SUPPLY 3. MAINTENANCE ACTION COMPLETED: NO PARTS REQUIRED 4. CANCELLED - DEFERRAL WILL BE REMOVED FROM CSMP 7. <b>MAINTENANCE ACTION COMPLETED: 3-M CAPABILITY UTILIZED</b> 0. NONE OF THE ABOVE, DESCRIBE IN REMARKS/DESCRIPTION SECTION		1. MANDATORY 2. ESSENTIAL 3. HIGHLY DESIRABLE 4. <b>DESIRABLE</b>			
DISCREPANCY DESCRIPTION: PER SEMAT I INSPECTION							
STBD side (5-292-0-E), Potable water tank (5-292-1-W), top of tank has heavy pitting, corrosion and paint separation. Several low U/T readings of <b>.112, .152, .181 and .190</b> . Approximately 60sf of tank top. Design thickness is .250 and the minimum is .213.

STBD SIDE, POTABLE WATER TANK (5-292-1-W)  
U/T READINGS NOTED IN DRAWING.

RECOMMEND REPAIR ACTIVITY: Cut out and replace approximately 60sf of tank top with .250 steel. Preserve and paint to match area. FTSC is to conduct risk assessment and to make final repair recommendations.							
SSPORT C221 POC: F. PRAISSMAN (757) 396-4001 EXT 2130, TPOC: T. ZWOLAK							
CSMP SUMMARY: Potable water tank top has heavy deterioration.					TEST# MRC 1102/1		
ROOT CAUSE/AMPLIFICATION: H1					STEP# 1,2,3,4 & 5		
SYSTEM LEVEL IMPACT:							
PART NO.	NOMEMCLATURE			QTY	NSN	COST	
1							
2							
3							
4							
5							
6							
FIRST CONTACT LARSEN	RATE EN3	SECOND CONTACT LARSEN		RATE EN3	PHONE 22		
ASSESSOR / ACT / TECH ID# J. LaROCK / T. ILGENFRITZ QED SYSTEMS				TD	TL	LOGISTICIAN	TSP

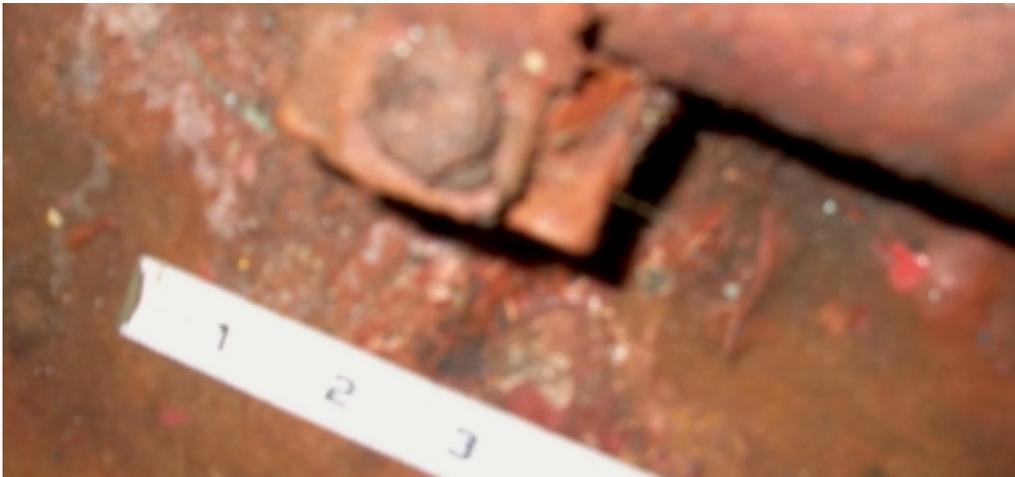
STBD SIDE, POTABLE WATER TANK (5-292-1-W)  
PIPE CLAMP ON TOP OF TANK. U/T READINGS ARE NOTED ON DRAWING.

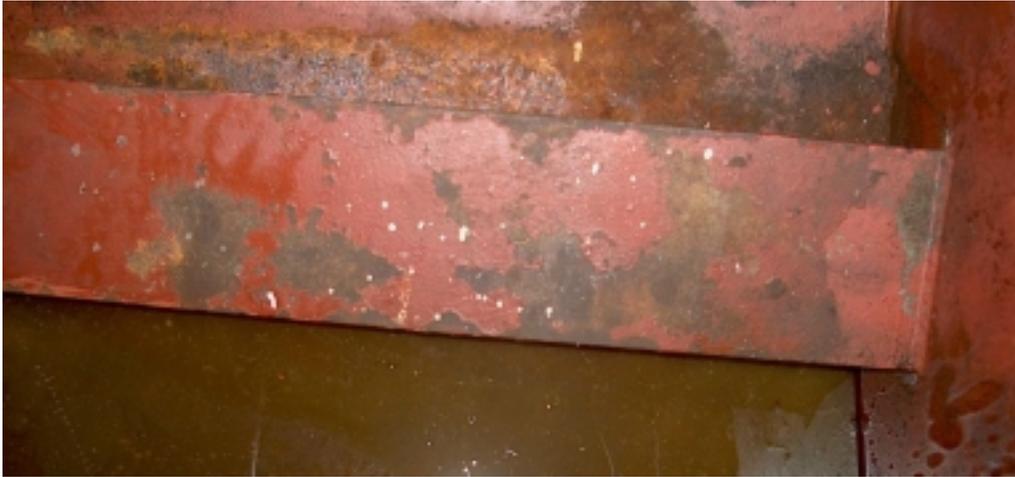
SSPORT C221 POC: F. PRAISSMAN (757) 396-4001 EXT 2130, TPOC: T. ZWOLAK								
CSMP SUMMARY: Bilge pocket has corrosion and paint separation.					TEST# MRC 1102/1			
ROOT CAUSE/AMPLIFICATION: H1					STEP# 1,2,3,4 & 5			
SYSTEM LEVEL IMPACT:								
PART NO.	NOMEMCLATURE			QTY	NSN		COST	
1								
2								
3								
4								
5								
6								
FIRST CONTACT LARSEN	RATE EN3	SECOND CONTACT LARSEN		RATE EN3	PHONE 22			
ASSESSOR / ACT / TECH ID# J. LaROCK / T. ILGENFRITZ QED SYSTEMS				TD	TL	LOGISTICIAN	TSP

STBD SIDE. BILGE POCKET; BETWEEN WEB FRAME (300-308).  
AREA RECOMMENDED FOR PRESERVATION.

<b>SAFETY HAZARD:</b> 1. SERIOUS - CORRECT AS SOON AS POSSIBLE 2. SERIOUS - SUSPENSION OF EQUIPMENT/SYSTEM/SPACE REQUIRED 3. SERIOUS - WAIVER OF EQUIPMENT/SYSTEM 4. <b>SAFETY ITEM - MINOR</b> 5. COMBUSTIBLE MATERIAL		1. MAINTENANCE ACTION COMPLETED: PARTS DRAWN FROM SUPPLY 2. MAINTENANCE ACTION COMPLETED: REQUIRED PARTS NOT DRAWN FROM SUPPLY 3. MAINTENANCE ACTION COMPLETED: NO PARTS REQUIRED 4. CANCELLED - DEFERRAL WILL BE REMOVED FROM CSMP 7. <b>MAINTENANCE ACTION COMPLETED: 3-M CAPABILITY UTILIZED</b> 0. NONE OF THE ABOVE, DESCRIBE IN REMARKS/DESCRIPTION SECTION			1. MANDATORY 2. ESSENTIAL 3. HIGHLY DESIRABLE 4. <b>DESIRABLE</b>			
DISCREPANCY DESCRIPTION: PER SEMAT I INSPECTION STBD side (5-292-0-E), bilge pocket between WF(300-308), has light corrosion and paint separation. Approximately 24sf.								
RECOMMENDED REPAIRS: Needle-gun approximately 24sf of bilge pocket, preserve and paint to match.

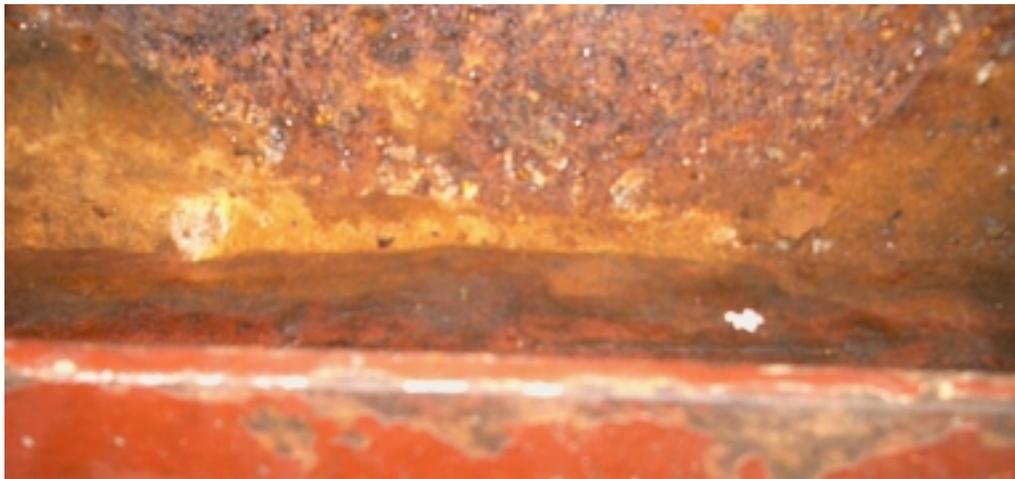
STBE SIDE BETWEEN STRINGERS (8-9) 2FT FWD OF WEB FRAME 300  
AREA RECOMMENDED FOR PRESERVATION.

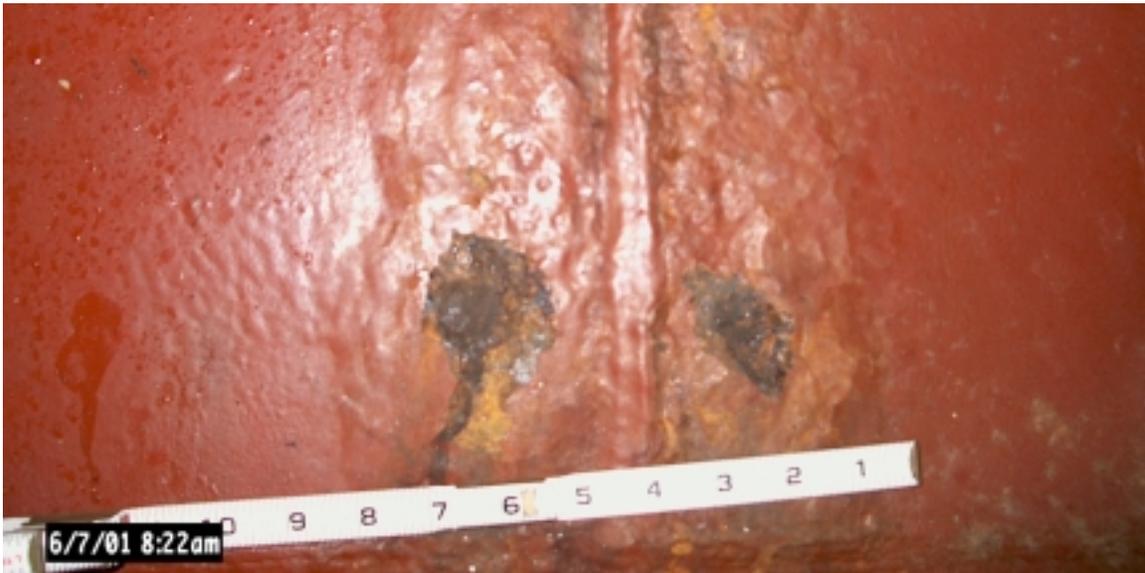
<b>SAFETY HAZARD:</b> 1. SERIOUS - CORRECT AS SOON AS POSSIBLE 2. SERIOUS - SUSPENSION OF EQUIPMENT/SYSTEM/SPACE REQUIRED 3. SERIOUS - WAIVER OF EQUIPMENT/SYSTEM 4. <b>SAFETY ITEM - MINOR</b> 5. COMBUSTIBLE MATERIAL			1. MAINTENANCE ACTION COMPLETED: PARTS DRAWN FROM SUPPLY 2. MAINTENANCE ACTION COMPLETED: REQUIRED PARTS NOT DRAWN FROM SUPPLY 3. MAINTENANCE ACTION COMPLETED: NO PARTS REQUIRED 4. CANCELLED - DEFERRAL WILL BE REMOVED FROM CSMP 7. <b>MAINTENANCE ACTION COMPLETED: 3-M CAPABILITY UTILIZED</b> 0. NONE OF THE ABOVE, DESCRIBE IN REMARKS/DESCRIPTION SECTION			1. MANDATORY 2. ESSENTIAL 3. HIGHLY DESIRABLE 4. <b>DESIRABLE</b>		
DISCREPANCY DESCRIPTION: PER SEMAT I INSPECTION <b>Port side (5-250-0-E), between WF (264-270), shell plate from stringers (11-13) is thinning with low U/T readings at .240, .248, .296 and .301. The design thickness is .313, the readings are within the 25% wastage, Transverse weld seam AFT of WF (270), from stringers (11-12), has shell thinned at .273, AFT of weld seam and .276 FWD of weld seam. Aft of transverse weld seam where "B" strake meets "C" strake, shell is thinning at .426, which is below the 25% wastage of .500 plate.</b>

PORT SIDE. TRANSVERSE WELD SEAM, AFT OF WEB FRAME 270.  
HISTORICAL HOT SPOT, SHELL IS THINNING AND U/T READINGS ARE  
INDICATED IN DRAWING.

RECOMMEND REPAIR ACTIVITY: Cut out and replace approximately 30sf of shell plate from stringer (11-13), with .313 steel. Approximately 4sf of shell plate between stringers (7-8), at transverse weld seam, replace with .500 steel. Preserve and paint to match area. <b>FTSC IS TO CONDUCT RISK ASSESSMENT AND MAKE FINAL REPAIR RECOMMENDATIONS.</b>								
SSPORT C221 POC: F. PRAISSMAN (757) 396-4001 EXT 2130, TPOC: T. ZWOLAK								
CSMP SUMMARY: Shell plate is thinning.					TEST# MRC 1102/1			
ROOT CAUSE/AMPLIFICATION: H1					STEP# 1,2,3,4 & 5			
SYSTEM LEVEL IMPACT:								
PART NO.	NOMEMCLATURE			QTY	NSN		COST	
1								
2								
3								
4								
5								
6								
FIRST CONTACT LARSEN	RATE EN3	SECOND CONTACT LARSEN		RATE EN3	PHONE 22			
ASSESSOR / ACT / TECH ID# J. LaROCK / T. ILGENFRITZ QED SYSTEMS				TD	TL	LOGISTICIAN	TSP

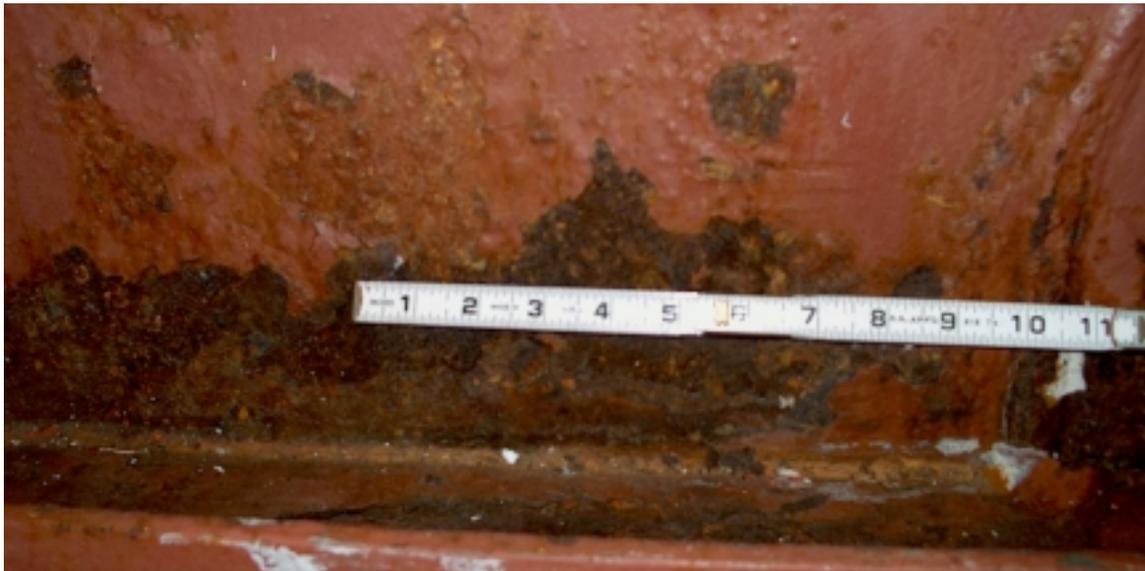
PORT SIDE ABOVE STRINGER 12  
AREA RECOMMENDED FOR PRESERVATION.

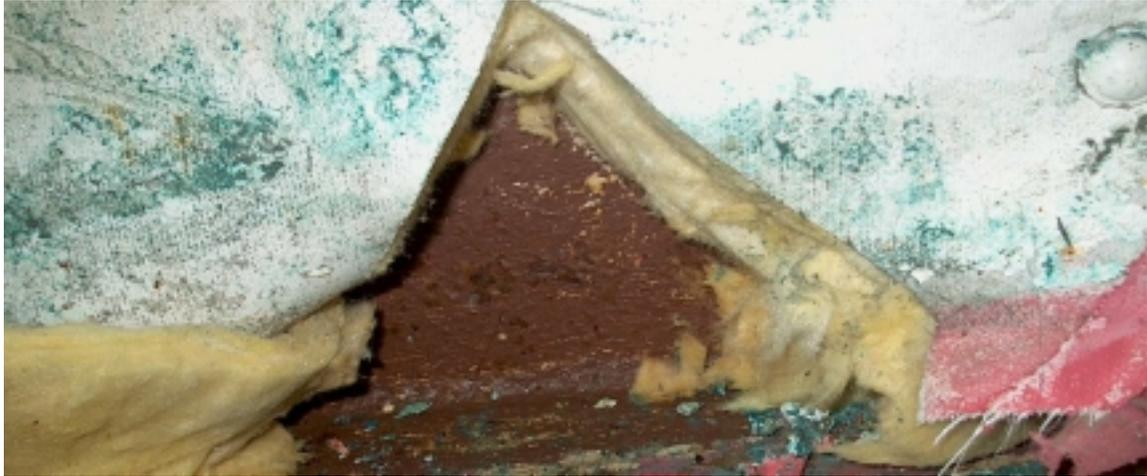
<b>SAFETY HAZARD:</b> 1. SERIOUS - CORRECT AS SOON AS POSSIBLE 2. SERIOUS - SUSPENSION OF EQUIPMENT/SYSTEM/SPACE REQUIRED 3. SERIOUS - WAIVER OF EQUIPMENT/SYSTEM 4. <b>SAFETY ITEM - MINOR</b> 5. COMBUSTIBLE MATERIAL		1. MAINTENANCE ACTION COMPLETED: PARTS DRAWN FROM SUPPLY 2. MAINTENANCE ACTION COMPLETED: REQUIRED PARTS NOT DRAWN FROM SUPPLY 3. MAINTENANCE ACTION COMPLETED: NO PARTS REQUIRED 4. CANCELLED - DEFERRAL WILL BE REMOVED FROM CSMP 7. <b>MAINTENANCE ACTION COMPLETED: 3-M CAPABILITY UTILIZED</b> 0. NONE OF THE ABOVE, DESCRIBE IN REMARKS/DESCRIPTION SECTION			1. MANDATORY 2. ESSENTIAL 3. HIGHLY DESIRABLE 4. <b>DESIRABLE</b>			
DISCREPANCY DESCRIPTION: PER SEMAT I INSPECTION								
Port side (5-250-0-E), Between WF (250-264) between stringers (10-11), approximately 40sf of saturated lagging, with light paint								
Separation. U/T reading under the Eductor overboard (3-255-2) shell is thinning at .297. but is within tolerance of design

PORT SIDE, AFT OF OVBD EDUCTOR AT STRINGER 10

thickness of .313.								
RECOMMENDED REPAIRS:								
Remove approximately 40sf of saturated lagging, needle-gun and preserve areas exposed, replace with 2" hull board and paint to match.								
SSPORT C221 POC: F. PRAISSMAN (757) 396-4001 EXT 2130, TPOC: T. ZWOLAK								
CSMP SUMMARY: Lagging is saturated, light corrosion under lagging.						TEST# MRC 1102/1		
ROOT CAUSE/AMPLIFICATION: H1						STEP# 1,2,3,4 & 5		
SYSTEM LEVEL IMPACT:								
PART NO.	NOMEMCLATURE			QTY	NSN		COST	
1								
2								
3								
4								
5								
6								
FIRST CONTACT LARSEN	RATE EN3	SECOND CONTACT LARSEN		RATE EN3	PHONE 22			
ASSESSOR / ACT / TECH ID# J. LaROCK / T. ILGENFRITZ QED SYSTEMS				TD	TL	LOGISTICIAN	TSP

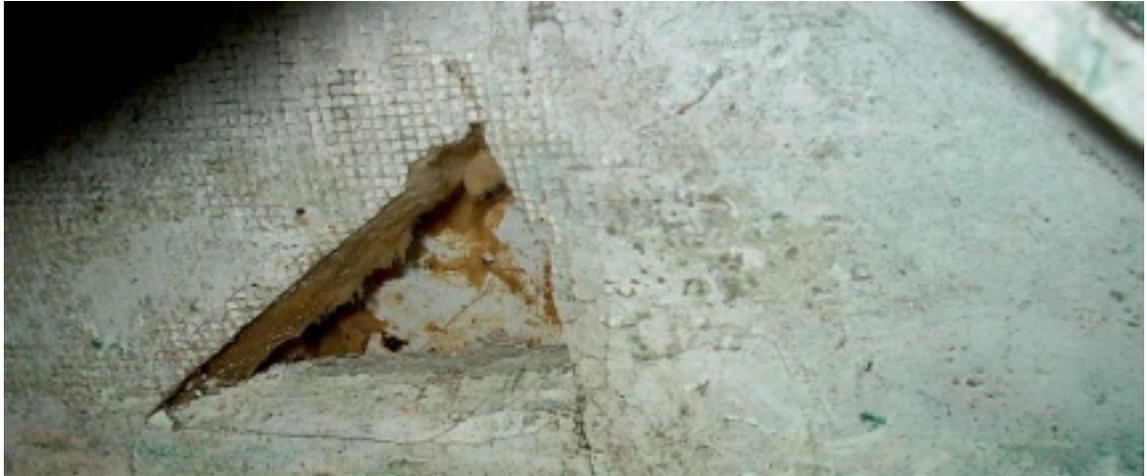
PORT SIDE. BETWEEN WEB FRAMES (250-258)  
UNDER OVER BOARD EDUCTOR, LAGGING IS SATURATED.  
REPLACEMENT RECOMMENDED. U/T READINGS ARE NOTED IN DRAWING.

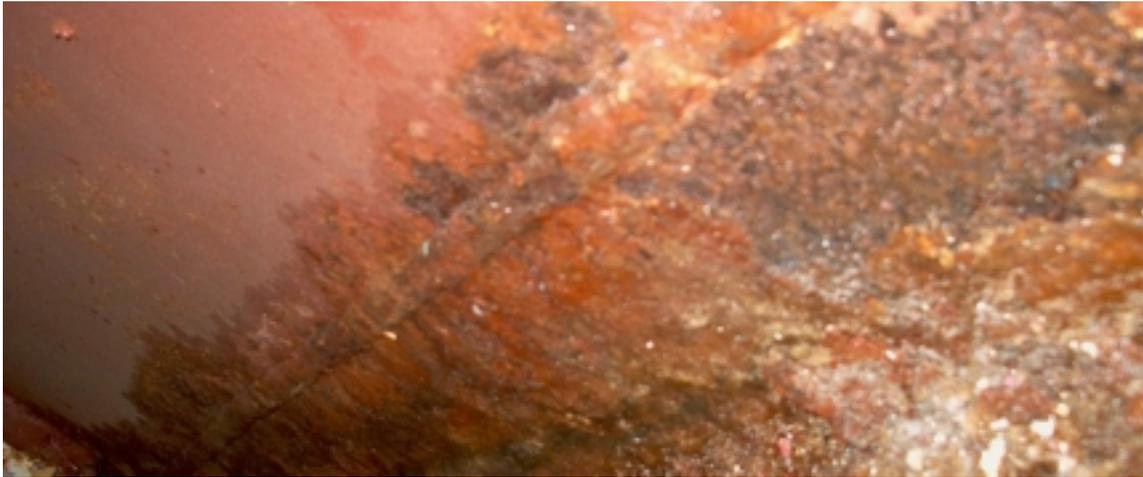
DISCREPANCY DESCRIPTION: PER SEMAT I INSPECTION							
Port side (5-212-0-E), from WF (220-228) between stringers (7-11), approximately 144sf of surface rust and paint separation. U/T readings were Satisfactory with minor reduction in design thickness.							
RECOMMENDED REPAIRS: Needle-gun approximately 144sf of area, preserve and paint to match.							
SSPORT C221 POC: F. PRAISSMAN (757) 396-4001 EXT 2130, TPOC: T. ZWOLAK							
CSMP SUMMARY: Area specified has light corrosion and paint separation.						TEST# MRC 1102/1	
ROOT CAUSE/AMPLIFICATION: H1						STEP# 1,2,3,4 & 5	
SYSTEM LEVEL IMPACT:							
PART NO.		NOMEMCLATURE		QTY	NSN	COST	
1							
2							
3							
4							
5							
6							
FIRST CONTACT LARSEN		RATE EN3	SECOND CONTACT LARSEN		RATE EN3	PHONE 22	
ASSESSOR / ACT / TECH ID# J. LaROCK / T. ILGENFRITZ QED SYSTEMS				TD	TL	LOGISTICIAN	TSP

PORT SIDE, AFT OF WEB FRAME 220, WELD SEAM WHERE "C" AND "D" STRAKE MEET.  
U/T READINGS ARE NOTED ON DRAWING.

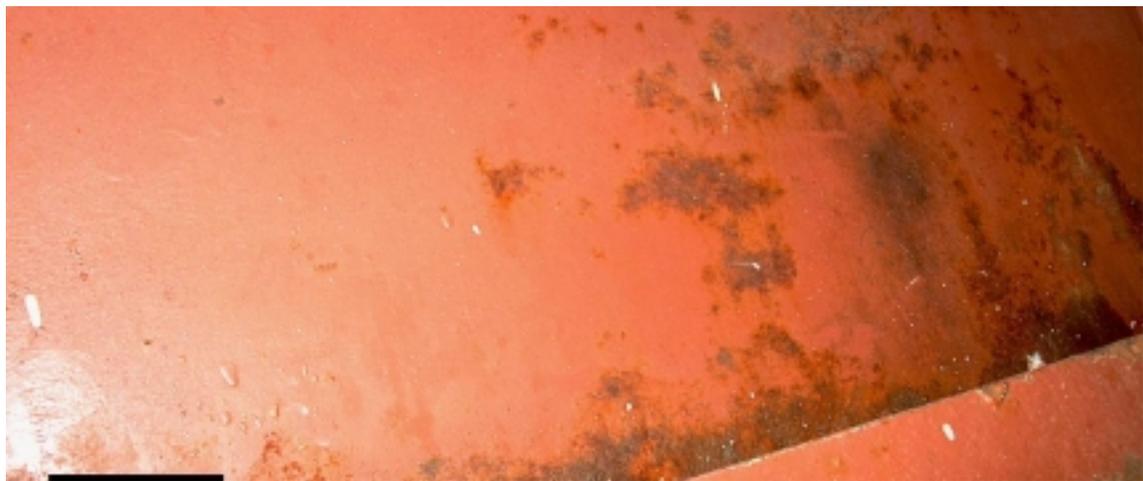
PORT SIDE, BETWEEN STRINGERS (8-9) AFT OF WEB FRAME 220.  
PRESERVATION AND PAINT RECOMMENDED.

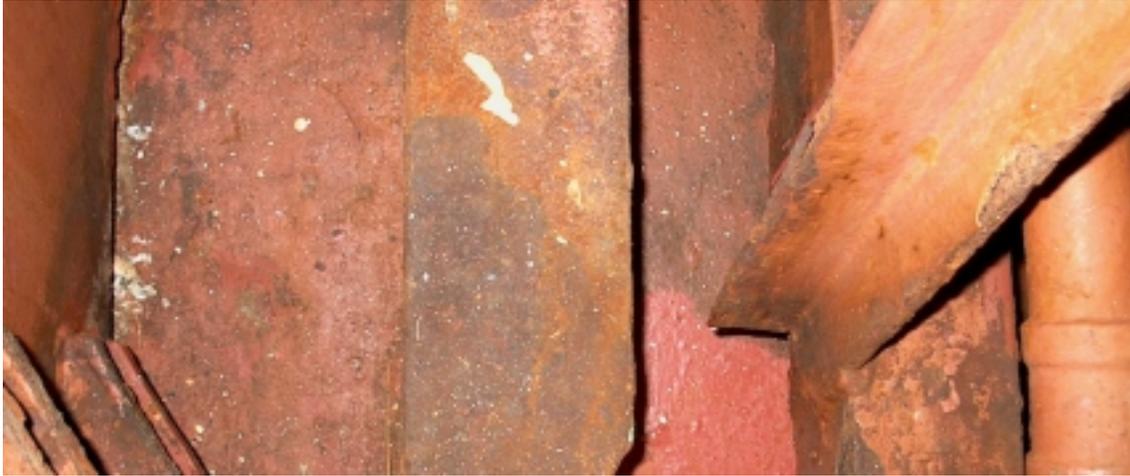
SSPORT C221 POC: F. PRAISSMAN (757) 396-4001 EXT 2130, TPOC: T. ZWOLAK							
CSMP SUMMARY: Area specified has light corrosion and paint separation.					TEST# MRC 1102/1		
ROOT CAUSE/AMPLIFICATION: H1					STEP# 1,2,3,4 & 5		
SYSTEM LEVEL IMPACT:							
PART NO.	NOMEMCLATURE			QTY	NSN	COST	
1							
2							
3							
4							
5							
6							
FIRST CONTACT LARSEN	RATE EN3	SECOND CONTACT LARSEN		RATE EN3	PHONE 22		
ASSESSOR / ACT / TECH ID# J. LaROCK / T. ILGENFRITZ QED SYSTEMS				TD	TL	LOGISTICIAN	TSP

PORT SIDE, AFT OF WEB FRAME 220, BILGE AREA RRECOMMENDED FOR PRESERVATION AND PAINT.

<b>SAFETY HAZARD:</b> 1. SERIOUS - CORRECT AS SOON AS POSSIBLE 2. SERIOUS - SUSPENSION OF EQUIPMENT/SYSTEM/SPACE REQUIRED 3. SERIOUS - WAIVER OF EQUIPMENT/SYSTEM 4. <b>SAFETY ITEM - MINOR</b> 5. COMBUSTIBLE MATERIAL		1. MAINTENANCE ACTION COMPLETED: PARTS DRAWN FROM SUPPLY 2. MAINTENANCE ACTION COMPLETED: REQUIRED PARTS NOT DRAWN FROM SUPPLY 3. MAINTENANCE ACTION COMPLETED: NO PARTS REQUIRED 4. CANCELLED - DEFERRAL WILL BE REMOVED FROM CSMP 7. <b>MAINTENANCE ACTION COMPLETED: 3-M CAPABILITY UTILIZED</b> 0. NONE OF THE ABOVE, DESCRIBE IN REMARKS/DESCRIPTION SECTION			1. MANDATORY 2. ESSENTIAL 3. HIGHLY DESIRABLE 4. <b>DESIRABLE</b>		
DISCREPANCY DESCRIPTION: PER SEMAT I INSPECTION							
Port side (5-212-0-E), from Frame (328-236) between stringers (3-5), has approximately 50sf of surface rust and paint Separation.							
RECOMMENDED REPAIRS: Needle-gun approximately 50sf of area, preserve and paint to match.

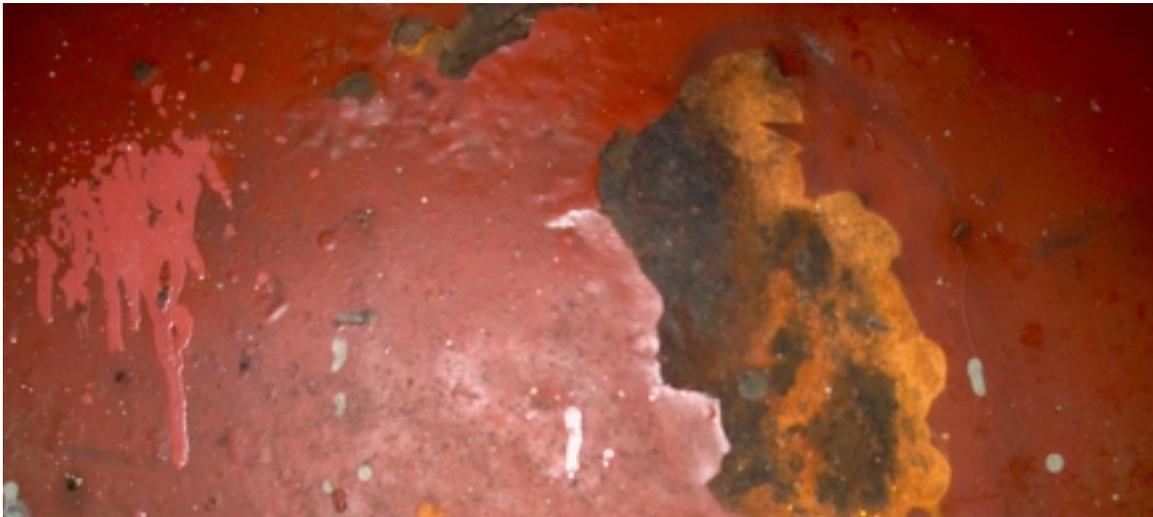
PORT SIDE, FORWARD OP WEB FRAME 236,BILGE AREA PRESERVATION AND PAINT RECOMMENDED.

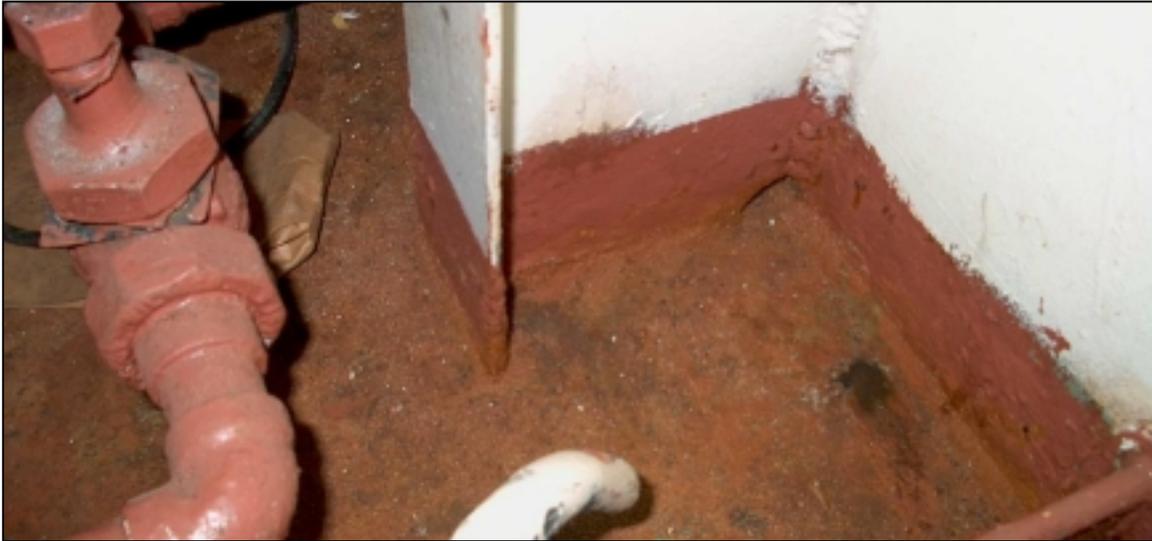
<b>SAFETY HAZARD:</b> 1. SERIOUS - CORRECT AS SOON AS POSSIBLE 2. SERIOUS - SUSPENSION OF EQUIPMENT/SYSTEM/SPACE REQUIRED 3. SERIOUS - WAIVER OF EQUIPMENT/SYSTEM 4. <b>SAFETY ITEM - MINOR</b> 5. COMBUSTIBLE MATERIAL		1. MAINTENANCE ACTION COMPLETED: PARTS DRAWN FROM SUPPLY 2. MAINTENANCE ACTION COMPLETED: REQUIRED PARTS NOT DRAWN FROM SUPPLY 3. MAINTENANCE ACTION COMPLETED: NO PARTS REQUIRED 4. CANCELLED - DEFERRAL WILL BE REMOVED FROM CSMP 7. <b>MAINTENANCE ACTION COMPLETED: 3-M CAPABILITY UTILIZED</b> 0. NONE OF THE ABOVE, DESCRIBE IN REMARKS/DESCRIPTION SECTION			1. MANDATORY 2. ESSENTIAL 3. HIGHLY DESIRABLE 4. <b>DESIRABLE</b>			
DISCREPANCY DESCRIPTION: PER SEMAT I INSPECTION								
Port side (4-160-0-Q), Tank top under drain line from sewage transfer pump, inside coaming behind oily waste separator has surface rust and Paint separation. Approximately 6sf. U/T readings were satisfactory.

PORT SIDE, TANK TOP UNDER DRAIN FROM SEWAGE TRANSFER PUMP INSIDE COAMING.  
RECOMMENDED FOR PRESERVATION AND PAINT.

RECOMMENDED REPAIRS:								
Needle-gun approximately 6sf of area, preserve and paint to match.								
SSPORT C221 POC: F. PRAISSMAN (757) 396-4001 EXT 2130, TPOC: T. ZWOLAK								
CSMP SUMMARY: Area specified has light corrosion and paint separation.					TEST# MRC 1102/1			
ROOT CAUSE/AMPLIFICATION: H1					STEP# 1,2,3,4 & 5			
SYSTEM LEVEL IMPACT:								
PART NO.	NOMEMCLATURE			QTY	NSN	COST		
1								
2								
3								
4								
5								
6								
FIRST CONTACT PEDRAZOLI	RATE DC1	SECOND CONTACT PEDRAZOLI		RATE DC1	PHONE 52			
ASSESSOR / ACT / TECH ID# J. LaROCK / T. ILGENFRITZ QED SYSTEMS				TD	TL	LOGISTICIAN	TSP

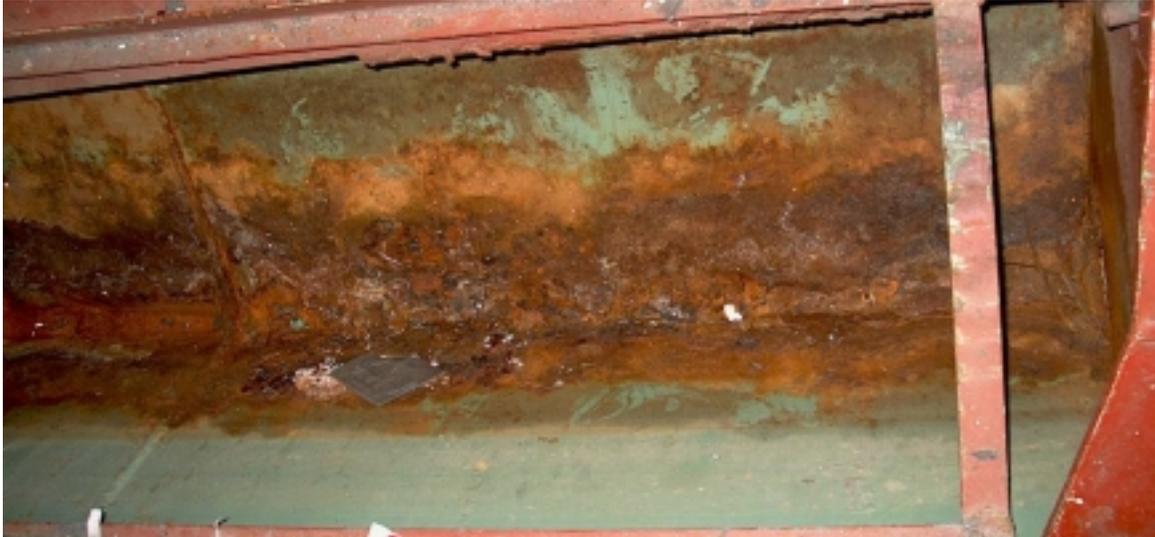
SSPORT C221 POC: F. PRAISSMAN (757) 396-4001 EXT 2130, TPOC: T. ZWOLAK								
CSMP SUMMARY: Area specified has surface rust and heavy paint separation.					TEST# MRC 1102/1			
ROOT CAUSE/AMPLIFICATION: H1					STEP# 1,2,3,4 & 5			
SYSTEM LEVEL IMPACT:								
PART NO.	NOMEMCLATURE			QTY	NSN		COST	
1								
2								
3								
4								
5								
6								
FIRST CONTACT KING	RATE SH2	SECOND CONTACT KING		RATE SH2	PHONE 22			
ASSESSOR / ACT / TECH ID# J. LaROCK / T. ILGENFRITZ QED SYSTEMS				TD	TL	LOGISTICIAN	TSP

PORT SIDE, BILGE POCKET, BETWEEN WEB FRAME (148-164) HAS HEAVY RUST AND PAINT SEPARATION. AREA IS RECOMMENDED FOR PRESERVATION AND PAINT.

<b>SAFETY HAZARD:</b> 1. SERIOUS - CORRECT AS SOON AS POSSIBLE 2. SERIOUS - SUSPENSION OF EQUIPMENT/SYSTEM/SPACE REQUIRED 3. SERIOUS - WAIVER OF EQUIPMENT/SYSTEM 4. <b>SAFETY ITEM - MINOR</b> 5. COMBUSTIBLE MATERIAL		1. MAINTENANCE ACTION COMPLETED: PARTS DRAWN FROM SUPPLY 2. MAINTENANCE ACTION COMPLETED: REQUIRED PARTS NOT DRAWN FROM SUPPLY 3. MAINTENANCE ACTION COMPLETED: NO PARTS REQUIRED 4. CANCELLED - DEFERRAL WILL BE REMOVED FROM CSMP 7. <b>MAINTENANCE ACTION COMPLETED: 3-M CAPABILITY UTILIZED</b> 0. NONE OF THE ABOVE, DESCRIBE IN REMARKS/DESCRIPTION SECTION			1. MANDATORY 2. ESSENTIAL 3. HIGHLY DESIRABLE 4. <b>DESIRABLE</b>			
DISCREPANCY DESCRIPTION: PER SEMAT I INSPECTION Port side (4-140-0-Q), bilge pocket between WF (148-164), approximately 48sf has surface rust and heavy paint separation.								
RECOMMENDED REPAIRS: Needle-gun approximately 48sf of area, preserve and paint to match.

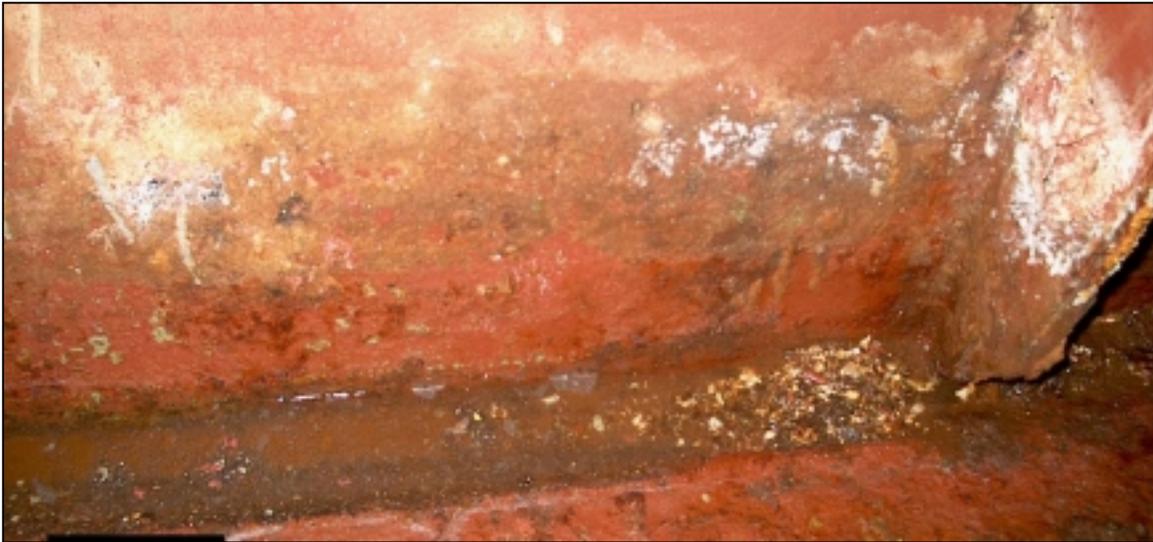
STBD SIDE, BILGE POCKET,  
RECOMMENDED FOR PRESERVATION AND PAINT.

RECOMMENDED REPAIRS: Needle-gun approximately 54sf of entire area, preserve and paint to match.								
SSPORT C221 POC: F. PRAISSMAN (757) 396-4001 EXT 2130, TPOC: T. ZWOLAK								
CSMP SUMMARY: Area specified has rust and paint separation.					TEST# MRC 1102/1			
ROOT CAUSE/AMPLIFICATION: H1					STEP# 1,2,3,4 & 5			
SYSTEM LEVEL IMPACT:								
PART NO.	NOMEMCLATURE			QTY	NSN	COST		
1								
2								
3								
4								
5								
6								
FIRST CONTACT PEDRAZOLI	RATE DC1	SECOND CONTACT PEDRAZOLI		RATE DC1	PHONE 52			
ASSESSOR / ACT / TECH ID# J. LaROCK / T. ILGENFRITZ QED SYSTEMS				TD	TL	LOGISTICIAN	TSP
