# SEMAT I

## USS SIMPSON (FFG 56)

### SHELL CONDITION ASSESSMENT SURVEY INTERIOR AREAS

6/1/01 TO 6/8/01

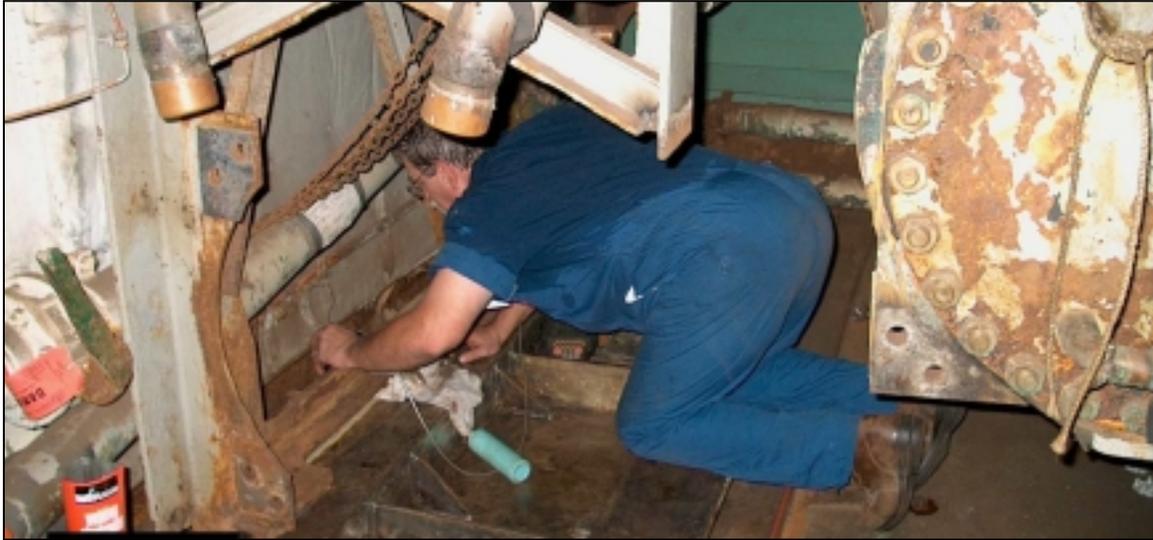
PORT SIDE, A/C CONDENSER FOUNDATION AT BHD 100

Were taken 2" above the deck, behind foundation were <b>.139, .180, .177, .176, .239 and .254.</b>								
<b>.108.</b> Readings on BHD (100) The minimum is <b>.213</b>								
RECOMMEND REPAIR Activity: Cut out approximately 30sf of tank top/deck, replace with .250 steel. Cut out approximately 10sf of BHD (100), from deck up 12", Replace with 250 steel, preserve and paint to match.								
FTSC is to conduct risk assessment and make final repair recommendations.								
SSPORT C221 POC: F. PRAISSMAN (757) 396-4001 EXT 2130, TPOC: T. ZWOLAK								
CSMP SUMMARY: Deck under A/C foundation and BHD (100) severely deteriorated.					TEST# MRC 1102/1			
ROOT CAUSE/AMPLIFICATION: H1					STEP# 1,2,3,4 & 5			
SYSTEM LEVEL IMPACT:								
PART NO.	NOMEMCLATURE			QTY	NSN		COST	
1								
2								
3								
4								
5								
6								
FIRST CONTACT LARSEN	RATE EN3	SECOND CONTACT LARSEN		RATE EN3	PHONE 22			
ASSESSOR / ACT / TECH ID# J. LaROCK / T. ILGENFRITZ QED SYSTEMS				TD	TL	LOGISTICIAN	TSP

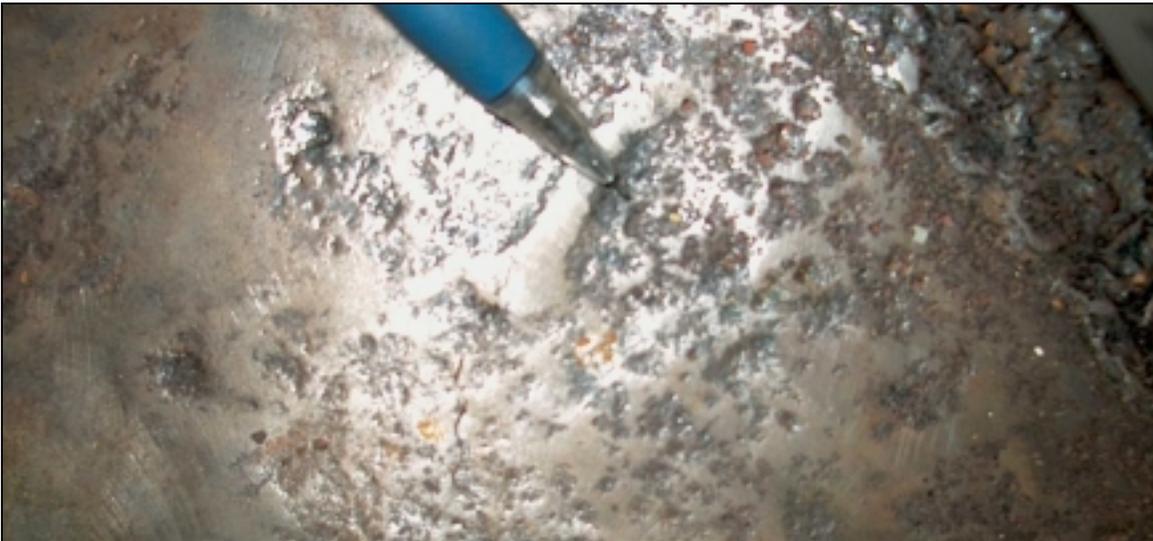
HEAVY PITTING NOTED INSIDE FOUNDATION FOR THE A/C CONDENSER UNIT.  
U/T READINGS ARE NOTED ON DRAWING.

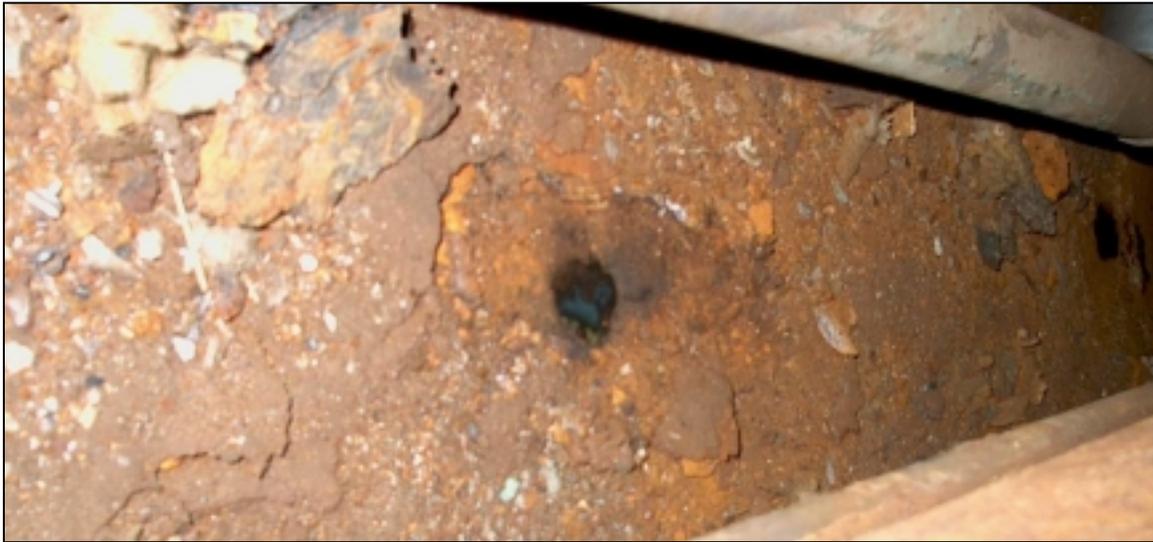
PORT SIDE, BETWEEN A/C CONDENSER FOUNDATION AND BHD 100  
U/T READINGS ARE ON DRAWING

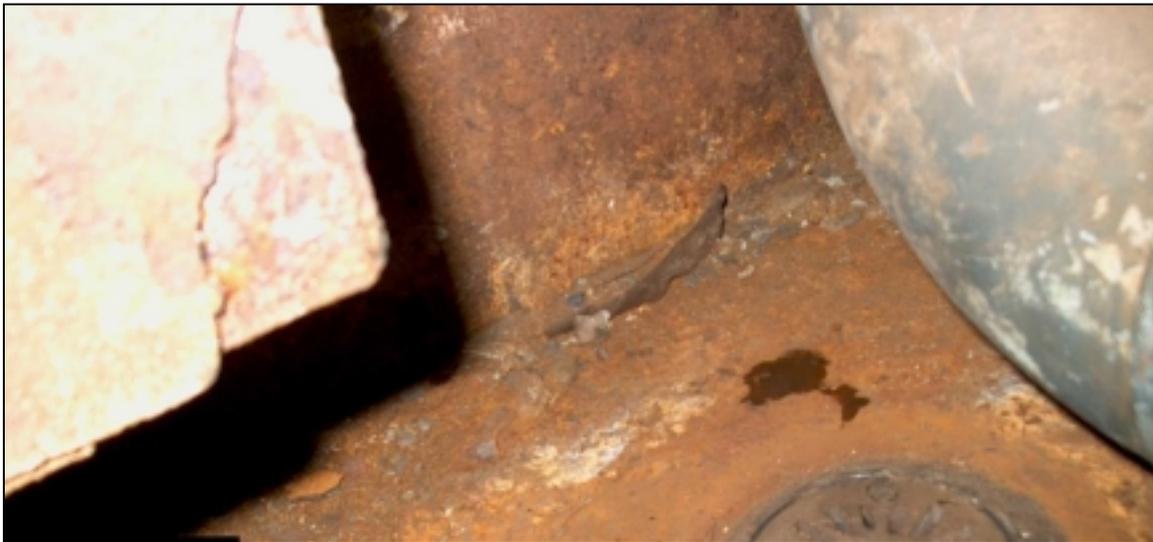
DECK AND BHD 100  
U/T READINGS ARE NOTED ON DRAWING.

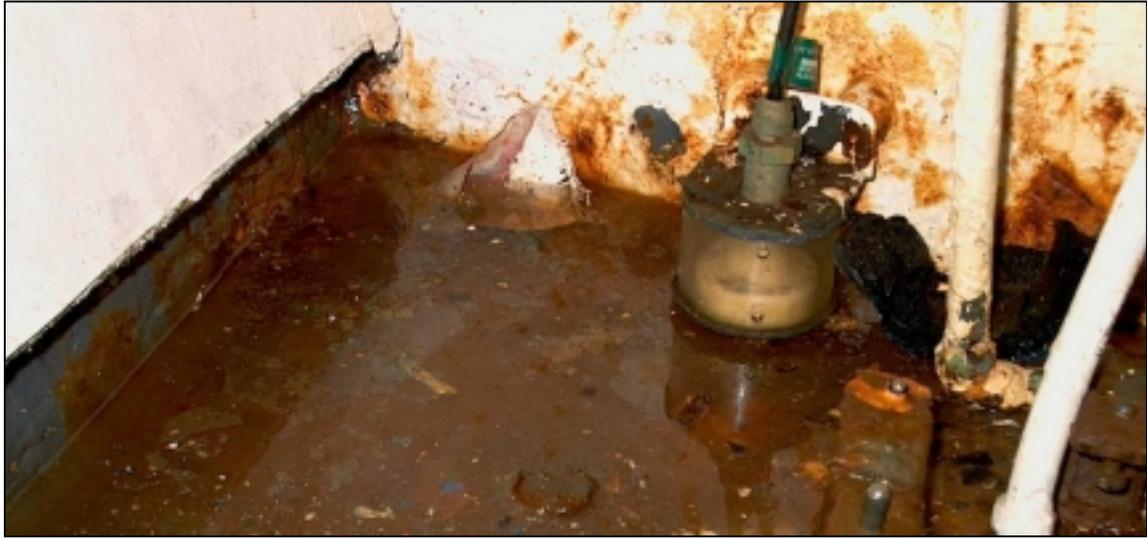
STBD SIDE, LOOKING AFT AT BHD 56 LIGHT THINNING WAS NOTED.  
U/T READINGS ARE SHOWN IN DRAWING.

RECOMMENDED REPAIRS:								
Remove approximately 48sf of lagging. Needle-gun, preserve and paint areas exposed by removals, replace with 2" hull board. Clean approx 4sf of BHD (56), preserve, paint to match area.								
SSPORT C221 POC: F. PRAISSMAN (757) 396-4001 EXT 2130, TPOC: T. ZWOLAK								
CSMP SUMMARY: saturated lagging, mild corrosion and paint separation.					TEST# MRC 1102/1			
ROOT CAUSE/AMPLIFICATION: H1					STEP# 1,2,3,4 & 5			
SYSTEM LEVEL IMPACT:								
PART NO.	NOMEMCLATURE			QTY	NSN		COST	
1								
2								
3								
4								
5								
6								
FIRST CONTACT HOPPER		RATE STG3	SECOND CONTACT HOPPER		RATE STG3	PHONE 28/700/720		
ASSESSOR / ACT / TECH ID# J. LaROCK / T. ILGENFRITZ QED SYSTEMS				TD	TL	LOGISTICIAN	TSP

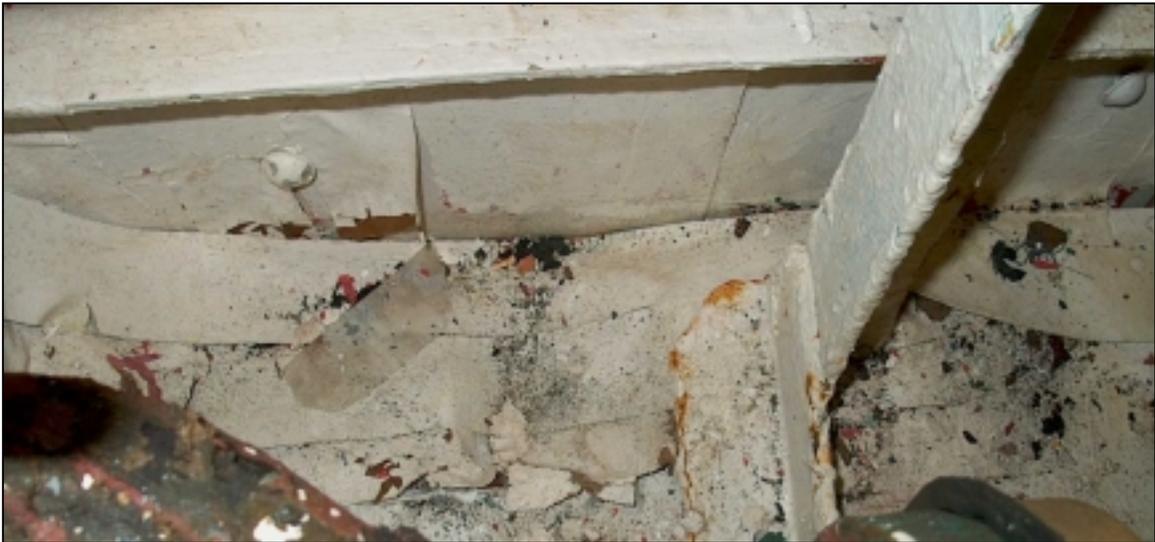
DAMAGED LAGGING ON SHELL PLATE  
REPLACEMENT RECOMMENDED.
