**USS SPRUANCE (DD 963)  
SHELL CONDITION ASSESSMENT SURVEY  
INTERIOR AREAS  
6/4/01 – 6/15/01**

**PREPARED BY:  
SUPSHIP PORTSMOUTH  
6/28/01**

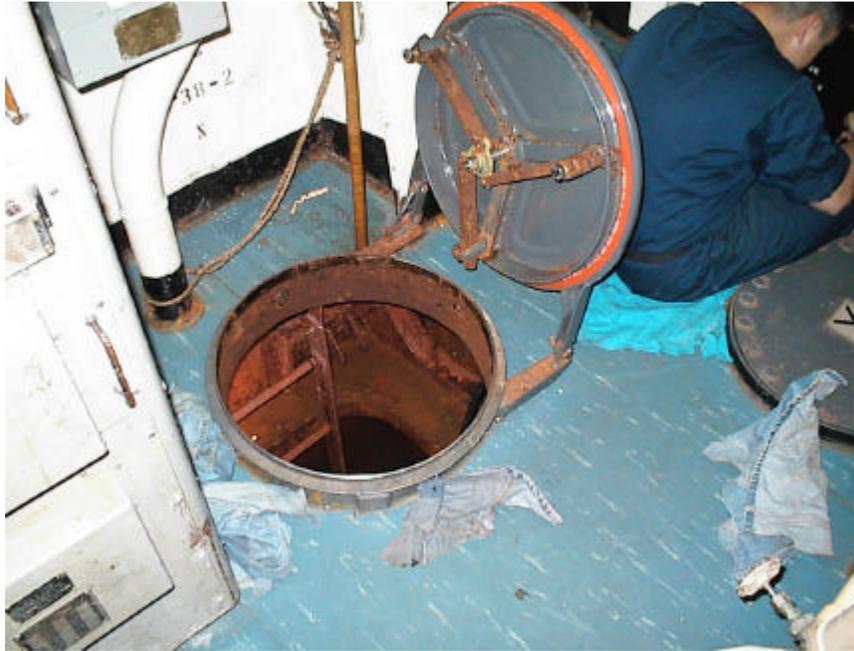
Looking at the access scuttle from SONAR 4, 4-34-0-Q. Space is only about 4' deep

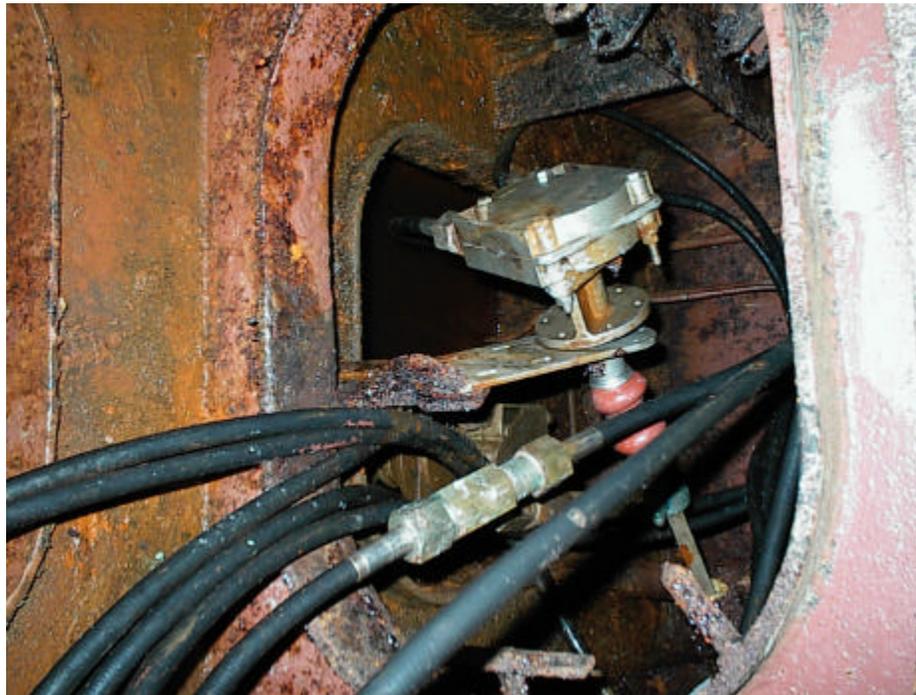
- 1. 2K submitted: CA01-A004 – Cleaning and preservation**
- 2. Heavy corrosion over the entire space**

Looking forward into the space, the extent of corrosion and inaccessibility is apparent.  
(CA01-A004)

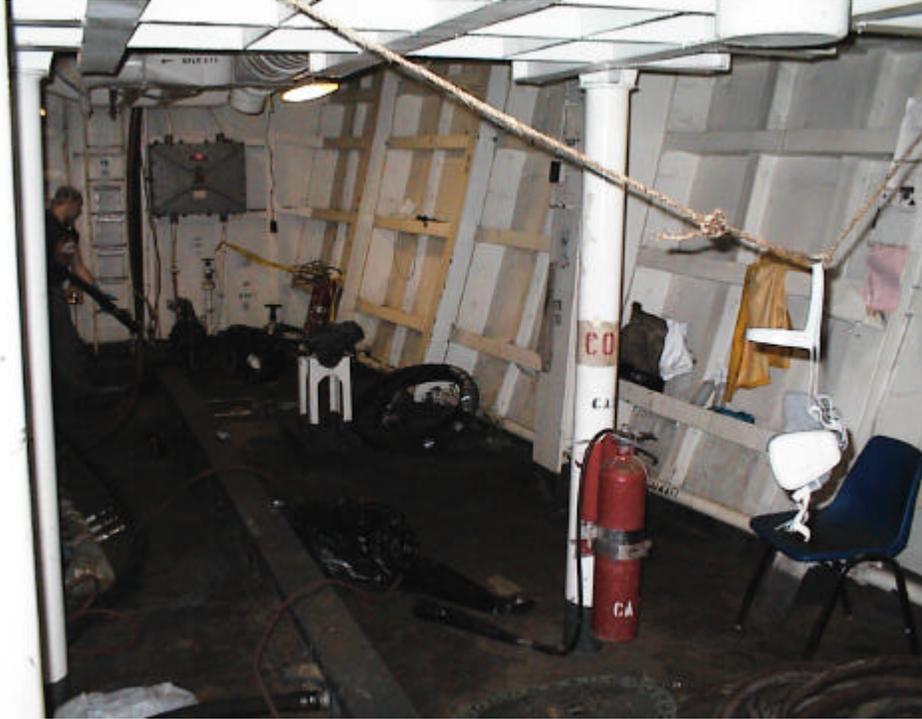
- 1. 2K's submitted: CA01-A002, CA01-A003**
- 2. Space appears to have been flooded about 2'. Some of the shell transverse members are corroded through at the deck. The transverse web frames are corroded but not structurally deteriorated. The space has no equipment at all in it.**

Looking aft at the port side. The bottom of some of the transverse stiffeners is 100% wasted

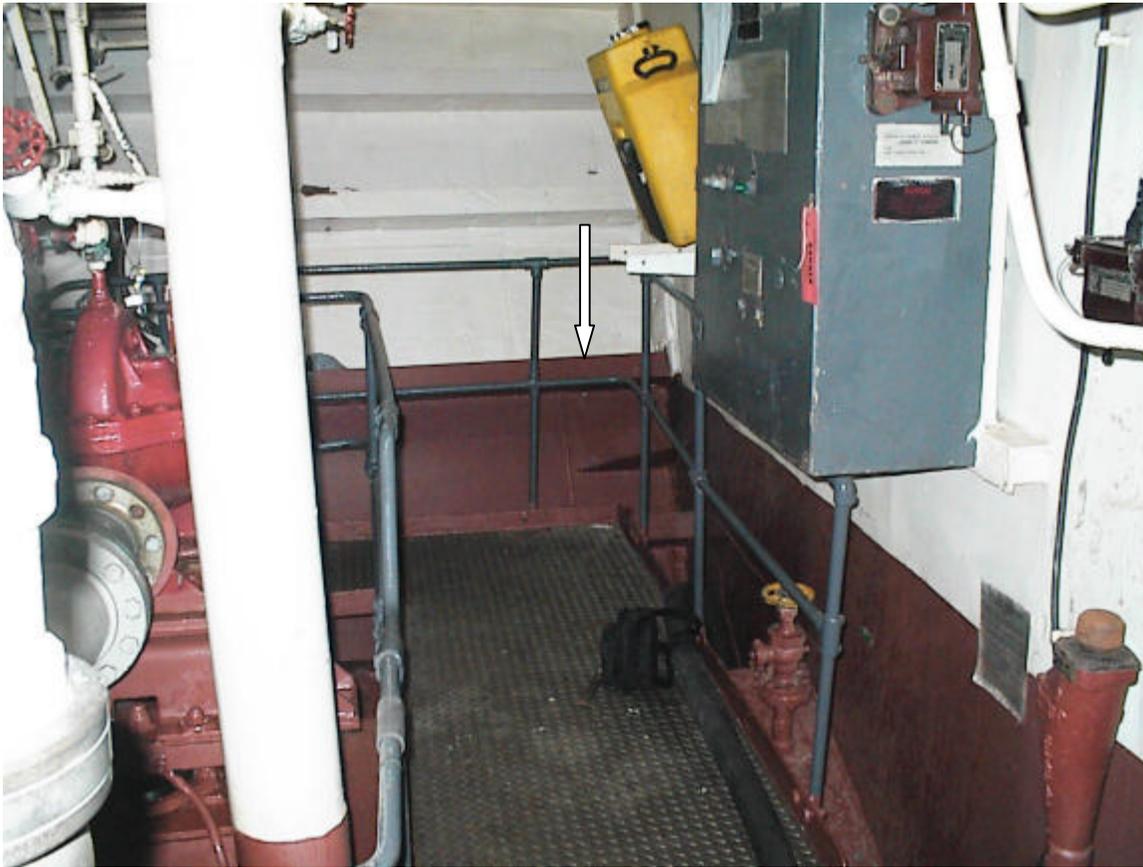
View looking outbd to stbd from FR 148. Firemain valve is leaking at FR 145, dripping into insulation. Stiffeners slant aft and moisture collects at FR 154, where arrow is pointed.(EE02-A170)

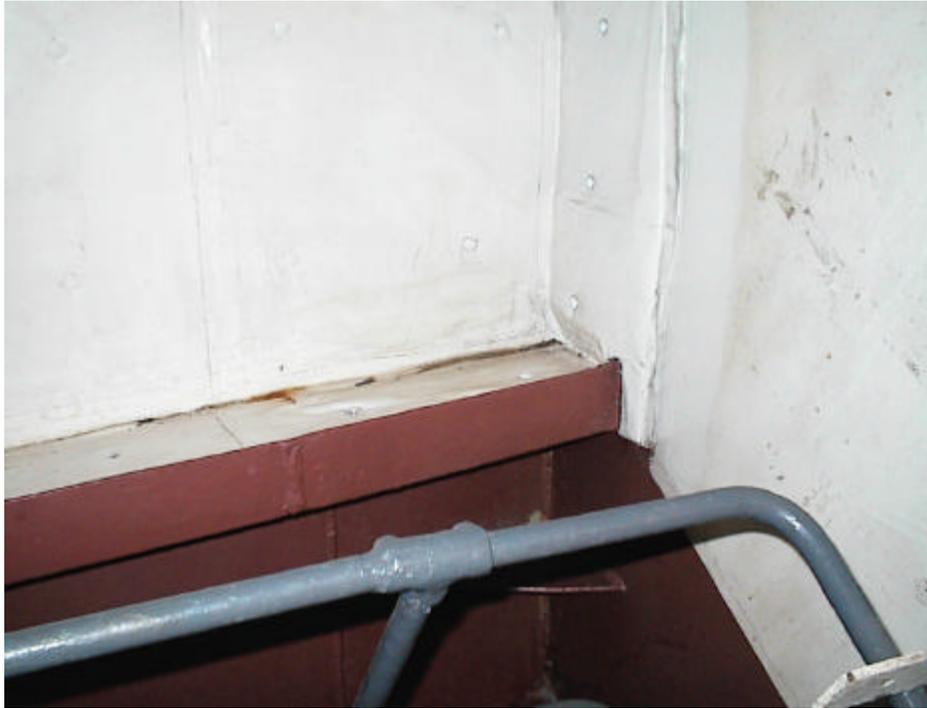
View looking at area indicated by the arrow on the previous page.

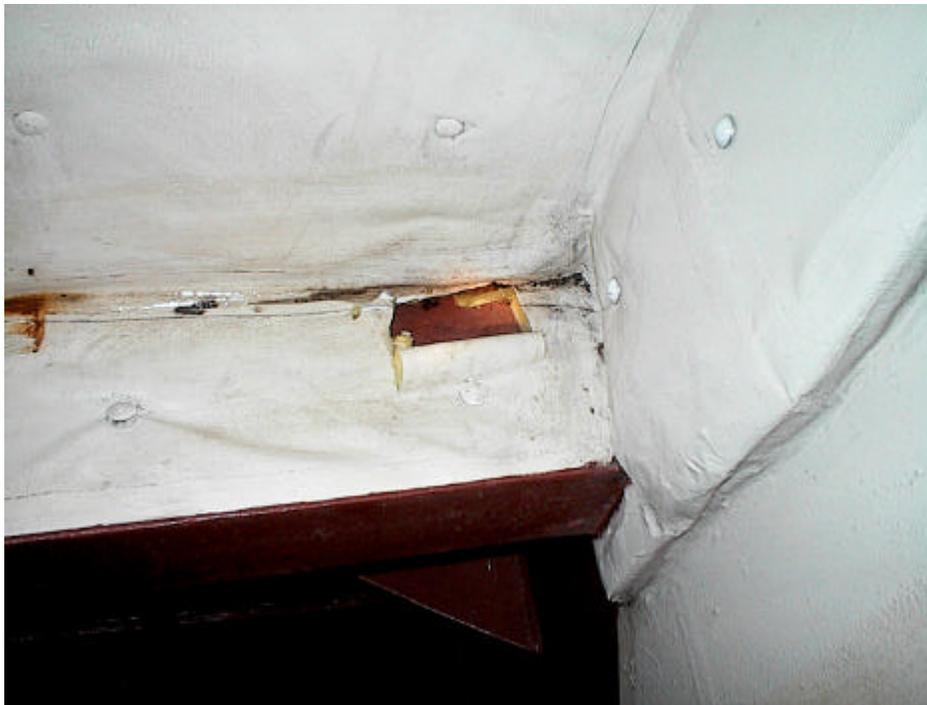
Insulation cutaway showing corrosion.

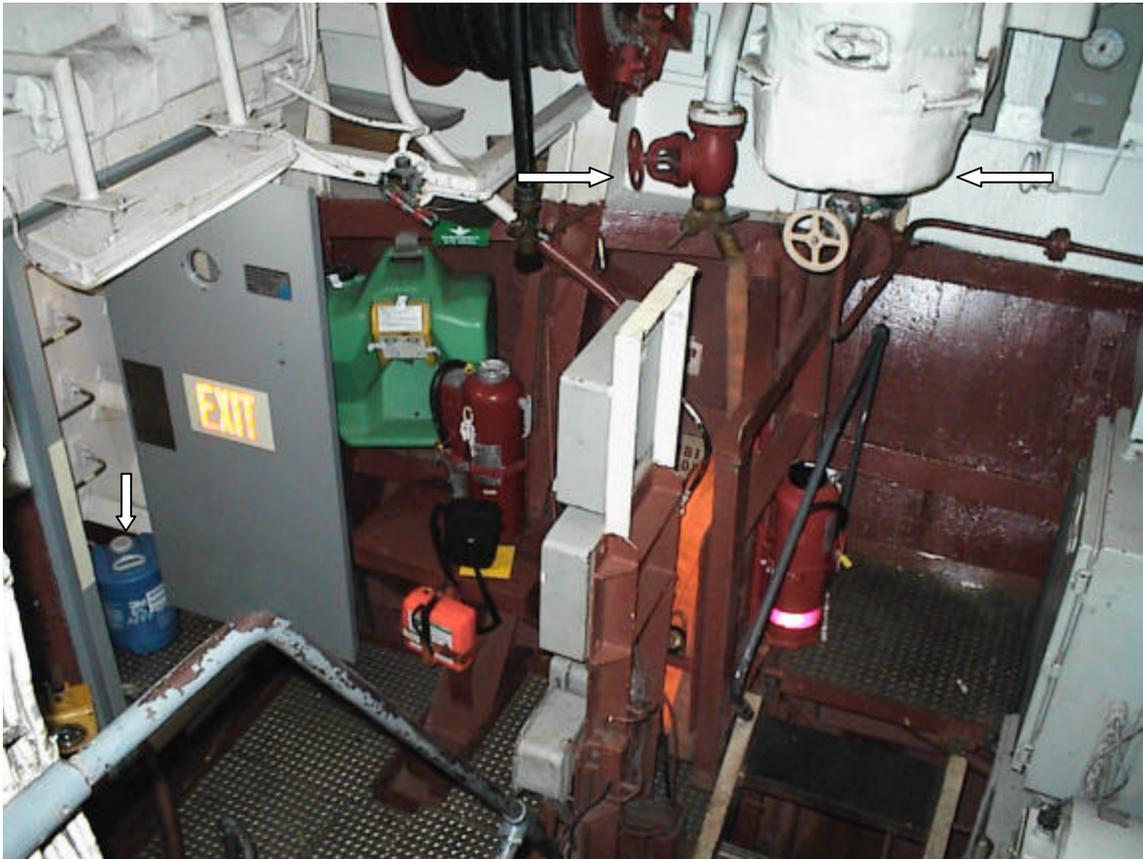
View facing outbd to stbd and forward at FR 174, looking from the throttle flats to the lower level. Note the AFFF drum in the trunk for reference. Also note the firestation and PRAIRIE MASKER cooler at FR 184.

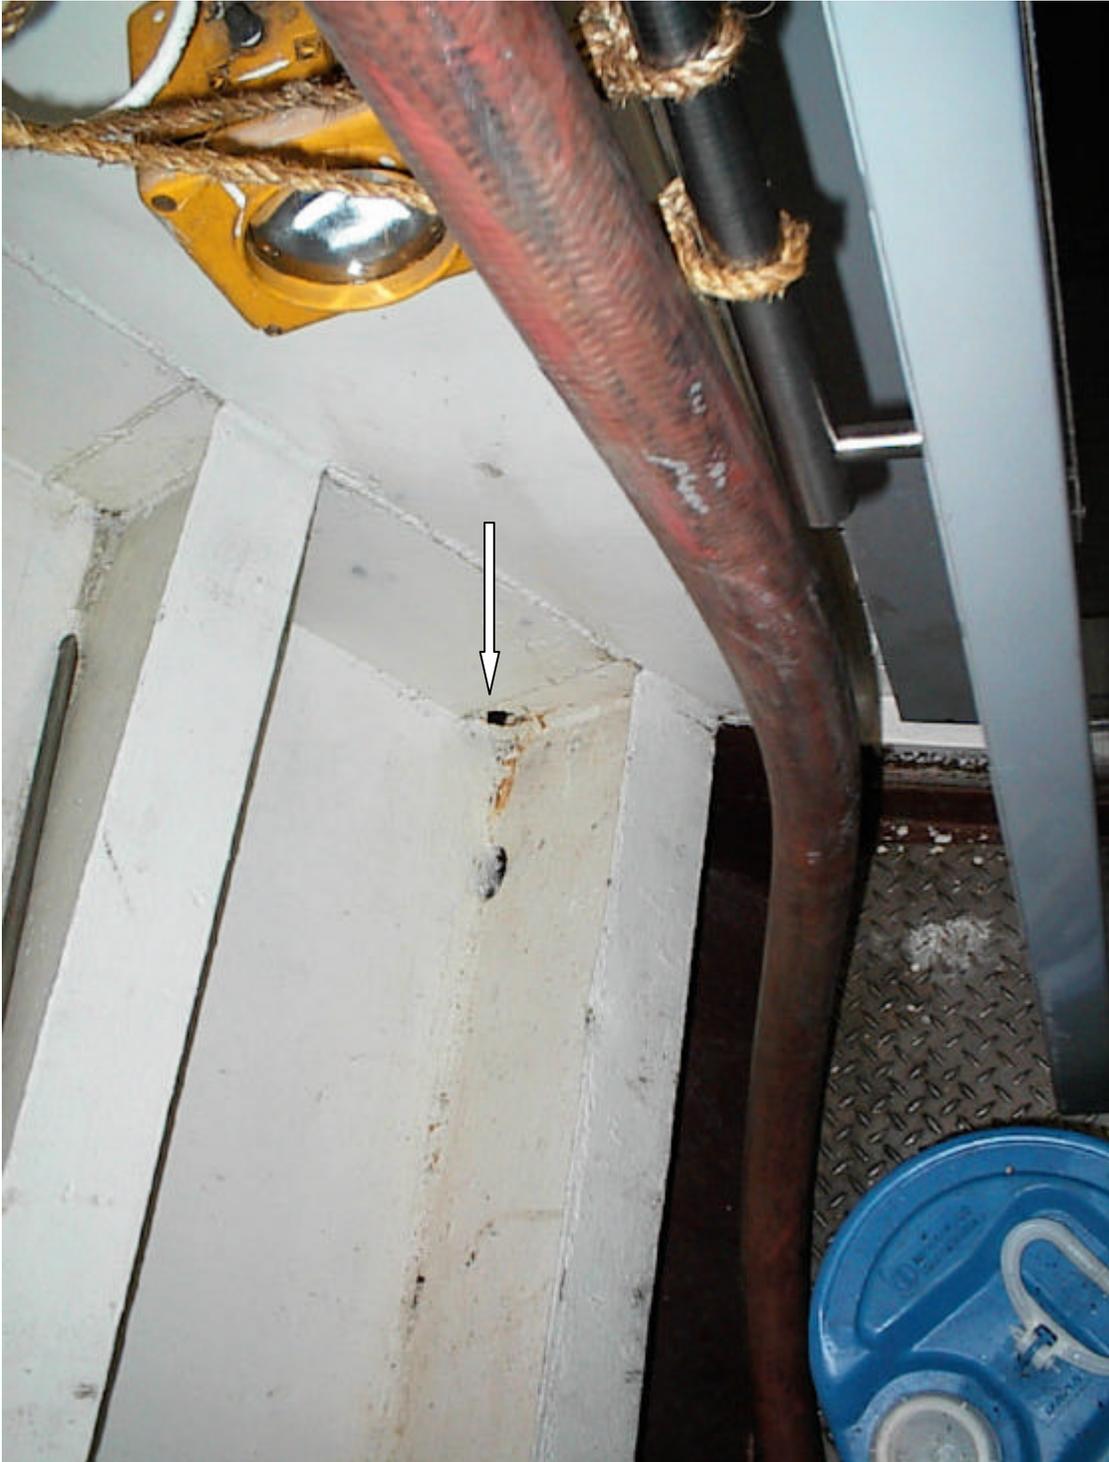
1. THE ESCAPE TRUNK AFT BULKHEAD AT FR 177 IS HOLED IN WAY OF THE 2ND AND 3RD LONGITUDINAL STIFFENERS ABOVE THE TANK TOP. APPROXIMATELY 6" DIAMETER AT EACH JOINT. PROBABLE CAUSE: FIRE STATION AT FR 182 AND MASKER AIR COOLER OVBD AT FR 184.

View looking aft toward FR 177, inside the escape trunk on the stbd side. The AFFF drum is visible in the corner. The watertight bulkhead is holed at the shell on both this stiffener and the next one under it.(EM01-A170)

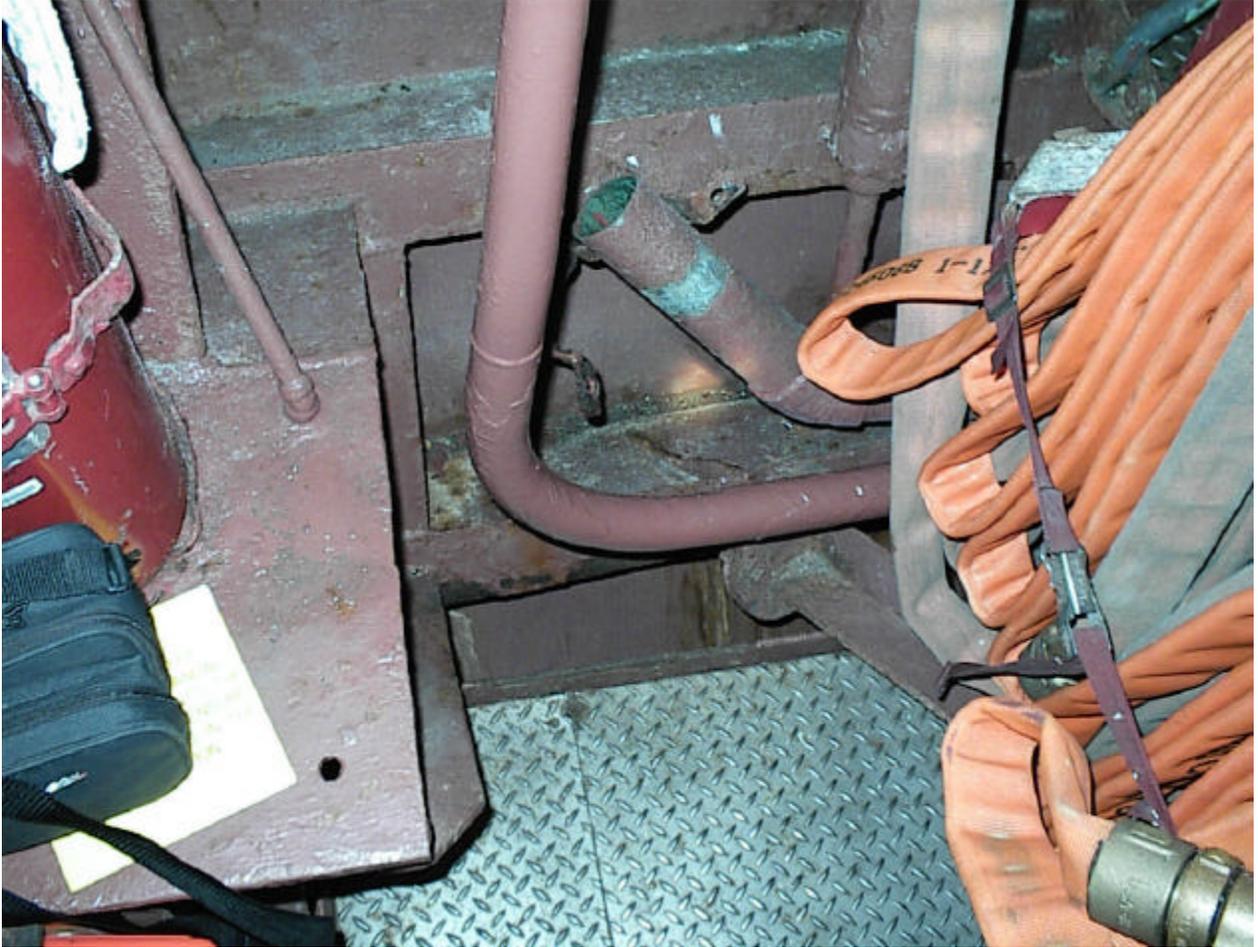
2. THE 3RD, 4TH AND 5TH LONGITUDINAL STIFFENERS ABOVE THE TANK TOP ARE HOLED APPROXIMATELY 20% OF THEIR LENGTH BETWEEN FR 180 AND 188. IT IS EXPECTED THAT POWER TOOL CLEANING WOULD RESULT IN MORE PINHOLES. PROBABLE CAUSE: FIRE STATION AT FR 182 AND MASKER AIR COOLER OVBD AT FR

This area is directly under the PRAIRIE MASKER cooler at FR 185. The stiffeners have been painted but have extreme corrosion and are holed.(EM01- A171 & EM01 A172)

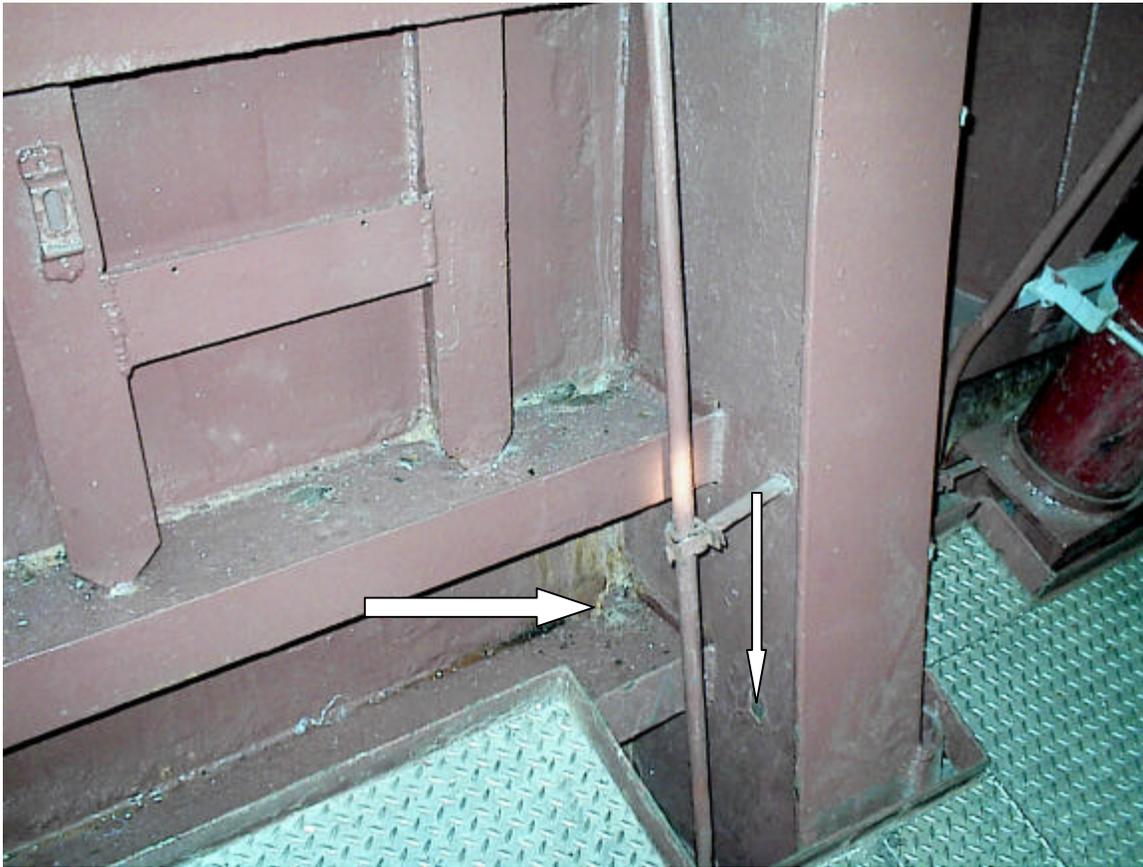
Heavy corrosion and pinholing at FR190 stbd. Note the heavy scaling and blistering on the transverse member and pitting of the shell.(EM01- A173)

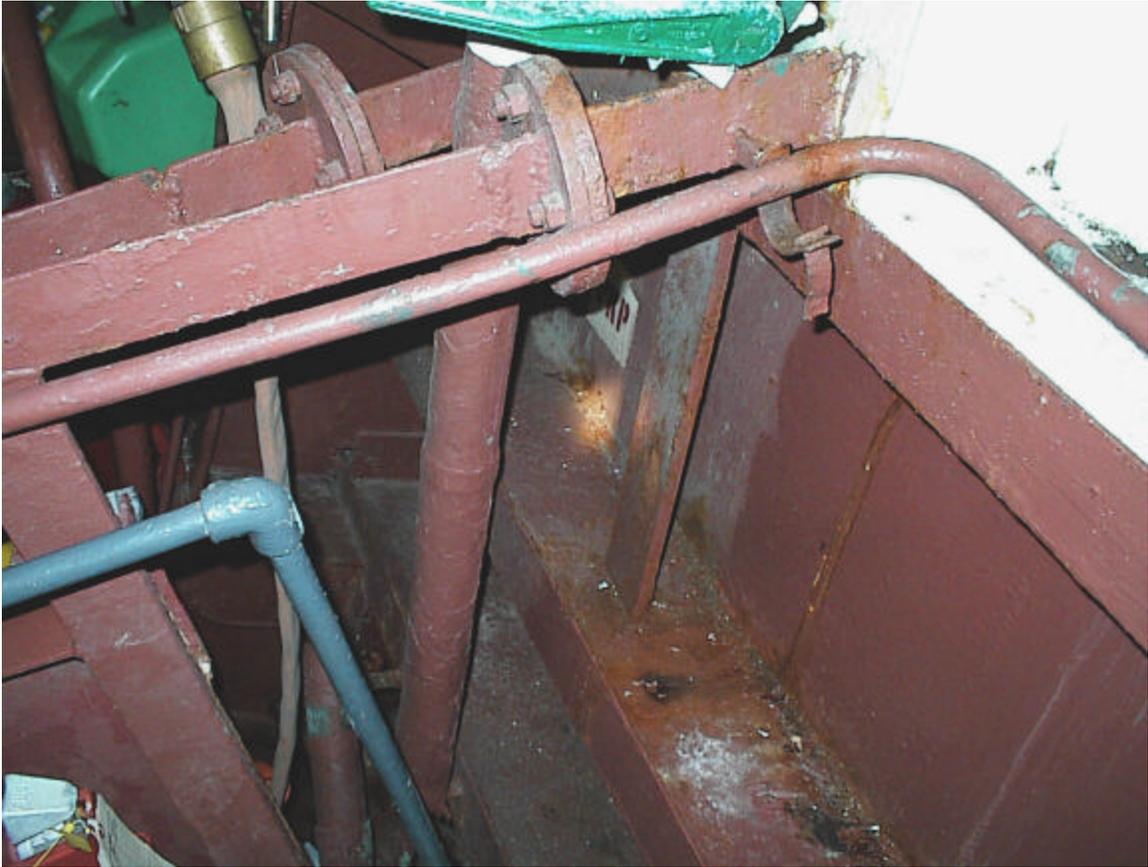
3. THE 1ST AND 2ND LONGITUDINAL STIFFENERS ABOVE THE TANK TOP ARE HEAVILY CORRODED BETWEEN FR 180 AND 188. THE AREA WAS FLOODED AT THE TIME OF THE SURVEY AND WILL REQUIRE INDUSTRIAL EFFORT TO ACCESS. IT IS EXPECTED THAT POWER TOOL CLEANING WOULD RESULT IN SIGNIFICANT HOLES. PROBABLE CAUSE: FIRE STATION AT FR 182 AND MASKER AIR COOLER OVBD AT FR

The 1<sup>st</sup> through the 4<sup>th</sup> stiffeners show heavy corrosion and pinholing at FR 184.  
Refraction of the image is due to approximately 18" of water in this section of the bilge.  
(EM01-A172)

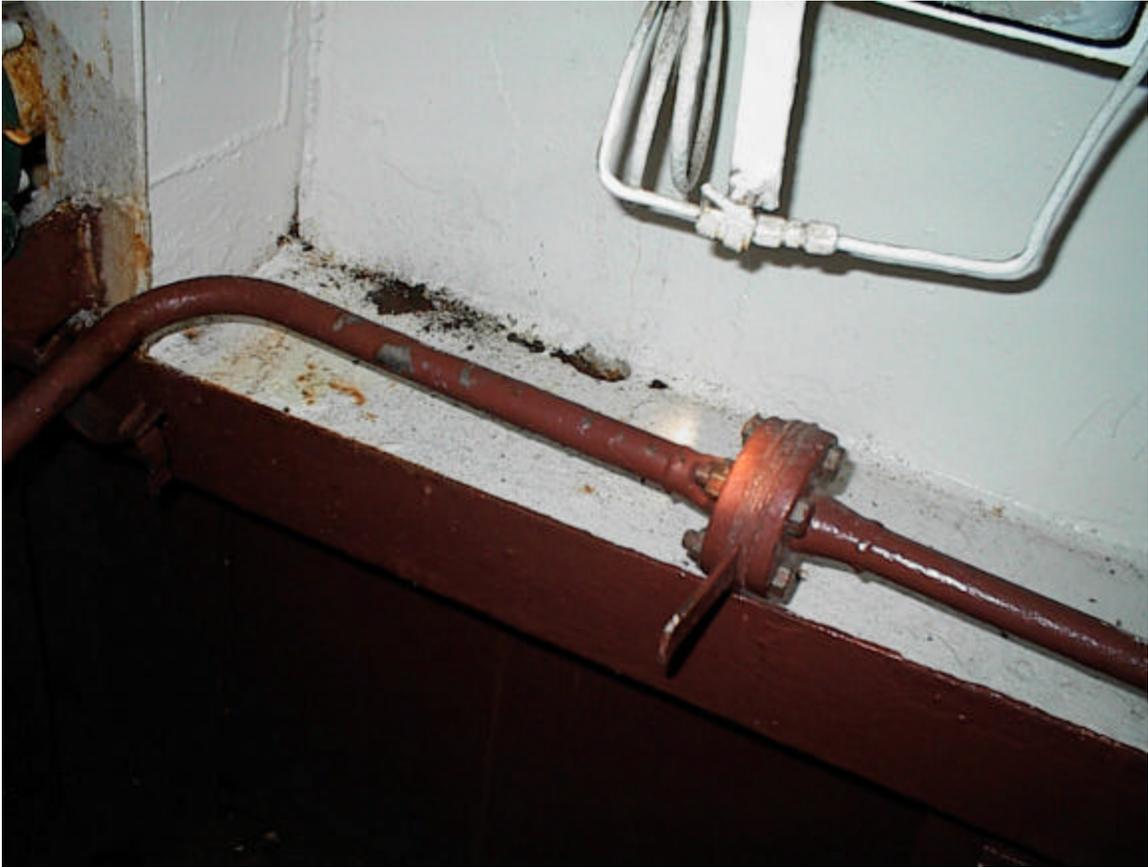
4. THE 3RD AND 4TH LONGITUDINAL STIFFENERS ABOVE THE TANK TOP ARE HEAVILY CORRODED AND 30% HOLED BETWEEN FR 190 AND 194. IT IS EXPECTED THAT POWER TOOL CLEANING WOULD RESULT IN MORE PINHOLES. PROBABLE CAUSE: GENERATOR L.O. COOLER SW VALVE AT FR 194.

Stiffener at FR194 is holed approximately one linear foot.(EM01-A173)

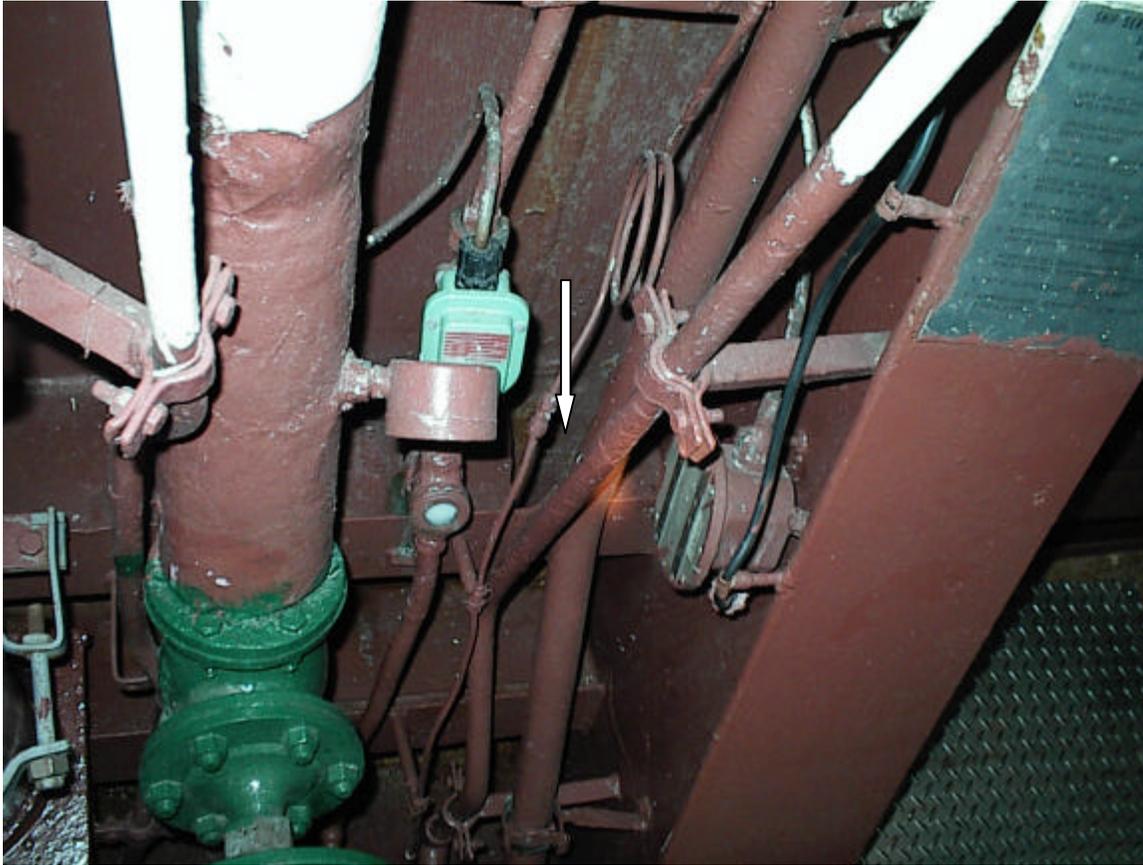
5. THE 5th LONGITUDINAL STIFFENER ABOVE THE TANK TOP IS MISSING APPROXIMATELY 1 SF OF WEB AT FR 195. CAUSE IS UNKNOWN.
6. THE 7TH LONGITUDINAL STIFFENER ABOVE THE TANK TOP IS HOLED (APPROX. 4" SQUARE) AT FR 204. CAUSE IS UNKNOWN.

A 1' section missing from the web of the 5<sup>th</sup> stiffener above the tank top at FR 195.(EM01-A174)

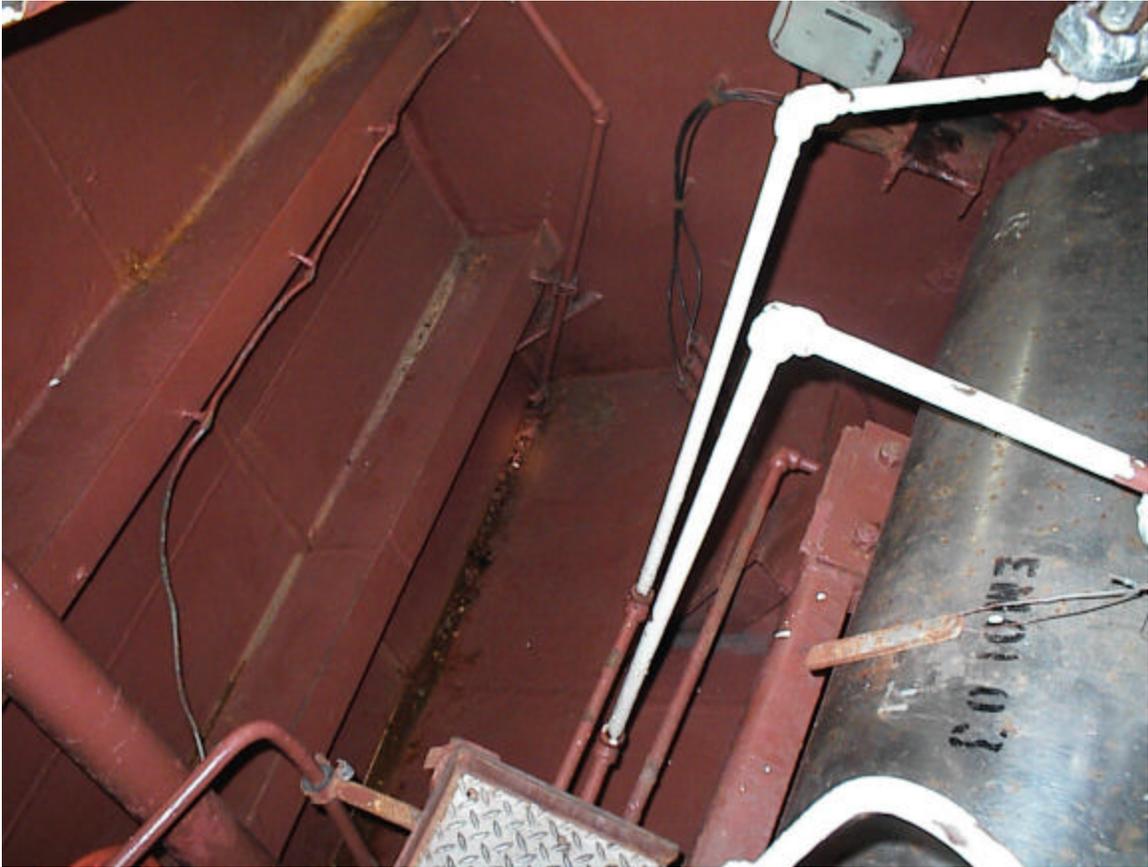
7. THE 3RD AND 4TH LONGITUDINAL STIFFENERS ABOVE THE TANK TOP ARE HEAVILY CORRODED AND 20% HOLED BETWEEN FR 204 AND 208. IT IS EXPECTED THAT POWER TOOL CLEANING WOULD RESULT IN MORE PINHOLES. PROBABLE CAUSE: SW PUMP AT FR 208 AND SW OVBD AT FR 205.

The stiffeners and tanktop joint are heavily corroded and the stiffeners are pinholed under the sw pump and strainers at FR 205 – 208. Deck grates are removed. (EM01-A176)

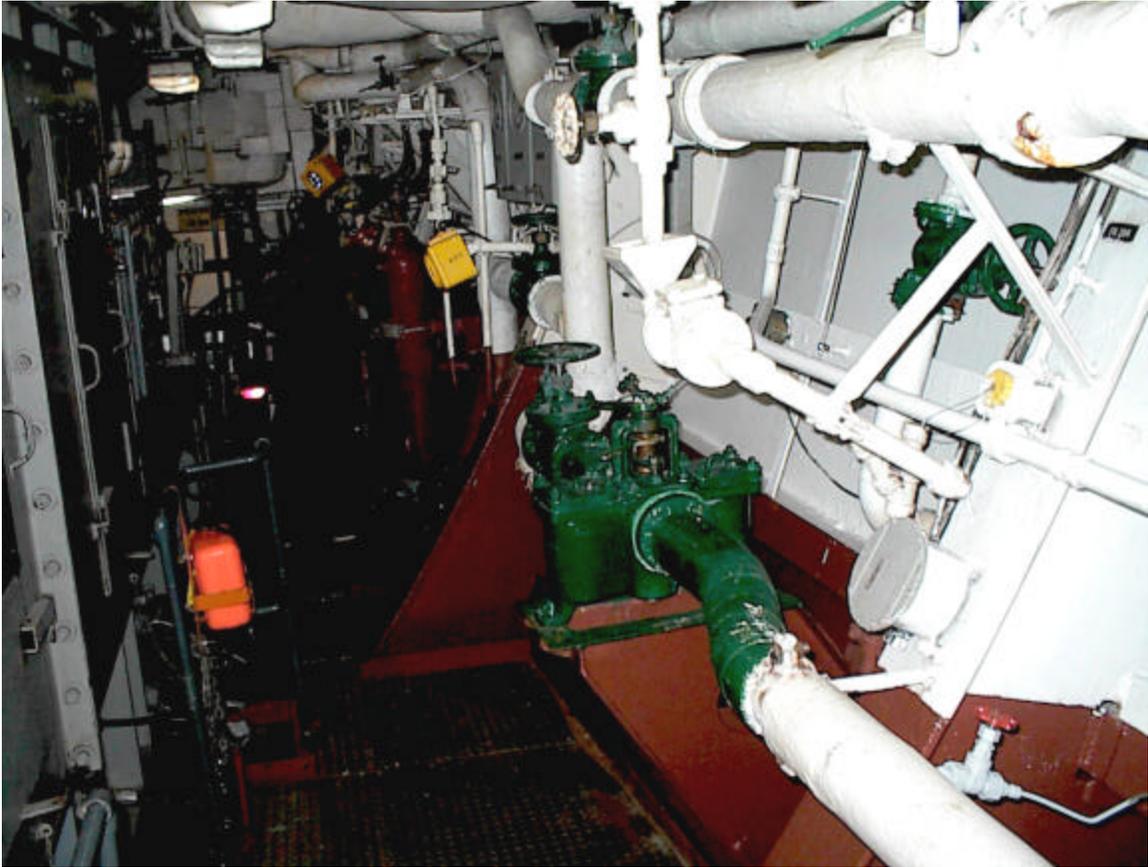
View facing forward from FR 220, along the port shell, lower level, outboard of the generator. This area has extensive structural corrosion, primarily due to the concentration of seawater service system components. The bilge area is accessible with some difficulty. Because of the limited accessibility, the area is corroded from the tanktop to the U/L gratings

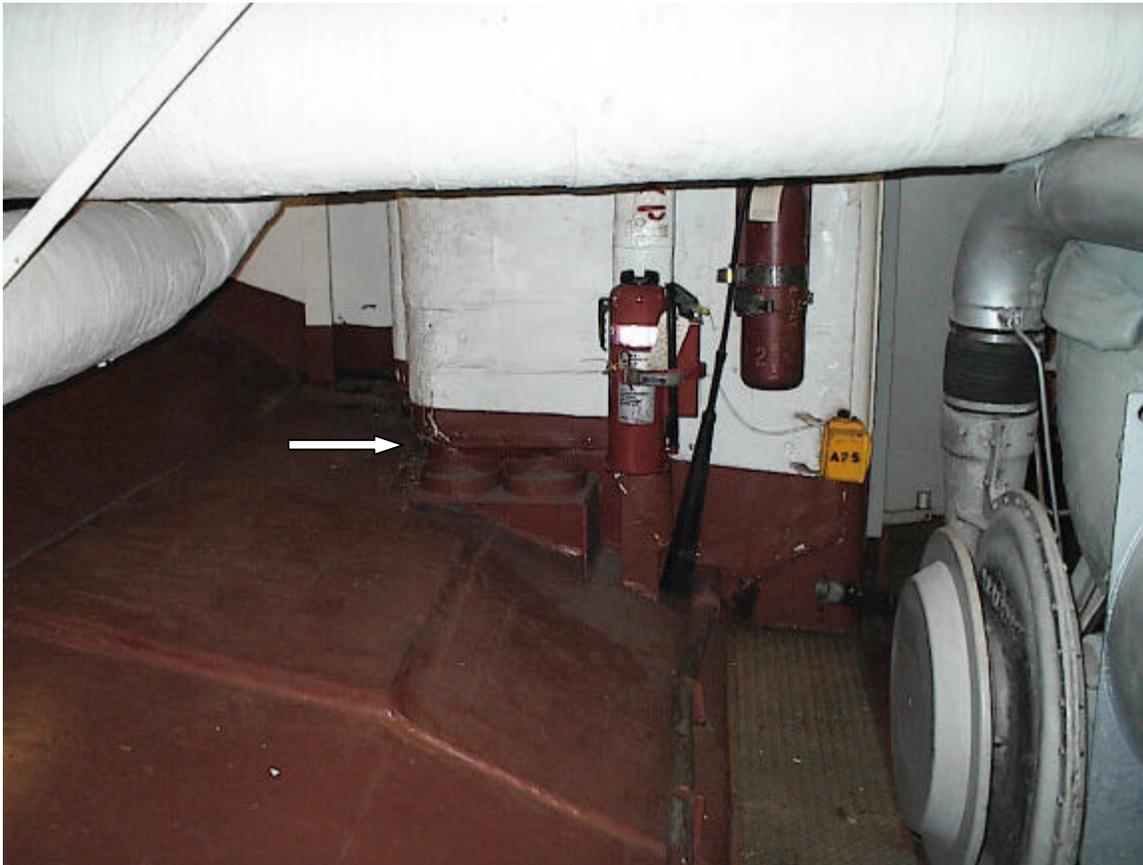
View, facing aft at FR 300 on the port side. The shell is outbd, where the deck appears to slope down. The arrow indicates the outbd side of the trunk. The pictures taken depict the corrosion typical throughout the area. (EA04-A463)

<b>REMOVE CORROSION AND PRESERVE THE 4' INBD AND OUTBD OF THE ESCAPE TRUNK AND THE ADJOINING 1' OF TANKTOP. TRIM BACK ACCOUSTIC COVERING IN WAY OF PRESERVATION.</b>					
<b>SSPORT C221 POC: J. BRUCKNER (757) 396-4001, TPOC: D. SMITH /HUGHES, CDI</b>					
CSMP SUMMARY <b>AMR NO. 2 (5-260-0-E) DECK AND BHD CORRODED</b>				TEST # <b>MRC 1102/1</b>	
ROOT CAUSE/AMPLIFICATION <b>H1</b>				STEP # <b>2.a.</b>	
SYSTEM LEVEL IMPACT					
PART NO.	NOMENCLATURE	QTY	NSN	COST	
FIRST CONTACT <b>DAVIS</b>	RATE <b>EN1</b>	SECOND CONTACT <b>LASSANDRO</b>	RATE <b>ENC</b>	PHONE	
BLUEPRINTS, TECH MANUALS, PLANS, ETC.				ON BOARD <b>YES</b> NO	
ASSESSOR / ACT / TECH ID# <b>SPORT 221/ D. SMITH/ HUGHES, CDI</b>			TD	TL	LOGISTICIAN TSP

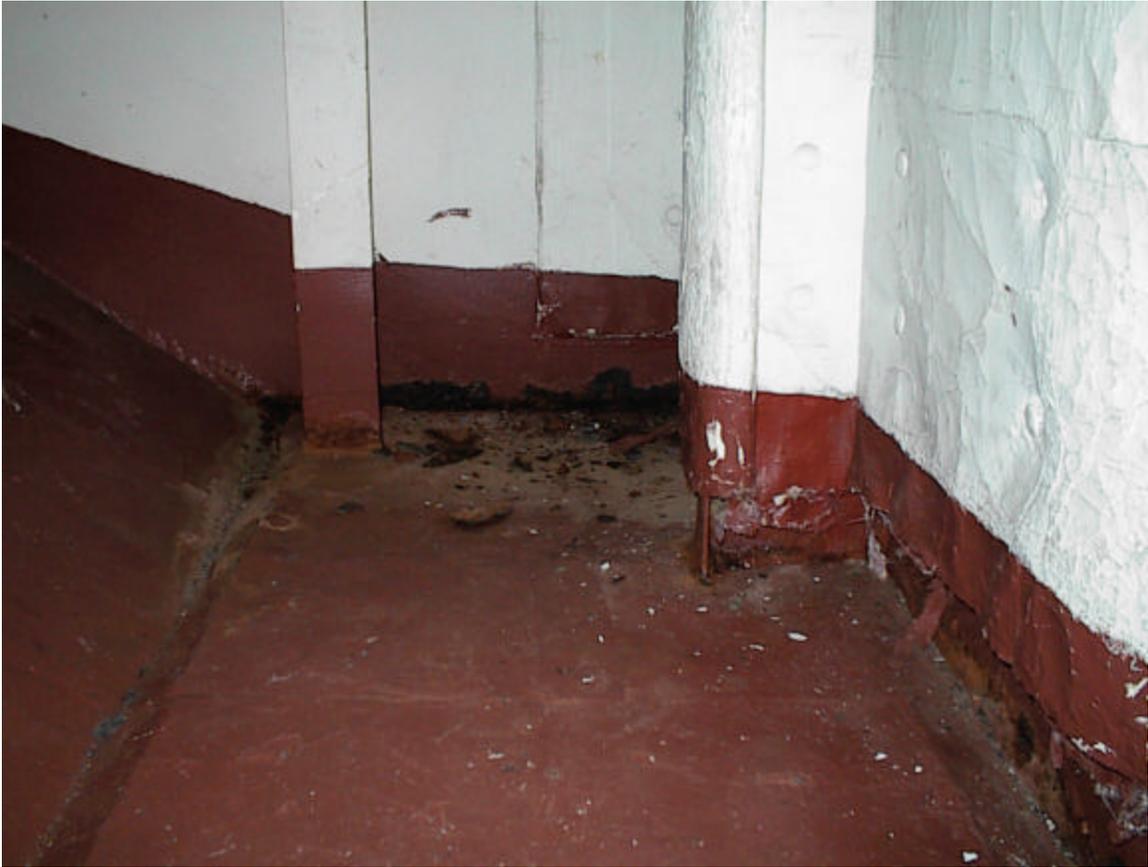
View looking at area indicated by the arrow on the previous page. Corrosion follows the perimeter of the escape trunk and then the joint between the tank top and shell.

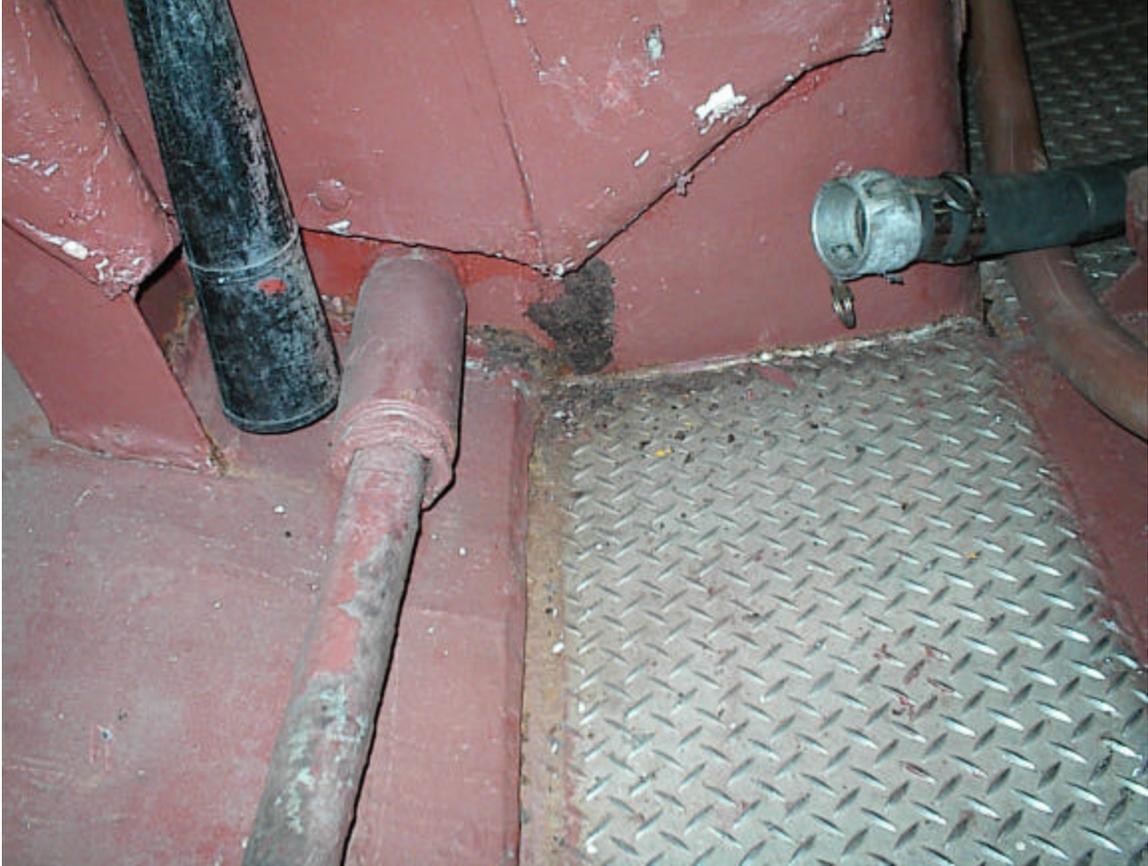
Aft bulkhead of the escape trunk, FR 300, showing corrosion at the edge of the acoustic tile. This is typical of the corrosion at the joint between the tank top and the shell where the tile is installed

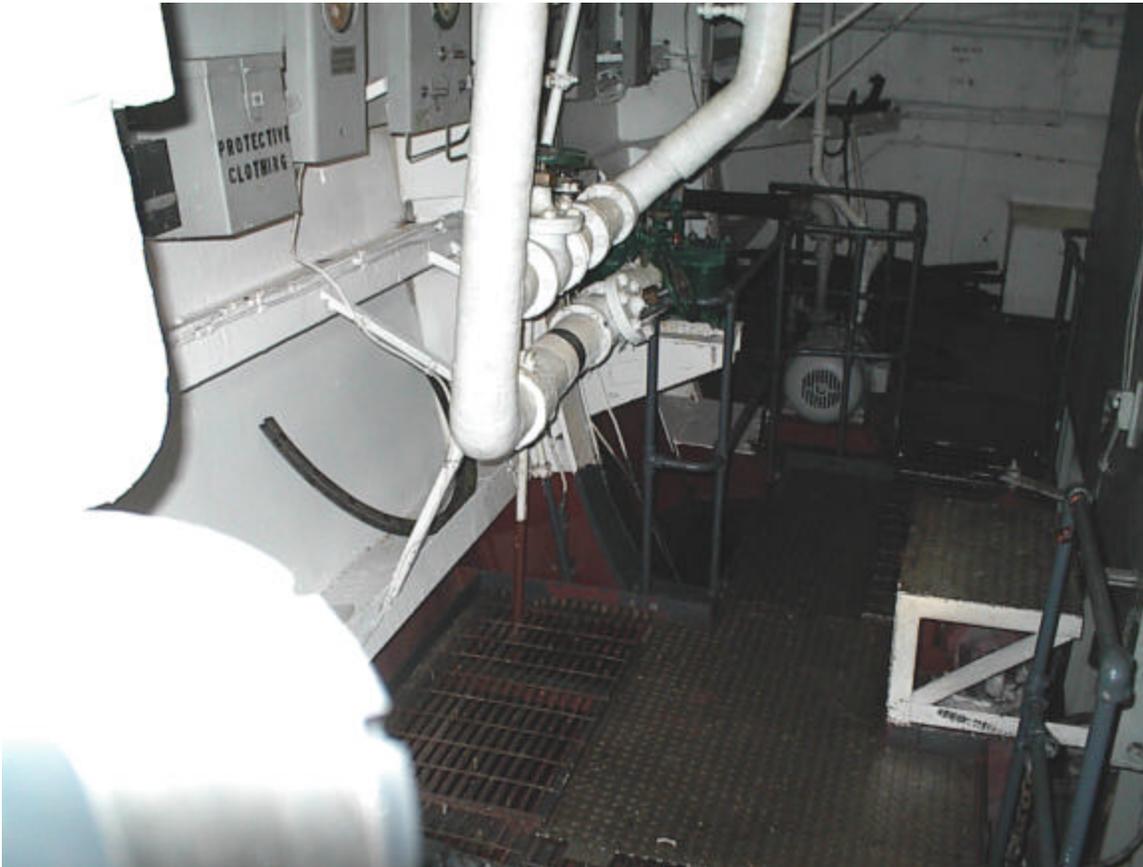
View facing forward from FR 330 along the port shell at the L/L. Notes the seawater reducing station, pump and strainers. These units contribute to seawater leakage into the structure, resulting in corrosion.

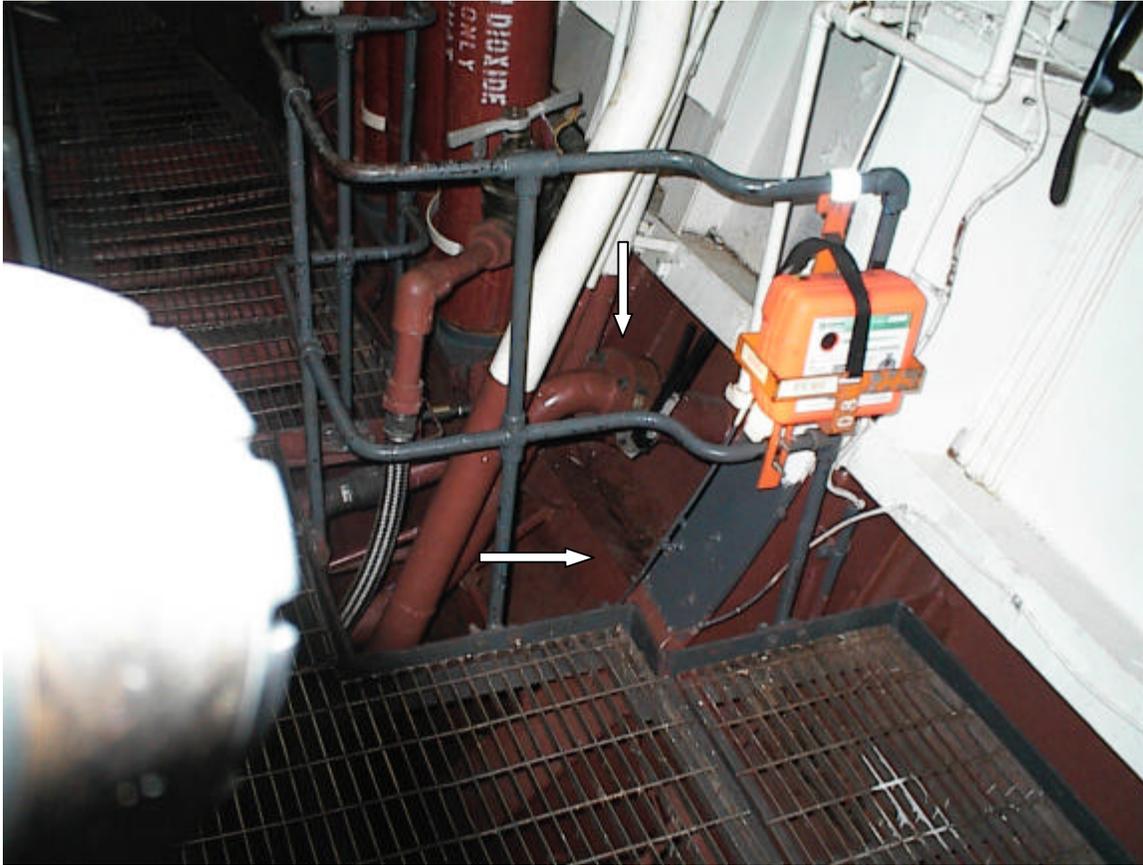
7. THE 1ST LONGITUDINAL STIFFENER ABOVE THE TANK TOP IS 100% HOLED BETWEEN FR 318 AND 324. PROBABLE CAUSE: ACCOUSTIC TILE ON THE SHELL

Facing aft from FR 324 at the Bilge pump overboard valve. Arrows indicate valve and S13, which is 100% wasted under the CO2 bottles.(EM02-A240 & A241)

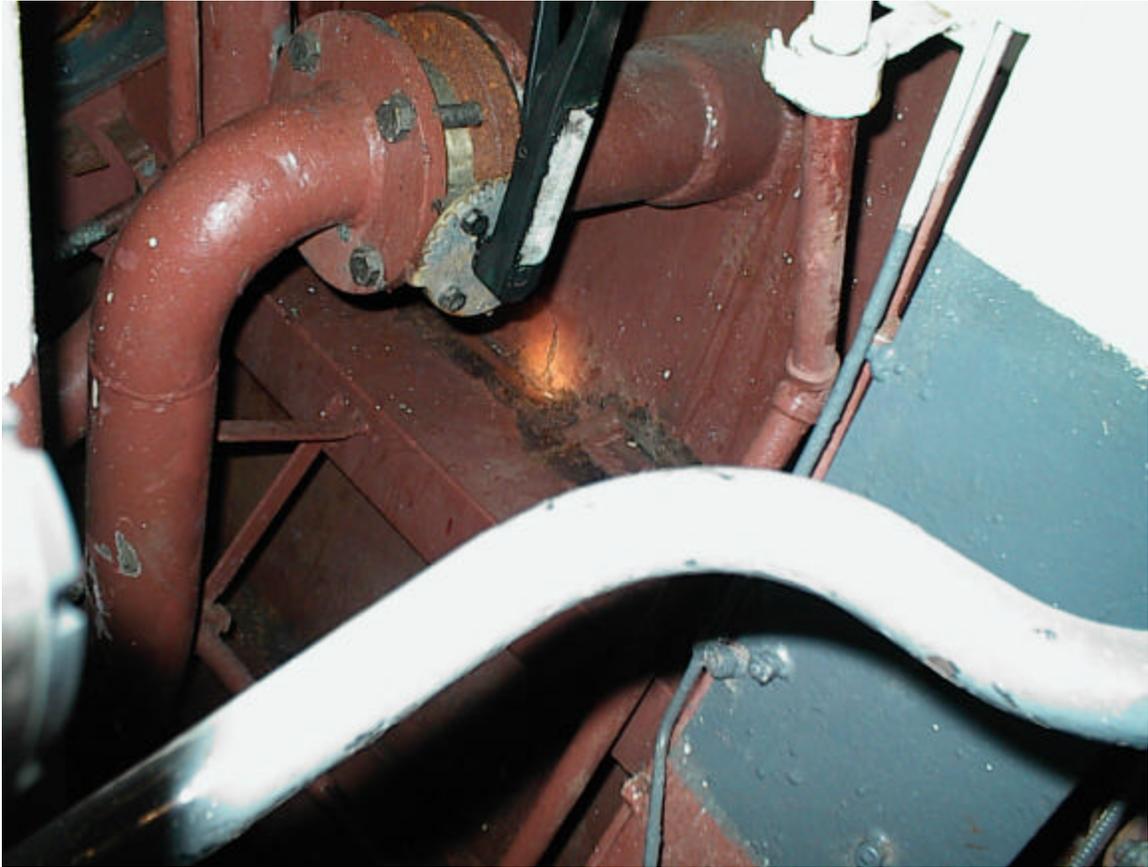
Closer view of bilge ovbd at FR 325. Note holes and heavy corrosion on stiffener. Valve was not leaking, but the system was not in operation.(EM02-A240 & A241)

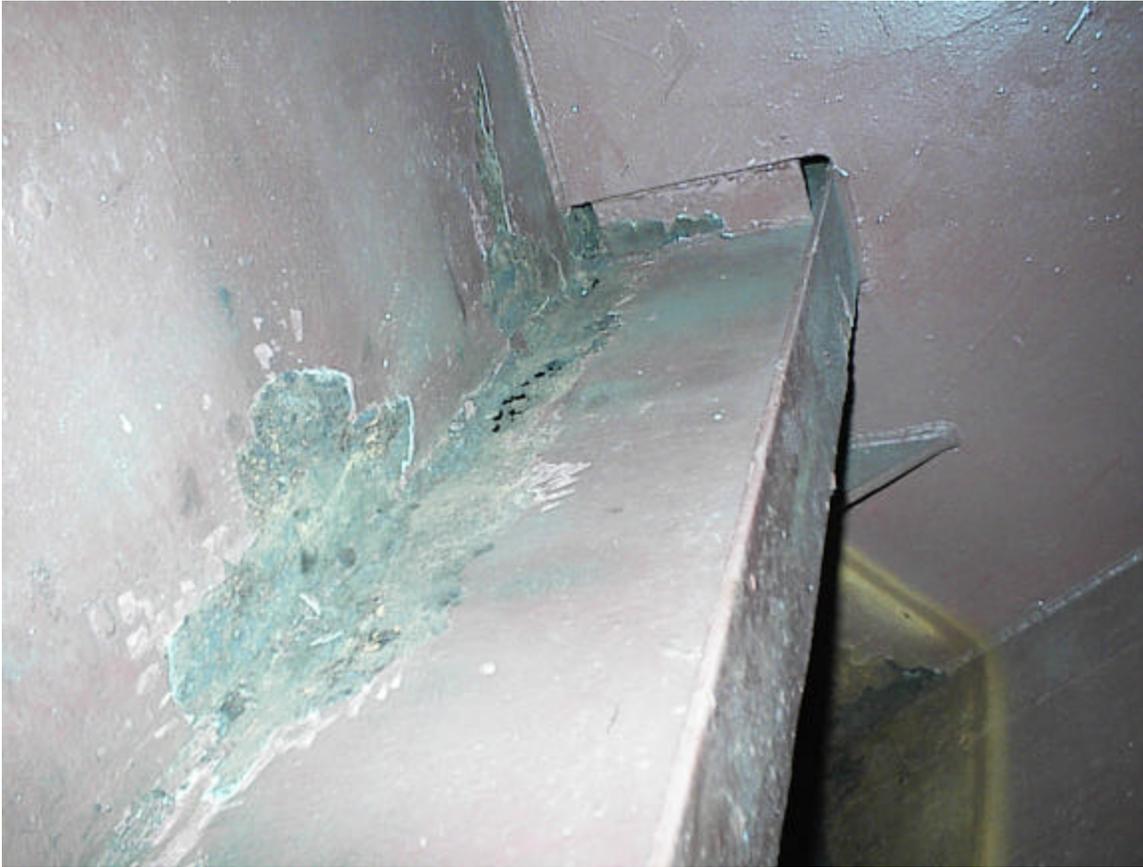
View of stiffener S13 from bilge area at FR 318, portside facing forward at FR 316. (EM02-A242). Note corrosion and paint failure at tanktop joint. This is covered by an existing CSMP item.
