**USS SPRUANCE (DD 963)  
SHELL CONDITION ASSESSMENT SURVEY  
INTERIOR AREAS  
6/4/01 – 6/15/01**

**PREPARED BY:  
SUPSHIP PORTSMOUTH  
6/28/01**

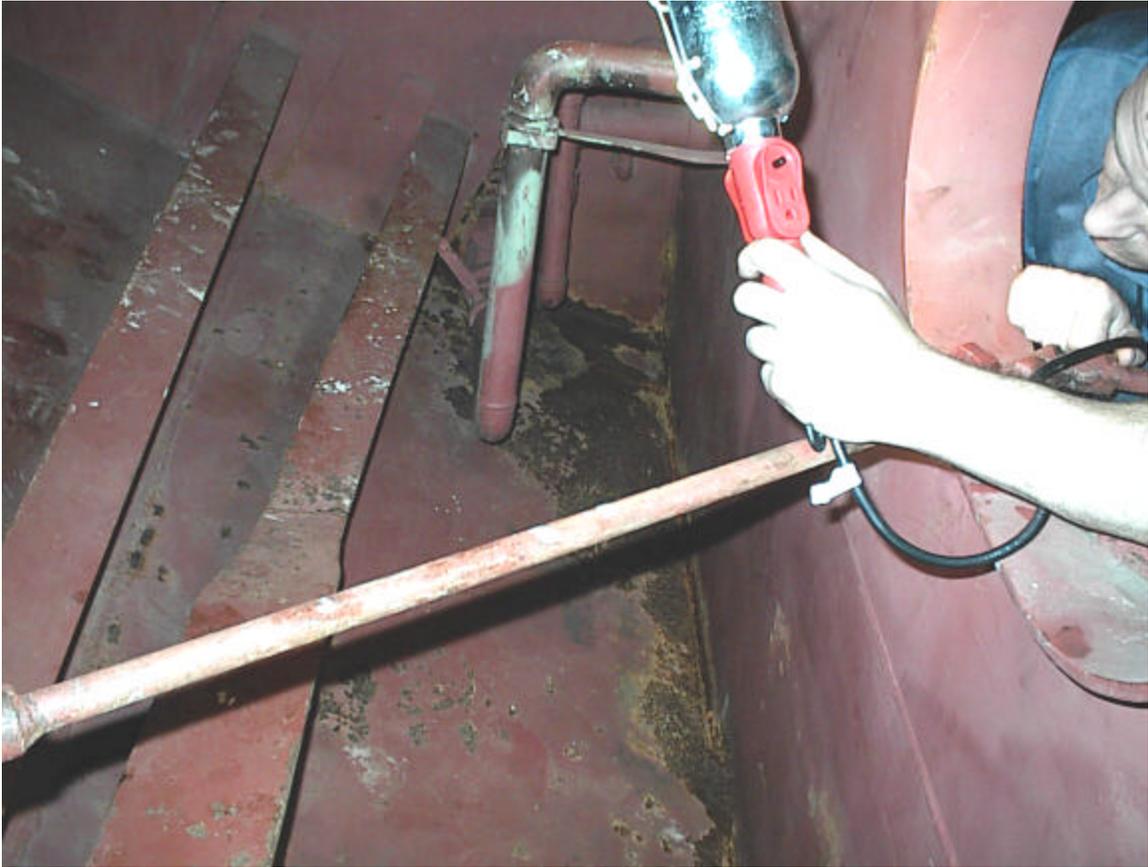
Due to the constrictive nature of the structure in this space, an overall view is not practical. This view is on the port side, in the aft section of the outbd area. Paint failure is visible where the drainage collects.

RECOMMENDED REPAIRS <b>REMOVE CORROSION AND PRESERVE APPROX 1800 SF OF SHELL</b>							
<b>&amp; STRUCTURE.</b>							
SSPORT C221 POC: J. BRUCKNER (757) 396-4001, TPOC: D. SMITH /HUGHES, CDI							
<b>SHAFT ALLEY &amp; SEWAGE PLANT NO. 2 (6-346-0-Q) STRUCTURE CORRODED</b>					TEST # MRC 1102/1		
ROOT CAUSE/AMPLIFICATION <b>H1</b>					STEP # <b>2.a.</b>		
SYSTEM LEVEL IMPACT							
PART NO.	NOMENCLATURE		QTY			COST	
FIRST CONTACT <b>DAVIS</b>	RATE <b>EN1</b>	SECOND CONTACT <b>LASSANDRO</b>		RATE <b>ENC</b>	PHONE		
BLUEPRINTS, TECH MANUALS, PLANS, ETC.					ON BOARD YES NO		
ASSESSOR / ACT / TECH ID# <b>SPORT 221/ D. SMITH/ HUGHES, CDI</b>				TD	TL	LOGISTICIAN TSP

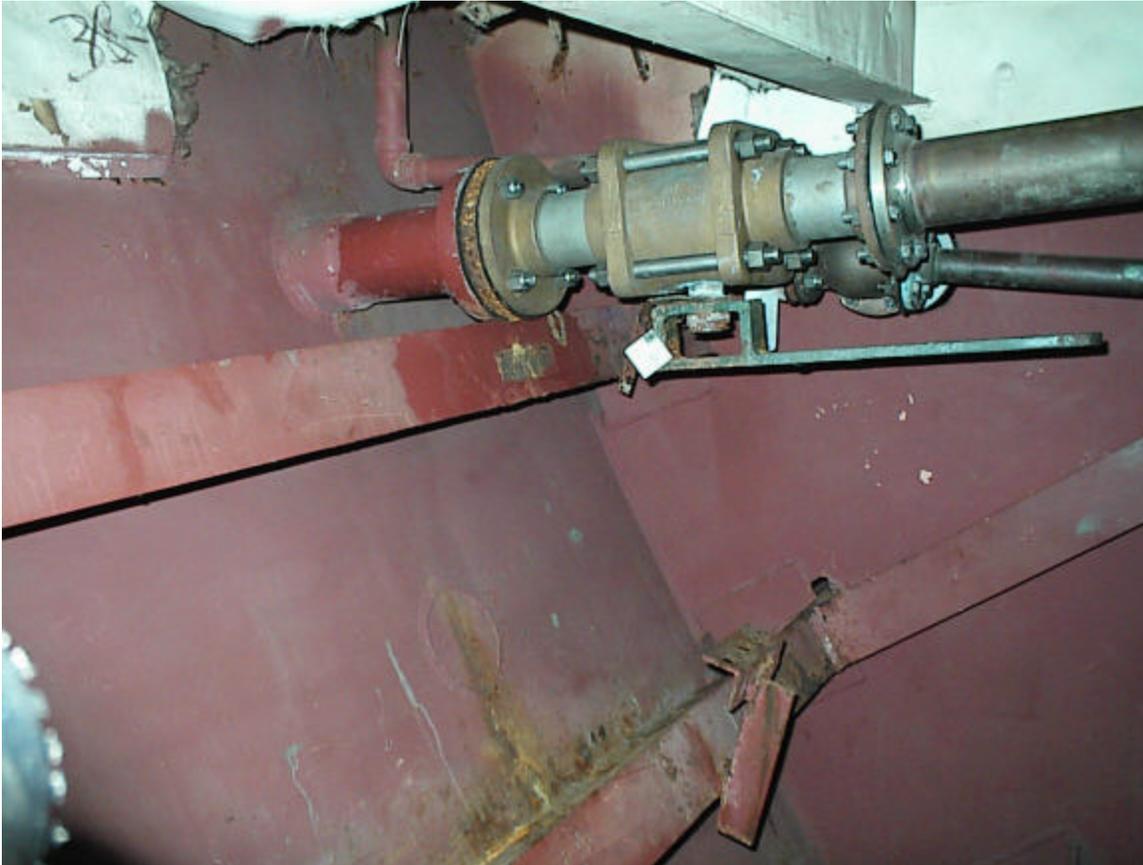
View looking aft toward FR 370, inside the enclosed area on the port side. The valve has been replaced, but the corrosion caused by the leakage was not repaired. In the ovhd, insulation damaged during the installation is visible.

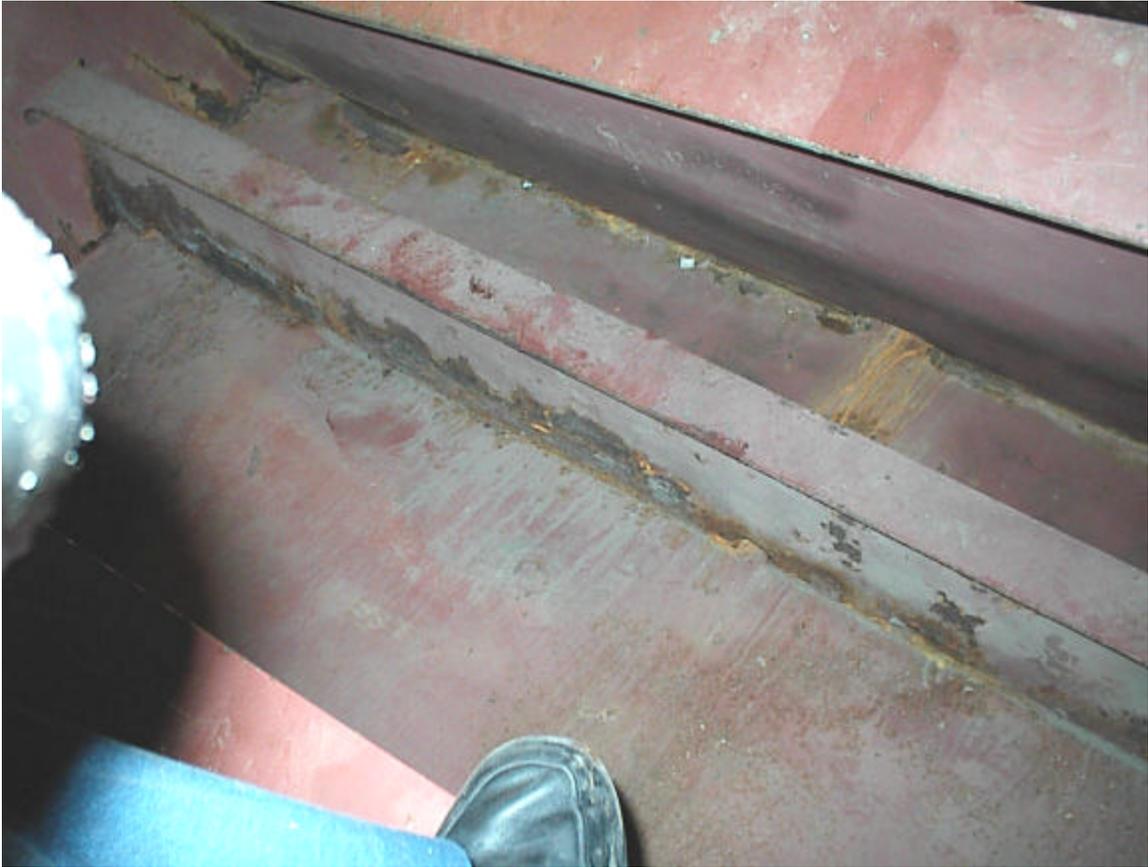
Inside the enclosed areas outside of the shaft. The insulation has been removed and this is a relatively low traffic area due to inaccessibility. The paint system has failed over approximately 40% of the surface area, similar to areas shown.

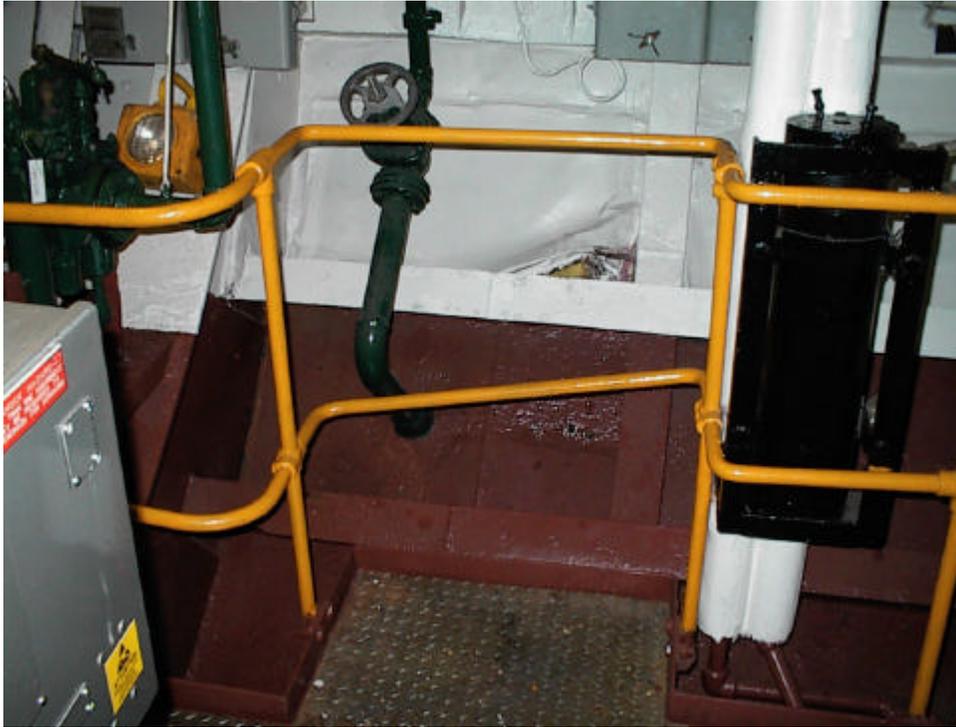
Standing at FR 471 facing outbd to stbd. Wastage of shell is visible.(EA04-A620)

RECOMMENDED REPAIRS: <b>CROP OUT AND REPLACE APPROXIMATELY 20 LF OF 10" X 7" TEE AND 10 LF OF 4" X 5" TEE. CROP OUT AND REPLACE APPROXIMATELY 4SF OF SHELL PLATING IN WAY OF HPAC OVBD.</b>					
SSPORT C221 POC: J. BRUCKNER (757) 396-4001, TPOC: D. SMITH /HUGHES, CDI					
CSMP SUMMARY <b>NO.2 HPAC ROOM(6-464-3-Q) STIFFENERS AND SHELL CORRODED</b>				TEST # <b>MRC 1102/1</b>	
ROOT CAUSE/AMPLIFICATION <b>H1</b>				STEP # <b>2.a.</b>	
SYSTEM LEVEL IMPACT					
PART NO.	NOMENCLATURE	QTY	NSN	COST	
FIRST CONTACT <b>SIMS</b>	RATE <b>EN1</b>	SECOND CONTACT <b>DAVIS</b>	RATE <b>EN1</b>	PHONE	
BLUEPRINTS, TECH MANUALS, PLANS, ETC.				ON BOARD YES NO	
ASSESSOR / ACT / TECH ID# <b>SPORT 221/ D. SMITH/ HUGHES, CDI</b>			TD	TL	LOGISTICIAN TSP

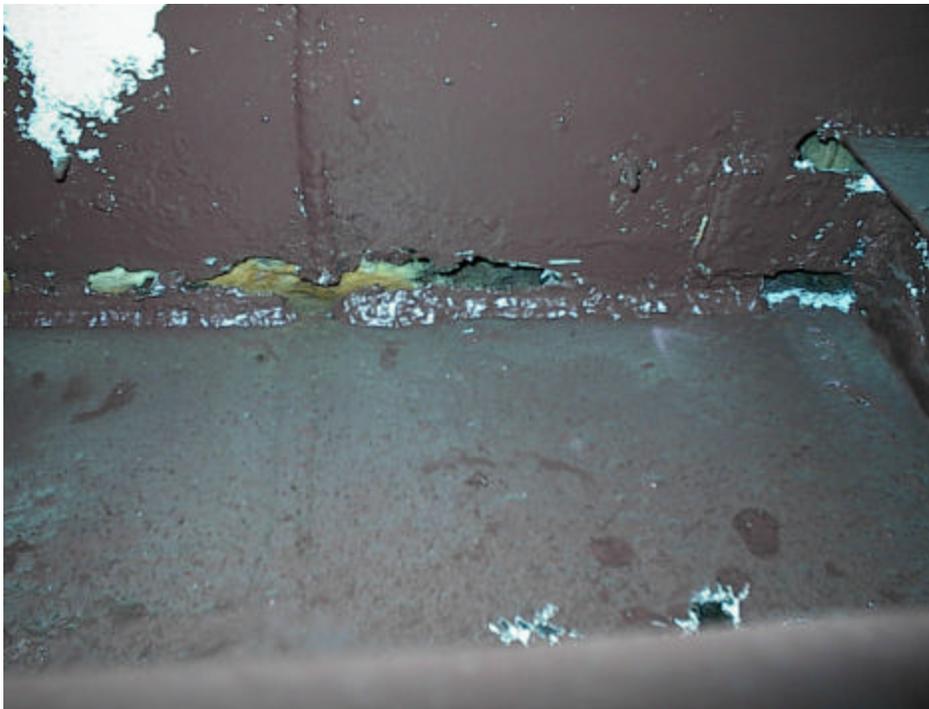
Underside of the stiffener immediately above the ovbd in the picture above. Note insulation visible through wasted area. (EA04-A620)

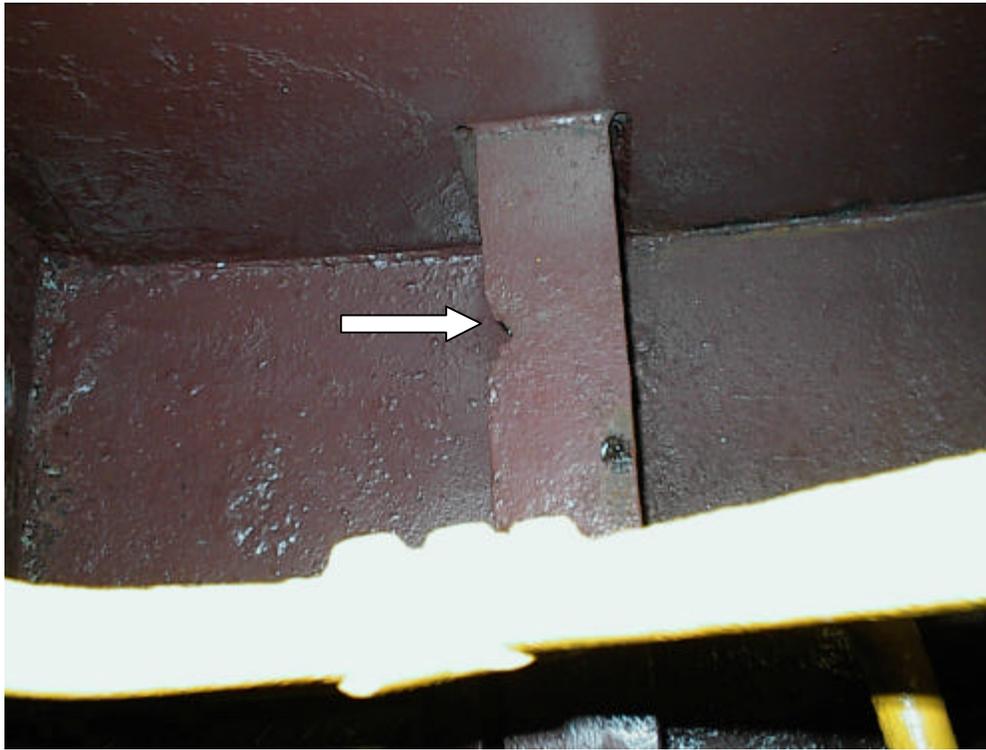
A hole in the flange on the stiffener directly under the ovbd, FR 470. (EA04-A620)

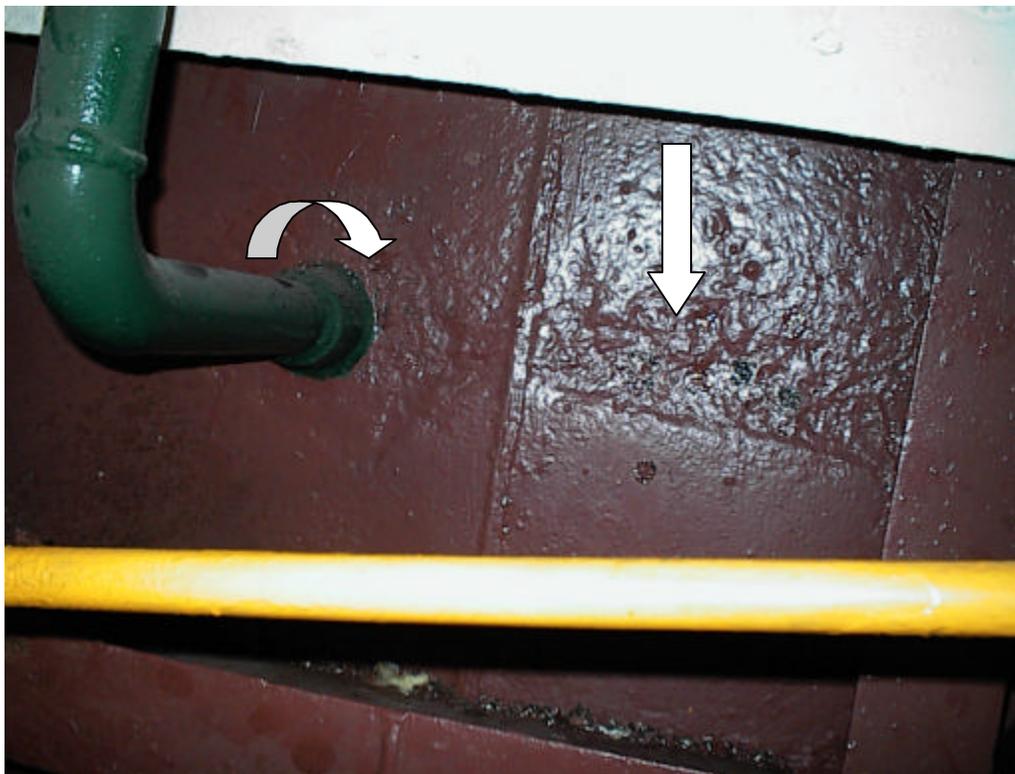
Areas of the shell that are 50% wasted. See UT grid. (EA04-A620)

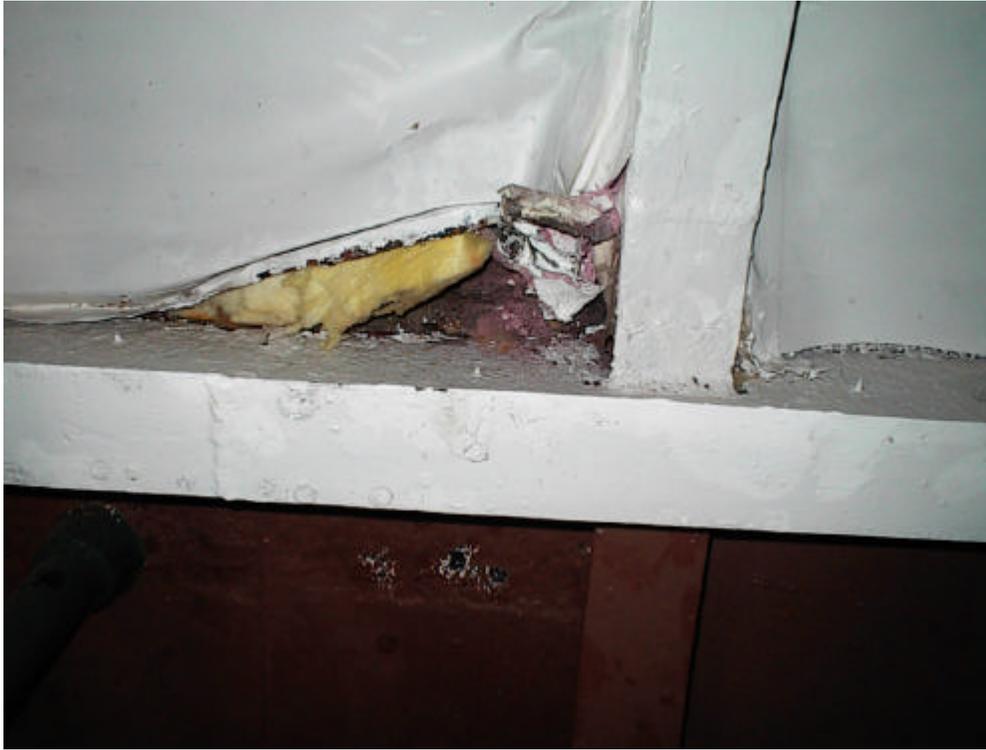
Shell is corroded under shell insulation at FR 473. Insulation is not saturated. (EA04-A620)

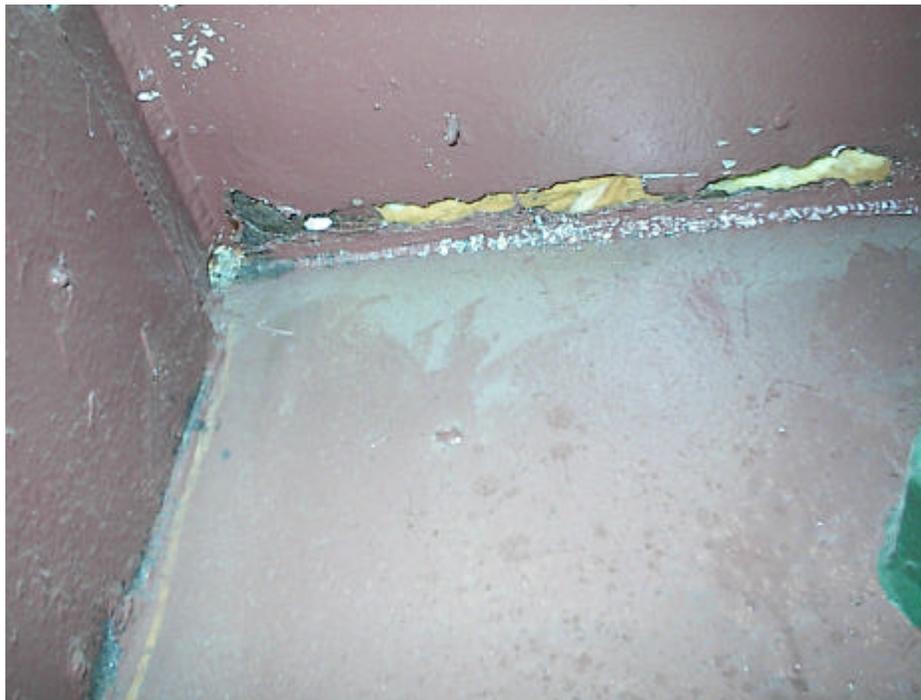
Corroded stiffener at FR 467, behind Degaussing Conn. Box. (EA04-A620)

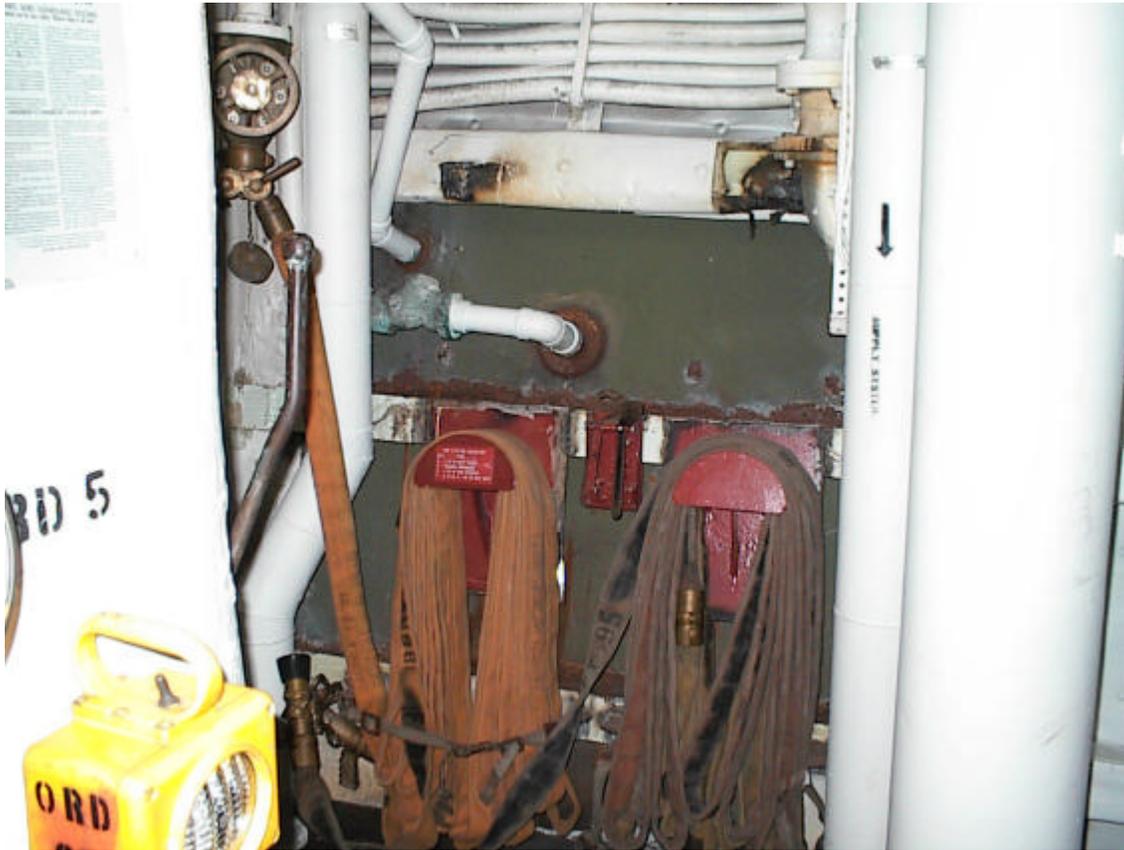
Looking forward at the port side, FR 58-62. Shipsforce removed the original firestation and discovered the stiffener is 100% wasted. Probable cause is a combination of leakage from the firestation and inaccessibility.

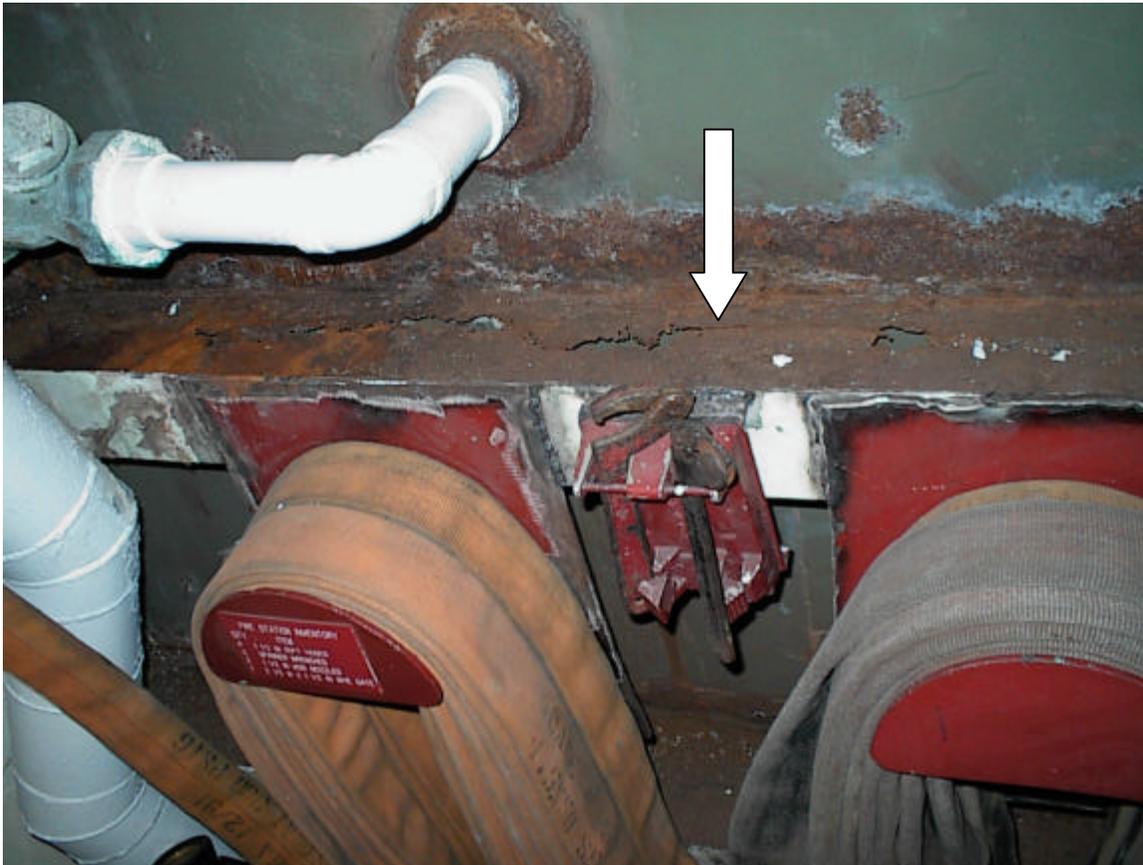
Second stiffener from the deck, port side FR 50-62. Arrow indicates where web is completely wasted. Ships force attempted repair, then decided it should be a SIMA job. Ships force reinstalled temporary firestation.  
(CSG2-A081)

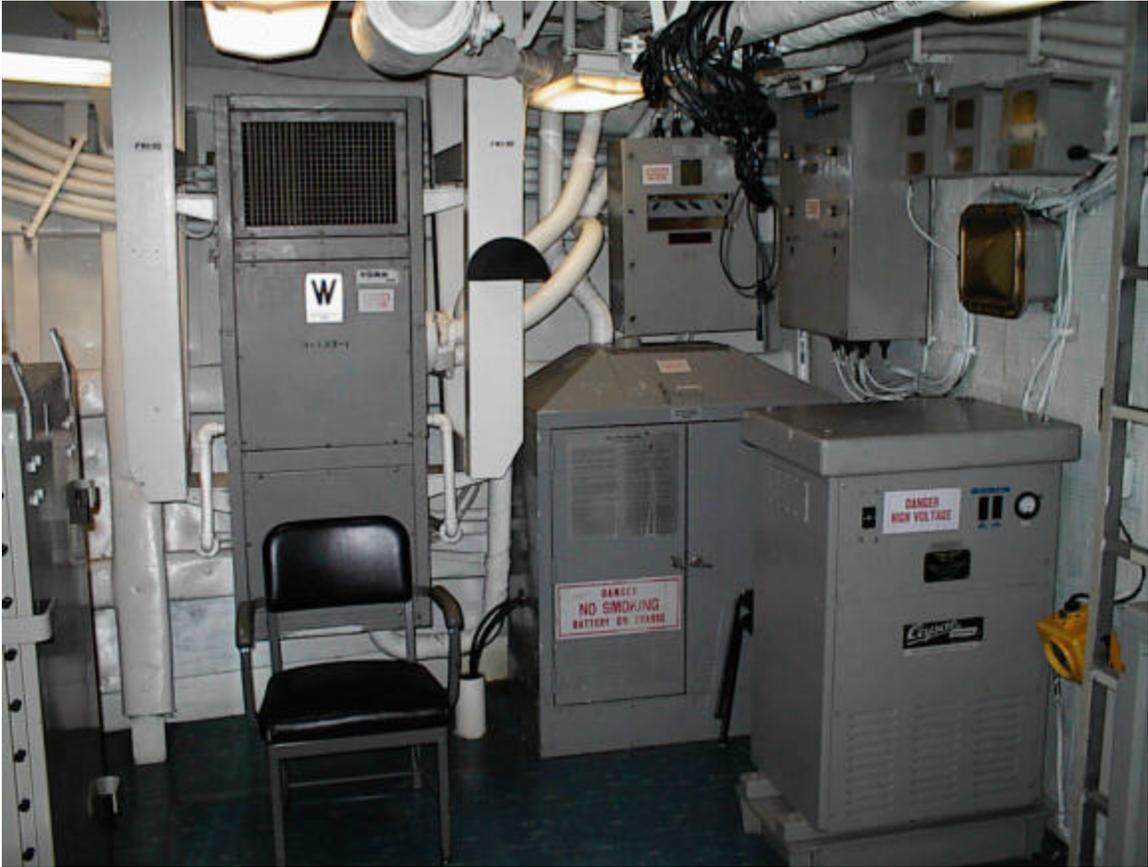
View looking outbd to stbd at FR 130. The FCU condensate drain line is leaking onto the lagging, saturating it behind the battery locker.  
(EE05-A014)

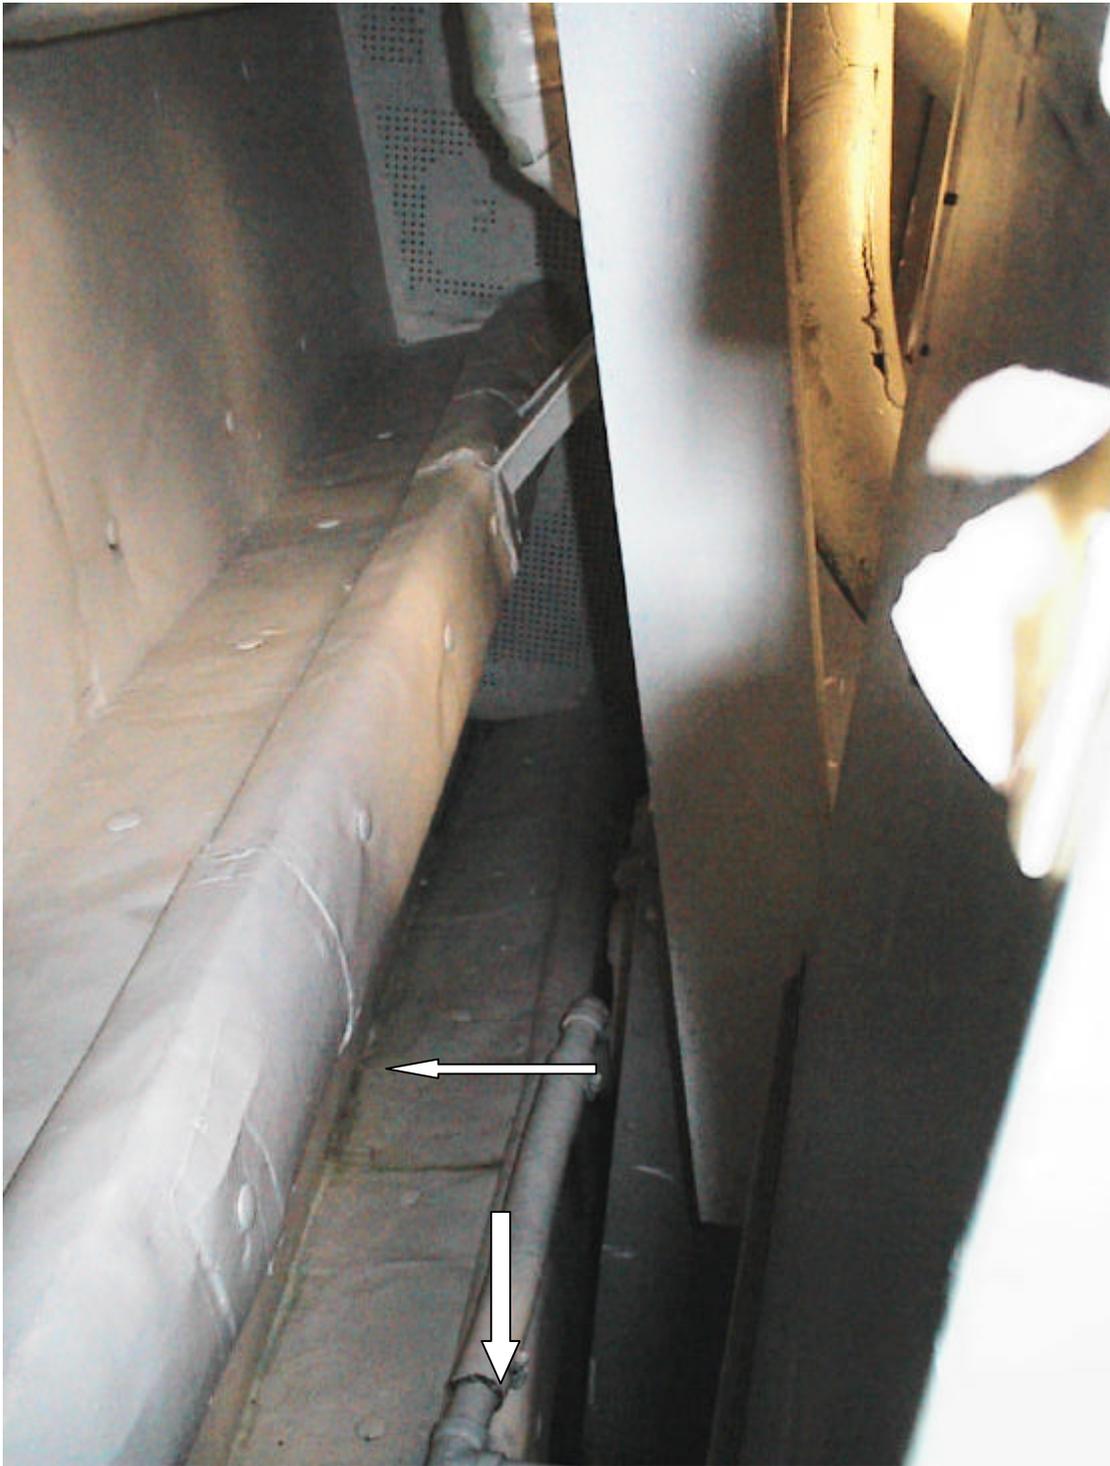
View looking outbd and aft of the FCU See the arrow on the previous page. The thin arrow indicates stained area. Heavier arrow is condensate drain line leak.  
(EE05-A014)

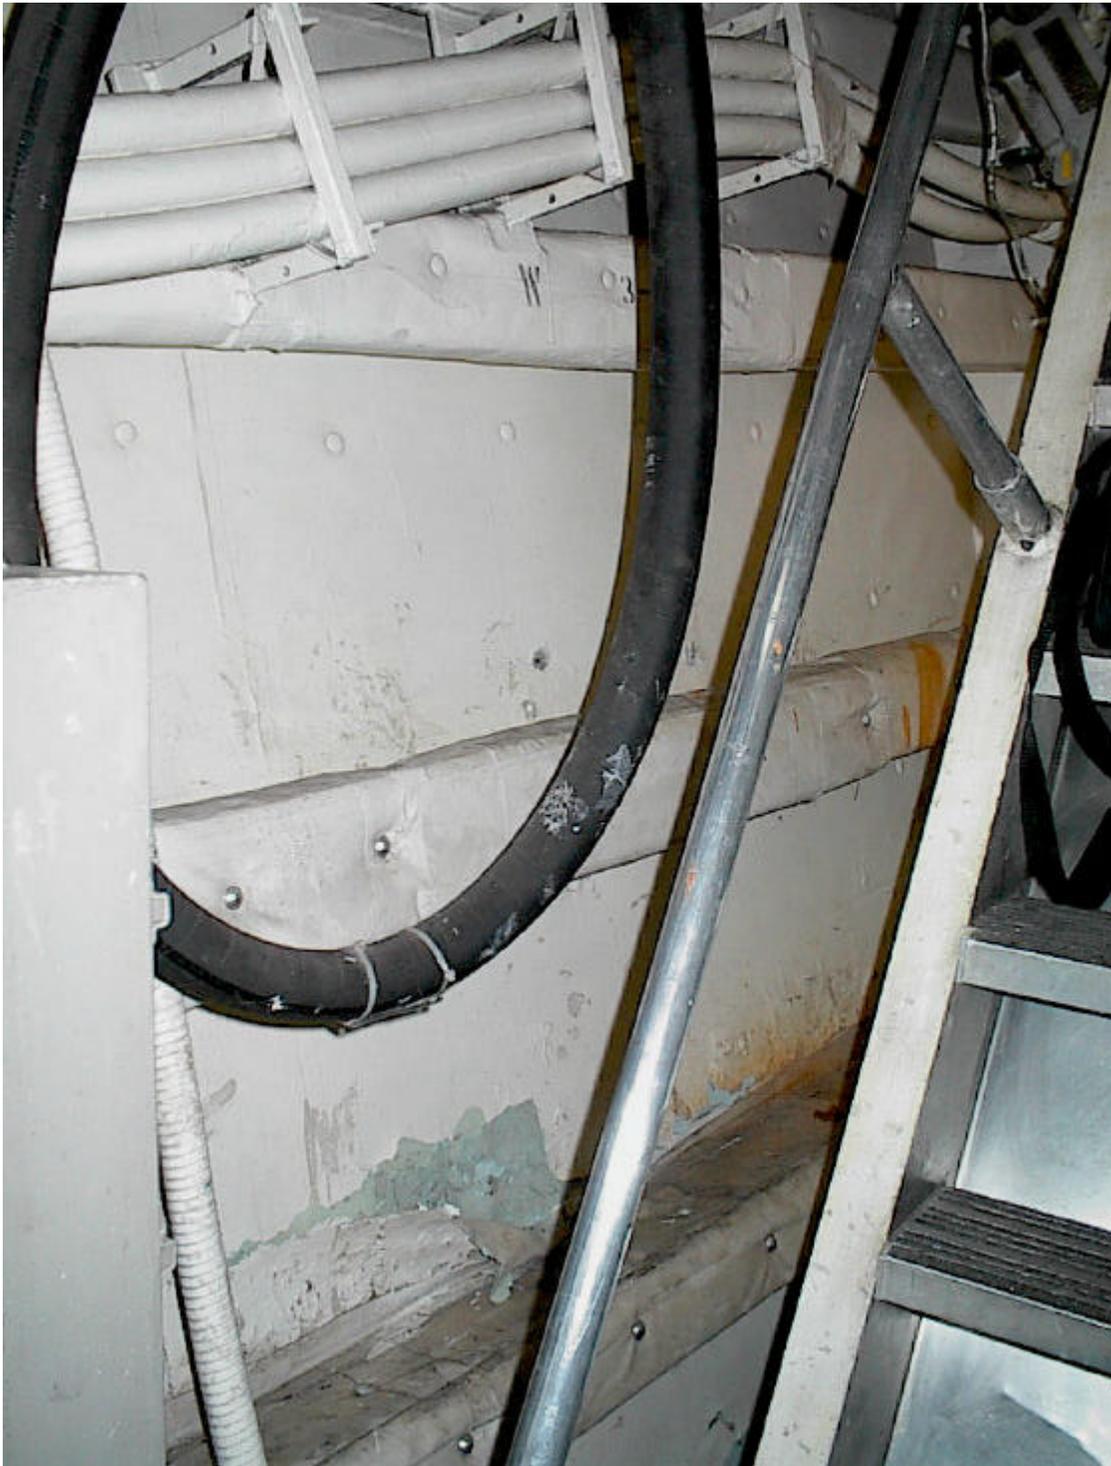
Looking forward at the stbd shell, FR 140-144. Shipsforce replaced the insulation after the valve was overhauled. The valve is still leaking and the insulation is saturated. Shell does not appear corroded. The hose in the foreground is part of the piping to the fuel fill line. Ships force does not know why it is so long.(CSE1-A005)

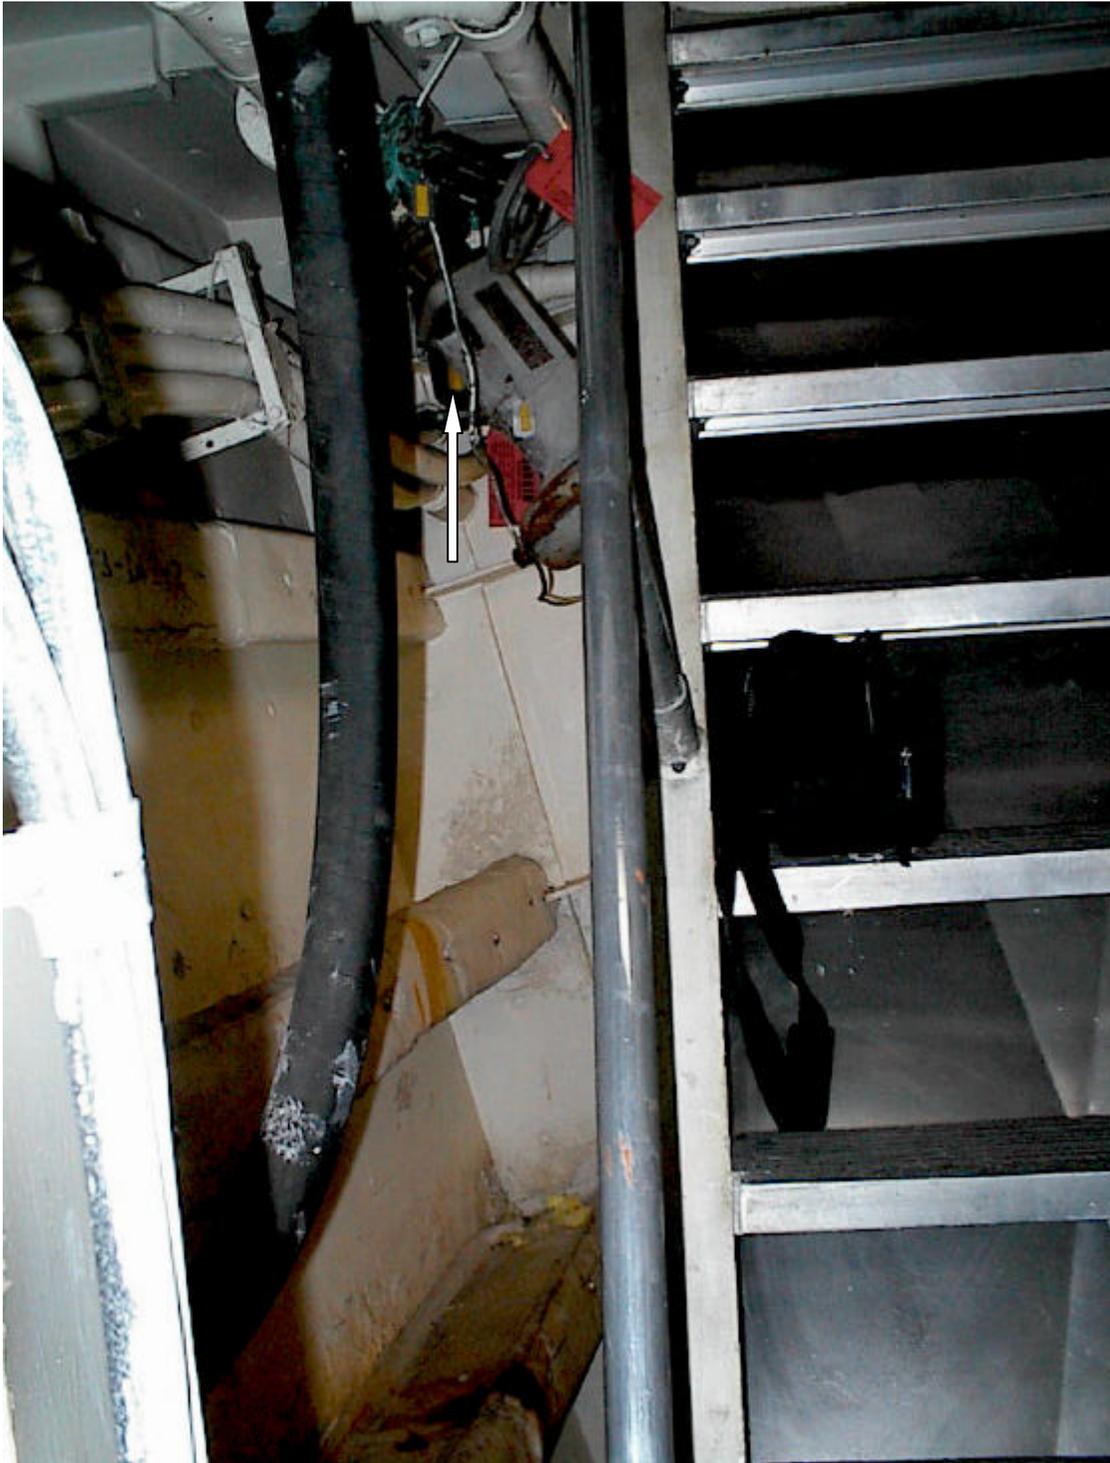
Facing fwd and stbd from FR 146. Fuel oil compensating system sw regulating valve is leaking at the packing. Valve has been rebuilt previously and the packing gland was probably never adjusted when it was pressurized. (CSE1-A006)
