# **USS ARTHUR W RADFORD (DD-968)**

## **SEMAT II SHELL CONDITION ASSESSMENT SURVEY INTERIOR AREAS**

**01/28/02 TO 02/08/02**

Q.E.D. Systems, Inc. was tasked by the Supervisor of Shipbuilding Conversion and Repair, USN (SPORT) Portsmouth, VA to conduct an Ultrasonic Thickness (U/T) Survey of specific locations on board USS ARTHUR W RADFORD (DD-968) during the period of 28 January 2002 – February 8 2002.

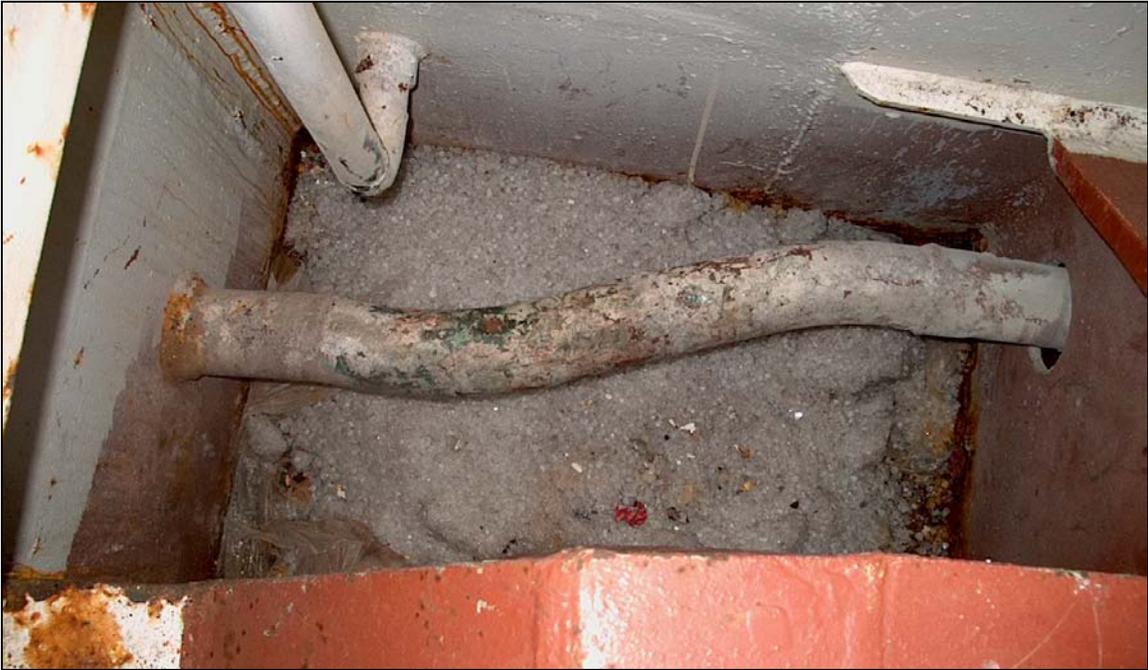
LARGE AMOUNT OF SALT CRYSTALS IN BILGE AT BHD (506)  
AND SWASH BHD.

<b>RECOMMENDED REPAIRS:</b>						
RECOMMEND SHIP'S FORCE REMOVE SALT CRYSTALS, REMOVE APPROXIMATELY 80 SF OF LAGGING, CLEAN ENTIRE BILGE AREA TO BARE METAL, PRIME AND PAINT APPROX 200 SF REPLACEMENT OF LAGGING IS NOT RECOMMENDED. REPAIR OR REPLACE LADDER						
SSPORT C221 POC: J. BRUCKNER (757) 396-4001 EXT , TPOC: J. LaROCK QED SYSTEMS INC (757) 490-5047						
<b>CSMP SUMMARY:</b> CORROSION IN BILGE, BROKEN LADDER RUNGS				TEST# MRC 1102/1		
<b>ROOT CAUSE/AMPLIFICATION:</b> H1				STEP# 1,2,3,4 & 5		
<b>SYSTEM LEVEL IMPACT:</b>						
PART NO.	NOMENCLATURE			QTY	NSN	COST
1						
2						
3						
4						
5						
6						
FIRST CONTACT ANDERSON	RATE HTC	SECOND CONTACT MILTON		RATE HT1	PHONE	
ASSESSOR / ACT / TECH ID# J. LaROCK/ T. WHITMORE QED SYSTEMS INC.			TD	TL	LOGISTICIAN	TSP

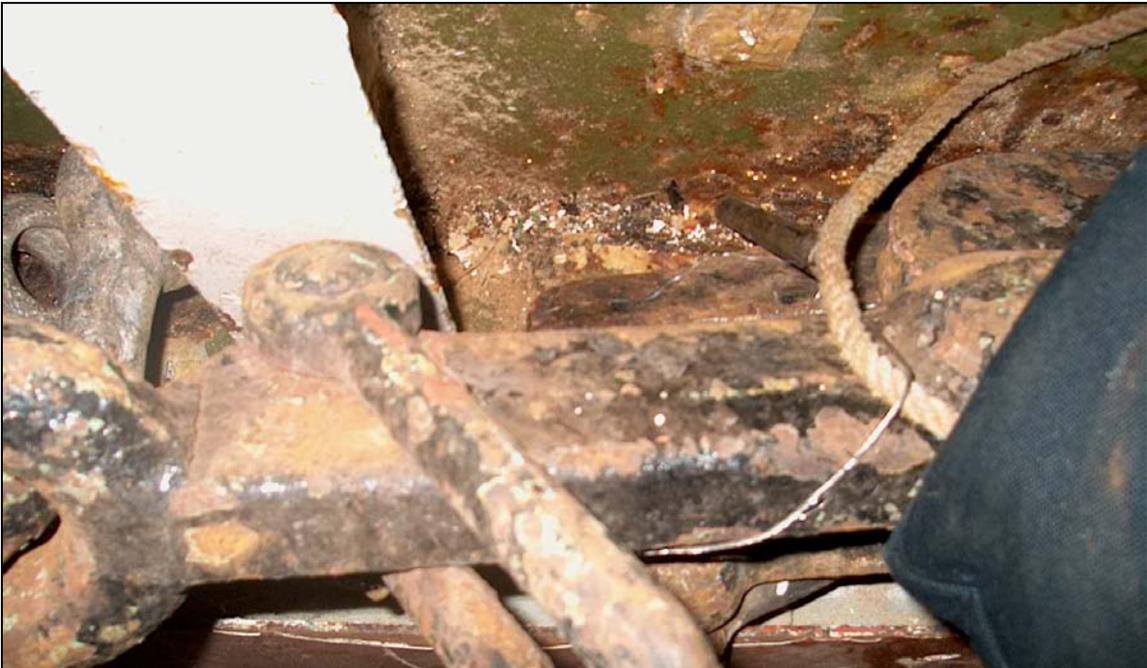
RIGGING GEAR STORED ON STRINGERS HAS DAMAGED LAGGING AND CAUSED  
CORROSION AND PAINT SEPARATION.

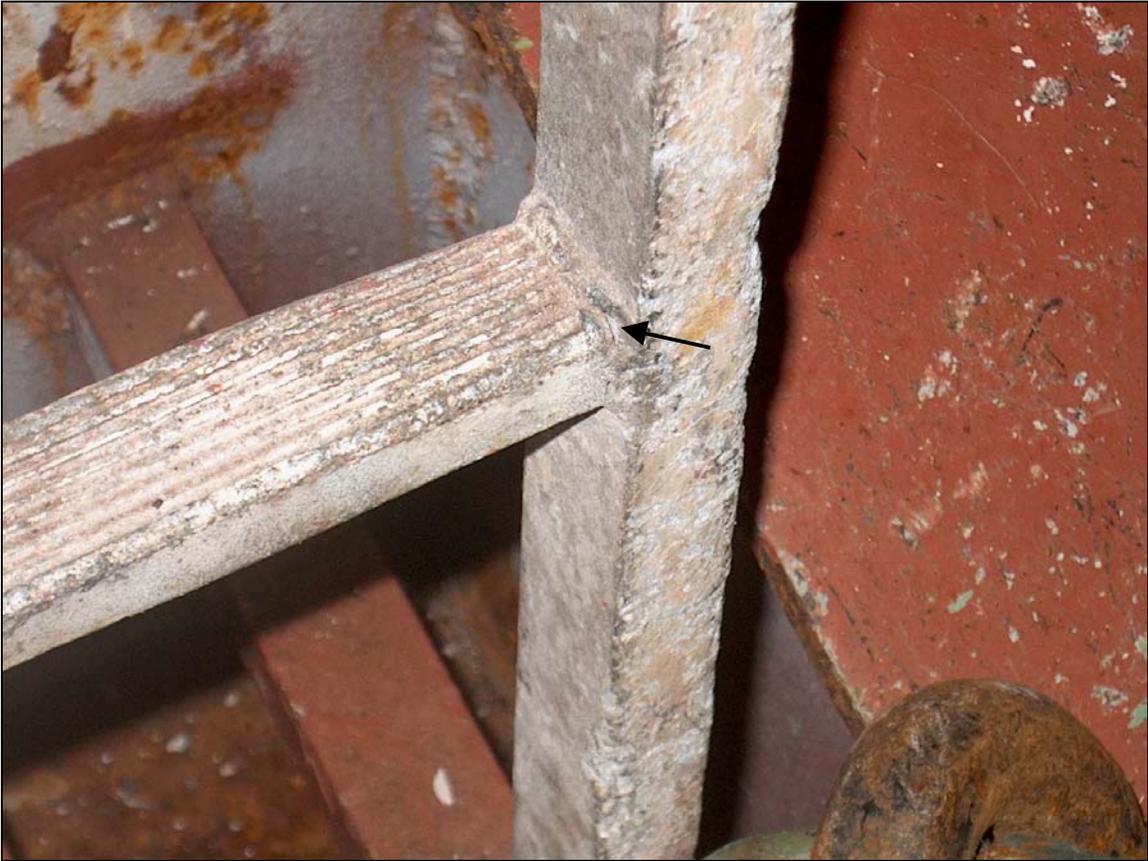
ARROW INDICATES CRACKED WELD ON LADDER RUNG. NOTE CORROSION ON BHD (506)  
AND BILGE AREA.

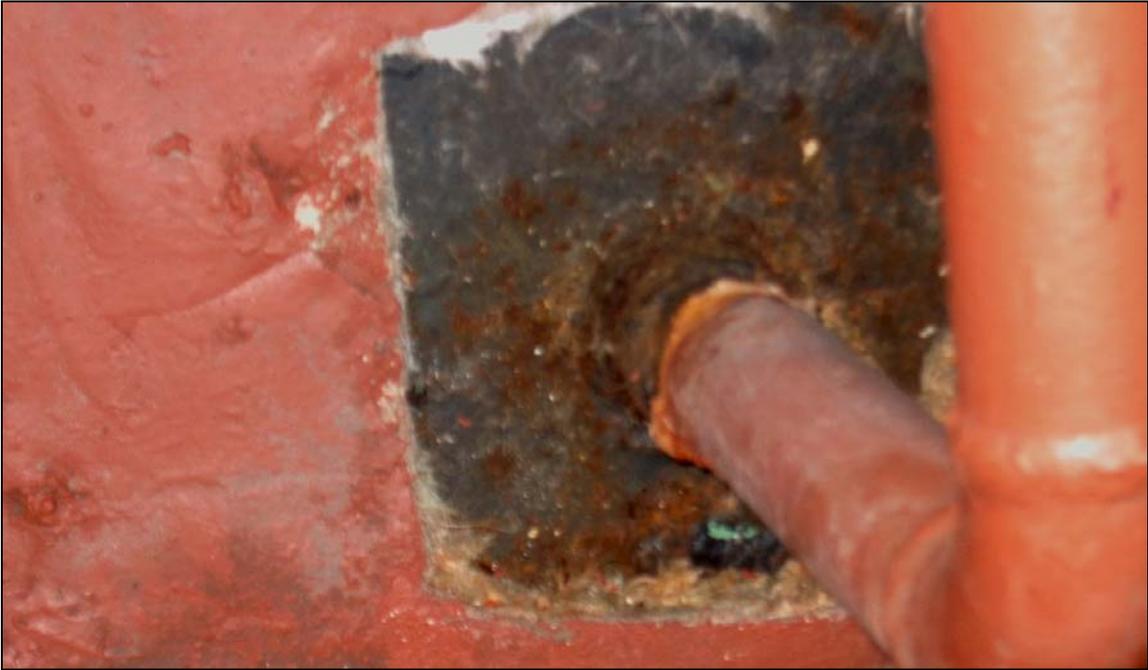
CORROSION ON SHELL PLATE AROUND OVBD DISCHARGE

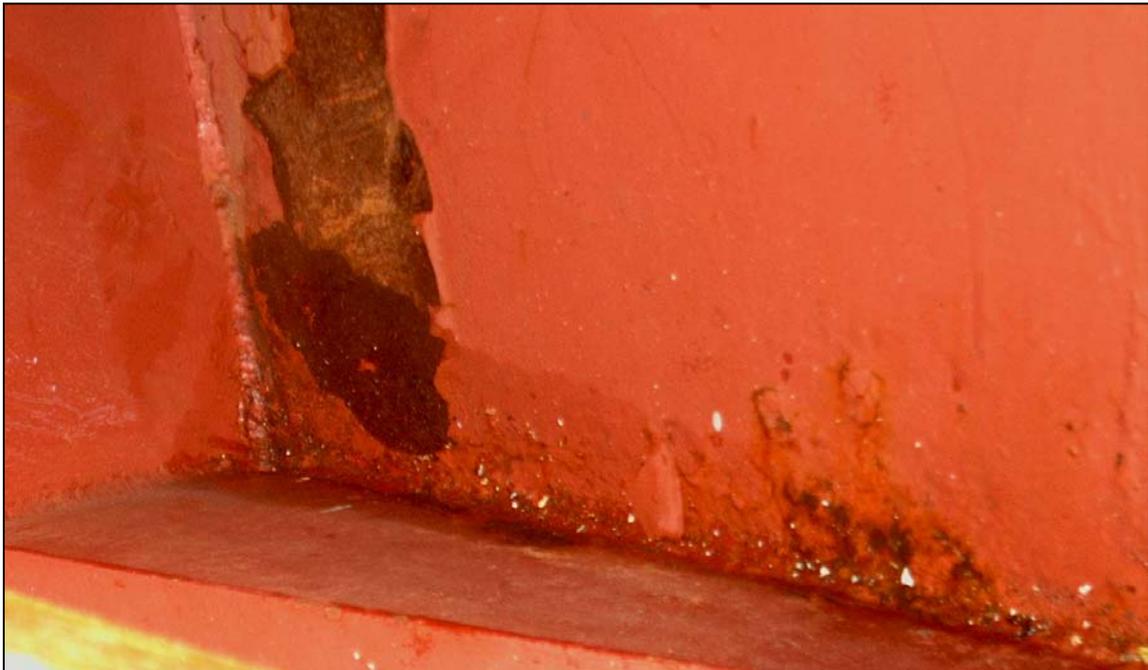
CORROSION AND PAINT FAILURE ON SHELL CAUSED BY WATER TRAPPED IN STRINGER

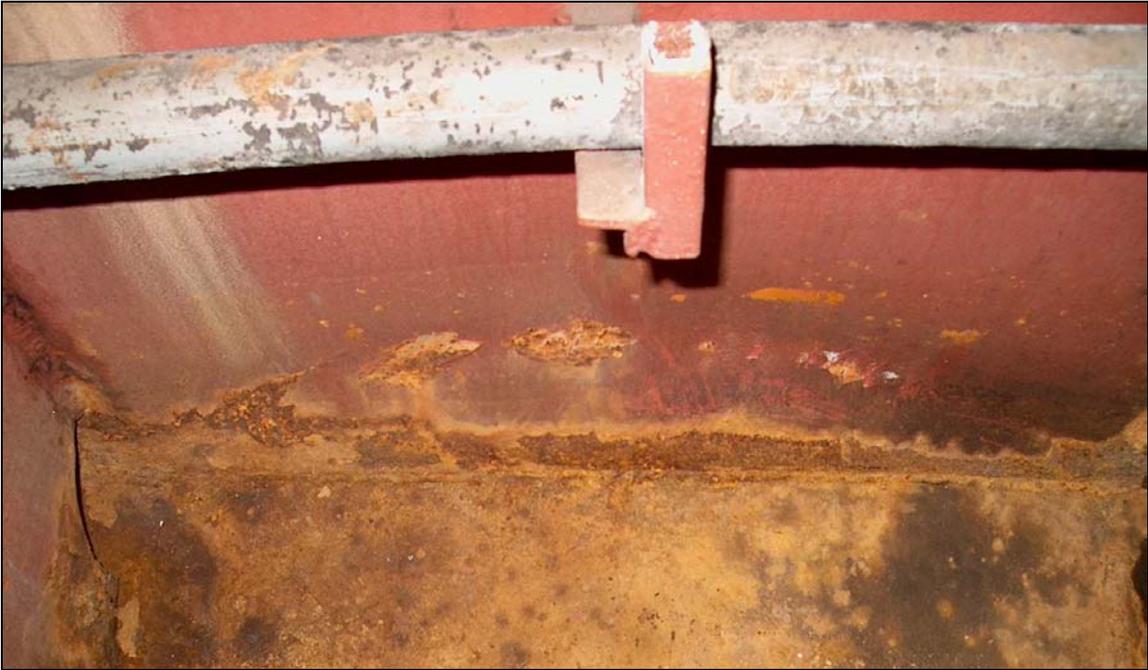
BUCKLED SWASH BULKHEAD OUTBOARD OF PORT SHAFT  
APPROXIMATELY 15 FEET AFT OF BHD (346)

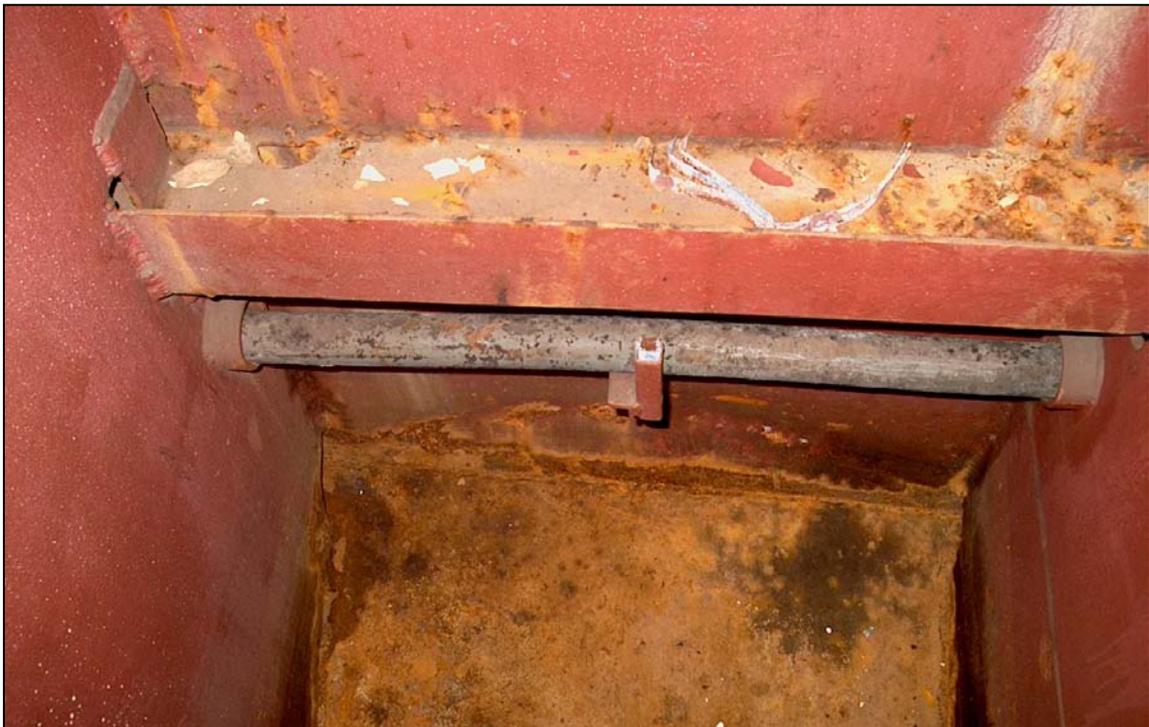
CORROSION ON SHELL OUTBOARD OF SHAFT

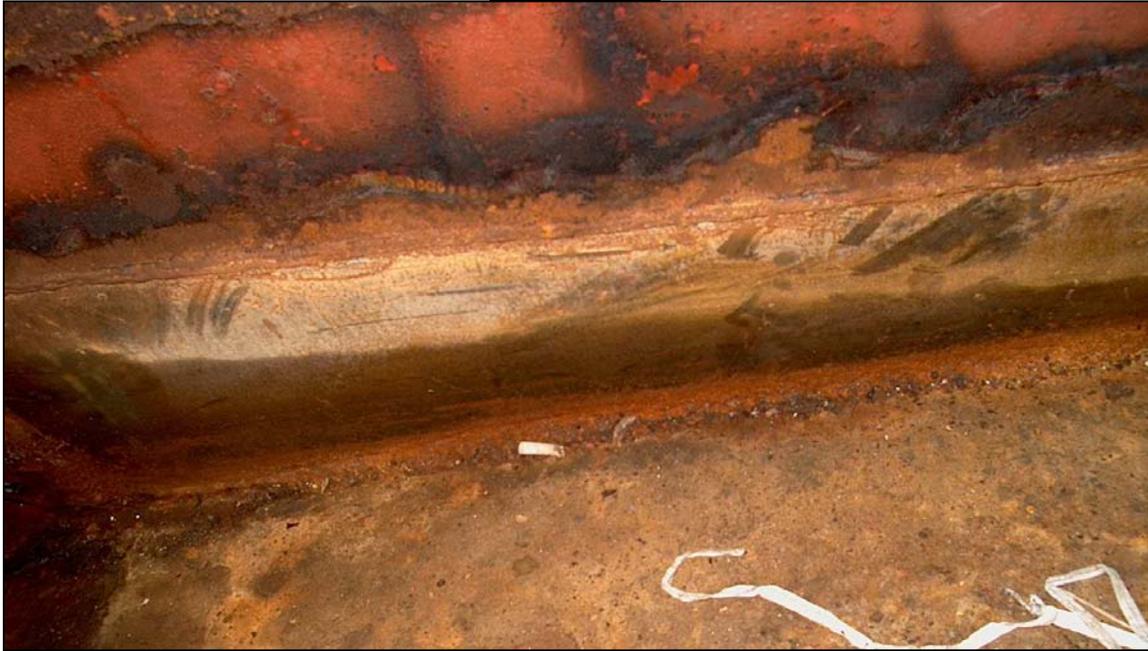
PORT SIDE LOOKING INBOARD AT SWASH BULKHEAD APPROXIMATELY  
10 FEET FORWARD OF BHD (346)

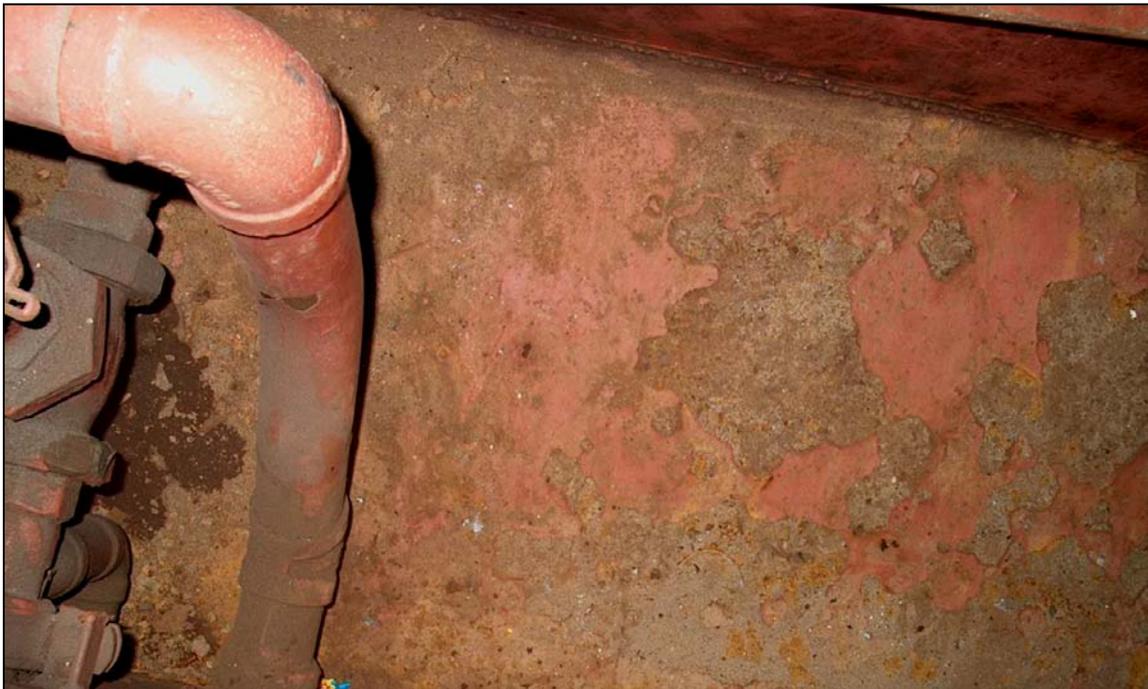
CORROSION ON SHELL; OUTBOARD OF PORT SHAFT.

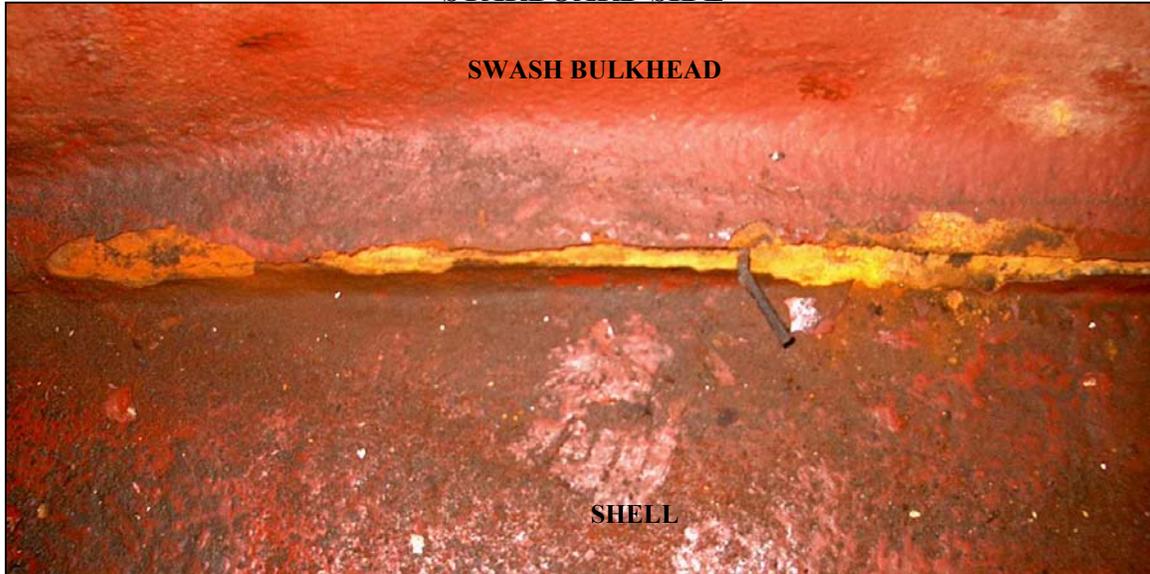
BUCKLED SWASH BULKHEAD OUTBOARD OF SHAFT APPROXIMATELY  
10 FEET AFT OF BHD (346)

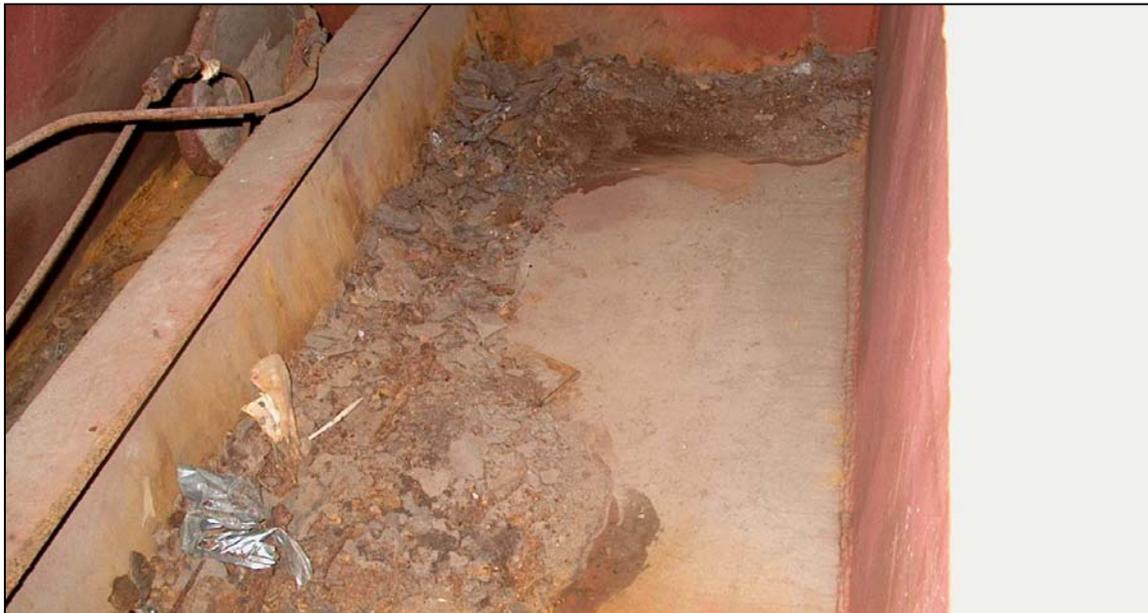
DEBRIS, RUST AND HEAVY PAINT SCALING IN POCKET OUTBOARD OF  
STARBOARD SHAFT.

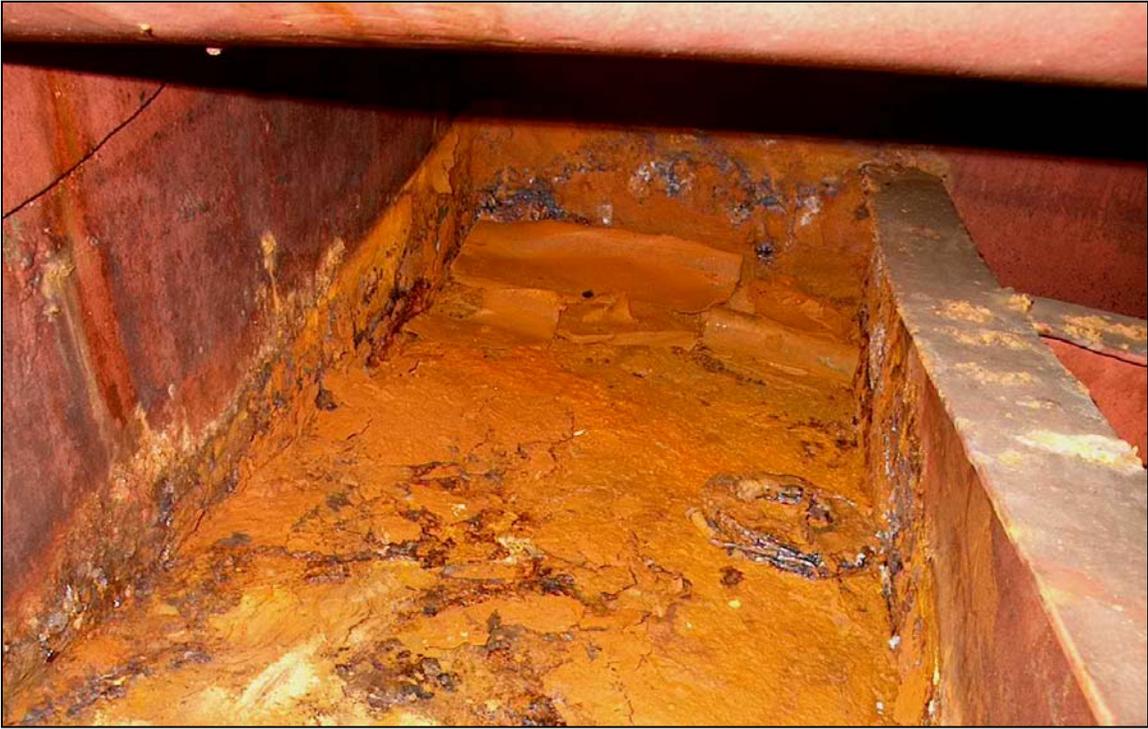
HEAVY CORROSION UNDER SHAFT

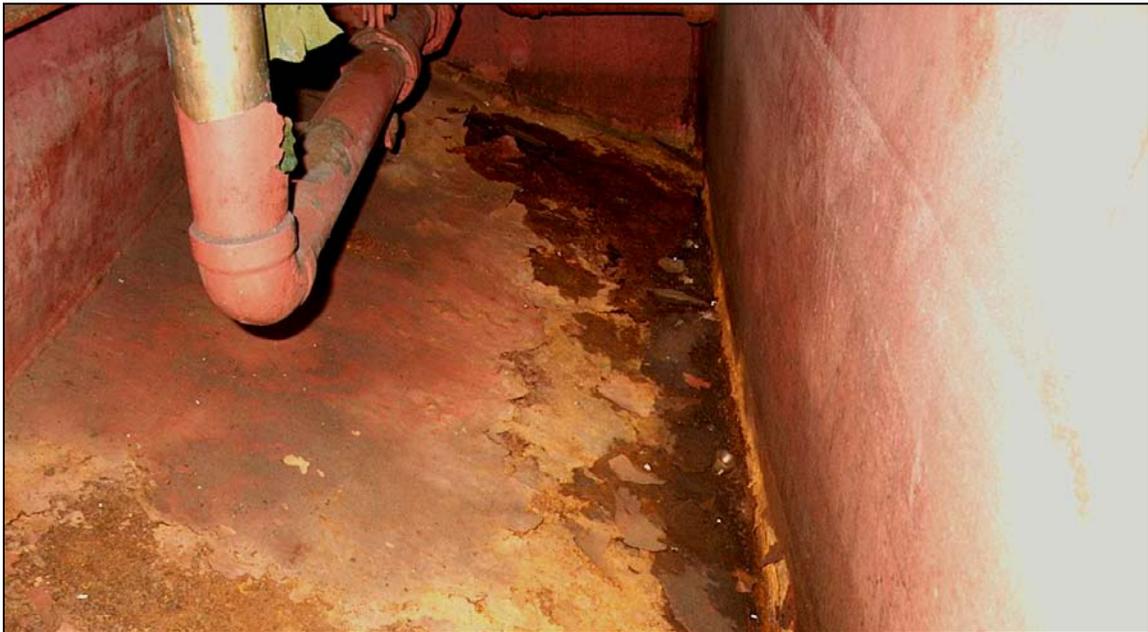
CORROSION ON SHELL AT FRAME (382)

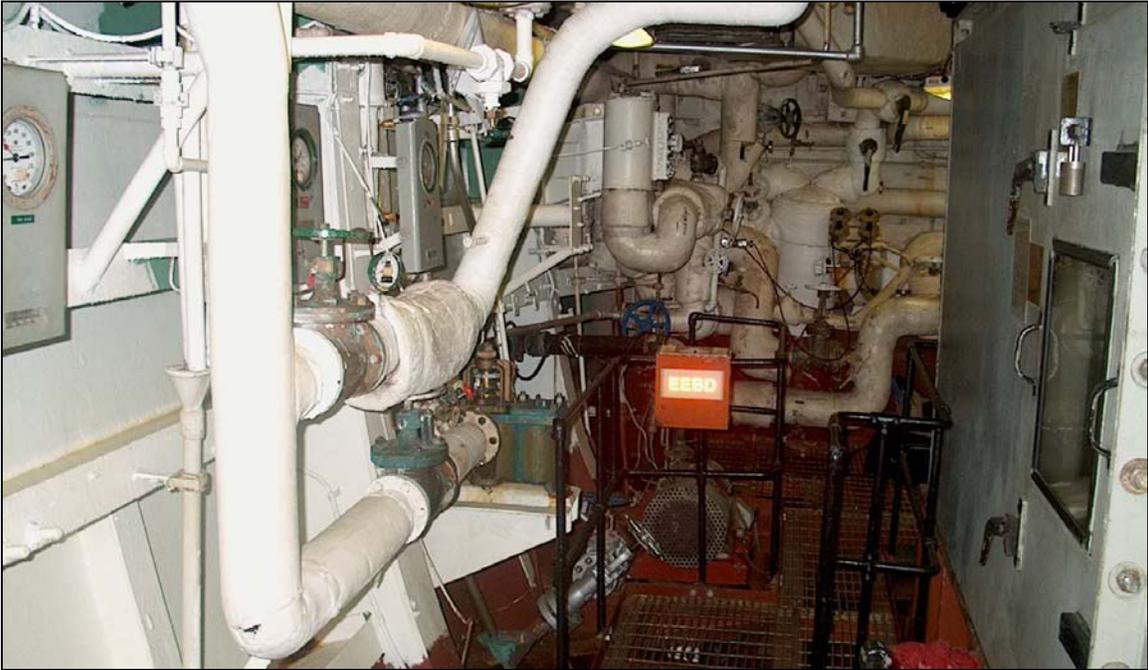
LOOKING FWD FROM WEB FRAME (324) (CONDENSATE CORNER)  
4<sup>TH</sup> STRINGER FROM MARGIN PLATE IS SEVERELY DETERIORATED FROM WEB FRAME  
(308-332)

STRINGER FROM MARGIN PLATE CAUSED BY TRAPPED WATER						
<b>RECOMMENDED REPAIRS:</b>						
RECOMMEND REPAIR ACTIVITY CUT OUT AND REPLACE APPROXIMATELY 30' FT OF 4 <sup>TH</sup> STRINGER FROM APPROXIMATELY 4' FWD OF WEB FRAME (308) TO WEB FRAME (332) 10 X 4 X 11.5# T-BEAM, PRIME AND PAINT AREAS DISTURBED BY REMOVALS AND REPAIRS.						
<b>SSPORT C221 POC: J. BRUCKNER (757) 396-4001 TPOC: J. LaROCK QED SYSTEMS INC. (757) 490-5047</b>						
<b>CSMP SUMMARY:</b>				<b>TEST#</b>		
4 <sup>TH</sup> STRINGER FROM MARGIN PLATE IS SEVERELY DETERIORATED.				MRC 1102/1		
<b>ROOT CAUSE/AMPLIFICATION:</b>				<b>STEP#</b>		
H1				1,2,3,4 & 5		
<b>SYSTEM LEVEL IMPACT:</b>						
PART NO.	NOMEMCLATURE			QTY	NSN	COST
1						
2						
3						
4						
5						
6						
FIRST CONTACT <b>ANDERSON</b>	RATE <b>HTC</b>	SECOND CONTACT <b>MILTON</b>		RATE <b>HT1</b>	PHONE	
ASSESSOR / ACT / TECH ID# <b>J. LaROCK/ T. WHITMORE QED SYSTEMS INC.</b>			TD	TL	LOGISTICIAN	TSP

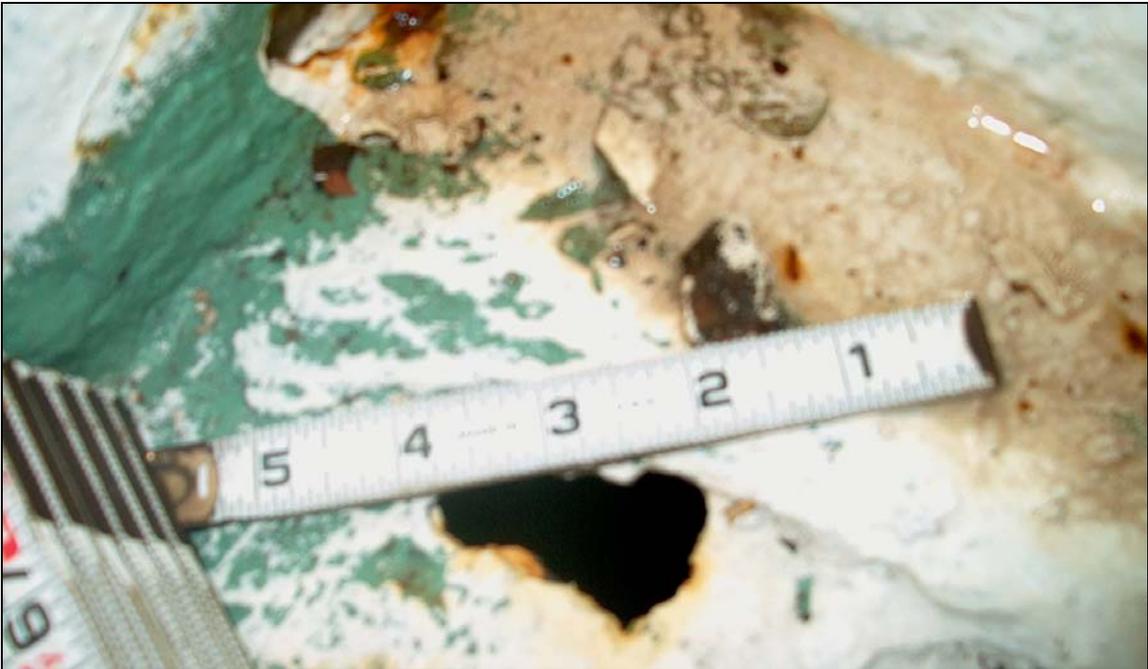
4<sup>TH</sup> STRINGER FROM MARGIN PLATE FWD OF WEB FRAME (308)

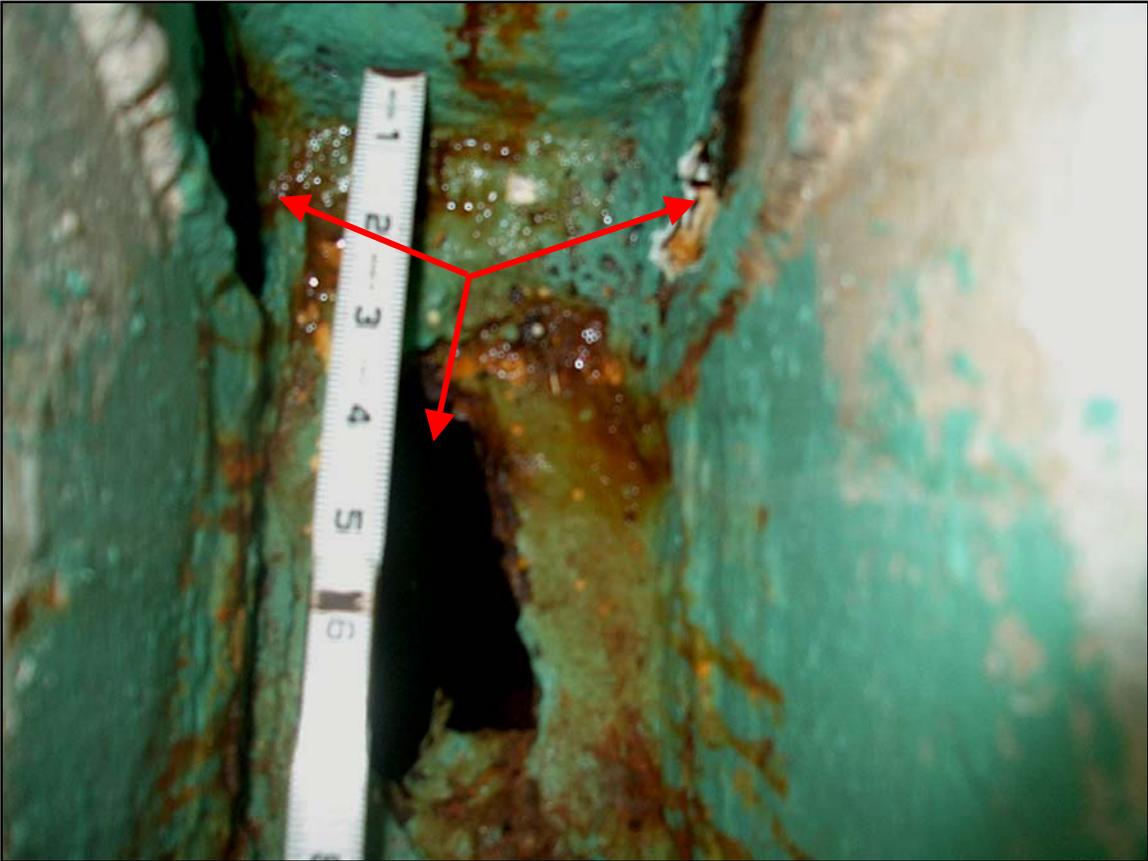
ARROW'S INDICATE HOLES IN 4<sup>TH</sup> STRINGER UP FROM MARGIN PLATE AND FOUNDATION FOR SALT WATER STRAINER, APPROXIMATELY 1' FWD OF WEB FRAME (316)

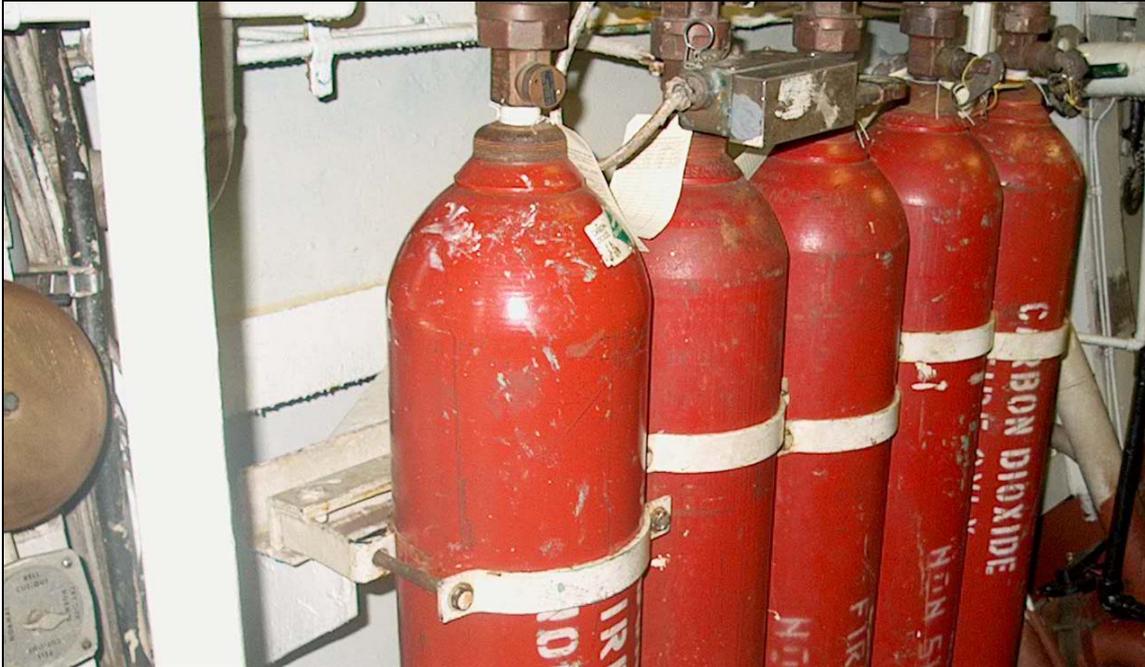
HALON BOTTLE STATION BETWEEN WEB FRAMES (324-332) 3 6X4 VERTICAL STIFFENERS ARE SEVERELY DETERIORATED OUTBOARD OF BOTTLES.

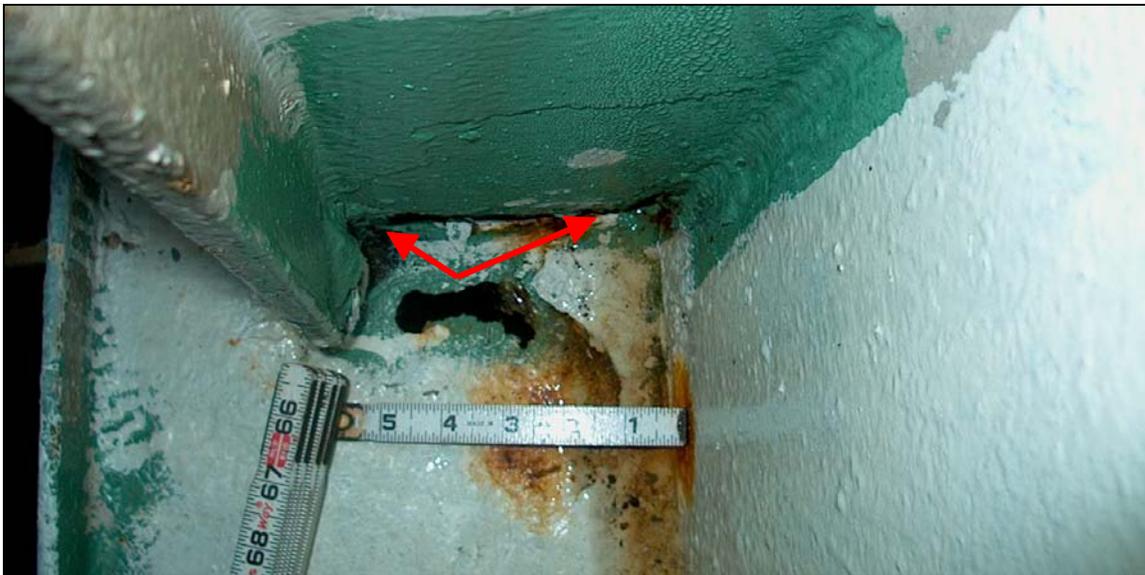
4<sup>TH</sup> STRINGER FROM MARGIN PLATE APPROXIMATELY 1' FWD OF WEB FRAME (332)  
ARROWS INDICATE DETERIORATION ON 6X4 VERTICAL STIFFENER.

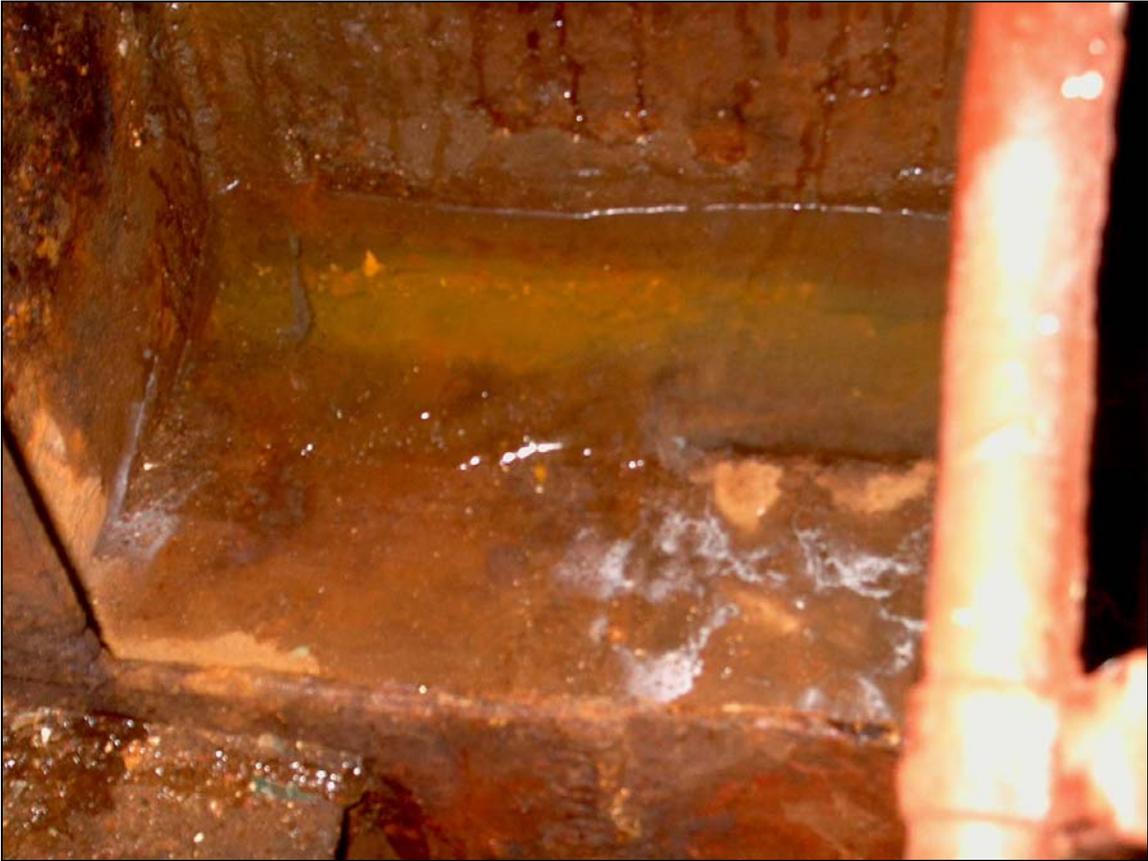
3<sup>RD</sup> STRINGER FROM MARGIN PLATE SHOWING TRAPPED WATER AT WEB FRAME (308). THIS IS "CONDENSATE CORNER" A CRITICAL AREA OF CORROSION ON (DD-963) CLASS SHIPS

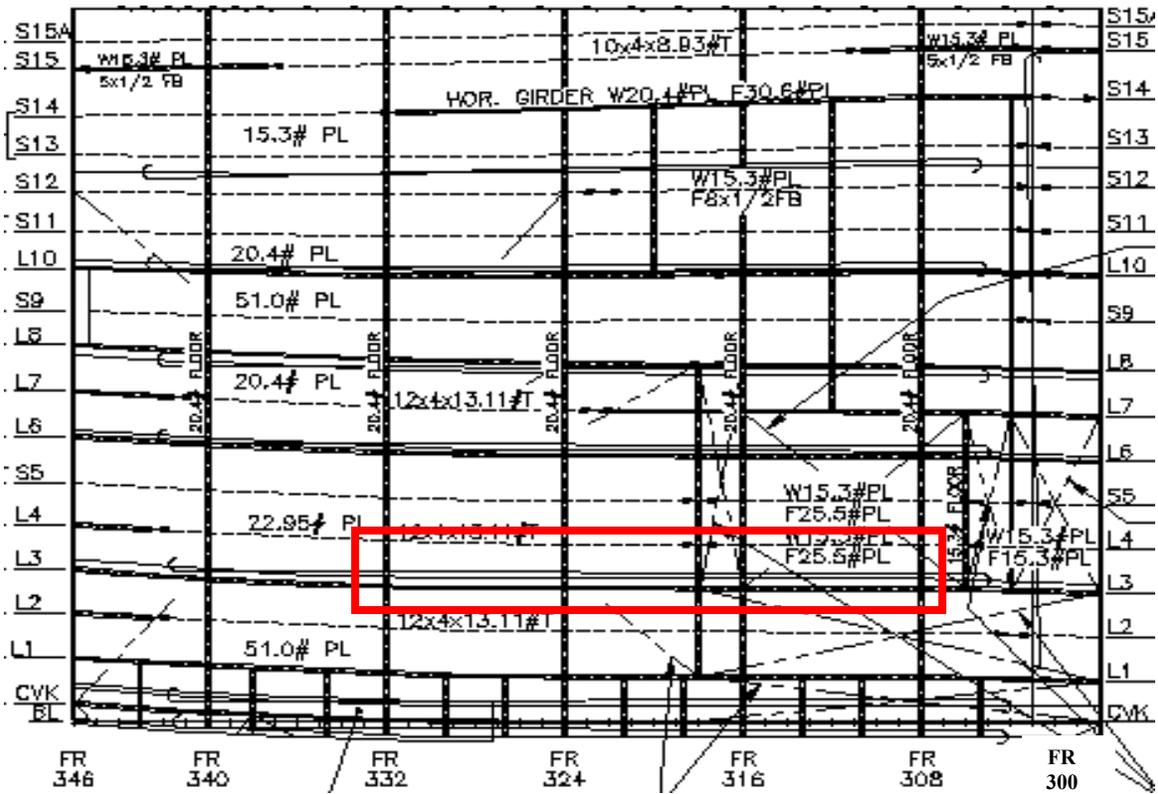
RED BOX INDICATES AREA WHERE CORROSION WAS FOUND.

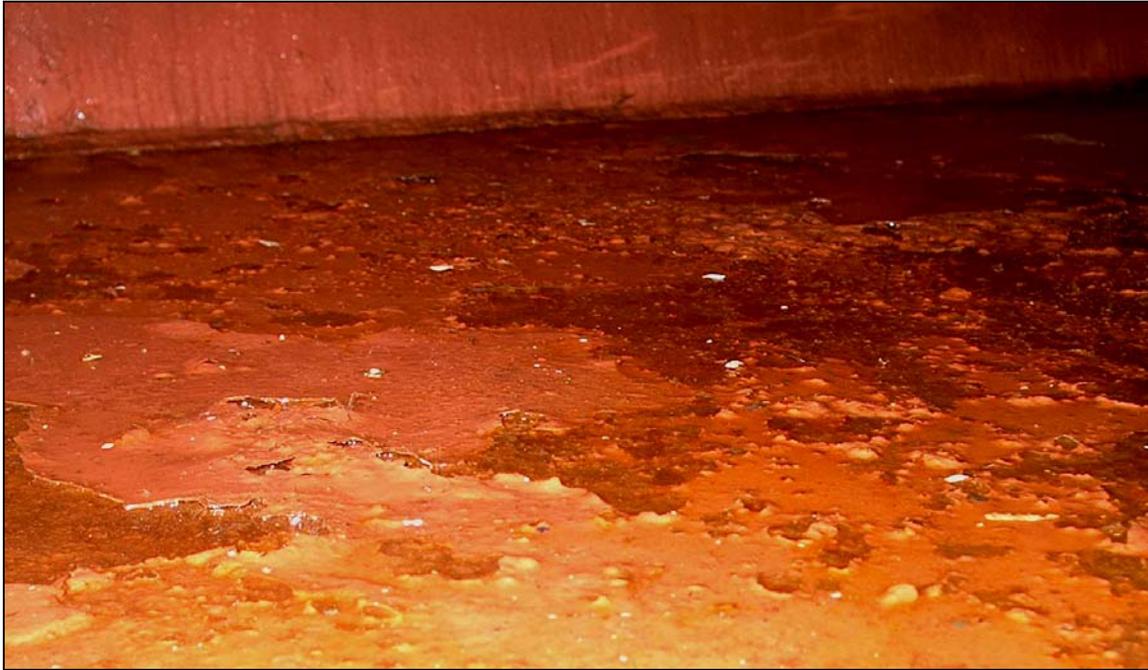
TYPICAL VIEW OF 40 X 8 HORIZONTAL GIRDER THAT RUNS FROM BHD (300) TO WEB FRAME (332).

<b>RECOMMENDED REPAIRS:</b>						
RECOMMEND SHIPS FORCE CLEAN ENTIRE AREA TO BARE METAL, PRIME AND PAINT APPROXIMATELY 200 SF.						
<b>SSPORT C221 POC: J. BRUCKNER (757) 396-4001 EXT , TPOC: J. LaROCK QED SYSTEMS INC (757) 490-5047</b>						
<b>CSMP SUMMARY:</b>				TEST#		
STBD SIDE BILGE CORROSION.				MRC 1102/1		
<b>ROOT CAUSE/AMPLIFICATION:</b>				STEP#		
H1				1,2,3,4 & 5		
<b>SYSTEM LEVEL IMPACT:</b>						
PART NO.	NOMENCLATURE			QTY	NSN	COST
1						
2						
3						
4						
5						
6						
FIRST CONTACT <b>ANDERSON</b>	RATE <b>HTC</b>	SECOND CONTACT <b>MILTON</b>		RATE <b>HT1</b>	PHONE	
ASSESSOR / ACT / TECH ID# <b>J. LaROCK/ T. WHITMORE QED SYSTEMS INC.</b>			TD	TL	LOGISTICIAN	TSP

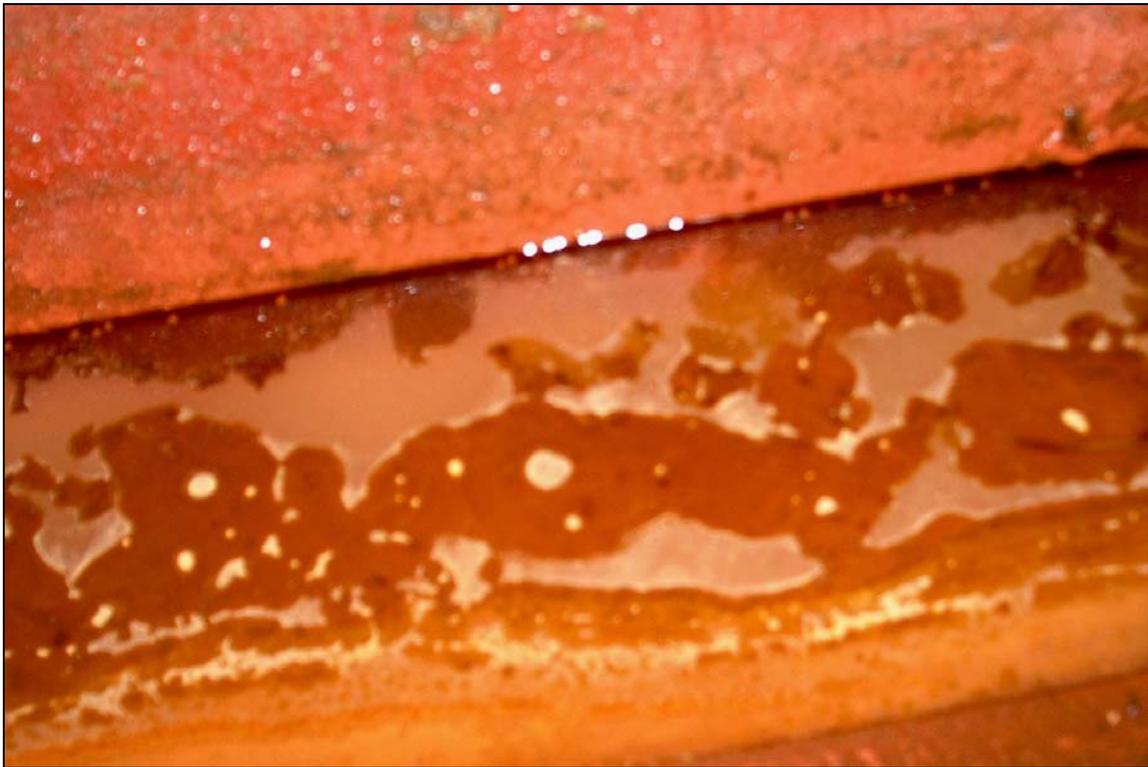
WATER TRAPPED IN STRINGER BELOW HORIZONTAL GIRDER

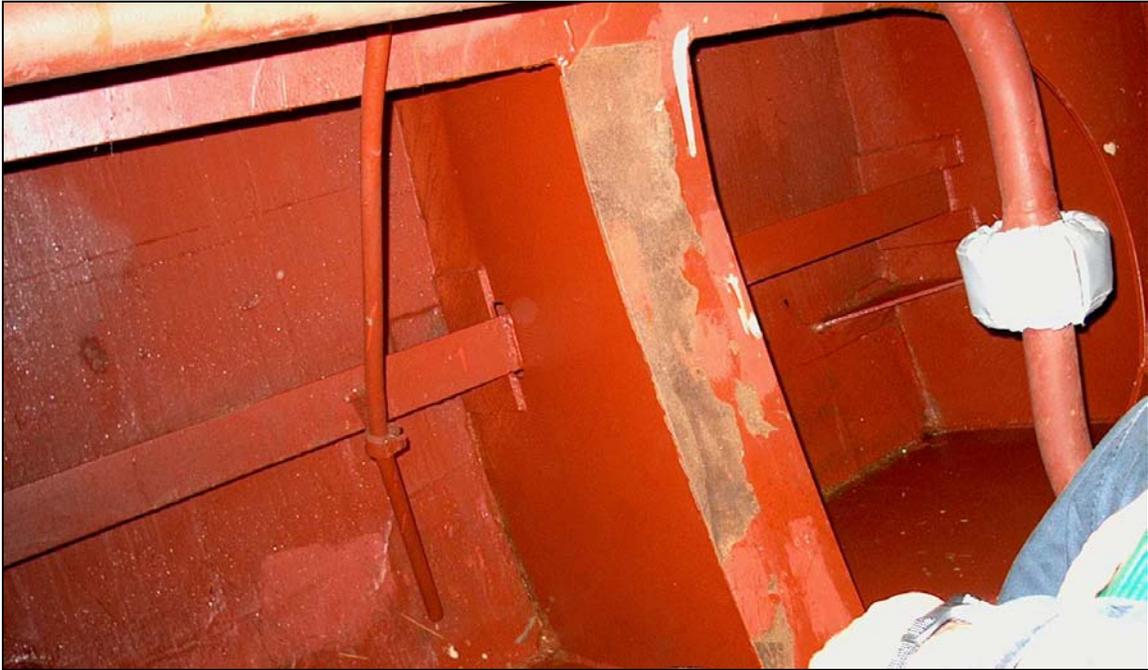
FRAME (320) HAS NO PAINT ON FLANGE.

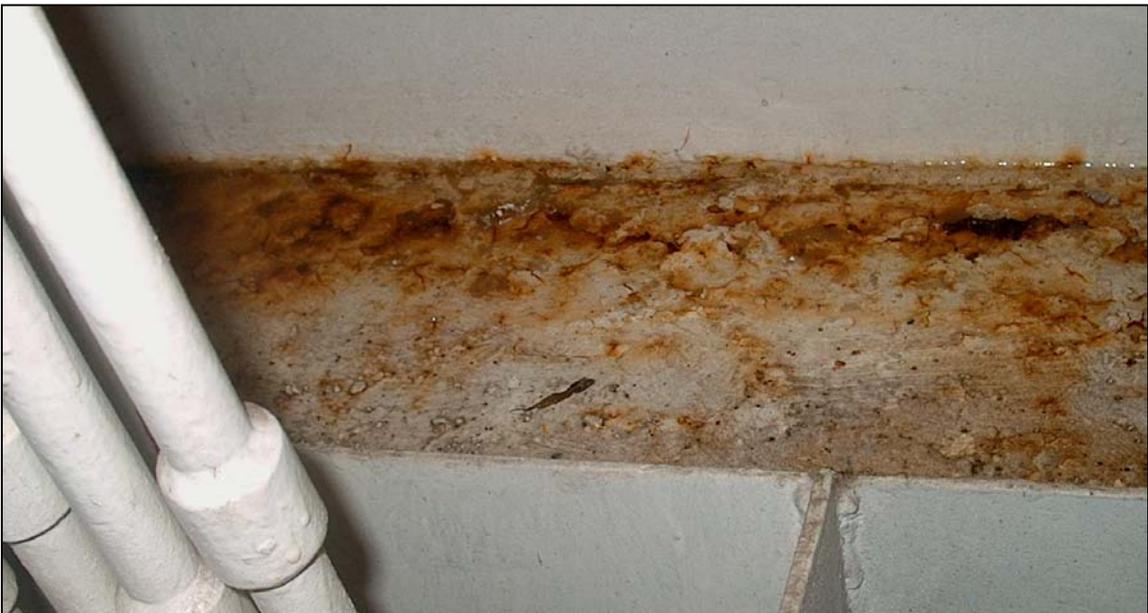
TYPICAL VIEW OF 1<sup>ST</sup> STRINGER FROM UPPER LEVEL DECK BETWEEN  
WEB FRAMES (308-316).

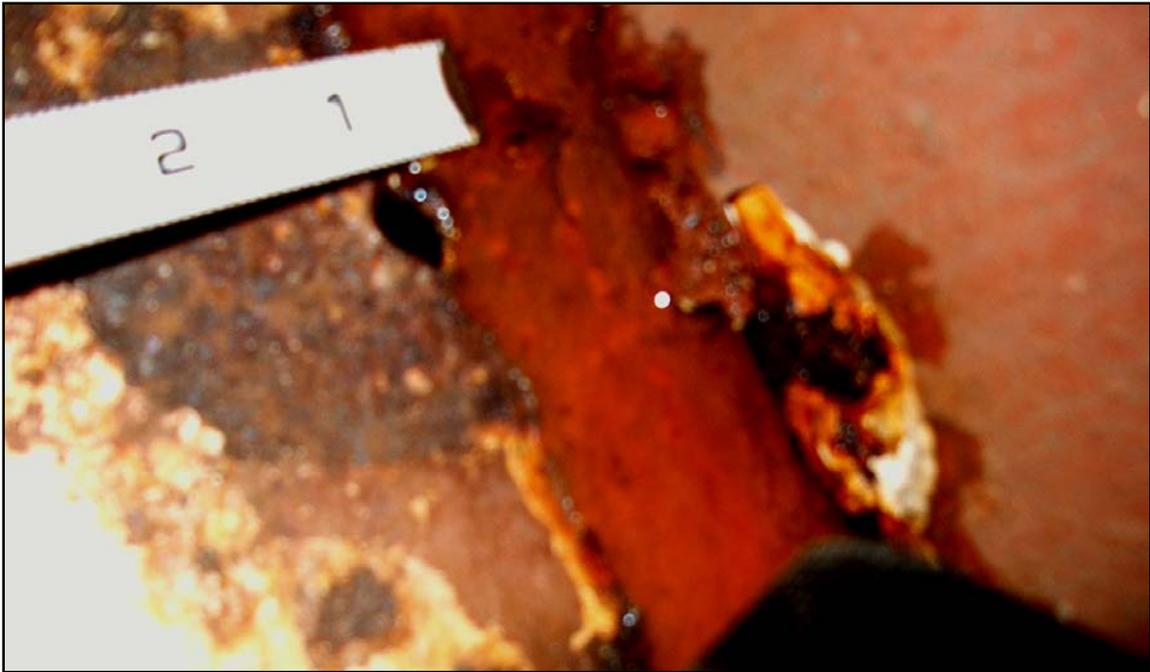
2<sup>ND</sup> STRINGER UP FROM MARGIN PLATE APPROXIMATELY 6" FWD OF WEB FRAME (280)  
IS HOLED.

RECOMMEND REPAIR ACTIVITY CLEAN ENTIRE STRINGER TO BARE METAL, CUT OUT HOLED AREA APPROXIMATELY 1 SF AND PATCH WITH .250 MILD STEEL, PRESERVE AND PAINT TO MATCH.						
<b>SSPORT C221 POC: J. BRUCKNER (757) 396-4001 TPOC: J. LaROCK QED SYSTEMS INC. (757) 490-5047</b>						
<b>CSMP SUMMARY:</b> 2 <sup>ND</sup> STRINGER UP FROM MARGIN PLATE IS HOLED.				<b>TEST#</b> MRC 1102/1		
<b>ROOT CAUSE/AMPLIFICATION:</b> H1				<b>STEP#</b> 1,2,3,4 & 5		
<b>SYSTEM LEVEL IMPACT:</b>						
PART NO.	NOMEMCLATURE			QTY	NSN	COST
1						
2						
3						
4						
5						
6						
FIRST CONTACT <b>ANDERSON</b>	RATE <b>HTC</b>	SECOND CONTACT <b>MILTON</b>		RATE <b>HT1</b>	PHONE	
ASSESSOR / ACT / TECH ID# <b>C. SHORT / T. WHITMORE QED SYSTEMS INC.</b>			TD	TL	LOGISTICIAN	TSP

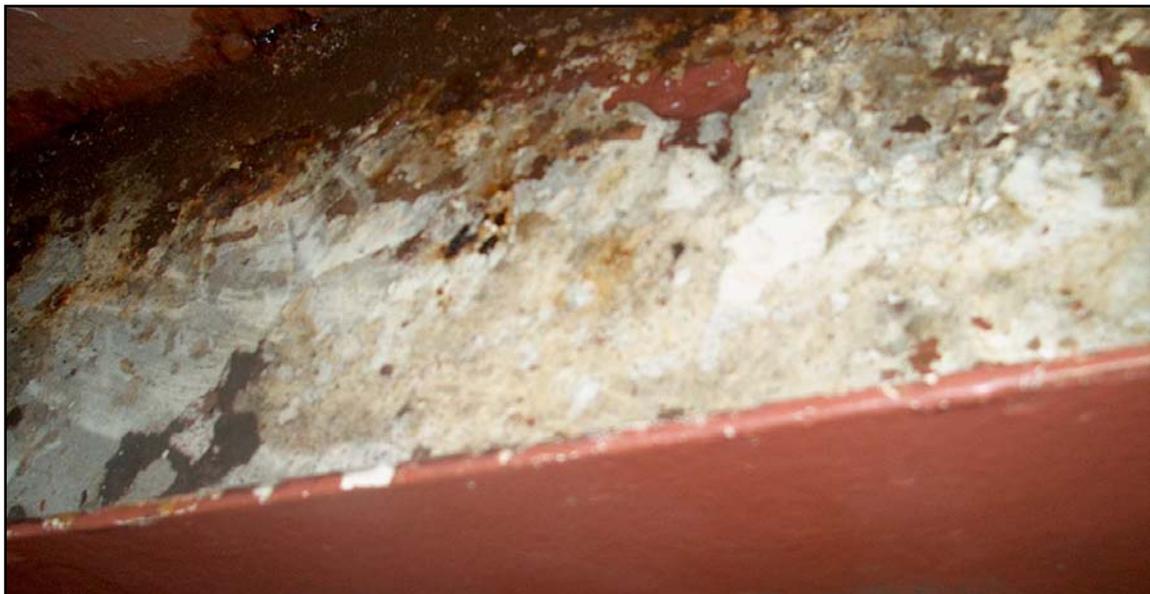
CORROSION AND PAINT SEPARATION IN 1<sup>ST</sup> AND 2<sup>ND</sup> STRINGERS UP FROM MARGIN PLATE  
FROM BHD (300) TO BHD (260)

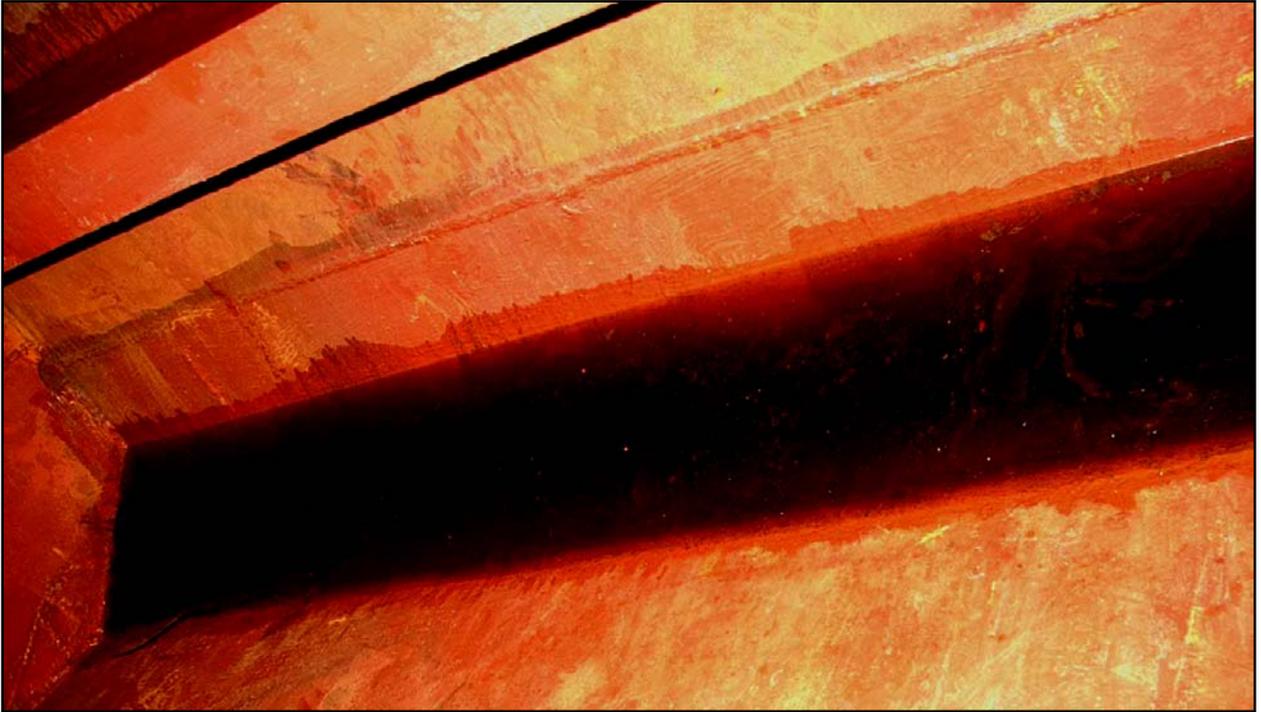
ENTIRE BILGE AREA, 1<sup>ST</sup> AND 2<sup>ND</sup> STRINGERS HAVE STANDING WATER, CORROSION AND PAINT SEPARATION FROM BHD (300) TO BHD (260)
