# **USS ARTHUR W RADFORD (DD-968)**

## **SEMAT II SHELL CONDITION ASSESSMENT SURVEY INTERIOR AREAS**

**01/28/02 TO 02/08/02**

Q.E.D. Systems, Inc. was tasked by the Supervisor of Shipbuilding Conversion and Repair, USN (SPORT) Portsmouth, VA to conduct an Ultrasonic Thickness (U/T) Survey of specific locations on board USS ARTHUR W RADFORD (DD-968) during the period of 28 January 2002 – February 8 2002.

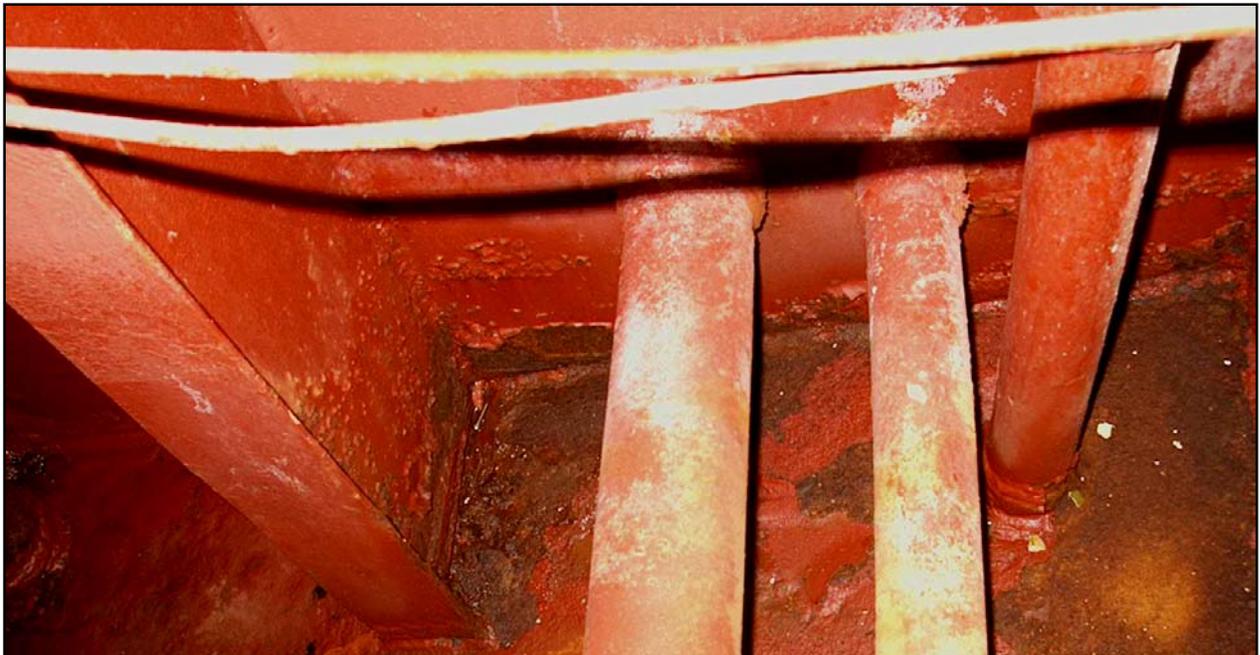
TANK TOP (6-292-2-F) AT BHD (300) HAS APPROXIMATELY 40 SF OF CORROSION AND PAINT SEPARATION.

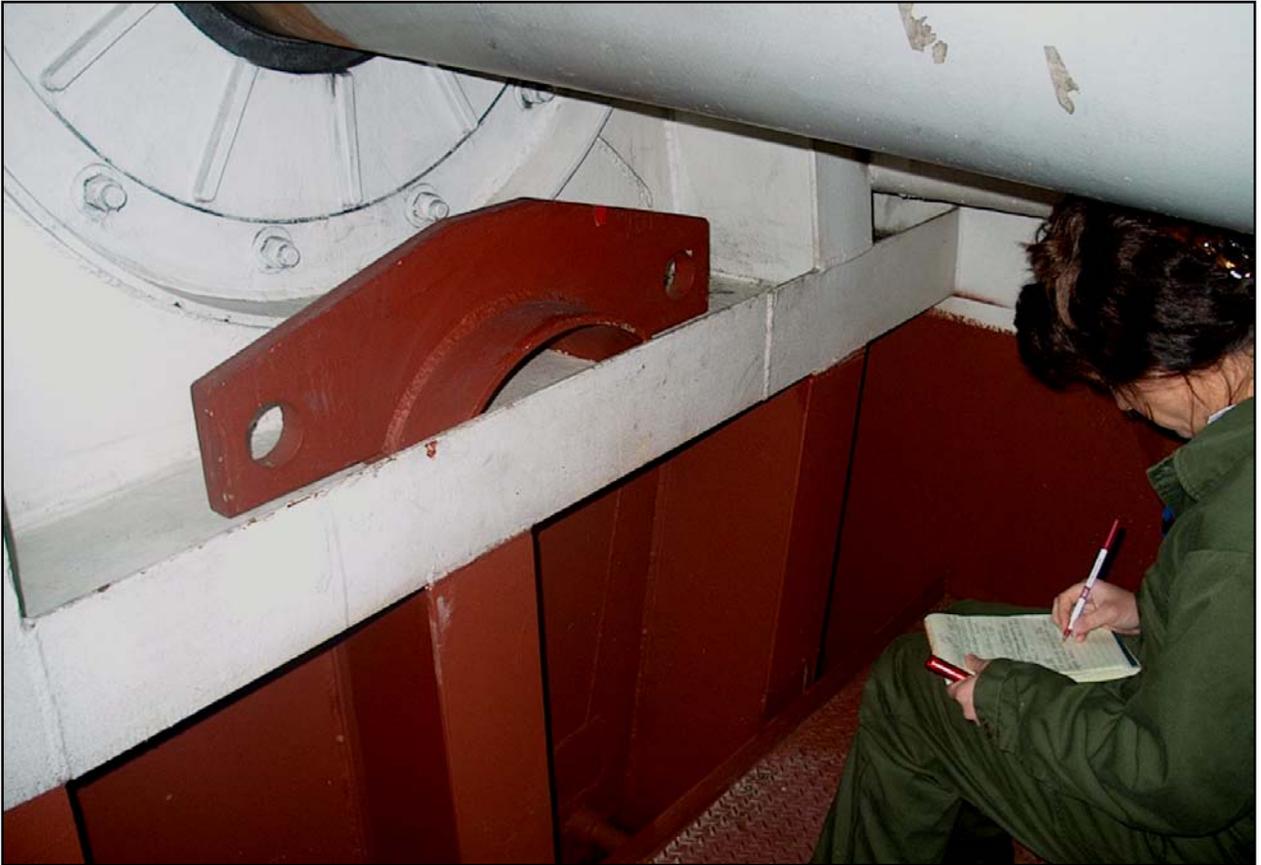
CORROSION WAS FOUND ON LOWER PORTION OF BHD (260) BELOW THE SHAFT.

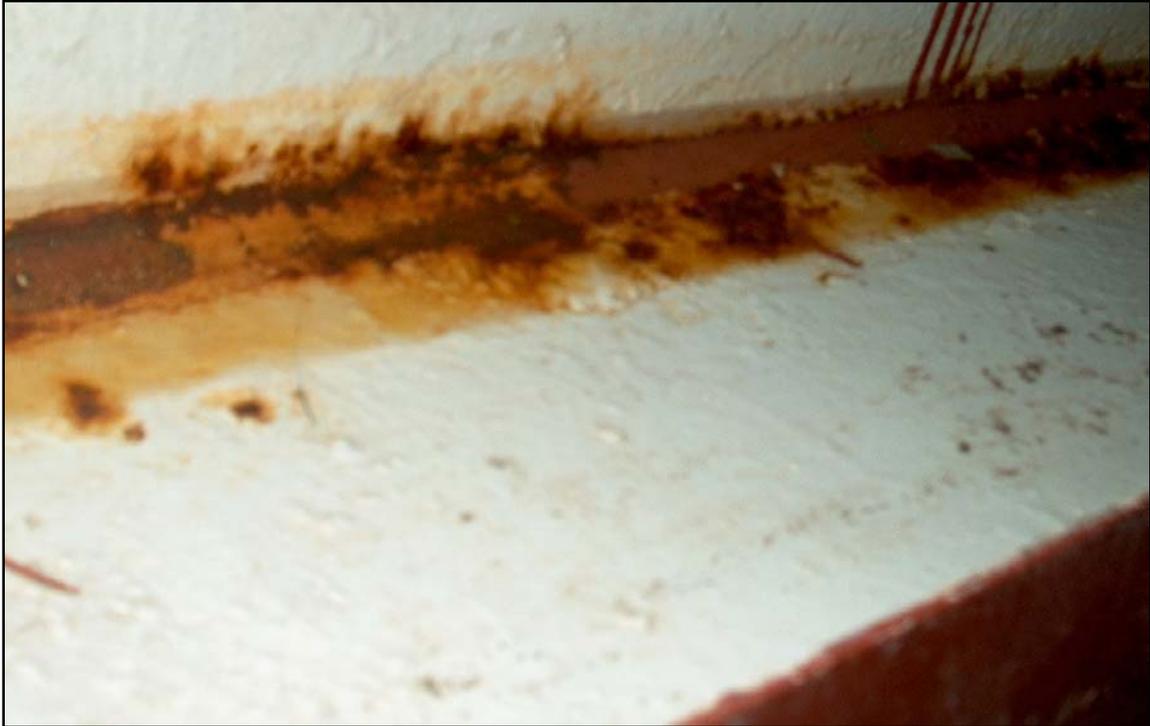
1<sup>ST</sup> STRINGER UP FROM MARGIN PLATE HAS CORROSION AND STANDING WATER, FROM FRAME (270) TO BHD (300).

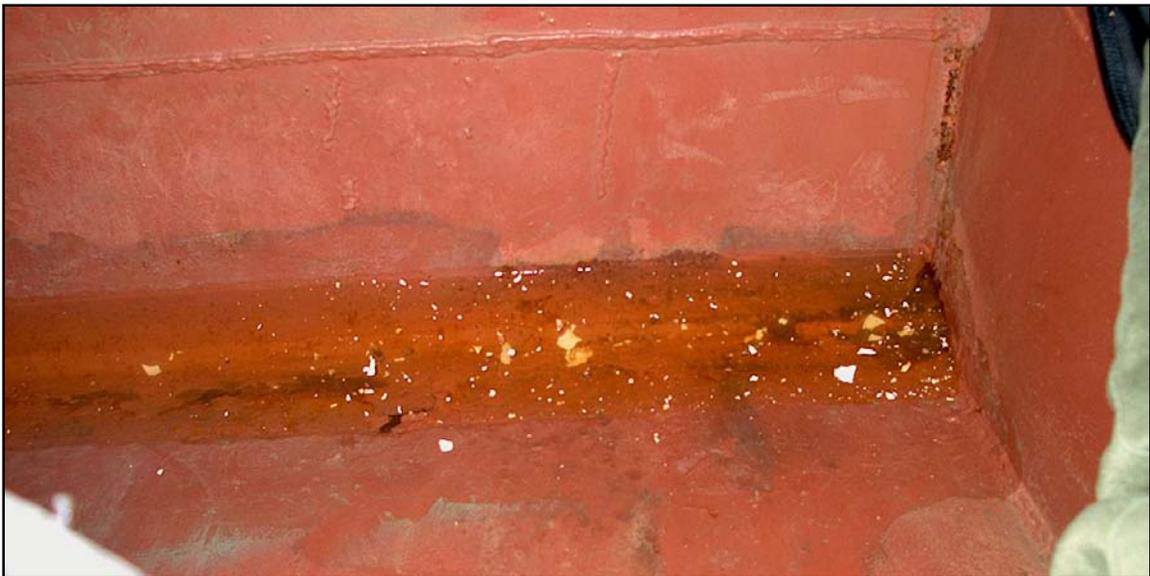
ENTIRE BILGE AREA HAS STANDING WATER FROM BHD (260) TO BHD (300)

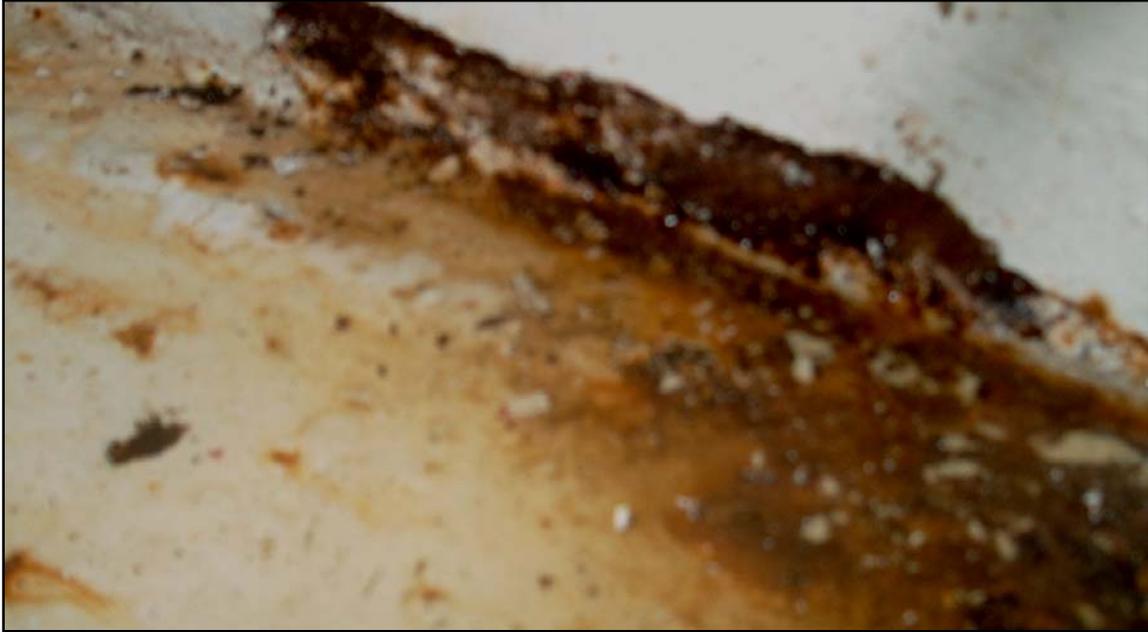
2<sup>ND</sup> STRINGER UP FROM MARGIN PLATE BETWEEN WEB FRAME (280) AND WEB FRAME (290) HAS STANDING WATER CAUSING SURFACE RUST AND PAINT SEPARATION.

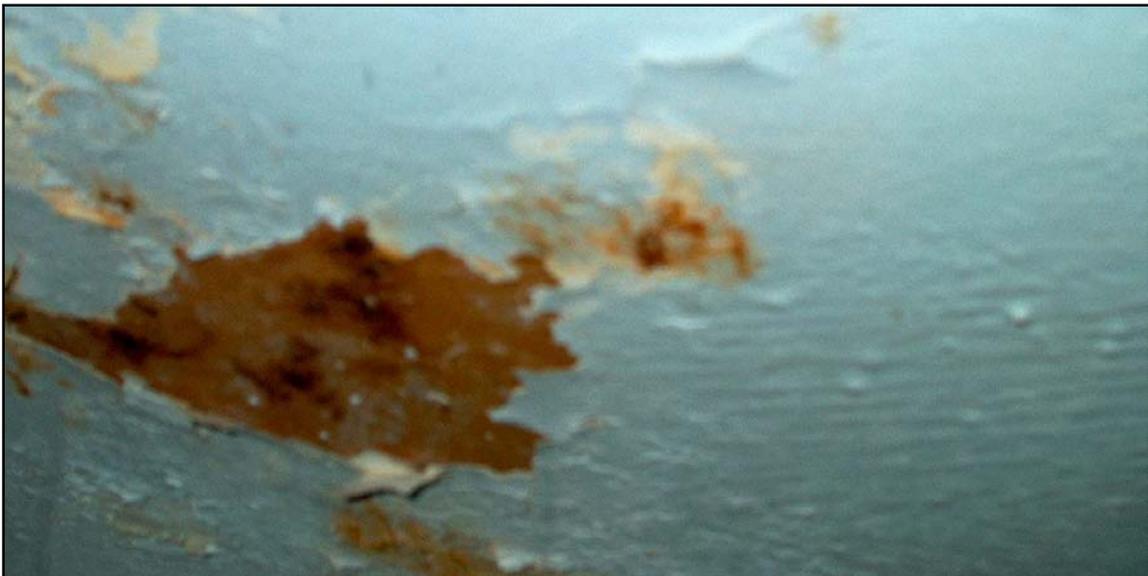
BOTTOM VIEW OF 2<sup>ND</sup> STRINGER UP FROM MARGIN PLATE BETWEEN WEB FRAME (280) AND WEB FRAME (290) HAS PAINT FAILURE.

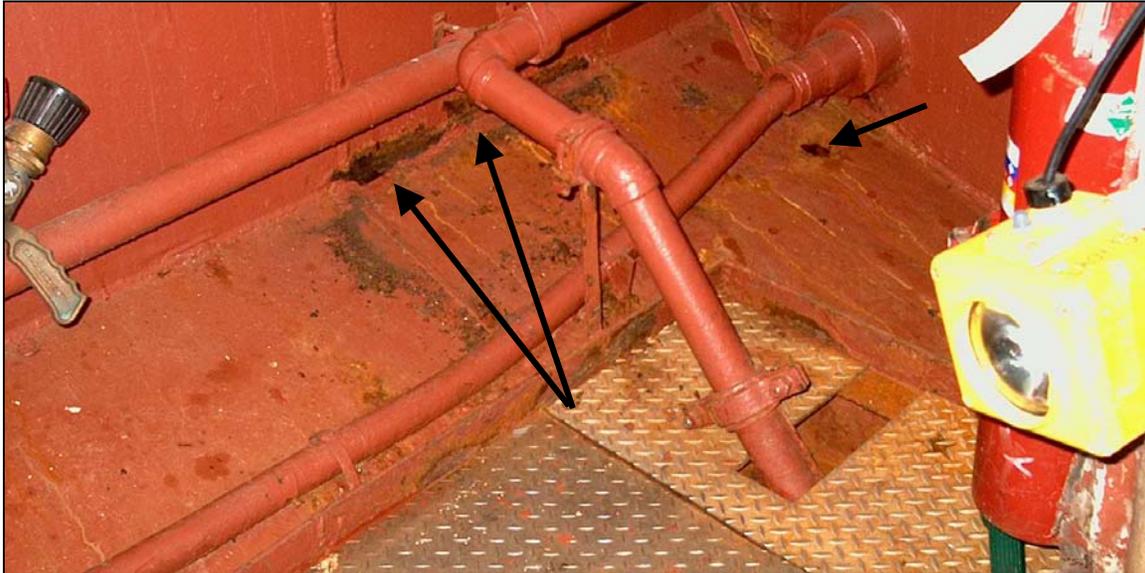
ARROWS INDICATE AREAS OF LOW U/T READINGS.

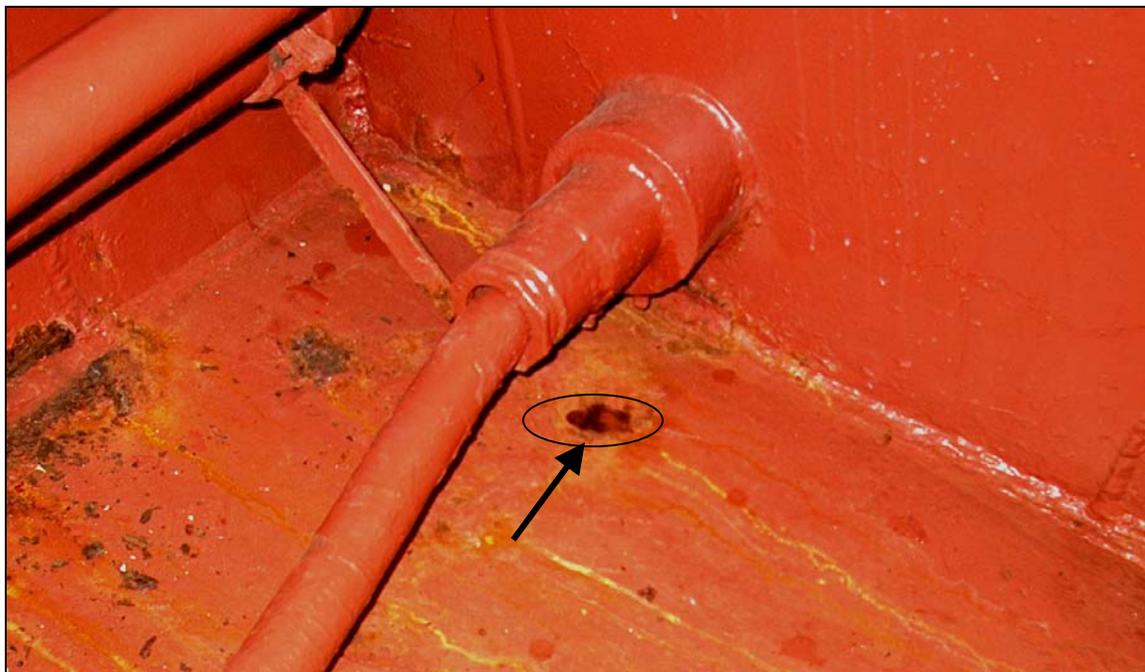
TANK TOP (6-220-3-F) AND BHD (260), ARROW INDICATES LOW U/T READING

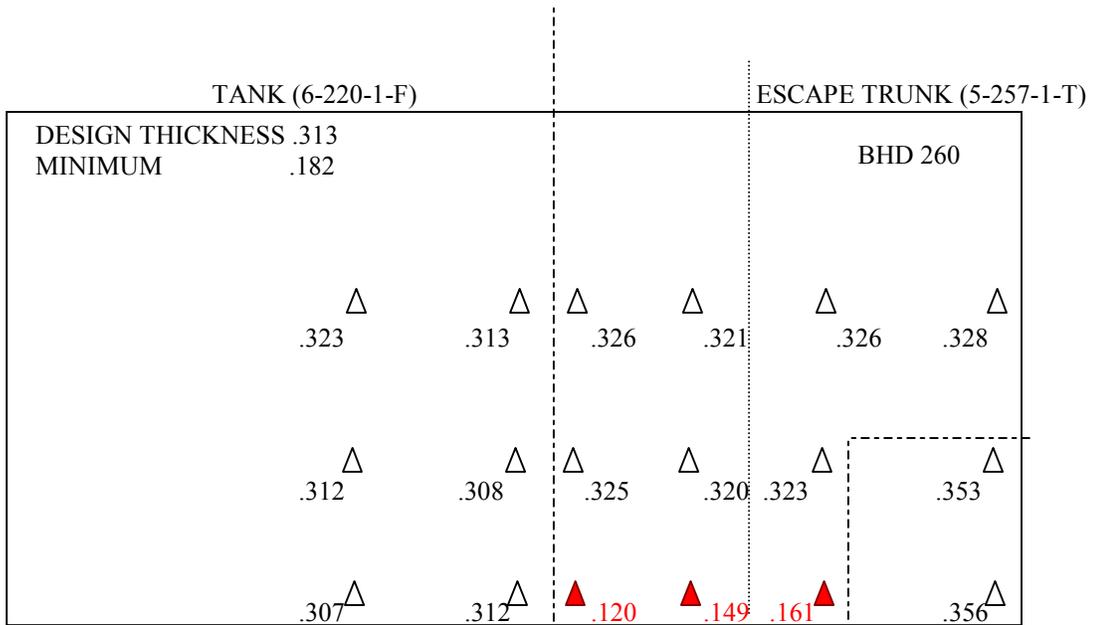
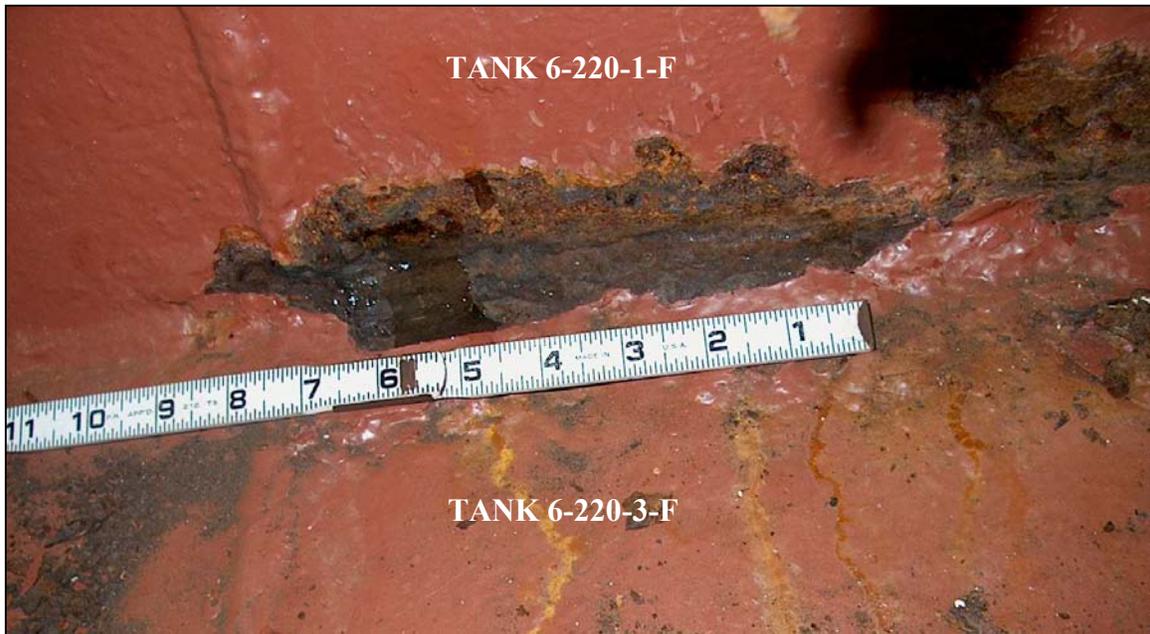
DEEP PITTING AND DETERIORATED WELD SEAM AT THE JUNCTION OF TANK (6-220-1-F) AND TANK (6-220-30F). DRAWING AT TOP INDICATES LOW U/T READINGS IN THIS AREA..

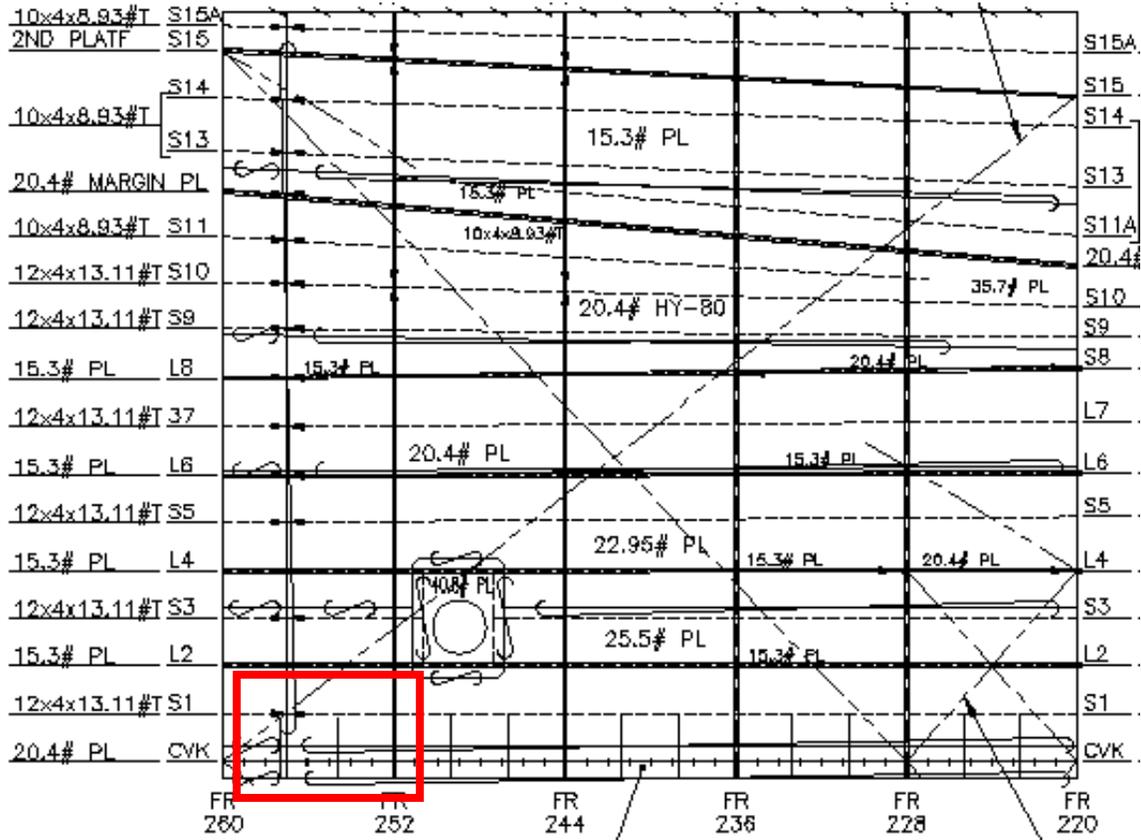
RED BOX INDICATES AREA WHERE CORROSION WAS FOUND.

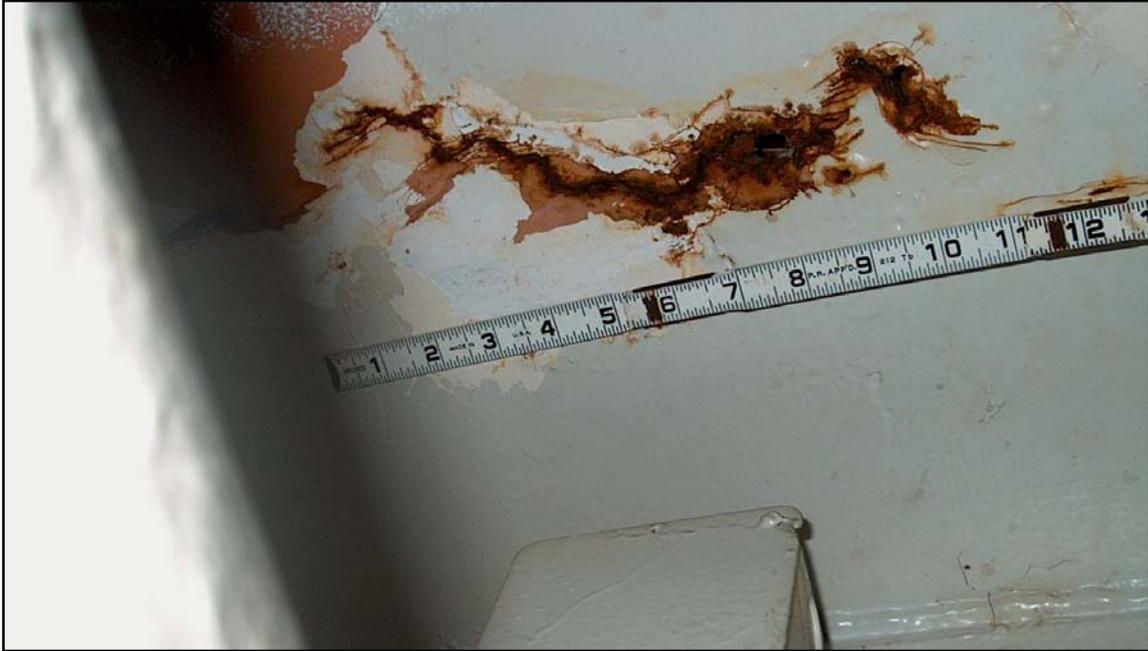
DETERIORATION OF UPPER LEVEL DECK APPROXIMATELY 10' FWD OF BHD (260) AND 3'  
INBOARD OF TANK (6-220-1-F)

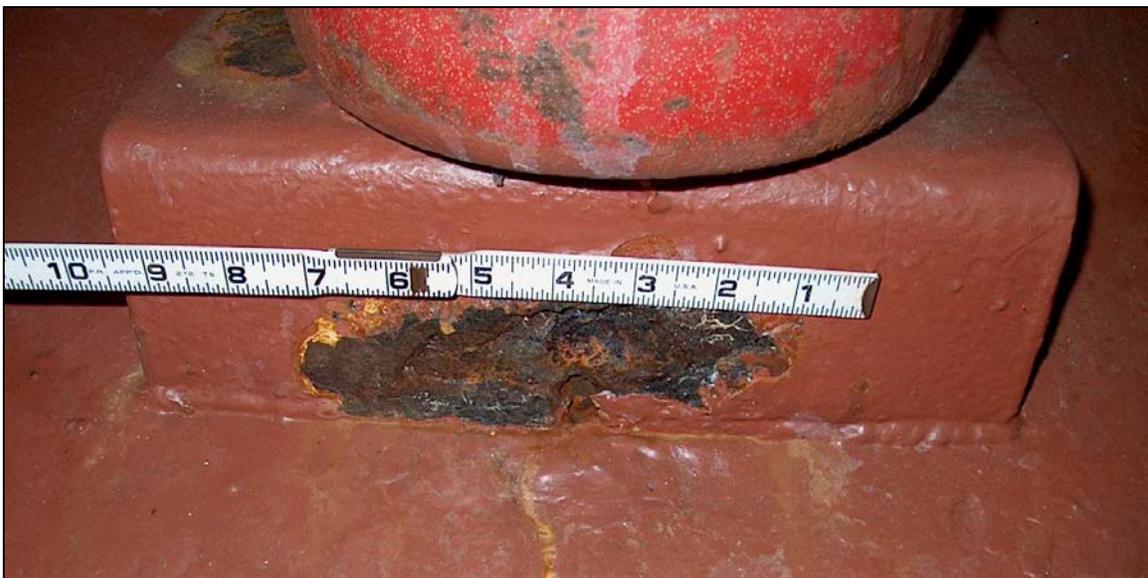
HALON BOTTLE STORAGE FOUNDATION IS SEVERELY DETERIORATED.

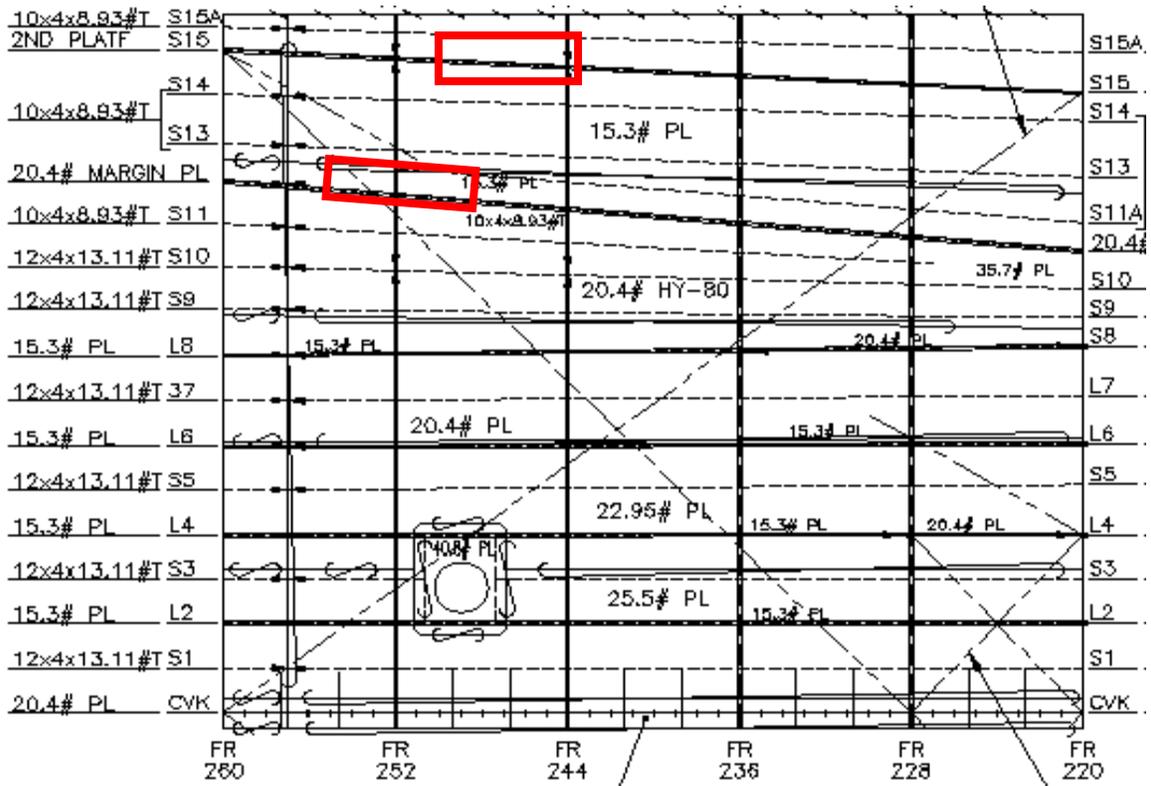
UPPER RED BOX INDICATES AREA OF DETERIORATION ON UPPER LEVEL DECK  
 LOWER RED BOX INDICATES AREA WHERE THE HALON BOTTLE STATION FOUNDATION IS SEVERELY DETERIORATED.

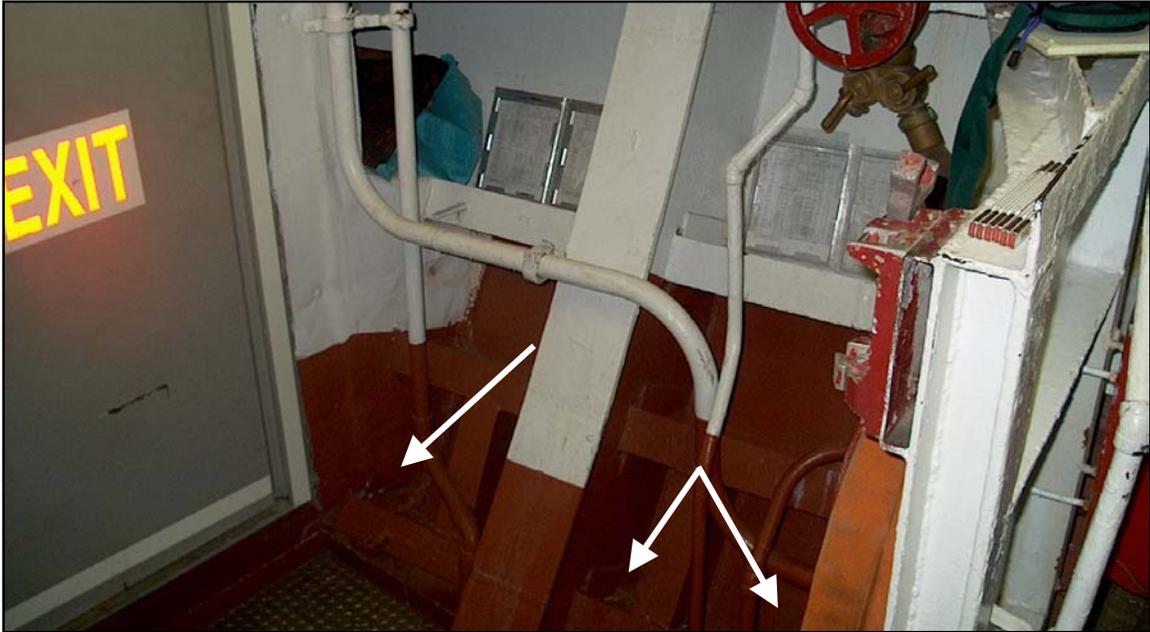
DOOR TO ESCAPE TRUNK (5-174-1-T), ARROWS INDICATE LOCATION OF HOLED STRINGER AND VERTICAL STIFFENERS. (CSMP/JSN-P104)

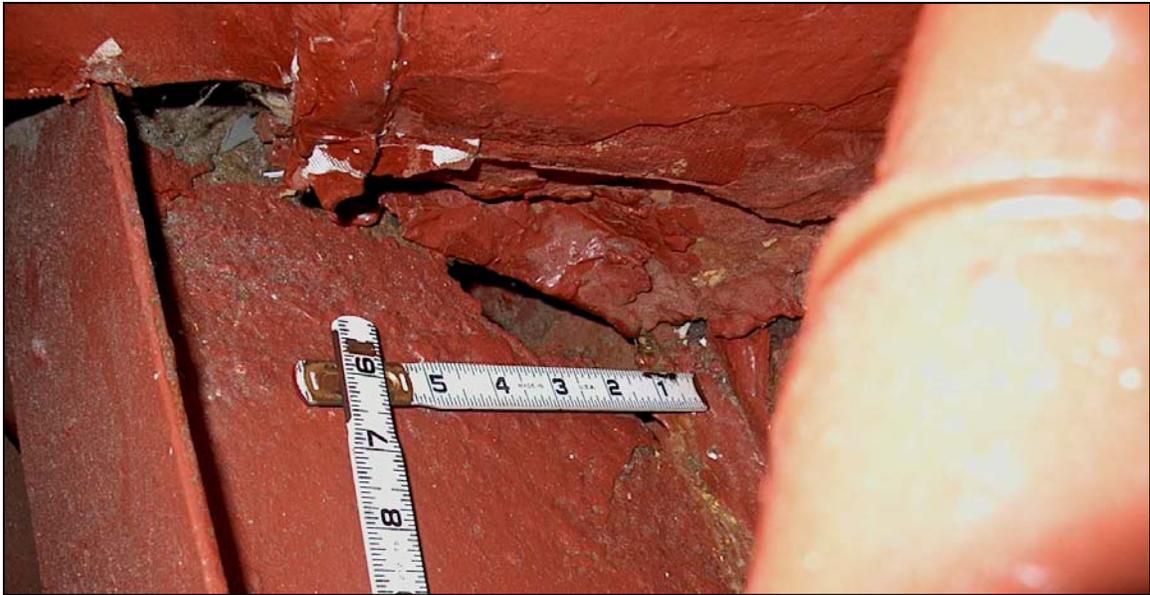
HOLED STRINGER AT FRAME (178), DECK LEVEL AFT OF ESCAPE TRUNK

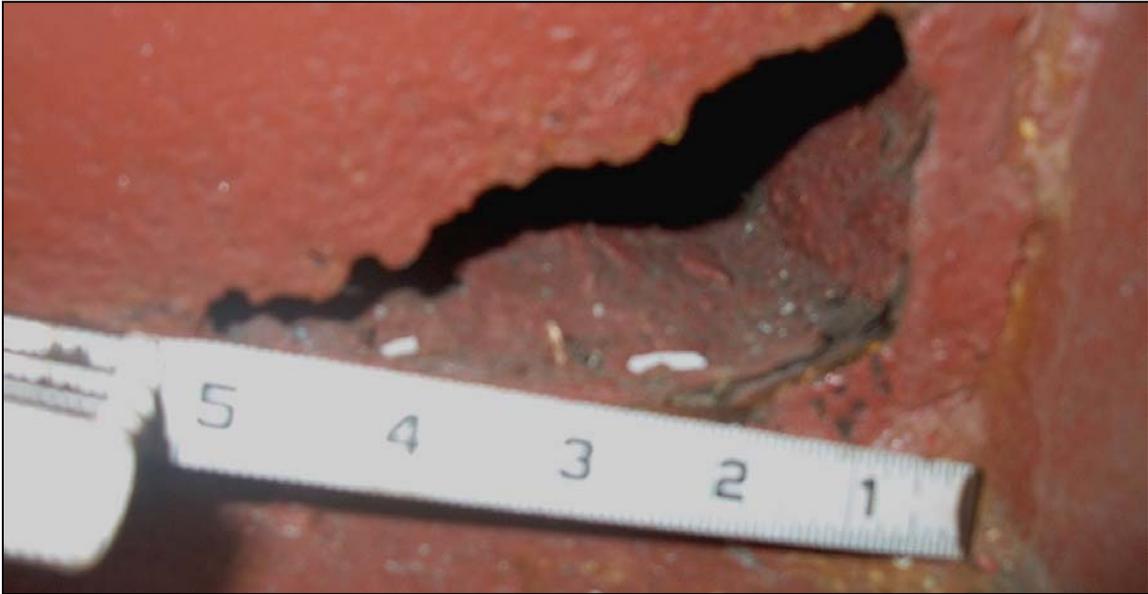
HOLED VERTICAL STIFFENER APPROXIMATELY 3' AFT OF FRAME (178)

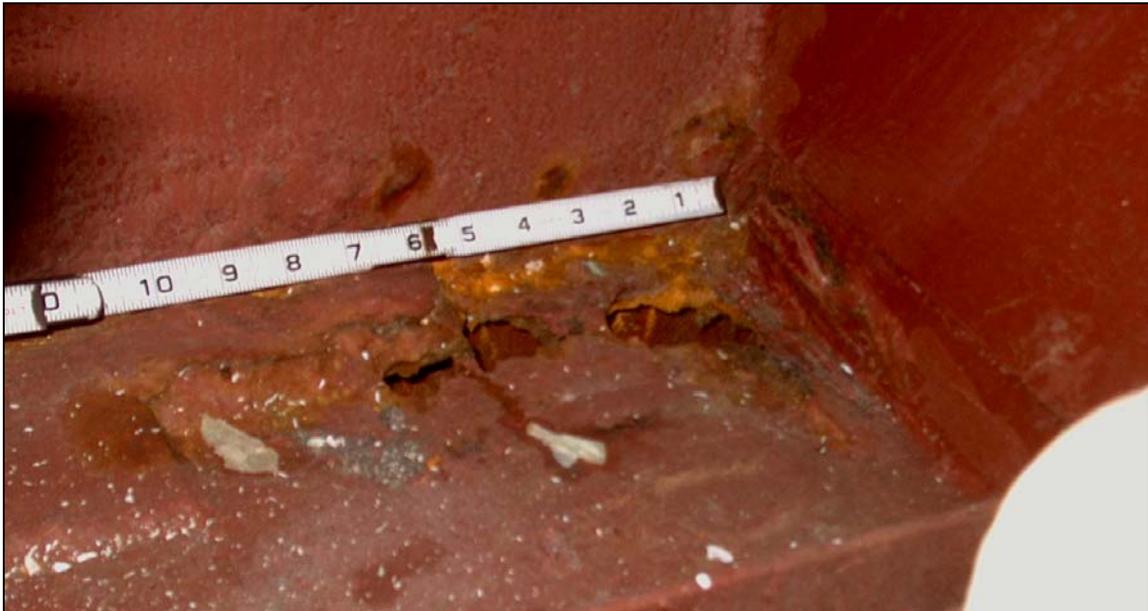
HOLED STRINGER FWD OF WEB FRAME (196) (CSMP / JSN-P104)

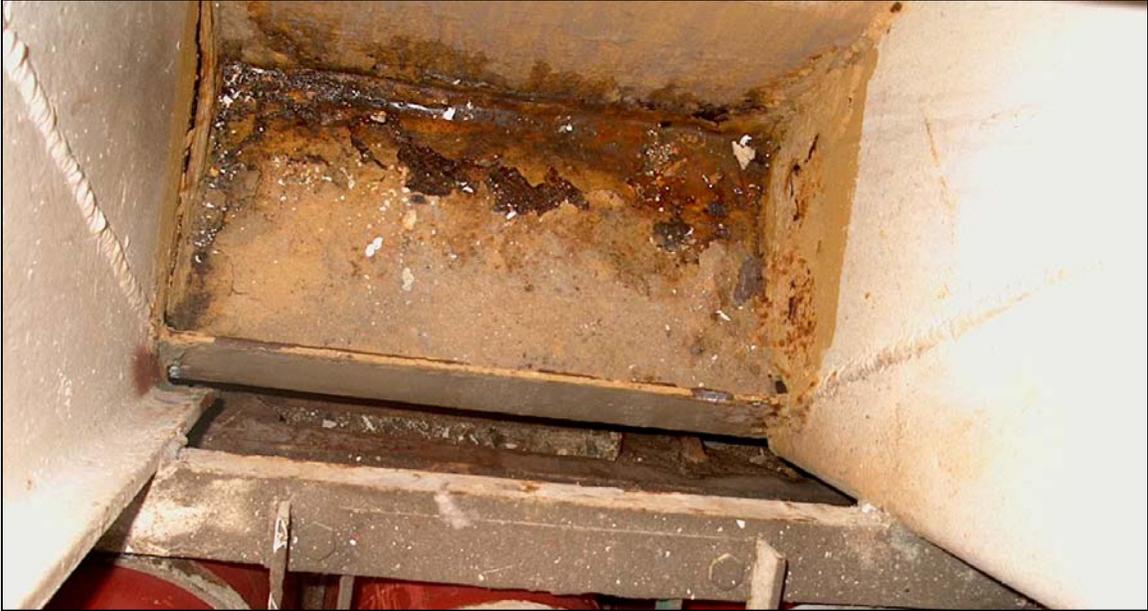
CORROSION ON STRINGER OUTBOARD OF HALON BOTTLE STATION.

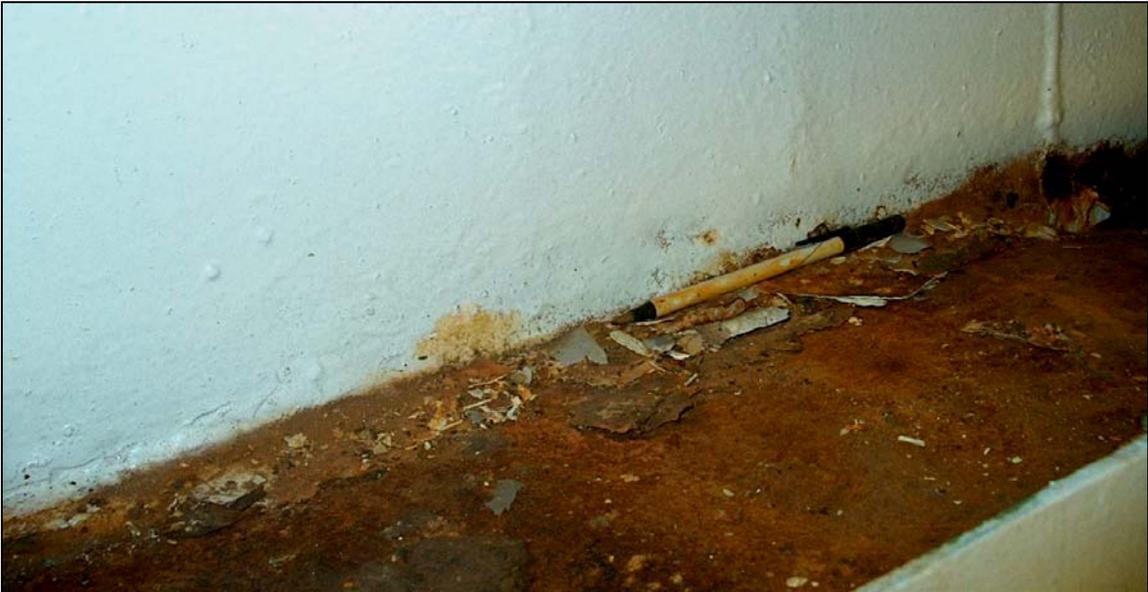
CORROSION ON STRINGER FWD OF BHD (220)

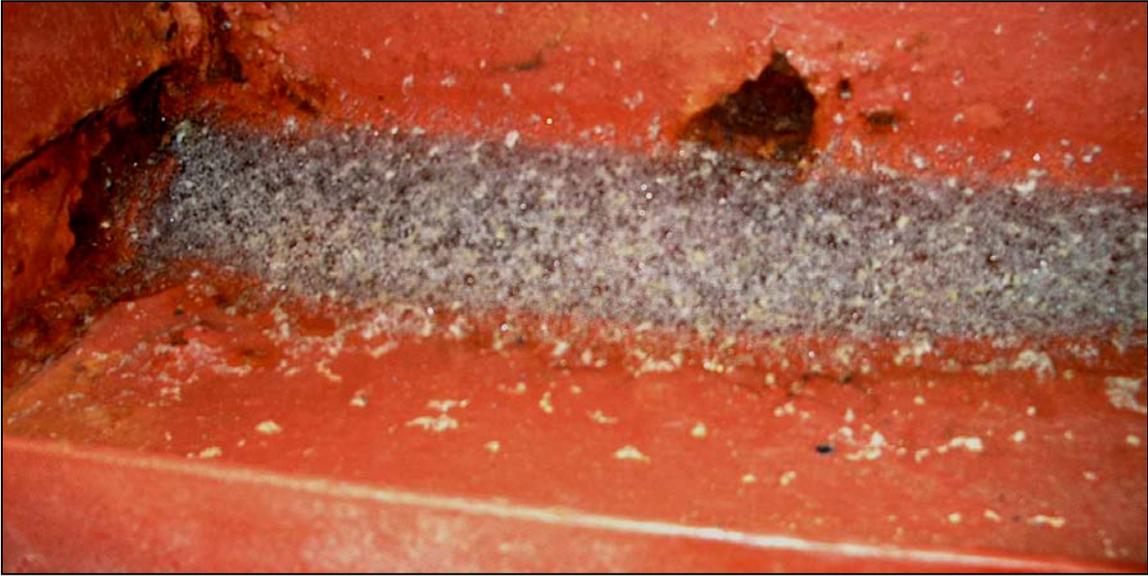
3<sup>RD</sup> STRINGER UP FROM MARGIN PLATE BETWEEN WEB FRAMES (212-204), HAS MILDEW AND CORROSION.

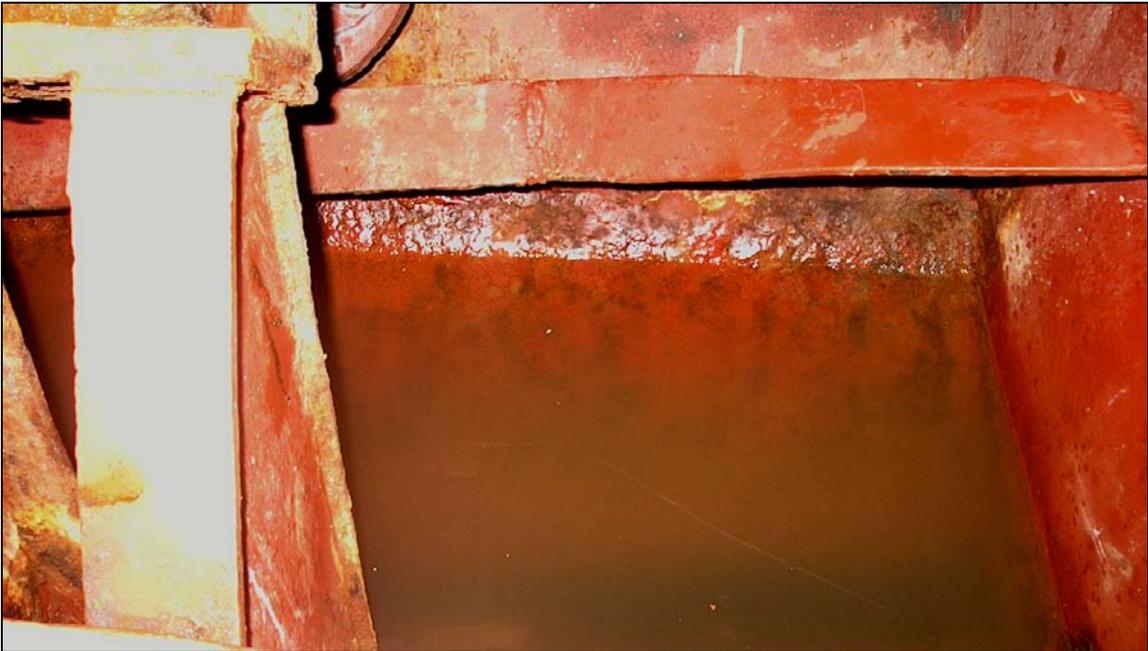
WATER TRAPPED IN PORT SIDE BILGE POCKET BELOW RODMETER. NOTE CORROSION ON SHELL PLATE.

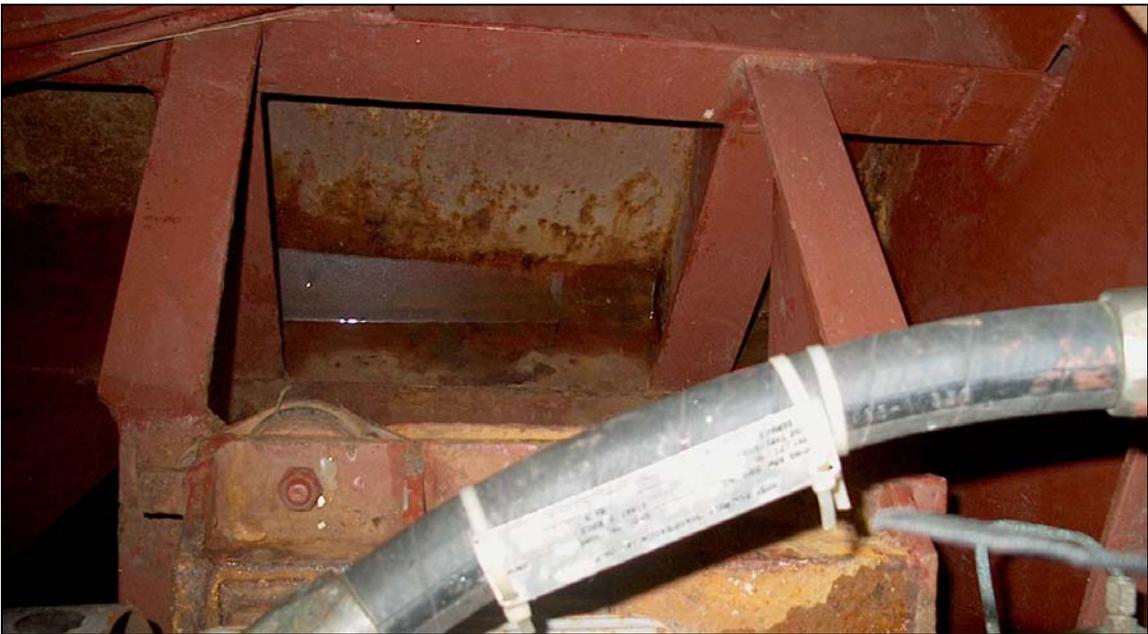
CORROSION ON SHELL PLATE OUTBOARD OF FRESH WATER PUMP NO. 1  
WEB FRAME (144) / PORT SIDE.

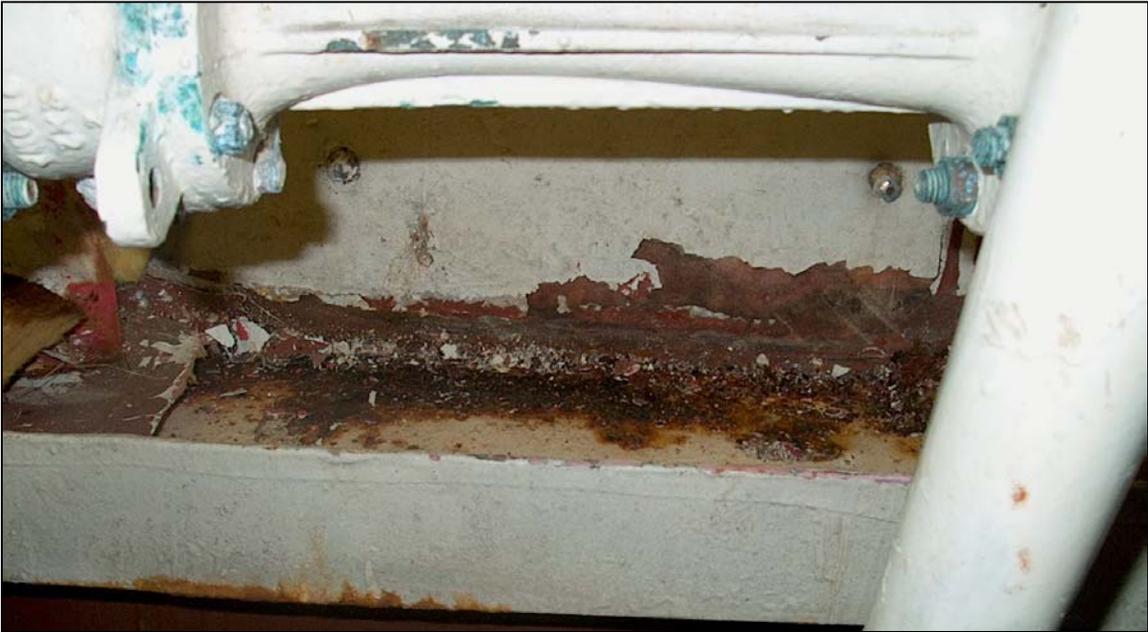
CORROSION ON SHELL AND STRINGER, HIDDEN BENEATH SATURATED LAGGING. PORT SIDE 3' AFT OF BHD (138)

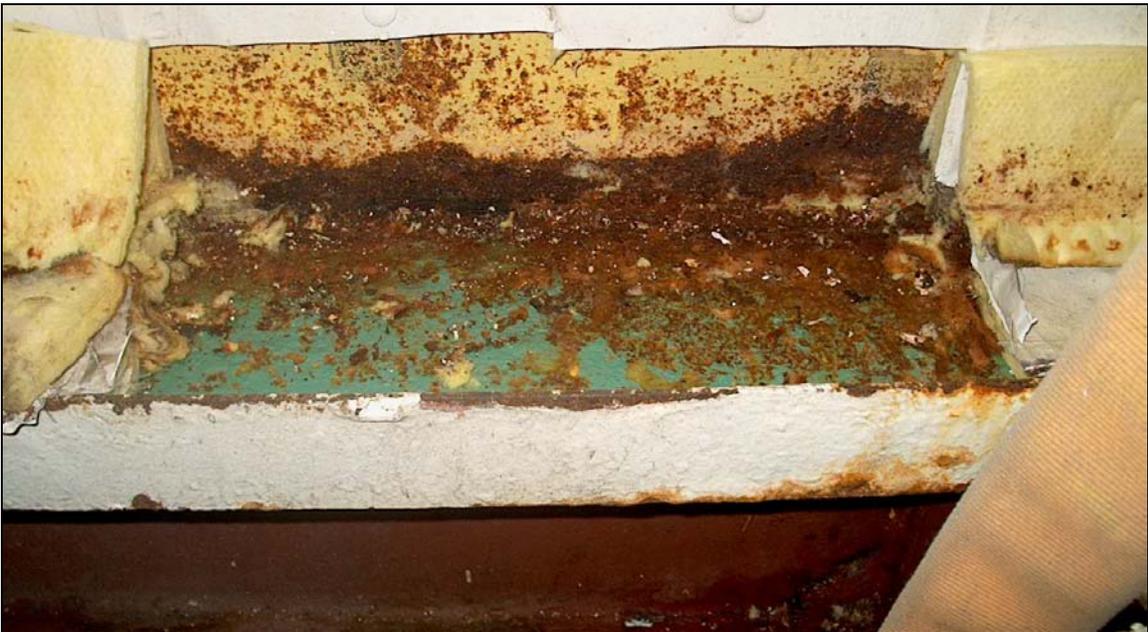
STARBOARD SIDE, 3' AFT OF BHD (138). PERMANENT REMOVAL OF LAGGING AND USE OF AN ANTI-SWEAT PAINT IS RECOMMENDED.

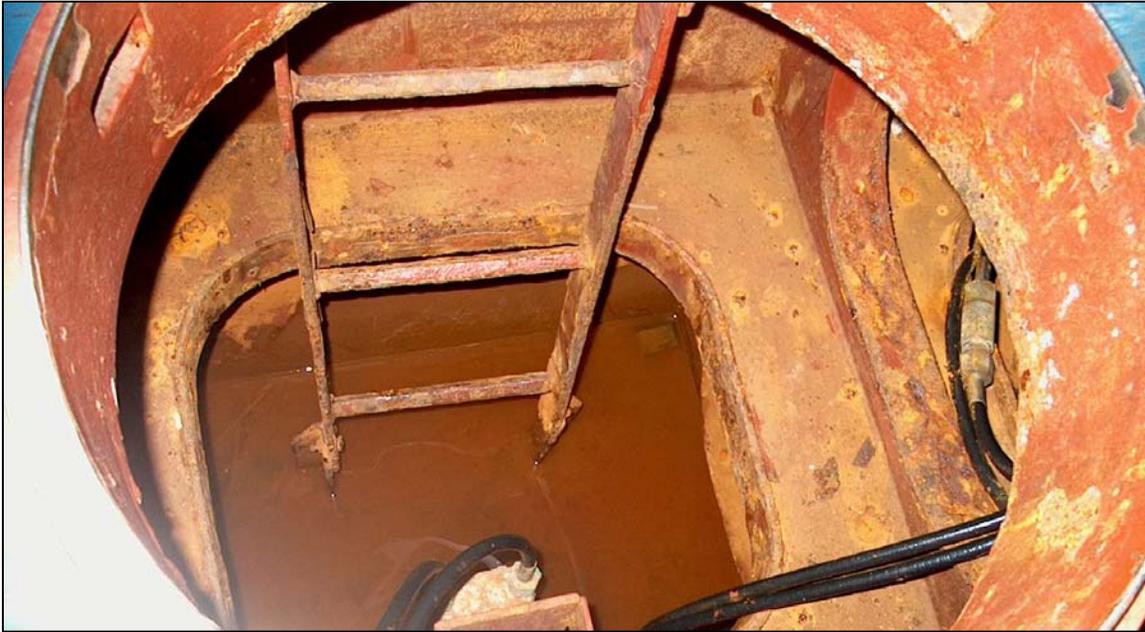
CORROSION IN EDUCTOR SPACE.

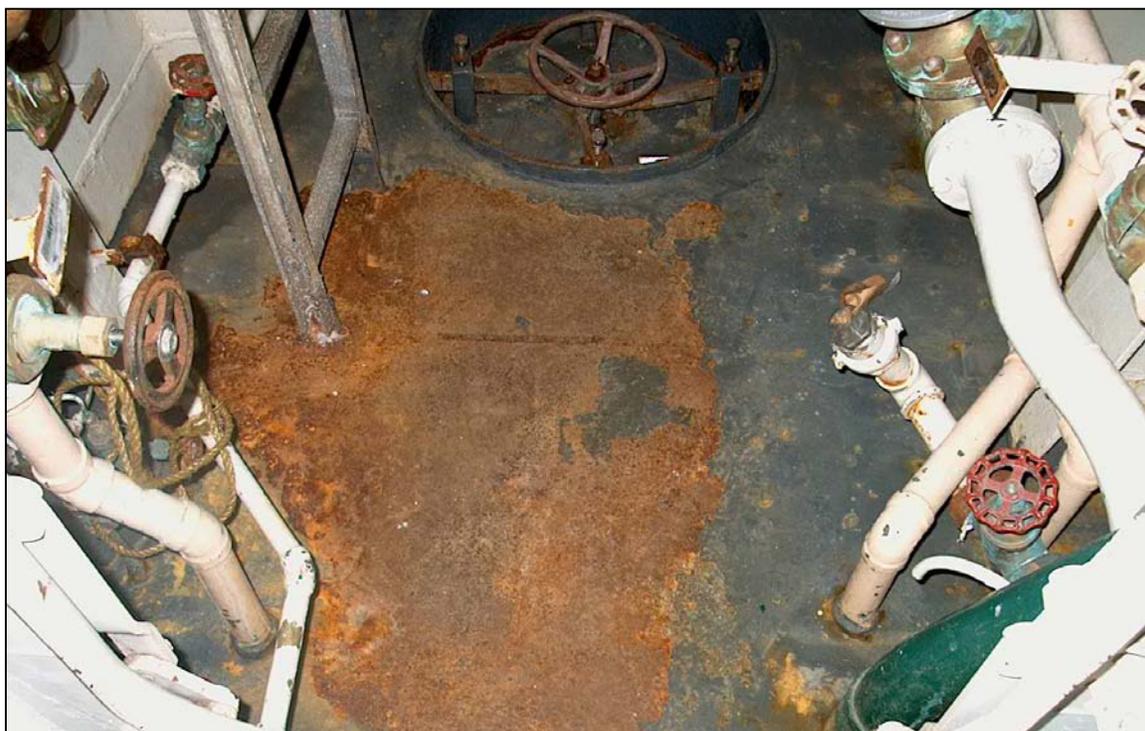
CORROSION ON DECK AT BOTTOM OF TRUNK (4-28-0-T)

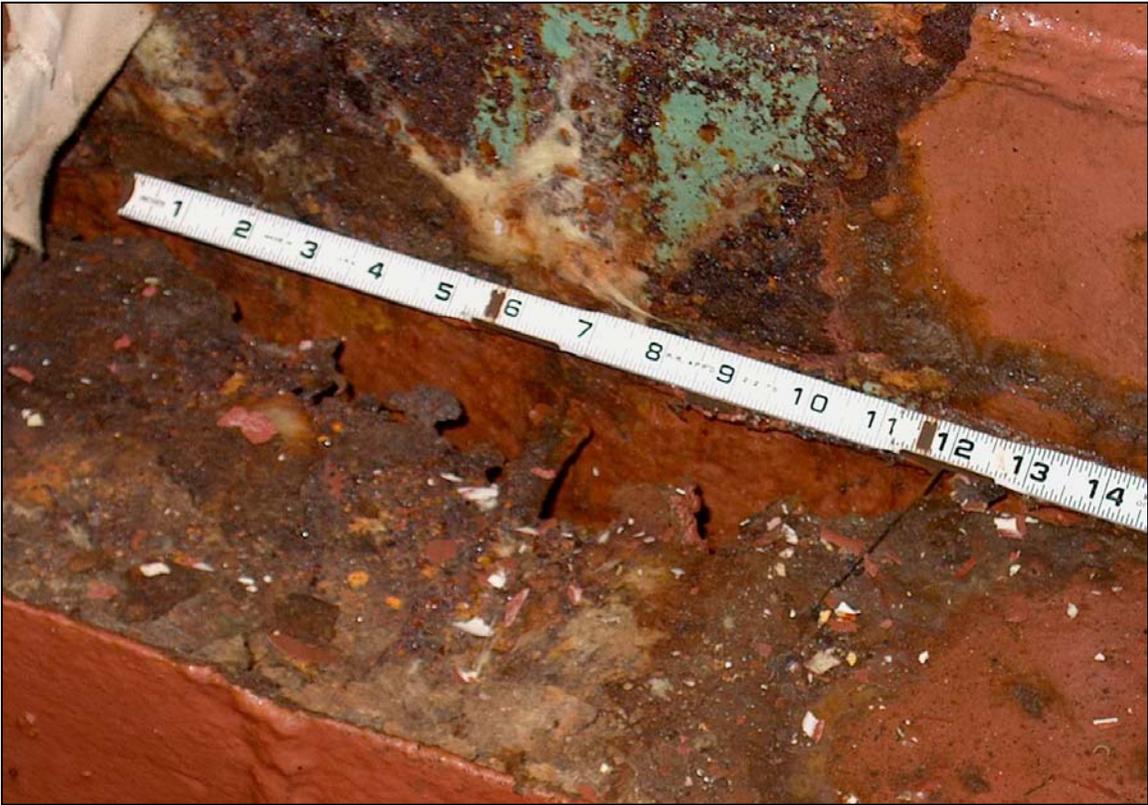
FIRST STRINGER FROM MARGIN PLATE AT BHD (426) IS HOLED.  
ENTIRE STRINGER FROM BHD (426) TO WEB FRAME (440) IS SEVERELY DETERIORATED  
THIS IS A HIGH CORROSION AREA ON THE (DD-963) CLASS

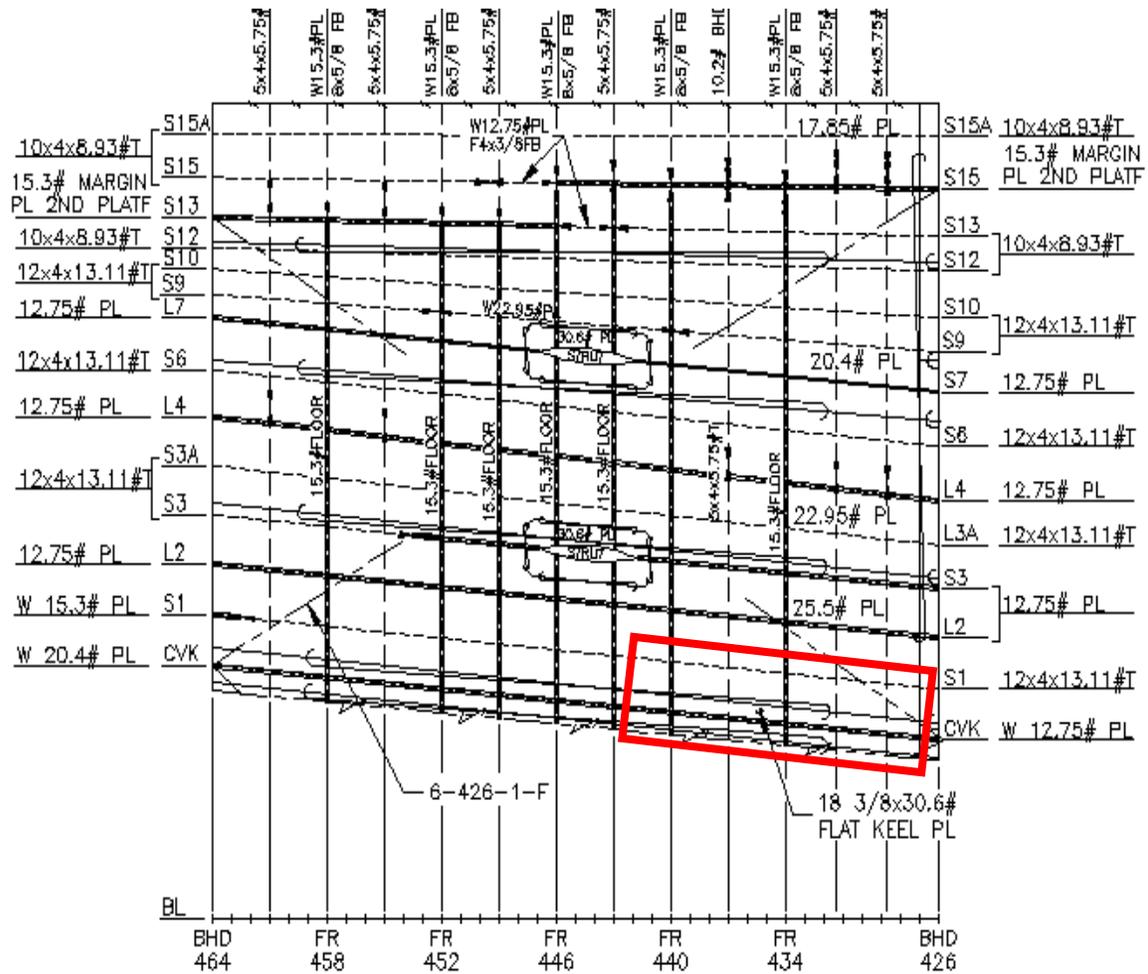
RED BOX INDICATES AREA WHERE CORROSION WAS FOUND.
