# **USS ARTHUR W RADFORD (DD-968)**

## **SEMAT II SHELL CONDITION ASSESSMENT SURVEY INTERIOR AREAS**

**01/28/02 TO 02/08/02**

Q.E.D. Systems, Inc. was tasked by the Supervisor of Shipbuilding Conversion and Repair, USN (SPORT) Portsmouth, VA to conduct an Ultrasonic Thickness (U/T) Survey of specific locations on board USS ARTHUR W RADFORD (DD-968) during the period of 28 January 2002 – February 8 2002.

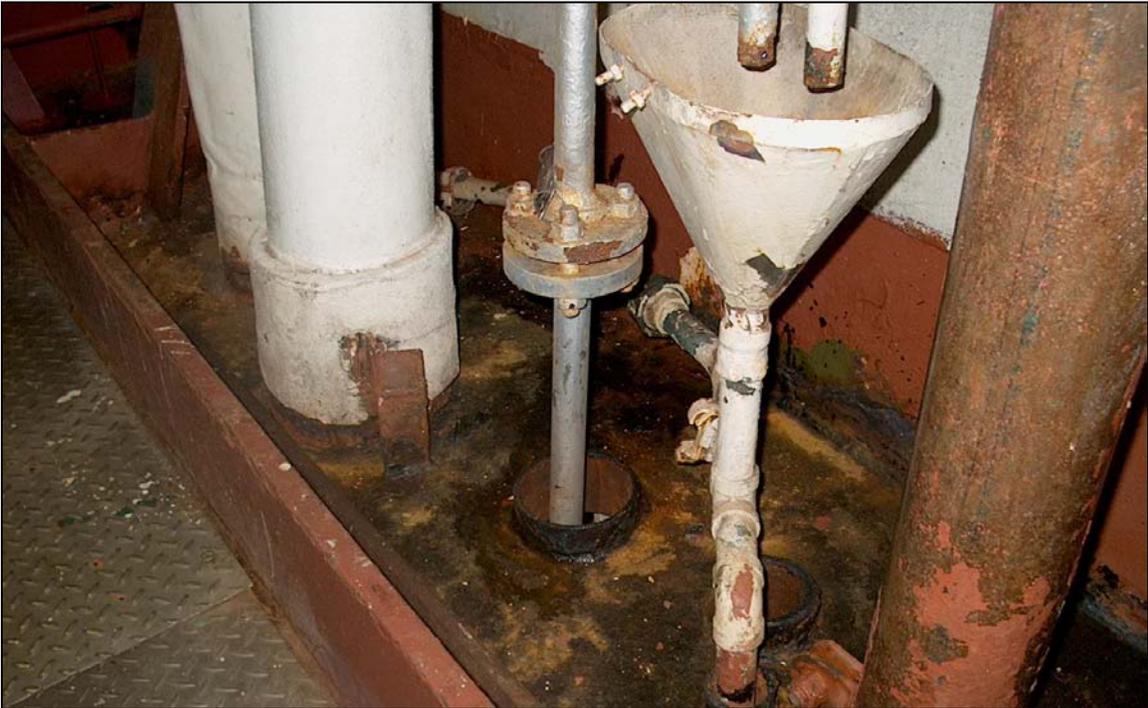
CORROSION ON HORIZONTAL GIRDER BETWEEN BHD (426) AND WEB FRAME (434)  
AT UPPER LEVEL DECK GRATING

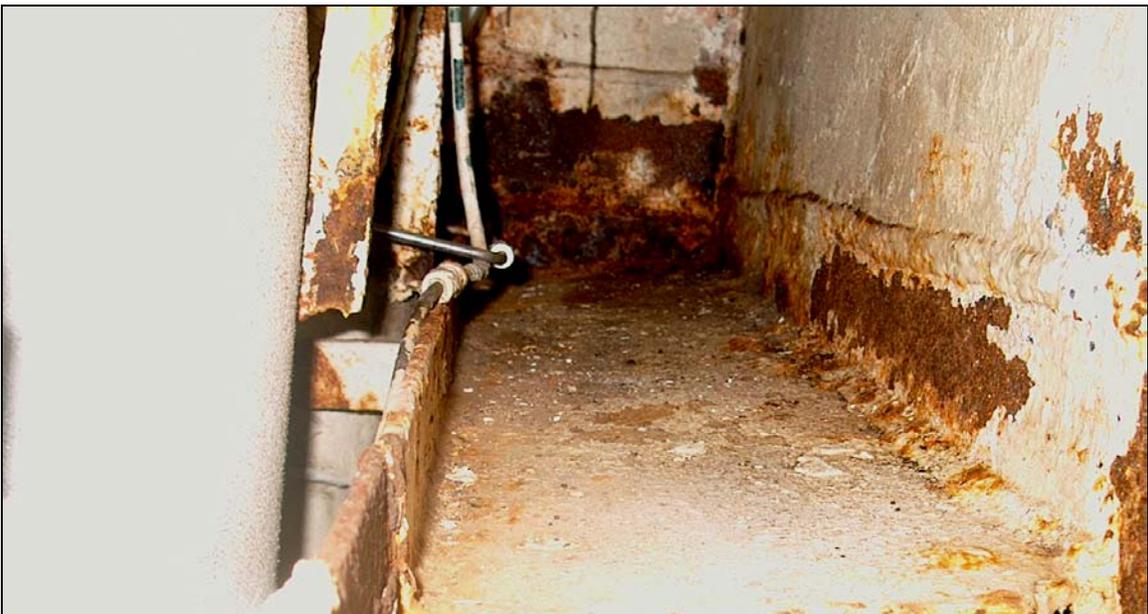
CORROSION ON 1<sup>ST</sup> STRINGER FROM DECK PLATE AND SHELL LOOKING FWD AT BHD (426)

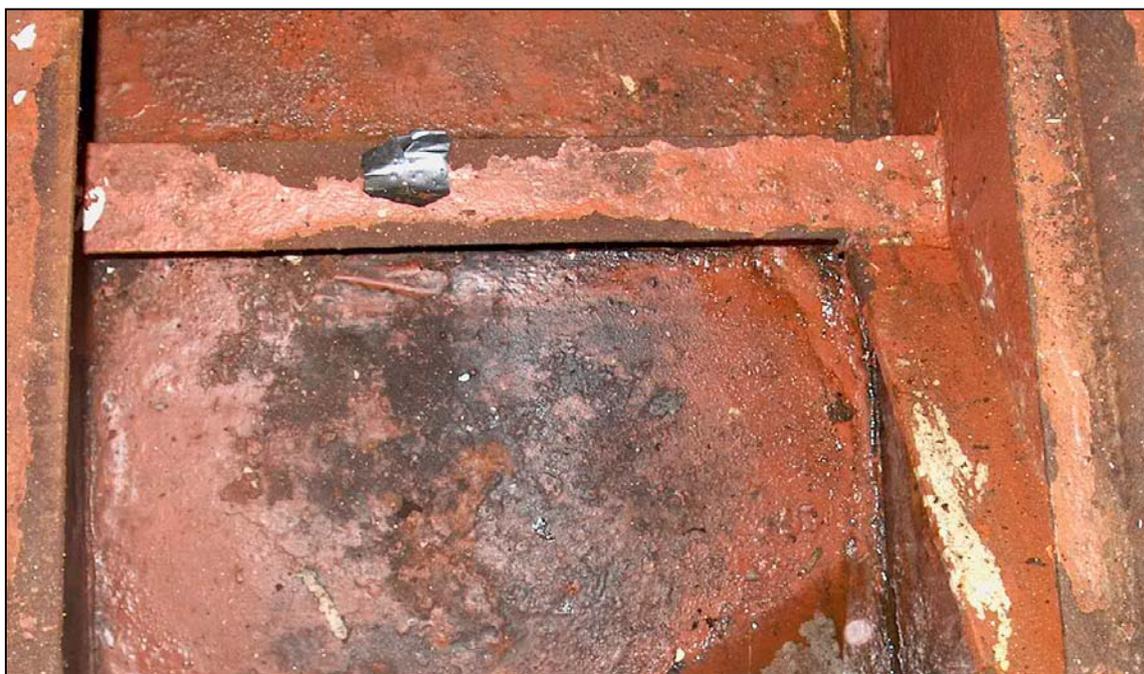
CORROSION ON SHELL AFT OF DOOR TO (6-482-2-A) CHEMICAL WARFARE DEFENSE  
EQUIPMENT STOREROOM

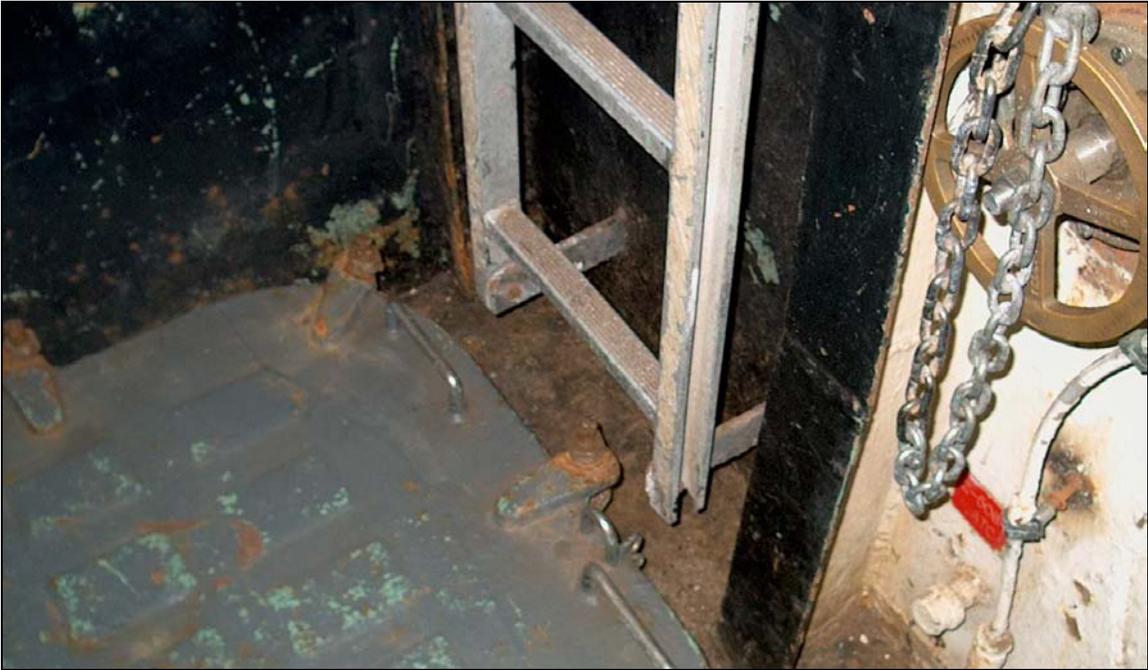
CORROSION ON DECK SURROUNDING (WTH 2-504-1) ENTRANCE TO LOWER REEL  
STOREROOM (6-488-3-A)
