USS DEYO (DD 989)

INTERNAL VIDEO VENTILATION ASSESSMENT

**PERFORMED BY
SUPERVISOR OF SHIPBUILDING CONVERSION AND
REPAIR**

5 THRU 15 SEPTEMBER 2000

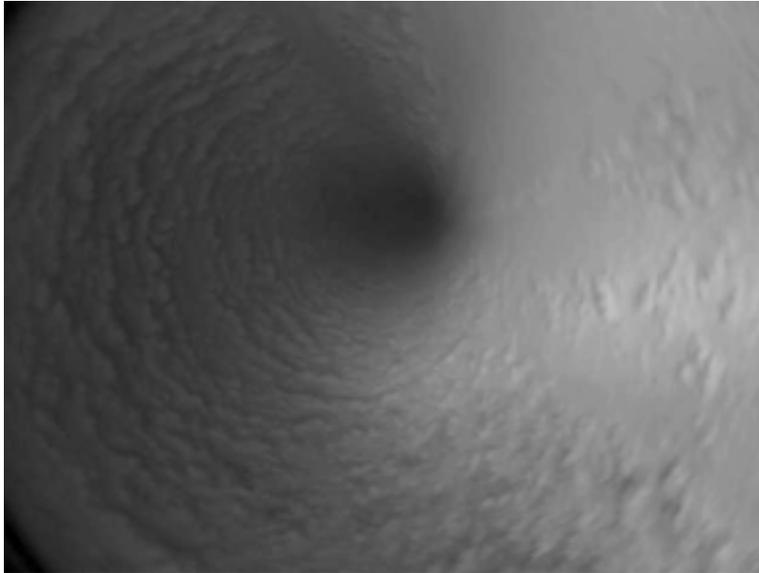
As per Internal Video Inspection: EXHAUST DUCT, SYSTEM E 01-148-1 IN COMPT.
CREW WR (2-138-0-L) IS DIRTY WITH LINT/DUST AND REQUIRES CLEANING.

3 FT Inside Duct Looking Starboard (Foreign material)

REPAIR ACTIVITY OPEN AND CLEAN EXHAUST DUCT, SYSTEM E 01-148-1
IN ITS ENTIRETY THEN RESTORE TO NORMAL OPERATION.

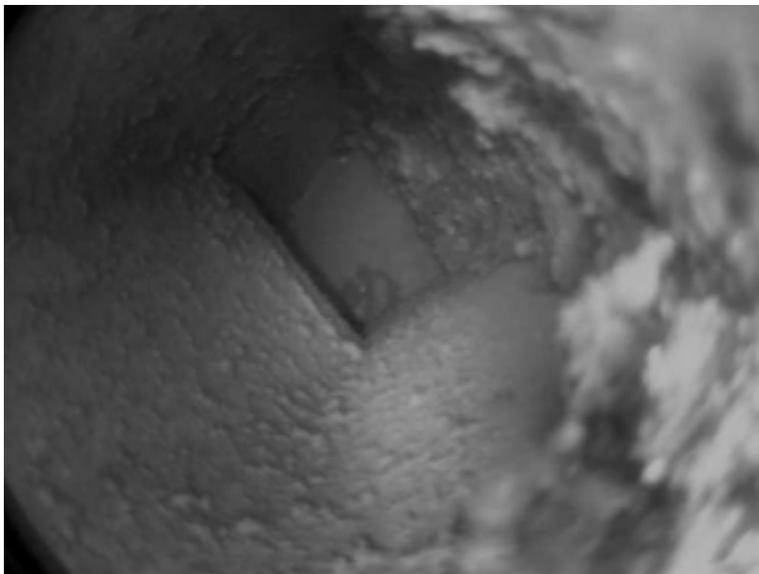
CREW WR (2-138-0-L)

7 FT Inside Duct Looking Starboard on Port Side (Foreign material)

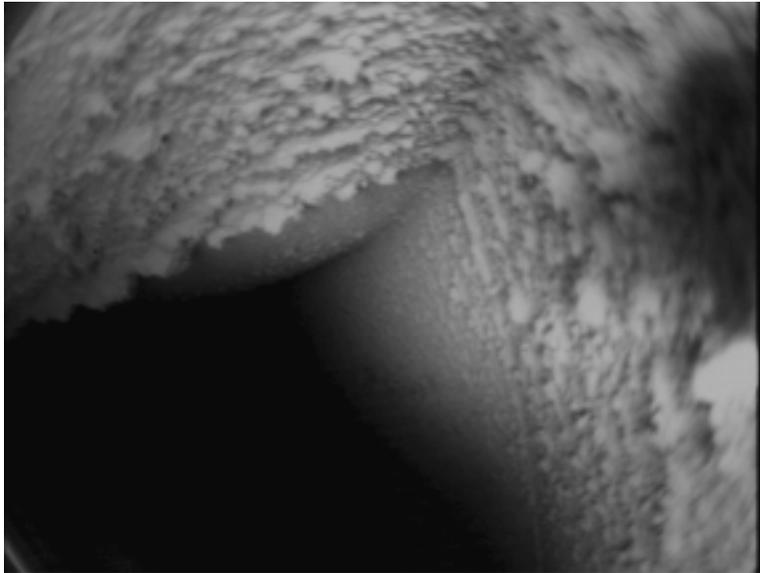
CIC SONAR CONTROL (02-139-2-C)

As per Internal Video Inspection: RECIRC RETURN DUCT R SYSTEM R 01-192-1& R 01-192-3 IN COMPT. CIC Sonar Control (02-139-2-C) IS DIRTY WITH LINT/DUST AND REQUIRES CLEANING.

4 FT Inside Duct (Foreign material)

REPAIR ACTIVITY OPEN AND CLEAN RECIRC RETURN DUCT R SYSTEM R 01-192-1& R 01-192-3 IN ITS ENTIRETY USING SUITABLE METHOD AND RESTORE IT TO ITS NORMAL OPERATION.

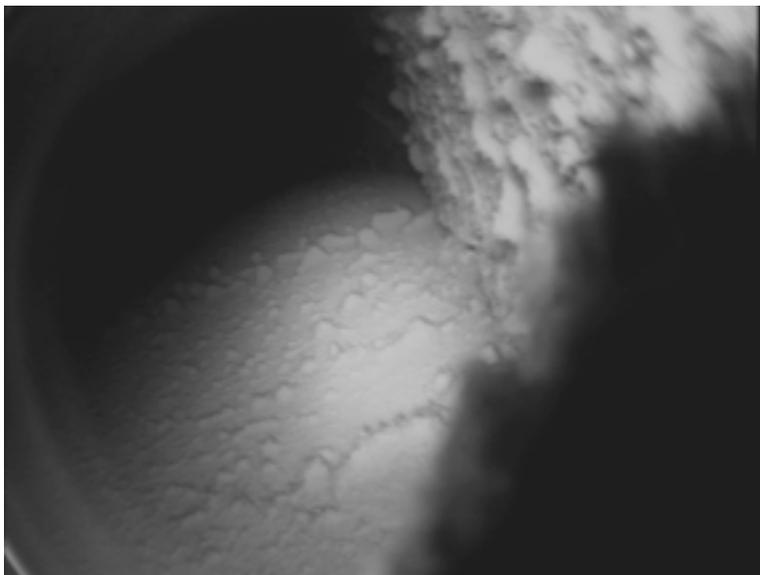
CIC SONAR CONTROL (02-139-2-C)

7 FT Inside Duct (Foreign material)

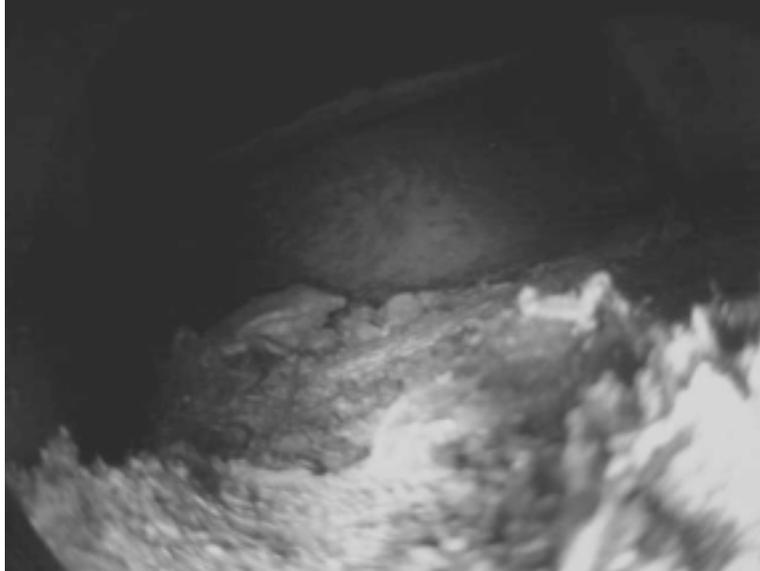
As per Internal Video Inspection: EXHAUST DUCT, SYSTEM E 01-245-1 IN COMPT.
CPO WR (1-240-1-L) IS DIRTY WITH LINT AND DUST AND REQUIRES CLEANING.

5 FT Inside Duct Looking Port (Foreign material)

REPAIR ACTIVITY OPEN AND CLEAN EXHAUST DUCT, SYSTEM E 01-245-1
IN ITS ENTIRETY THEN RESTORE TO NORMAL OPERATION.

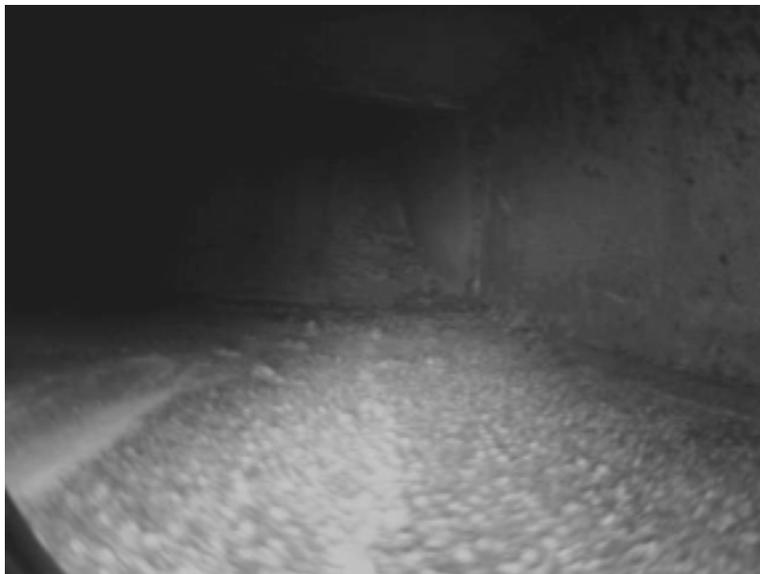
CPO WR (1-240-1-L)

8 FT Inside Duct Looking Starboard (Foreign material)

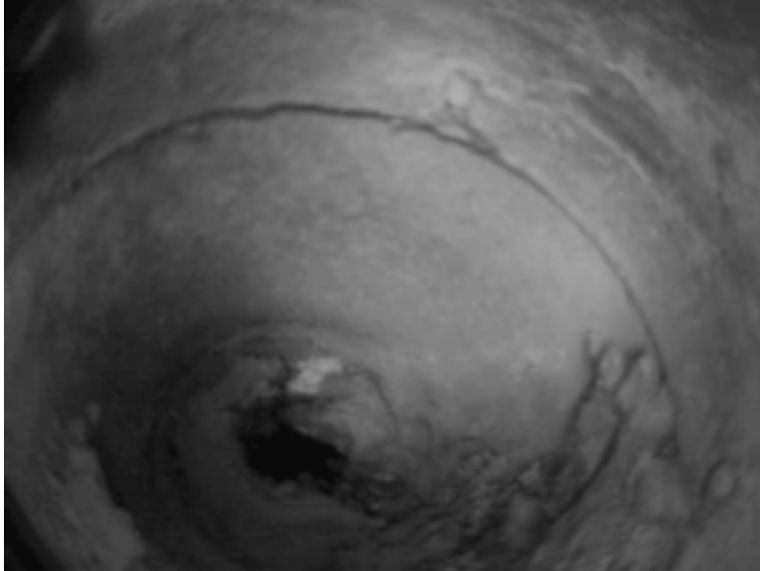
As per Internal Video Inspection: EXHAUST DUCT, SYSTEM E 01-248-1 IN COMPT.
CPO SH (1-235-3-L) IS DIRTY WITH LINT/DUST AND REQUIRES CLEANING.

1 FT Inside Duct (Foreign material)

REPAIR ACTIVITY OPEN AND CLEAN EXHAUST DUCT, SYSTEM E 01-248-1
IN ITS ENTIRETY THEN RESTORE TO NORMAL OPERATION.

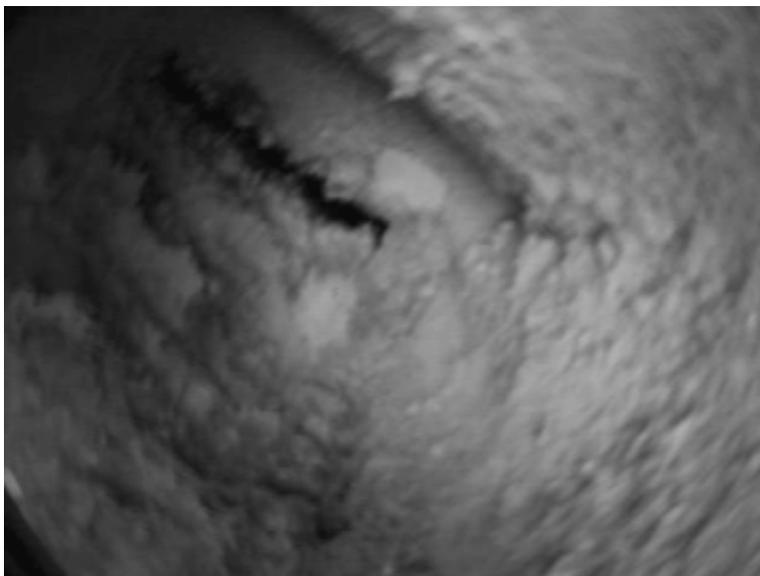
CPO WR (1-240-1-L)

1 FT Inside Duct (Foreign material)

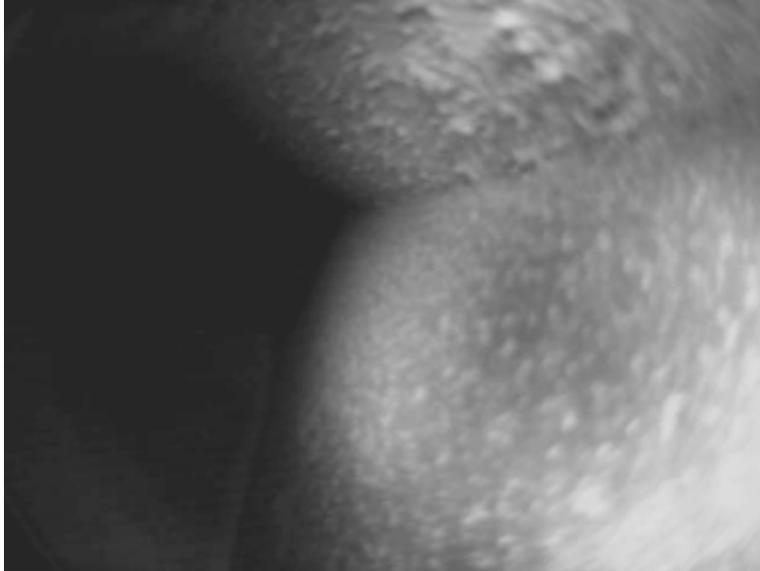
As per Internal Video Inspection: RECIRC SUPPLY DUCT, SYSTEM R 01-270-1 IN COMPT.
WR MESS (01-270-0-L) IS DIRTY WITH LINT/DUST AND REQUIRES CLEANING.

3 FT Inside Duct (Foreign material)

REPAIR ACTIVITY OPEN AND CLEAN RECIRC SUPPLY DUCT, SYSTEM R 01-270-1
IN ITS ENTIRETY THEN RESTORE TO NORMAL OPERATION.

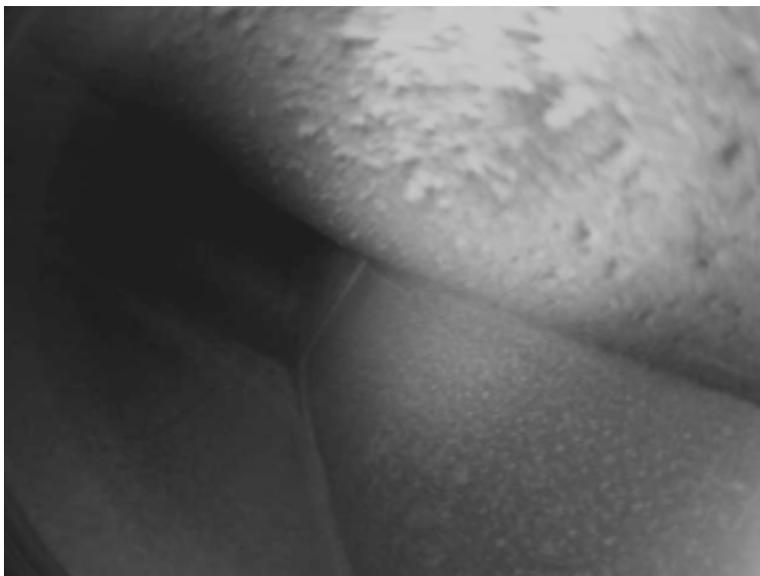
WR MESS (01-270-0-L)

5 FT Inside Duct (Foreign material)

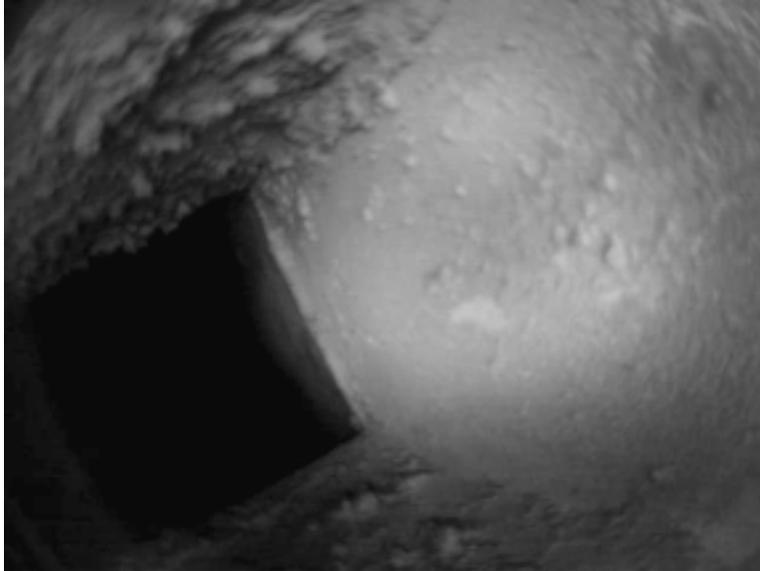
As per Internal Video Inspection: EXHAUST DUCT, SYSTEM E 01-280-1 IN COMPT. SCULLERY (1-284-1-Q) IS DIRTY WITH LINT/DUST AND REQUIRES CLEANING.

2 FT Inside Duct Over Dishwasher (Foreign material)

REPAIR ACTIVITY OPEN AND CLEAN EXHAUST DUCT, SYSTEM E 01-280-1 IN ITS ENTIRETY THEN RESTORE TO NORMAL OPERATION.

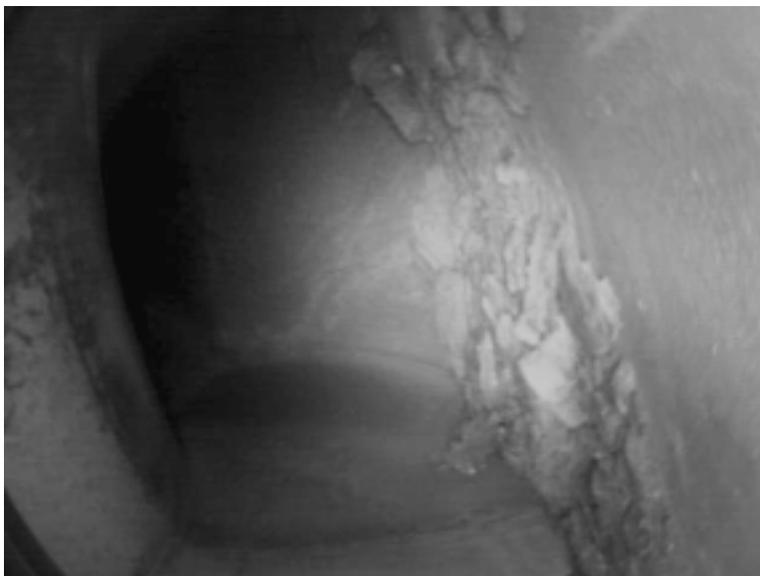
SCULLERY (1-284-1-Q)

6 FT Inside Duct Over Dishwasher (Foreign material)

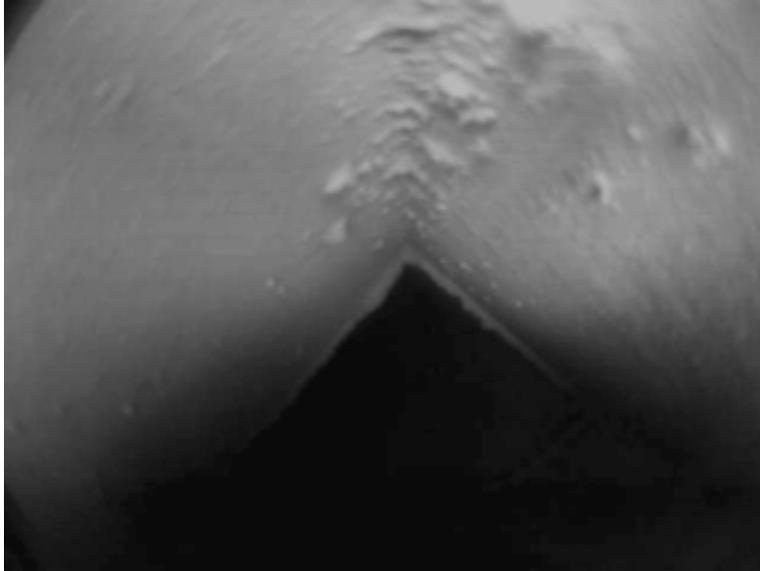
As per Internal Video Inspection: EXHAUST DUCT, SYSTEM E 01-393-2 IN COMPT.
CREW BERTHING (1-356-0-L) IS DIRTY WITH LINT/DUST AND REQUIRES CLEANING.

10 FT Inside Duct Looking Aft (Foreign material)

REPAIR ACTIVITY OPEN AND CLEAN EXHAUST DUCT, SYSTEM E 01-393-2
IN ITS ENTIRETY THEN RESTORE TO NORMAL OPERATION.

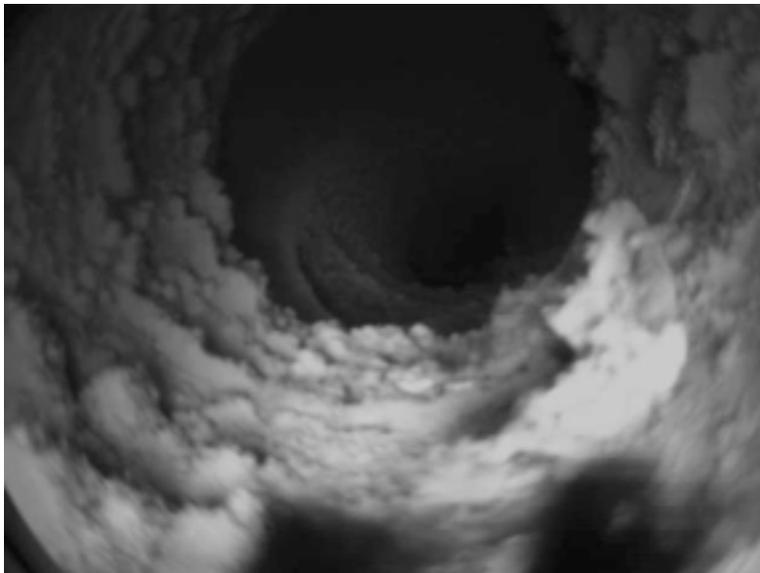
CREW WR, WC, & SH (3-346-3-L)

7 FT Inside Duct Looking Starboard (Foreign material)

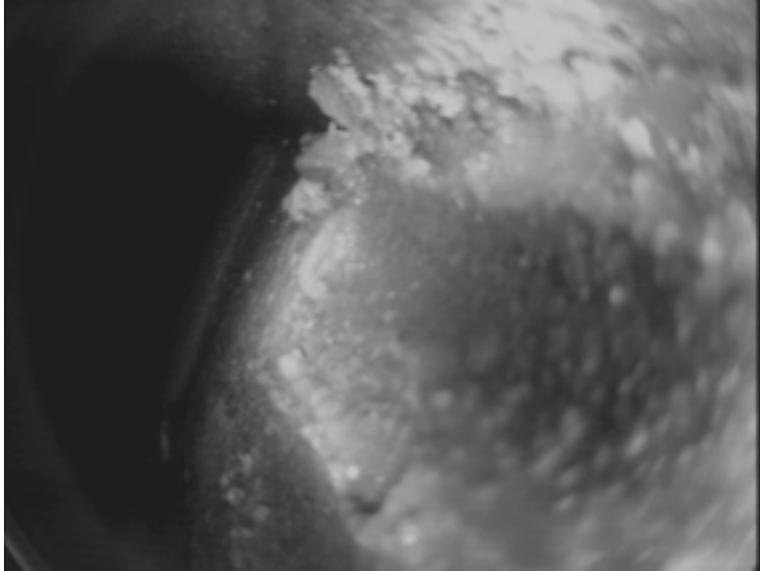
As per Internal Video Inspection: SUPPLY DUCT, SYSTEM S 02-230-2 IN COMPT.
AMR 1 (5-220-0-E) IS DIRTY WITH SALT/DUST AND REQUIRES CLEANING.

7 FT Inside Duct By Phone Booth (Foreign material)

REPAIR ACTIVITY OPEN AND CLEAN SUPPLY DUCT, SYSTEM S 02-230-2
IN ITS ENTIRETY THEN RESTORE TO NORMAL OPERATION.

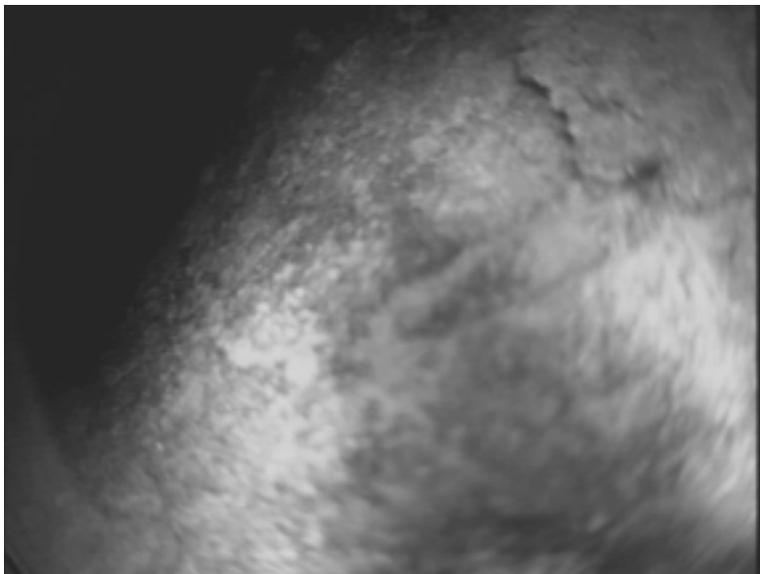
AMR 1 (5-220-0-E)

28 FT Inside Duct By HP Compressor No. 1 (Foreign material)

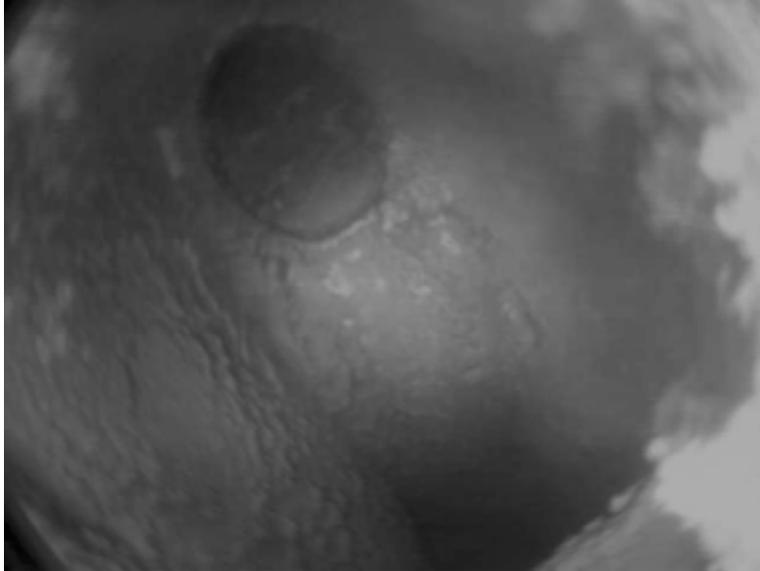
As per Internal Video Inspection: EXHAUST DUCT, SYSTEM E 02-298-1 IN COMPT.
OFFICER WR, WC (01-322-0-L) IS DIRTY WITH LINT/DUST AND REQUIRES CLEANING.

2 FT Inside Duct (Foreign material)

REPAIR ACTIVITY OPEN AND CLEAN EXHAUST DUCT, SYSTEM E 02-298-1
IN ITS ENTIRETY THEN RESTORE TO NORMAL OPERATION.

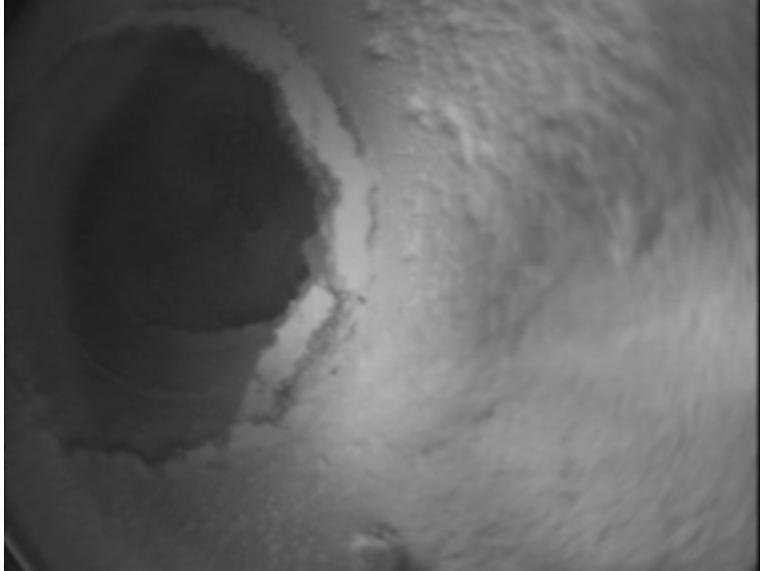
As per Internal Video Inspection: EXHAUST DUCT, SYSTEM E 03-194-1 IN COMPT. PASSAGE (03-174-0-L) IS DIRTY WITH LINT/DUST AND REQUIRES CLEANING.

2 FT Inside Duct Looking Aft (Foreign material)

REPAIR ACTIVITY OPEN AND CLEAN EXHAUST DUCT, SYSTEM E 03-194-1 IN ITS ENTIRETY THEN RESTORE TO NORMAL OPERATION.

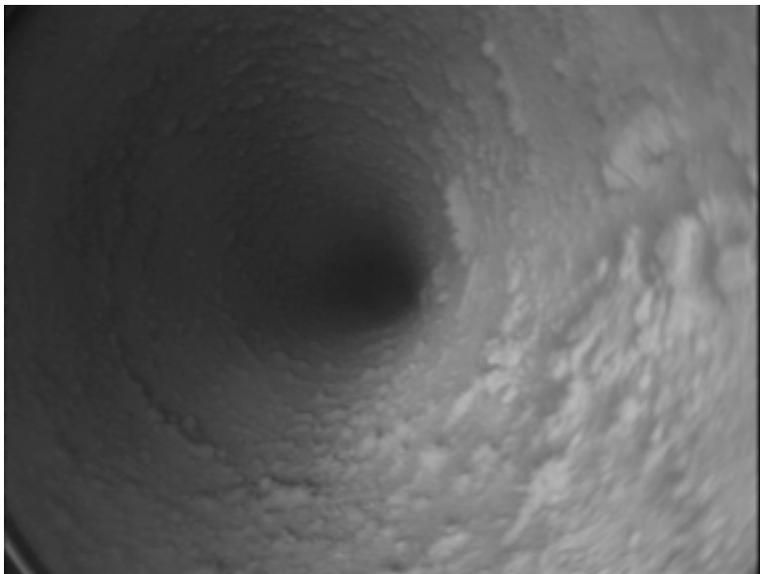
PASSAGE (03-174-0-L)

5 FT Inside Duct Looking Aft (Foreign material)

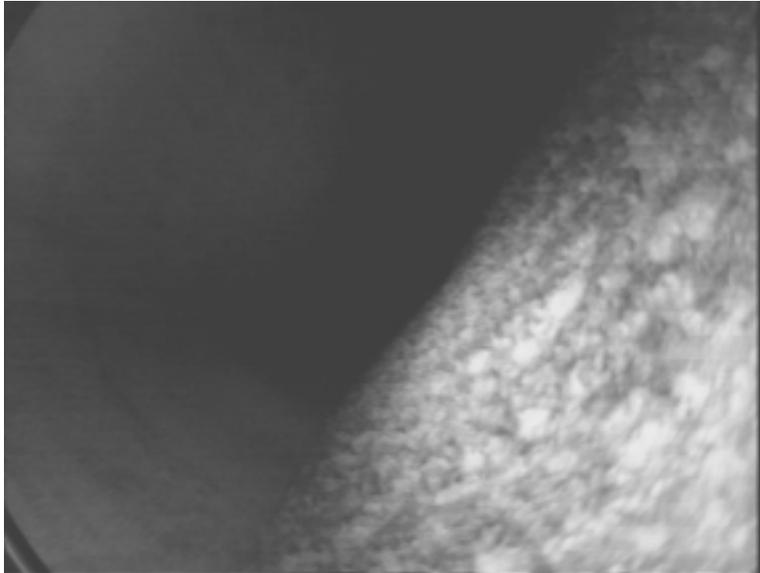
As per Internal Video Inspection: RECIRC SUPPLY DUCT, SYSTEM R 1-317-1 (UNIT COOLER) IN COMPT. CREWS MESSROOM (1-300-0-L) IS DIRTY WITH LINT/DUST AND REQUIRES CLEANING

4 FT Inside Duct (Foreign material)

REPAIR ACTIVITY OPEN AND CLEAN RECIRC SUPPLY DUCT, SYSTEM R 1-317-1 IN ITS ENTIRETY THEN RESTORE TO NORMAL OPERATION.

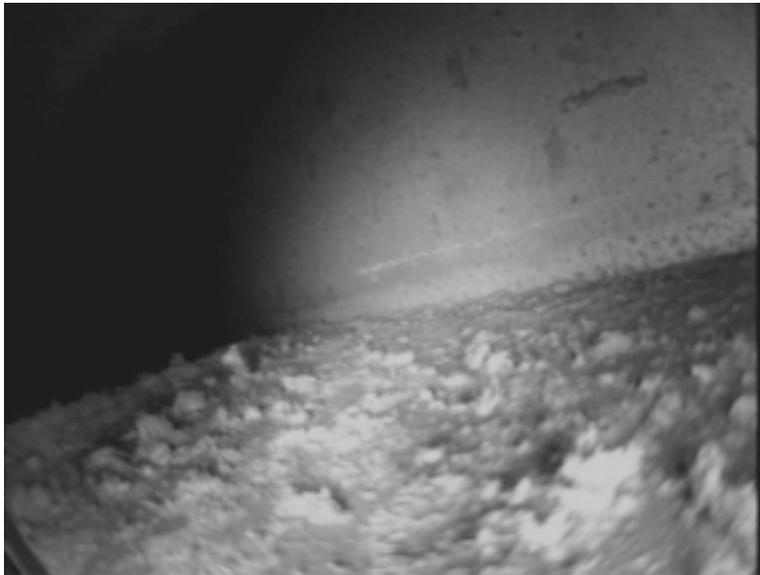
CREWS MESSROOM (1-300-0-L)

6 FT Inside Duct (Foreign material)

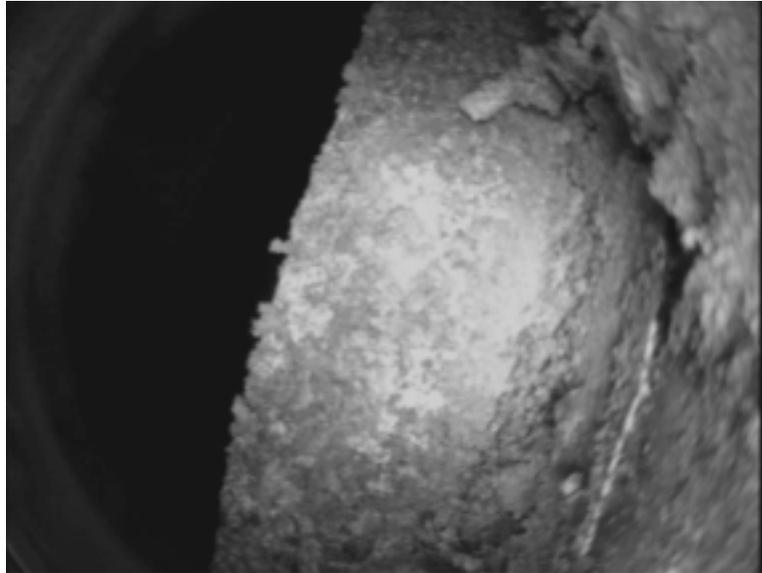
As per Internal Video Inspection: RECIRC SUPPLY DUCT, SYSTEM R 1-341-2 (UNIT COOLER) IN COMPT. CREWS MESSROOM (1-300-0-L) IS DIRTY WITH LINT/DUST AND REQUIRES CLEANING

3 FT Inside Duct From Unit Cooler (Foreign material)

REPAIR ACTIVITY OPEN AND CLEAN RECIRC SUPPLY DUCT, SYSTEM R 1-341-2 IN ITS ENTIRETY THEN RESTORE TO NORMAL OPERATION.

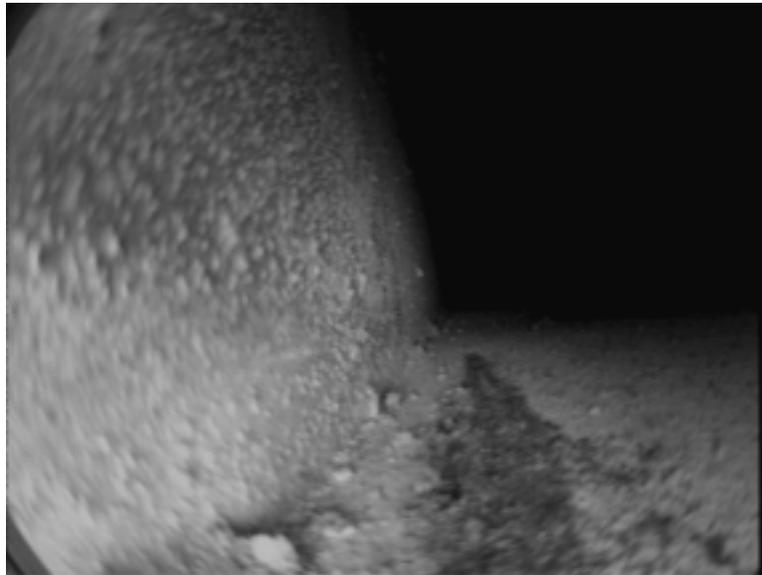
CREWS MESSROOM (1-300-0-L)

6 FT Inside Duct Looking Aft From Vent Terminal (Foreign material)

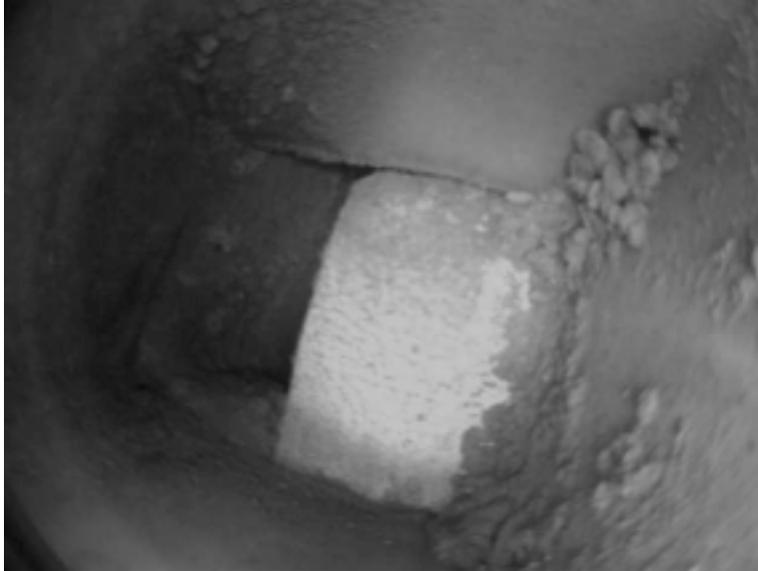
As per Internal Video Inspection: RECIRC SUPPLY DUCT, SYSTEM R 3-148-1 IN COMPT. CREW BERTHING (3-146-0-L) IS DIRTY WITH LINT/DUST AND REQUIRES CLEANING.

3 FT Inside Duct Looking Starboard on Port Side (Foreign material)

REPAIR ACTIVITY OPEN AND CLEAN RECIRC SUPPLY DUCT, SYSTEM R 3-148-1 IN ITS ENTIRETY THEN RESTORE TO NORMAL OPERATION.

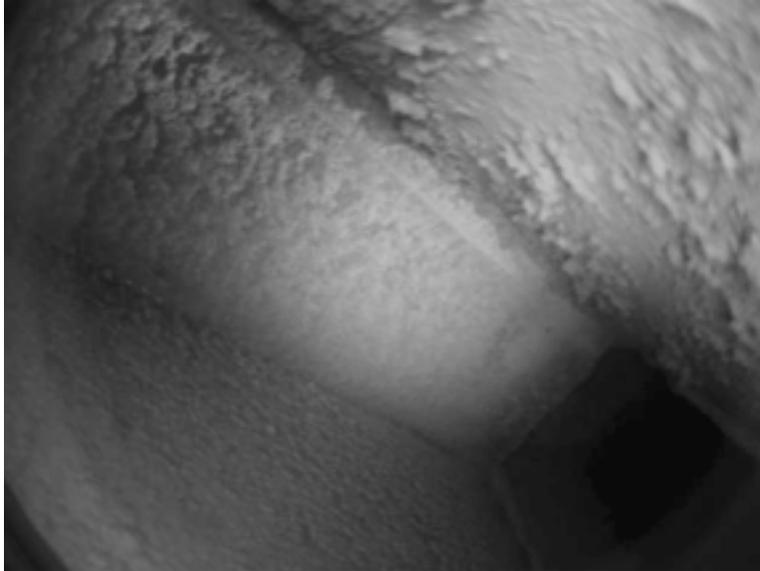
As per Internal Video Inspection: RECIRC SUPPLY DUCT, SYSTEM R 3-149-2 IN COMPT. CREW BERTHING (3-146-0-L) IS DIRTY WITH LINT/DUST AND REQUIRES CLEANING.

5 FT Inside Duct Looking Port on Starboard Side (Foreign material)

REPAIR ACTIVITY OPEN AND CLEAN RECIRC SUPPLY DUCT, SYSTEM R 3-149-2 IN ITS ENTIRETY THEN RESTORE TO NORMAL OPERATION.
