SEMAT I

USS BATAAN (LHD 5)

INTERNAL VIDEO VENTILATION ASSESSMENT

09 THRU 28 AUGUST 2000

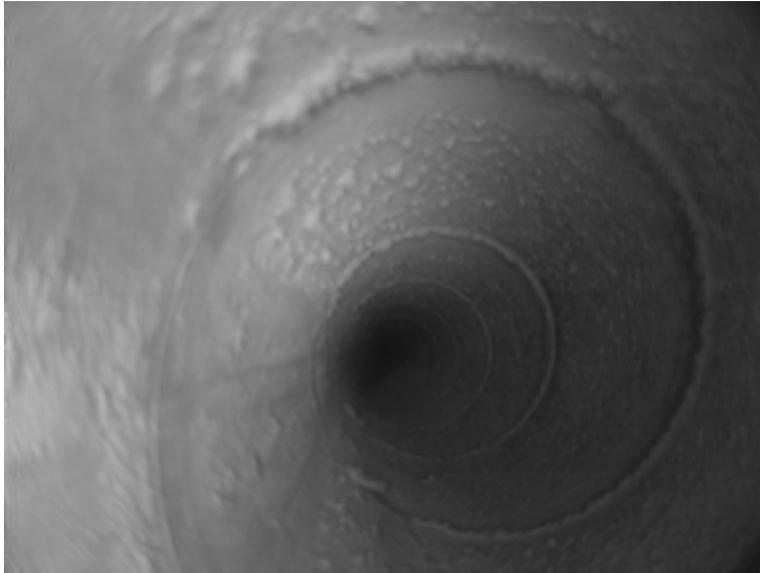
As per Internal Video Inspection: EXHAUST DUCT, SYSTEM E 01-32-1 IN COMPT.
TROOP OFFICER'S SH (02-25-2-L) IS DIRTY AND REQUIRES CLEANING.

5 FT Inside Duct (Foreign material)

REPAIR ACTIVITY OPEN AND CLEAN EXHAUST DUCT, SYSTEM E 01-32-1
IN ITS ENTIRETY THEN RESTORE TO NORMAL OPERATION.

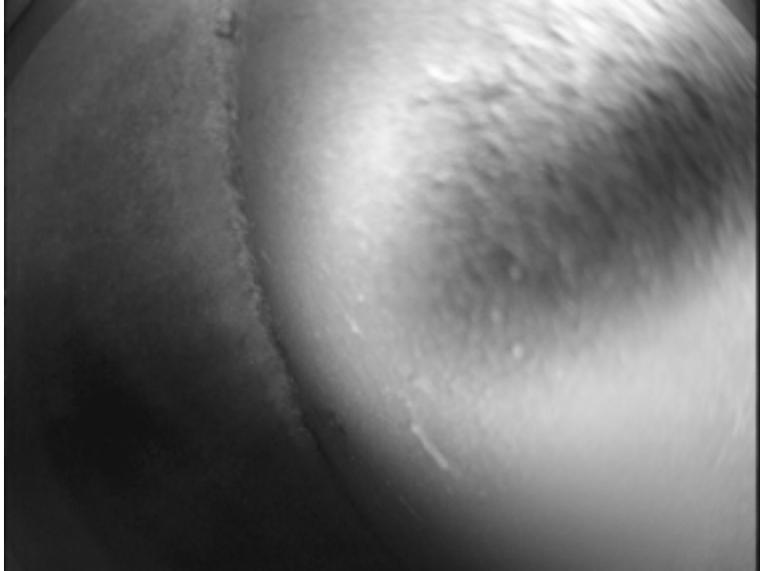
As per Internal Video Inspection: SUPPLY DUCT, SYSTEM S 01-33-1 IN COMPT. CREW LIVING SPACE (3-41-0-L) IS DIRTY INTERNALLY WITH MIXTURE OF LINT, DUST, AND DIRT AND REQUIRES CLEANING.

4 FT Inside Duct (Foreign material)

REPAIR ACTIVITY OPEN AND CLEAN SUPPLY DUCT, SYSTEM S 01-33-1 IN ITS ENTIRETY THEN RESTORE TO NORMAL OPERATION.

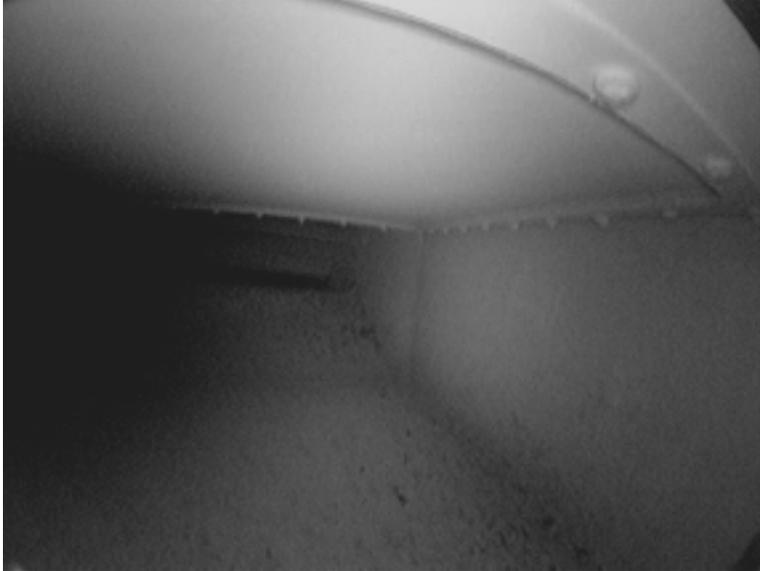
As per Internal Video Inspection: RECIRC RETURN DUCT, SYSTEM R 01-33-2 IN COMPT. TROOP LIV SP & CASUALTY OVFL (01-33-01-L) IS DIRTY AND REQUIRES CLEANING.

2 FT Inside Duct (Foreign material)

REPAIR ACTIVITY OPEN AND CLEAN RECIRC RETURN DUCT, SYSTEM R 01-33-2 IN ITS ENTIRETY THEN RESTORE TO NORMAL OPERATION.

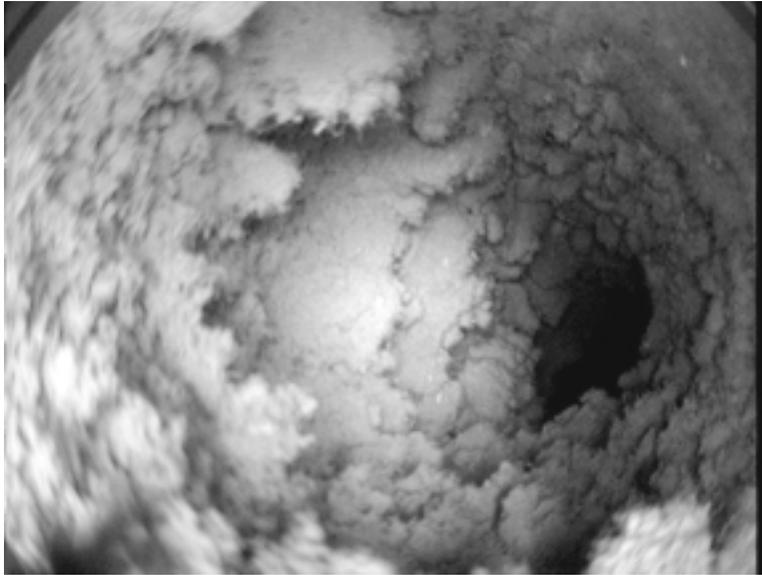
As per Internal Video Inspection: EXHAUST DUCT, SYSTEM E 01-42-2 IN COMPT.
DIESEL GEN RM # 1 (4-41-2-E) IS DIRTY AND REQUIRES CLEANING.

20 FT Inside Duct (Foreign material)

REPAIR ACTIVITY OPEN AND CLEAN EXHAUST DUCT, SYSTEM E 01-42-2
IN ITS ENTIRETY THEN RESTORE TO NORMAL OPERATION.

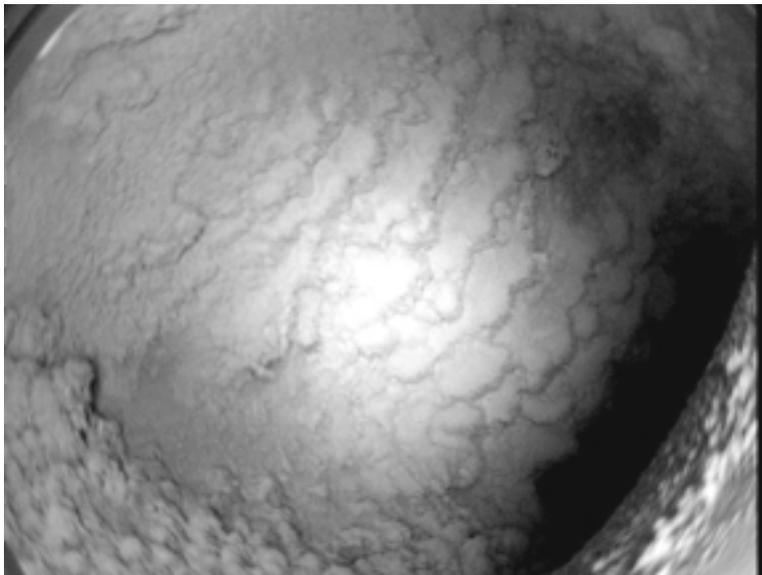
DIESEL GEN RM # 1 (4-41-2-E)

8 FT Inside Duct (Foreign material)

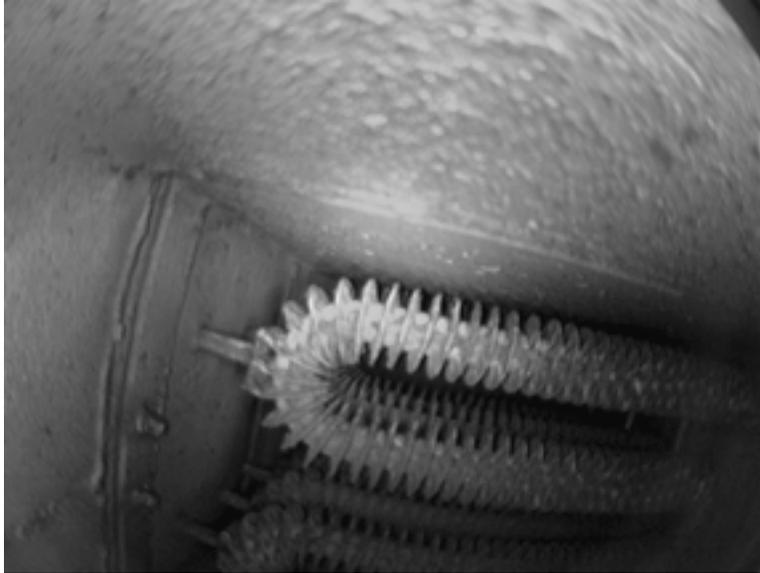
As per Internal Video Inspection: SUPPLY DUCT, SYSTEM S 01-50-4 IN COMPT.
MED LAUNDRY (01-57-4-Q) IS DIRTY AND REQUIRES CLEANING.

3 FT Inside Duct (Foreign material)

REPAIR ACTIVITY OPEN AND CLEAN SUPPLY DUCT, SYSTEM S 01-50-4
IN ITS ENTIRETY THEN RESTORE TO NORMAL OPERATION.

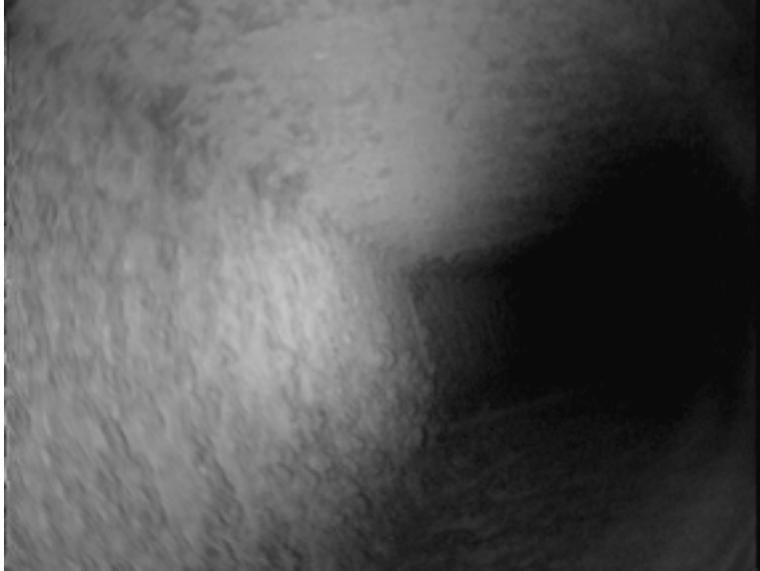
As per Internal Video Inspection: RECIRC RETURN DUCT, SYSTEM R 01-51-1 IN COMPT. TROOP LIV SP & CASUALTY OVFL (01-49-01-L) IS DIRTY AND REQUIRES CLEANING.

1 FT Inside Duct (Foreign material)

REPAIR ACTIVITY OPEN AND CLEAN RECIRC RETURN DUCT, SYSTEM R 01-51-1 IN ITS ENTIRETY THEN RESTORE TO NORMAL OPERATION.

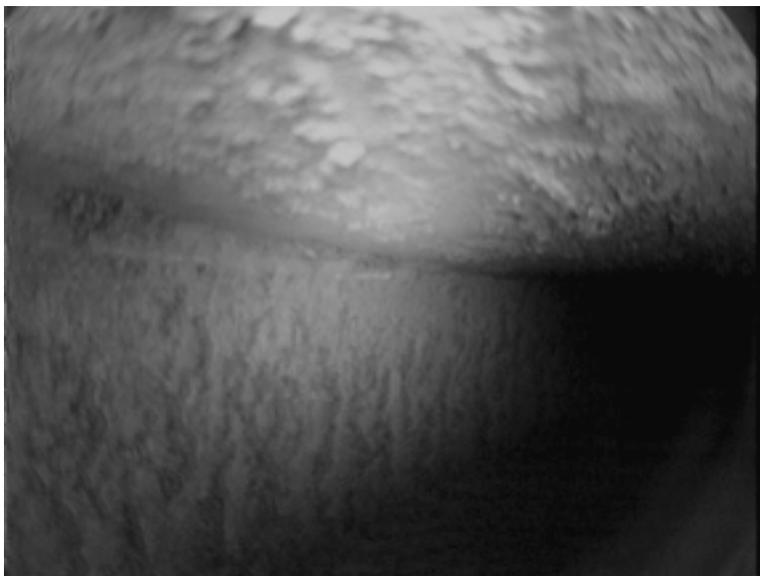
TROOP LIV SP & CASUALTY OVFL (01-49-01-L)

5 FT Inside Duct (Foreign material)

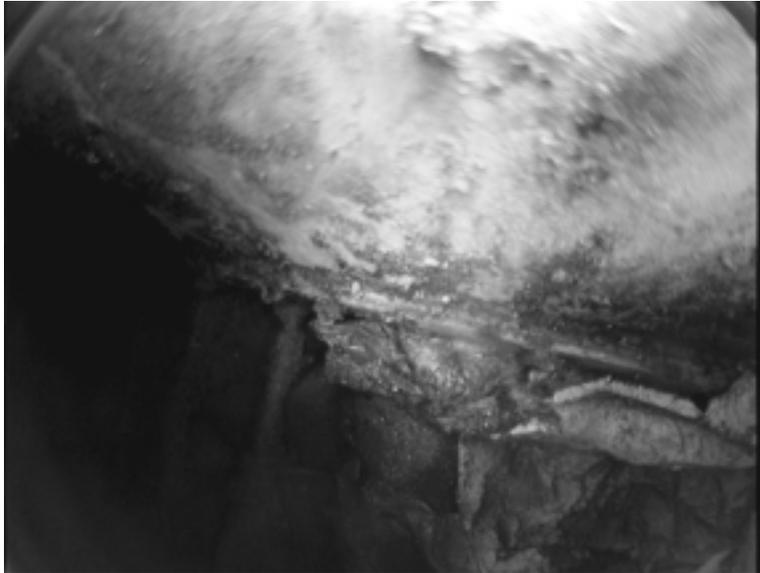
As per Internal Video Inspection: EXHAUST DUCT, SYSTEM E 01-53-2 IN COMPT. CREW & TROOP GALLEY (1-49-0-Q) IS DIRTY INTERNALLY WITH COATING OF GREASE, DIRT, AND IS PARTIALLY BLOCKED WITH A RAG AND REQUIRES CLEANING.

12 FT Inside Duct {PORT} (Foreign material)

REPAIR ACTIVITY OPEN AND CLEAN RECIRC RETURN DUCT, SYSTEM E 01-53-2 IN ITS ENTIRETY THEN RESTORE TO NORMAL OPERATION.

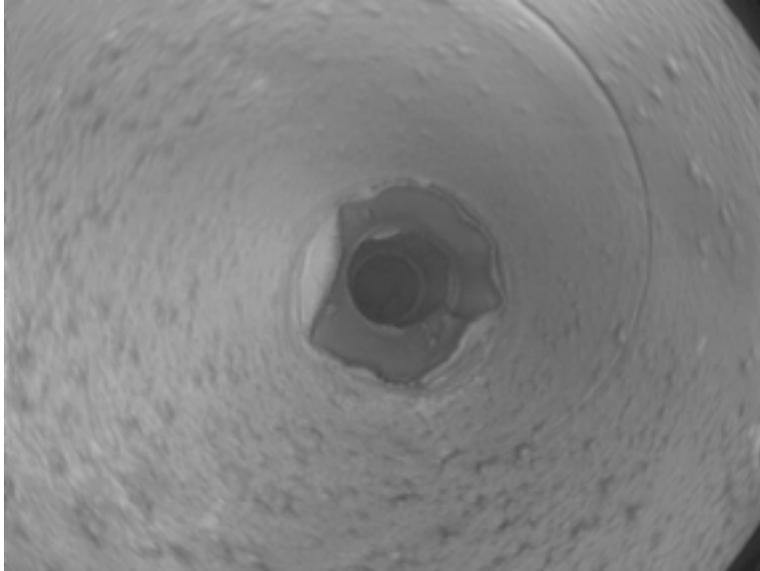
As per Internal Video Inspection: EXHAUST DUCT, SYSTEM E 01-57-1 IN COMPT.
QUITE ROOM 1 WR, WC & SH (01-57-3-L) IS DIRTY AND REQUIRES CLEANING.

1 FT Inside Duct (Foreign material)

REPAIR ACTIVITY OPEN AND CLEAN EXHAUST DUCT, SYSTEM E 01-57-1
IN ITS ENTIRETY THEN RESTORE TO NORMAL OPERATION.

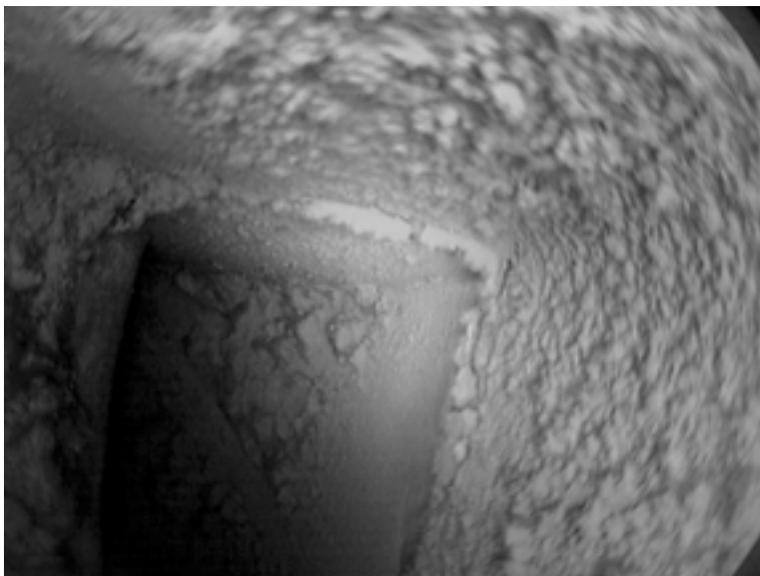
TROOP WR (01-49-1-L)

2 FT Inside Duct (Foreign material)

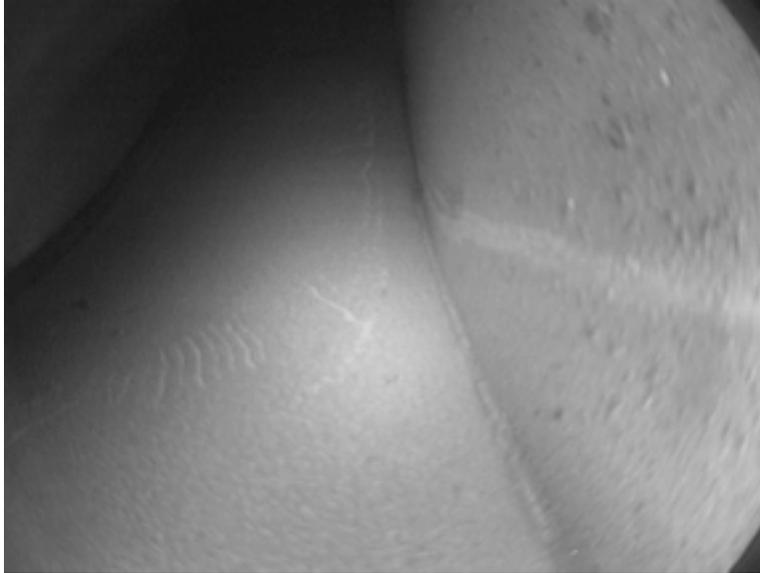
As per Internal Video Inspection: RECIRC RETURN DUCT, SYSTEM R 01-57-2 IN COMPT. PASSAGE (01-57-2-L) IS DIRTY AND REQUIRES CLEANING.

5 FT Inside Duct (Foreign material)

REPAIR ACTIVITY OPEN AND CLEAN RECIRC RETURN DUCT, SYSTEM R 01-57-2 IN ITS ENTIRETY THEN RESTORE TO NORMAL OPERATION.

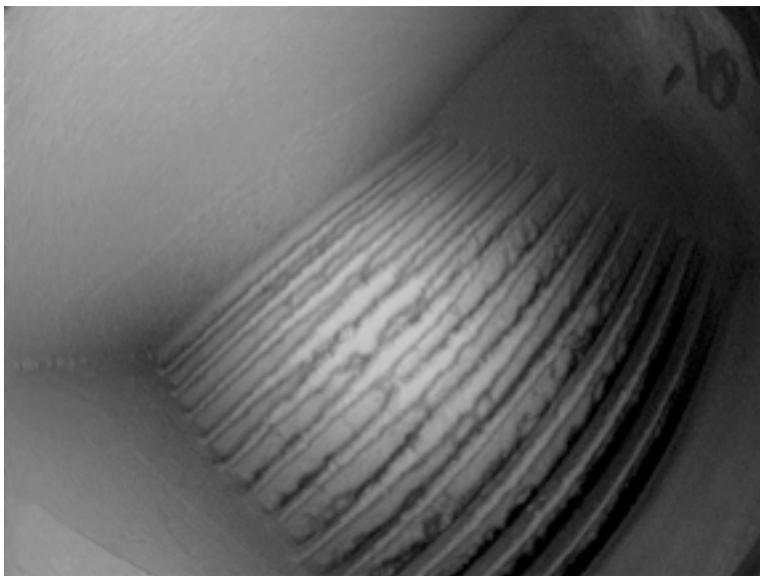
PASSAGE (01-57-2-L)

3 FT Inside Duct (Foreign material)

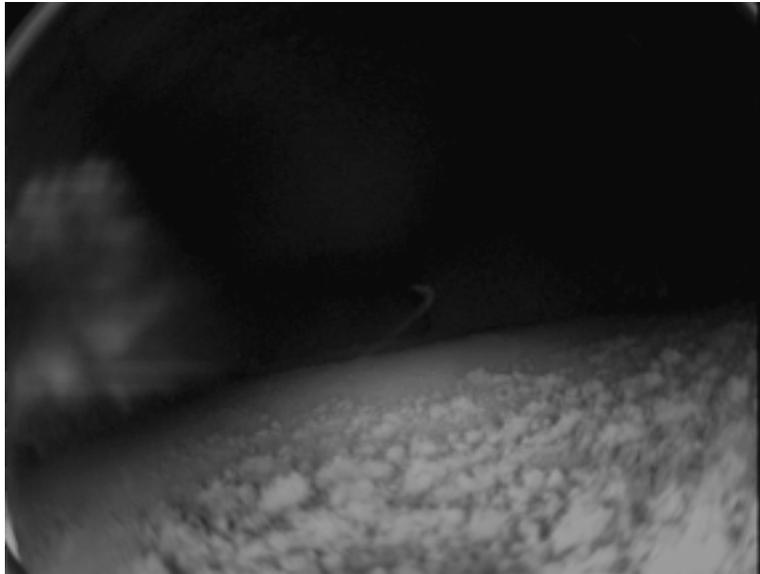
As per Internal Video Inspection: RECIRC RETURN DUCT, SYSTEM R 01-58-1 IN COMPT.
CREW MESS (1-57-0-L) IS DIRTY AND REQUIRES CLEANING.

6 FT Inside Duct Looking Forward (Foreign material)

REPAIR ACTIVITY OPEN AND CLEAN RECIRC RETURN DUCT, SYSTEM R 01-58-1
IN ITS ENTIRETY THEN RESTORE TO NORMAL OPERATION.

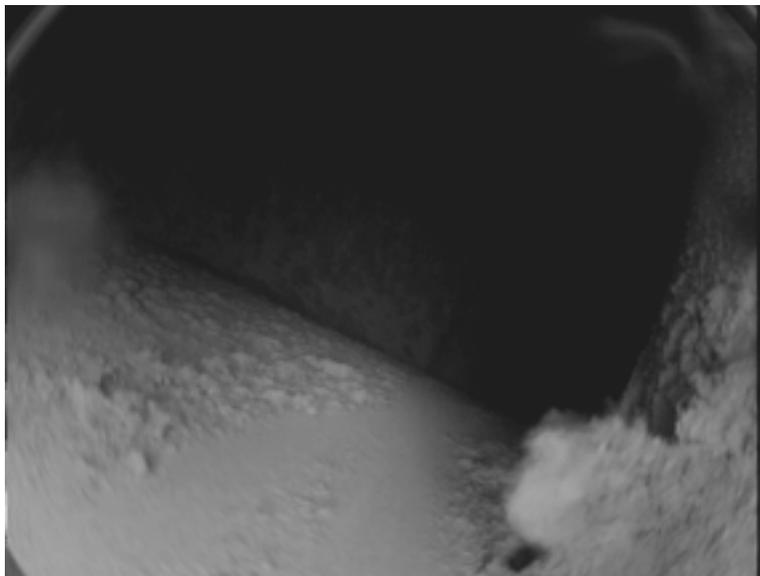
CREW MESS (1-57-0-L)

12 FT Inside Duct Looking Forward (Foreign material)

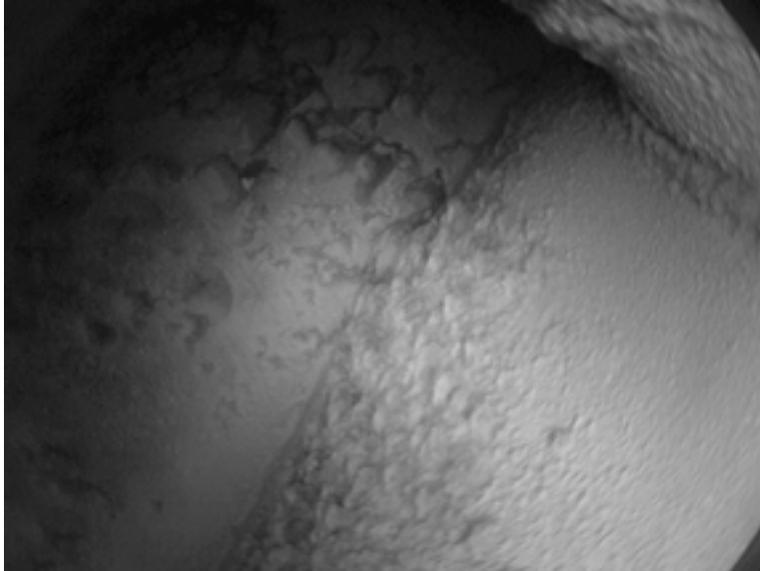
As per Internal Video Inspection: EXHAUST DUCT, SYSTEM E 01-58-2 IN COMPT.
ACCESS (01-61-2-L) IS DIRTY AND REQUIRES CLEANING.

3 FT Inside Duct (Foreign material)

REPAIR ACTIVITY OPEN AND CLEAN EXHAUST DUCT, SYSTEM E 01-58-2
IN ITS ENTIRETY THEN RESTORE TO NORMAL OPERATION.

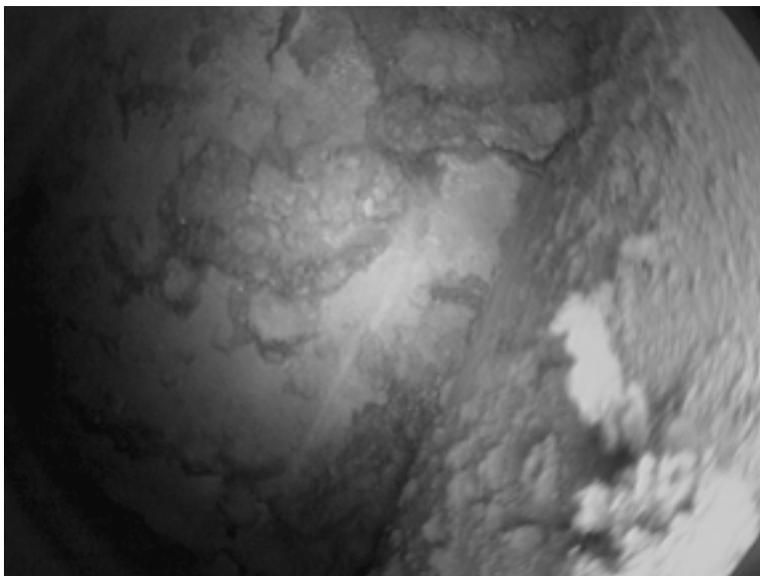
ACCESS (01-61-2-L)

5 FT Inside Duct (Foreign material)

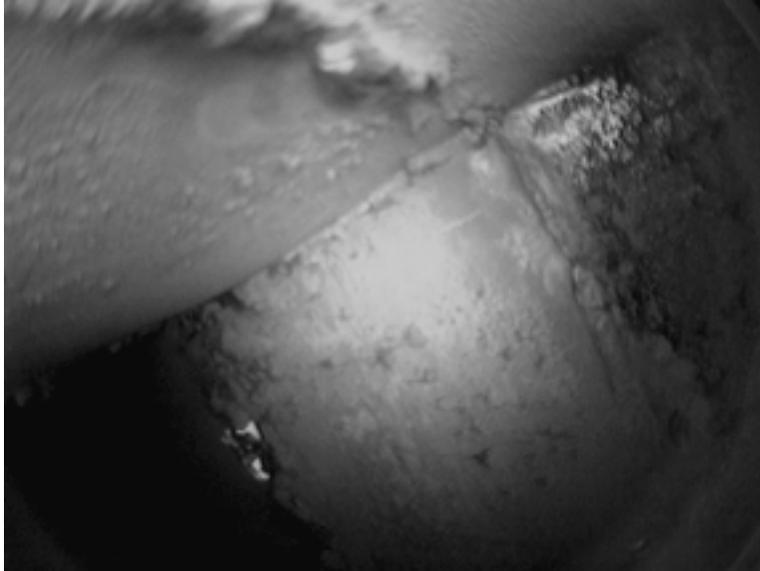
As per Internal Video Inspection: RECIRC RETURN DUCT, SYSTEM R 01-59-2 IN COMPT.
PRIMARY WARD (01-59-2-L) IS DIRTY AND REQUIRES CLEANING.

3 FT Inside Duct (Foreign material)

REPAIR ACTIVITY OPEN AND CLEAN RECIRC RETURN DUCT, SYSTEM R 01-59-2
IN ITS ENTIRETY THEN RESTORE TO NORMAL OPERATION.

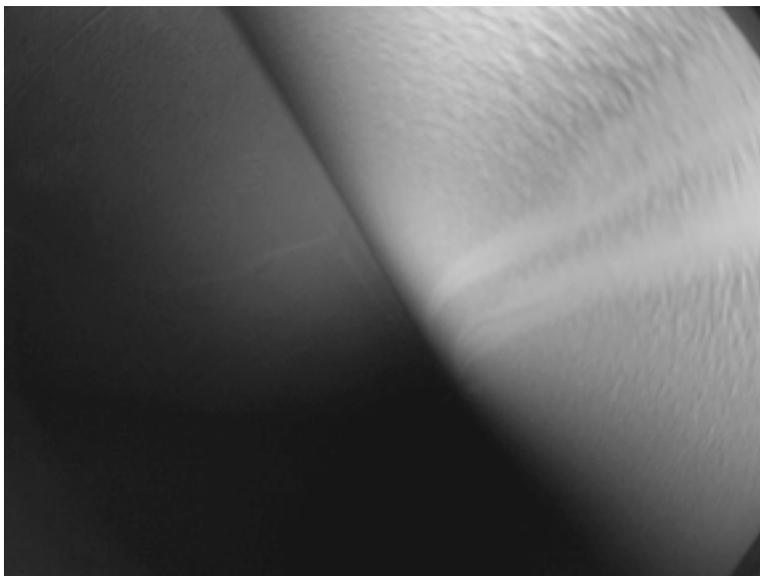
PRIMARY WARD (01-59-2-L)

12 FT Inside Duct (Foreign material)

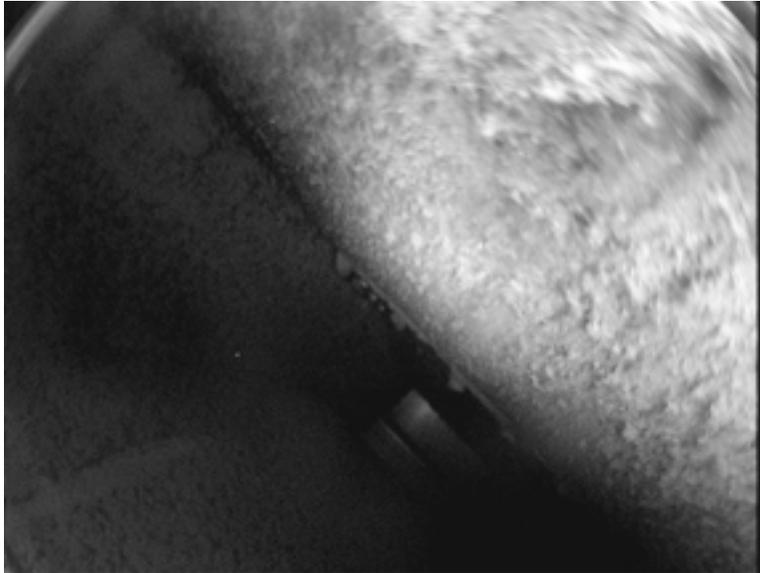
As per Internal Video Inspection: EXHAUST DUCT, SYSTEM E 01-60-2 IN COMPT. CREW & TROOP GALLEY (1-49-0-Q) IS DIRTY INTERNALLY WITH MIXTURE OF GREASE AND DIRT AND REQUIRES CLEANING.

2 FT Inside Duct {STBD} (Foreign material)

REPAIR ACTIVITY OPEN AND CLEAN EXHAUST DUCT, SYSTEM E 01-60-2 IN ITS ENTIRETY THEN RESTORE TO NORMAL OPERATION.

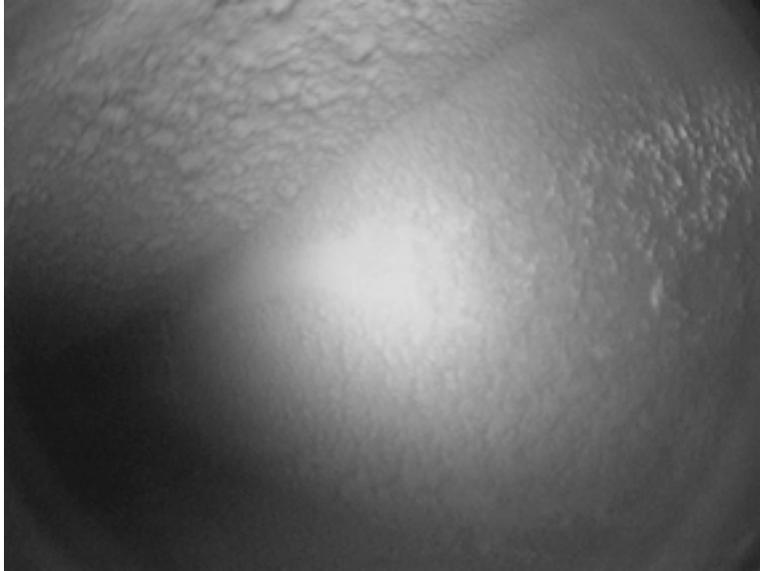
As per Internal Video Inspection: RECIRC RETURN DUCT, SYSTEM R 01-63-1 IN COMPT. PASSAGE (01-57-5-L) IS DIRTY AND REQUIRES CLEANING.

3 FT Inside Duct (Foreign material)

REPAIR ACTIVITY OPEN AND CLEAN RECIRC RETURN DUCT, SYSTEM R 01-63-1 IN ITS ENTIRETY THEN RESTORE TO NORMAL OPERATION.

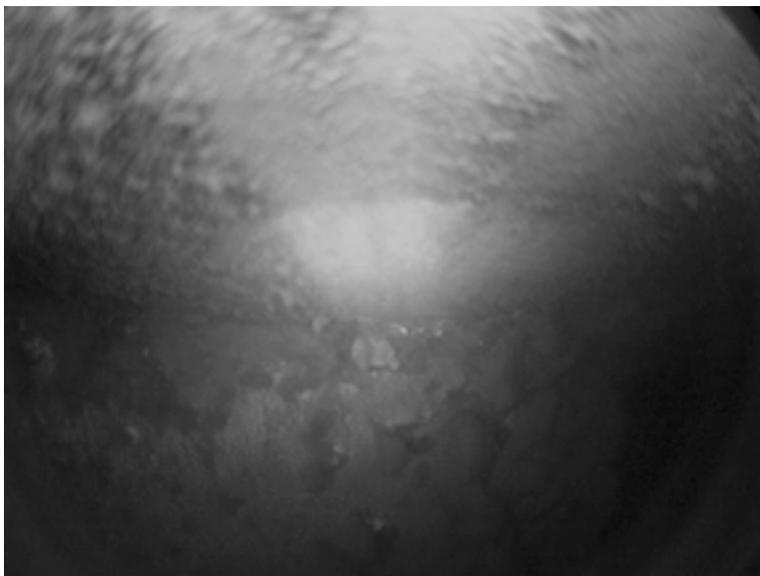
PASSAGE (01-57-5-L)

5 FT Inside Duct (Foreign material)

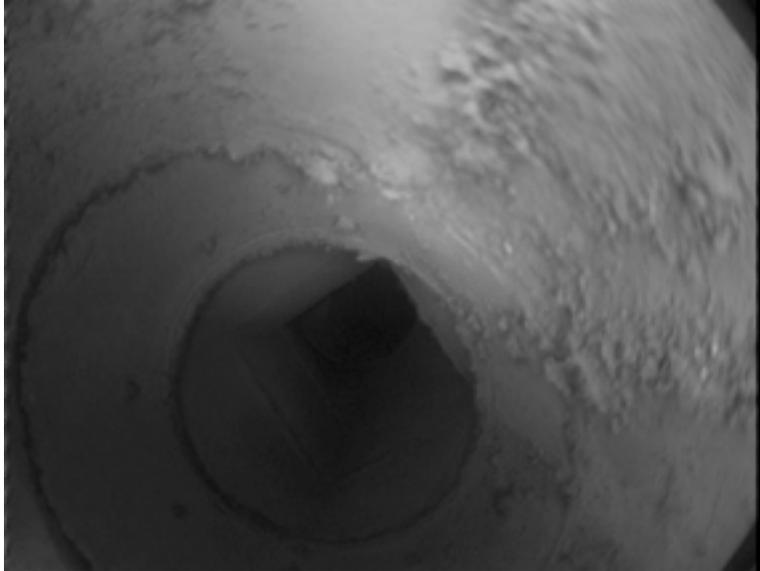
As per Internal Video Inspection: RECIRC RETURN DUCT, SYSTEM R 01-66-2 IN COMPT. MED OPR RM NO. 1 (01-73-0-L) IS DIRTY AND REQUIRES CLEANING

10 FT Inside Duct At Frame 48 (Foreign material)

REPAIR ACTIVITY OPEN AND CLEAN RECIRC RETURN DUCT, SYSTEM R 01-66-2 IN ITS ENTIRETY THEN RESTORE TO NORMAL OPERATION.

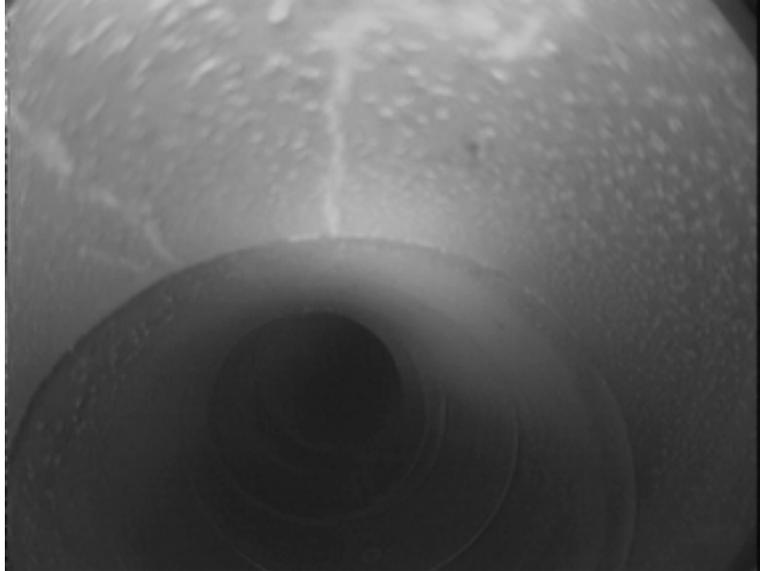
As per Internal Video Inspection: RECIRC RETURN DUCT, SYSTEM R 01-69-2 IN COMPT.
MED OPR RM NO. 2 (01-73-2-L) IS DIRTY AND REQUIRES CLEANING.

10 FT Inside Duct (Foreign material)

REPAIR ACTIVITY OPEN AND CLEAN RECIRC RETURN DUCT, SYSTEM R 01-69-2
IN ITS ENTIRETY THEN RESTORE TO NORMAL OPERATION.

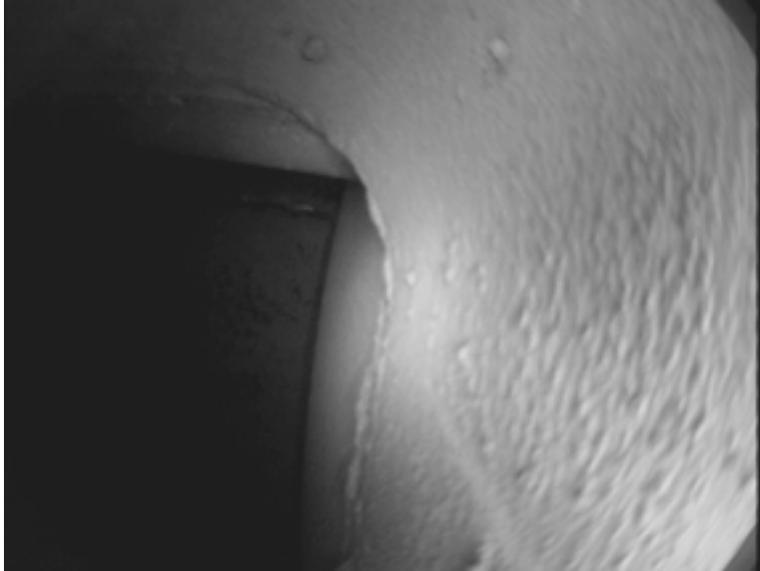
As per Internal Video Inspection: RECIRC RETURN DUCT, SYSTEM R 01-70-2 IN COMPT. PASSAGE (01-65-01-L) IS DIRTY AND REQUIRES CLEANING.

4 FT Inside Duct (Foreign material)

REPAIR ACTIVITY OPEN AND CLEAN RECIRC RETURN DUCT, SYSTEM R 01-70-2 IN ITS ENTIRETY THEN RESTORE TO NORMAL OPERATION.

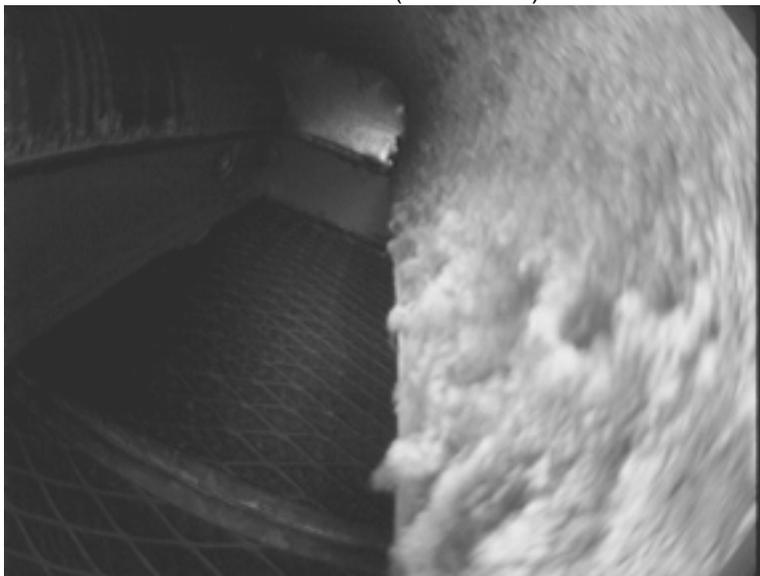
PASSAGE (01-65-01-L)

10 FT Inside Duct (Foreign material)

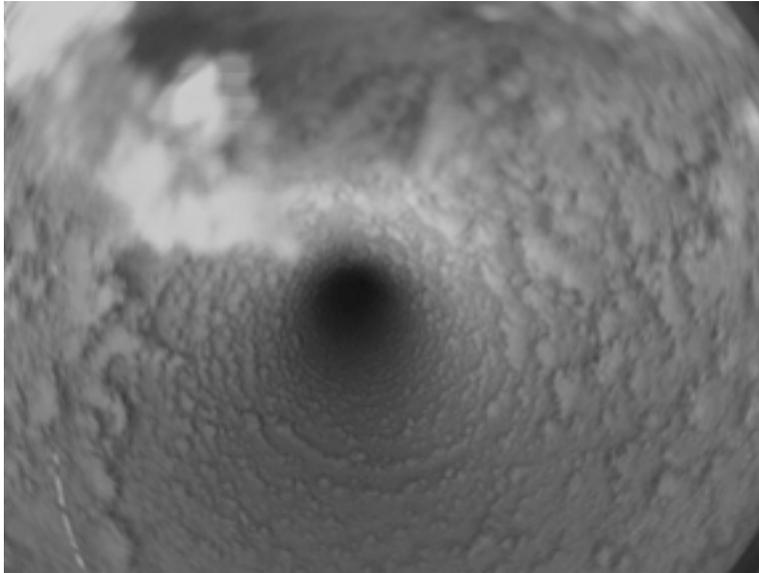
As per Internal Video Inspection: EXHAUST DUCT, SYSTEM E 01-75-3 IN COMPT.
WR/WC (02-68-2-L) IS DIRTY AND REQUIRES CLEANING.

3 FT Inside Duct (Foreign material)

REPAIR ACTIVITY OPEN AND CLEAN EXHAUST DUCT, SYSTEM E 01-75-3
IN ITS ENTIRETY THEN RESTORE TO NORMAL OPERATION.

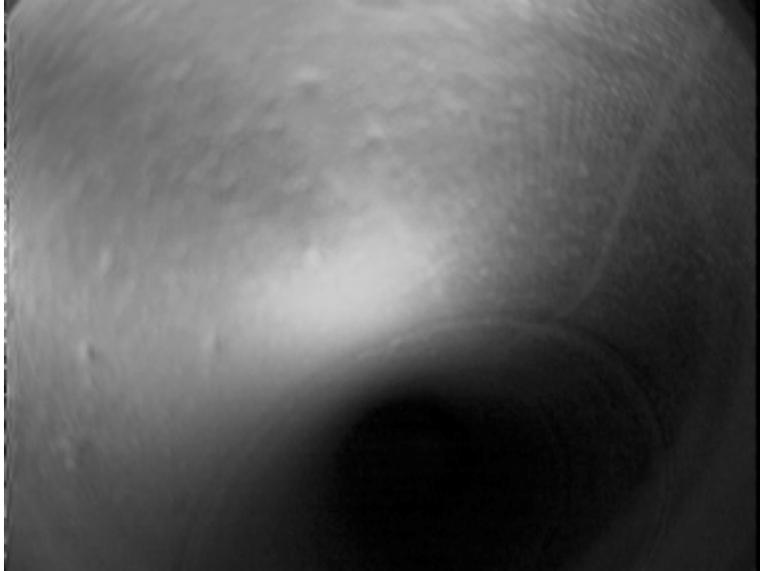
As per Internal Video Inspection: RECIRC RETURN DUCT, SYSTEM R 01-81-2 IN COMPT.
MED OPR RM NO. 3 (01-77-0-L) IS DIRTY AND REQUIRES CLEANING.

15 FT Inside Duct (Foreign material)

REPAIR ACTIVITY OPEN AND CLEAN RECIRC RETURN DUCT, SYSTEM R 01-81-2
IN ITS ENTIRETY THEN RESTORE TO NORMAL OPERATION.

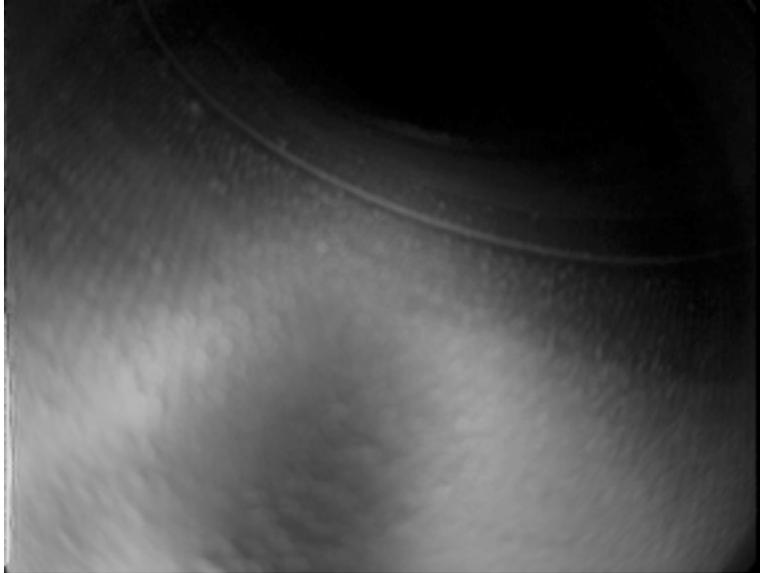
MED OPR RM NO. 5 (01-75-0-L)

4 FT Inside Duct (Foreign material)

REPAIR ACTIVITY OPEN AND CLEAN RECIRC RETURN DUCT, SYSTEM R 01-81-4
IN ITS ENTIRETY THEN RESTORE TO NORMAL OPERATION.

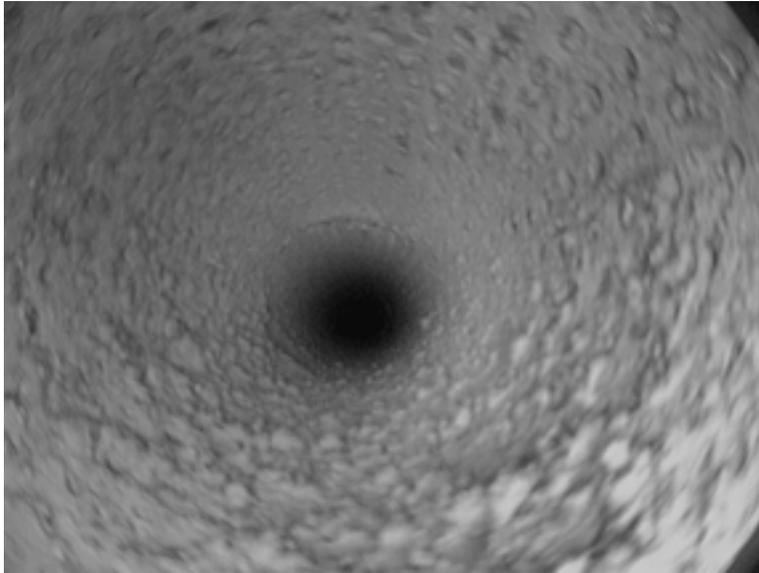
FEMALE WR/WC (02-102-4-L)

3 FT Inside Duct (Foreign material)

REPAIR ACTIVITY OPEN AND CLEAN EXHAUST DUCT, SYSTEM E 01-103-4
IN ITS ENTIRETY THEN RESTORE TO NORMAL OPERATION.

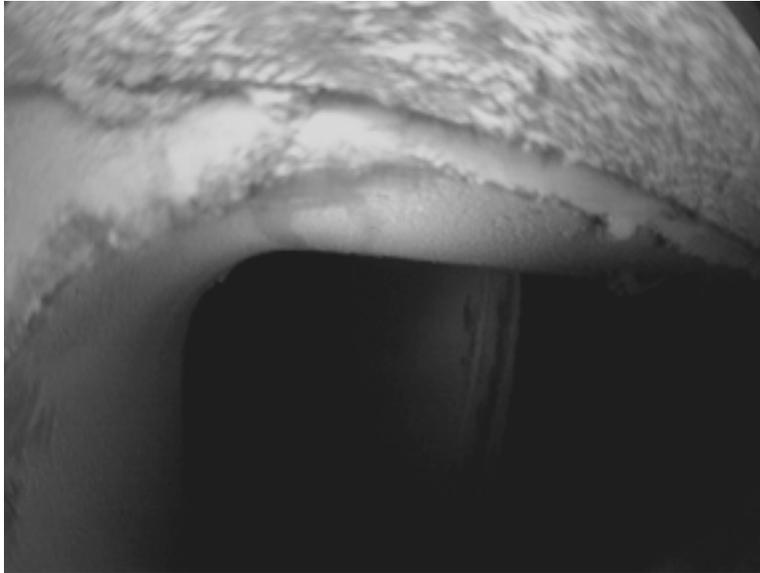
TROOP TRAINING & MARSHALLING AREA [GYM] (02-L-0-Q)

2 FT Inside Duct (Foreign material)

REPAIR ACTIVITY OPEN AND CLEAN RECIRC RETURN DUCT, SYSTEM R 02-P-1 IN ITS ENTIRETY THEN RESTORE TO NORMAL OPERATION.

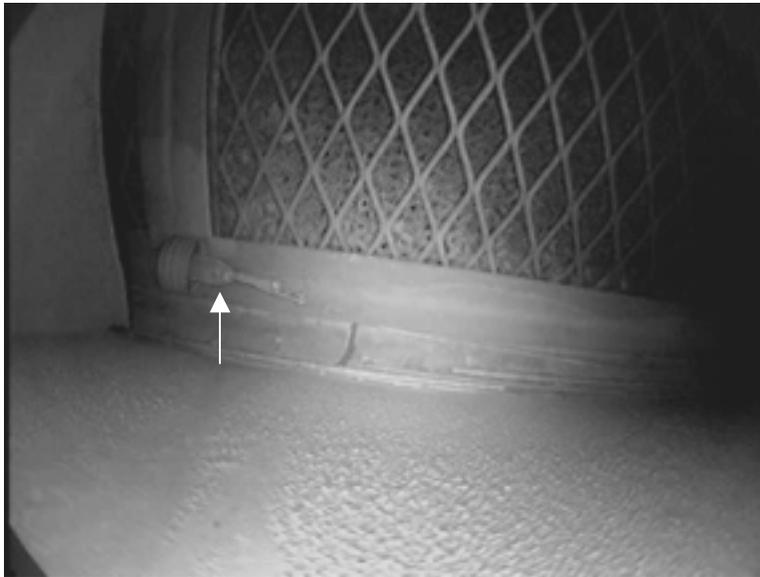
TROOP TRAINING & MARSHALLING AREA [GYM] (02-L-0-Q)

8 FT Inside Duct (Foreign material)

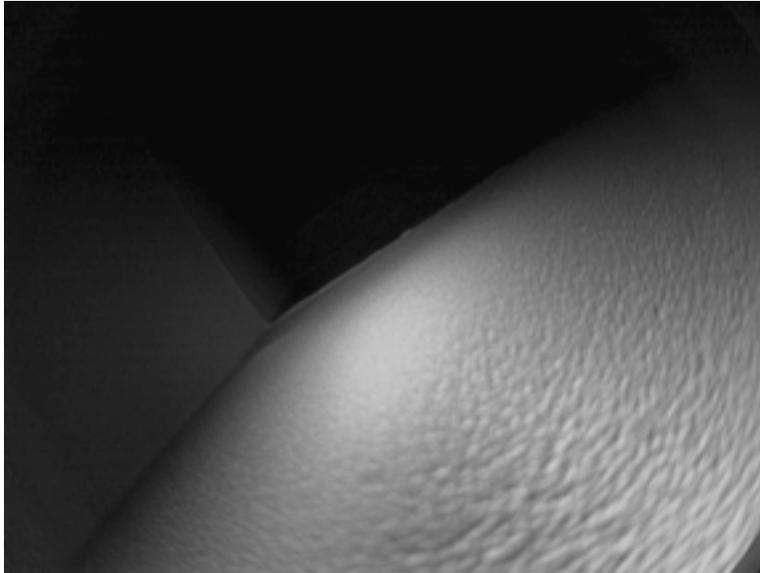
TROOP TRAINING & MARSHALLING AREA [GYM] (02-L-0-Q)

2 FT Inside Duct (Foreign material)

REPAIR ACTIVITY OPEN AND CLEAN RECIRC RETURN DUCT, SYSTEM R 02-R-3 IN ITS ENTIRETY THEN RESTORE TO NORMAL OPERATION.

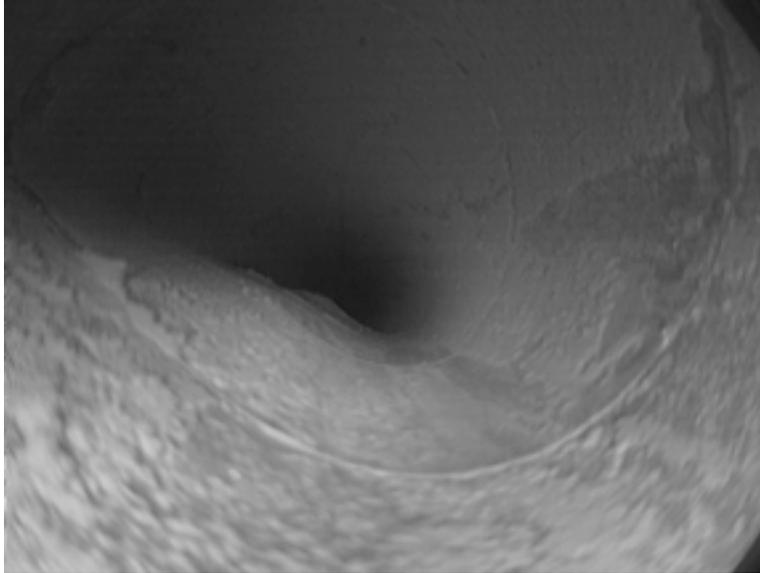
TROOP LIV SP & CASUALTY OVFL (01-33-01-L)

3 FT Inside Duct (Foreign material)

REPAIR ACTIVITY OPEN AND CLEAN RECIRC RETURN DUCT, SYSTEM R 02-33-1 IN ITS ENTIRETY THEN RESTORE TO NORMAL OPERATION.

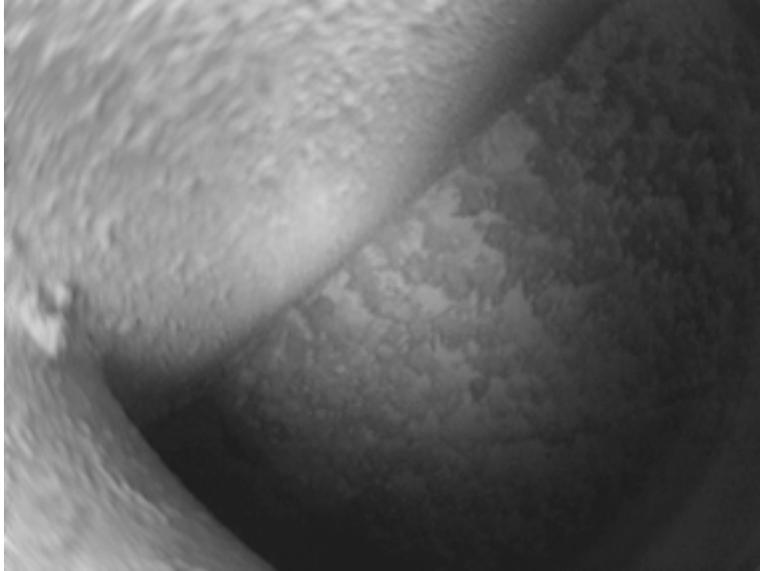
PASSAGE (02-33-01-L)

3 FT Inside Duct (Foreign material)

REPAIR ACTIVITY OPEN AND CLEAN RECIRC RETURN DUCT, SYSTEM R 02-34-1 IN ITS ENTIRETY THEN RESTORE TO NORMAL OPERATION.

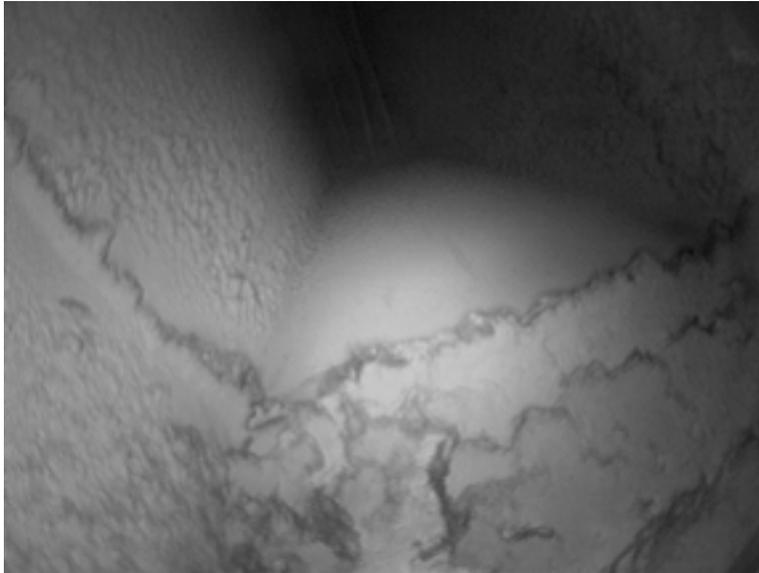
PASSAGEWAY (02-33-8-L)

5 FT Inside Duct (Foreign material)

REPAIR ACTIVITY OPEN AND CLEAN RECIRC RETURN DUCT, SYSTEM R 02-39-2 IN ITS ENTIRETY THEN RESTORE TO NORMAL OPERATION.

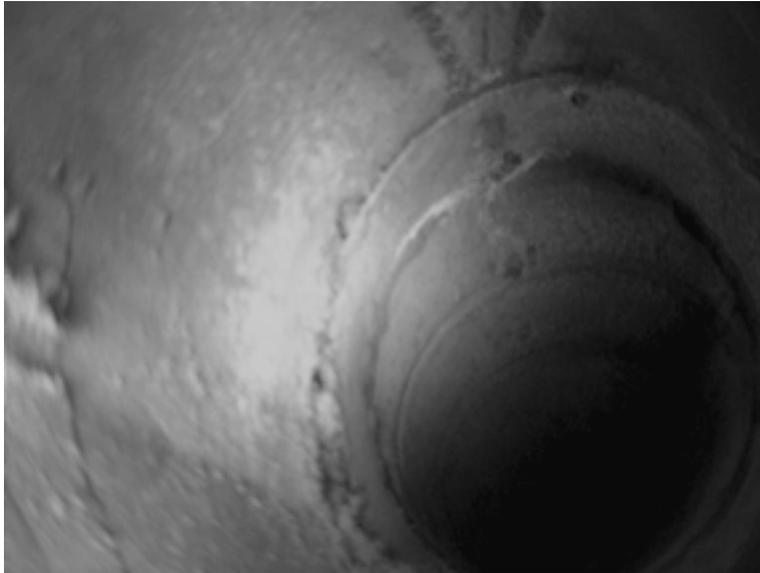
WARDROOM GALLEY (02-37.5-0-Q)

2 FT Inside Duct (Foreign material)

REPAIR ACTIVITY OPEN AND CLEAN RECIRC RETURN DUCT, SYSTEM R 02-39-4 IN ITS ENTIRETY THEN RESTORE TO NORMAL OPERATION.

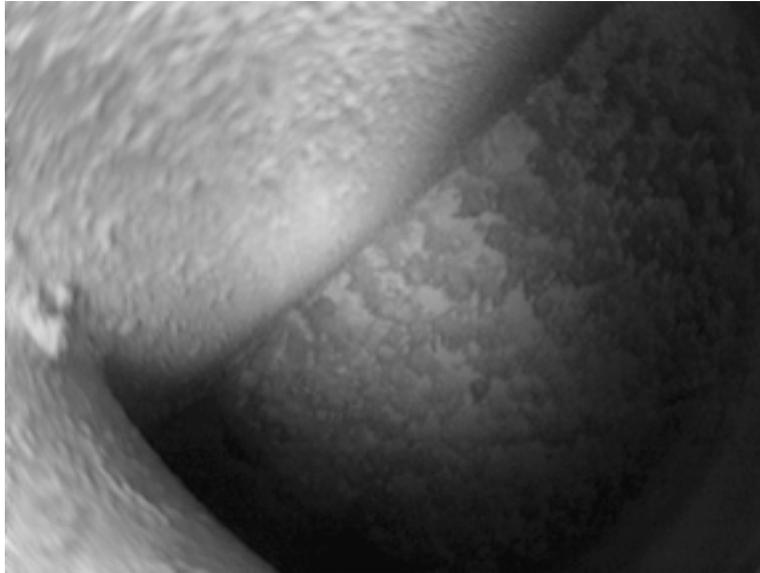
WARDROOM GALLEY (02-37.5-0-Q)

2 FT Inside Duct By Deep Fat Fryer (Foreign material)

REPAIR ACTIVITY OPEN AND CLEAN EXHAUST DUCT, SYSTEM E 02-40-2 IN ITS ENTIRETY THEN RESTORE TO NORMAL OPERATION.

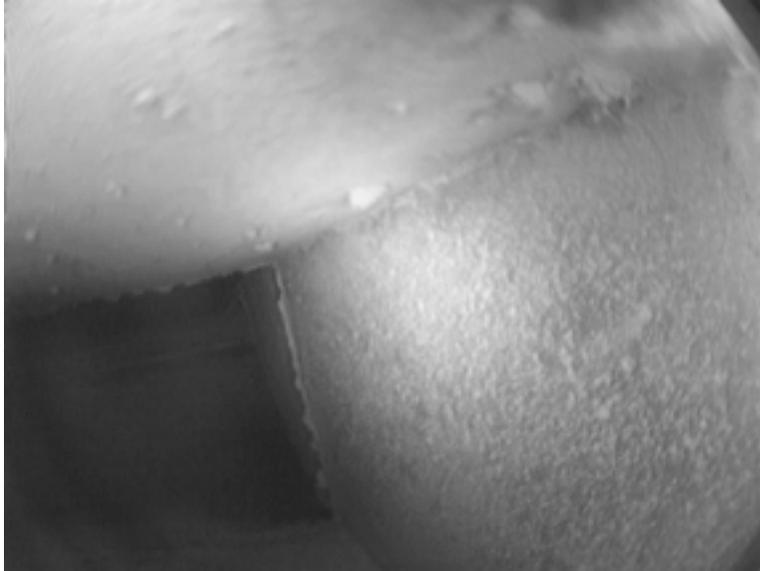
PASSAGE (02-41-1-L)

2 FT Inside Duct (Foreign material)

REPAIR ACTIVITY OPEN AND CLEAN RECIRC RETURN DUCT, SYSTEM R 02-41-1 IN ITS ENTIRETY THEN RESTORE TO NORMAL OPERATION.

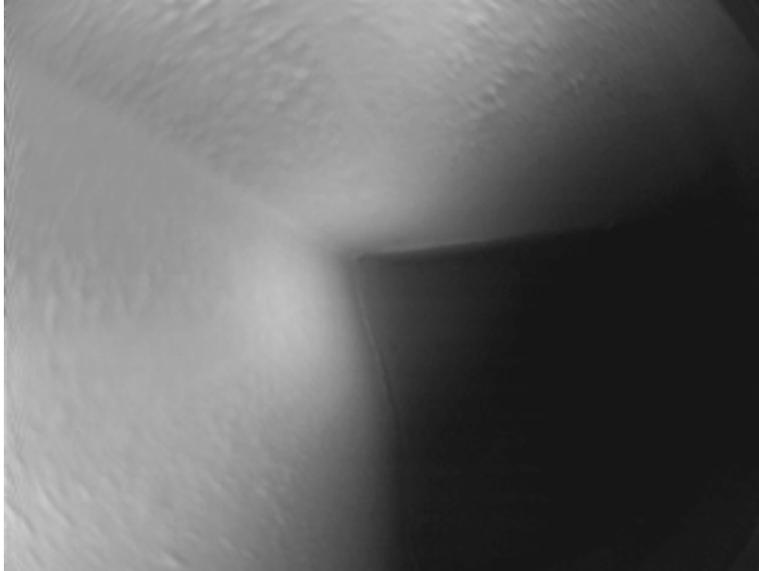
PASSAGE (02-49-0-L)

5 FT Inside Duct (Foreign material)

REPAIR ACTIVITY OPEN AND CLEAN RECIRC RETURN DUCT, SYSTEM R 02-50-1 IN ITS ENTIRETY THEN RESTORE TO NORMAL OPERATION.

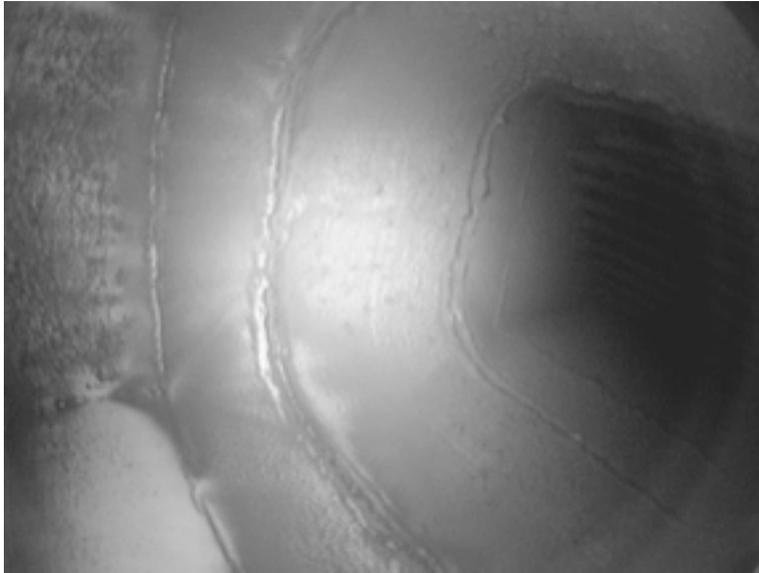
PASSAGE (02-49-0-L)

1 FT Inside Duct (Foreign material)

REPAIR ACTIVITY OPEN AND CLEAN RECIRC RETURN DUCT, SYSTEM R 02-55-2 IN ITS ENTIRETY THEN RESTORE TO NORMAL OPERATION.

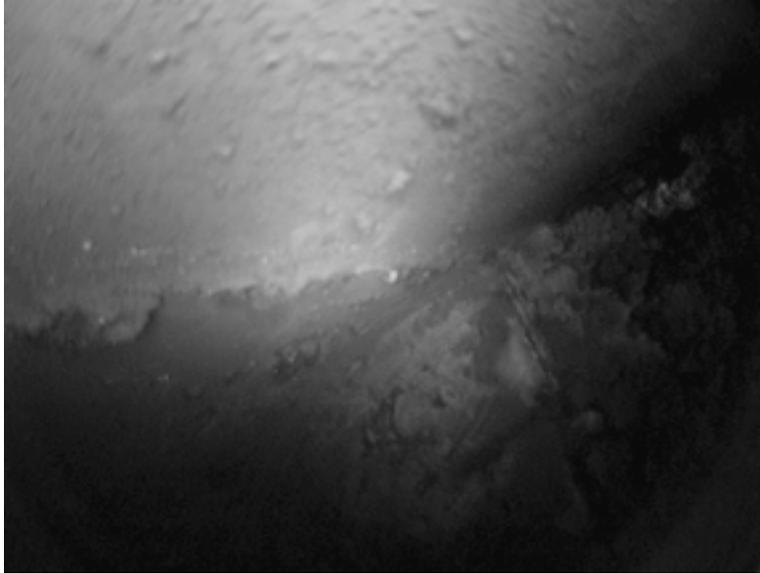
PASSAGE (01-65-01-L)

3 FT Inside Duct (Foreign material)

REPAIR ACTIVITY OPEN AND CLEAN RECIRC RETURN DUCT, SYSTEM R 02-65-1 IN ITS ENTIRETY THEN RESTORE TO NORMAL OPERATION.

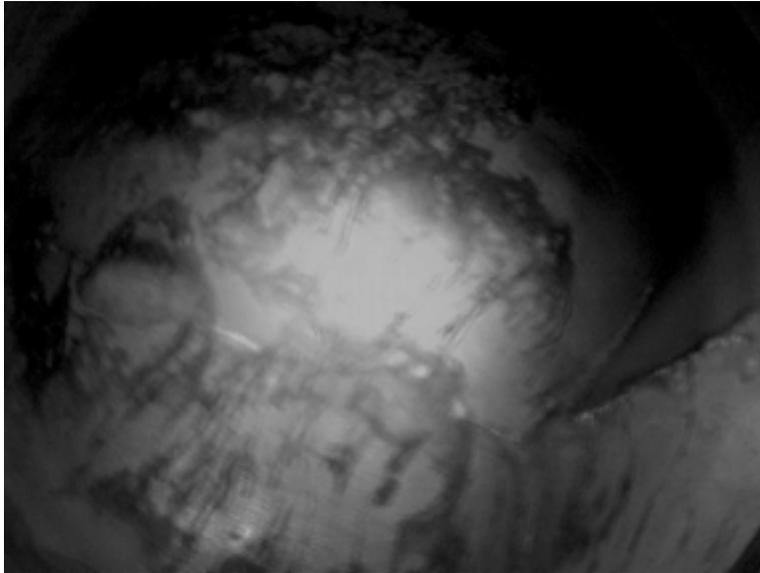
PASSAGE (02-73-4-L)

1 FT Inside Duct (Foreign material)

REPAIR ACTIVITY OPEN AND CLEAN RECIRC RETURN DUCT, SYSTEM R 02-73-2 IN ITS ENTIRETY THEN RESTORE TO NORMAL OPERATION.

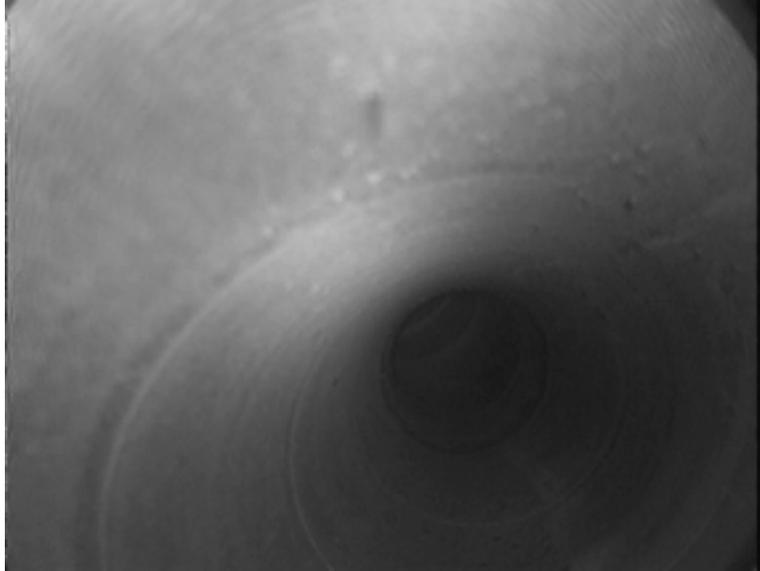
MED OPR RM NO. 4 (01-75-2-L)

4 FT Inside Duct (Foreign material)

REPAIR ACTIVITY OPEN AND CLEAN RECIRC RETURN DUCT, SYSTEM R 02-74-2
IN ITS ENTIRETY THEN RESTORE TO NORMAL OPERATION.

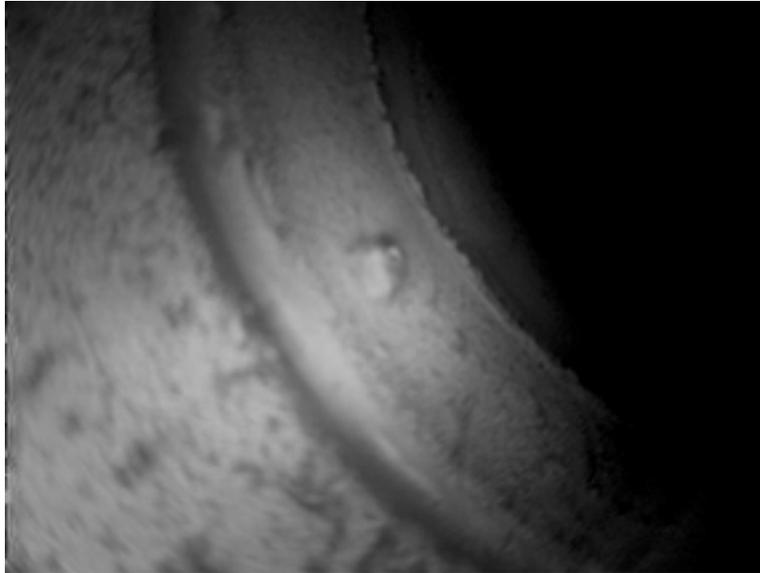
MED OPR RM NO. 6/MN BD STA/EAR,NOSE,& THROAT TRMT RM (01-77-2-L)

4 FT Inside Duct (Foreign material)

REPAIR ACTIVITY OPEN AND CLEAN RECIRC RETURN DUCT, SYSTEM R 02-75-2
IN ITS ENTIRETY THEN RESTORE TO NORMAL OPERATION.

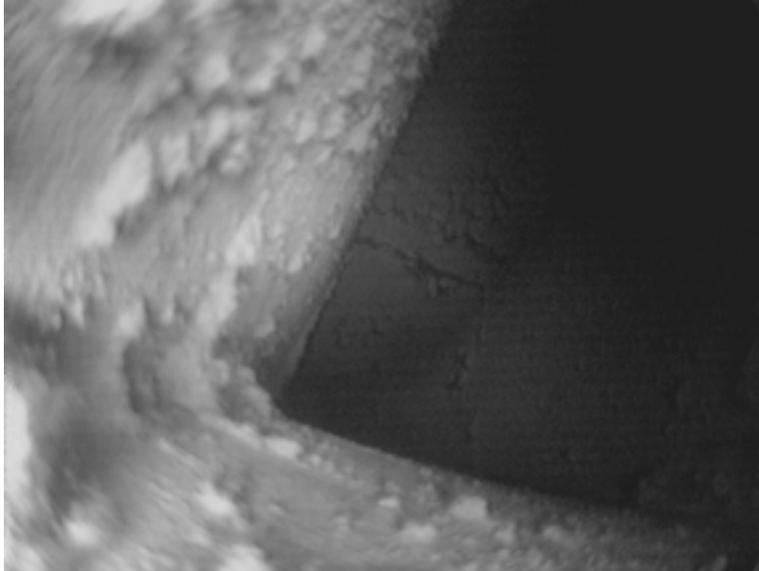
PASSAGE (02-81-3-L)

2 FT Inside Duct (Foreign material)

REPAIR ACTIVITY OPEN AND CLEAN RECIRC RETURN DUCT, SYSTEM R 02-84-1 IN ITS ENTIRETY THEN RESTORE TO NORMAL OPERATION.
