SEMAT I

USS BATAAN (LHD 5)

INTERNAL VIDEO VENTILATION ASSESSMENT

09 THRU 28 AUGUST 2000

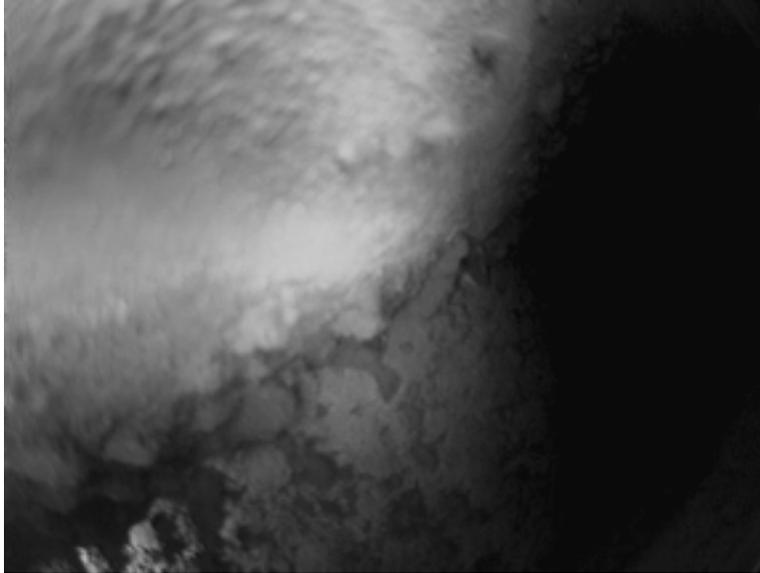
PASSAGE (02-81-3-L)

2 FT Inside Duct (Foreign material)

REPAIR ACTIVITY OPEN AND CLEAN RECIRC RETURN DUCT, SYSTEM R 02-96-1 IN ITS ENTIRETY THEN RESTORE TO NORMAL OPERATION.

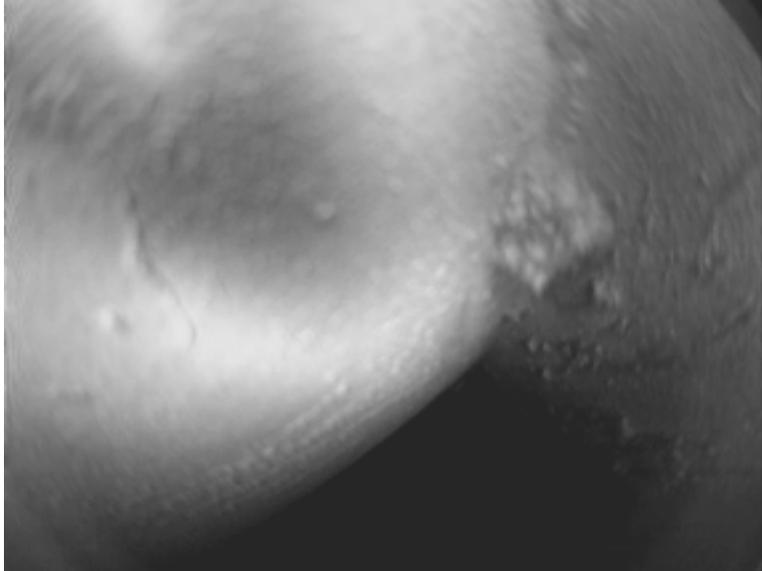
PASSAGE (02-97-0-L)

2 FT Inside Duct (Foreign material)

REPAIR ACTIVITY OPEN AND CLEAN RECIRC RETURN DUCT, SYSTEM R 02-99-1 IN ITS ENTIRETY THEN RESTORE TO NORMAL OPERATION.

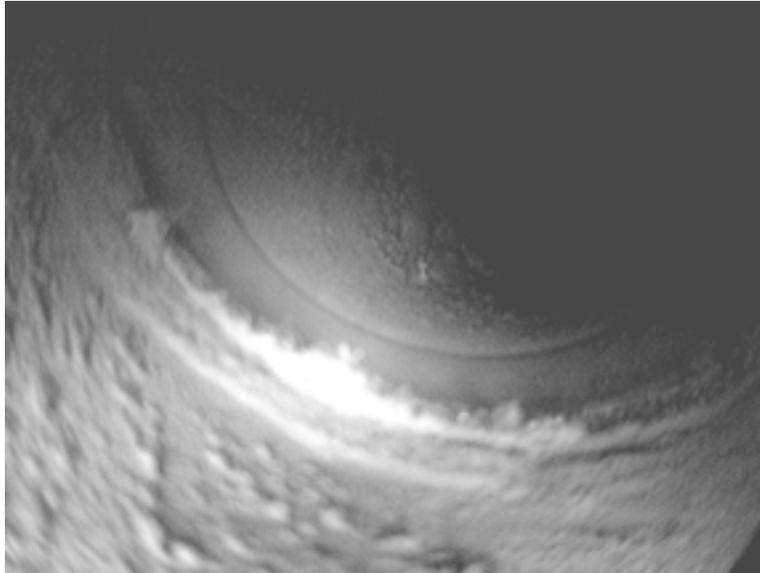
PASSAGE (02-97-0-L)

1 FT Inside Duct (Foreign material)

REPAIR ACTIVITY OPEN AND CLEAN RECIRC RETURN DUCT, SYSTEM R 02-103-2 IN ITS ENTIRETY THEN RESTORE TO NORMAL OPERATION.

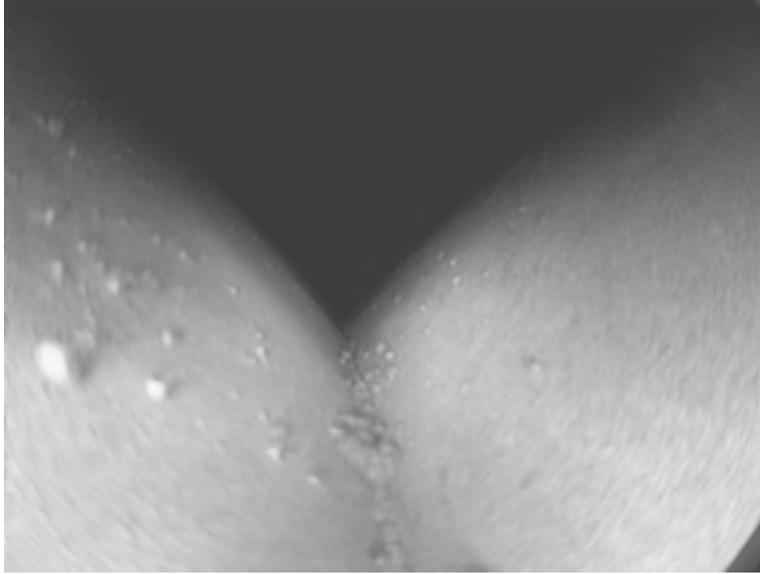
PASSAGE (02-97-0-L)

3 FT Inside Duct (Foreign material)

REPAIR ACTIVITY OPEN AND CLEAN RECIRC RETURN DUCT, SYSTEM R 02-111-1 IN ITS ENTIRETY THEN RESTORE TO NORMAL OPERATION.

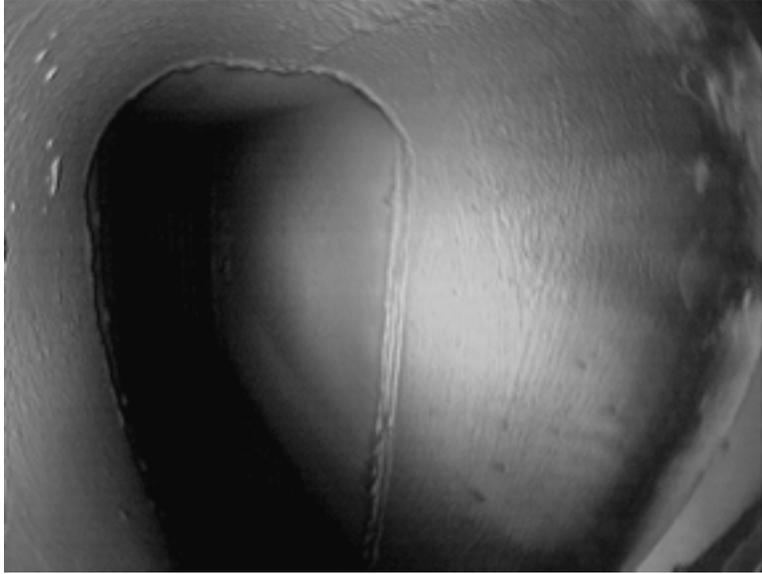
PASSAGE (02-113-01-L)

1 FT Inside Duct (Foreign material)

REPAIR ACTIVITY OPEN AND CLEAN RECIRC RETURN DUCT, SYSTEM R 02-118-1 IN ITS ENTIRETY THEN RESTORE TO NORMAL OPERATION.

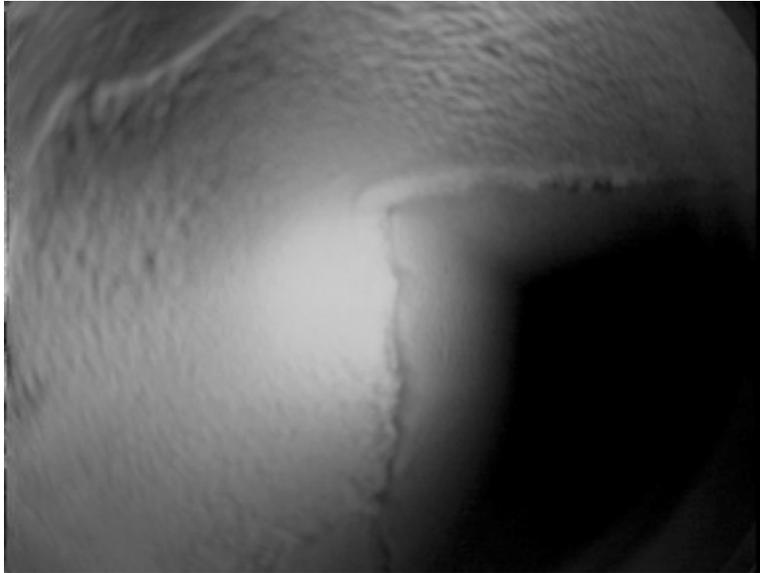
METALSMITH SHOP (02-121-0-Q)

2 FT Inside Duct (Foreign material)

REPAIR ACTIVITY OPEN AND CLEAN EXHAUST DUCT, SYSTEM R E 02-129-4
IN ITS ENTIRETY THEN RESTORE TO NORMAL OPERATION.

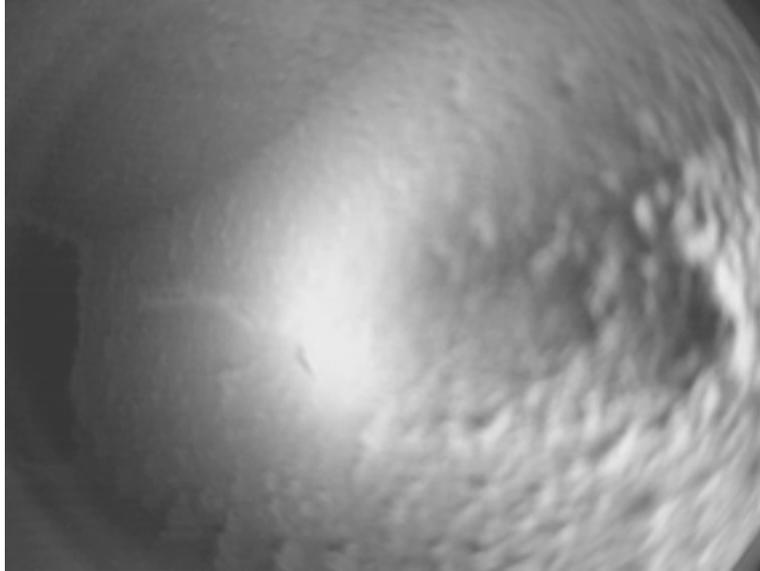
CO Sea Cabin WR, WC, & SH (06-69.5-L)

4 FT Inside Duct (Foreign material)

REPAIR ACTIVITY OPEN AND CLEAN EXHAUST DUCT, SYSTEM E 04-65-1
IN ITS ENTIRETY THEN RESTORE TO NORMAL OPERATION.

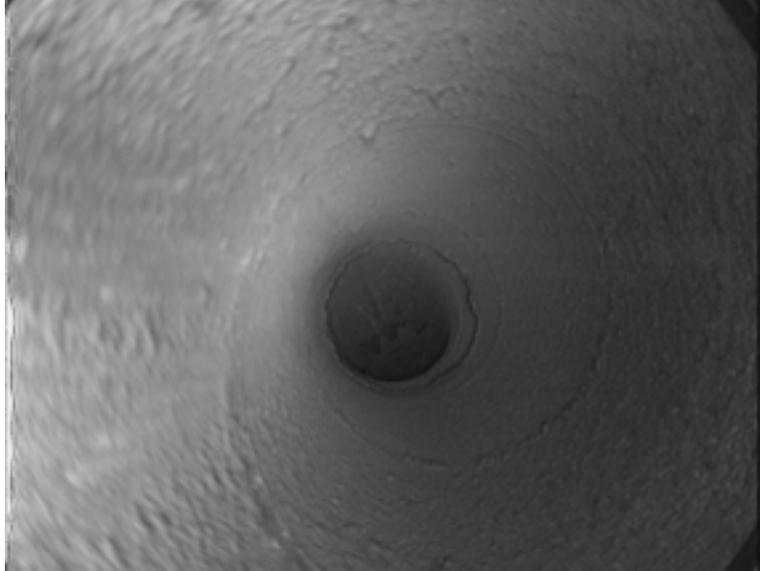
CASUALTY CLTG AREA/ASSY (03-73-3-Q)

10 FT Inside Duct (Foreign material)

REPAIR ACTIVITY OPEN AND CLEAN EXHAUST DUCT, SYSTEM E 05-78-3
IN ITS ENTIRETY THEN RESTORE TO NORMAL OPERATION.

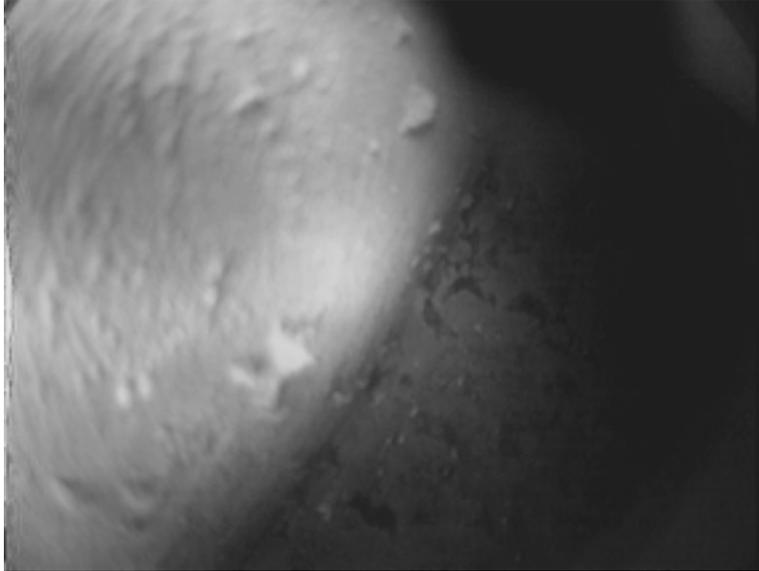
PASSAGE (04-79-5-L)

4 FT Inside Duct (Foreign material)

REPAIR ACTIVITY OPEN AND CLEAN RECIRC RETURN DUCT, SYSTEM R 05-88-1 IN ITS ENTIRETY THEN RESTORE TO NORMAL OPERATION.

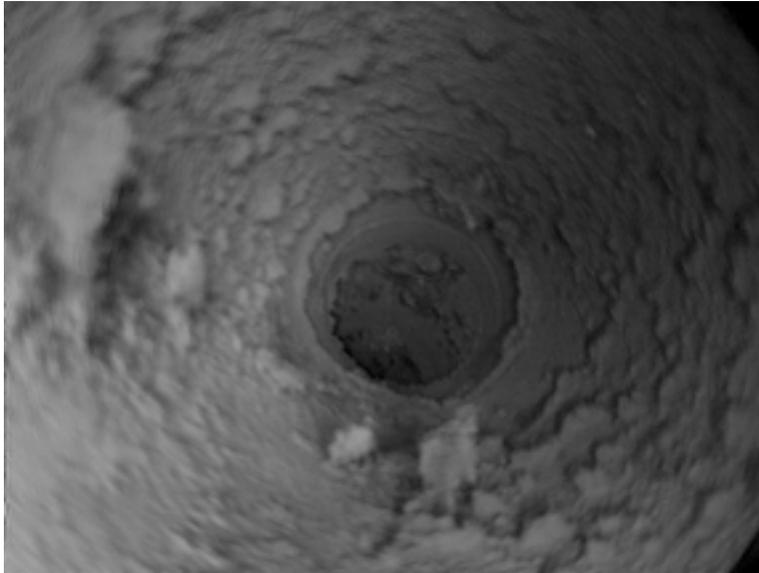
PASSAGE (06-67-3-L)

3 FT Inside Duct (Foreign material)

REPAIR ACTIVITY OPEN AND CLEAN RECIRC RETURN DUCT, SYSTEM R 06-70-1
IN ITS ENTIRETY THEN RESTORE TO NORMAL OPERATION.

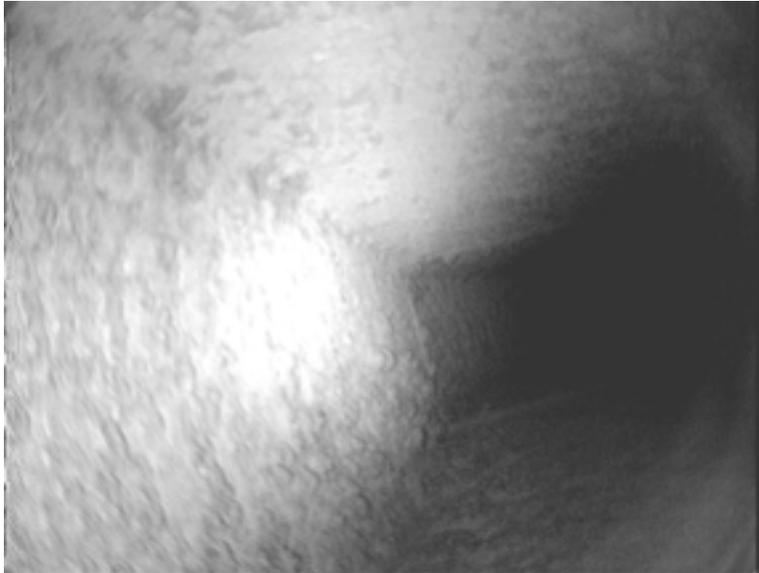
TRP LIVING SPACE (01-1-4-L)

8 FT Inside Duct (Foreign material)

REPAIR ACTIVITY OPEN AND CLEAN RECIRC RETURN DUCT SYSTEM R 1-15-2 IN ITS ENTIRETY THEN RESTORE TO NORMAL OPERATION.

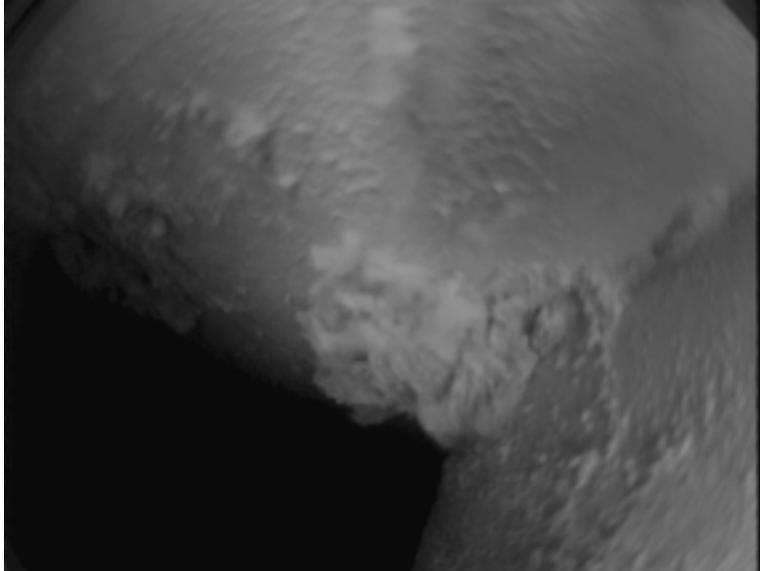
PASSAGE (1-27-1-L)

24 FT Inside Duct (STBD) (Foreign material)

REPAIR ACTIVITY OPEN AND CLEAN RECIRC RETURN DUCT, SYSTEM R 1-25-1
IN ITS ENTIRETY THEN RESTORE TO NORMAL OPERATION.

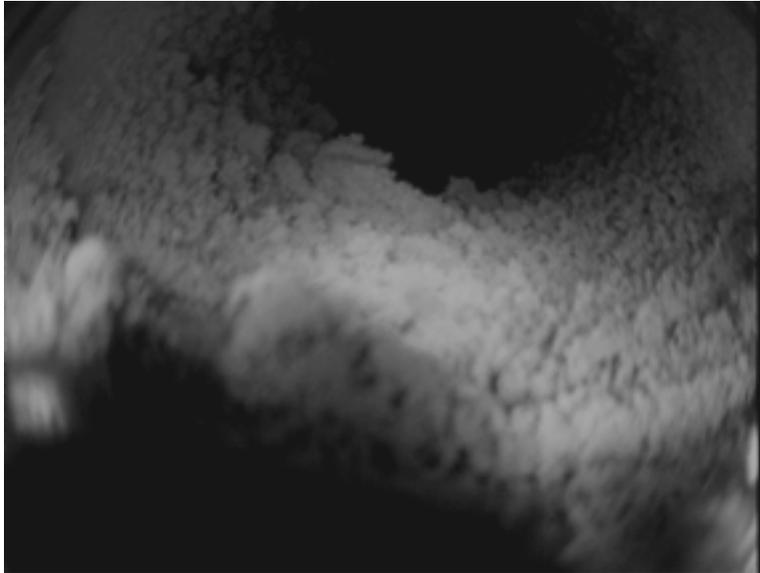
CREW SHOWER (2-39.5-1-L)

6 FT Inside Duct (Foreign material)

REPAIR ACTIVITY OPEN AND CLEAN EXHAUST DUCT, SYSTEM E 1-40-1
IN ITS ENTIRETY THEN RESTORE TO NORMAL OPERATION.

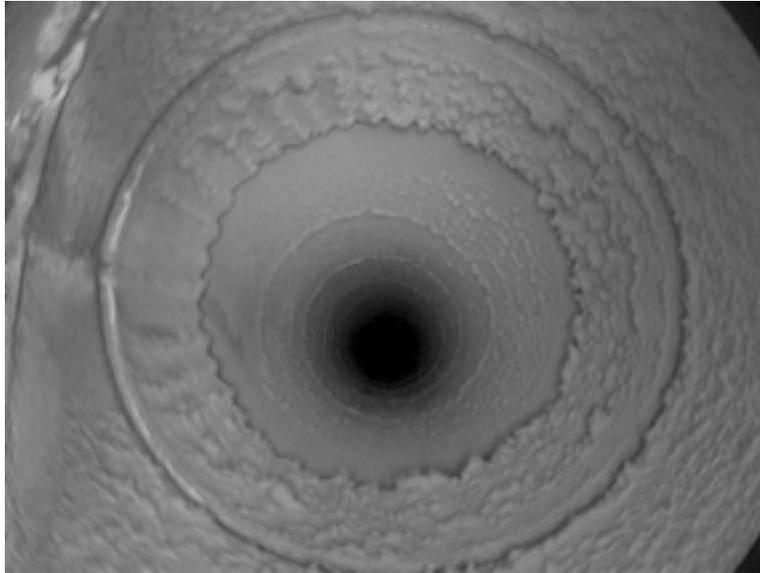
WR, WC, & SH (02-45-1-L)

1 FT Inside Duct (Foreign material)

REPAIR ACTIVITY OPEN AND CLEAN EXHAUST DUCT, SYSTEM E 1-40-3
IN ITS ENTIRETY THEN RESTORE TO NORMAL OPERATION.

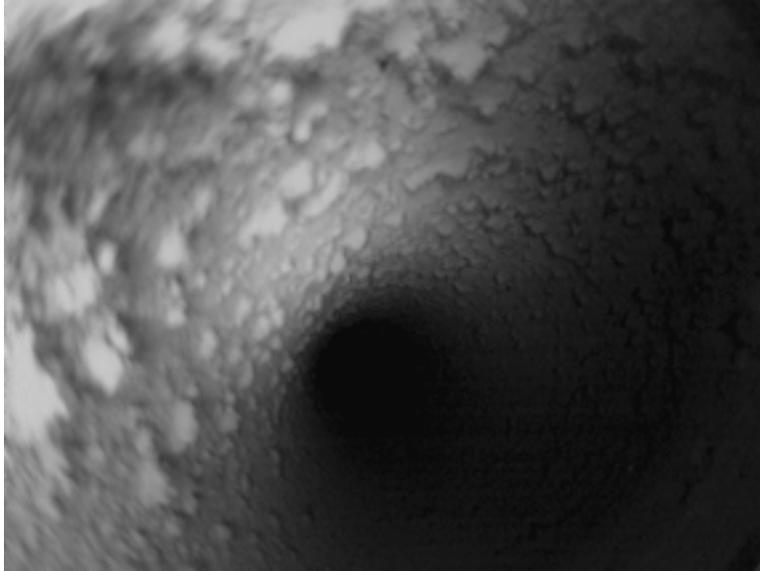
PASSAGE (02-81-2-L)

1 FT Inside Duct (Foreign material)

REPAIR ACTIVITY OPEN AND CLEAN EXHAUST DUCT, SYSTEM E 1-84-4 IN ITS ENTIRETY THEN RESTORE TO NORMAL OPERATION.

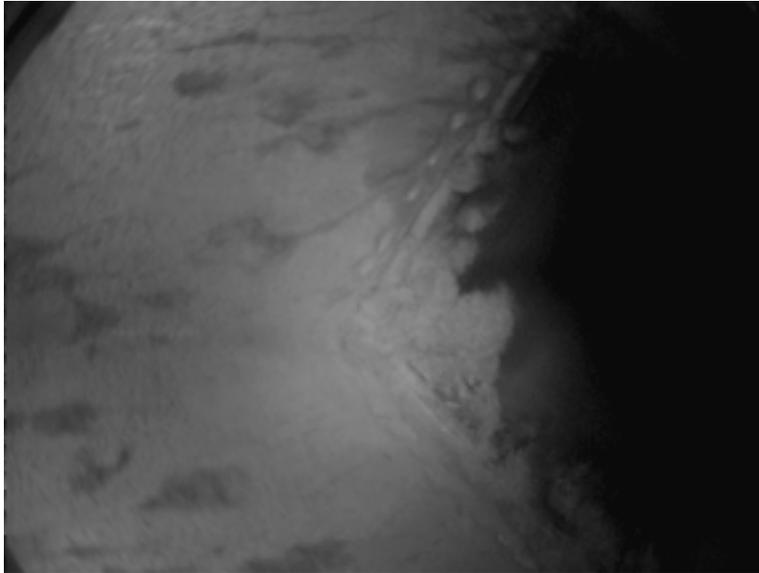
PASSAGEWAY (1-39.5-1-L)

5 FT Inside Duct (Foreign material)

REPAIR ACTIVITY OPEN AND CLEAN RECIRC RETURN DUCT, SYSTEM R 2-40-3 IN ITS ENTIRETY THEN RESTORE TO NORMAL OPERATION.

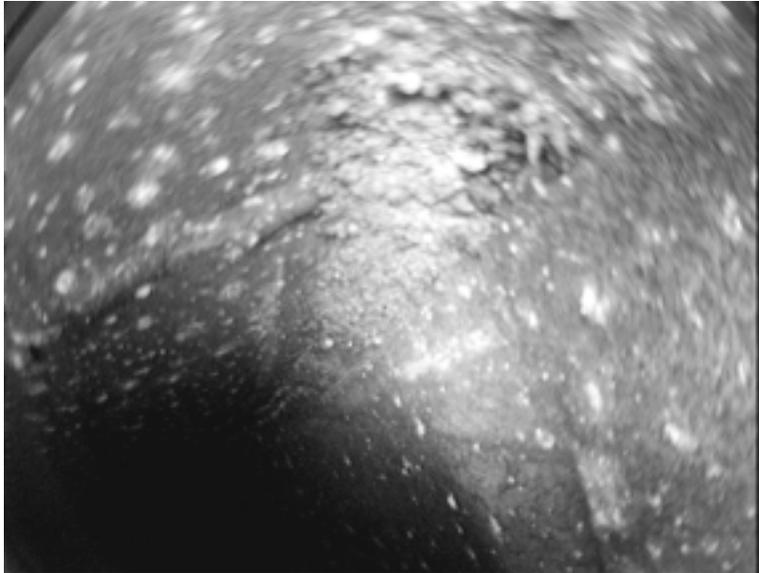
DIESEL GEN RM # 1 (4-41-2-E)

As per Internal Video Inspection: SUPPLY DUCT SYSTEM 4-44-2 IN COMPT. 4-41-2-E (DIESEL GEN RM # 1) IS DIRTY INTERNALLY WITH MIXTURE OF DIRT/DUST AND LIGHT CORROSION AND REQUIRES CLEANING.

20 FT Inside Duct (Foreign material)

REPAIR ACTIVITY OPEN AND CLEAN SUPPLY DUCT, SYSTEM S 4-44-2 IN ITS ENTIRETY THEN RESTORE TO NORMAL OPERATION.

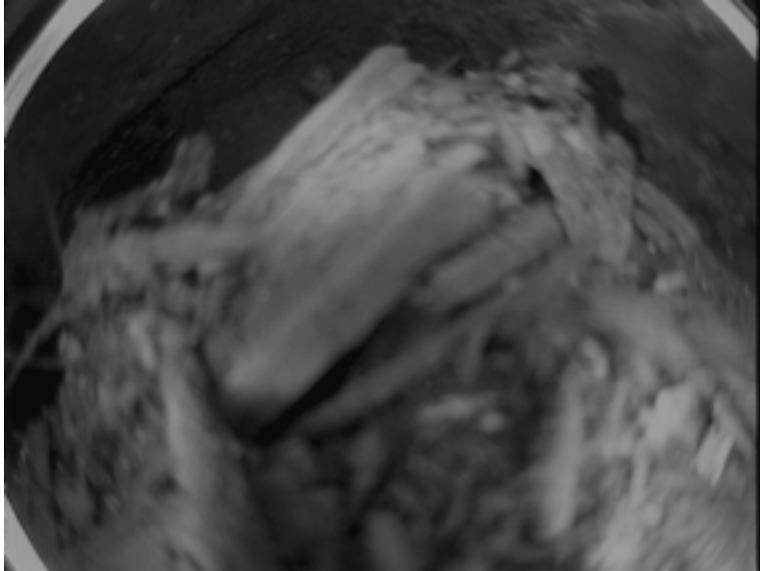
MCHRY RM 1 (6-65-0-E)

4 FT Inside Duct (Foreign material)

REPAIR ACTIVITY OPEN AND CLEAN SUPPLY DUCT, SYSTEM S 4-68-2
IN ITS ENTIRETY THEN RESTORE TO NORMAL OPERATION.

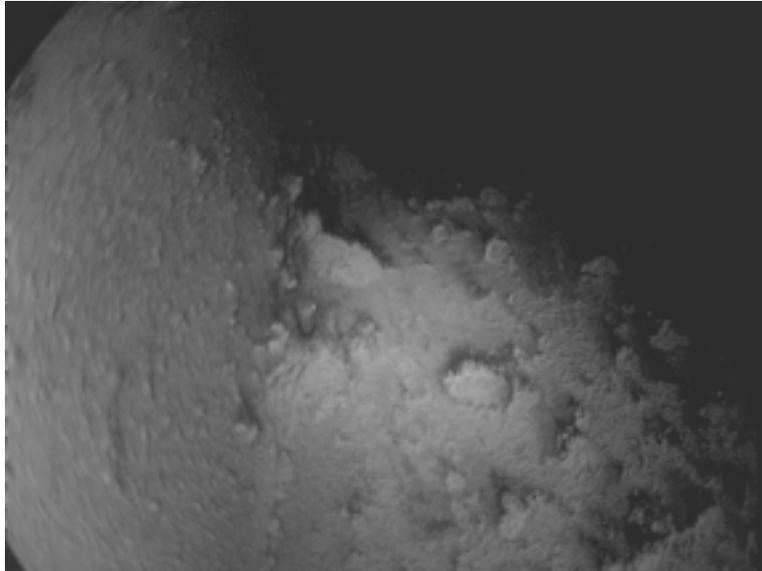
LAUNDRY (4-73-0-Q)

4 FT Inside Duct (Foreign material)

REPAIR ACTIVITY OPEN AND CLEAN EXHAUST DUCT, SYSTEM E 4-79-2 IN ITS ENTIRETY THEN RESTORE TO NORMAL OPERATION.
