# SEMIAT I

## USS WHIDBEY ISLAND (LSD 41)

### INTERNAL VIDEO VENTILATION ASSESSMENT

**PORTSMOUTH, VIRGINIA**  
SUPSHIP: C. BUCK & QED: B. CAREW, R. DAVENPORT, B. PARSONS  
**17 THRU 28 JULY 2000**

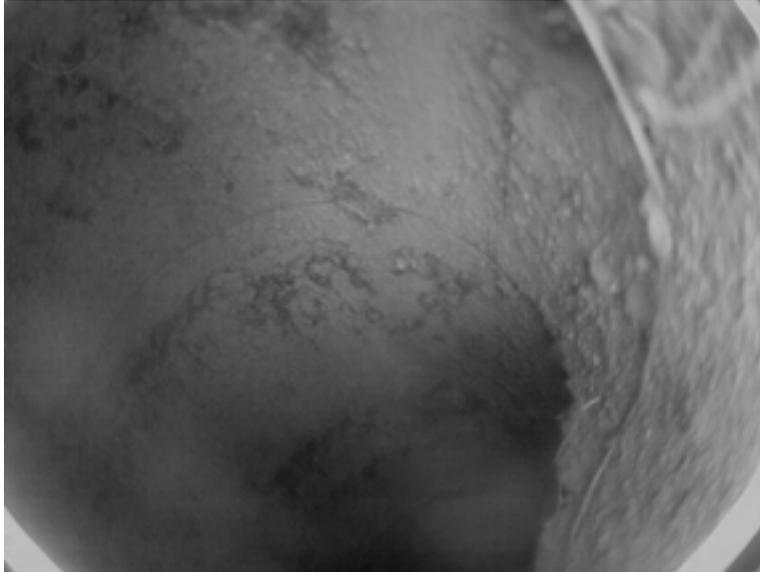
## LAUNDRY FINISHING ROOM (2-129-1-Q)

As per Internal Video Inspection: EXHAUST DUCT, SYSTEM E 01-128-1 IN COMPT.  
LAUNDRY FINISHING ROOM (2-129-1-Q) IS DIRTY AND REQUIRES CLEANING.

3 FT Inside Duct Looking Forward (Foreign material)

REPAIR ACTIVITY OPEN AND CLEAN EXHAUST DUCT, SYSTEM E 01-128-1 IN COMPT.  
LAUNDRY FINISHING ROOM (2-129-1-Q) IN ITS ENTIRETY THEN RESTORE TO NORMAL  
OPERATION.

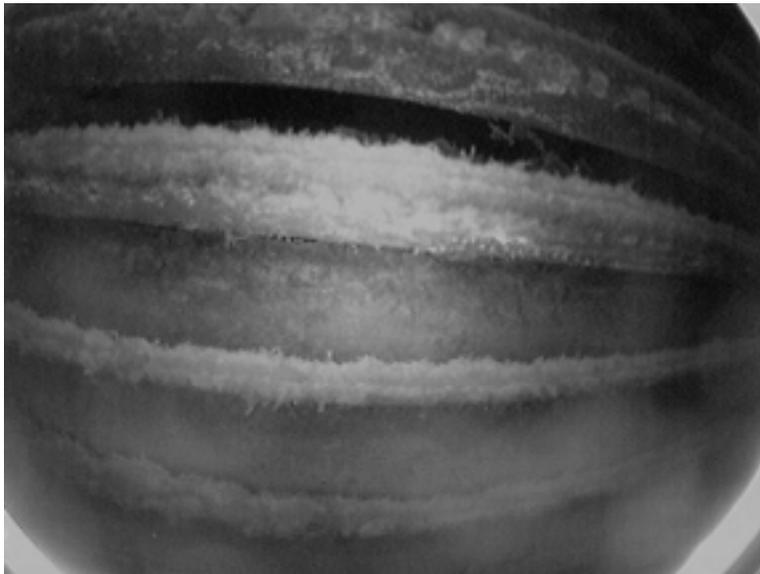
## LAUNDRY & DRY CLEANING ROOM (2-121-1-Q)

1 FT Inside Duct By The Back Of Dryers (Foreign material)

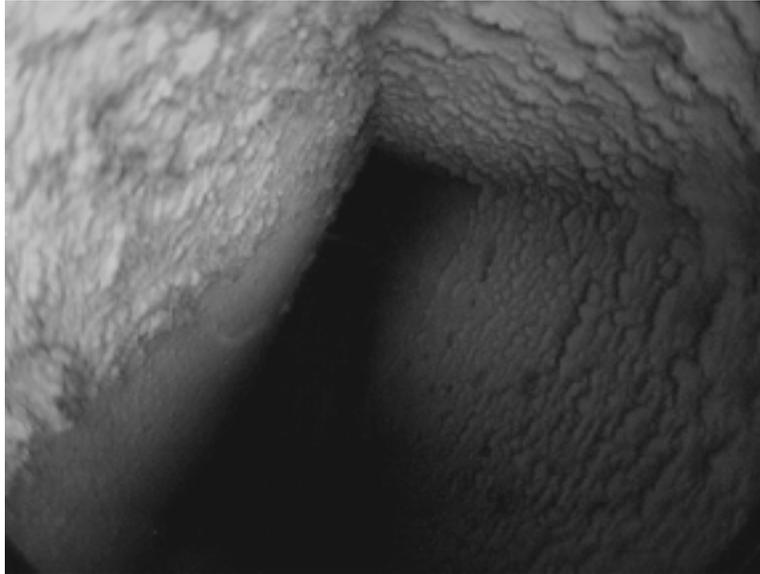
PASSAGEWAY (02-20-1-L)

As per Internal Video Inspection: RECIRC RETURN DUCT, SYSTEM R 01-14-2 IN COMPT.  
Passageway (02-20-1-L) IS DIRTY AND REQUIRES CLEANING.

10 FT Inside Duct (Foreign material)

REPAIR ACTIVITY OPEN AND CLEAN RECIRC RETURN DUCT, SYSTEM R 01-14-2 IN COMPT.  
Passageway (02-20-1-L) IN ITS ENTIRETY THEN RESTORE TO NORMAL OPERATION.

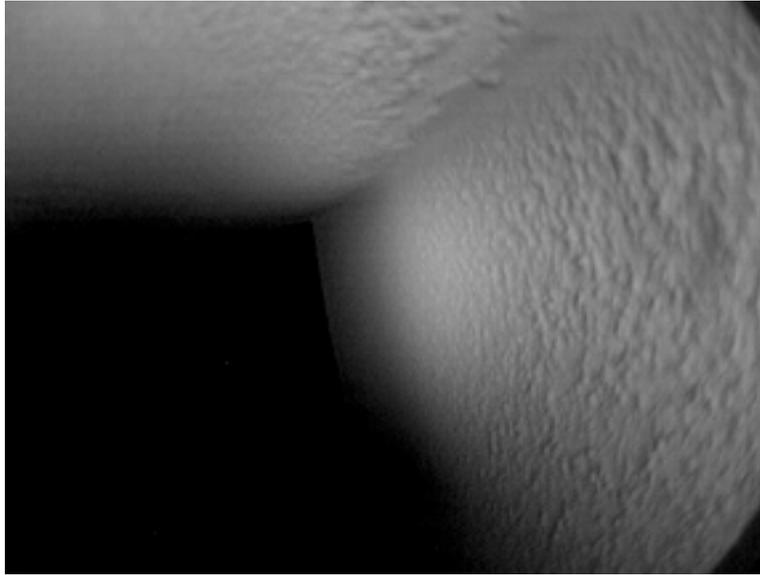
As per Internal Video Inspection: EXHAUST DUCT, SYSTEM E 01-20-2 IN COMPT.  
DECK WR & WC (01-27-6-L) IS DIRTY AND REQUIRES CLEANING.

15 FT Inside Duct (Foreign material)

REPAIR ACTIVITY OPEN AND CLEAN EXHAUST DUCT, SYSTEM E 01-20-2 IN COMPT.  
DECK WR & WC (01-27-6-L) IN ITS ENTIRETY THEN RESTORE TO NORMAL OPERATION.

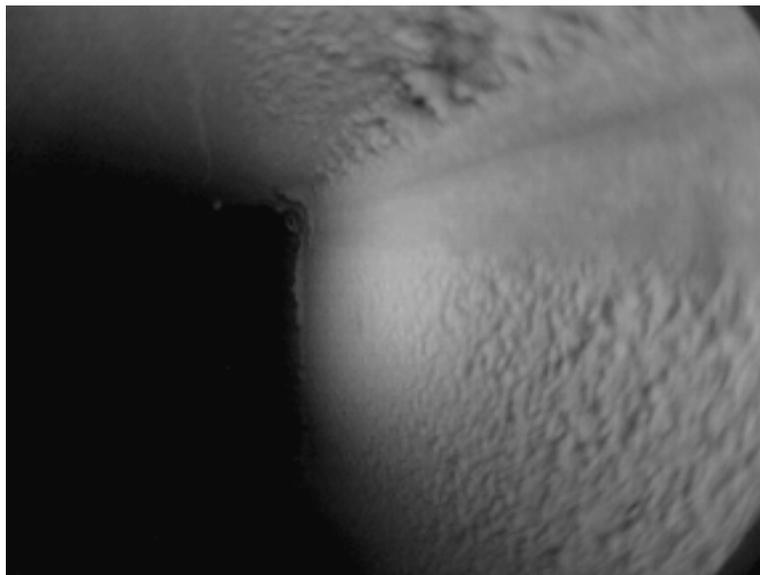
DECK WR & WC (01-27-6-L)

8 FT Inside Duct (Foreign material)

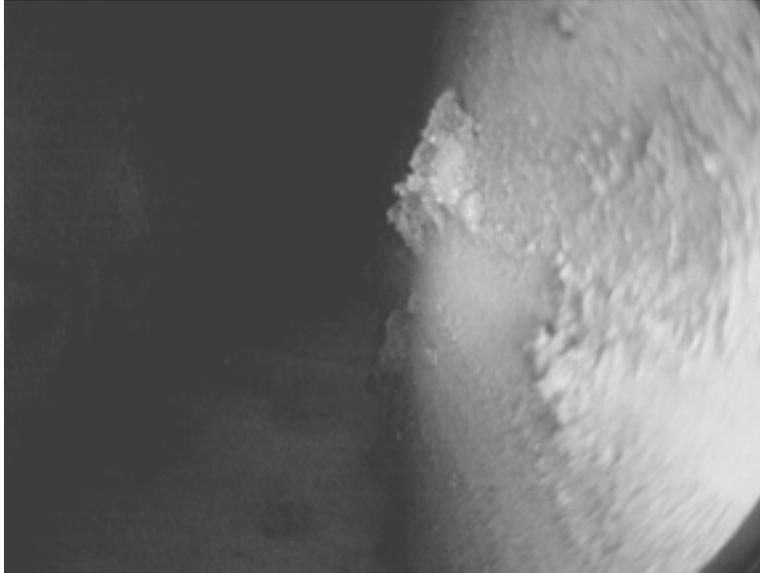
As per Internal Video Inspection: EXHAUST DUCT, SYSTEM E 01-33-1 IN COMPT.  
FILTER CLEANING SHOP (01-29-7-Q) IS DIRTY AND REQUIRES CLEANING.

10 FT Inside Duct (Foreign material)

REPAIR ACTIVITY OPEN AND CLEAN EXHAUST DUCT, SYSTEM E 01-33-1 IN COMPT.  
FILTER CLEANING SHOP (01-29-7-Q) IN ITS ENTIRETY THEN RESTORE TO NORMAL  
OPERATION.

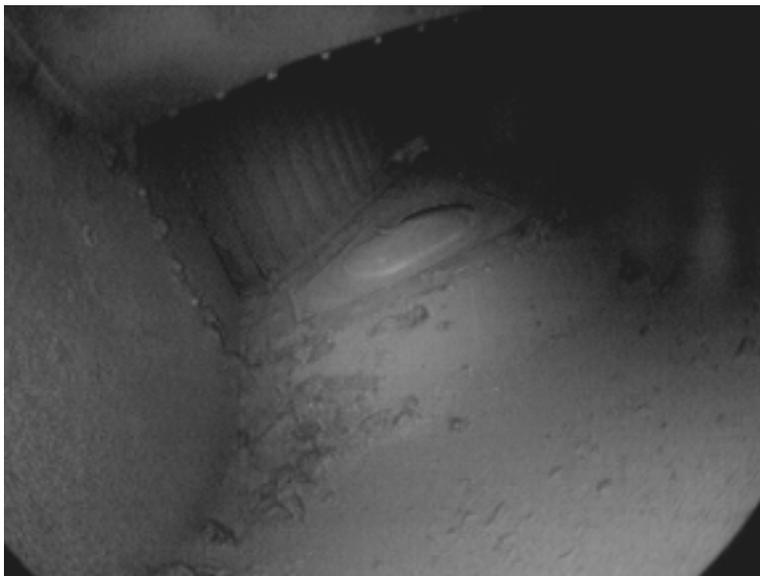
FILTER CLEANING SHOP (01-29-7-Q)

15 FT Inside Duct (Foreign material)

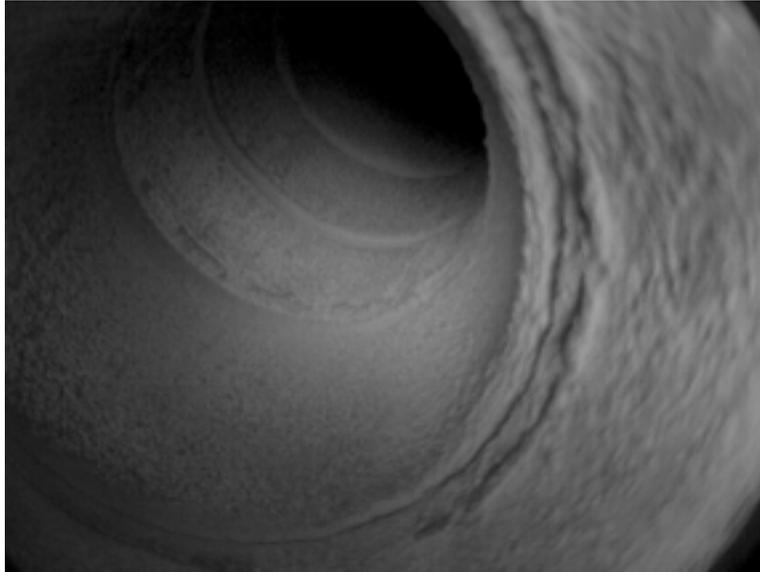
As per Internal Video Inspection: EXHAUST DUCT, SYSTEM E 01-34-1 IN COMPT.  
ELEVATOR MCHRY ROOM (01-27-1-Q) IS DIRTY AND REQUIRES CLEANING.

10 FT Inside Duct (Foreign material)

REPAIR ACTIVITY OPEN AND CLEAN EXHAUST DUCT, SYSTEM E 01-34-1 IN COMPT.  
ELEVATOR MCHRY ROOM (01-27-1-Q) IN ITS ENTIRETY THEN RESTORE TO NORMAL  
OPERATION.

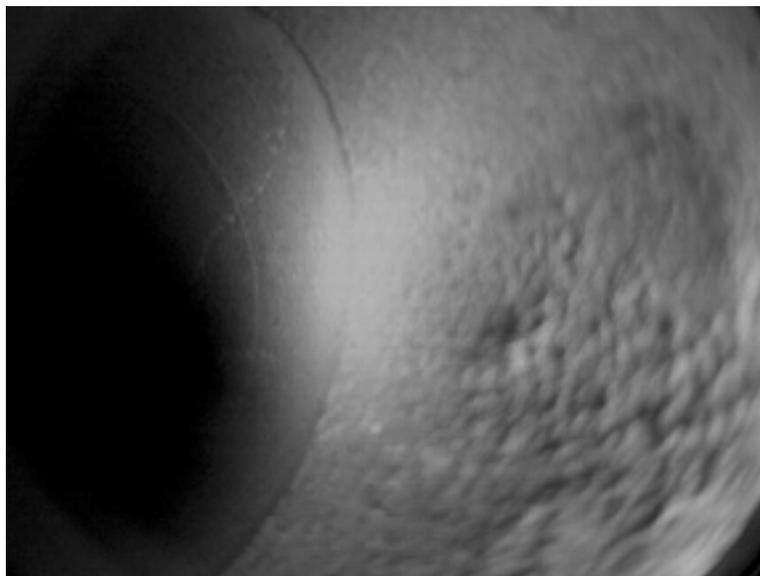
ELEVATOR MCHRY ROOM (01-27-1-Q)

5 FT Inside Duct (Foreign material)

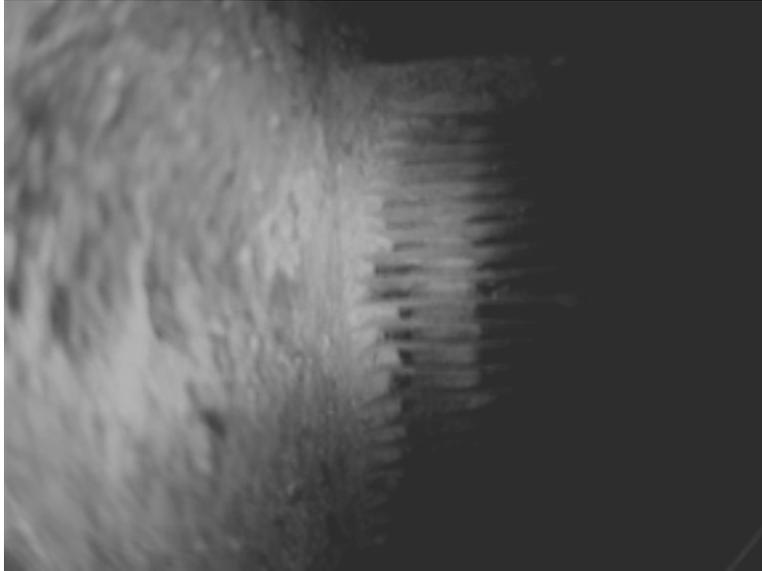
As per Internal Video Inspection: SUPPLY DUCT, SYSTEM S 01-52-2 IN COMPT.  
CARPENTER SHOP (01-52-2-Q) IS DIRTY AND REQUIRES CLEANING.

2 FT Inside Duct (Foreign material)

REPAIR ACTIVITY OPEN AND CLEAN SUPPLY DUCT, SYSTEM S 01-52-2 IN COMPT.  
CARPENTER SHOP (01-52-2-Q) IN ITS ENTIRETY THEN RESTORE TO NORMAL OPERATION.

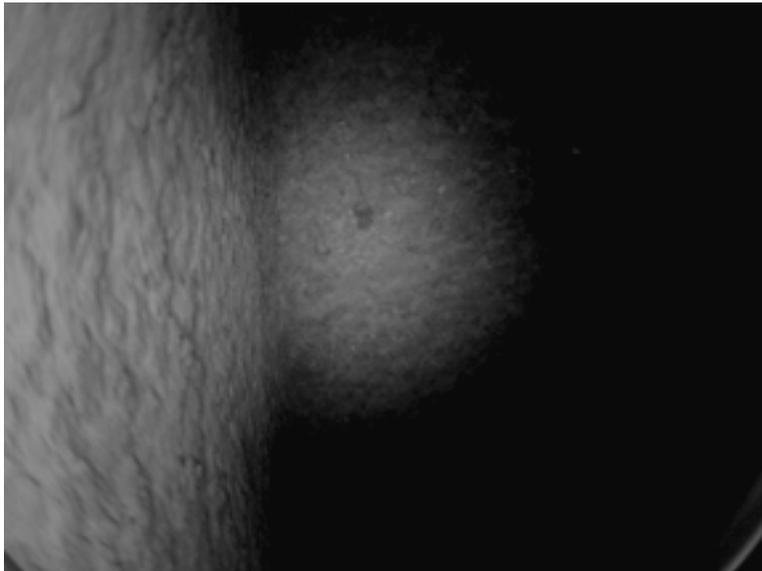
CARPENTER SHOP (01-52-2-Q)

10 FT Inside Duct (Foreign material)

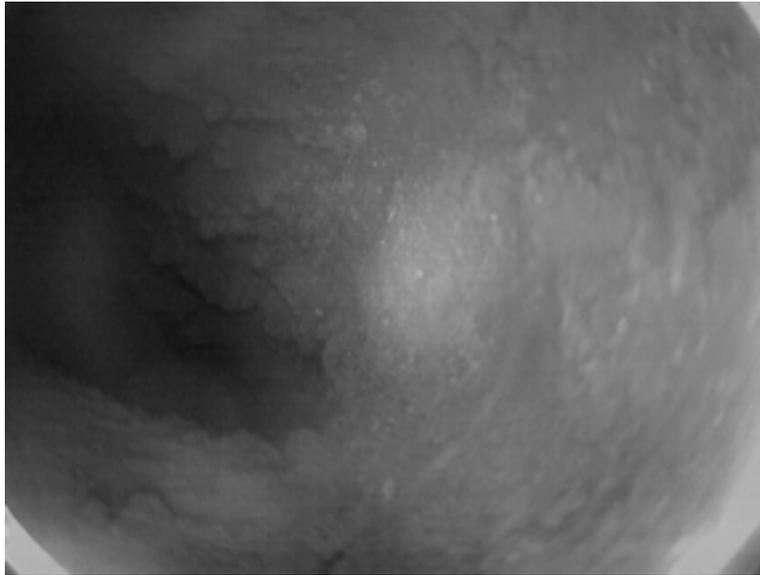
As per Internal Video Inspection: EXHAUST DUCT, SYSTEM E 01-59-1 IN COMPT.  
PASSAGE (01-43-3-L) IS DIRTY AND REQUIRES CLEANING.

2 FT Inside Duct At FR 53 (Foreign material)

REPAIR ACTIVITY OPEN AND CLEAN EXHAUST DUCT, SYSTEM E 01-59-1 IN COMPT.  
PASSAGE (01-43-3-L) IN ITS ENTIRETY THEN RESTORE TO NORMAL OPERATION.

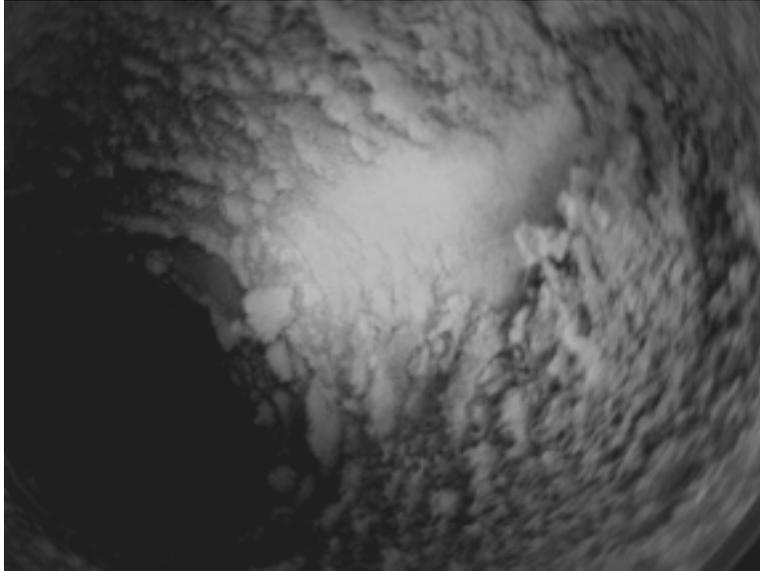
As per Internal Video Inspection: EXHAUST DUCT, SYSTEM E 02-14-1 IN COMPT. CO Bath (06-29-2-L) IS DIRTY AND REQUIRES CLEANING.

1 FT Inside Duct (Foreign material)

REPAIR ACTIVITY OPEN AND CLEAN EXHAUST DUCT, SYSTEM E 02-14-1 IN COMPT. CO Bath (06-29-2-L) IN ITS ENTIRETY THEN RESTORE TO NORMAL OPERATION.

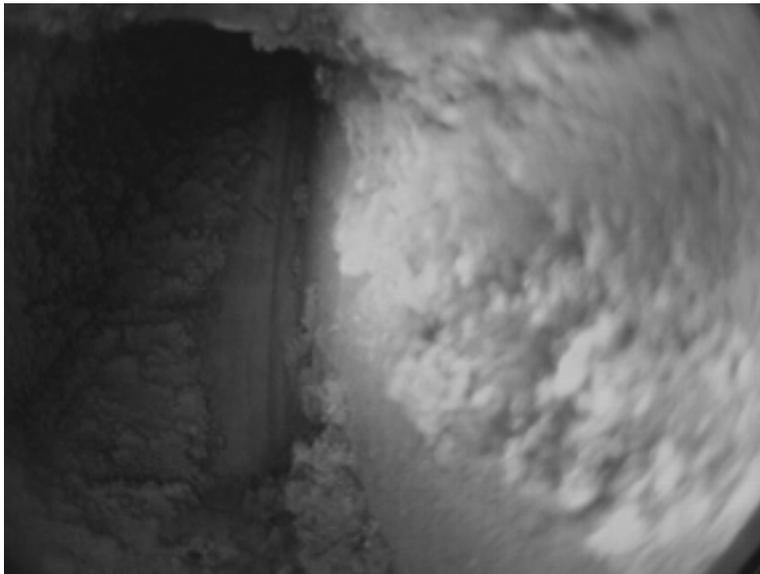
TROOP WR & WC (02-26-0-L)

2 FT Inside Duct (Foreign material)

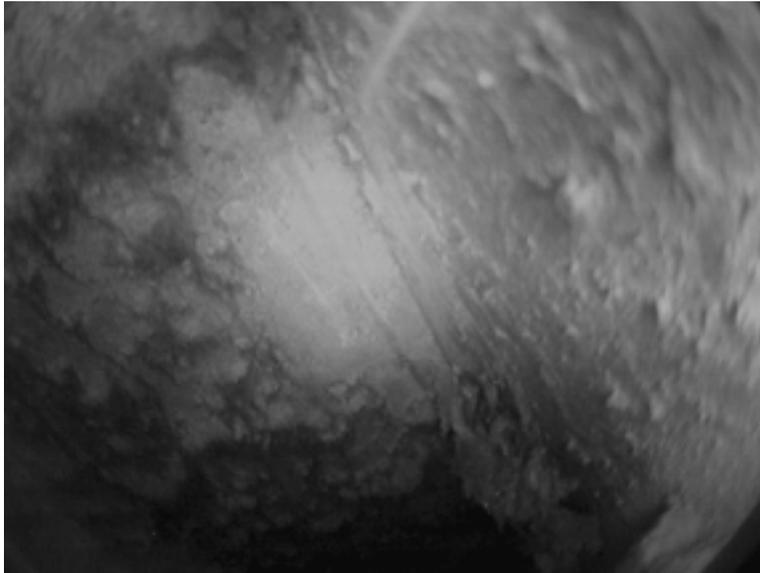
As per Internal Video Inspection: RECIRC RETURN DUCT, SYSTEM R 02-38-2 IN COMPT. MEDICAL OPERATING ROOM (02-43-2-L) IS DIRTY AND REQUIRES CLEANING.

5 FT Inside Duct (Foreign material)

REPAIR ACTIVITY OPEN AND CLEAN RECIRC RETURN DUCT, SYSTEM R 02-38-2 IN COMPT. MEDICAL OPERATING ROOM (02-43-2-L) IN ITS ENTIRETY THEN RESTORE TO NORMAL OPERATION.

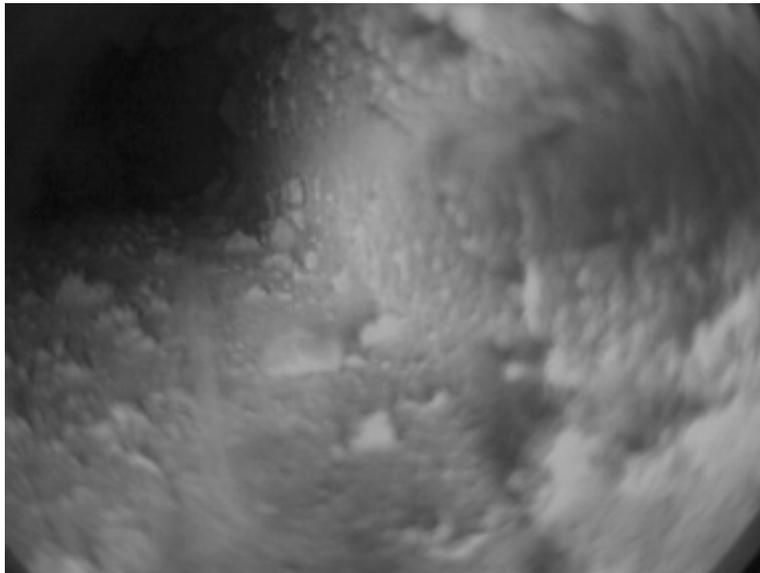
MEDICAL OPERATING ROOM (02-43-2-L)

3 FT Inside Duct (Foreign material)

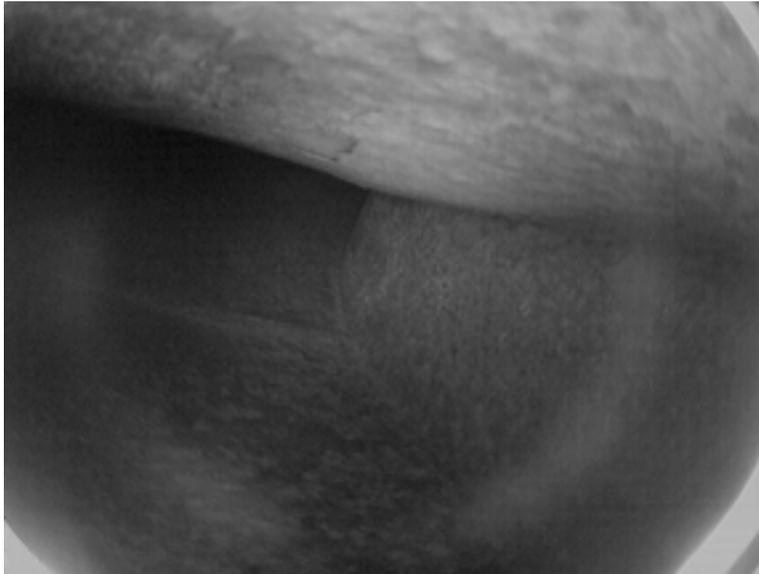
As per Internal Video Inspection: SUPPLY DUCT, SYSTEM S 02-47-2 IN COMPT.  
AUX MCHRY ROOM NO. 1 (5-43-0-E) IS DIRTY AND REQUIRES CLEANING.

15 FT Inside Duct At FR 45 (Foreign material)

REPAIR ACTIVITY OPEN AND CLEAN SUPPLY DUCT, SYSTEM S 02-47-2 IN COMPT.  
AUX MCHRY ROOM NO. 1 (5-43-0-E) IN ITS ENTIRETY THEN RESTORE TO NORMAL  
OPERATION.

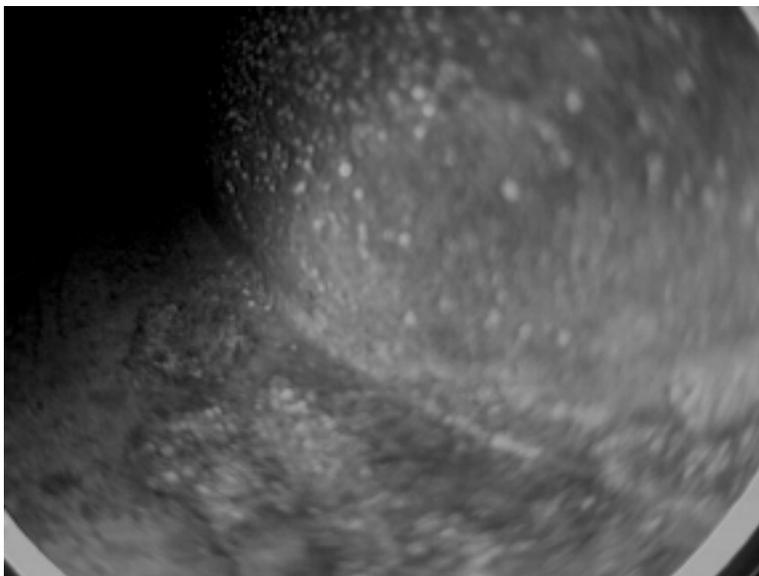
AUX MCHRY ROOM NO. 1 (5-43-0-E))

12 FT Inside Duct At FR 46 (Foreign material)

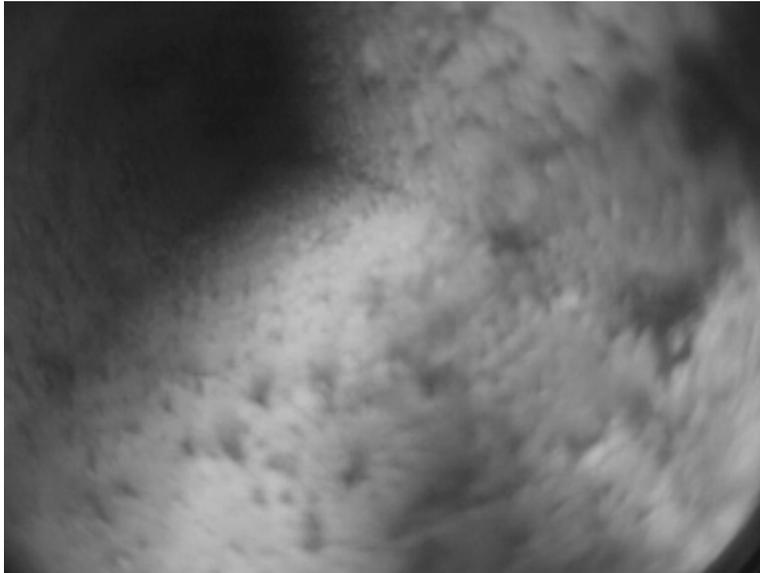
### SURGICAL DRESSING ROOM & MAIN BDS (02-48-2-L)

As per Internal Video Inspection: RECIRC RETURN DUCT, SYSTEM R 02-61-2 IN COMPT.  
SURGICAL DRESSING ROOM & MAIN BDS (02-48-2-L) IS DIRTY AND REQUIRES CLEANING.

3 FT Inside Duct (Foreign material)

REPAIR ACTIVITY OPEN AND CLEAN RECIRC RETURN DUCT, SYSTEM R 02-61-2 IN COMPT.  
SURGICAL DRESSING ROOM & MAIN BDS (02-48-2-L) IN ITS ENTIRETY THEN RESTORE TO  
NORMAL OPERATION.

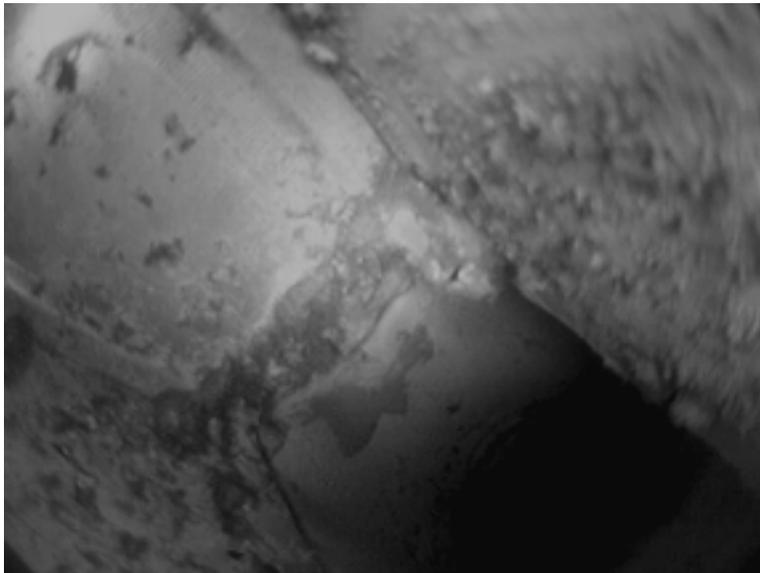
### SURGICAL DRESSING ROOM & MAIN BDS (02-48-2-L)

5 FT Inside Duct (Foreign material)

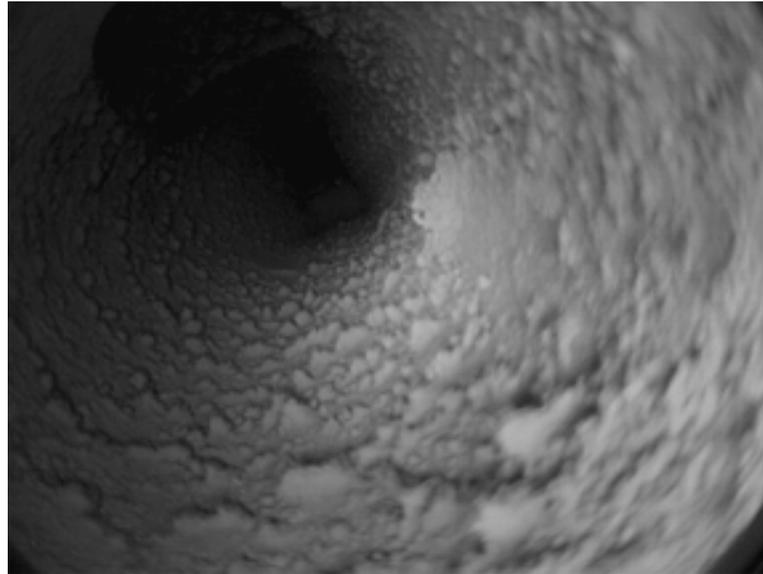
As per Internal Video Inspection: EXHAUST DUCT, SYSTEM E 02-61-4 IN COMPT. WARD BATH (02-56-2-L) IS DIRTY AND REQUIRES CLEANING.

3 FT Inside Duct (Foreign material)

REPAIR ACTIVITY OPEN AND CLEAN EXHAUST DUCT, SYSTEM E 02-61-4 IN COMPT. WARD BATH (02-56-2-L) IN ITS ENTIRETY THEN RESTORE TO NORMAL OPERATION.

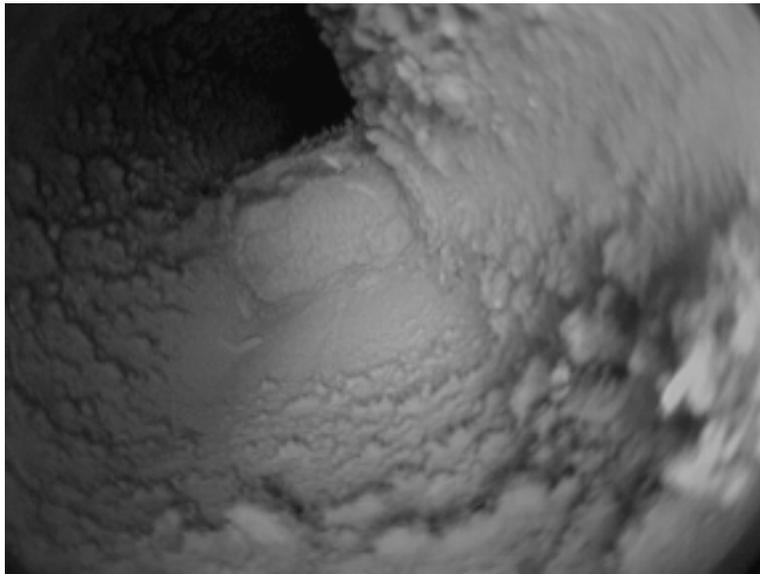
WARD BATH (02-56-2-L)

6 FT Inside Duct (Foreign material)

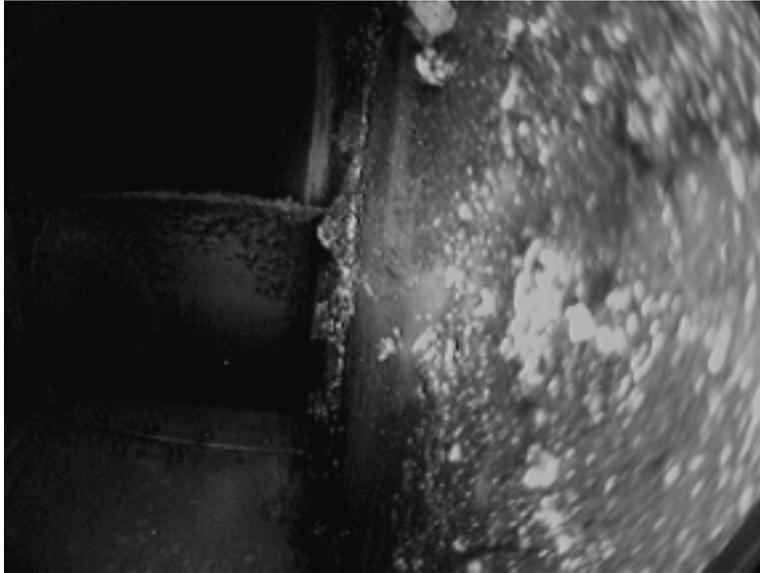
As per Internal Video Inspection: EXHAUST DUCT, SYSTEM E 03-61-3 IN COMPT. GALLEY (03-37-0-Q) IS DIRTY AND REQUIRES CLEANING.

4 FT Inside Duct Looking Toward Deep Fat Fryers (Foreign material)

REPAIR ACTIVITY OPEN AND CLEAN EXHAUST DUCT, SYSTEM E 03-61-3 IN COMPT. GALLEY (03-37-0-Q) IN ITS ENTIRETY THEN RESTORE TO NORMAL OPERATION.

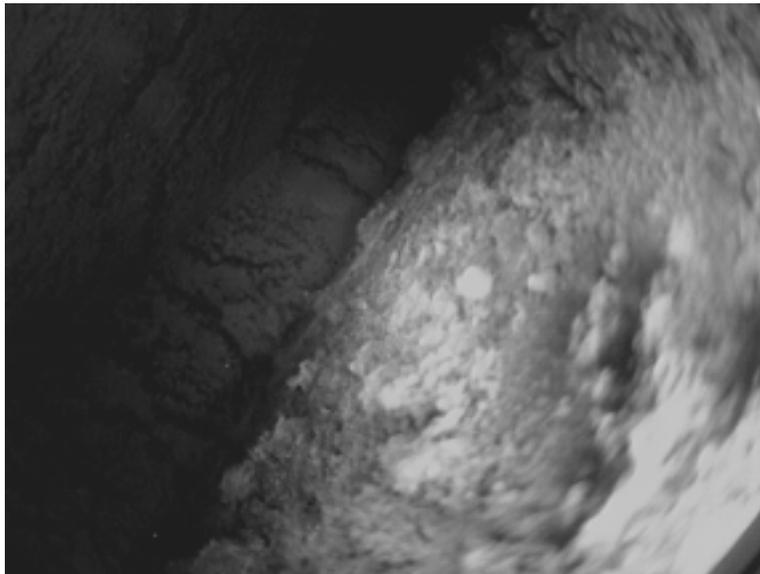
GALLEY (03-37-0-Q)

1 FT Inside Duct Looking Up Vent Hood Over STEAM IT (Foreign material)

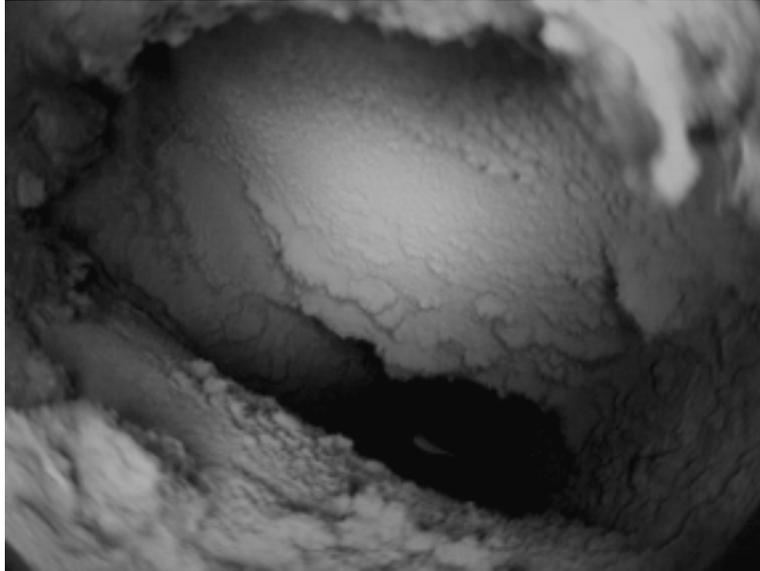
As per Internal Video Inspection: RECIRC RETURN DUCT, SYSTEM R 04-23-1 IN COMPT. PASSAGEWAY (04-21-1-L) IS DIRTY AND REQUIRES CLEANING.

2 FT Inside Duct (Foreign material)

REPAIR ACTIVITY OPEN AND CLEAN RECIRC RETURN DUCT, SYSTEM R 04-23-1 IN COMPT. PASSAGEWAY (04-21-1-L) IN ITS ENTIRETY THEN RESTORE TO NORMAL OPERATION.

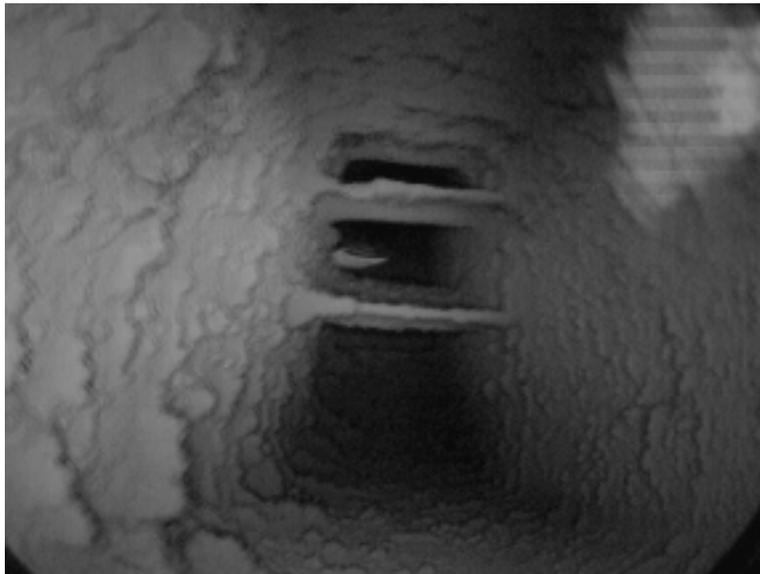
PASSAGEWAY (04-21-1-L)

4 FT Inside Duct (Foreign material)

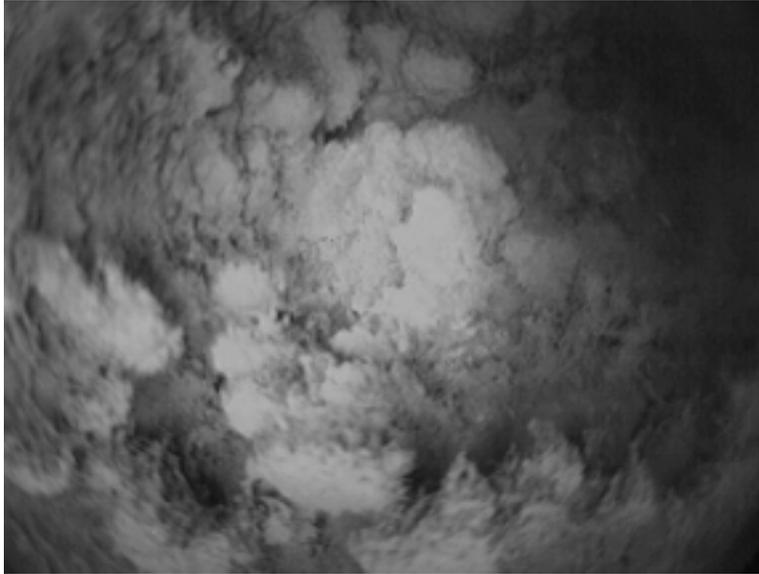
As per Internal Video Inspection: EXHAUST DUCT, SYSTEM E 04-29-2 IN COMPT. WARDROOM, CPO, SR TROOP NCO SCULLERY (03-34-2-Q) IS DIRTY AND REQUIRES CLEANING.

1 FT Inside Duct Looking Up Vent Hood Over Dishwasher (Foreign material)

REPAIR ACTIVITY OPEN AND CLEAN EXHAUST DUCT, SYSTEM E 04-29-2 IN COMPT. WARDROOM, CPO, SR TROOP NCO SCULLERY (03-34-2-Q) IN ITS ENTIRETY THEN RESTORE TO NORMAL OPERATION.

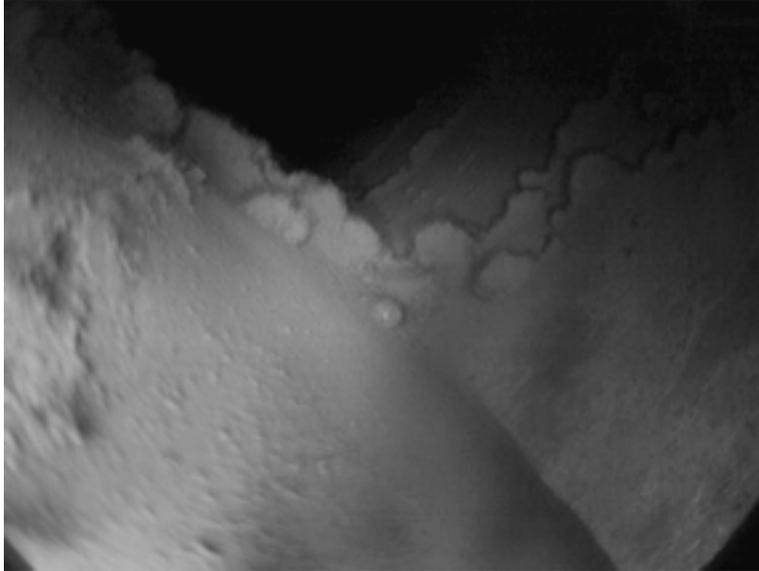
As per Internal Video Inspection: RECIRC RETURN DUCT, SYSTEM R 04-43-1 IN COMPT. COMMUNICATION CENTER (04-30-0-C) IS DIRTY AND REQUIRES CLEANING.

10 FT Inside Duct (Foreign material)

REPAIR ACTIVITY OPEN AND CLEAN RECIRC RETURN DUCT, SYSTEM R 04-43-1 IN COMPT. COMMUNICATION CENTER (04-30-0-C) IN ITS ENTIRETY THEN RESTORE TO NORMAL OPERATION.

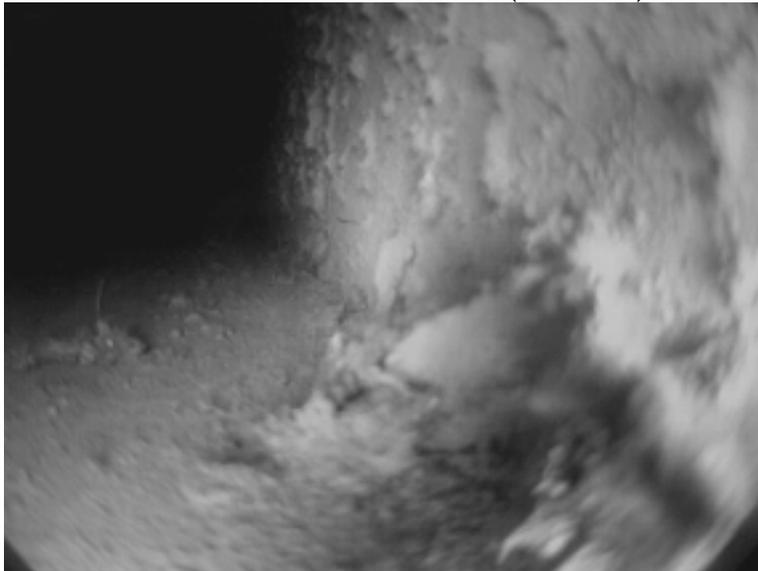
COMMUNICATION CENTER (04-30-0-C)

4 FT Inside Duct (Foreign material)

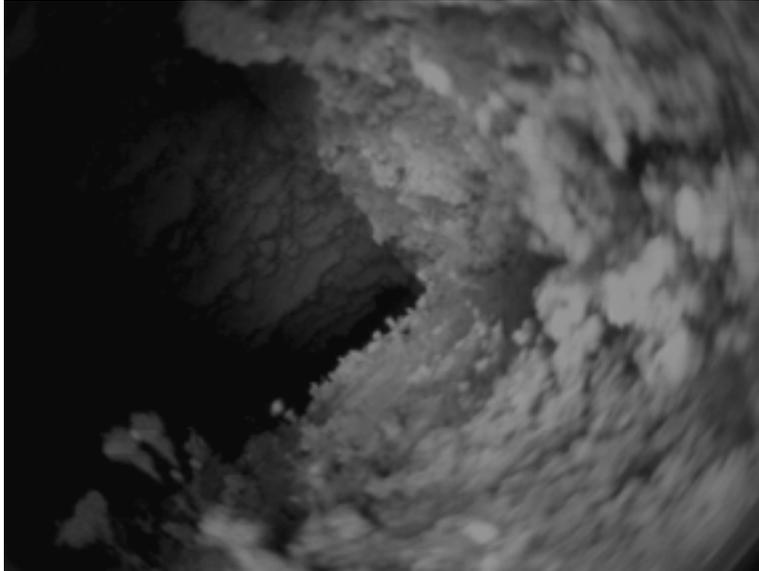
As per Internal Video Inspection: RECIRC RETURN DUCT, SYSTEM R 04-54-1 IN COMPT.  
PASSAGEWAY (04-52-2-L) IS DIRTY AND REQUIRES CLEANING.

3 FT Inside Duct (Foreign material)

REPAIR ACTIVITY OPEN AND CLEAN RECIRC RETURN DUCT SYSTEM R 04-54-1 IN COMPT.  
Passageway (04-52-2-L) IN ITS ENTIRETY THEN RESTORE TO NORMAL OPERATION.

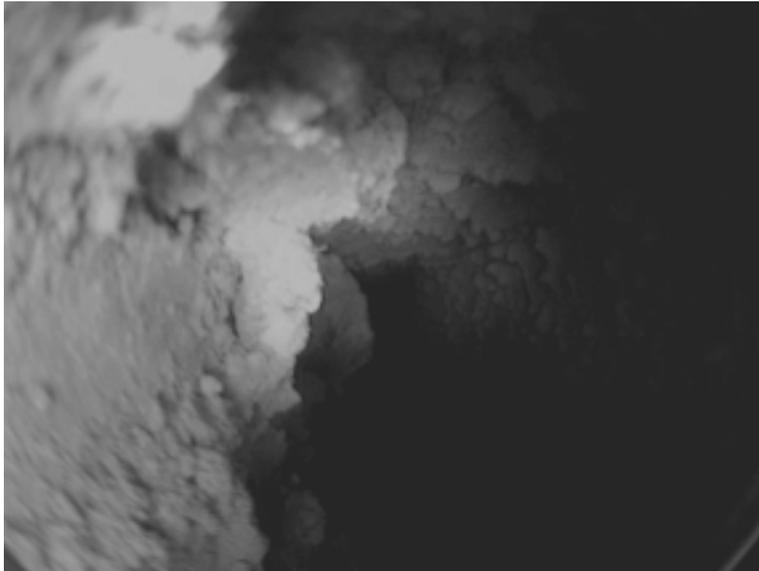
PASSAGEWAY (04-52-2-L)

10 FT Inside Duct (Foreign material)

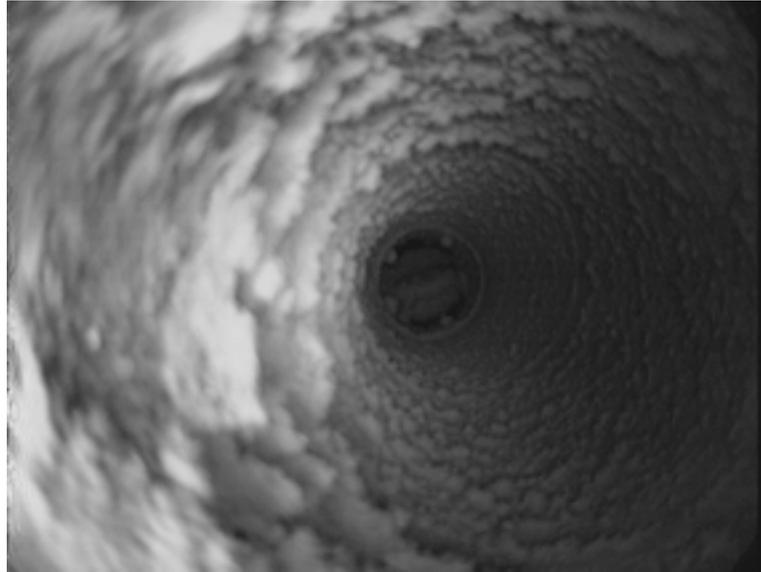
As per Internal Video Inspection: EXHAUST DUCT, SYSTEM E 04-54-2 IN COMPT. CREW WR & WC (03-52-6-L) IS DIRTY AND REQUIRES CLEANING.

3 FT Inside Duct (Foreign material)

REPAIR ACTIVITY OPEN AND CLEAN EXHAUST DUCT, SYSTEM E 04-54-2 IN COMPT. CREW WR & WC (04-52-4-L) IN ITS ENTIRETY THEN RESTORE TO NORMAL OPERATION.

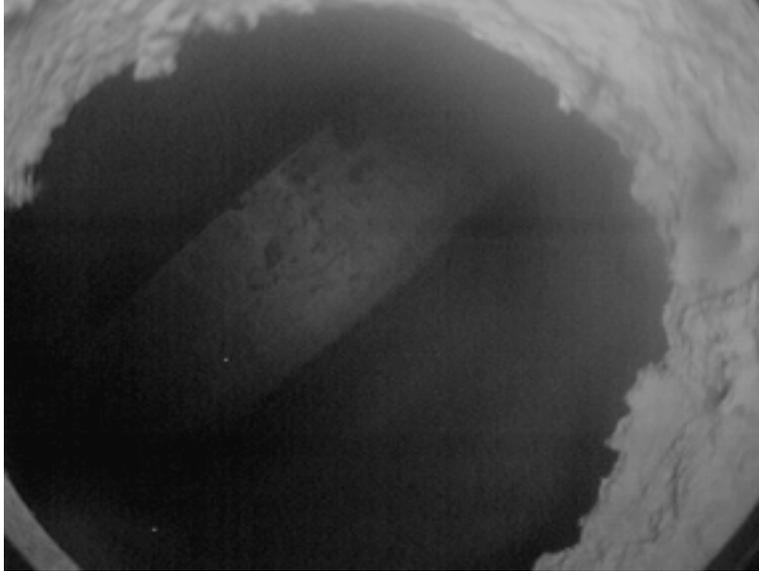
PASSAGEWAY (03-52-6-L)

As per Internal Video Inspection: RECIRC EXHAUST DUCT, SYSTEM E 04-54-4 IN COMPT. PASSAGE (03-52-6-L) IS DIRTY AND REQUIRES CLEANING.

2 FT Inside Duct (Foreign material)

REPAIR ACTIVITY OPEN AND CLEAN EXHAUST DUCT, SYSTEM E 04-54-4 IN COMPT. PASSAGE (03-52-6-L) IN ITS ENTIRETY THEN RESTORE TO NORMAL OPERATION.

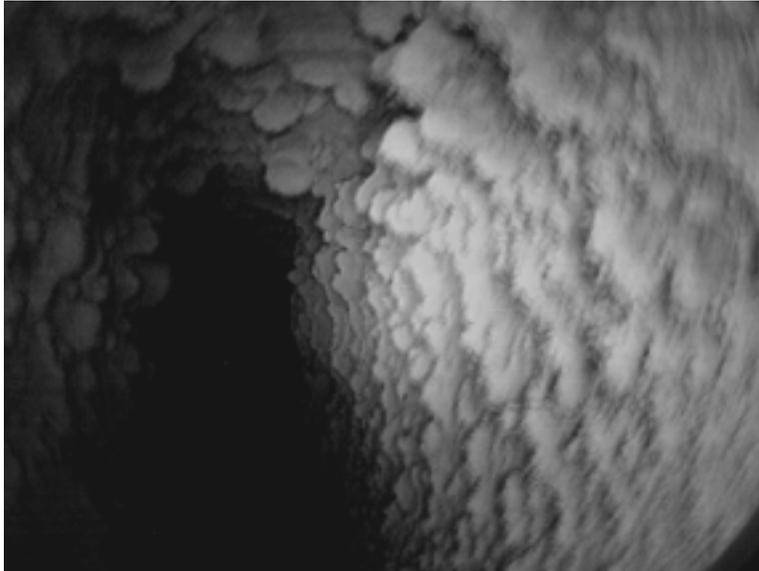
SCULLERY (03-43-2-Q)

8 FT Inside Duct (Foreign material)

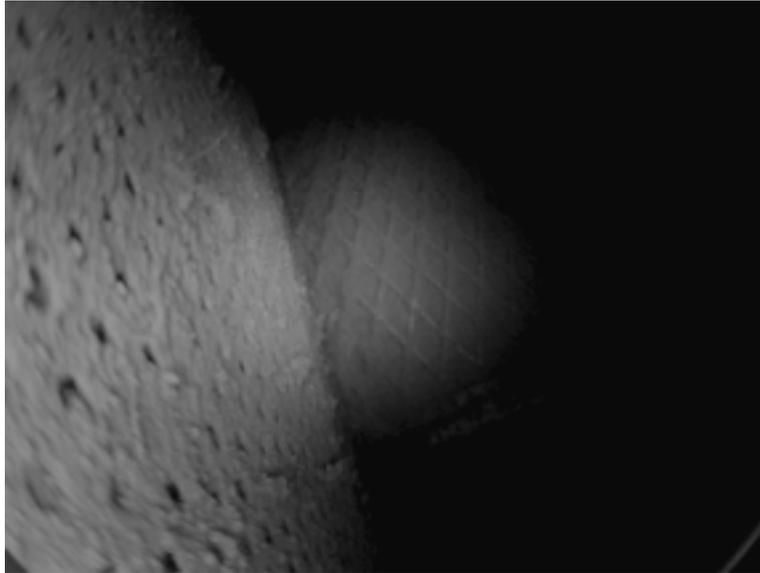
PASSAGEWAY (05-48-0-L)

As per Internal Video Inspection: RECIRC RETURN DUCT, SYSTEM R 05-51-2 IN COMPT. PASSAGE (05-48-0-L) IS DIRTY AND REQUIRES CLEANING.

1 FT Inside Duct Looking Towards Fan Room (Foreign material)

REPAIR ACTIVITY OPEN AND CLEAN RECIRC RETURN DUCT, SYSTEM R 05-51-2 IN COMPT. PASSAGE (05-48-0-L) IN ITS ENTIRETY THEN RESTORE TO NORMAL OPERATION.

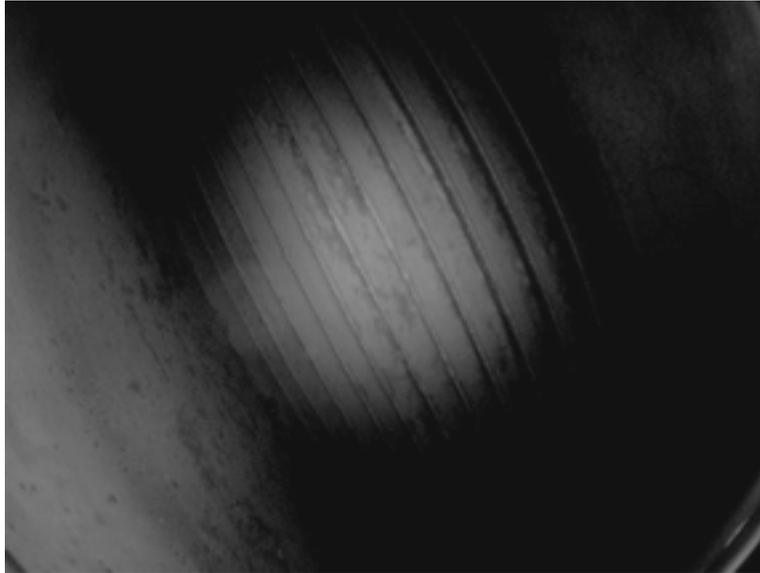
PASSAGEWAY (05-48-0-L)

As per Internal Video Inspection: RECIRC RETURN DUCT, SYSTEM R 05-51-4 IN COMPT.  
Passageway (05-48-0-L) IS DIRTY AND REQUIRES CLEANING.

Inside Duct Looking Toward Fan Room (Foreign material)

REPAIR ACTIVITY OPEN AND CLEAN RECIRC RETURN DUCT, SYSTEM R 05-51-4 IN COMPT.  
Passageway (05-48-0-L) IN ITS ENTIRETY THEN RESTORE TO NORMAL OPERATION.

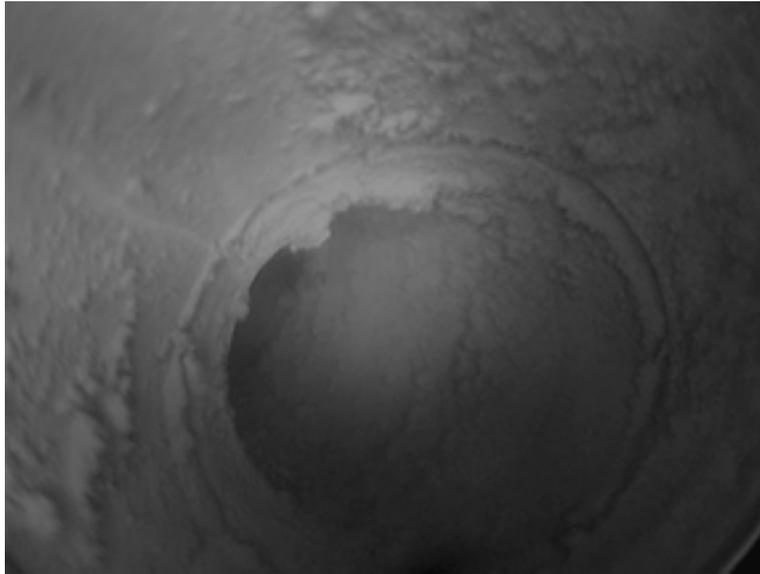
As per Internal Video Inspection: EXHAUST DUCT, SYSTEM E 06-38-2 IN COMPT. OFFICER SHOWER & DRYING (06-31-5-L) IS DIRTY AND REQUIRES CLEANING.

5 FT Inside Duct (Foreign material)

REPAIR ACTIVITY OPEN AND CLEAN EXHAUST DUCT, SYSTEM E 06-38-2 IN COMPT. OFFICER SHOWER & DRYING (06-31-5-L) IN ITS ENTIRETY THEN RESTORE TO NORMAL OPERATION.

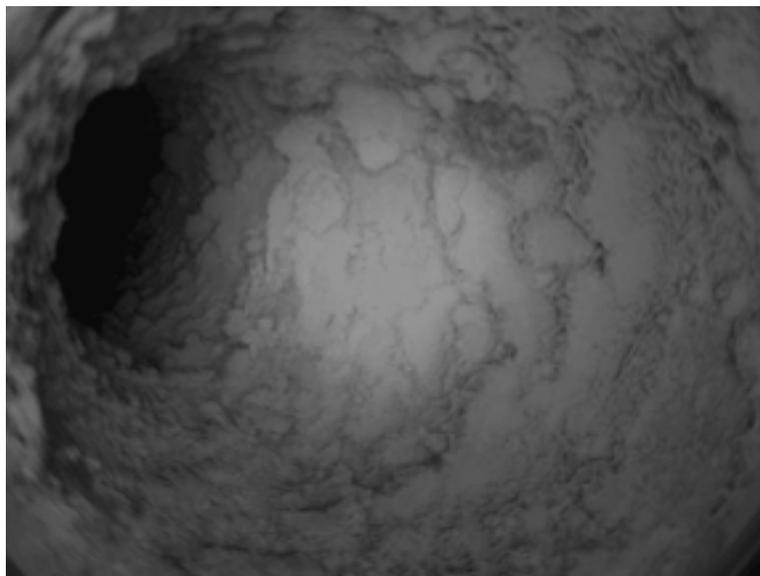
CPO & SR Troop NCO WR & WC (05-35-5-L)

2 FT Inside Duct (Foreign material)

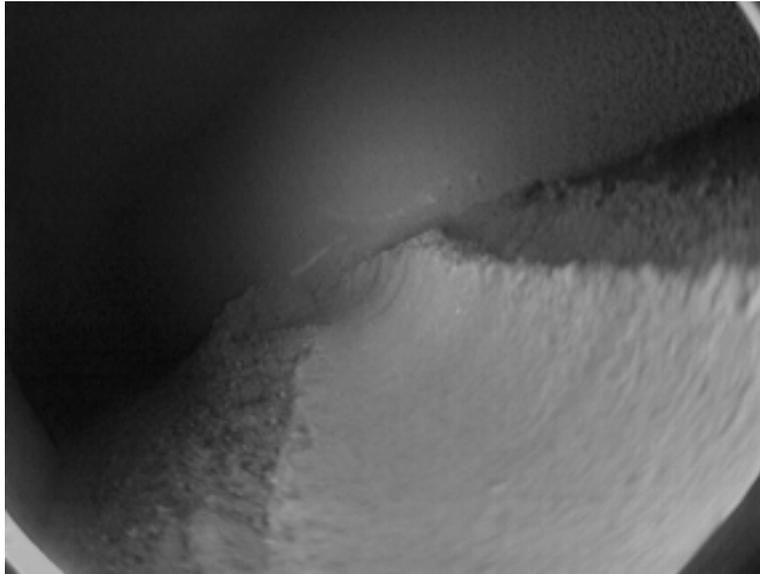
As per Internal Video Inspection: SUPPLY DUCT, SYSTEM S 1-118-1 IN COMPT.  
LAUNDRY RCVG & ISSUE (2-115-1-Q) IS DIRTY AND REQUIRES CLEANING.

1 FT Inside Duct Looking Aft (Foreign material)

REPAIR ACTIVITY OPEN AND CLEAN SUPPLY DUCT, SYSTEM S 1-118-1 IN COMPT.  
LAUNDRY RCVG & ISSUE (2-115-1-Q) IN ITS ENTIRETY THEN RESTORE TO NORMAL  
OPERATION.

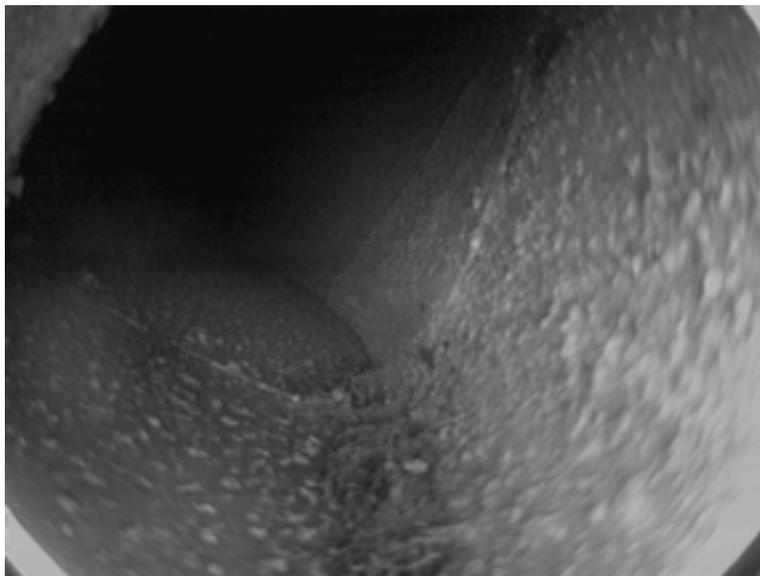
LAUNDRY & DRY CLEANING ROOM (2-121-1-Q)

2 FT Inside Duct (Foreign material)

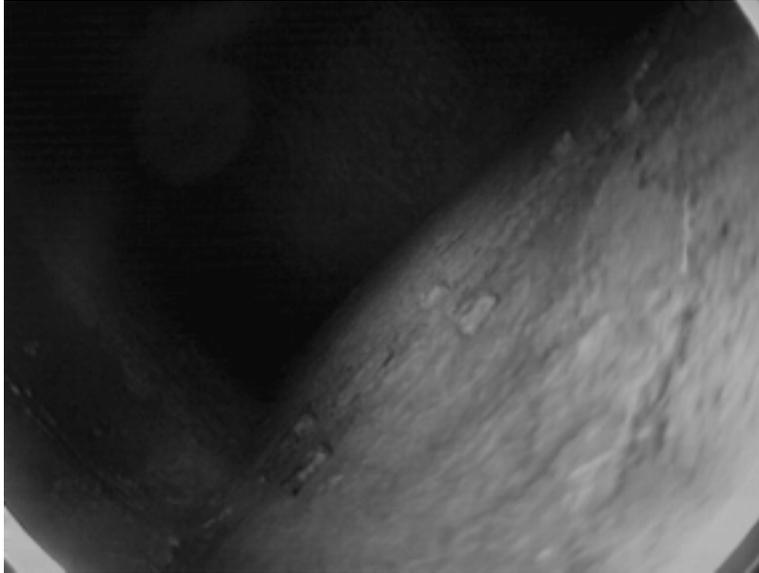
As per Internal Video Inspection: SUPPLY DUCT, SYSTEM S 1-52-1 IN COMPT.  
MAIN MCHRY ROOM NO. 1 (5-52-0-E) IS DIRTY AND REQUIRES CLEANING.

4 FT Inside Duct At FR 54 (Foreign material)

REPAIR ACTIVITY OPEN AND CLEAN SUPPLY DUCT, SYSTEM S 1-52-1 IN COMPT.  
MAIN MCHRY ROOM NO. 1 (5-52-0-E) IN ITS ENTIRETY THEN RESTORE TO NORMAL  
OPERATION.

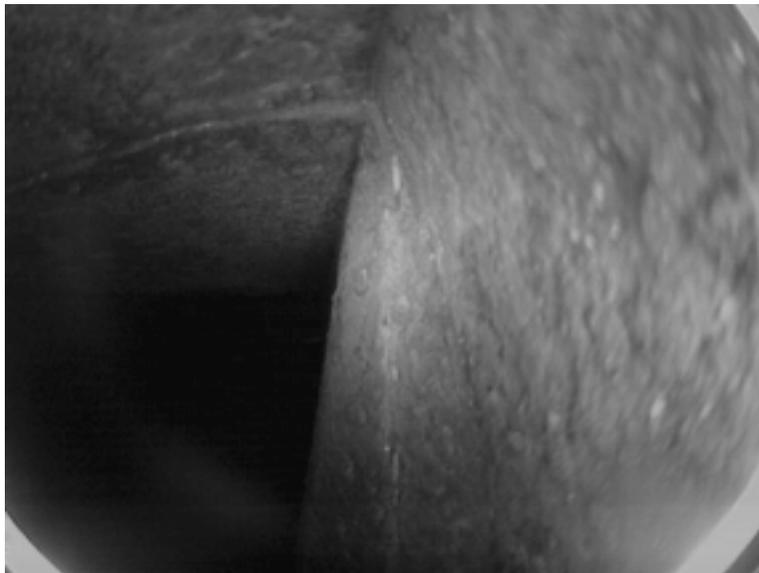
MAIN MCHRY ROOM NO. 1 (5-52-0-E)

8 FT Inside Duct At FR 54 (Foreign material)

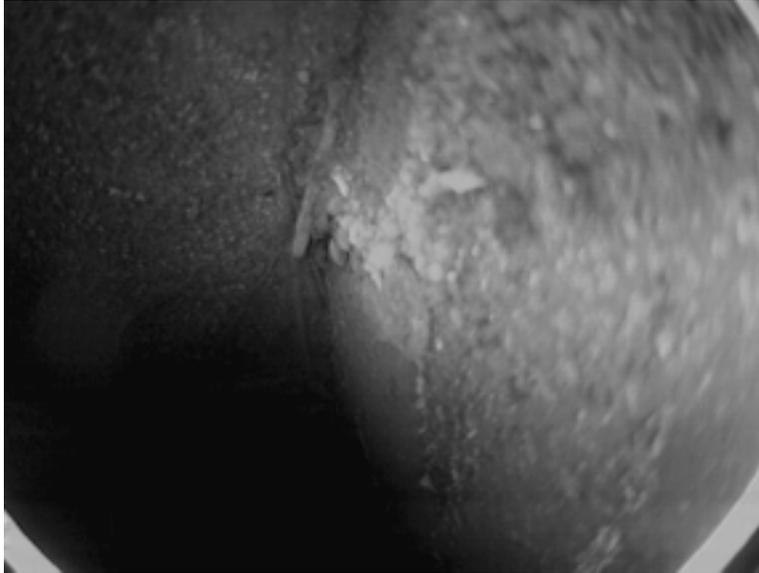
As per Internal Video Inspection: SUPPLY DUCT, SYSTEM S 1-60-2 IN COMPT.  
MAIN MCHRY ROOM NO. 1 (5-52-0-E) IS DIRTY AND REQUIRES CLEANING.

3 FT Inside Duct At FR 63 (Foreign material)

REPAIR ACTIVITY OPEN AND CLEAN SUPPLY DUCT, SYSTEM S 1-60-2 IN COMPT.  
MAIN MCHRY ROOM NO. 1 (5-52-0-E) IN ITS ENTIRETY THEN RESTORE TO NORMAL  
OPERATION.

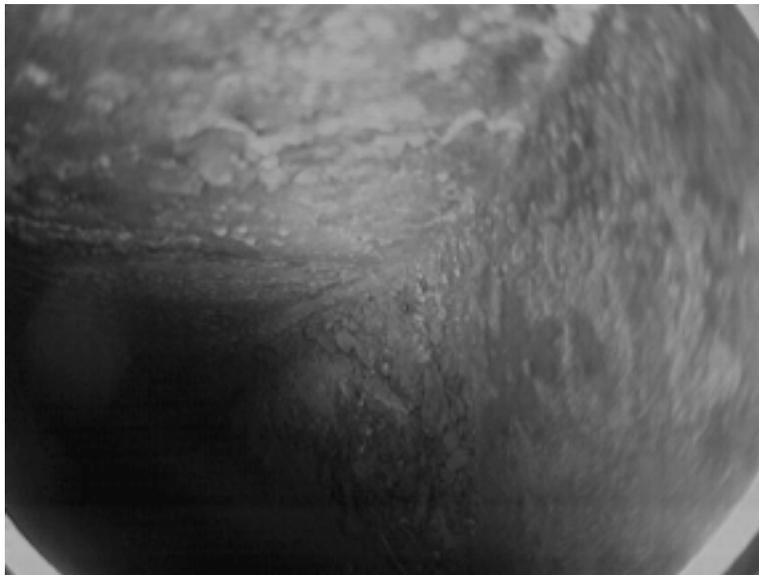
MAIN MCHRY ROOM NO. 1 (5-52-0-E)

6 FT Inside Duct At FR 63 (Foreign material)

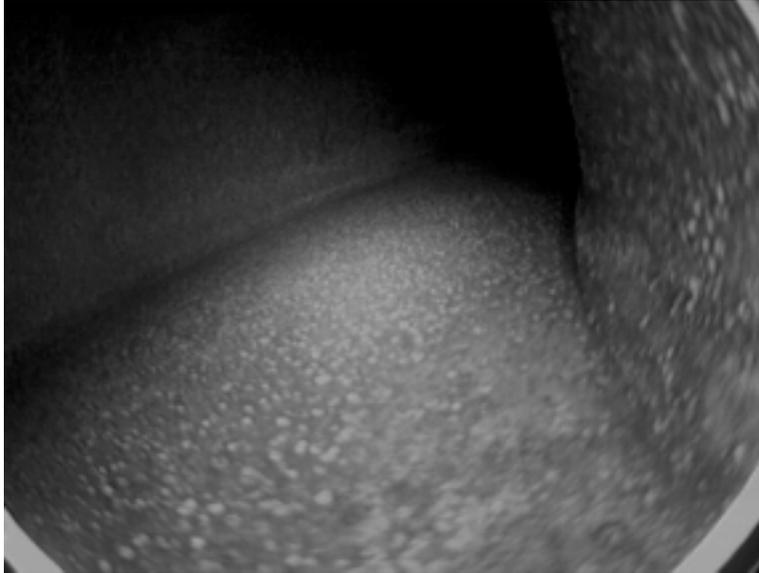
As per Internal Video Inspection: SUPPLY DUCT, SYSTEM S 1-80-2 IN COMPT.  
MAIN MCHRY ROOM NO. 2 (5-74-0-E) IS DIRTY AND REQUIRES CLEANING.

3 FT Inside Duct At FR 74 (Foreign material)

REPAIR ACTIVITY OPEN AND CLEAN SUPPLY DUCT, SYSTEM S 1-80-2 IN COMPT.  
MAIN MCHRY ROOM NO. 2 (5-74-0-E) IN ITS ENTIRETY THEN RESTORE TO NORMAL  
OPERATION.

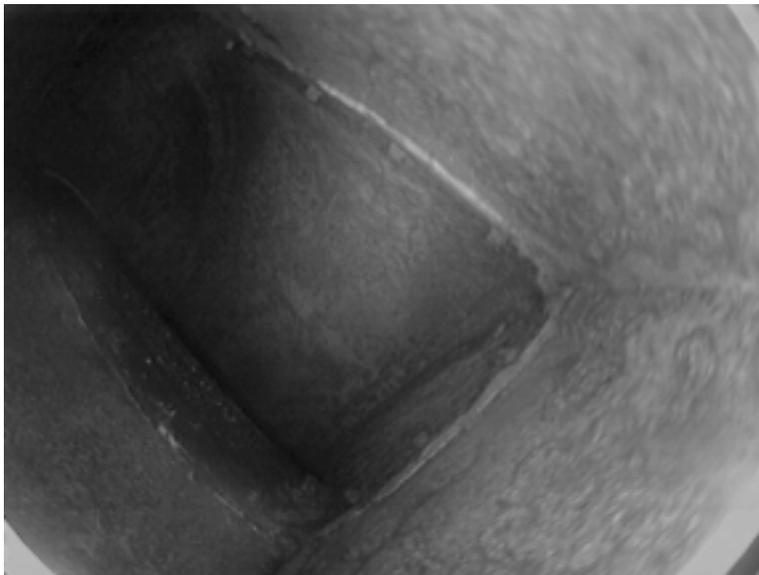
MAIN MCHRY ROOM NO. 2 (5-74-0-E)

12 FT Inside Duct At FR 74 (Foreign material)
