# SEMIAT I

## USS WHIDBEY ISLAND (LSD 41)

### INTERNAL VIDEO VENTILATION ASSESSMENT

**PORTSMOUTH, VIRGINIA**  
SUPSHIP: C. BUCK & QED: B. CAREW, R. DAVENPORT, B. PARSONS  
**17 THRU 28 JULY 2000**

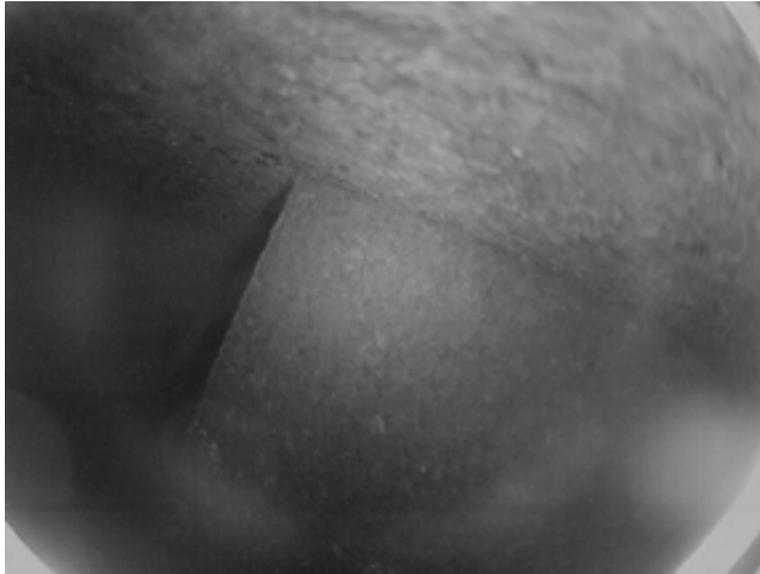
As per Internal Video Inspection: SUPPLY DUCT, SYSTEM S 1-85-1 IN COMPT.  
MAIN MCHRY ROOM NO. 2 (5-74-0-E) IS DIRTY AND REQUIRES CLEANING.

6 FT Inside Duct At FR 87 (Foreign material)

REPAIR ACTIVITY OPEN AND CLEAN SUPPLY DUCT, SYSTEM S 1-85-1 IN COMPT.  
MAIN MCHRY ROOM NO. 2 (5-74-0-E) IN ITS ENTIRETY THEN RESTORE TO NORMAL  
OPERATION.

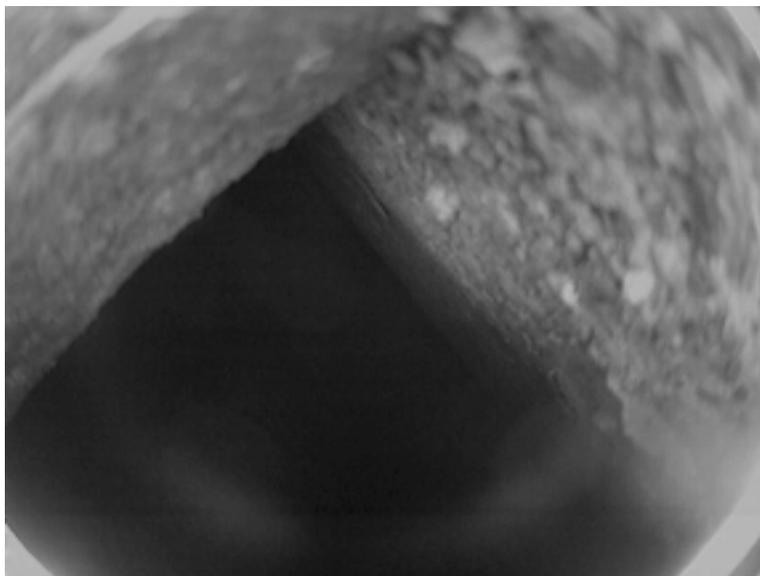
MAIN MCHRY ROOM NO. 2 (5-74-0-E)

3 FT Inside Duct At FR 87 (Foreign material)

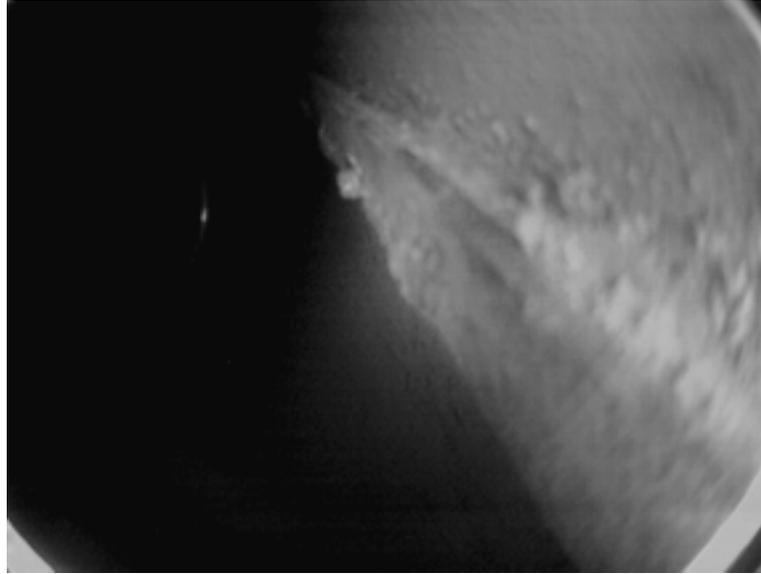
As per Internal Video Inspection: EXHAUST DUCT, SYSTEM E 2-109-1 IN COMPT. INCLUDING DUCTING FROM DRYERS IN COMPT. LAUNDRY (SELF-SERVICE) (2-111-1-Q) IS DIRTY AND REQUIRES CLEANING.

8 FT Inside Duct Looking Toward Fan Room (Foreign material)

REPAIR ACTIVITY OPEN AND CLEAN EXHAUST DUCT, SYSTEM E 2-109-1 IN COMPT. INCLUDING DUCTING FROM DRYERS IN COMPT. LAUNDRY (SELF-SERVICE) (2-111-1-Q) IN ITS ENTIRETY THEN RESTORE TO NORMAL OPERATION.

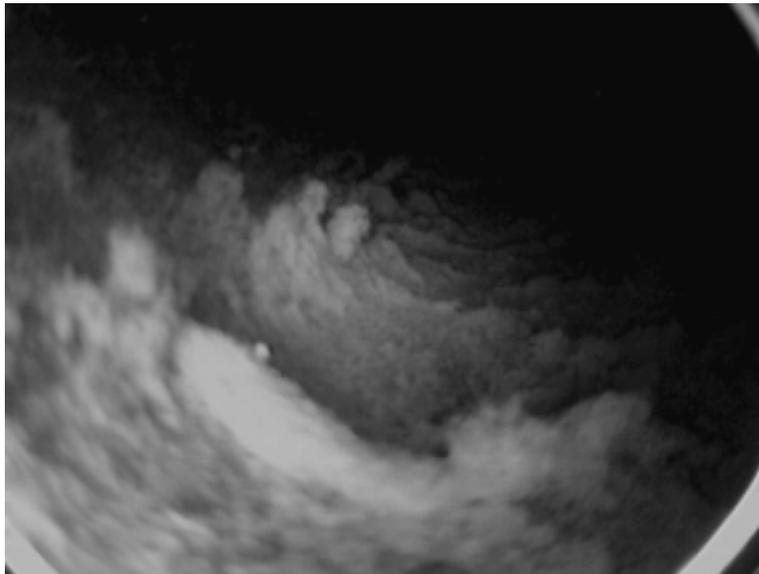
LAUNDRY (SELF-SERVICE) (2-111-1-Q)

1 FT Inside Duct From Dryers (Foreign material)
