USS GETTYSBURG (CG 64)
INTERNAL VIDEO VENTILATION ASSESSMENT

PREFORMED BY
SUPERVISOR OF SHIPBUILDING CONVERSION & REPAIR
PORTSMOUTH,VIRGINIA
SUPSHIP: A PUGH /QED: T. BENTON & G. HELMS
02 THRU 14 DECEMBER 2001

SUMMARY

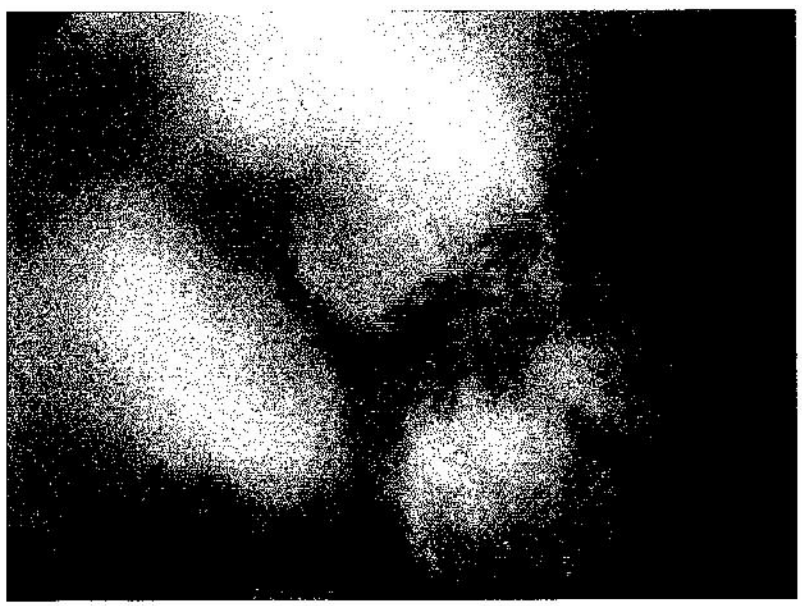
PIC. # 2

EXHAUST DUCT E01-396-2
1-398-1-L WARD WR. WC. & SH.
PIC. # 1

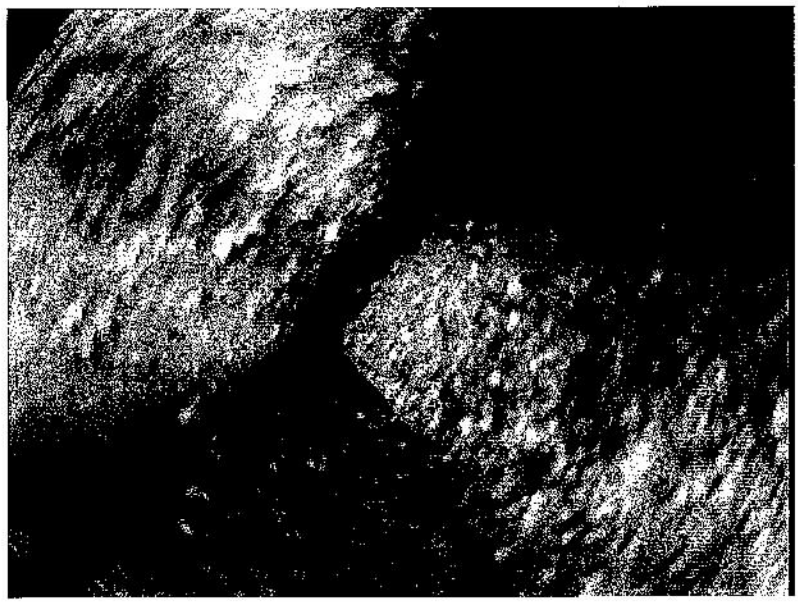
PIC. # 2

SUPPLY DUCT S01-198-1
5-174-0-E ENGINE RM. # 1
PIC. # 1
