— USS STEPHEN W GROVES —

(FFG-29)

**SEMAT II SHELL CONDITION ASSESSMENT SURVEY
INTERIOR AREAS
6/24/01 – 7/6/01**

**PREPARED BY SUPSHIP
PORTSMOUTH
07/10/01**

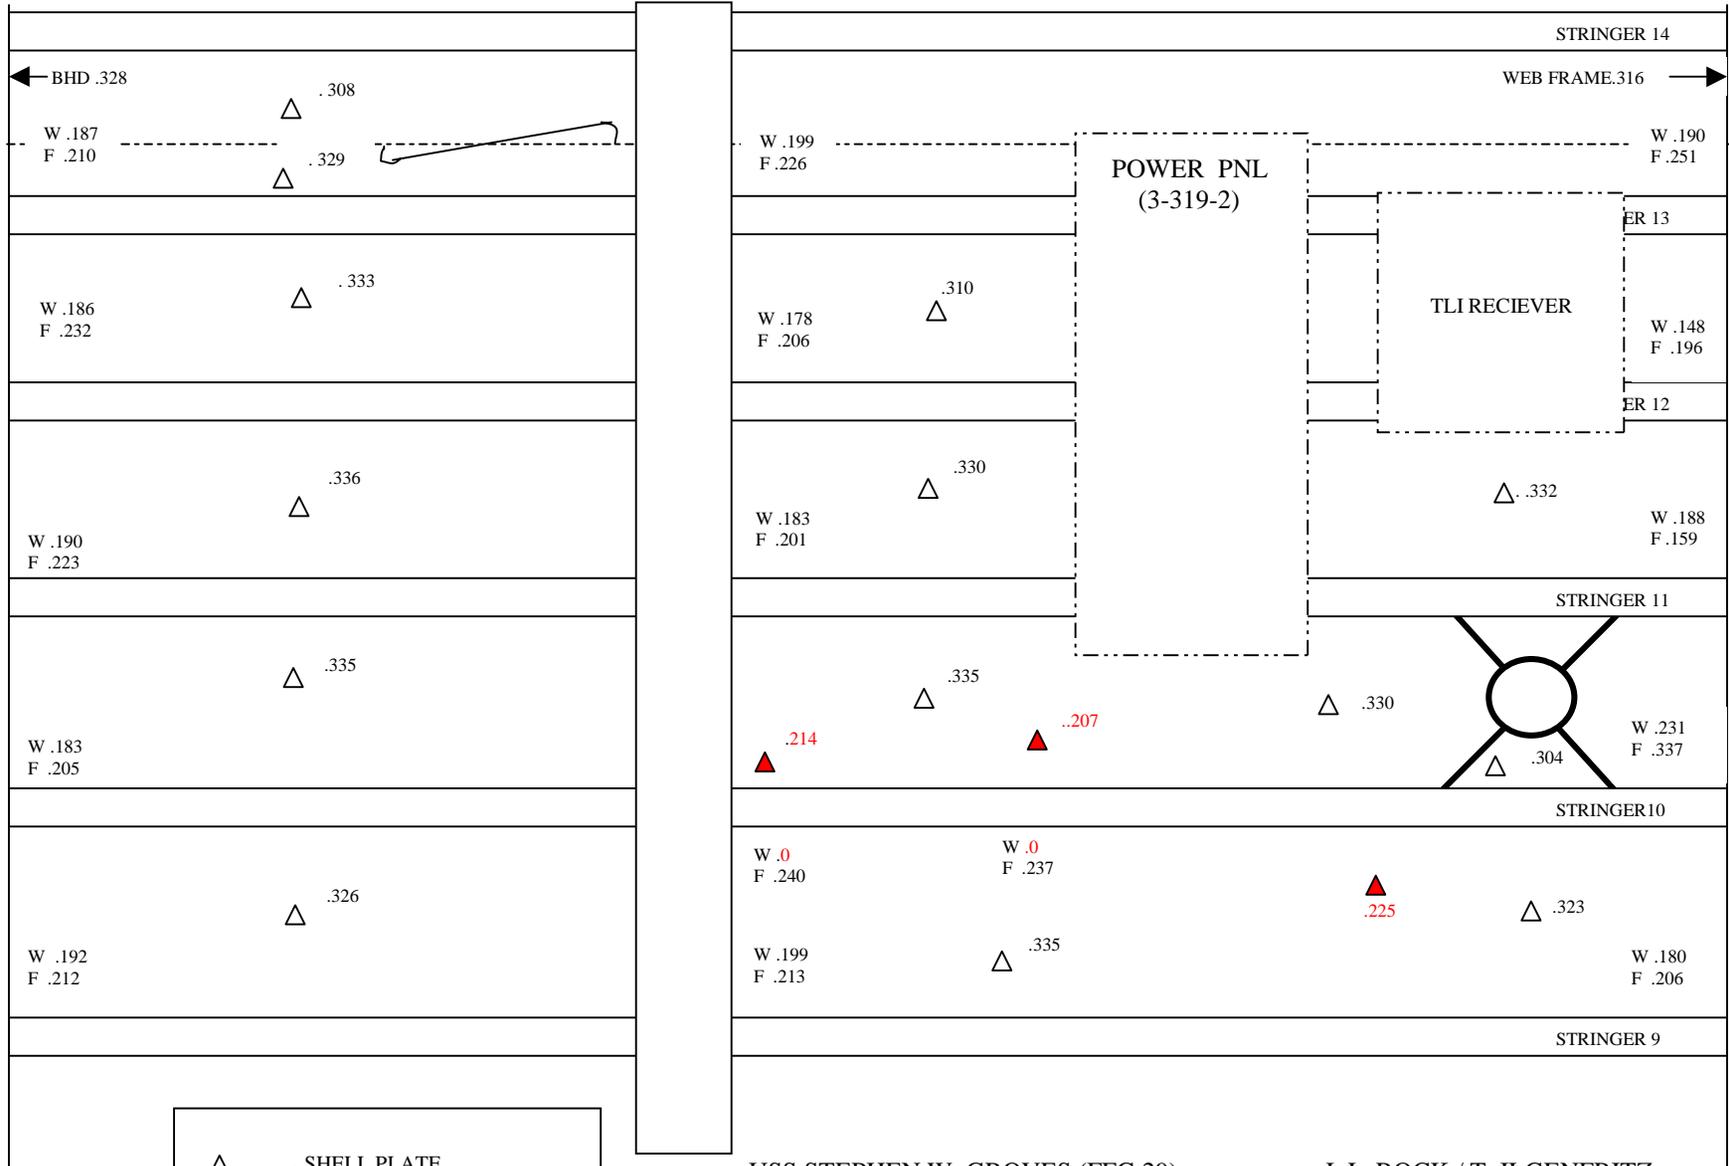
USS STEPHEN W. GROVES (FFG 29)
AUXILLIARY MACH RM 3
(5-292-0-E) PORT SIDE

SAFETY HAZARD: 1. SERIOUS - CORRECT AS SOON AS POSSIBLE 2. SERIOUS - SUSPENSION OF EQUIPMENT/SYSTEM/SPACE REQUIRED 3. SERIOUS - WAIVER OF EQUIPMENT/SYSTEM 4. SAFETY ITEM - MINOR 5. COMBUSTIBLE MATERIAL			1. MAINTENANCE ACTION COMPLETED: PARTS DRAWN FROM SUPPLY 2. MAINTENANCE ACTION COMPLETED: REQUIRED PARTS NOT DRAWN FROM SUPPLY 3. MAINTENANCE ACTION COMPLETED: NO PARTS REQUIRED 4. CANCELLED - DEFERRAL WILL BE REMOVED FROM CSMP 7. MAINTENANCE ACTION COMPLETED: 3-M CAPABILITY UTILIZED 0. NONE OF THE ABOVE. DESCRIBE IN REMARKS/DESCRIPTION SECTION		1. MANDATORY 2. ESSENTIAL 3. HIGHLY DESIRABLE 4. DESIRABLE		
DISCREPANCY DESCRIPTION: PER SEMAT II UNDERWATER HULL ASSESSMENT: PORT SIDE, (5-292-0-E) AUX 3, BETWEEN WF (316-324)							
STRINGER (11) BEHIIND/UNDER POWER PNL (3-319-2) IS HOLED. SHELL PLATE APPROXIMATELY 1.5" ABOVE HOLES IN							
STRINGER (11) IS THINNING. REFER TO DRAWING FOR U/T READINGS.

UNDERNEATH VIEW OF STRINGER (11)
RECOMMENDED FOR REPLACEMENT.

RECOMMENDED REPAIRS: REMOVE AND REPLACE APPROXIMATELY 8 LINEAR FEET OF 4X6 T-BEAM. PRESERVE AND PAINT TO MATCH.							
FTSC is to conduct risk assessment and make final repair recommendations.							
SSPORT C221 POC: F. PRAISSMAN (757) 396-4001 EXT 2130, TPOC: B. WILLIAMS/M. MELVIN							
CSMP SUMMARY: STRINGER (11) BETWEEN WF (316-324) IS DETERIORATED.				TEST# MRC 1102/1			
ROOT CAUSE/AMPLIFICATION: H1				STEP# 1,2,3,4 & 5			
SYSTEM LEVEL IMPACT:							
PART NO.	NOMEMCLATURE			QTY	NSN	COST	
1							
2							
3							
4							
5							
6							
FIRST CONTACT HURST	RATE HTC	SECOND CONTACT GERMAN		RATE ENS	PHONE		
ASSESSOR / ACT / TECH ID# J. LaROCK/ T. ILGENFRITZ QED SYSTEMS INC.			TD	TL	LOGISTICIAN	TSP

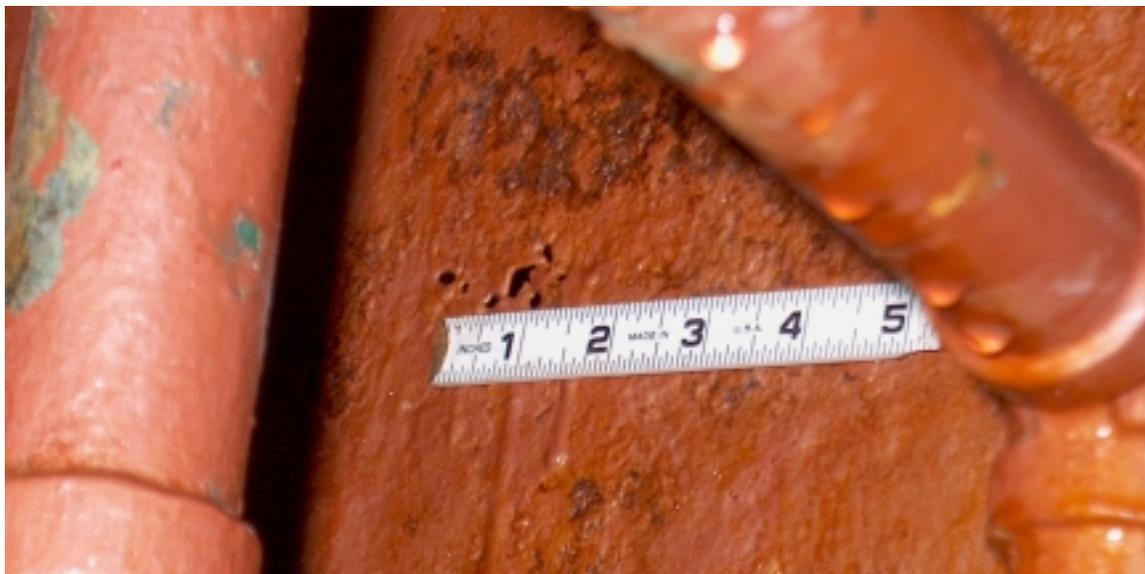
AUXILIARY MACHINERY ROOM 3 (5-292-0-E)

TRANSVERSE WEB FRAME (316) STBD OF CENTER LINE LOOKING FWD
REFER TO DRAWING REGARDING U/T READINGS.

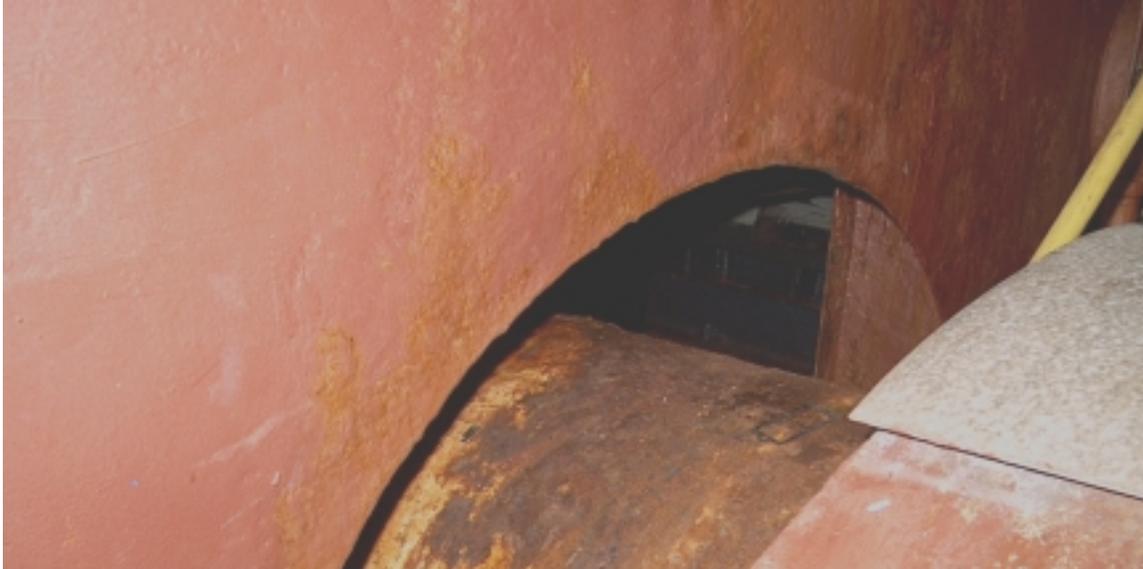
AUXILIARY MACHINERY ROOM 3 (5-292-0-E)

TRANSVERSE WEB FRAME (316) AT CENTER LINE LOOKING FWD
REFER TO DRAWING REGARDING U/T READINGS.

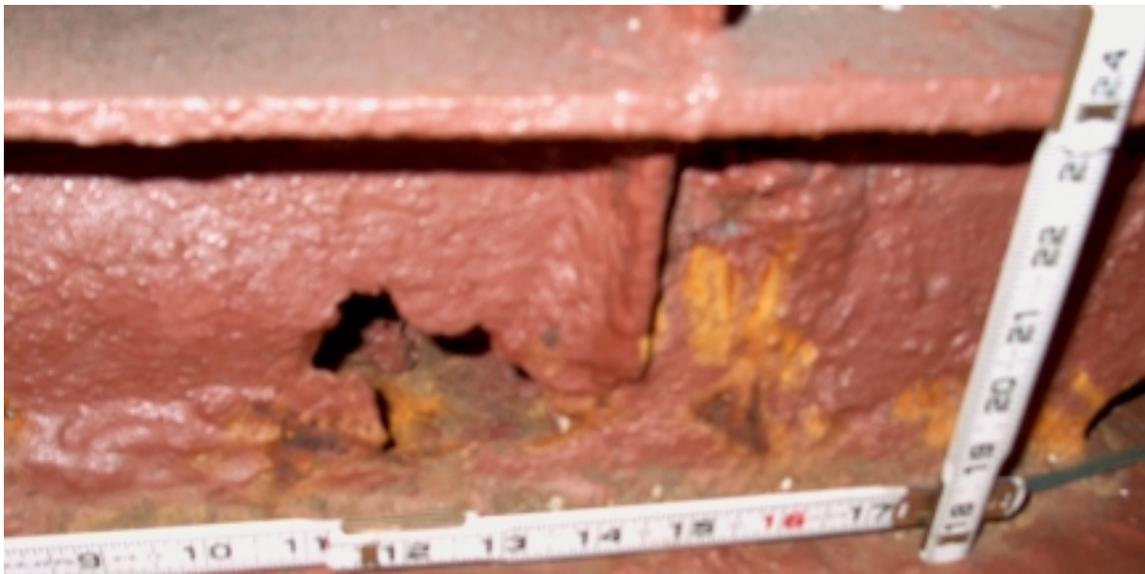
STBD SIDE UNDER HOT POTABLE WATER ACCUMULATOR TANK
STRINGER (8) HAS HEAVY DETERIORATION.

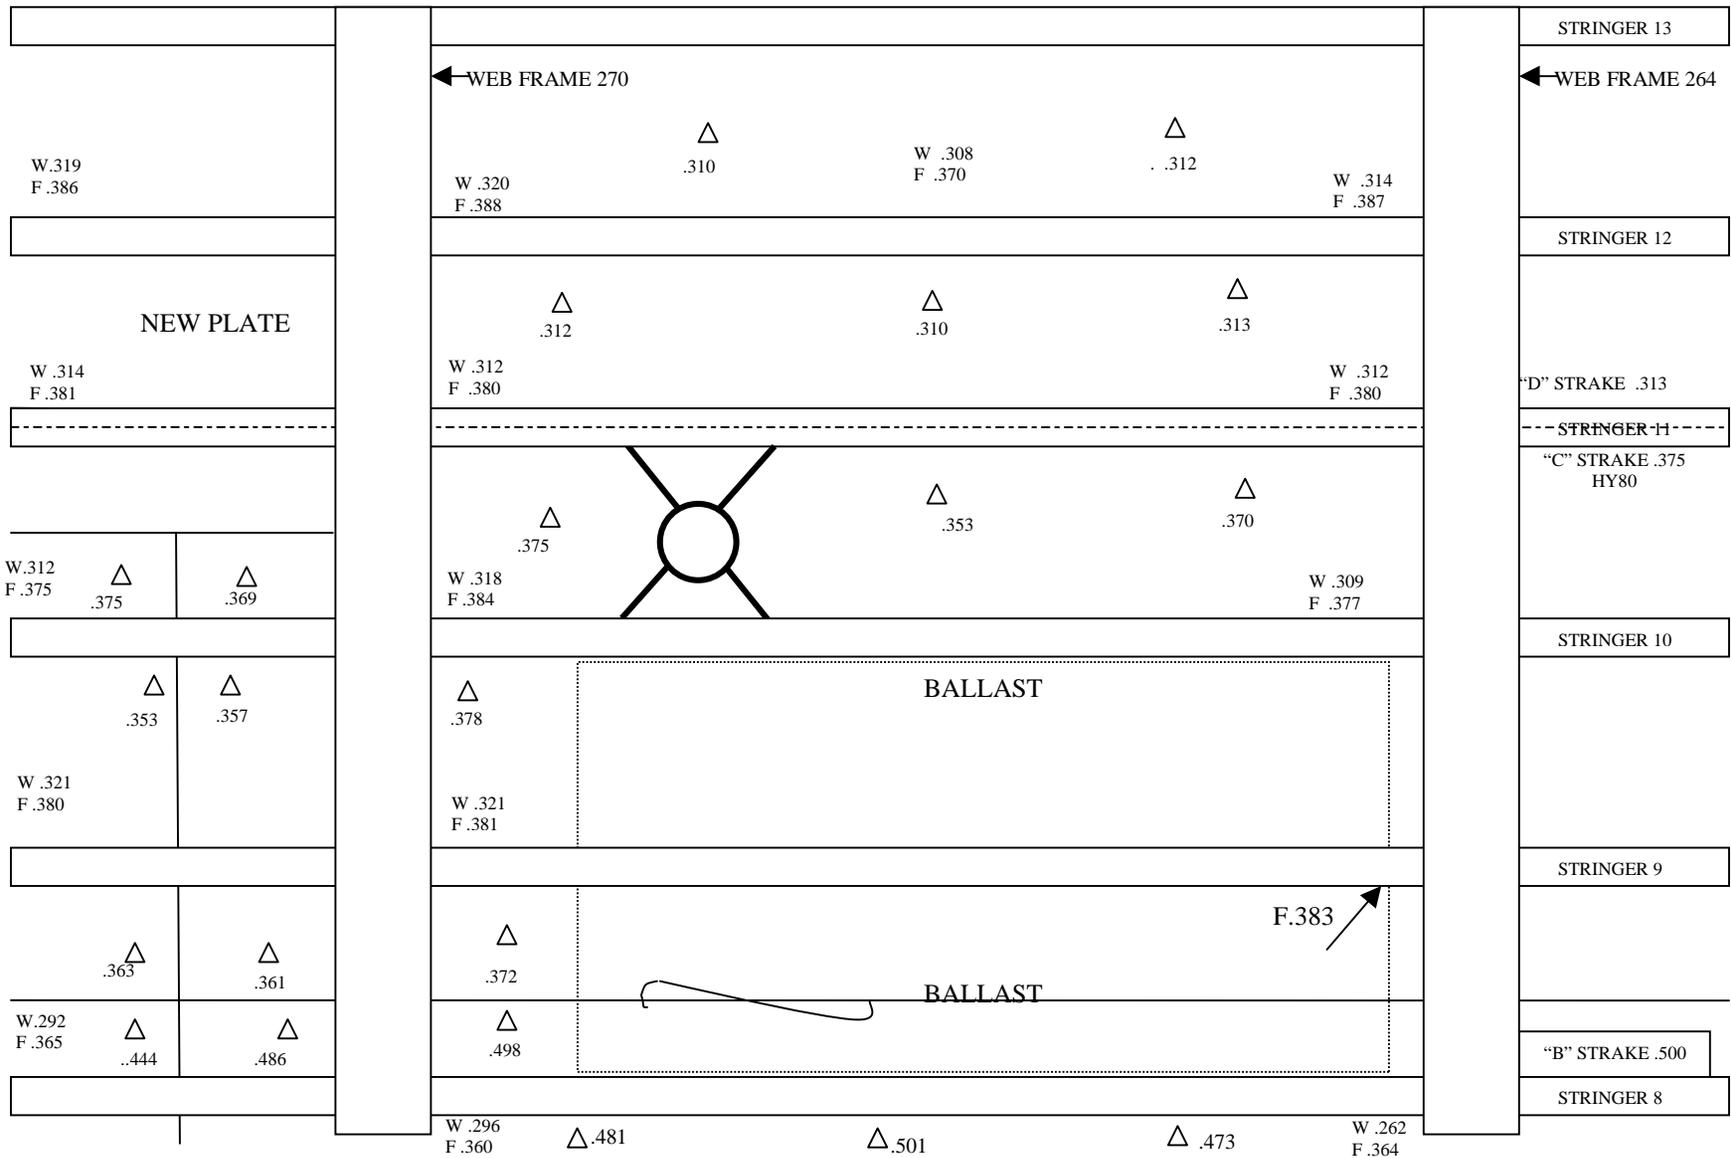
USS STEPHEN W. GROVES (FFG-29)
 MAIN ENGINE ROOM
 (5-250-0-E) PORT SIDE

TRANSVERSE WELD SEAM, REFER TO DRAWING FOR U/T READINGS.

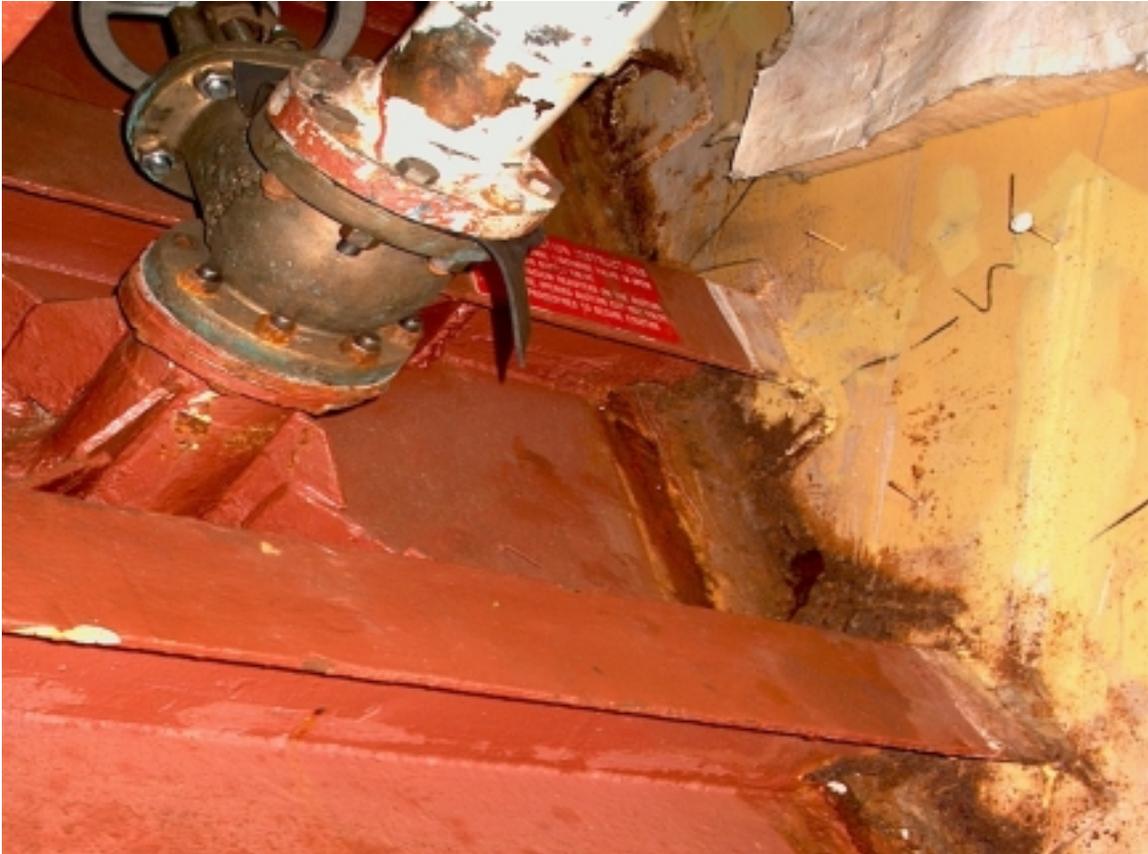
PORT SIDE, WHERE BHD (212) MEETS SHELL PLATE
U/T READINGS ARE NOTED IN DRAWINGS

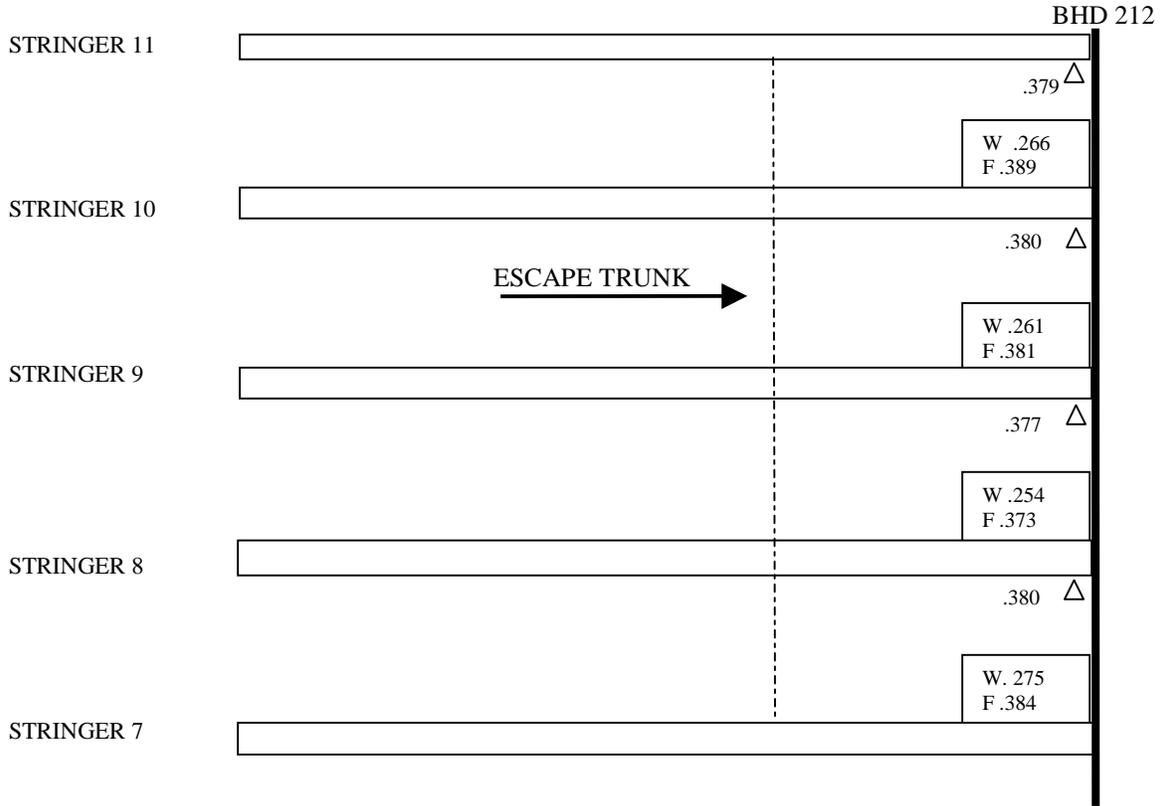
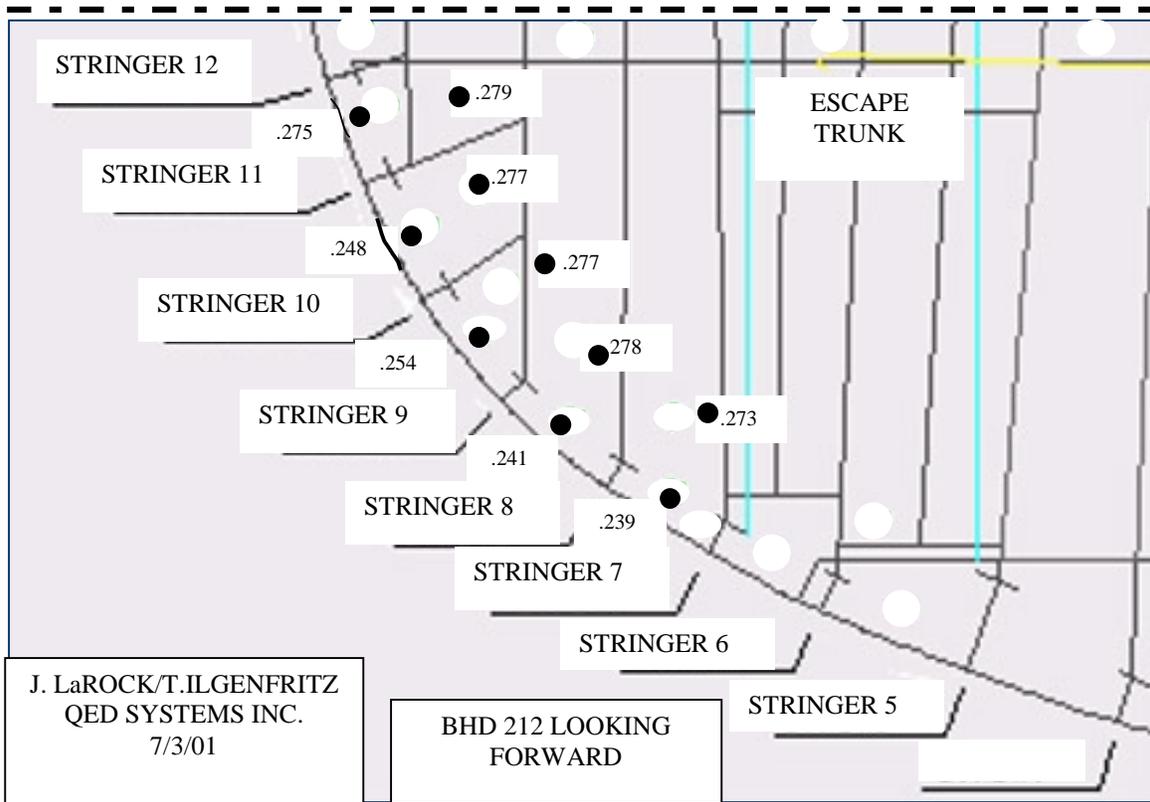
USS STEPHEN W GROVES (FFG-29)
 AUXILIARY MACHINERY ROOM 2
 (5-212-0-E) PORT SIDE

5-212-0-E AMR 2	PORT SIDE, BHD (212) FROM STRINGERS (7-12)	APPROXIMATELY 10 SF OF AREA HAS RUST AND PAINT SEPARATION.
5-180-0-E AMR 1	STBD SIDE, INSIDE SSDG ENCLOSURE. 34" AFT OF WF (196) BTWN STRINGERS (10-11)	PITTING IN SHELL PLATE.
5-51-0-Q FWD EDUCTOR RM	ENTIRE BILGE POCKET	APPROXIMATELY 60 SF HAS SURFACE RUST AND PAINT SEPARATION.
4-100-0-E APU RM	STBD BILGE POCKET,	APPROXIMATELY 40 SF OF RUST AND PAINT SEPARATION.
4-48-1-Q SONAR COOLING ROOM	STBD SIDE, FROM THE DECK UP THE THIRD STRINGER AND BHD (56)	APPROXIMATELY 12 SF OF AREA HAS RUST AND PAINT SEPARATION.
3-84-0-E A/C MACHINERY ROOM	PORT SIDE, BETWEEN WF (90) AND BHD (100) UP TO FIRST STRINGER OFF THE DECK	APPROXIMATELY 20 SF OF AREA HAS SURFACE RUST AND PAINT SEPARATION.
3-84-0-E A/C MACHINERY ROOM	PORT SIDE, AT BHD (100), TANK TOP/DECK AND FOUNDATION OF A/C UNIT.	APPROXIMATELY 50 SF OF RUST AND PAINT SEPARATION.

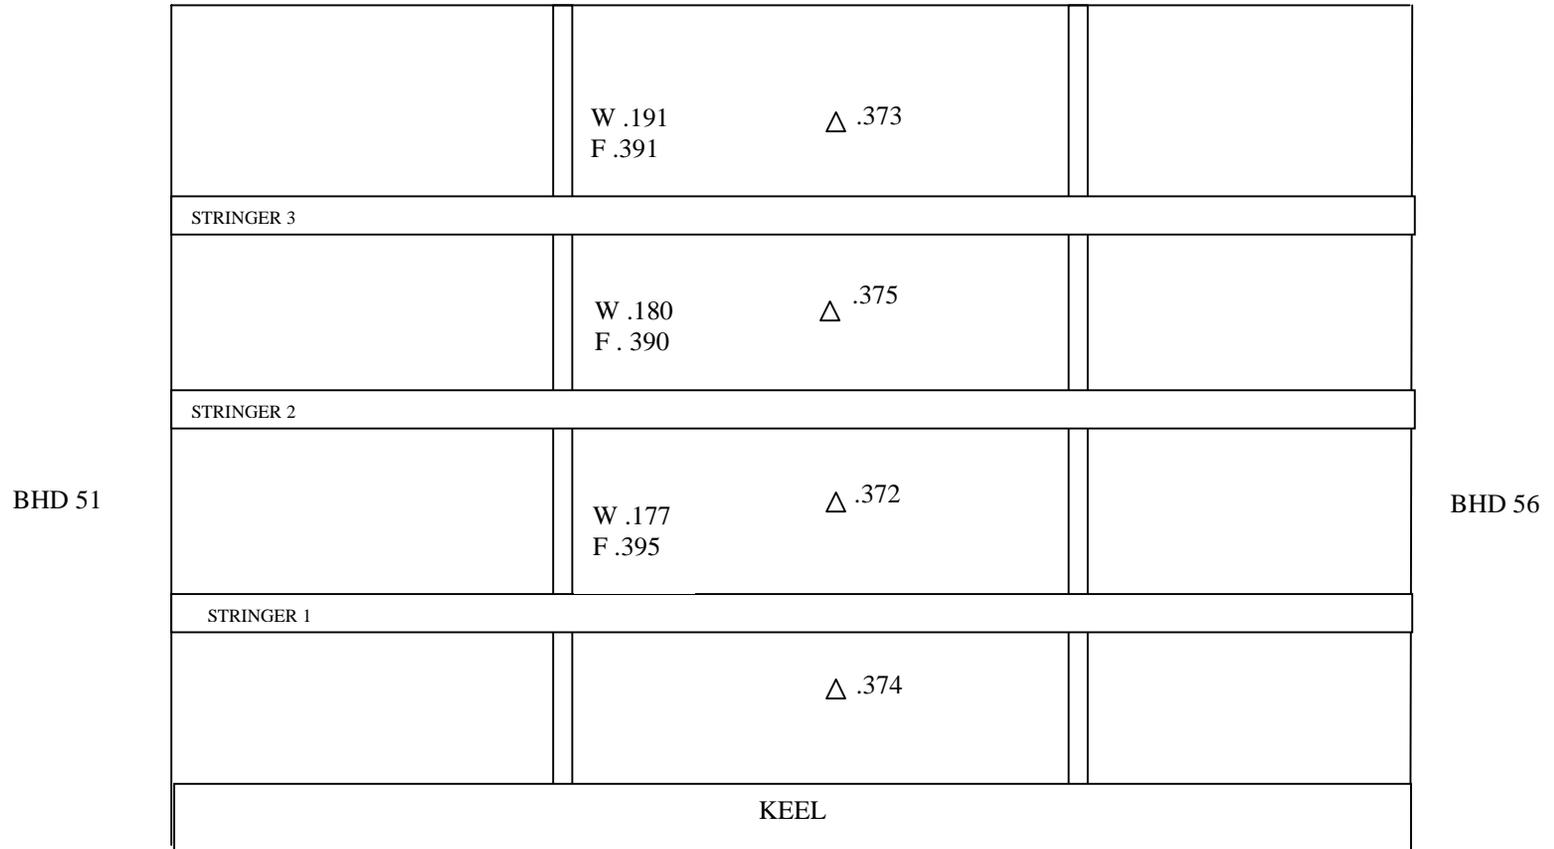
USS STEPEN W GROVES (FFG-29)
 EDUCATOR ROOM (5-51-0-Q)
 Side view looking starboard

RED BOX INDICATES AREA WHERE U/T
READINGS WERE TAKEN
SEE PAGE 36

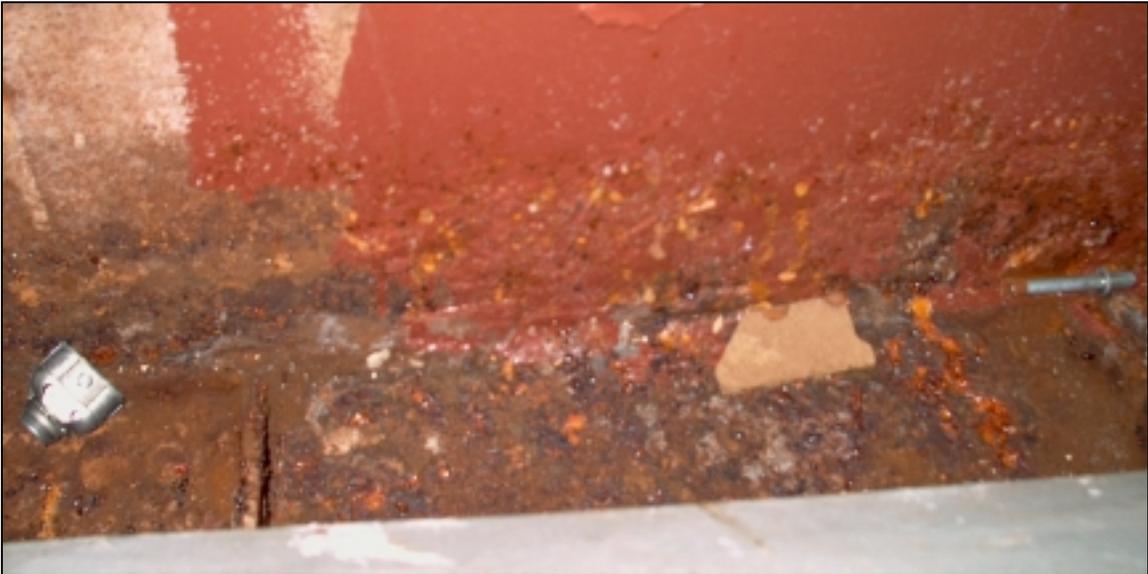
STBD SIDE, AREA VIEW OF BILGE POCKET

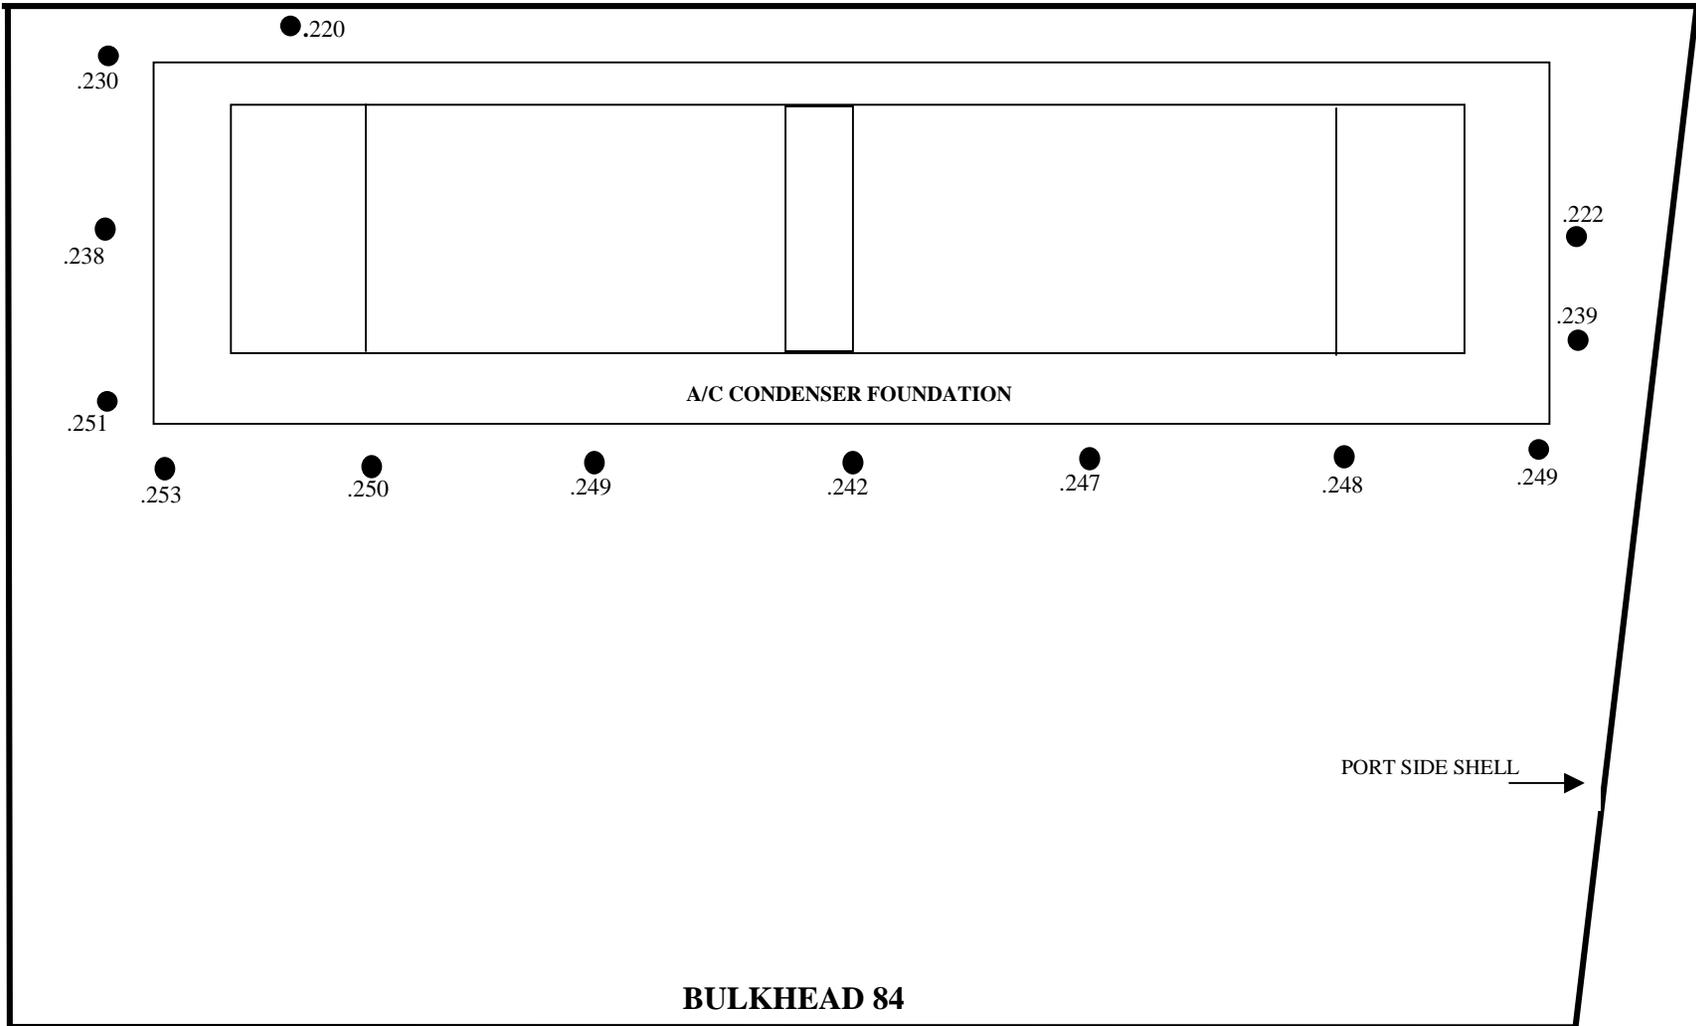
USS STEPHEN W GROVES (FFG-29)
A/C MACHINERY ROOM (3-84-0-E)
Top view

TANK TOP/ DECK UNDER A/C UNIT NO. 1
