USS UNDERWOOD (FFG 36)

SEMAT II SHELL CONDITION ASSESSMENT SURVEY
INTERIOR AREAS

7/23/01 TO 8/3/01

PREPARED BY
SUPERVISOR OF SHIPBUILDING CONVERSION AND REPAIR
PORTSMOUTH, VIRGINIA

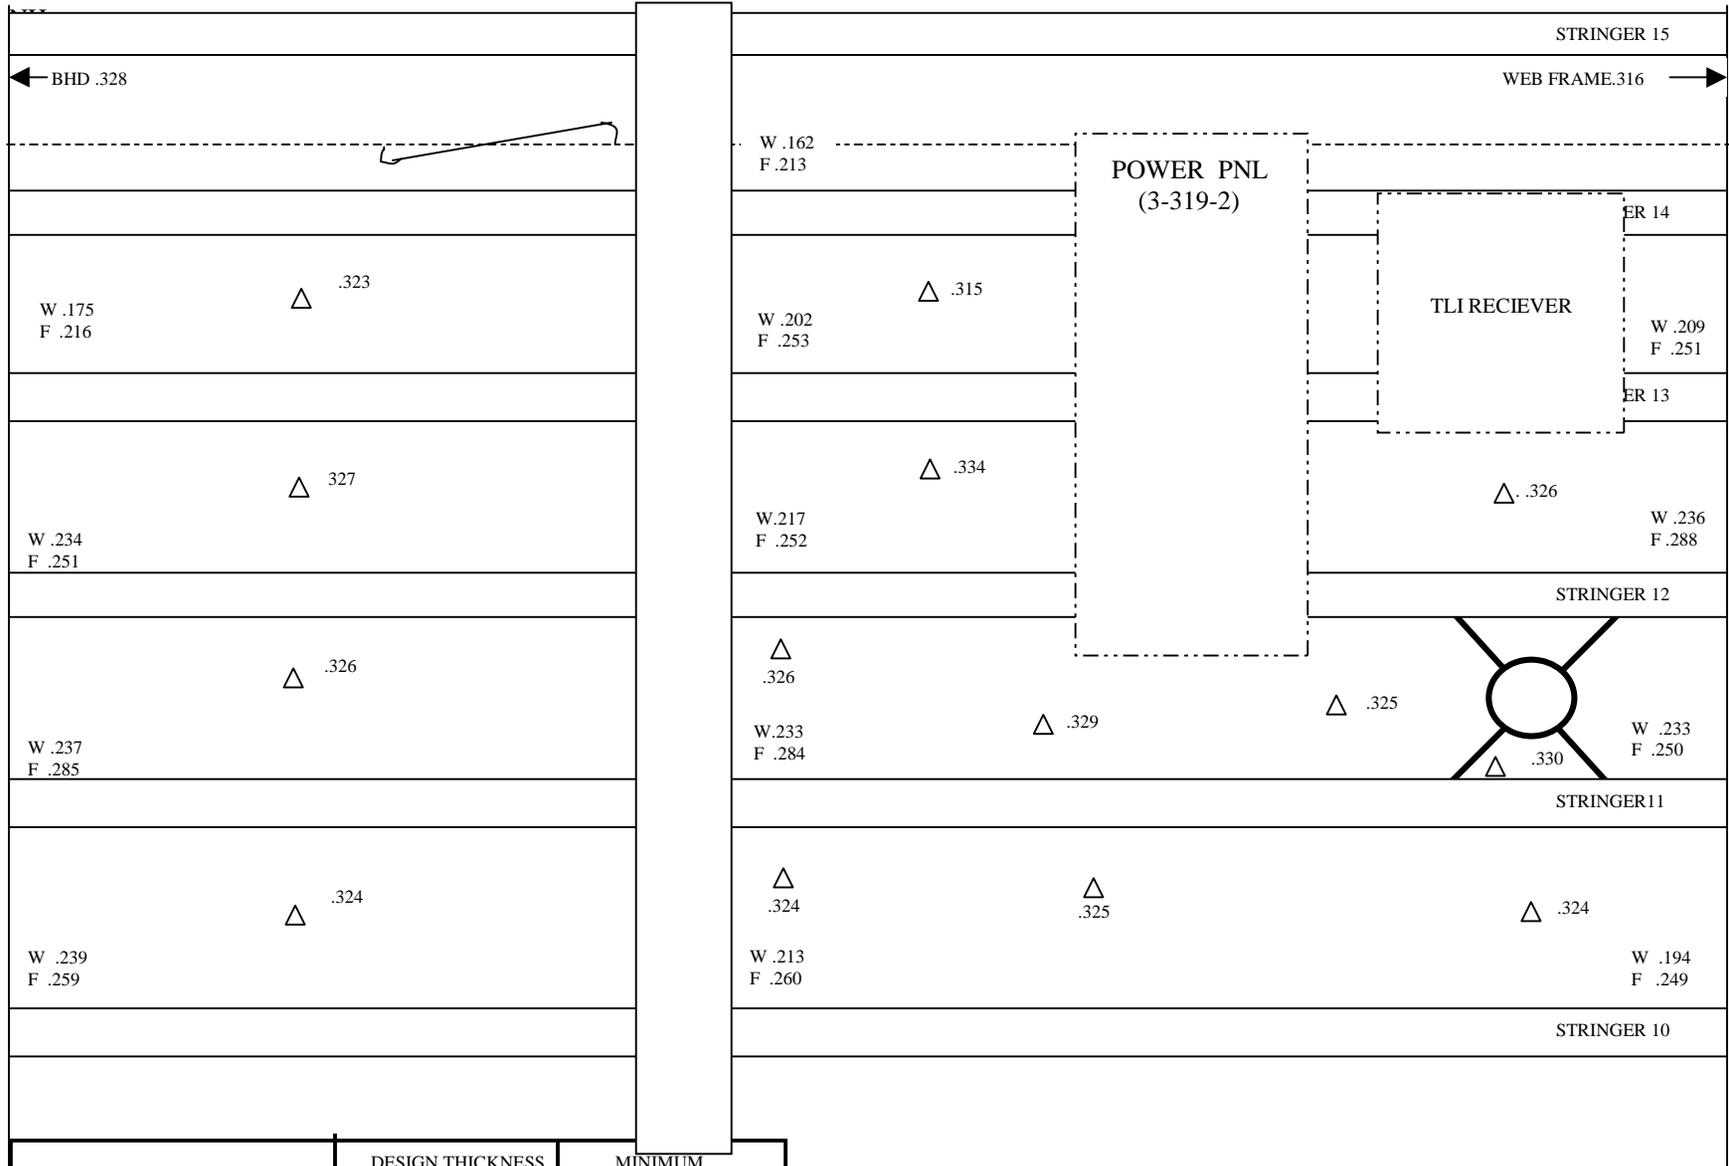
USS UNDERWOOD (FFG 36)
AUXILLIARY MACH RM 3
(5-292-0-E) PORT SIDE

RED BOX INDICATES LOCATION
 OF U/T READINGS
 DRAWING ON FOLLOWING PAGE

WEB FRAME
.324

△	SHELL PLATE	DESIGN THICKNESS	MINIMUM
		.313	.234
W	STRINGER WEB	.220	.165
F	STRINGER FLANGE	.265	.198

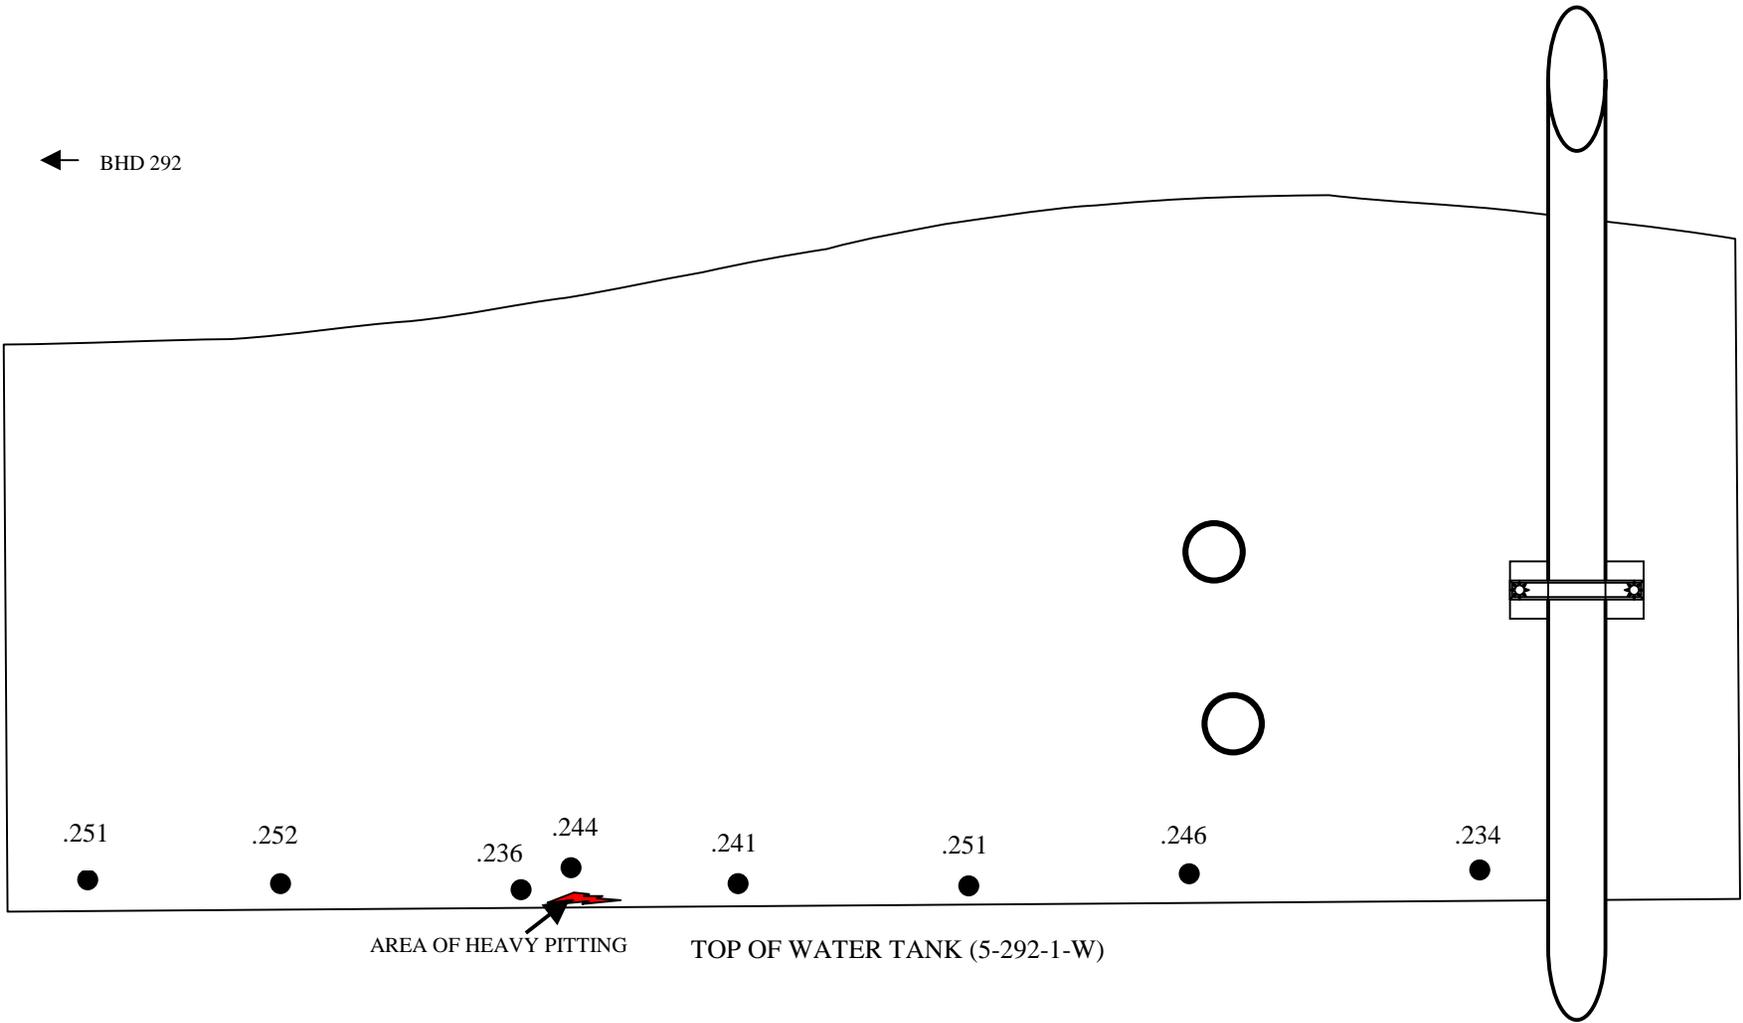
TOP OF WATER TANK (5-292-1-W) NOTE STANDING WATER
WHICH IS MAIN CAUSE FOR CORROSION.

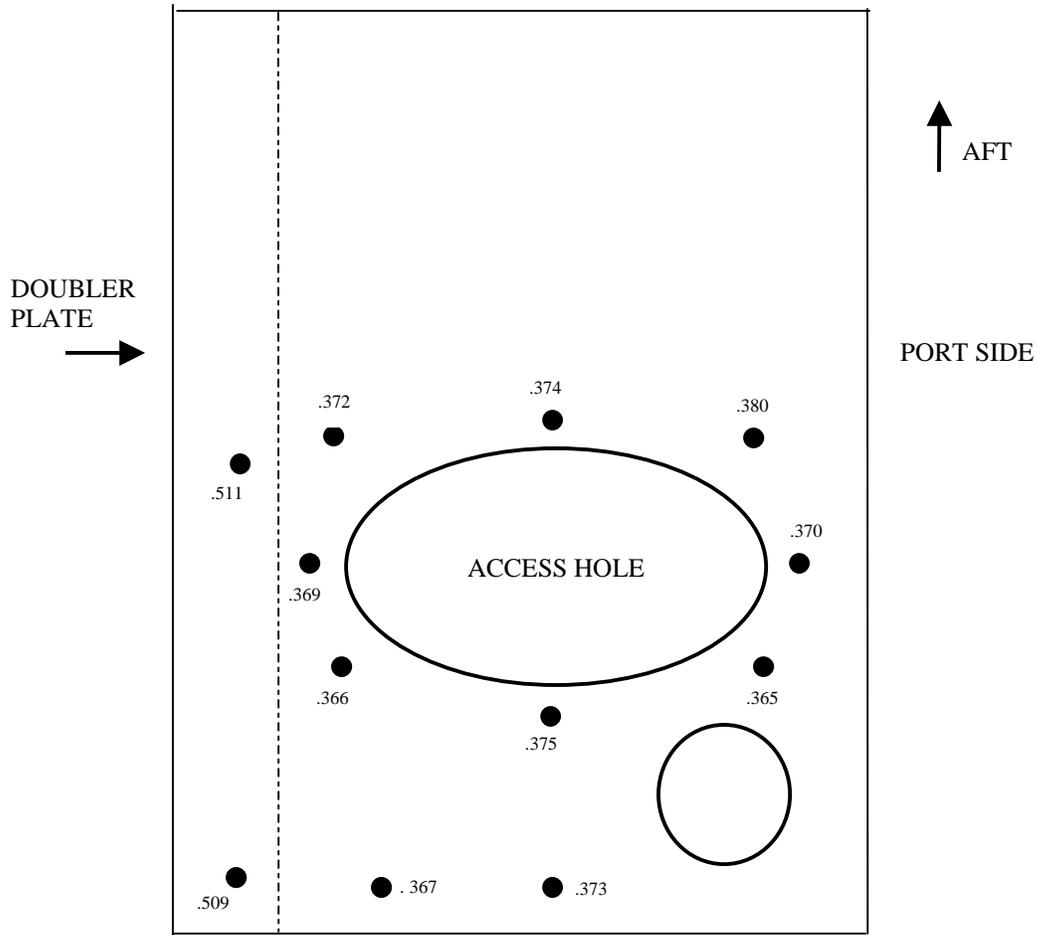
AUXILIARY MACHINERY ROOM 3
 (5-292-0-E) PORT SIDE
 POTABLE WATER TANK (5-308-2-W)

RED BOX INDICATES WHERE U/T
 READINGS WERE TAKEN
 SEE FOLLOWING PAGE

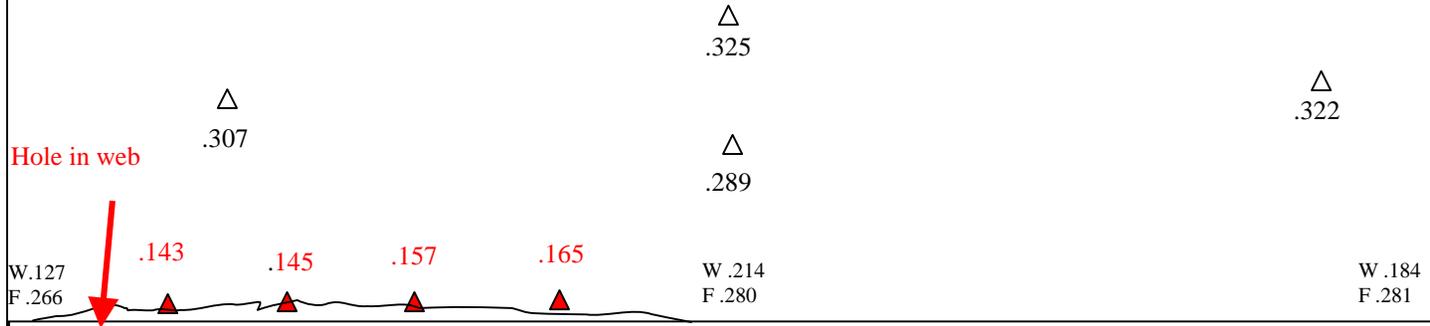
USS UNDERWOOD (FFG-36)
MAIN ENGINE ROOM (5-250-0-E)
STBD SIDE

W .184
F .281

STRINGER 11

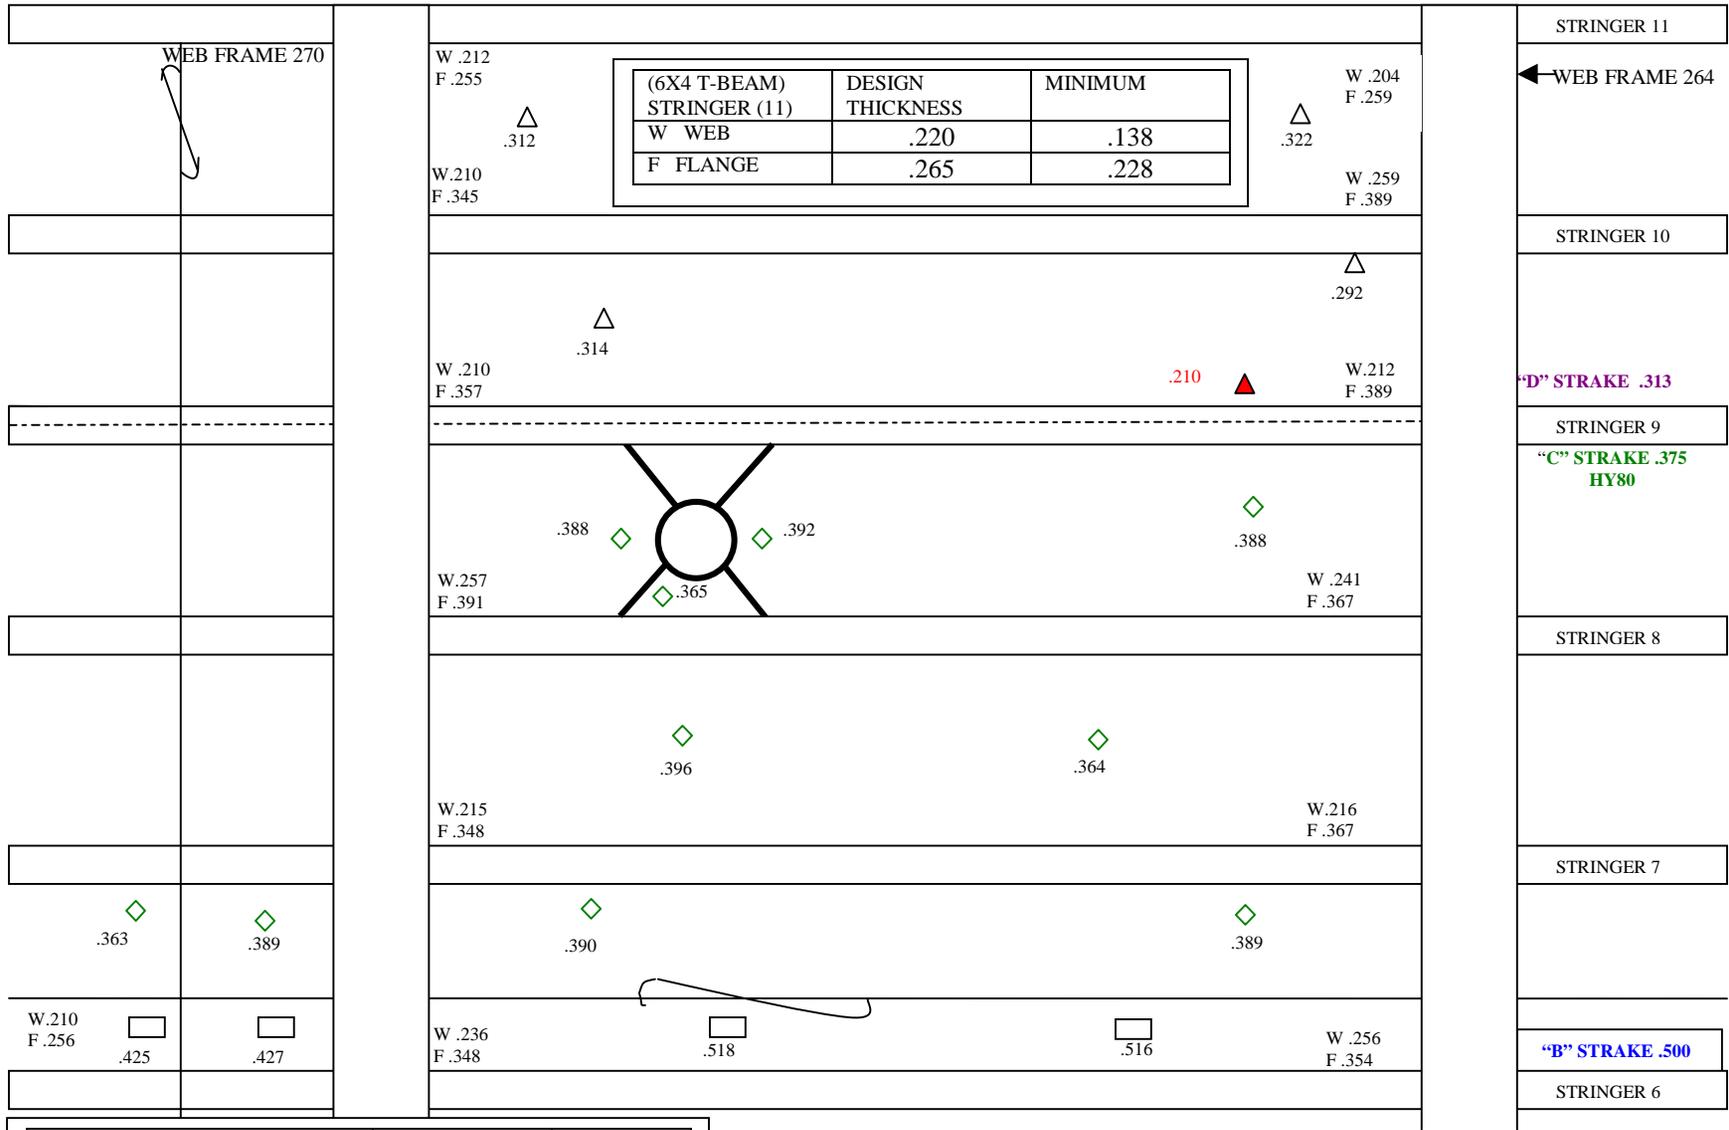
USS UNDERWOOD (FFG-36)
MAIN ENGINE ROOM
(5-250-0-E) PORT SIDE

PORT SIDE, TRANSVERSE WELD SEAM AFT OF WF (270)
U/T READINGS ARE NOTED IN DRAWING.

DESIGN THICKNESS	MINIMUM
△ D-STRAKE	.313	.234
◇ C-STRAKE	.375	.281
□ B-STRAKE	.500	.375
W STRINGER WEB (6X61/2 T-BEAM)	.230	.196
F STRINGER FLANGE	.380	.323

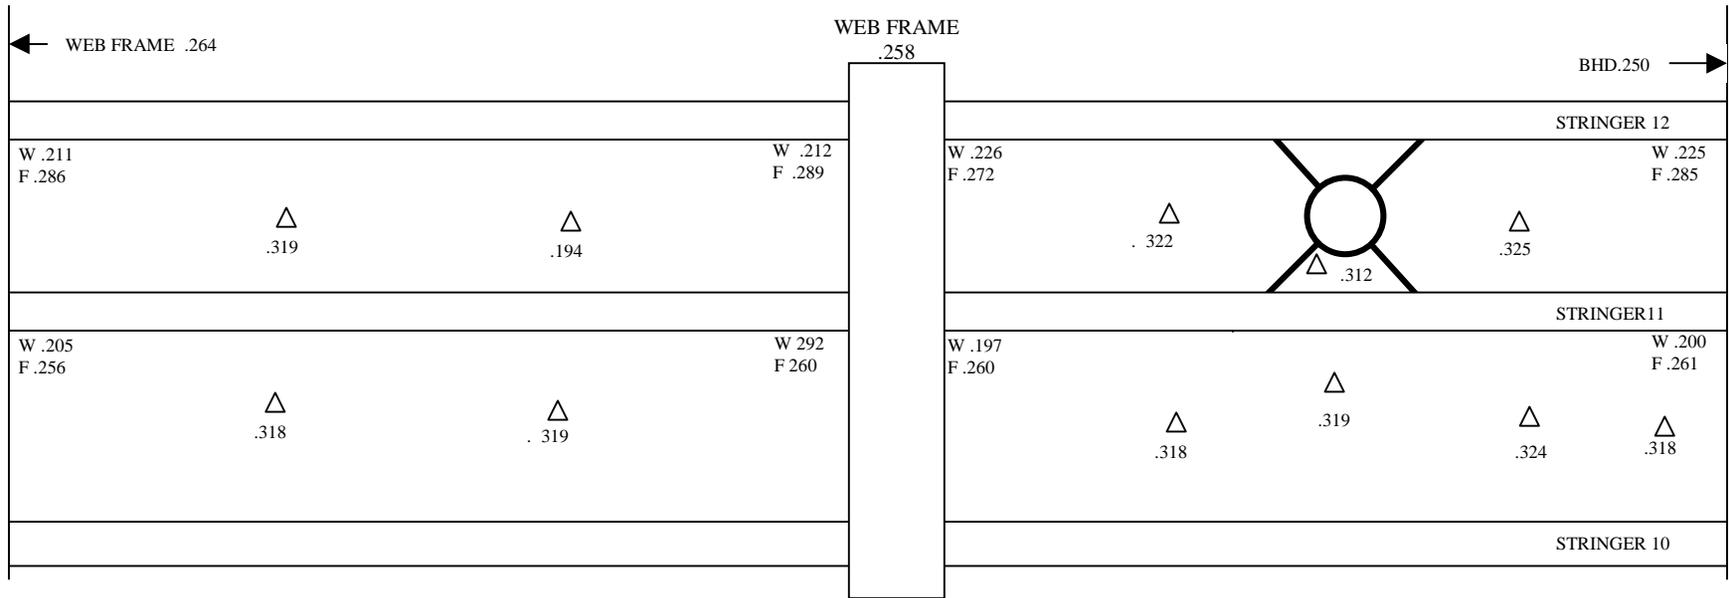
USS UNDERWOOD (FFG 36)
 MAIN ENGINE ROOM
 (5-250-0-E) PORT SIDE

PORT SIDE, STRINGER (10) BETWEEN BHD (250) AND WF (264)
REFER TO DRAWING FOR U/T READINGS.

DESIGN THICKNESS	MINIMUM
△ SHELL PLATE	.313	.234
W STRINGER WEB	.220	.165
F STRINGER FLANGE	.265	.198

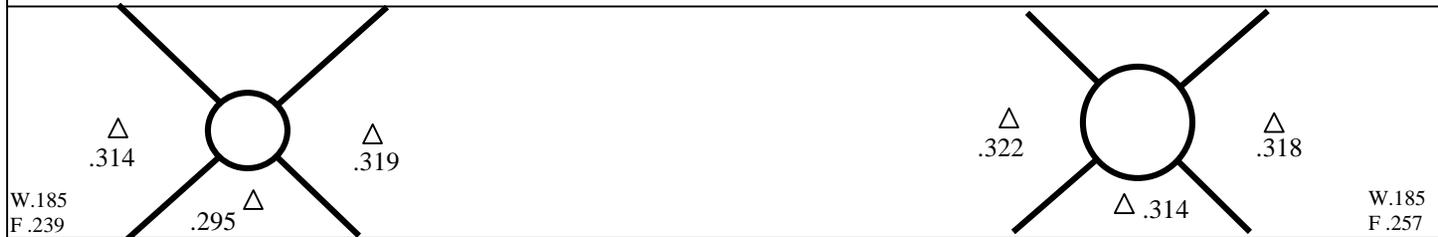
STRINGER 12

STBD SIDE BETWEEN WF (264-270) CORROSION ON STRINGER (12).
REFER TO DRAWING FOR U/T READINGS OF AREA.

W .212
F .280

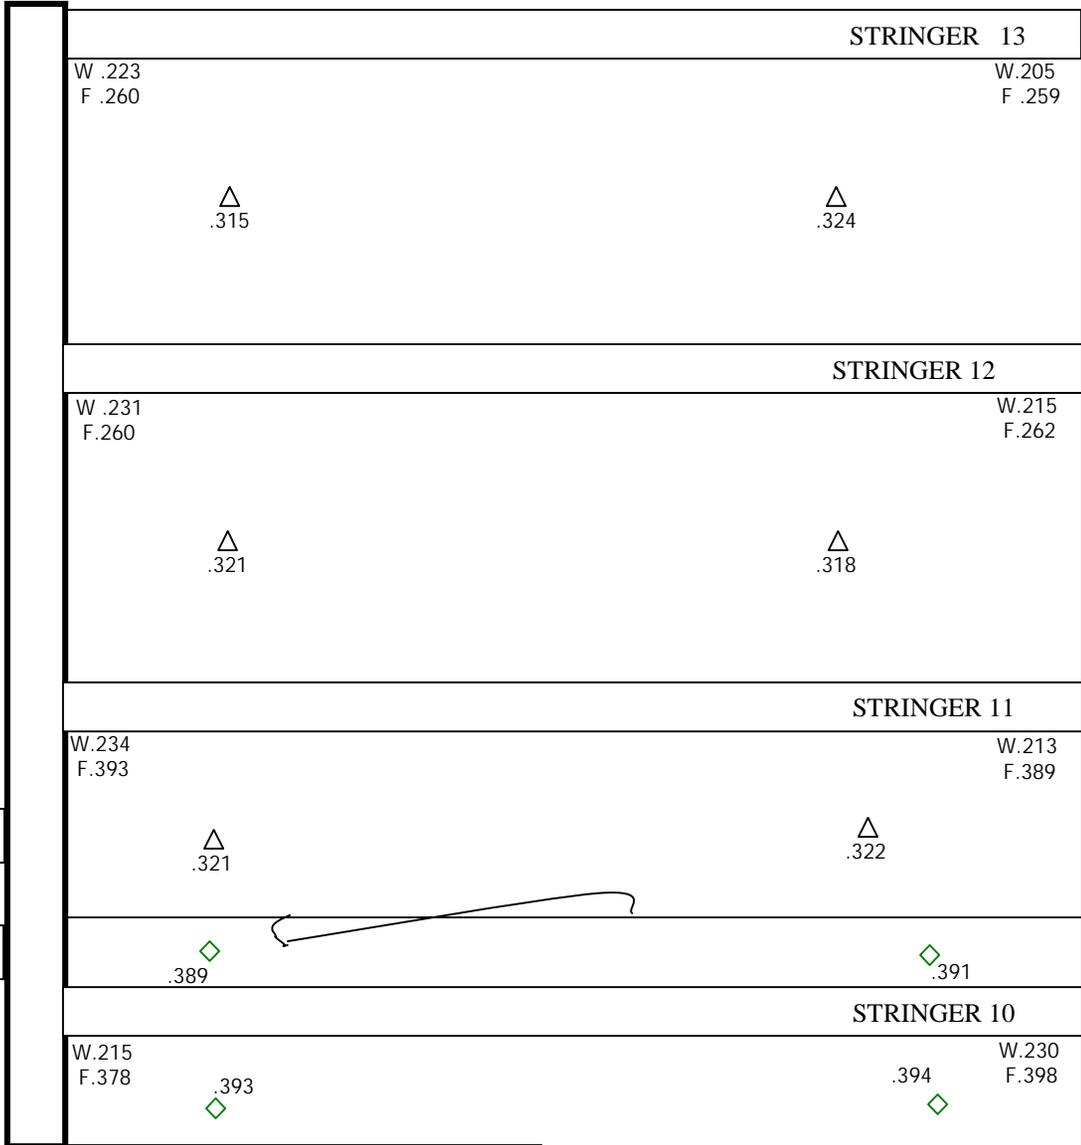
DESIGN THICKNESS	MINIMUM
△ D STRAKE	.313	.234
◇ C STRAKE	.375	.281
W STRINGER WEB (6X4 T-BEAM) (12-13)	.220	.138
F STRINGER FLANGE	.265	.228
W STRINGER WEB (6X6 1/2 T-BEAM) (10-11)	.230	.196
F STRINGER FLANGE	.380	.323

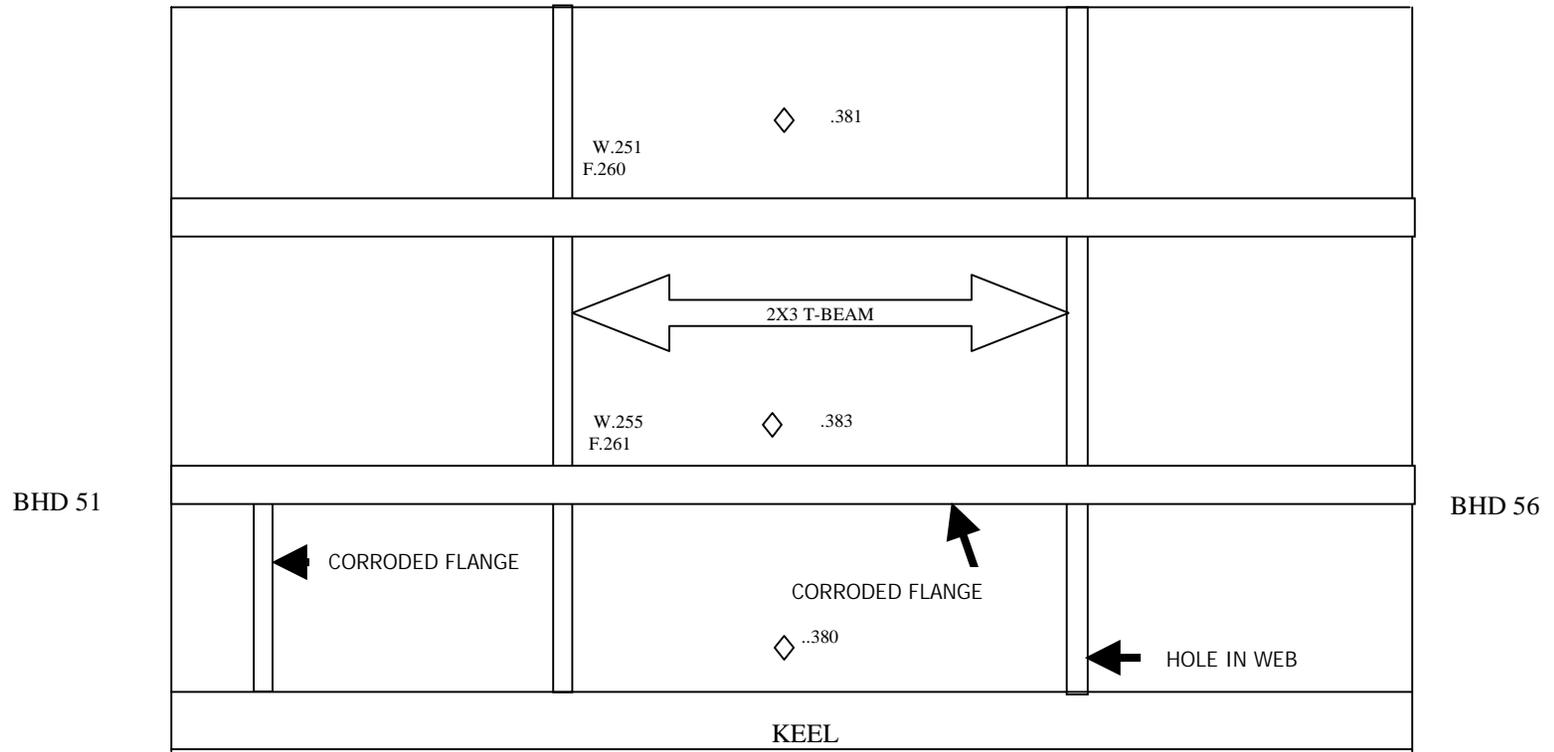
USS UNDERWOOD (FFG-36)
 EDUCATOR ROOM (5-51-0-Q)
 SIDE VIEW LOOKING STARBOARD

RED BOX INDICATES AREA WHERE U/T
READINGS WERE TAKEN
SEE FOLLOWING PAGE FOR DRAWING

DESIGN THICKNESS	MINIMUM
◇ SHELL	.375	.281
W STRINGER WEB (8X4 T-BEAM)	.230	.173
F STRINGER FLANGE	.255	.192

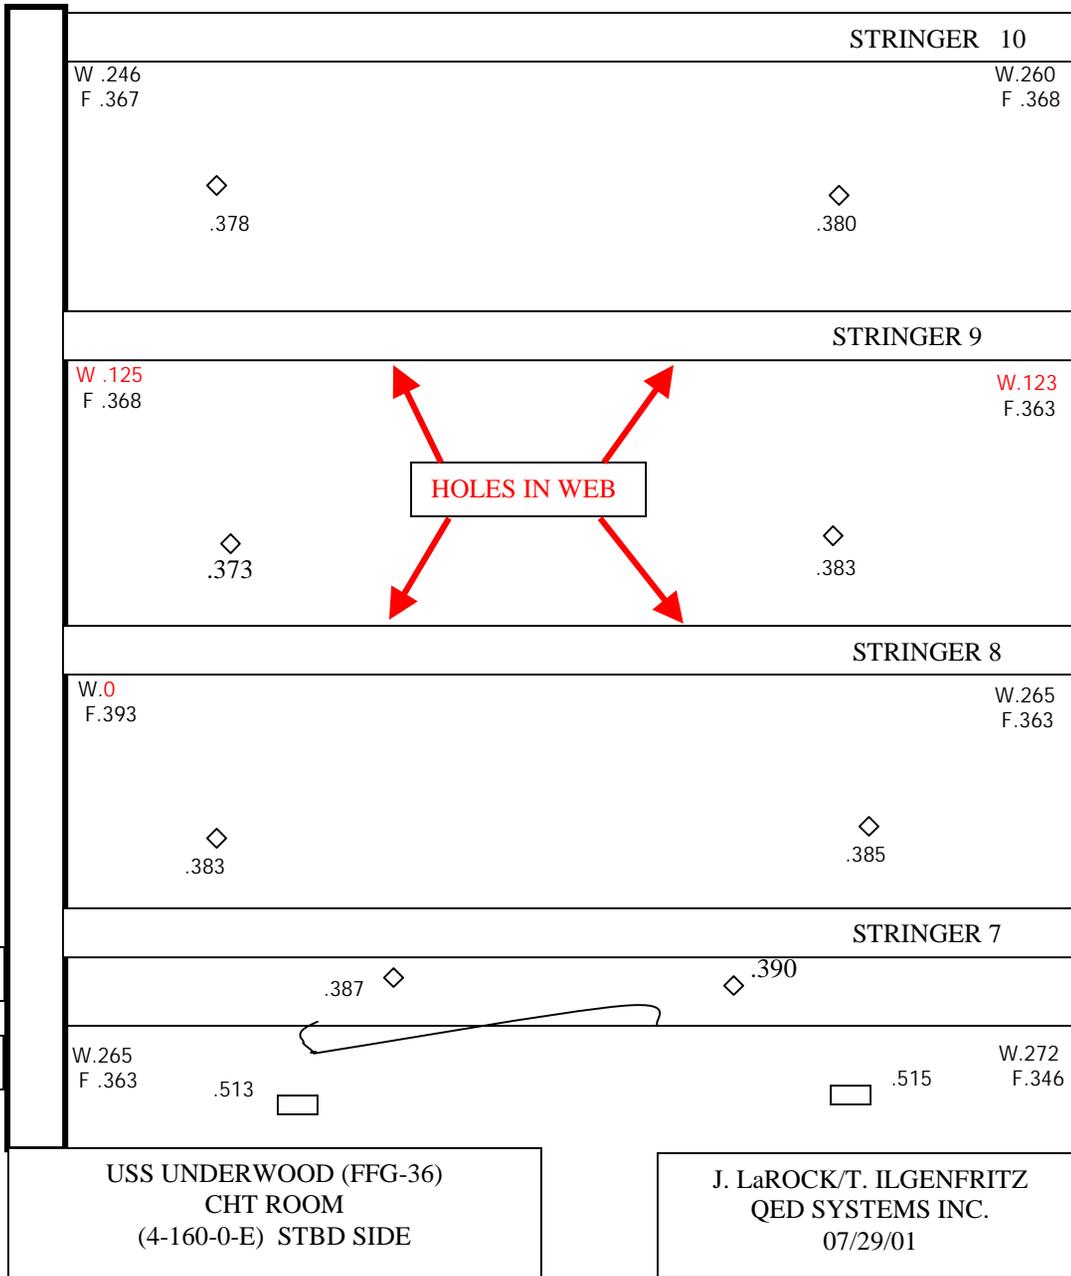
RED BOX INDICATES AREA WHERE U/T
READINGS WERE TAKEN
SEE THE FOLLOWING PAGE FOR DRAWING

DESIGN THICKNESS	MINIMUM
□ B STRAKE	.500	.375
◇ C STRAKE	.375	.281
W STRINGER WEB (6X61/2 T-BEAM) (10-11)	.230	.196
F STRINGER FLANGE	.380	.323

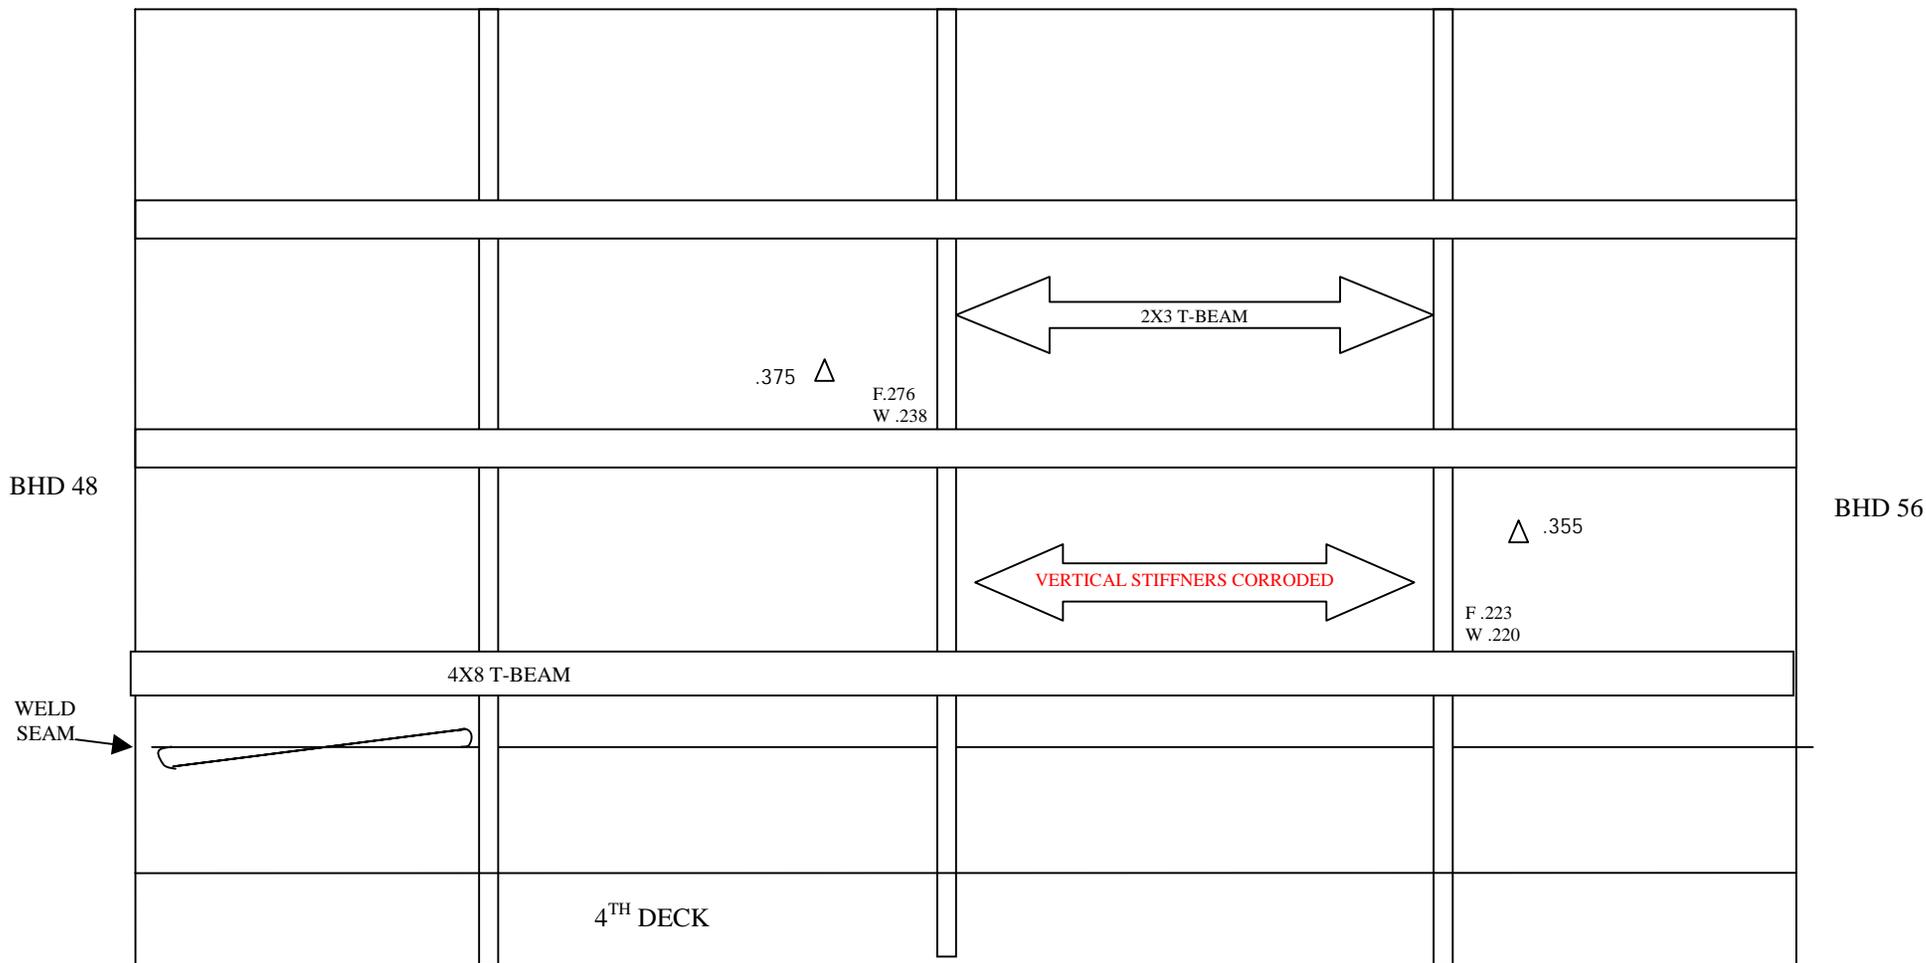
USS UNDERWOOD (FFG-36)
SONAR COOLING ROOM (4-48-1-Q)
SIDE VIEW LOOKING STARBOARD

RED BOX INDICATES AREA WHERE
U/T READINGS WERE TAKEN
REFER TO THE FOLLOWING PAGE FOR
DRAWING
