USS KLAKRING - FFG 42

SHELL CONDITION ASSESSMENT SURVEY
INTERIOR AREAS
DECEMBER 3, 2001 - DECEMBER 14, 2001

PREPARED BY SUPSHIP PORTSMOUTH
JANUARY 2002

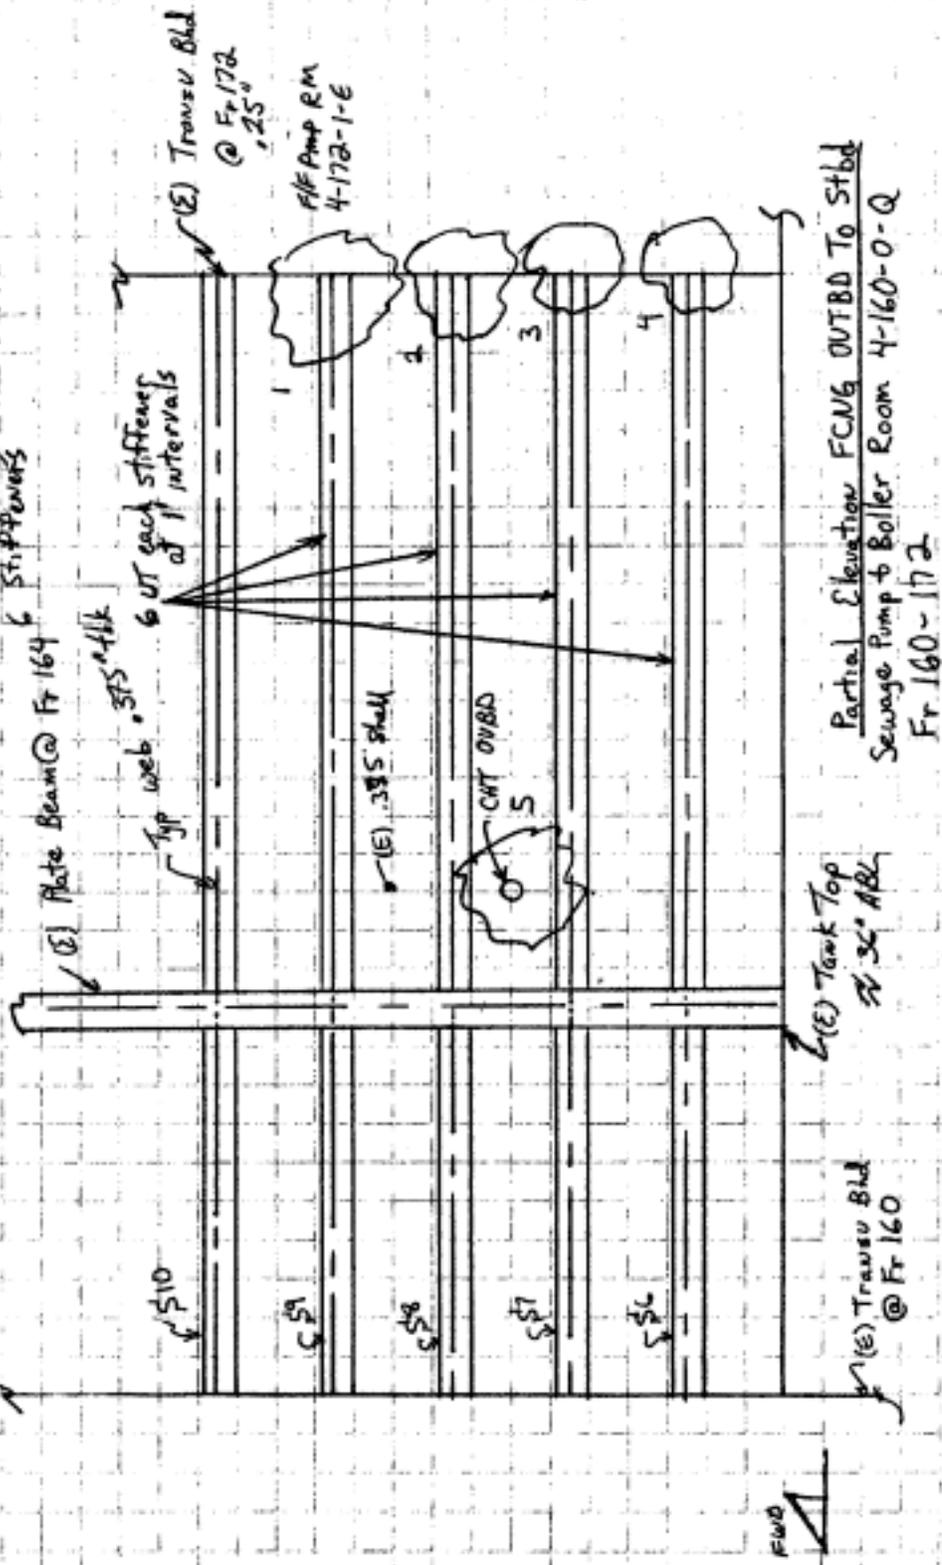
Partial Elevation FCNG OUTBD To Stbd
Sewage Pump to Boiler Room 4-160-0-Q
Fr 160-172

- 1 Shell and bld in way of S9
- 2 Shell and bld in way of S8
- 3 Shell and bld in way of S7
- 4 Shell and bld in way of S6
- 5 CHT OVBD 3 SF
- 6 Stiffeners

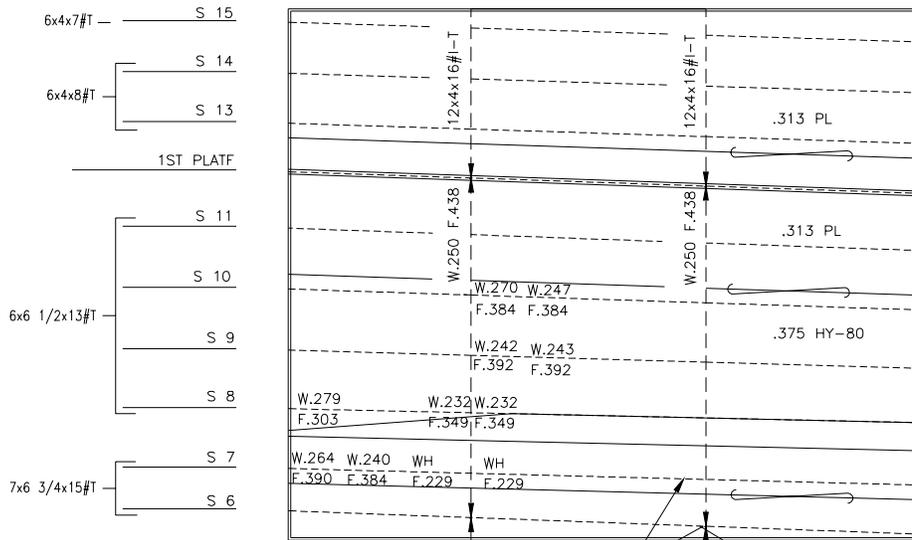
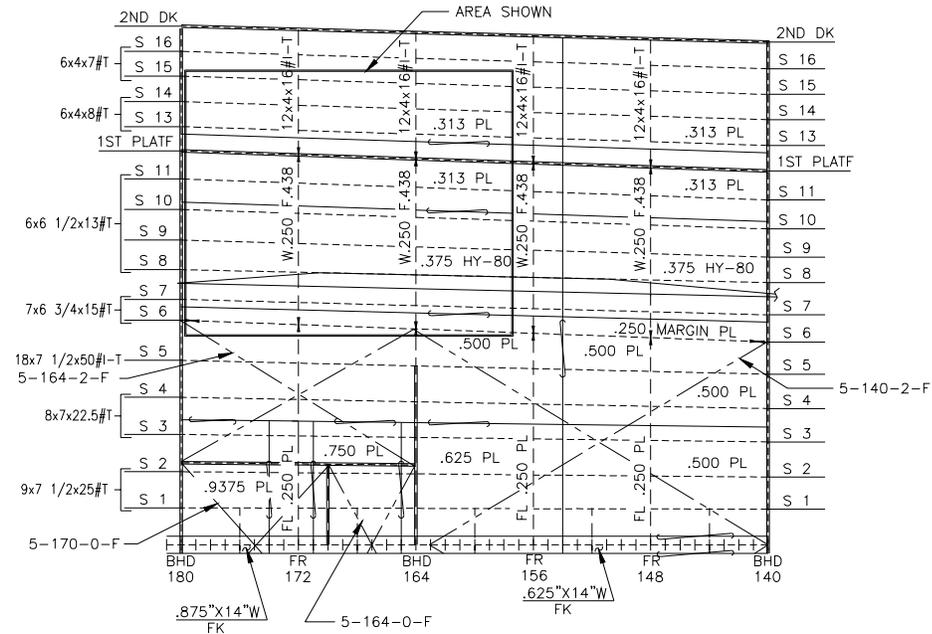
FFG 42 UT SURVEY 12/01, PORT SIDE SEWAGE HANDLING & BOILER ROOM (4-160-0-0)

S.374 = SHELL READING
 W.150 = WEB READING
 F.390 = FLANGE READING
 H = HOLED

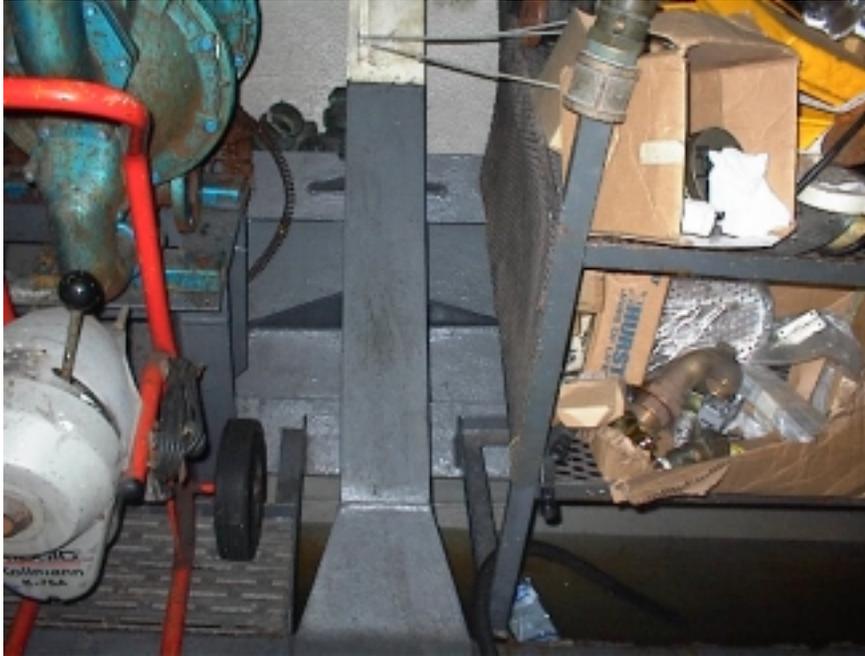
EMO4-P423

USS KLAKRING (FFG 42)
Sewage Handling & Boiler Rm (4-160-0-E) – 12/01

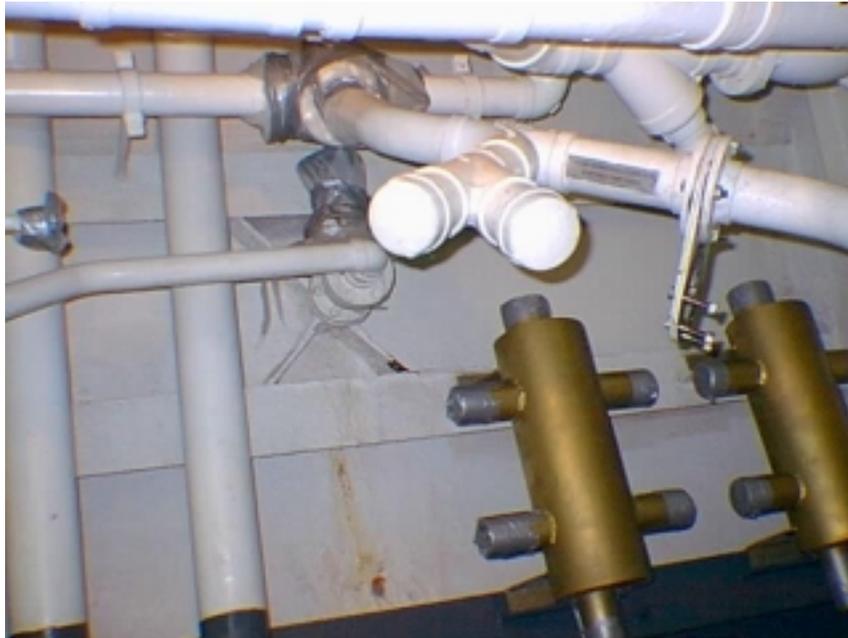
EM04-P423

View of the stbd shell and stringer no. 7 at Fr 164-172. Fresh anti-sweat coating masks heavy scaling of shell and stiffeners.

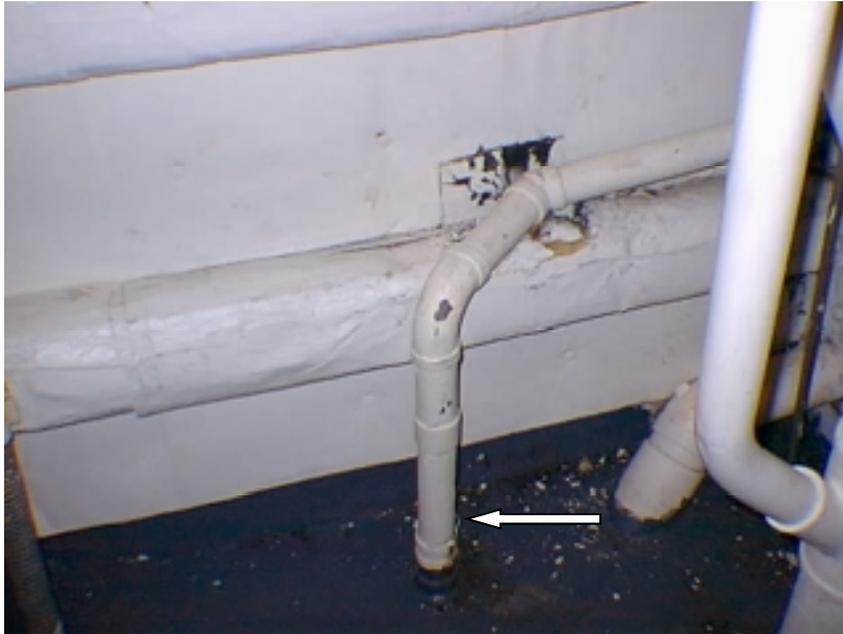
SS02-P022/A028

FR 186-203, stbd, lagging on shell stringer no. 13 is saturated.

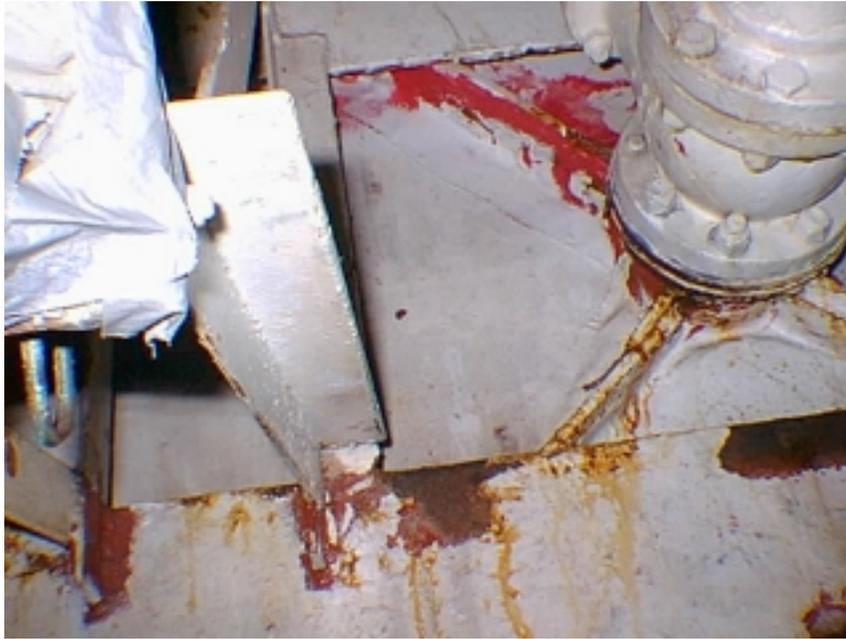
EM02-P030/A745

Seawater overboard, Fr 216, U/L. Shell is not thinned below specs. This area should not be lagged.

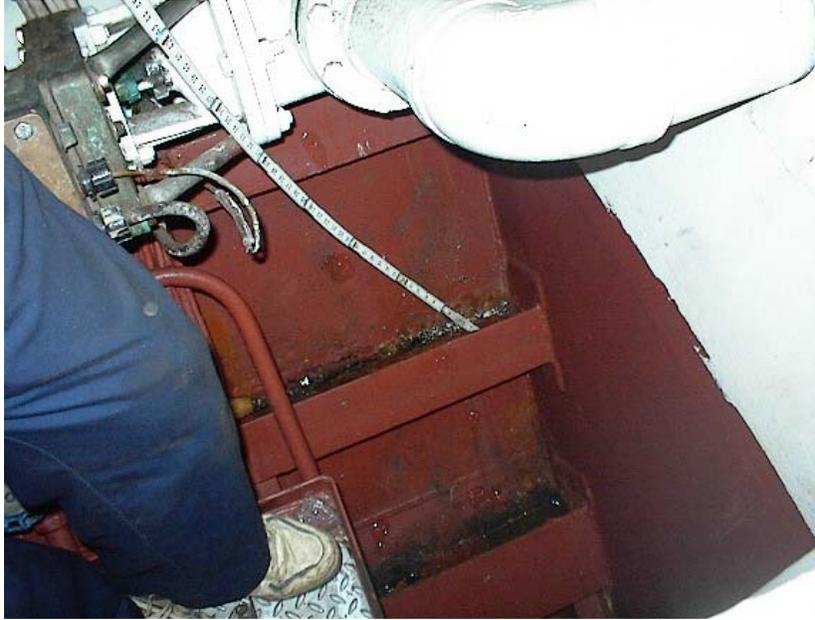
EM02-A746/749

FR.316-324,P, SHELL STRINGER, P11 & P12 WEBS UT READING ARE BELOW ALLOWABLE (DESIGN .190 -READ,G, P11, .120 & P12, .140 - ALLOWABLE, .142 - LOSS 37 & 27 % RESPECTIVELY) AND ARE HOLED DUE TO STANDING WATER AT OVERBOARD VALVE.

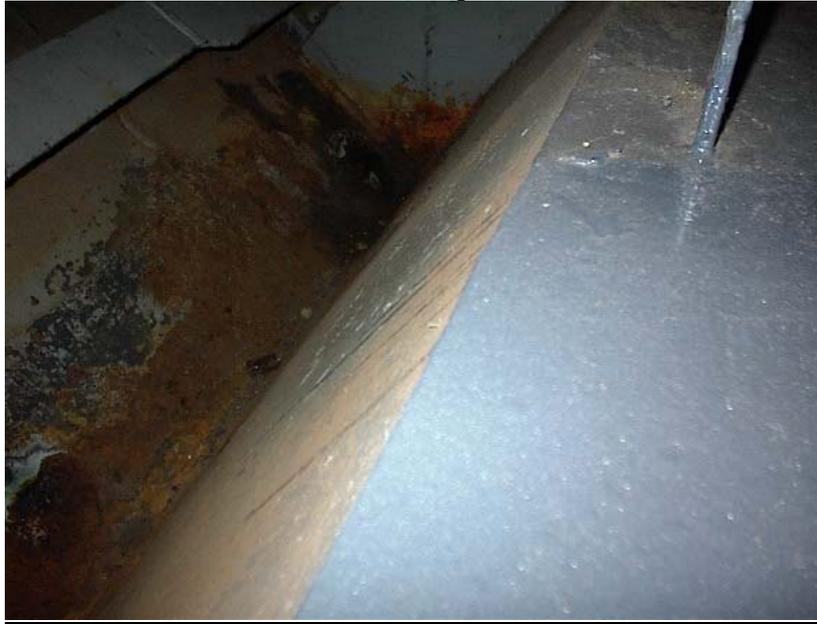
SSO1-A009

FR.328-336,P/S,TROUGH BETWEEN TANK MARGIN PLATE & SHELL AND BULKHEAD, FR.328,IS RUSTED DUE TO STANDING WATER.

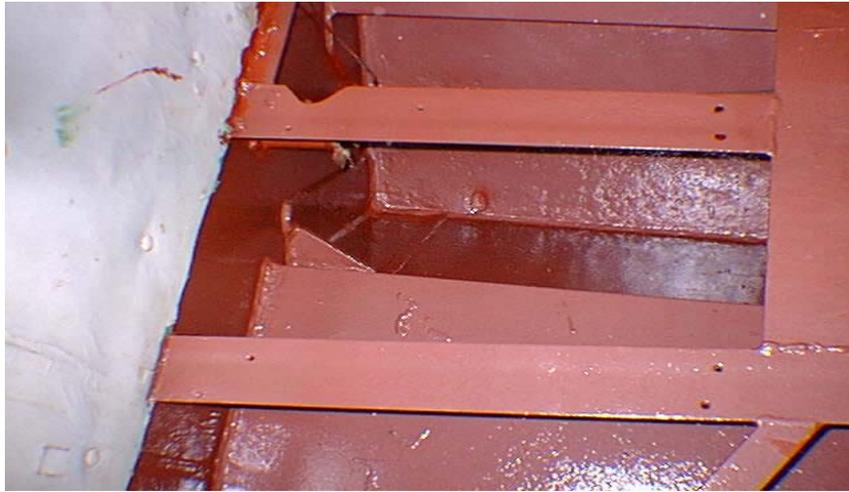
Deep pit in shell, Fr 106, port. Shell is 1/2" thick. (COMPLETE)
