USS NICHOLAS (FFG-47)

SEMAT SHELL CONDITION ASSESSMENT SURVEY INTERIOR AREAS

11/12/01 TO 11/21/01

**PREPARED BY
SUPERVISOR OF SHIPBUILDING CONVERSION AND REPAIR
PORTSMOUTH, VIRGINIA**

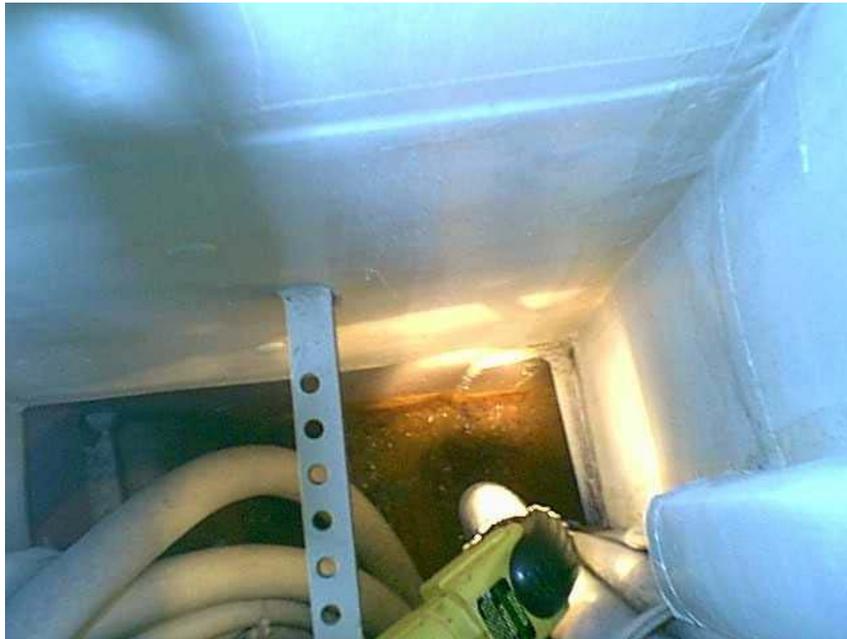
Photo 5: FWD STBD BILGE AREA AND WIREWAY
FRAME 100, FWD No 1 AND 2 APU DISTRIBUTION
POWER PANELS, LOOKING DOWN AND FORWARD

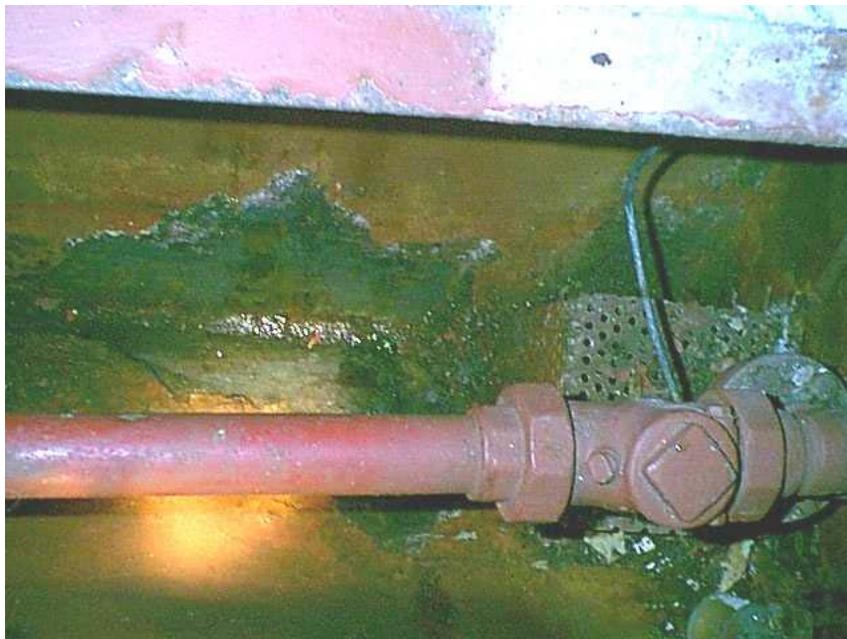
Photo 6: UT SECTION INBD SIDE OF FRAME 108
PORTSIDE AFT BILGE POCKET LOOKING DOWN
AND INBOARD

- PHOTO 1:** APU ROOM BILGE AREA, DETERIORATED BILGE POCKET PORTSIDE AFT FRAME 108, LOOKING DOWN, AFT AND OUTBOARD.
- PHOTO 2:** APU ROOM BILGE AREA, DETERIORATED BILGE PORTSIDE FWD FRAME 100, LOOKING FORWARD AND OUTBOARD.
- PHOTO 3:** APU ROOM BILGE AREA, DETERIORATED BILGE POCKET, STARBOARD SIDE FRAME 108, LOOKING DOWN.
- PHOTO 4:** APU ROOM BILGE AREA, STARBOARD SIDE BELOW NO.1 APU DISTRIBUTION PANEL LOOKING FORWARD.
- PHOTO 5:** APU ROOM, FORWARD STARBOARD SIDE BILGE AREA AND WIREWAY FRAME 100, FORWARD OF NO.1 AND 2 APU POWER PANELS, LOOKING DOWN AND FORWARD.
- PHOTO 6:** APU ROOM, UT SECTION INBOARD SIDE OF FRAME 108, PORTSIDE AFT BILGE POCKET, LOOKING DOWN AND INBOARD.

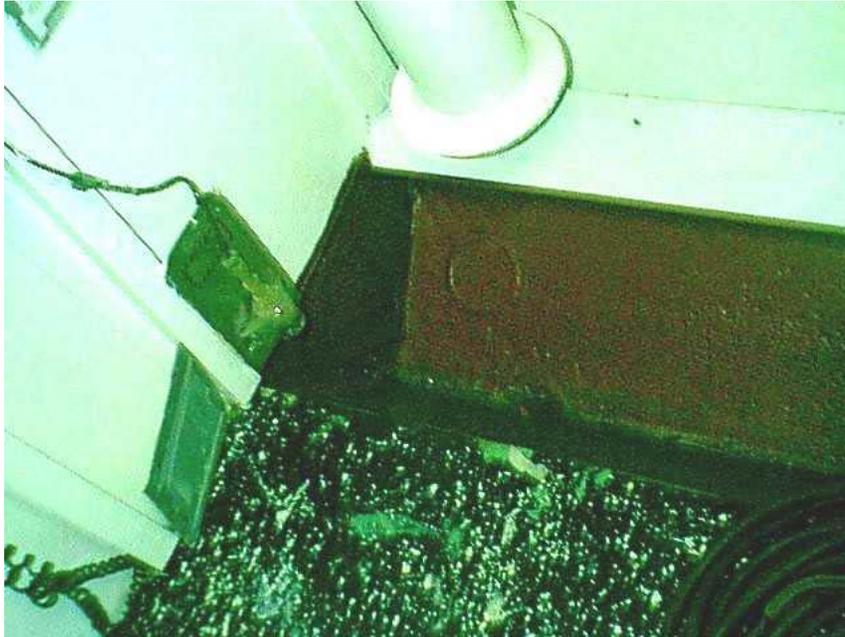
Photo 7: FWD STARBOARD BILGE POCKET,
LOOKING DOWN/FWD/OUTBOARD

- PHOTO 7:** CHT PUMP ROOM, FWD STARBOARD BILGE AREA LOOKING DOWN, FORWARD AND OUTBOARD.
- PHOTO 8:** CHT PUMP ROOM, 4-172-1 OVERBOARD DISCHARGE, SHELL AND LONGITUDINAL DETERIORATION, LOOKING OUTBOARD.

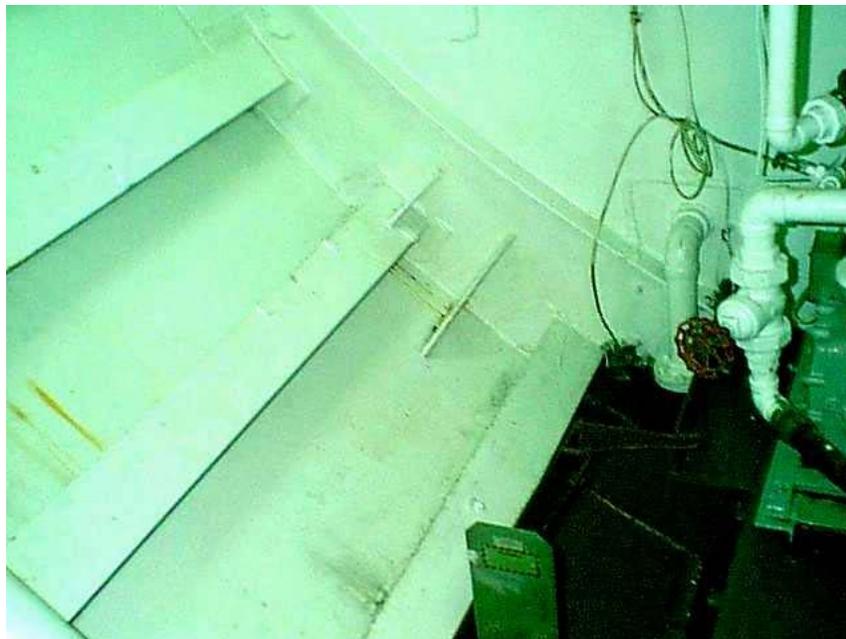
Photo 14: STBD SIDE SHELL AND FRAME 178, LOOKING AFT

- PHOTO 13:** CHT PUMP ROOM, 4-172-1 OVERBOARD DISCHARGE, STARBOARD SIDE SHELL, LOOKING OUTBOARD.
- PHOTO 14:** CHT PUMP ROOM, STARBOARD SIDE SHELL AND FRAME 178, LOOKING AFT

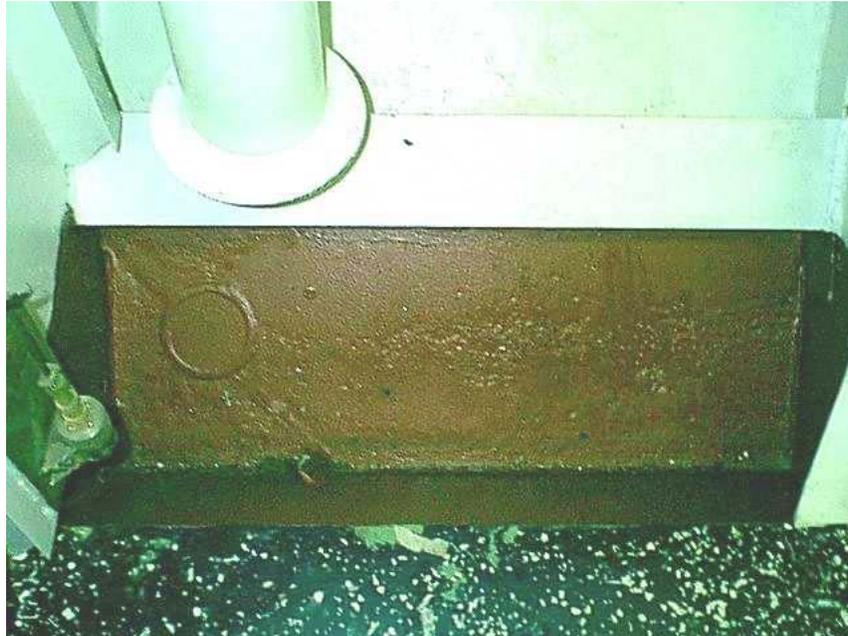
Photo 15: STBD BILGE POCKET SHELL, UT AREA
LOOKING OUTBOARD/DOWN

- PHOTO 15:** CHT PUMP ROOM, STARBOARD BILGE POCKET SHELL, UT AREA, LOOKING OUTBOARD AND DOWN.
- PHOTO 16:** CHT PUMP ROOM, STARBOARD BILGE POCKET TANK PLATING, UT AREA, LOOKING INBOARD AND DOWN.

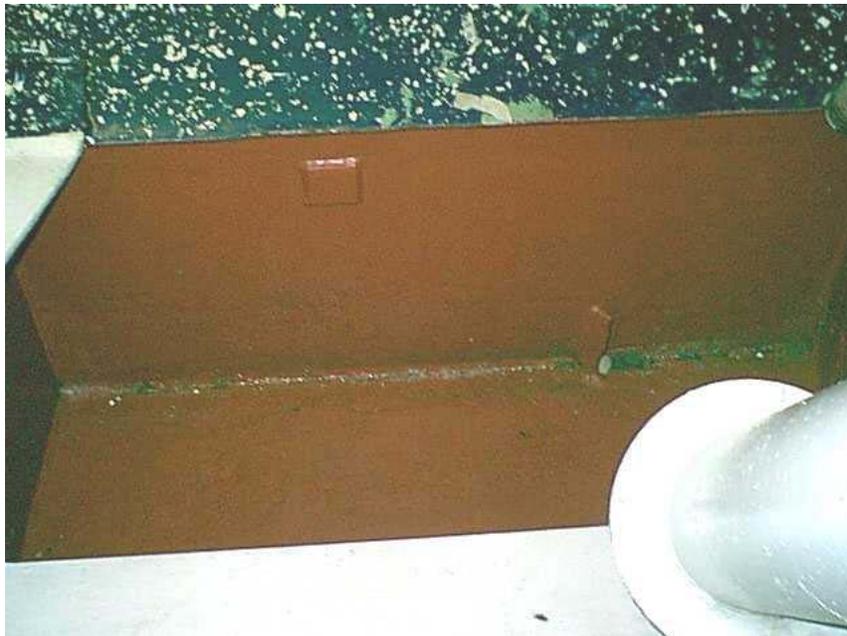
Photo 16: STBD BILGE POCKET TANK PLATING,
UT AREA LOOKING INBOARD/DOWN

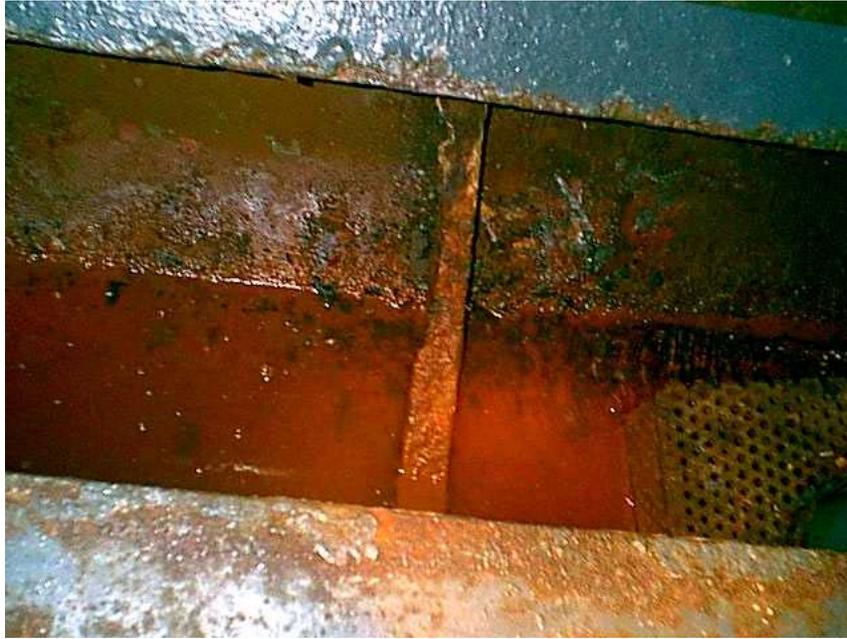
Photo 19: AFT STBD BILGE POCKET SHELL BELOW EDUCTOR, LOOKING DOWN/OUTBOARD

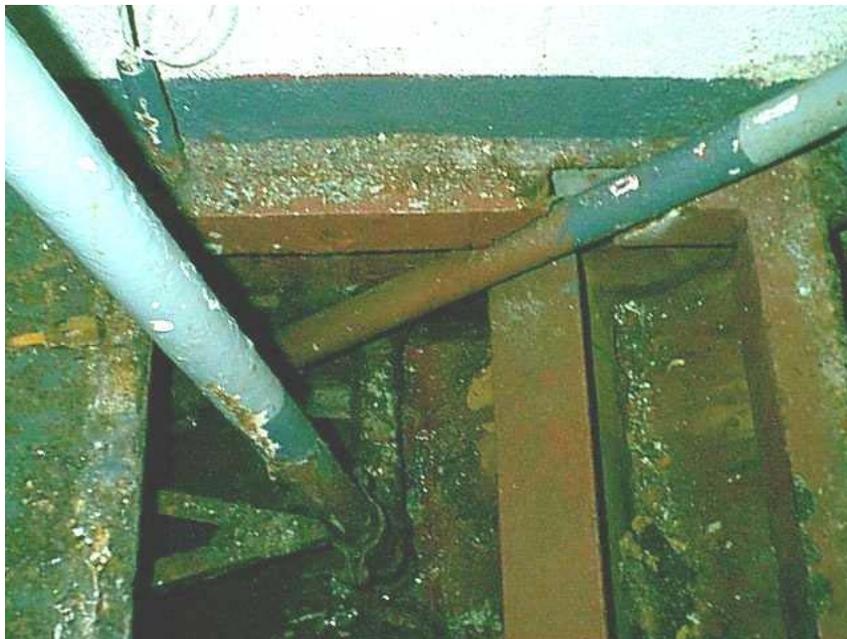
Photo 20: AFT PORT BILGE POCKET, FRAME 56, LOOKING DOWN/AFT

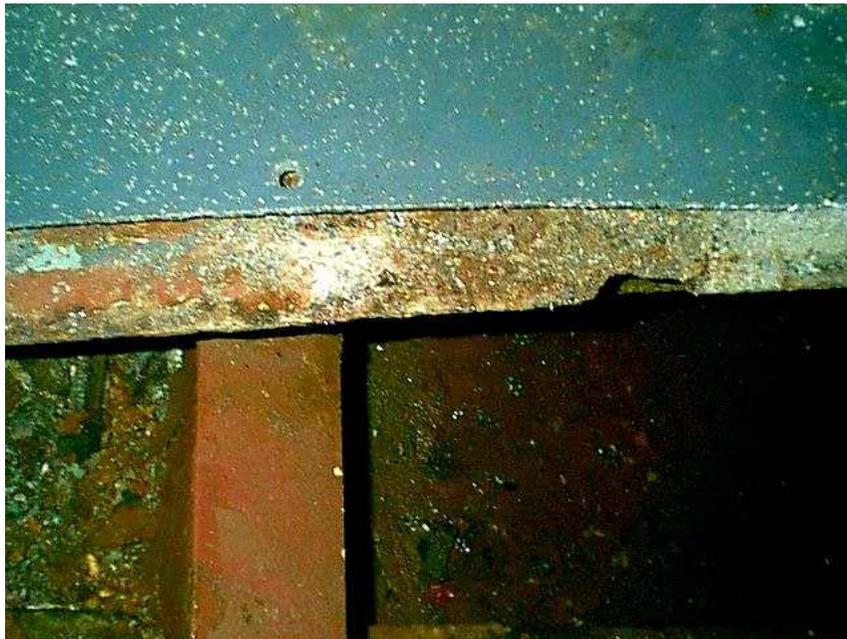
Photo 21: THINNED PORTSIDE BILGE AREA
DECK PLATE SUPPORT AND FRAMING,
LOOKING FORWARD

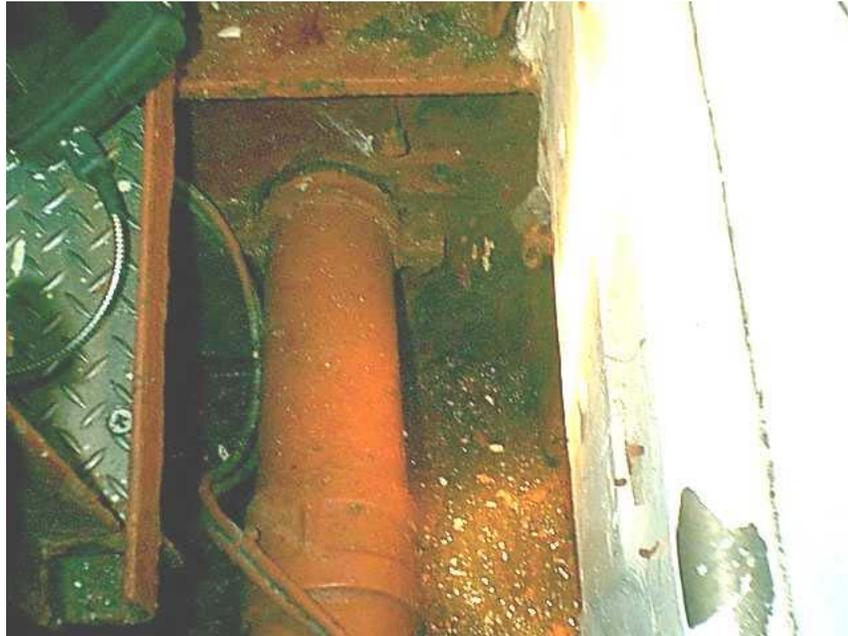
Photo 31: LONGITUDINAL No. 6 AFT OF FRAME 204
LOOKING INBOARD

- PHOTO 25:** AMR 1, PORTSIDE FRAME 196, LONGITUDINAL No. 7 TO 8, BALLAST, LOOKING FORWARD.
- PHOTO 26:** AMR 1, PORTSIDE FRAME 180, LONGITUDINAL No. 5 TO 6, BALLAST, LOOKING OUTBOARD.
- PHOTO 27:** AMR 1, DETERIORATION AT FRAME 180 PORTSIDE, LONGITUDINAL No. 6 TO 7, BALLAST AND FUNNEL FOR SSDG JACK WATER COOLER, LOOKING FORWARD.
- PHOTO 28:** AMR 1, BALLAST FRAME 180-188 PORTSIDE, DETERIORATION AT LONGITUDINALS, LOOKING OUTBOARD AND AFT, BALLAST BELOW 5-183-2-F
- PHOTO 29:** AMR 1, FRAME 204 PORTSIDE FILLED FUNNEL LOOKING OUTBOARD AND AFT.
- PHOTO 30:** AMR 1, UT AREA LOWER LEVEL PORTSIDE SHELL PLATING BETWEEN LONGITUDINAL No. 6 AND LONGITUDINAL No. 7, LOOKING DOWN AND AFT.
- PHOTO 31:** AMR 1, LONGITUDINAL No. 6, AFT OF FRAME 204, LOOKING INBOARD.

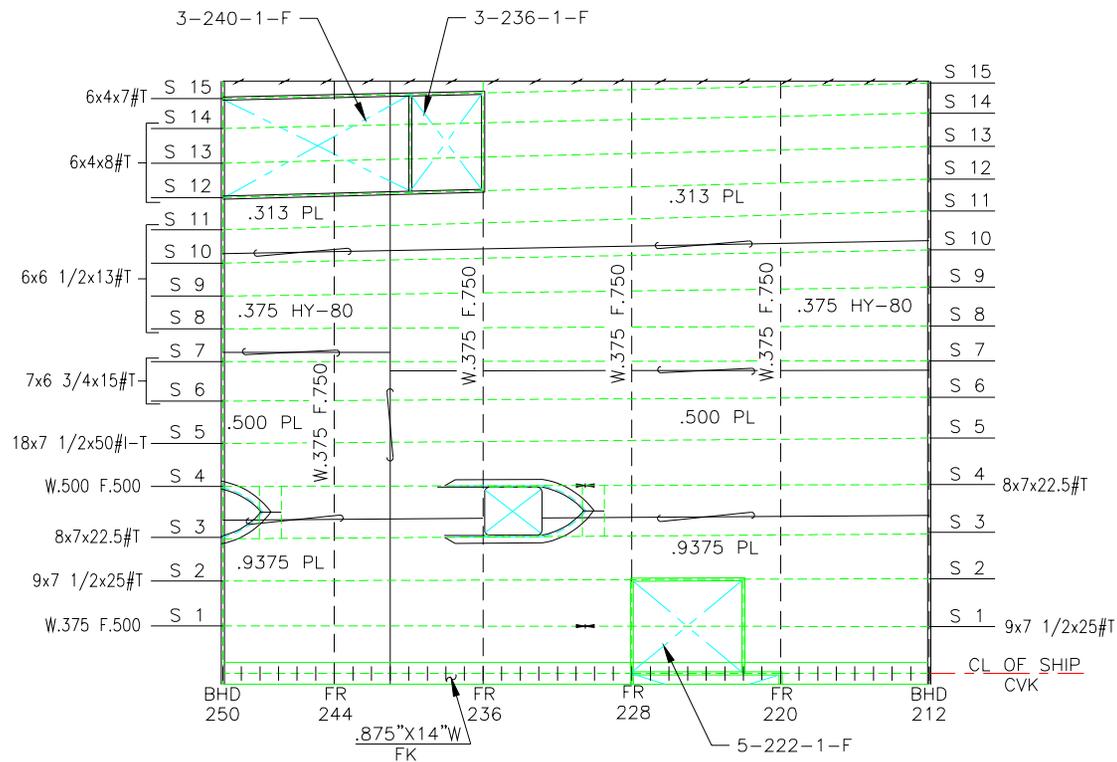
AMR No. 2 STARBOARD SIDE STRUCTURAL DIAGRAM

NOTE: NO SHELL AREAS OF STRUCTURALLY SIGNIFICANT DAMAGE OR DETERIORATION.

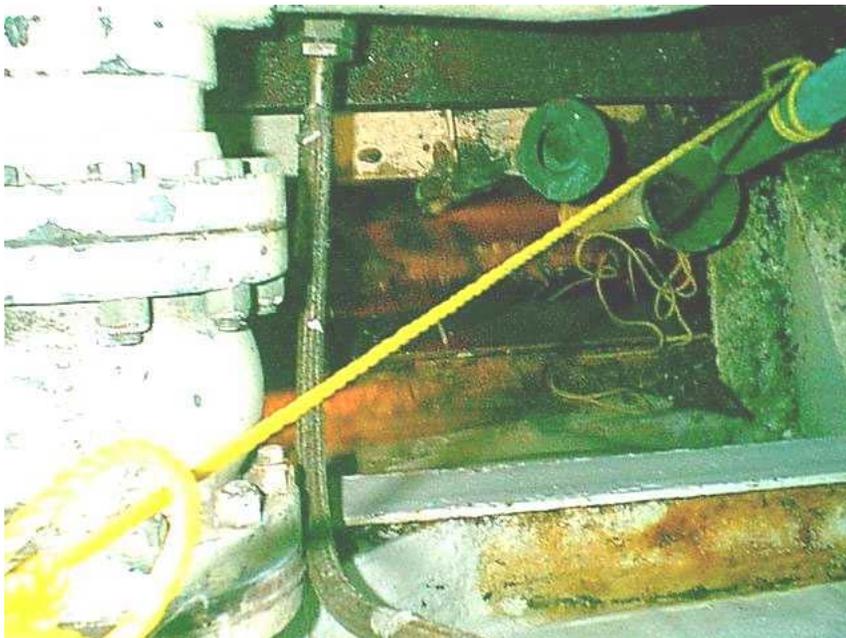
Photo 38: LOWER LEVEL PORTSIDE SHELL AND
LONGITUDINALS IMPACTED BY COOLING WATER
OVBD VALVE, LOOKING DOWN BEHIND HPAC

- PHOTO 38:** AMR 2, LOWER LEVEL PORTSIDE SHELL AND LONGITUDINALS IMPACTED BY COND AND AIR COMPRESSOR COOLING WATER OVERBOARD DISCHARGE ASW-V21-3-216-2 LOOKING DOWN BEHIND HPAC AT UPPER AND LOWER LEVELS

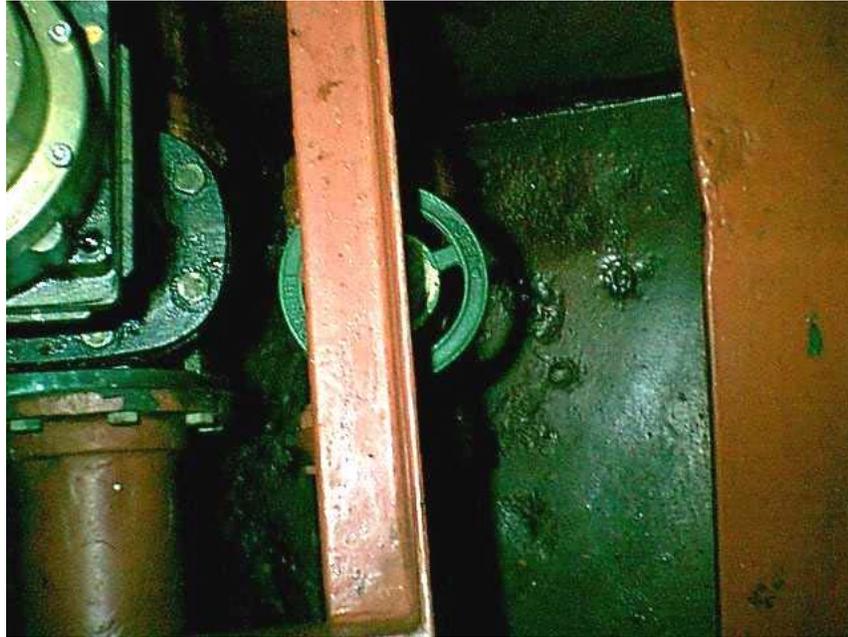
Photo 41: PITTED SHELL FORWARD OF SSDG SW CLG PUMP SEA CHEST, PORTSIDE BTWN LONGITUDINAL No.3 AND 4, LOOKING DOWN/AFT

- PHOTO 41:** AMR 2 LOWER LEVEL, PITTED SHELL FORWARD OF SSDG SEAWATER COOLING PUMP SEA CHEST, PORTSIDE BETWEEN LONGITUDINAL No. 3 AND 4, LOOKING DOWN AND AFT.

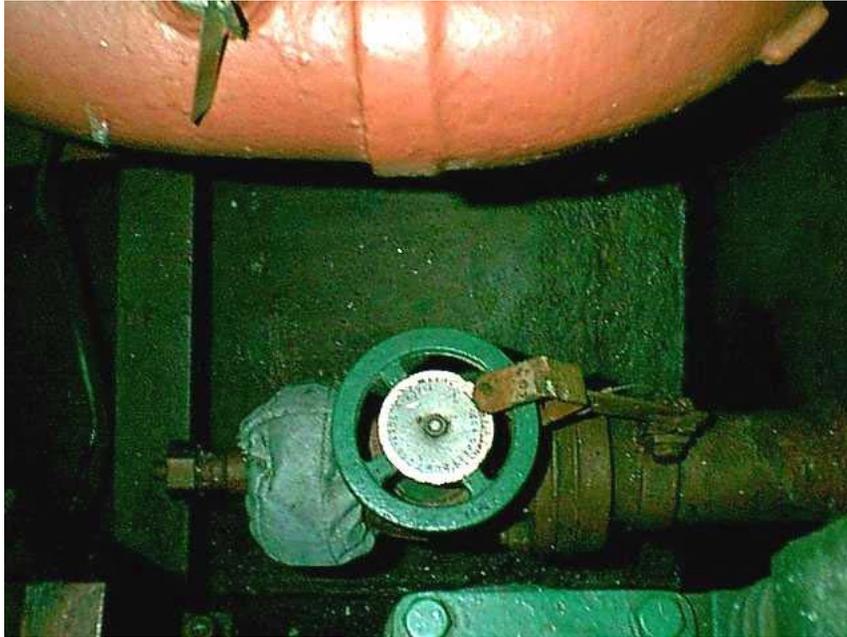
Photo 43: COMPARISON OF SHELL FORWARD OF SSDG SW CLG PUMP SEA CHEST, STBD SIDE BTWN LONGITUDINAL No.3 AND 4, LOOKING DOWN/OUTBOARD

- PHOTO 43:** AMR 2 LOWER LEVEL, STARBOARD SIDE BETWEEN LONGITUDINAL No. 3 AND 4 AND FORWARD OF SSDG SW CLG PUMP SEA CHEST FWD BULKHEAD, LOOKING OUTBOARD AND DOWN, COMPARISON WITH PHOTO 41,

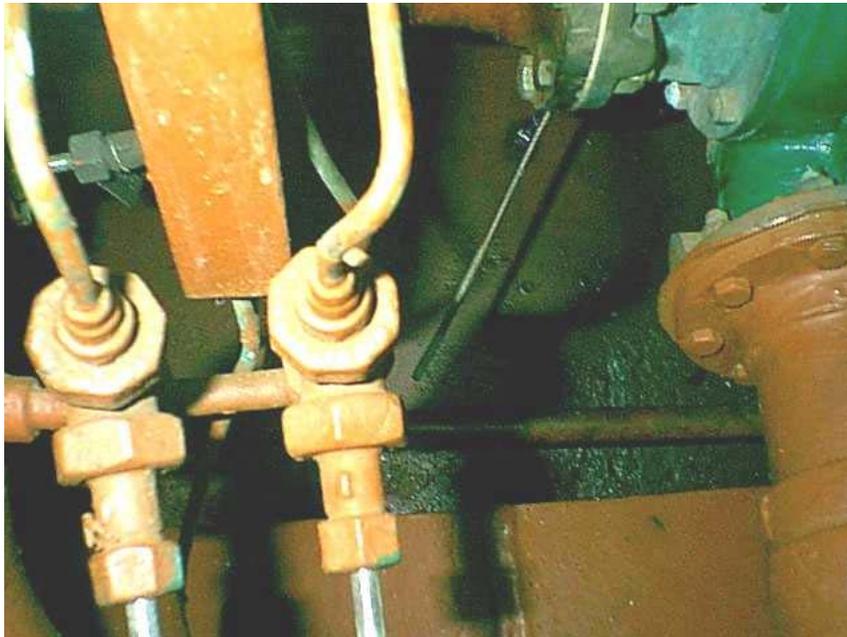
Photo 44: COMPARISON OF SHELL FWD/OUTBOARD SSDG SW CLG PUMP SEA CHEST, STBD SIDE BTWN LONGITUDINAL No. 4 and 5, LOOKING OUTBOARD

- PHOTO 44:** AMR 2 LOWER LEVEL STARBOARD SIDE BETWEEN LONGITUDINAL No. 4 AND 5 AND FIVE FEET FORWARD AND OUTBOARD OF SSDG SW CLG PUMP SEA CHEST FWD BULKHEAD, LOOKING OUTBOARD, COMPARISON WITH PHOTO 42,

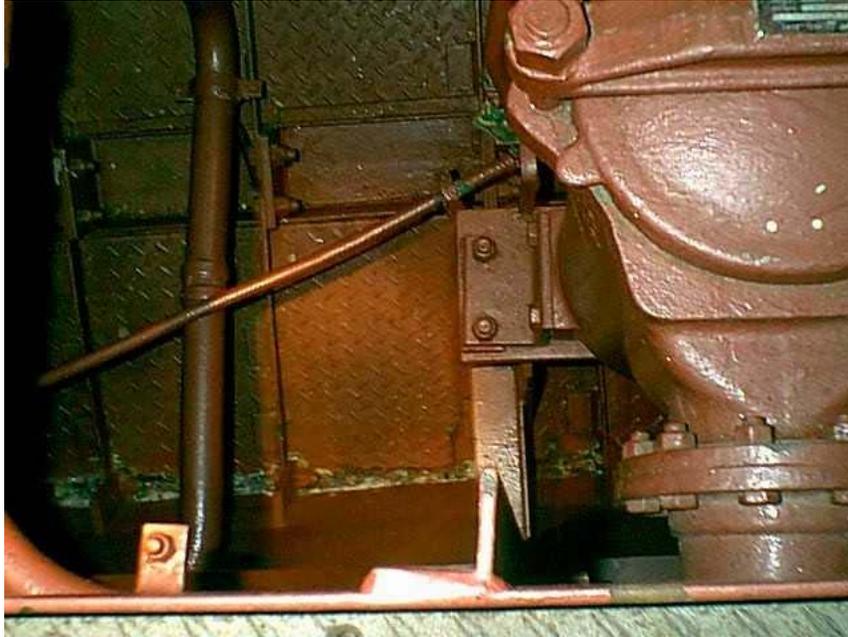
Photo 46: LOWER LEVEL PORTSIDE BELOW DECK PLATES, AFT OF SW STRAINER 1B GTM, BALLAST,

- PHOTO 46:** MER LOWER LEVEL PORTSIDE BELOW DECK PLATES, AFT OF SEAWATER STRAINER FOR 1B GTM, SHOWING BALLAST AND SALT BUILDUP, LOOKING DOWN AND OUTBOARD.

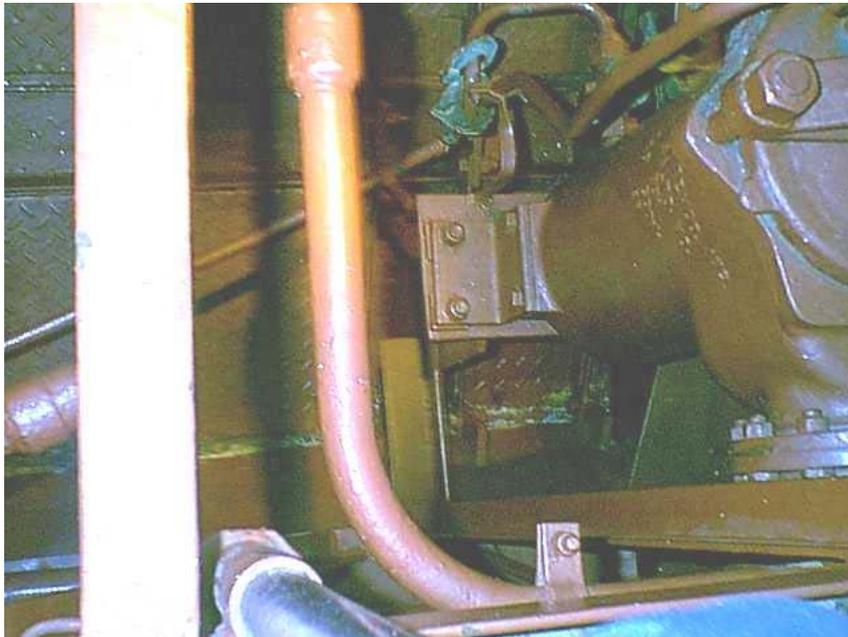
Photo 47: LOWER LEVEL PORTSIDE BELOW DECK PLATES, AFT OF SW STRAINER 1B GTM, BALLAST,

- PHOTO 47:** MER LOWER LEVEL PORTSIDE BELOW DECK PLATES, AFT OF SEAWATER STRAINER FOR 1B GTM, SHOWING BALLAST AND SALT BUILDUP, LOOKING DOWN AND OUTBOARD.

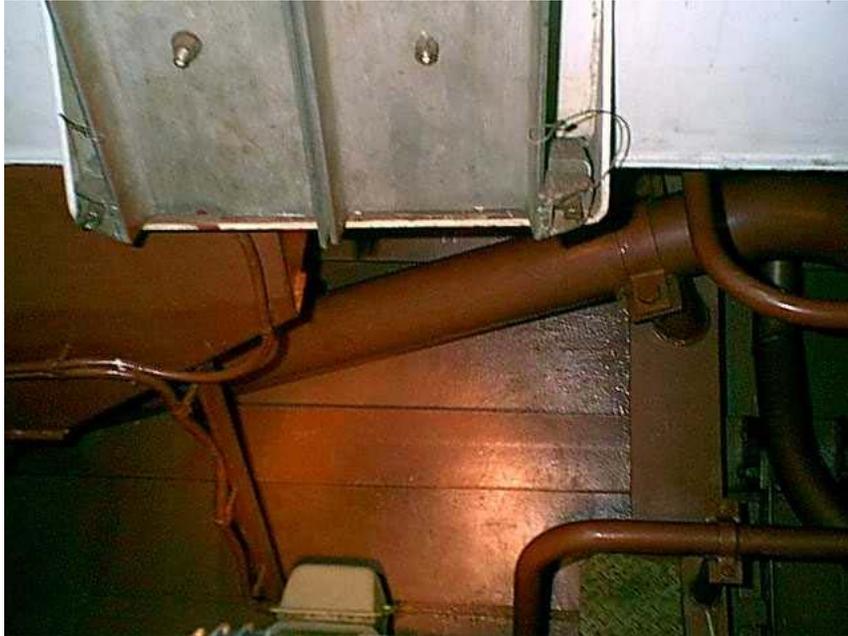
Photo 56: WELL PRESERVED BILGE AREA, STBD SIDE BELOW ESCAPE TRUNK, LOOKING OUTBOARD/DOWN

- PHOTO 55:** MER LOWER LEVEL BILGE AREA, STARBOARD SIDE, FRAME 262, INDICATES SALT BUILDUP, LOOKING DOWN AND AFT.
- PHOTO 56:** GOOD BILGE PRESERVATION MER LOWER LEVEL STARBOARD SIDE, FWD AND BELOW THE STARBOARD ESCAPE TRUNK, LOOKING OUTBOARD AND DOWN.

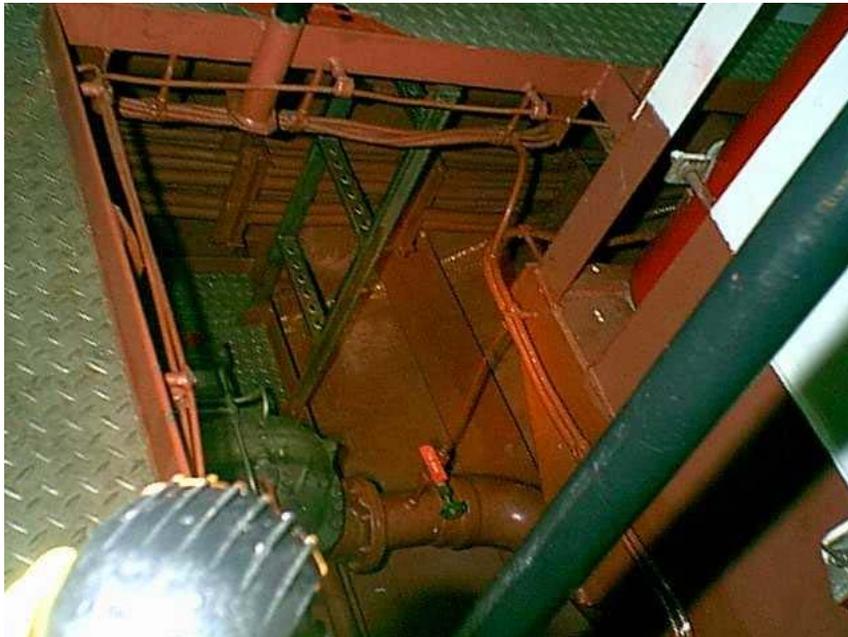
Photo 57: WELL PRESERVED BILGE AREA, STBD SIDE FORWARD ESCAPE TRUNK, LOOKING FWD/OUTBOARD/DOWN

- PHOTO 57:** GOOD BILGE PRESERVATION MER LOWER LEVEL STARBOARD SIDE, FWD OF THE STARBOARD ESCAPE TRUNK, LOOKING FORWARD, OUTBOARD AND DOWN

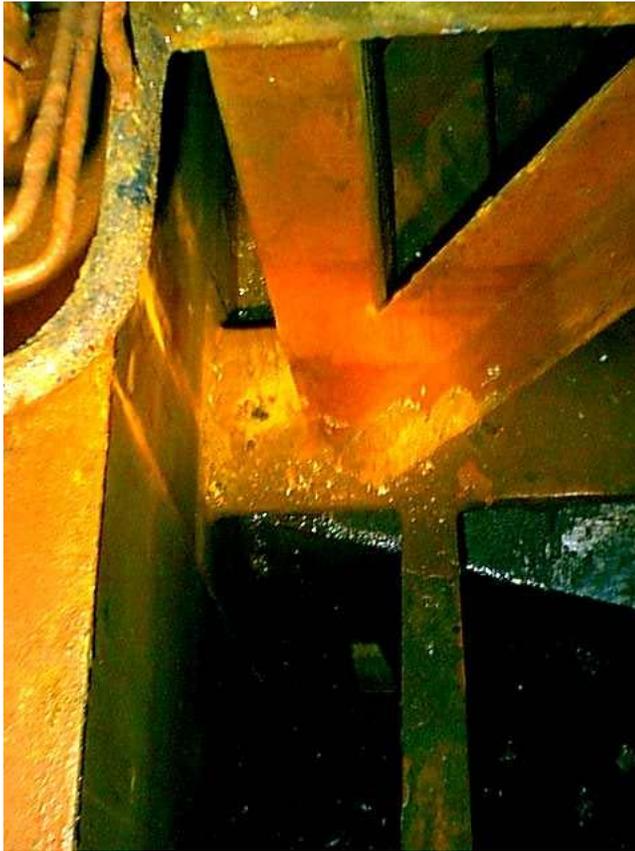
Photo 58: LOWER LEVEL
STBD SIDE AFT
BULKHEAD WASTE
WATER TANK AND
LONGITUDINAL No. 1
STBD, LOOKING
DOWN/OUTBOARD

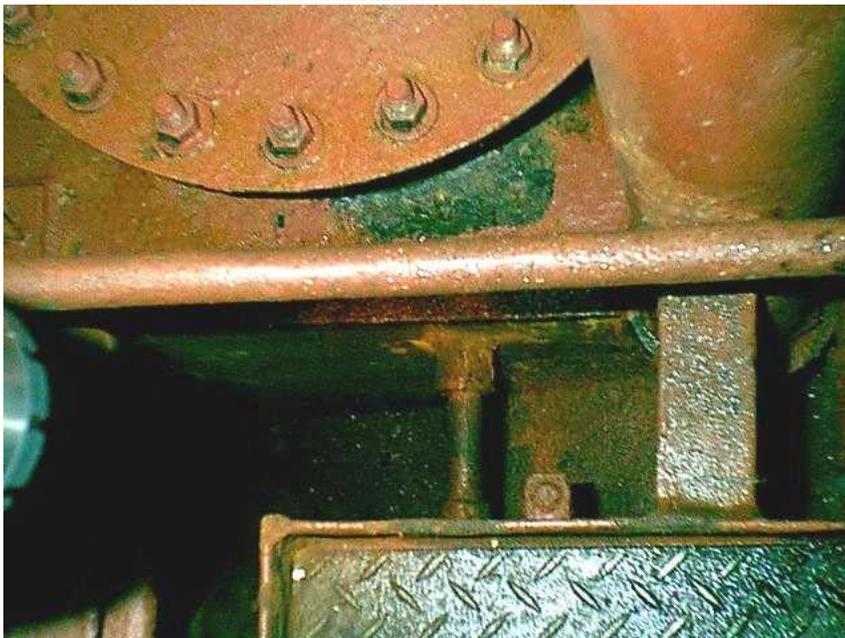
Photo 59: LOWER LEVEL STBD SIDE AFT BULKHEAD
AND TOP OF WASTE WATER TANK, LOOKING
DOWN/FORWARD

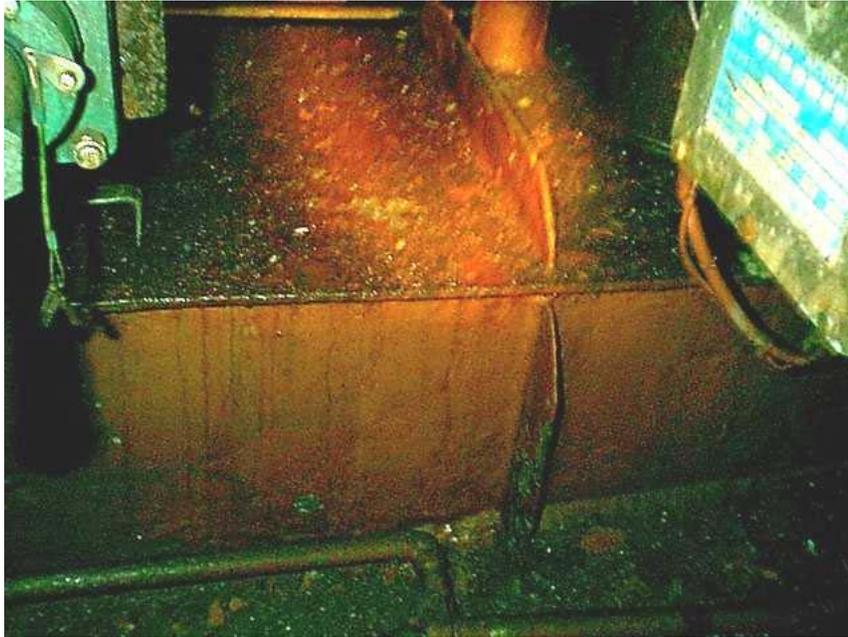
Photo 62: LOWER LEVEL STBD SIDE, No. 4 AND 5
FIRE PUMP SUCTION SEA CHEST, LOOKING
OUTBOARD

- PHOTO 62:** AMR 3 LOWER LEVEL, NO. 4 AND 5 FIRE PUMP SEA CHEST, LOOKING OUTBOARD.
- PHOTO 63:** AMR 3 LOWER LEVEL, PORTSIDE FORWARD END OF SSDG SW CLG PUMP SEA CHEST LOOKING AFT.

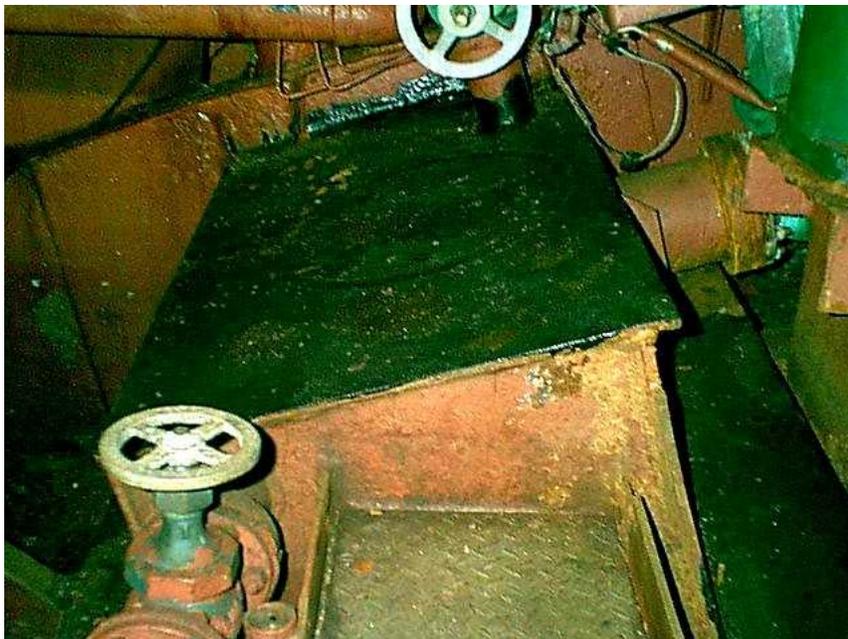
Photo 63: LOWER LEVEL PORTSIDE, SSDG SW CLG
PUMP SEA CHEST, LOOKING AFT

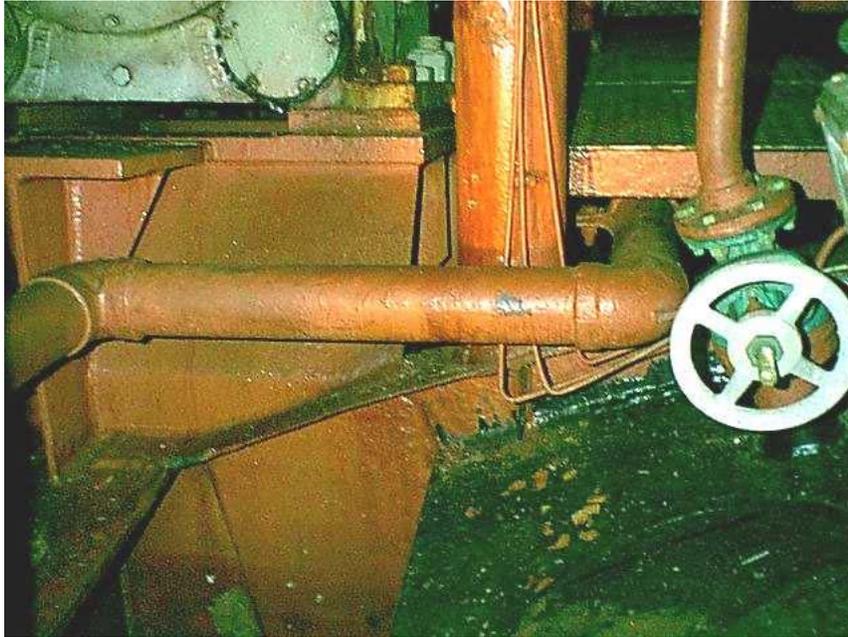
Photo 64: LOWER LEVEL PORTSIDE, TRANSVERSE FRAME 308, SSDG SW CLG PUMP SEA CHEST TANK TOP AND PORTSIDE VERTICAL STANCHION, LOOKING AFT

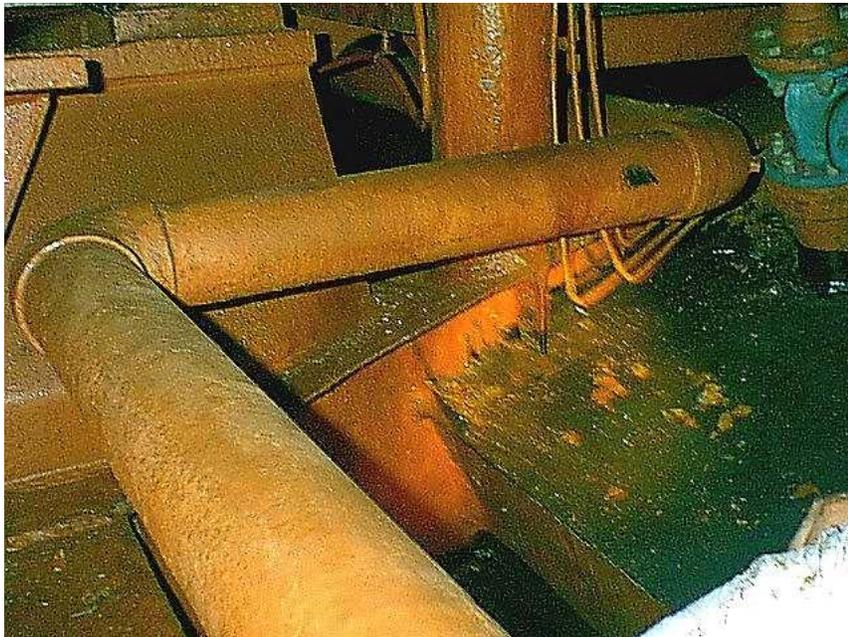
Photo 65: LOWER LEVEL PORTSIDE, TRANSVERSE FRAME 308, SSDG SW CLG PUMP SEA CHEST TANK TOP AND PORTSIDE VERTICAL STANCHION, LOOKING AFT/OUTBOARD

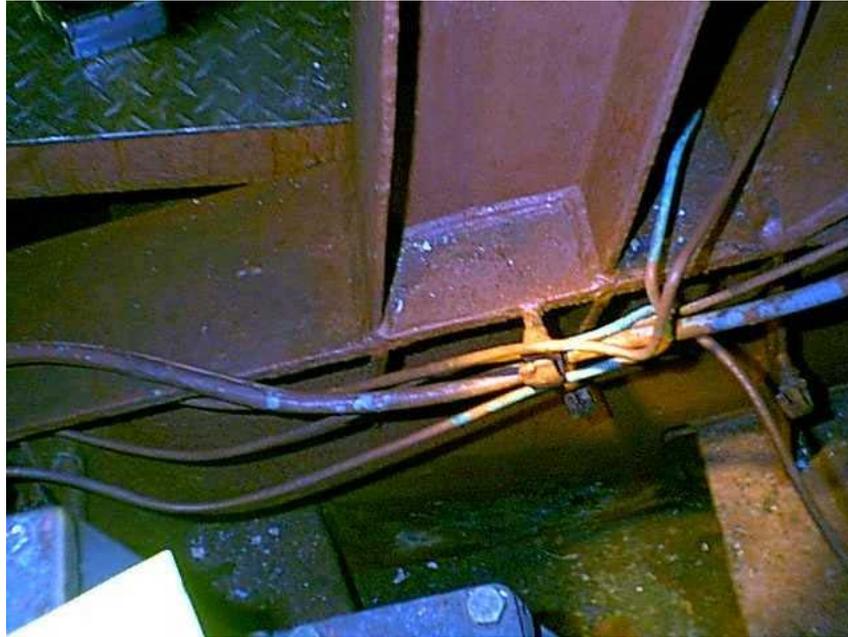
Photo 66: LOWER LEVEL PORTSIDE TRANSVERSE FRAME 308, LONGITUDINAL No. 2 AND 3 PORT, LOOKING DOWN/OUTBOARD/AFT

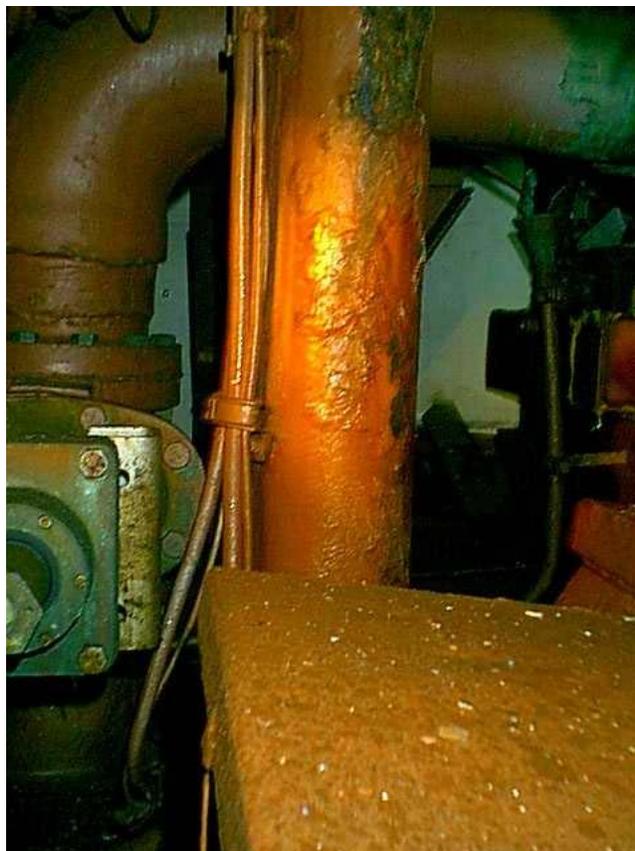
Photo 67: LOWER LEVEL, STBD SIDE, FRAME 308 STANCHION, LOOKING OUTBOARD FROM ABOVE BEARING PEDESTAL

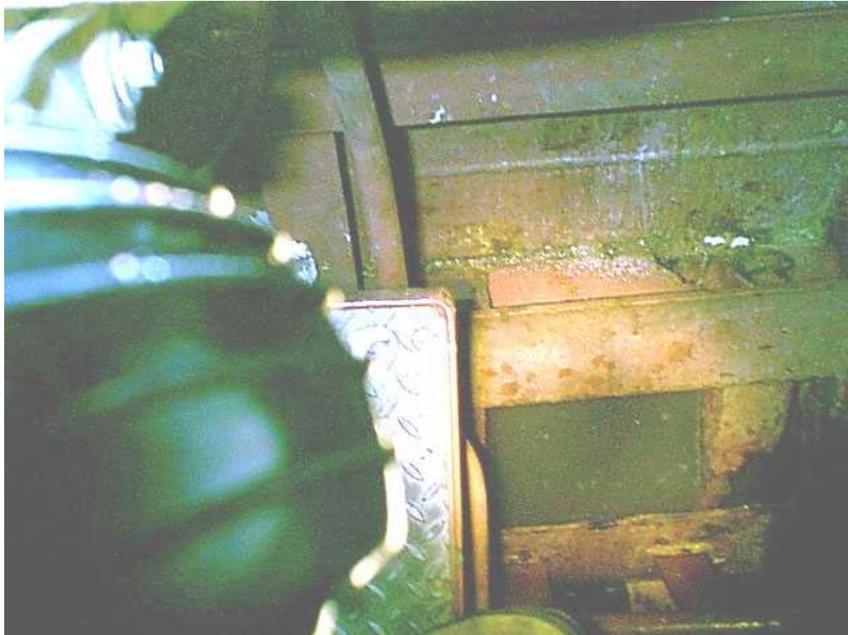
Photo 81: LOWER LEVEL PORTSIDE SHELL AND LONGITUDINAL No. 7 AND 8 FROM OVERHEAD, AREA IS BELOW SSDG CLG WATER OVBD, LOOKING OUTBOARD/DOWN

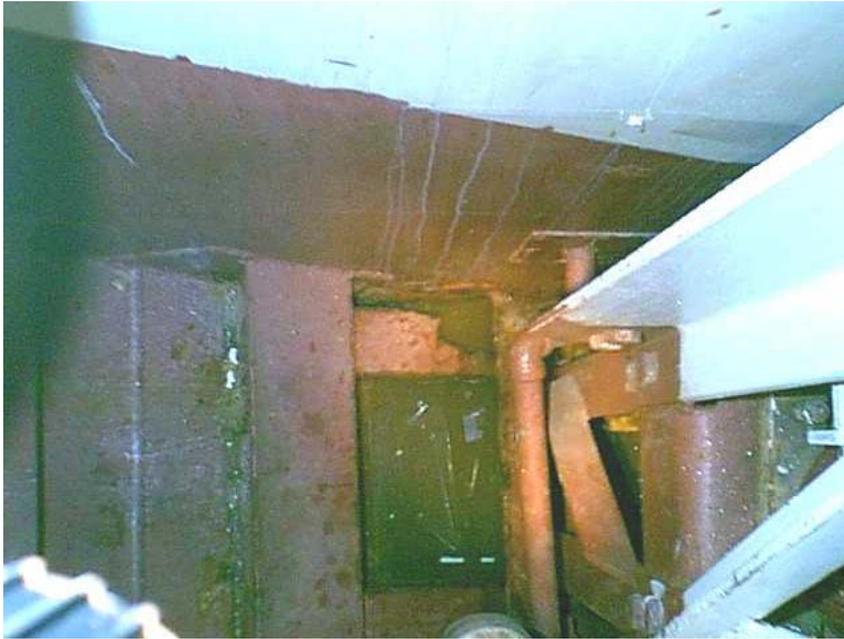
Photo 82: LOWER LEVEL PORTSIDE SHELL AND LONGITUDINAL No. 8 AND 9 FROM OVERHEAD, AREA IS BELOW SSDG CLG WATER OVBD, LOOKING DOWN

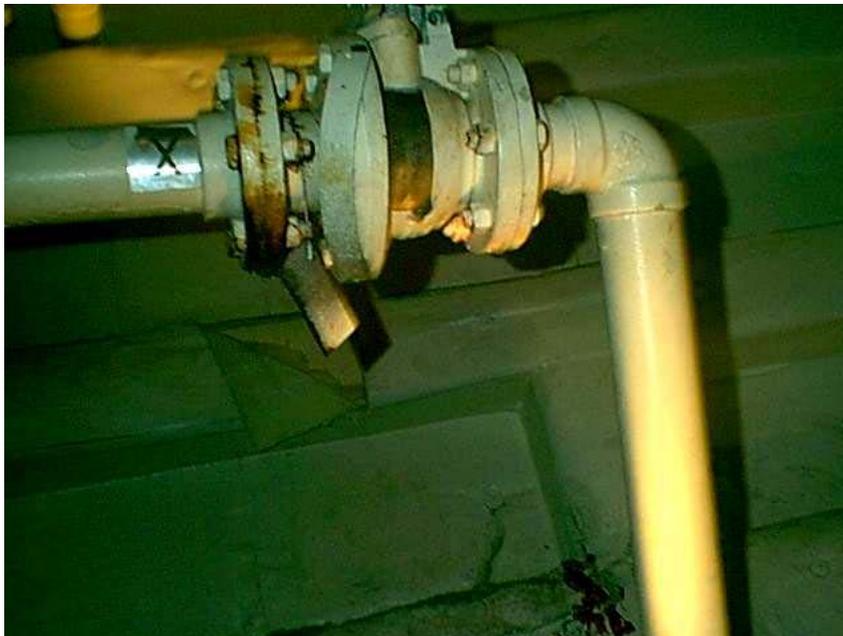
Photo 84: STBD SIDE, EDUCTOR OVERBOARD VALVE, LOOKING OUTBOARD

- PHOTO 83:** AFTER STEERING EDUCTOR ROOM BILGE SECTION BELOW STEERING GEAR ROOM DRAIN PUMP, LOOKING INBOARD AND AFT.
- PHOTO 84:** AFTER STEERING EDUCTOR ROOM EDUCTOR DISCHARGE VALVE, LOOKING OUTBOARD.

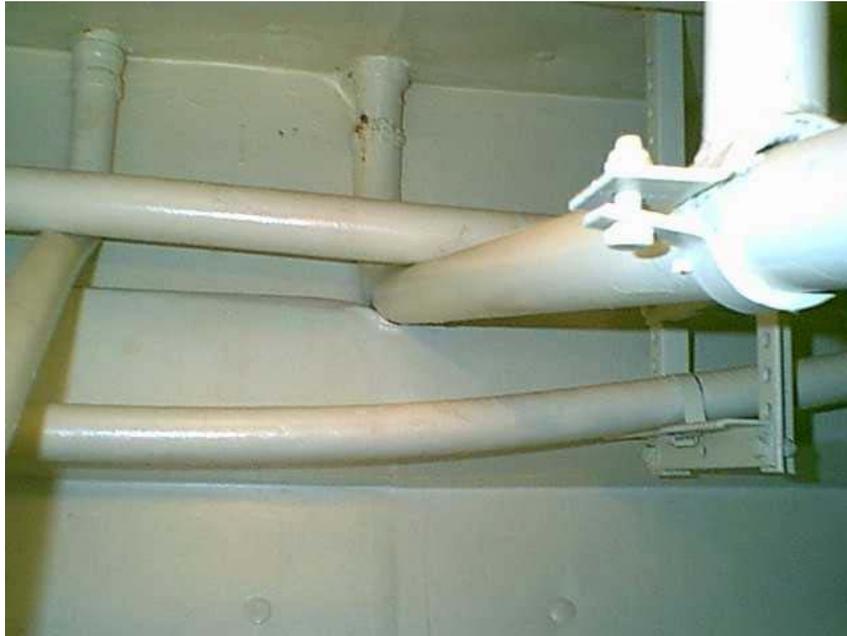
Photo 85: STBD SIDE, HOLED VENT PIPE JUST BELOW OVERHEAD AND INBOARD OF SHELL, LOOKING UP/OUTBOARD

- PHOTO 85:** AFTER STEERING EDUCTOR ROOM HOLED VENT PIPE JUST BELOW OVERHEAD AND INBOARD OF SHELL, LOOKING UP AND OUTBOARD.
- PHOTO 86:** AFTER STEERING EDUCTOR ROOM FRAME 368 STARBOARD SIDE, SALT ENCRUSTED LAGGING ON SHELL AND LONGITUDINAL NO. 4 FROM OVERHEAD, LOOKING OUTBOARD.
- PHOTO 87:** AFTER STEERING EDUCTOR ROOM FRAME 368 STARBOARD SIDE, SALT ENCRUSTED LAGGING ON SHELL AND LONGITUDINAL NO. 5 FROM OVERHEAD, LOOKING OUTBOARD.
- PHOTO 88:** AFTER STEERING EDUCTOR ROOM FORWARD INBOARD BILGE AREA, FRAME 368, LOOKING DOWN AND FORWARD.

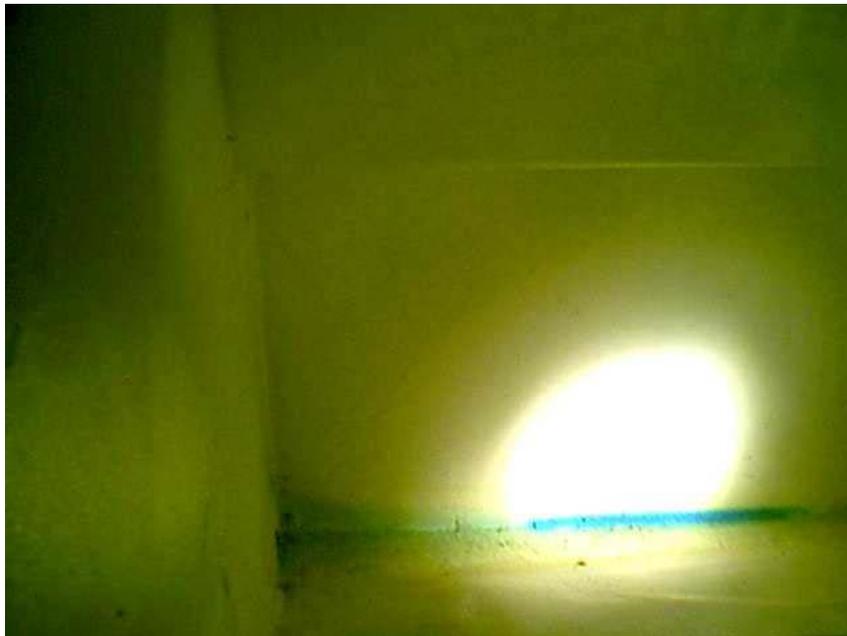
Photo 86: SALT ENCRUSTED LONGITUDINAL No. 4 FROM OVERHEAD AND SHELL INSULATION, FRAME 368 STBD SIDE LOOKING OUTBOARD

RECOMMENDED REPAIRS					
REMOVE APPROX. 110 SF OF SATURATED SHELL INSULATION.					
REMOVE CORROSION EXPOSED BY REMOVALS. PRIME AND PRESERVE SHELL EXPOSED BY					
INSULATION REMOVALS. INSTALL NEW INSULATION IN PLACE OF THAT REMOVED. PAINT NEW					
SURFACES TO MATCH SURROUNDING AREAS.					
SSPORT C221 POC: J. BRUCKNER (757) 396-4001, TPOC: A. DAVIS /HUGHES, CDI					
CSMP SUMMARY STEERING (5-368-01-E) SHELL INSULATION SATURATED.				TEST # MRC 1102/1	
ROOT CAUSE/AMPLIFICATION H1				STEP # 1.e	
SYSTEM LEVEL IMPACT					
PART NO.	NOMENCLATURE	QTY	NSN	COST	
FIRST CONTACT HERBERT	RATE DCC	SECOND CONTACT WELLS	RATE LT	PHONE	
BLUEPRINTS, TECH MANUALS, PLANS, ETC.				ON BOARD YES NO	
ASSESSOR / ACT / TECH ID# SPORT 221/ A. DAVIS/ HUGHES, CDI			TD	TL	LOGISTICIAN TSP

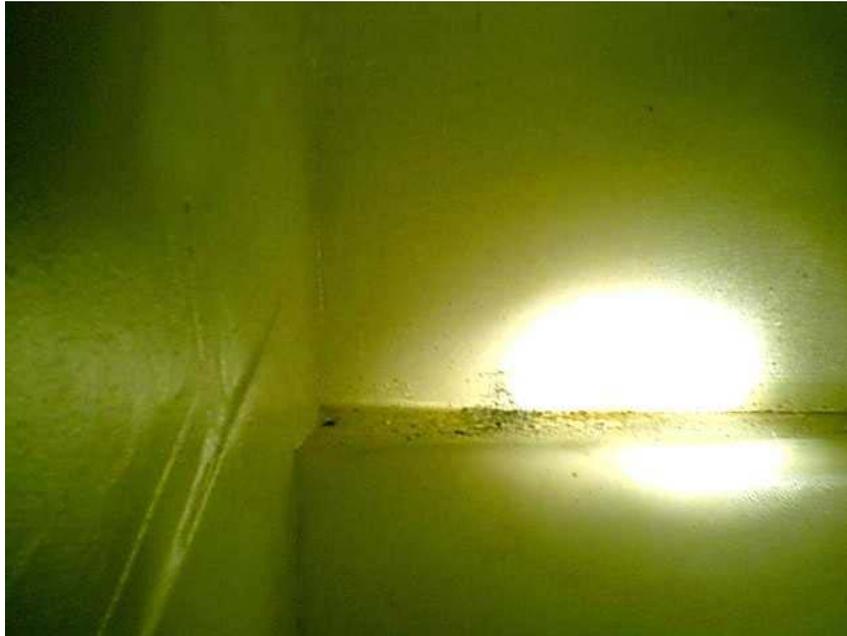
Photo 87: SALT ENCRUSTED LONGITUDINAL No.5
FROM OVERHEAD AND SHELL INSULATION,
FRAME 368 STBD SIDE LOOKING OUTBOARD

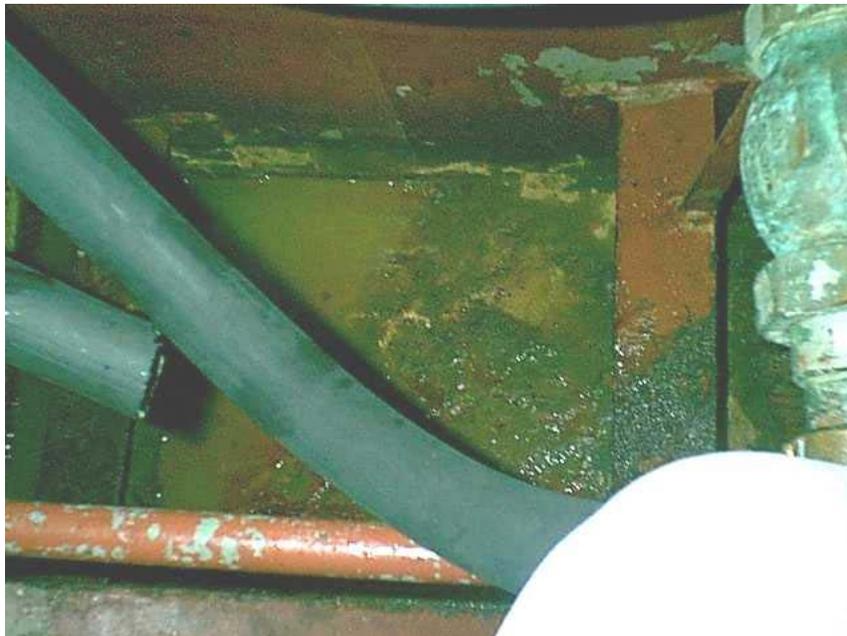
Photo 88: INBOARD FORWARD BILGE AREA, FRAME
368, LOOKING DOWN/FORWARD
