USS ELROD (FFG-55)

SHELL CONDITION ASSESSMENT SURVEY INTERIOR AREAS

5/9/01 – 5/18/01

**PREPARED BY
SUPSHIP PORTSMOUTH
05/25/01**

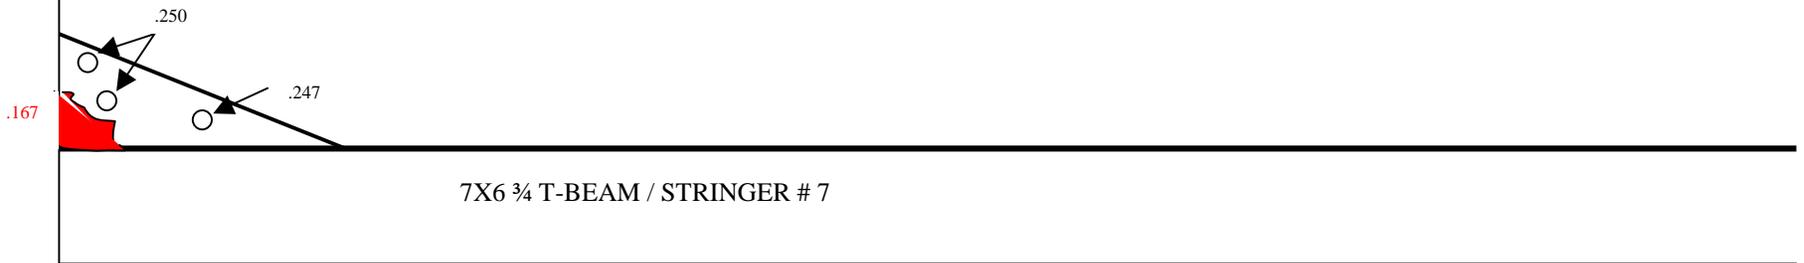
USS ELROD FFG 55
AUXILARY MACHINERY ROOM #1
(5-180-0-E) PORT SIDE LOOKING
INBOARD.

LOCATION	AREA	RESULTS
5-180-0-E AMR 1	PORT, GUSSET ON STRINGER (7) AT BHD (180).	FAILED U/T READING AT .167, WHEREAS THE MINIMUM IS .213 FOR .250 PLATE.
5-180-0-E AMR 1	PORT, STRINGER (9) AND SURROUNDING AREA. FROM WF (196) TO BHD (204).	APPROX 30 SF OF SURFACE RUST AND PAINT SEPARATION.
5-180-0-E AMR 1	PORT SIDE OF CENTER LINE, UNDER SALT WATER STRAINER AND PUMP NO. 1	APPROX 40 SF OF SURFACE RUST AND PAINT SEPARATION.
5-51-0-Q EDUCTOR ROOM.	STBD, STRINGER (1), AND ENTIRE BILGE AREA.	WEB OF STRINGER (1) IS THIN WITH RANDOM U/T READING AT .104, .181 & .197. VERTICAL STIFFENERS FROM KEEL TO STRINGER (2), APPROX 5' ARE THIN AND HOLED. APPROX 50 SF OF BILGE AREA HAS SURFACE RUST AND PAINT SEPARATION.
4-172-1-E FIRE PUMP ROOM.	ENTIRE BILGE AREA AND FOUNDATION UNDER FIRE PUMP.	APPROX 80 SF OF SURFACE RUST AND PAINT SEPARATION.
4-160-0-Q CHT RM	PORT WF (164) TO BHD (180) THE UNION ON THE CHECK VALVE. APPROX 8" FROM BHD (180) AND SURROUNDING AREA.	UNION IS LEAKING HUMAN WASTE. ALL STRINGERS BELOW AND BILGE POCKET ARE FULL OF WATER AND HUMAN WASTE. APPROX 60 SF OF SATURATED LAGGING SURFACE RUST AND PAINT SEPARATION.

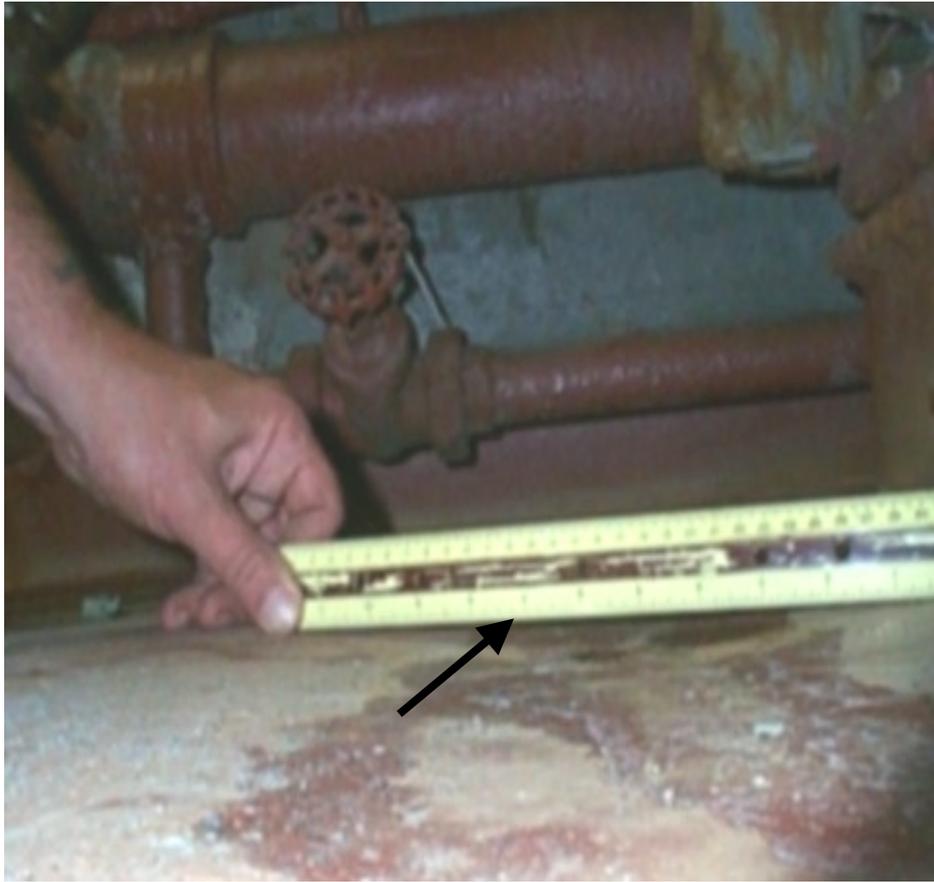
A/C MACHINERY ROOM (3-84-0-E)

3-140-1-L STORAGE ROOM IN P-WAY	STBD, FIRST AND SECOND STRINGERS FROM DECK.	APPROX 20 SF OF SATURATED LAGGING, SURFACE RUST AND PAINT SEPARATION.
3-84-0-E A/C MACHINERY ROOM	PORT, TANK TOP/DECK AT BHD (100) BEHIND/UNDERNEATH AIRCONDITIONING CONDENSER.	TANK TOP IS BUCKLING, RANDOM U/T READINGS BEHIND AND PORT SIDE WERE BELOW THE MINIMUM DESIRABLE THICKNESS OF .213 AT .127, .209 AND .204 AREA BEHIND THE CONDENSER WAS UNACCESSABLE FOR FURTHER U/T READINGS.

(Bottom) Port side of center. Arrow indicates buckling in tank top.
