# **USS ELROD (FFG-55)**

## **SPECIAL U/T SURVEY**

### **MAIN ENGINE ROOM (5-250-0-E)**

**AUGUST 28, 2002**

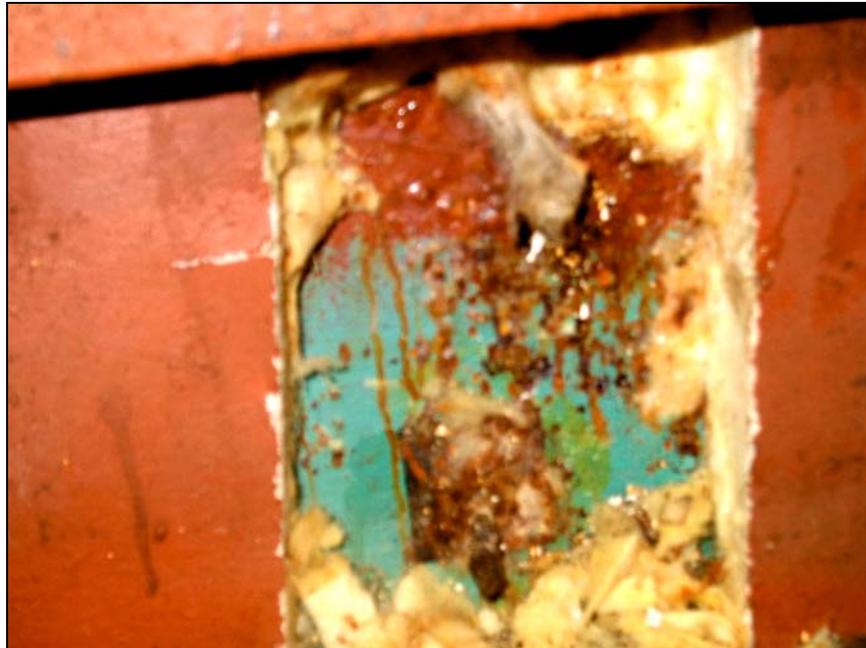
STRINGER (11) AT FRAME (258) PORT SIDE OUTBOARD OF THE ACCESS TRUNK.  
NOTE THE CORROSION ON THE SHELL WHERE THE INSULATION WAS REMOVED  
IN ORDER TO TAKE U/T READINGS.
