# SEMAT I

## USS SIMPSON (FFG 56)

### SHELL CONDITION ASSESSMENT SURVEY INTERIOR AREAS

6/1/01 TO 6/8/01

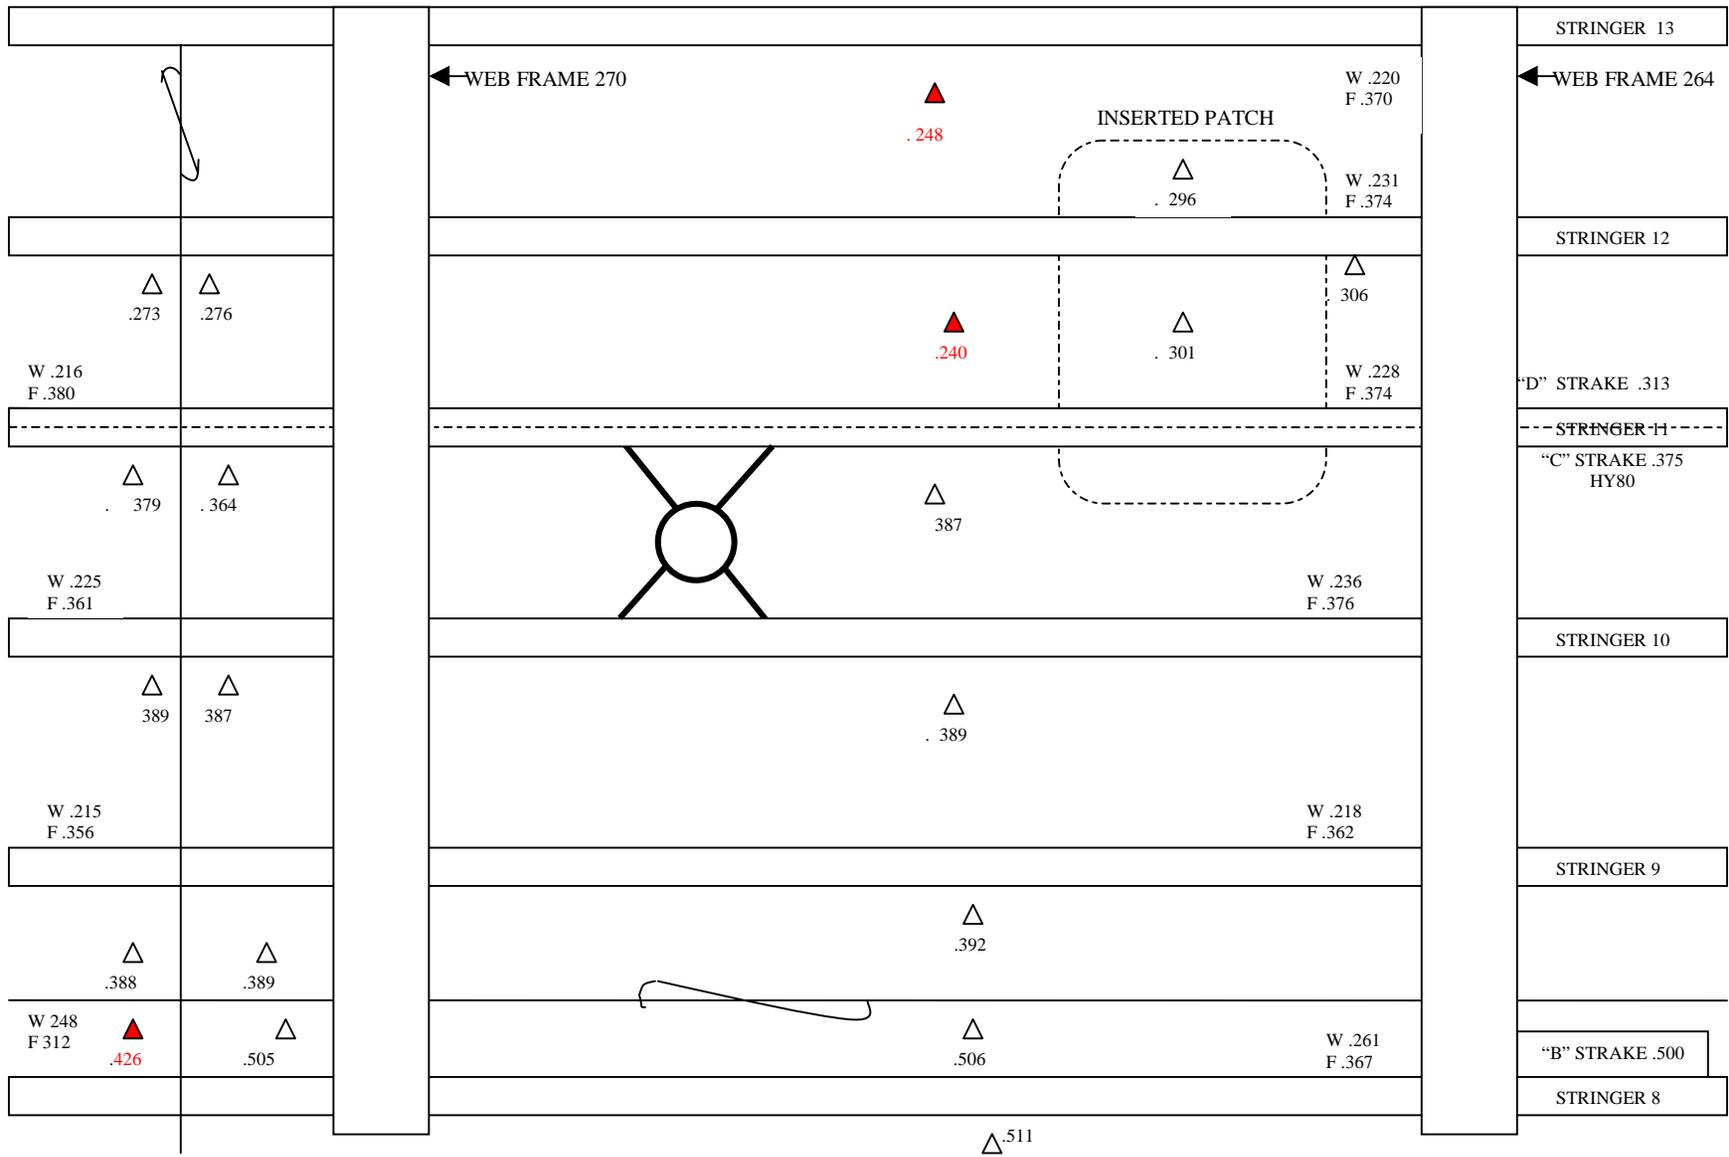
USS SIMPSON (FFG 56)  
 AUXILIARY ROOM #3  
 (5-292-0-E) PORT SIDE

PORT SIDE ABOVE STRINGER 12  
AREA RECOMMENDED FOR PRESERVATION.
