**USS SPRUANCE (DD 963)  
SHELL CONDITION ASSESSMENT SURVEY  
INTERIOR AREAS  
6/4/01 – 6/15/01**

**PREPARED BY:  
SUPSHIP PORTSMOUTH  
6/28/01**

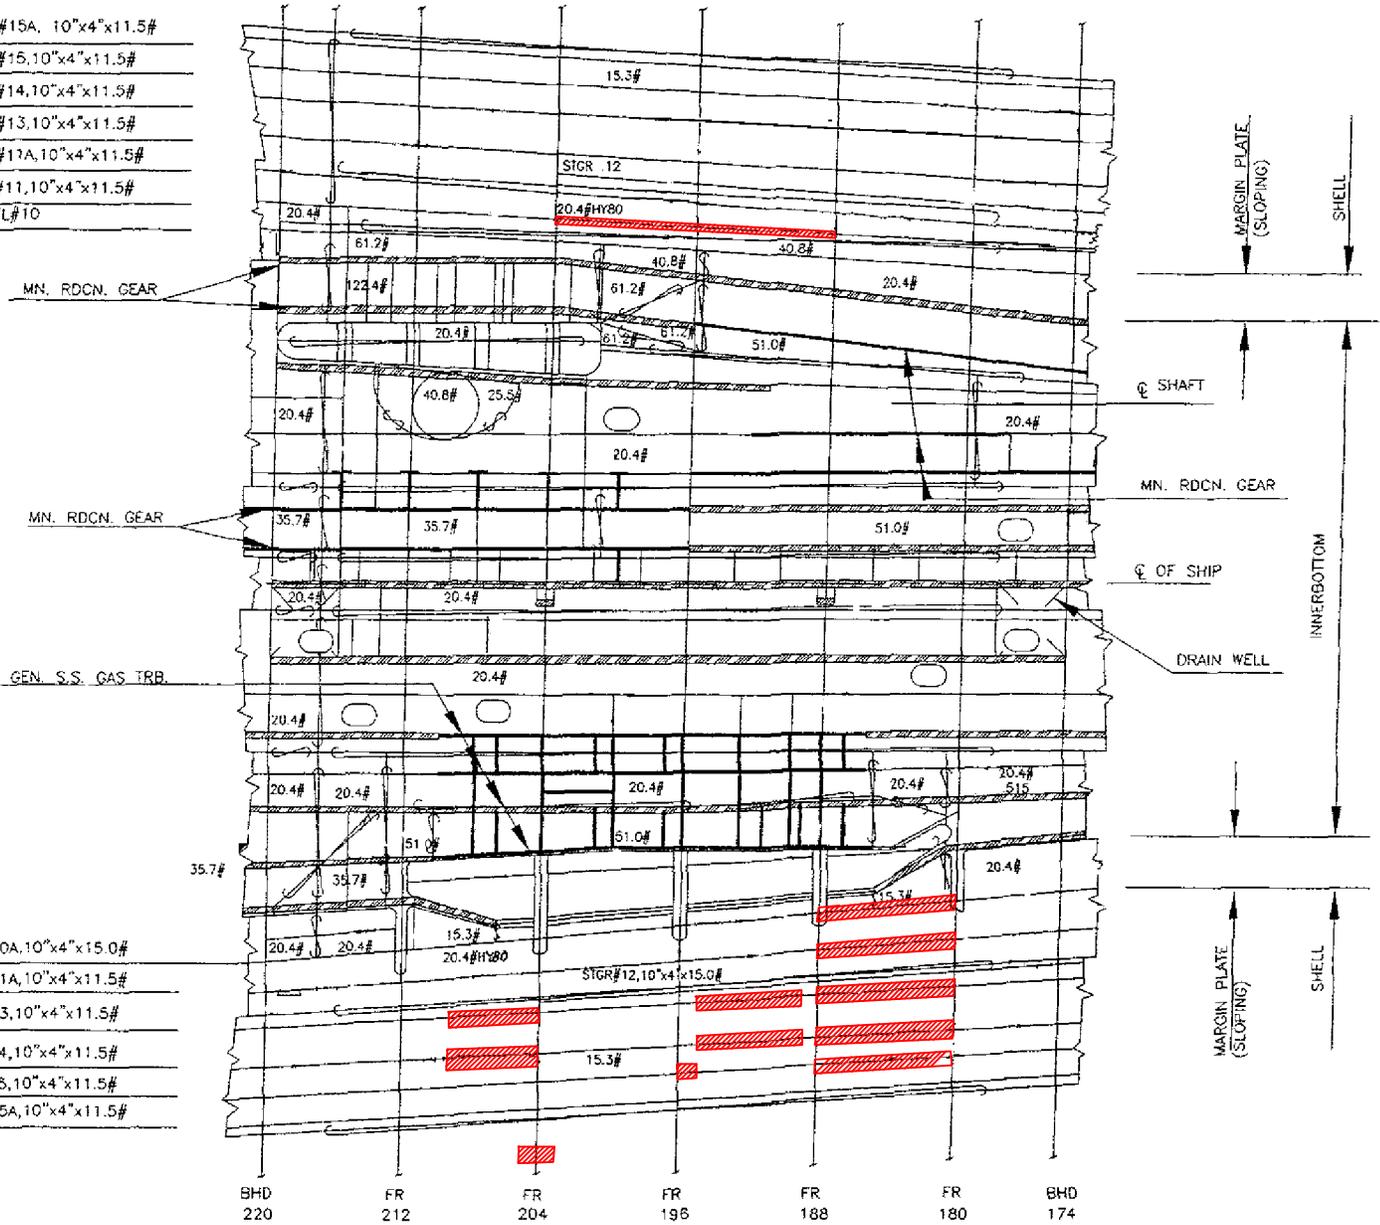
PLAN  
SHELL & INNERBOTTOM PLATING  
ENGINE ROOM #1 / 5174OE

1. THE ESCAPE TRUNK AFT BULKHEAD AT FR 177 IS HOLED IN WAY OF THE 2ND AND 3RD LONGITUDINAL STIFFENERS ABOVE THE TANK TOP. APPROXIMATELY 6" DIAMETER AT EACH JOINT. PROBABLE CAUSE: FIRE STATION AT FR 182 AND MASKER AIR COOLER OVBD AT FR 184.

DD 963  
SHELL ASSESSMENT SURVEY  
ENGINE ROOM NO. 1, 5-174-0-E

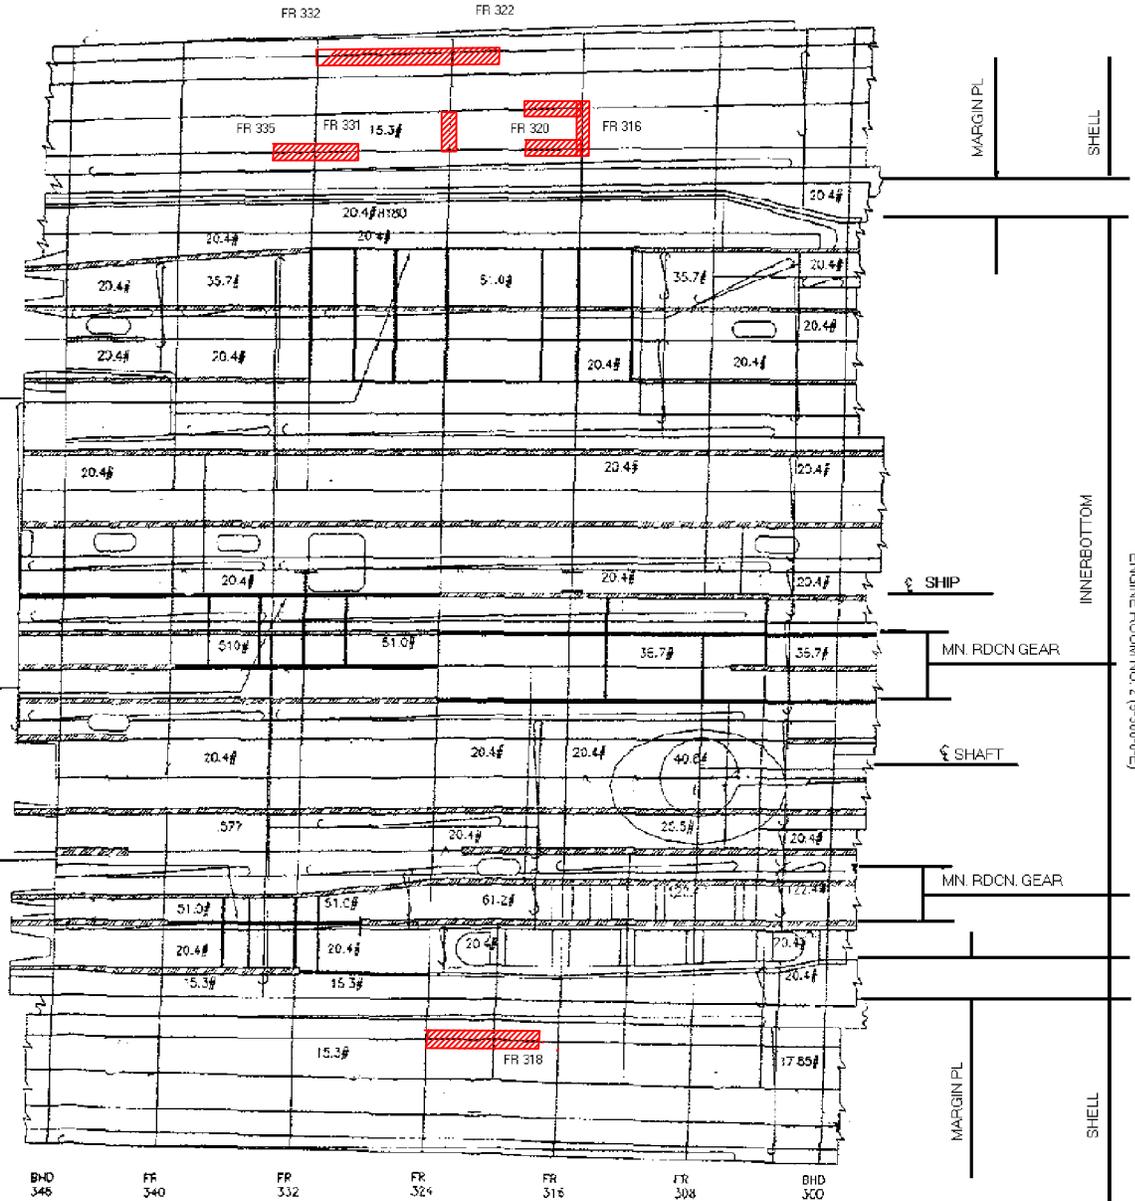
PLAN  
 SHELL & INNERBOTTOM PLATING  
 ENGINE ROOM #2 (5-300-0-E)

AMR NO. 2 5-260-01-E	YES	1' BELOW OVHD		06/14/01	YES	CORROSION AROUND THE ESCAPE TRUNK AT FR 300	YES	UNSAT	
MER NO.2 5-300-0-E	YES	1' BELOW I/L OVHD		06/14/01	YES	SEE ATTACHED LIST. ACCOUSTIC TILE ON TANKTOP IS TRAPPING MOISTURE AND CAUSING CORROSION	YES	UNSAT	(3)

DD 983  
 SHELL ASSESSMENT SURVEY  
 ENGINE ROOM NO. 2 (5-300-0-E)
