# **USS ARTHUR W RADFORD (DD-968)**

## **SEMAT II SHELL CONDITION ASSESSMENT SURVEY INTERIOR AREAS**

**01/28/02 TO 02/08/02**

Q.E.D. Systems, Inc. was tasked by the Supervisor of Shipbuilding Conversion and Repair, USN (SPORT) Portsmouth, VA to conduct an Ultrasonic Thickness (U/T) Survey of specific locations on board USS ARTHUR W RADFORD (DD-968) during the period of 28 January 2002 – February 8 2002.

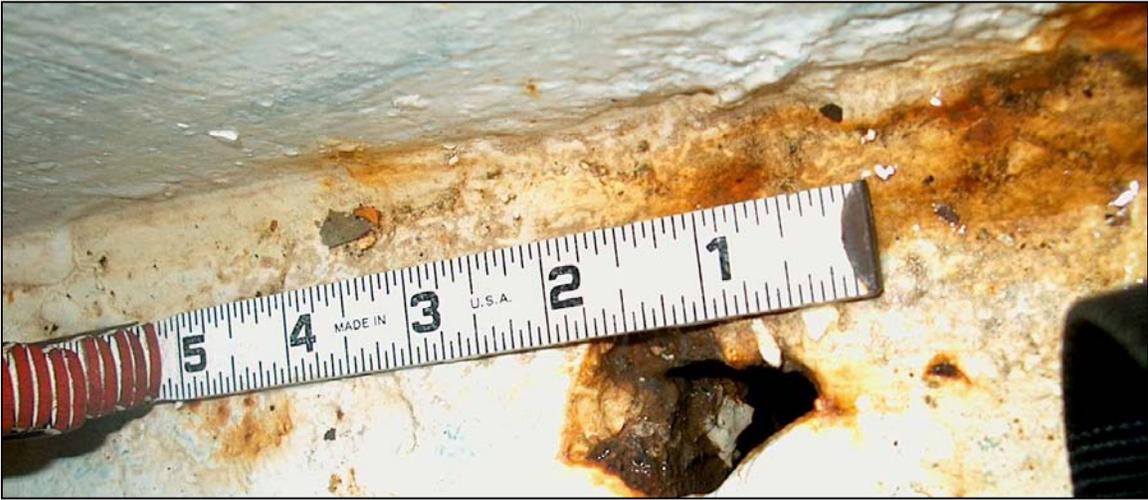
**USS ARTHUR W RADFORD (DD-968)**  
**MAIN ENGINE ROOM NO. 2 (5-300-0-E)**  
**PORT SIDE**

4<sup>TH</sup> STRINGER FROM MARGIN PLATE, AFT OF WEB FRAME (308).

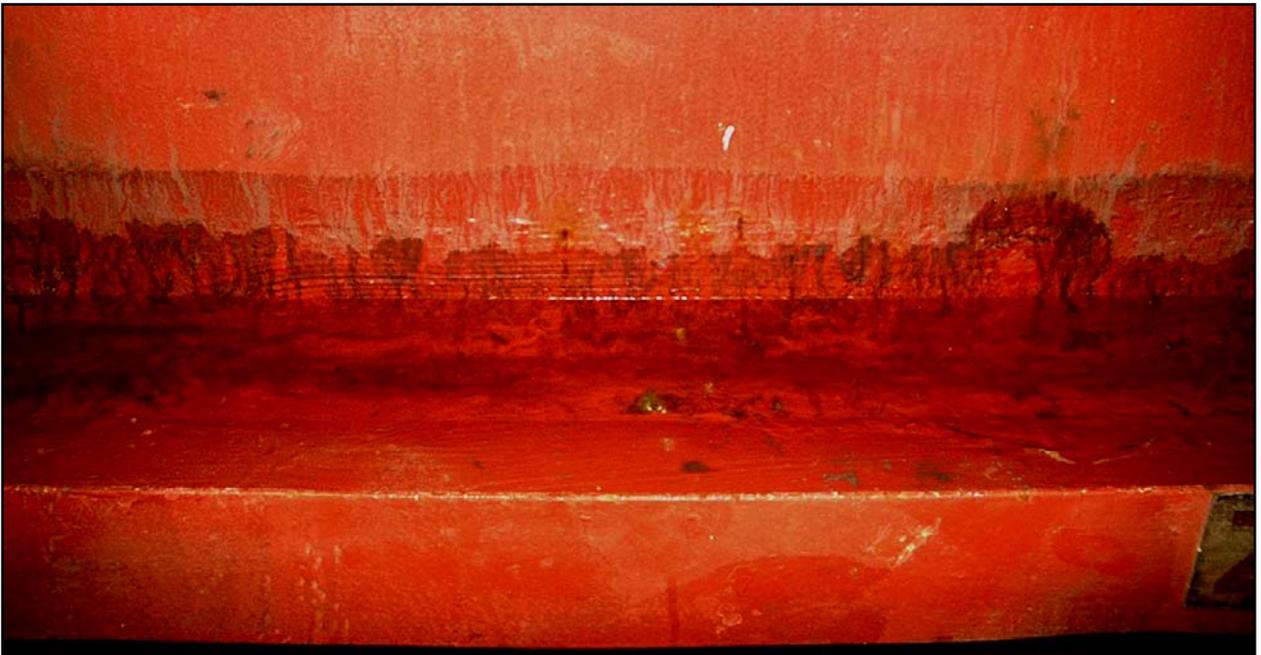
**USS ARTHUR W RADFORD (DD-968)**  
**AUXILIARY MACHINERY ROOM NO. 2 (5-260-01-E)**  
**PORT SIDE**

ENTIRE BILGE AREA, 1<sup>ST</sup> AND 2<sup>ND</sup> STRINGERS HAVE STANDING WATER, CORROSION AND PAINT SEPARATION FROM BHD (300) TO BHD (260)

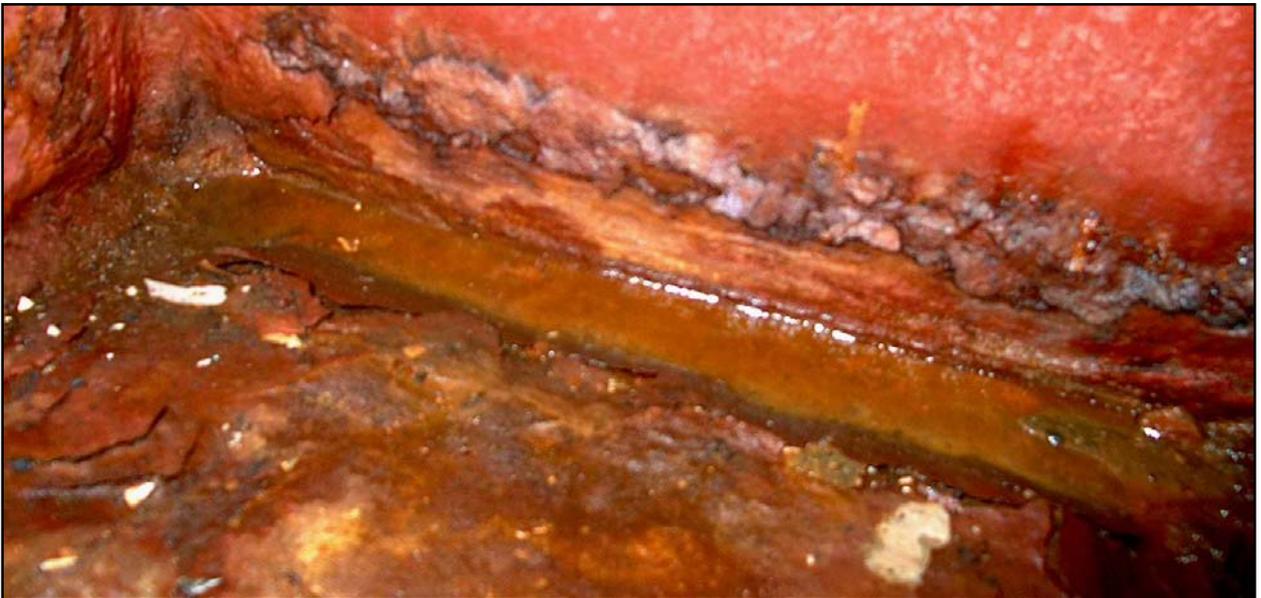
CORROSION WAS FOUND ON LOWER PORTION OF BHD (260) BELOW THE SHAFT.

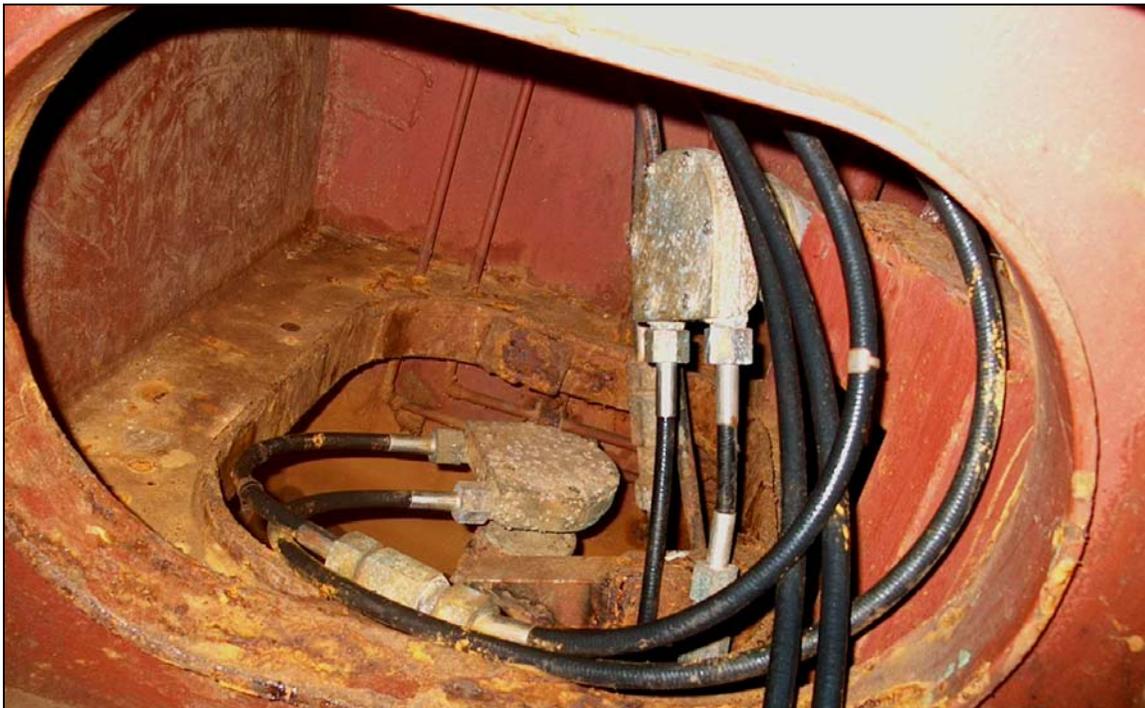
CORROSION IN EDUCTOR SPACE.

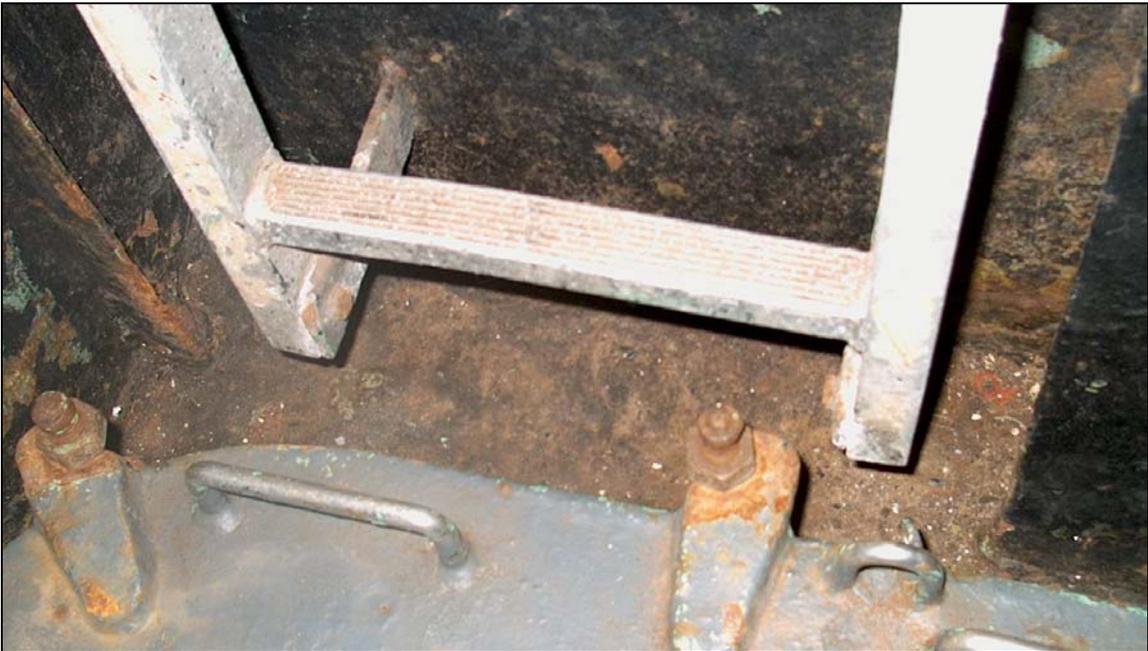
CORROSION ON DECK SURROUNDING (WTH 2-504-1) ENTRANCE TO LOWER REEL  
STOREROOM (6-488-3-A)
