== USS ESTOCIN (FFG-15) ==
SEMAT SHELL CONDITION ASSESSMENT
SURVEY
INTERIOR AREAS

PREPARED BY
SUPERVISOR OF SHIPBUILDING CONVERSION
AND
REPAIR
PORTSMOUTH, VIRGINIA
3/13/02 TO 3/22/02

SHELL CONDITION ASSESSMENT SURVEY INTERIOR AREAS TABLE OF CONTENTS

A SEMAT UNDERWATER HULL AND SUPPORTING STRUCTURE SURVEY OF INTERIOR AREAS WAS CONDUCTED ON BOARD **USS ESTOCIN (FFG-15)** FROM 03/13/02 TO 03/22/02 AT NAVAL STATION MAYPORT, JACKSONVILLE FLORIDA.

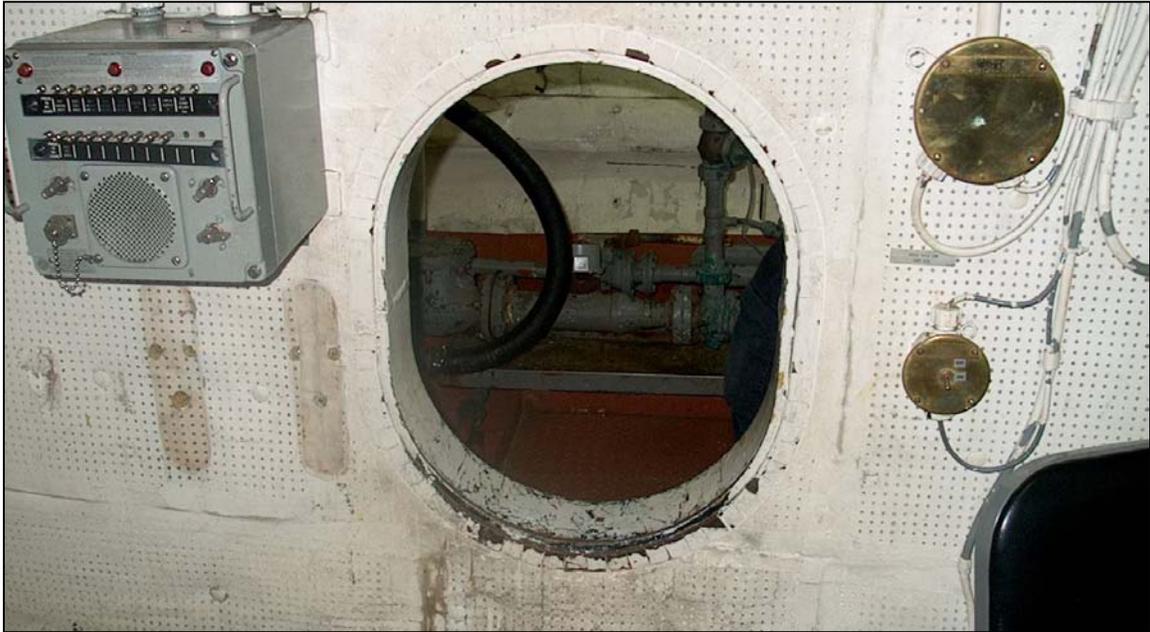
STBD SIDE EDUCTOR SPACE AT BHD (368)

| DISCREPANCY DESCRIPTION: PER SEMAT II UNDERWATER HULL ASSESSMENT: STEERING GEAR ROOM (5-368-01-E), PORT AND STARBOARD EDUCTOR SPACES HAVE APPROXIMATELY 140 SF OF HEAVY PAINT SEPARATION AND RUST. | | | | | | | |

| RECOMMENDED REPAIRS: RECOMMEND SHIPS FORCE POWER CLEAN APPROXIMATELY 140 SF OF AREA, PRIME AND PAINT USING EURO-NAVY COATING. | | | | | | | |

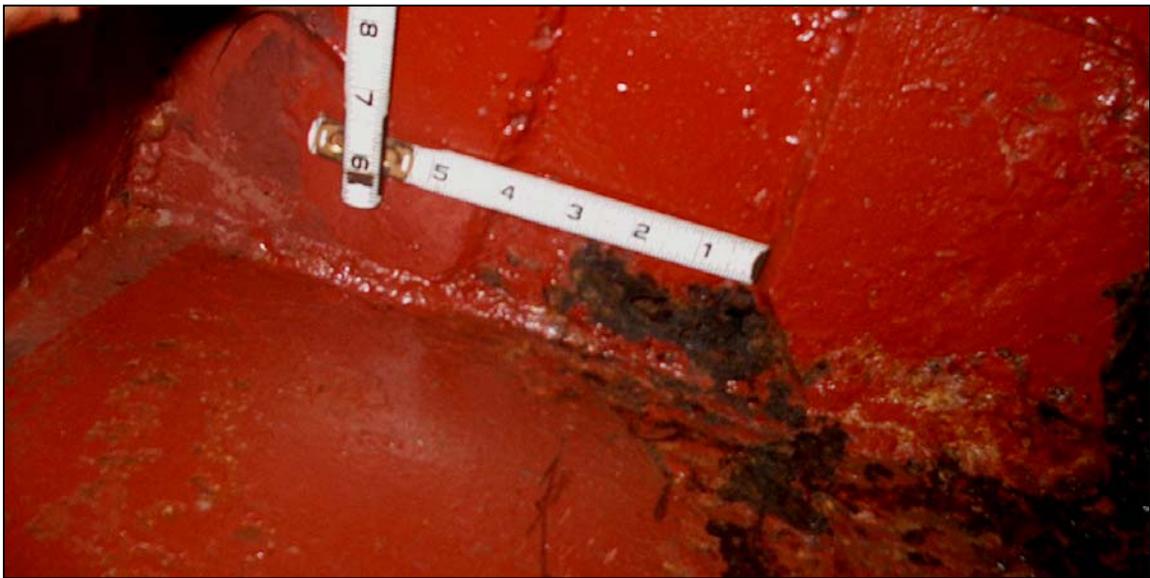
| 6 X 4 STRINGER AT DECK LEVEL UNDER POWER PANEL. (3-319-2) IS SEVERELY DETERIORATED. THE SHELL IS THINNING IN SEVERAL PLACES ALONG THIS STRINGER AND THE ONE ABOVE. WEB FRAME (316) IS HOLED IN SEVERAL PLACES. THE HULL INSULATION IS TRAPPING WATER AND HIDING CORROSION. | | | | | | |

LARGE HOLE IN WEB FRAME (316)

| RECOMMEND REPAIR ACTIVITY REMOVE HULL INSULATION FROM DECK LEVEL UP APPROXIMATELY 5', FROM WEB FRAME (316) TO BHD (328). CUT OUT APPROXIMATELY 60 SF OF HULL FROM WELD SEAM ABOVE (7 X 6 T-BEAM) TO STRINGER ABOVE OVBD DISCHARGE FROM WEB FRAME (316) TO BHD (328), REPLACE WITH .313 OS. CUT OUT AND REPLACE APPROX 10' OF (6 X 4 T-BEAM). CUT OUT AND REPLACE LOWER 10" OF FRAME (316) FROM SIDE OF TANK (5-308-2-W) TO STRINGER BELOW OVBD DISCHARGE, REPLACE WITH .250 OS. PRIME AND PAINT, REPLACEMENT OF INSULATION IS NOT RECOMMENDED | | | | | | |

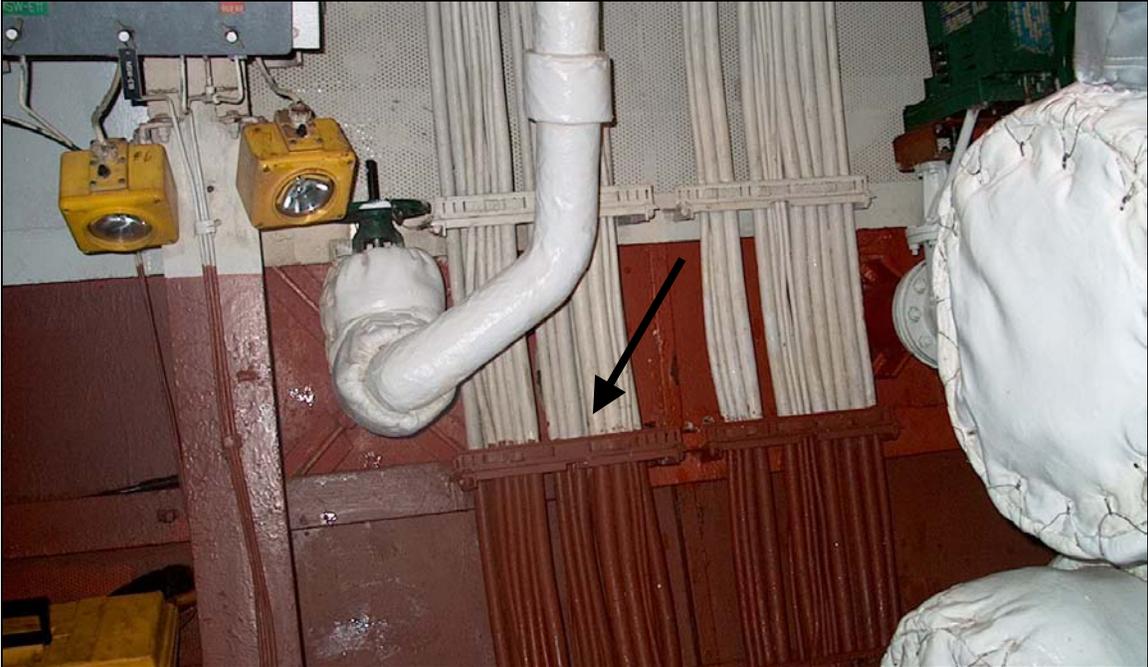
BETWEEN FRAMES (264-270) ARROW INDICATES LOCATION OF LOW U/T READINGS.

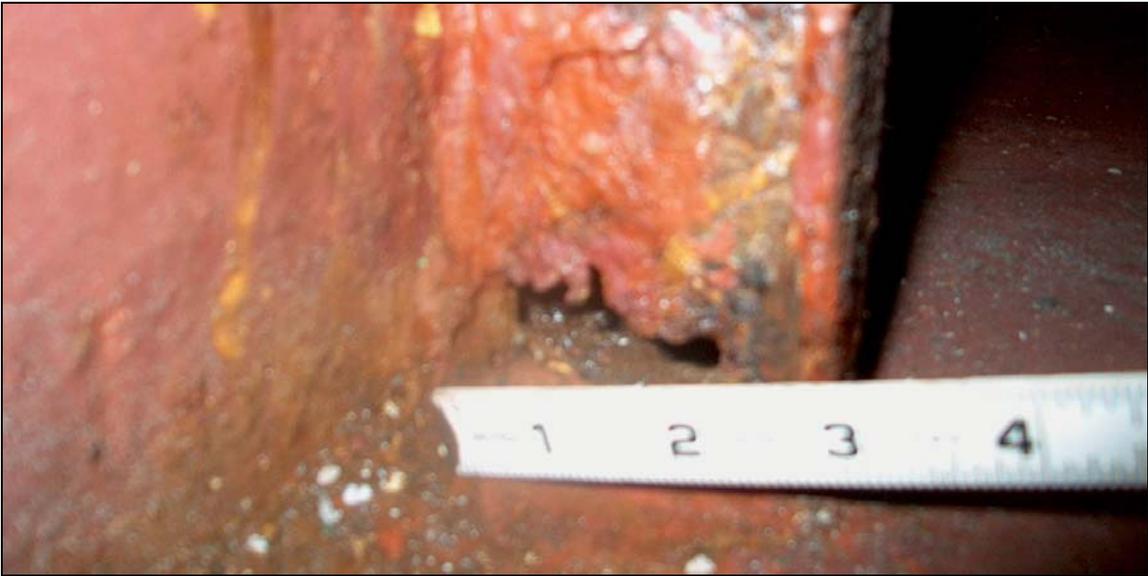
PORT SIDE, 3 X 2 VERTICAL STIFFENER

PORT SIDE, 3 X 2 VERTICAL STIFFENER. APPROXIMATELY 16 FT OF THESE STIFFENERS ARE CORRODED, PORT AND STARBOARD.

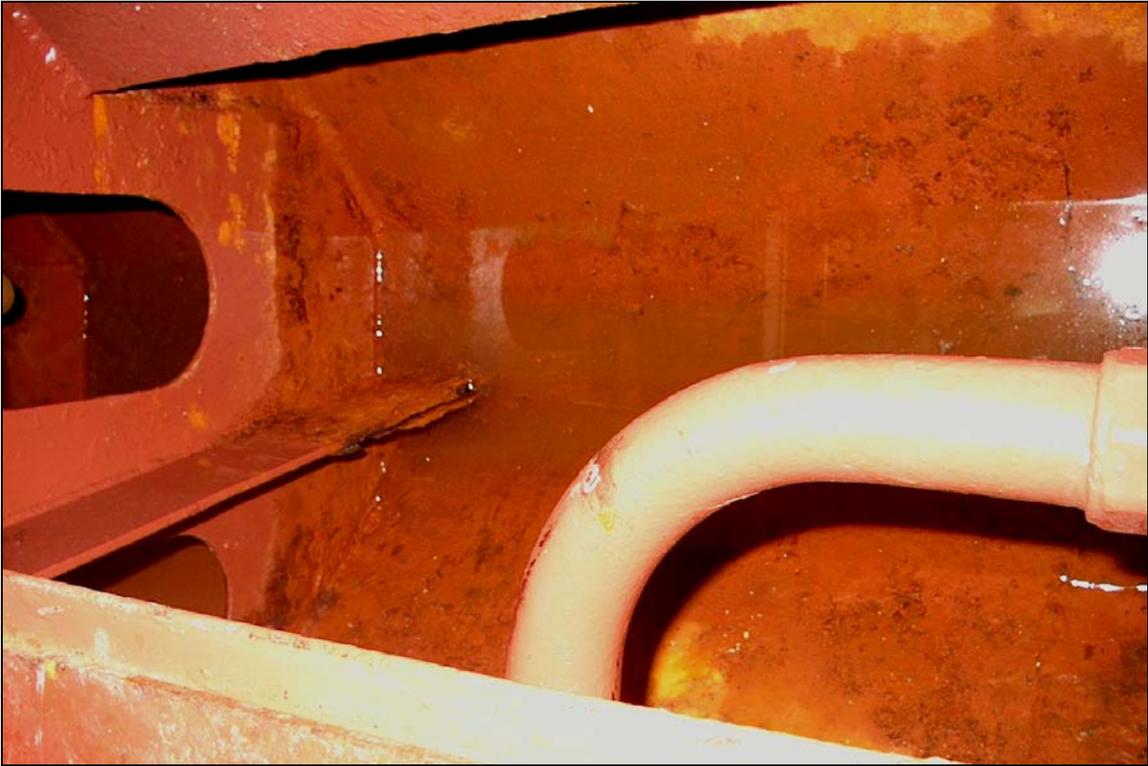
STARBOARD SIDE, BETWEEN POWER DISTRIBUTION PANELS AND BHD (108)

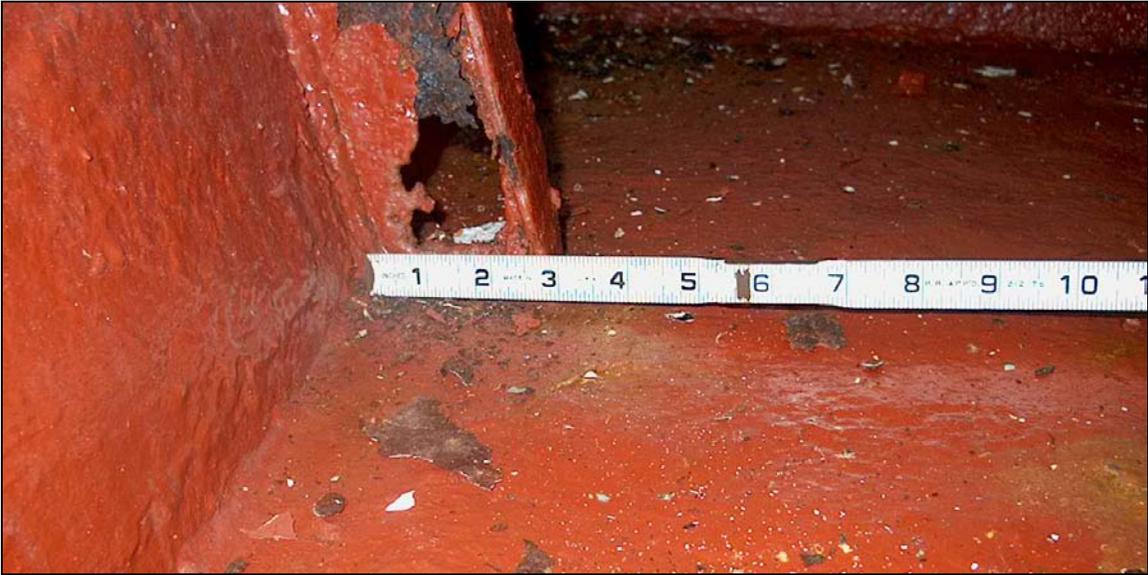
1ST STRINGER AT BHD (56).

1ST 3 X 2 VERTICAL STIFFENER FORWARD OF BHD (56)

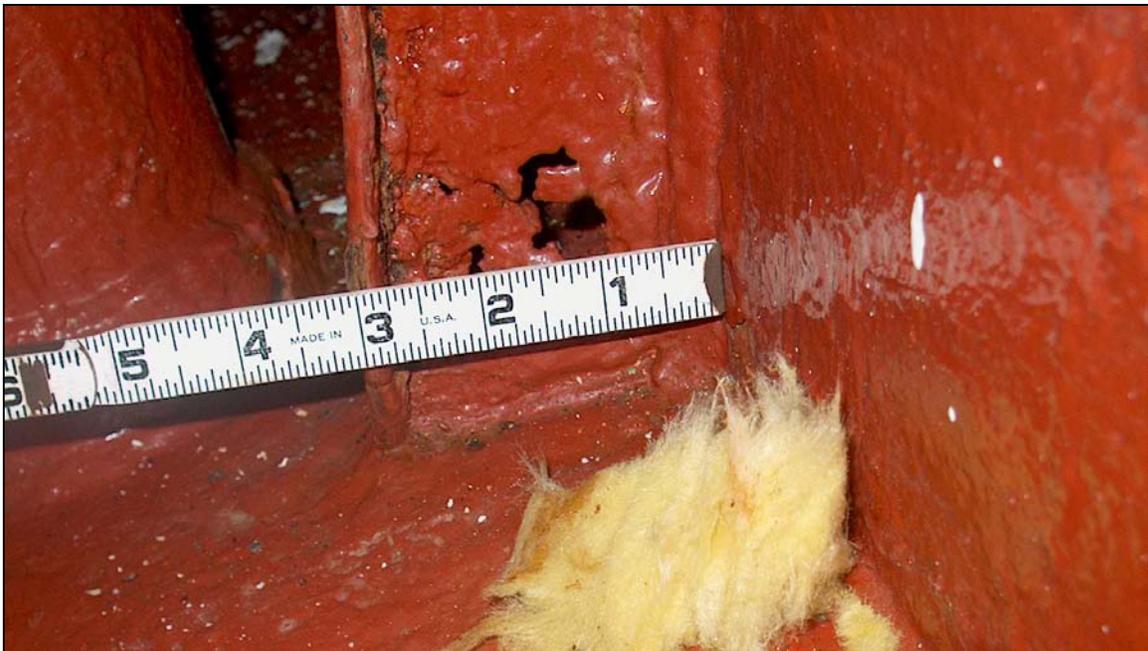
2ND VERTICAL STIFFENER FORWARD OF BHD (56)

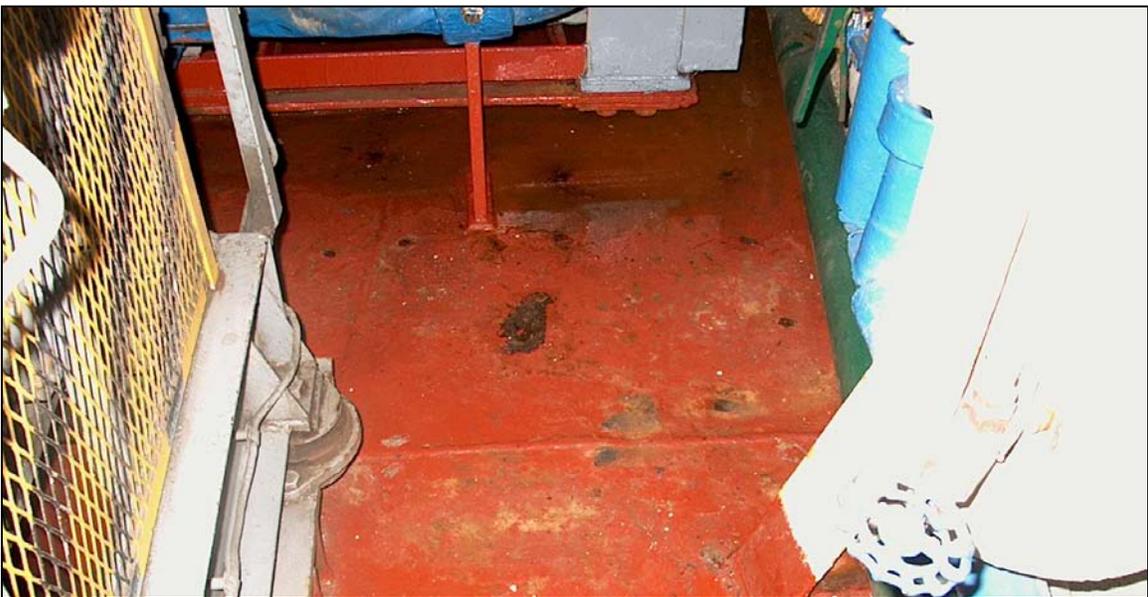
TANK TOP / DECK BETWEEN A/C COMPRESSOR AND A/C PLANT. LOW U/T READINGS WERE RECORDED IN THIS AREA.
